# Technical note

| <b>Project:</b> | Swansea Bay Campus | <b>Client:</b> | St Modwen Developments Ltd |
| <b>Subject:</b> | Rock Revetment Survey | | |
| <b>Date:</b> | 19 <sup>th</sup> August 2016 | | |

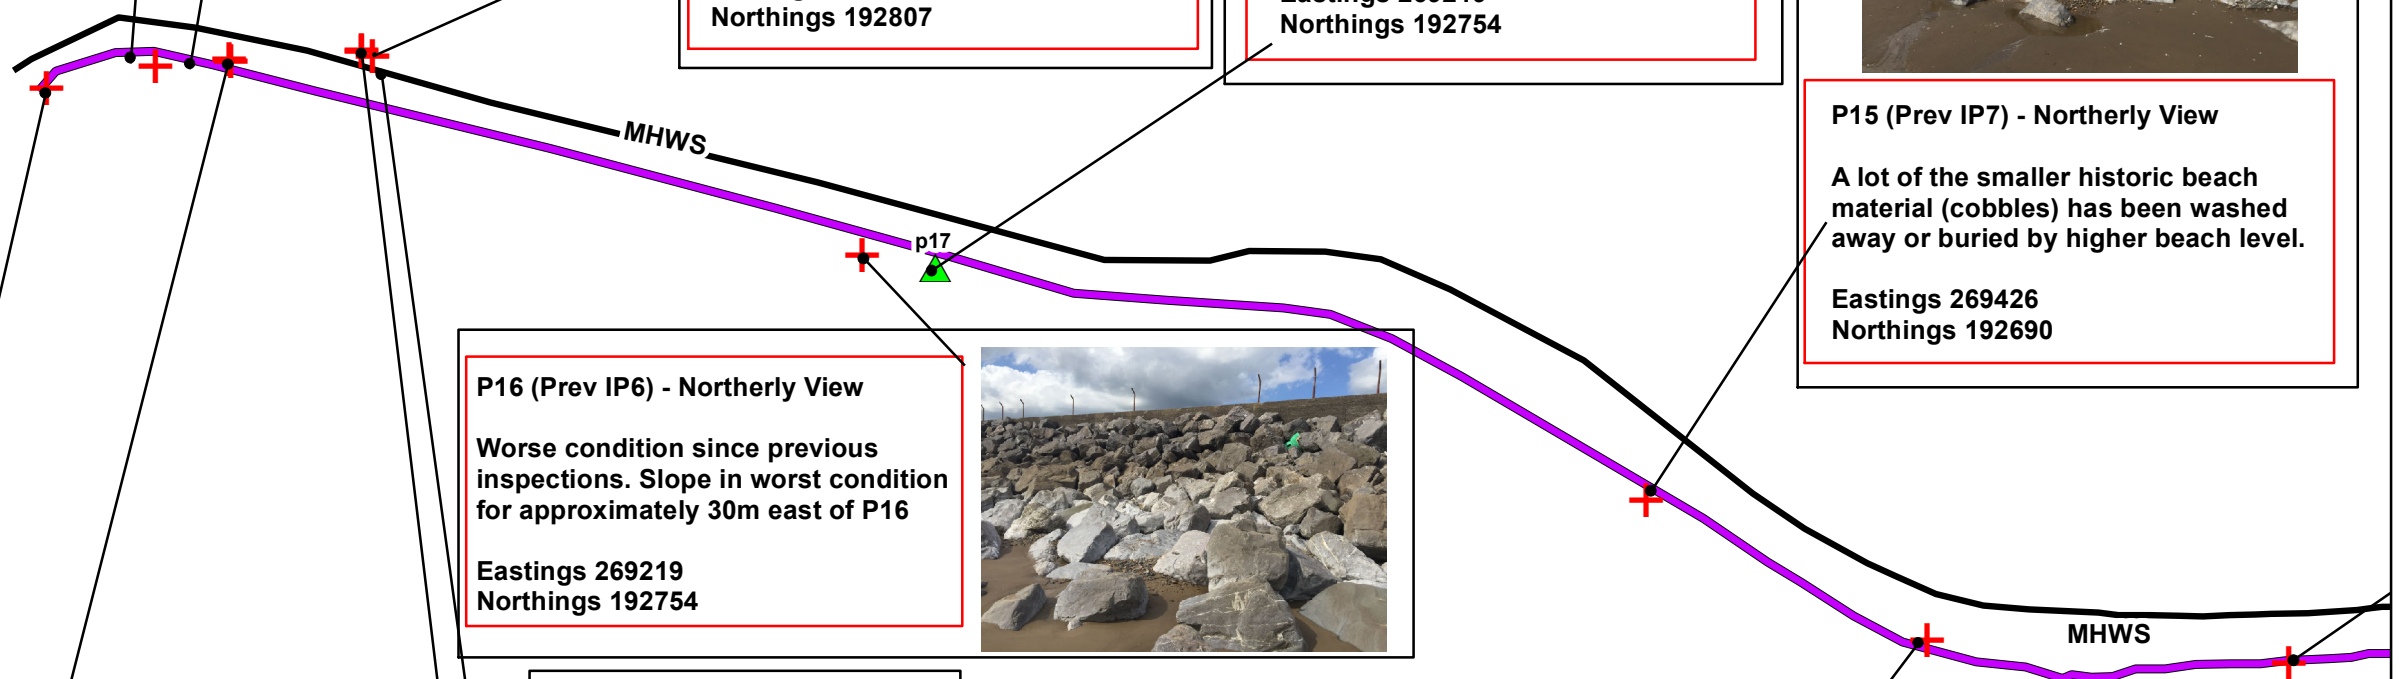
**P16 (Prev IP6) - Northerly View**

Worse condition since previous  
inspections. Slope in worst condition  
for approximately 30m east of P16

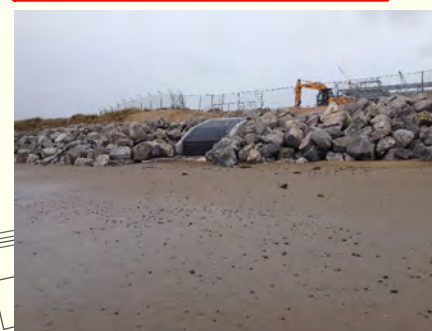
IP18 North Westerly View

Revetment has been formalised, voids previously evident have been filled.
