**Plaza, Port Talbot**

**HISTORIC BUILDING RECORDING**

(385)1902-GWP-A-2A-HBR-P00

Date: 06.01.20

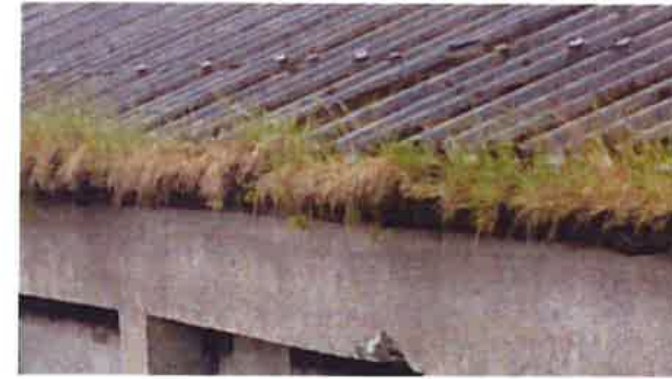
Close up of overgrowth (June 2017)

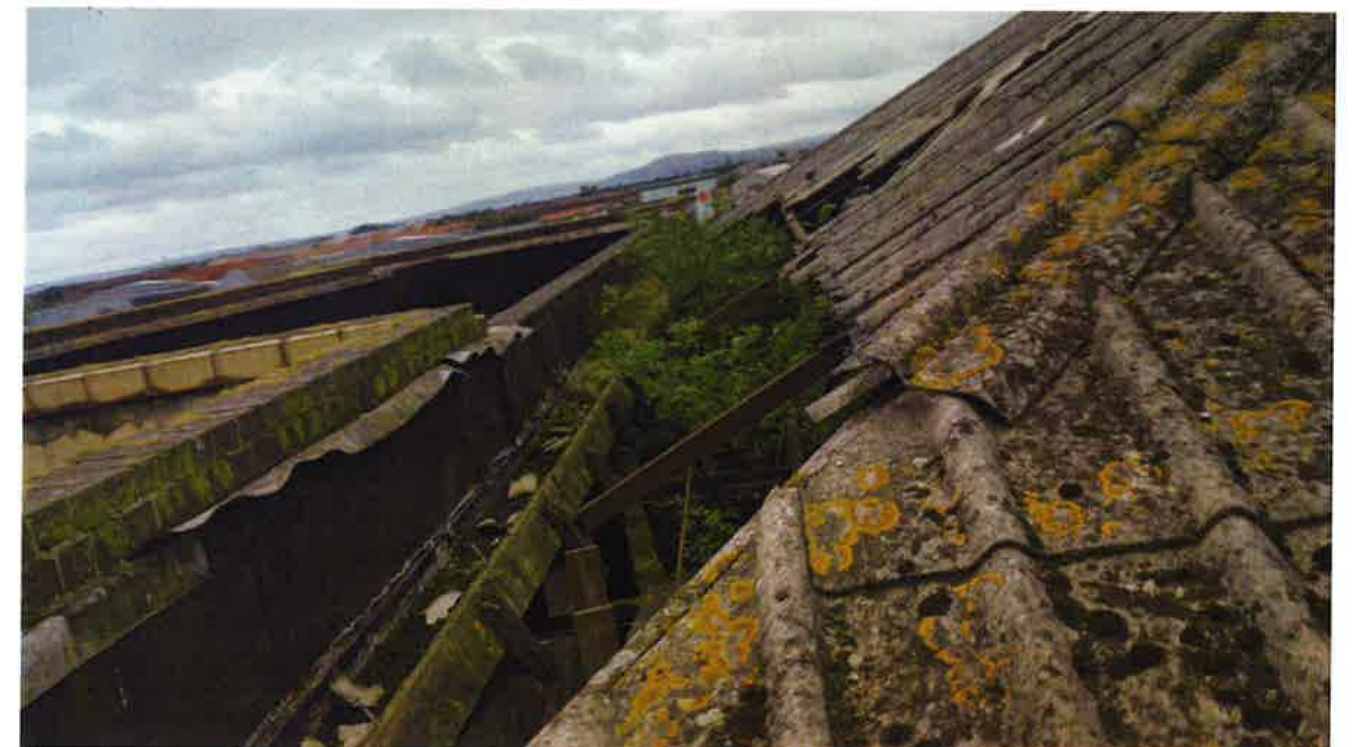
Broken section of asbestos cement roof sheeting, exposed steel trusses (rusted) to the elements (Photograph taken from MEWP July 2017)

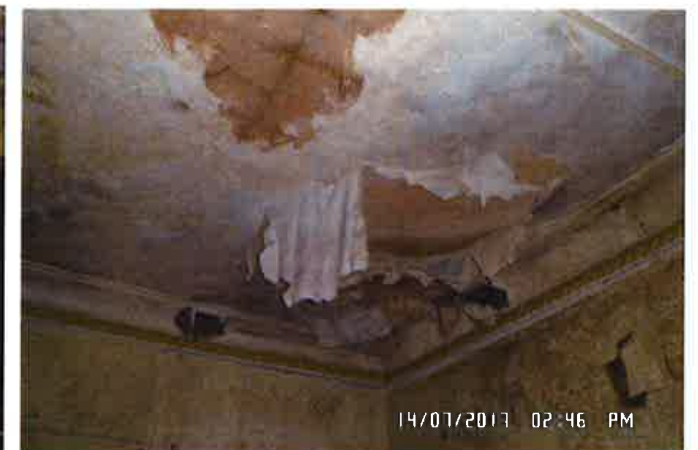
The paintwork to the soffit of the concrete slab, down stand beams and columns are peeling away badly in all locations. There is clearly standing water on the slab above as there are hairline cracks in the soffit with rust staining and damp areas. This area is clearly in a poor state of repair and has deteriorated further since 2012 with the majority of the feature cornicing breaking away from the ceiling. Refer to photographs below:

Cracked ceiling slab/damp, July 2017

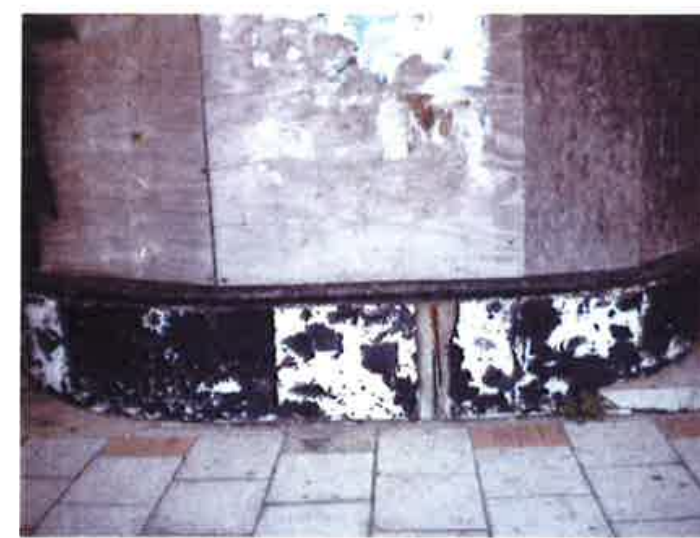
Cladding panels below window 2012

There are concrete cladding plinth units under the front window. The 2012 report only identified one as being badly spalled with reinforcement showing. The current inspection showed cracking to a few additional cladding panels which indicates ongoing dilapidation. Refer to photographs below:

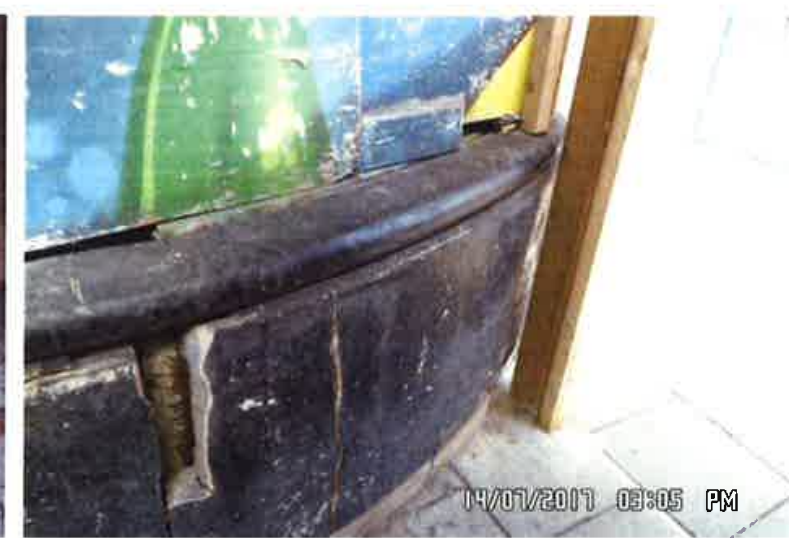
Additional cracking July 2017

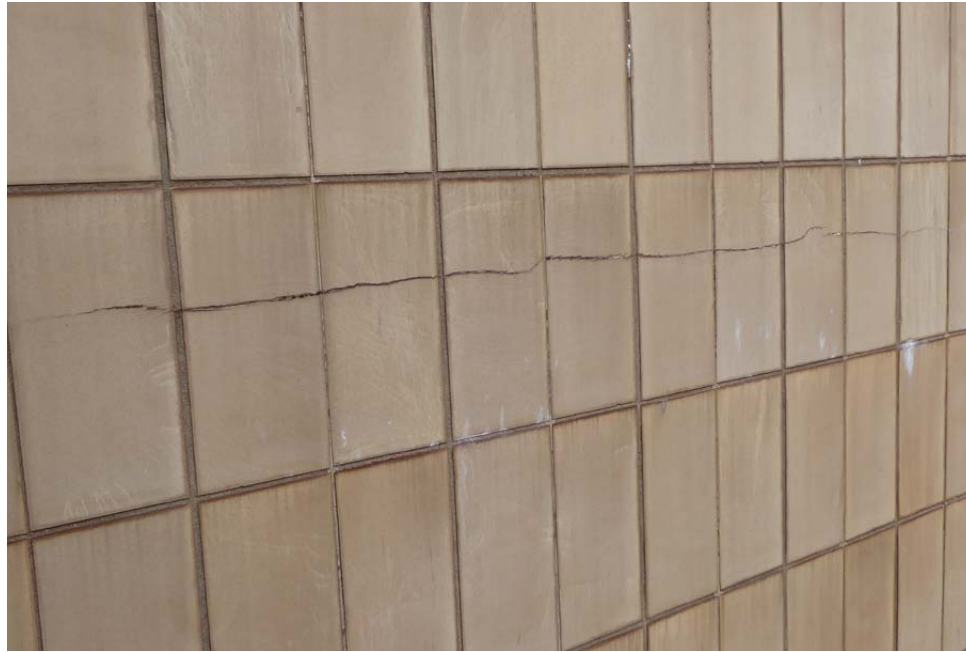
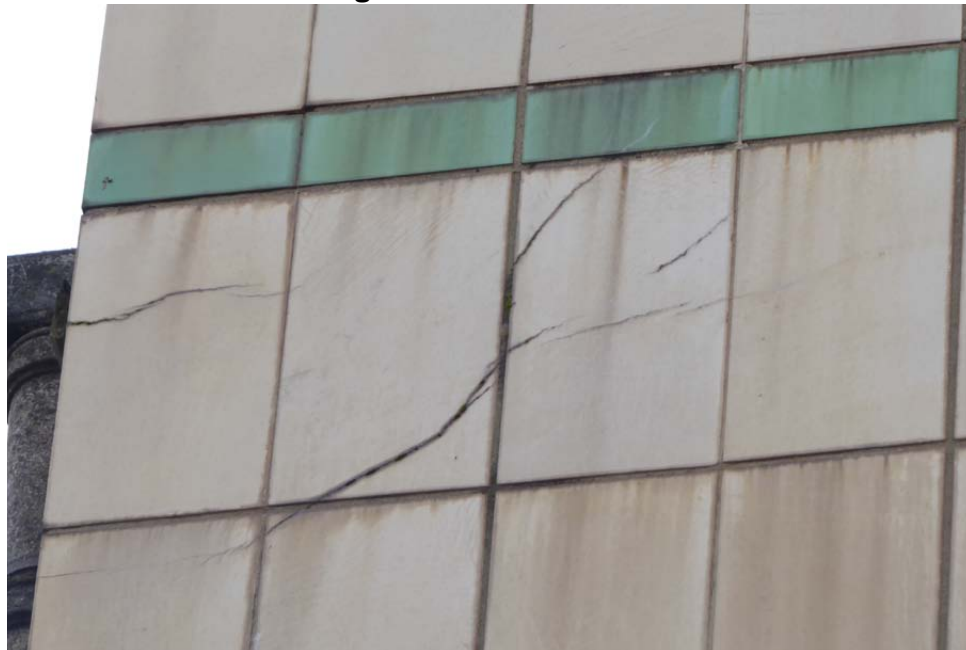
The façade feature tiles have a small area where a tile has fallen off and a clearly visible hairline crack in the same location which indicated the tiles are susceptible to de-bonding with water getting behind which could exasperate the situation. The tiles however are superficial and the structure behind should not be affected to any large extent.

**A Cracks in Faience Tiling**

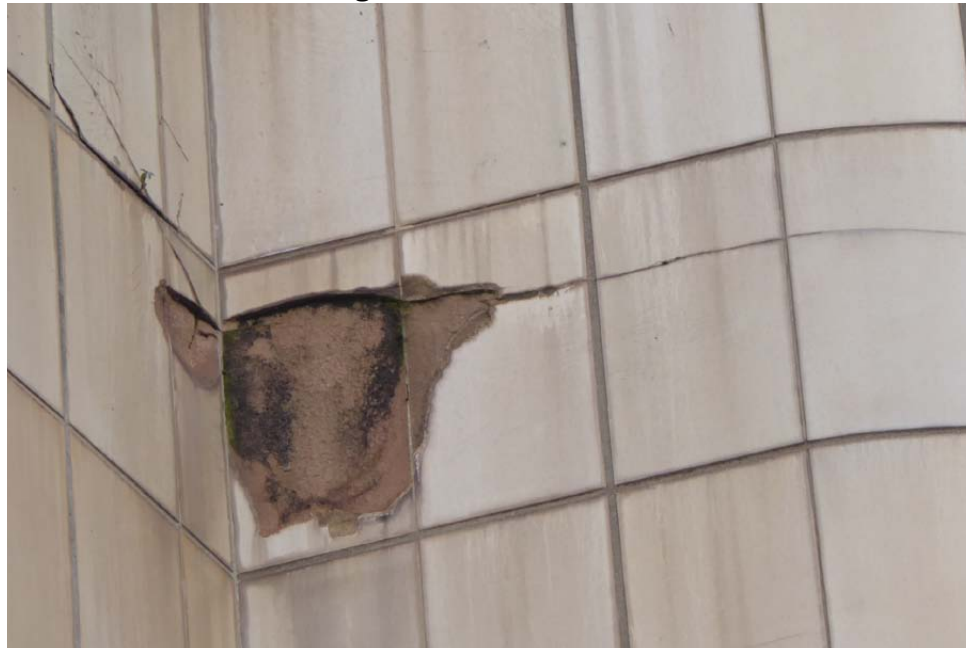
**B Faience Tiling probably needing replacement**

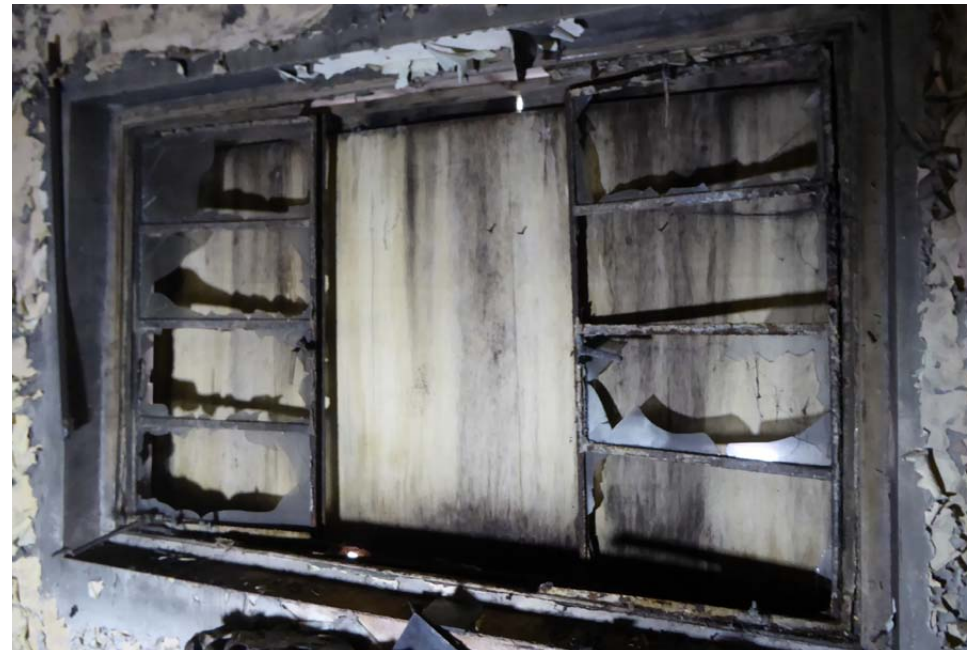
**D Crittall Window to be Replaced like-for-like - Window F8**

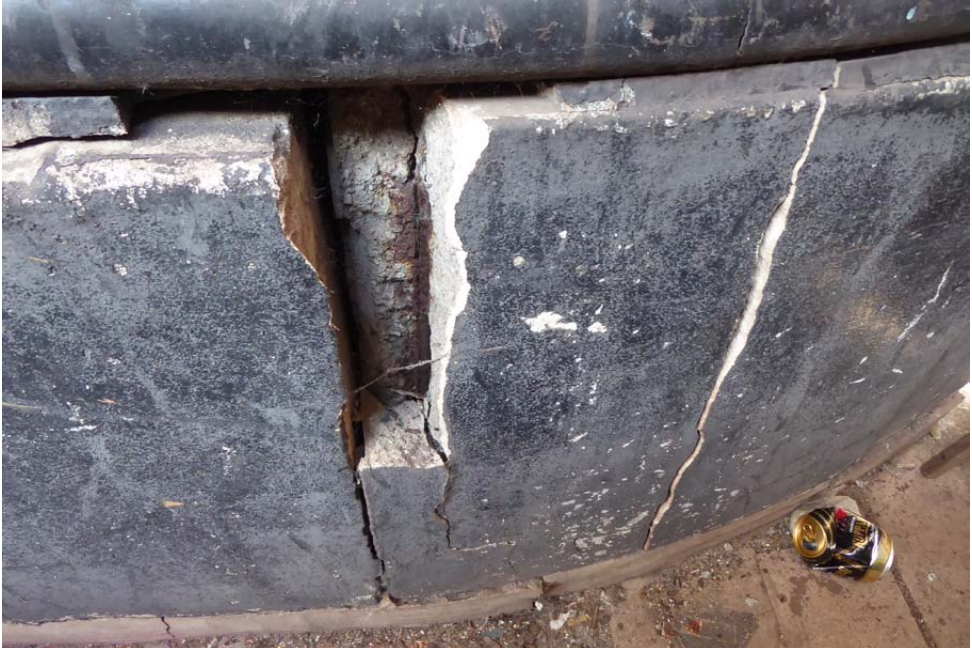
N Example of Damage to Masonry

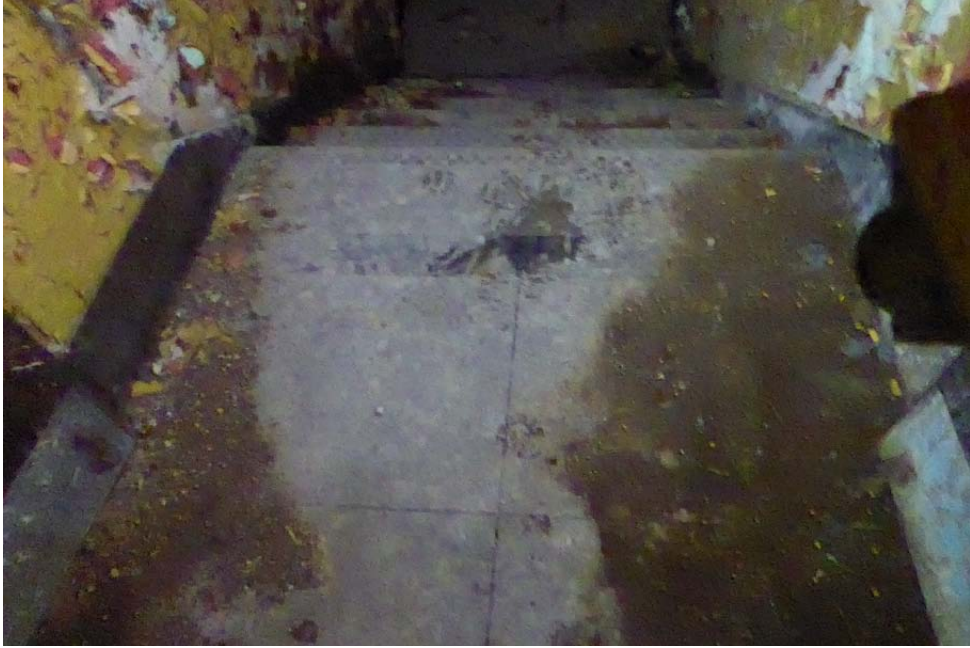
**V** Existing Steps to be Repaired

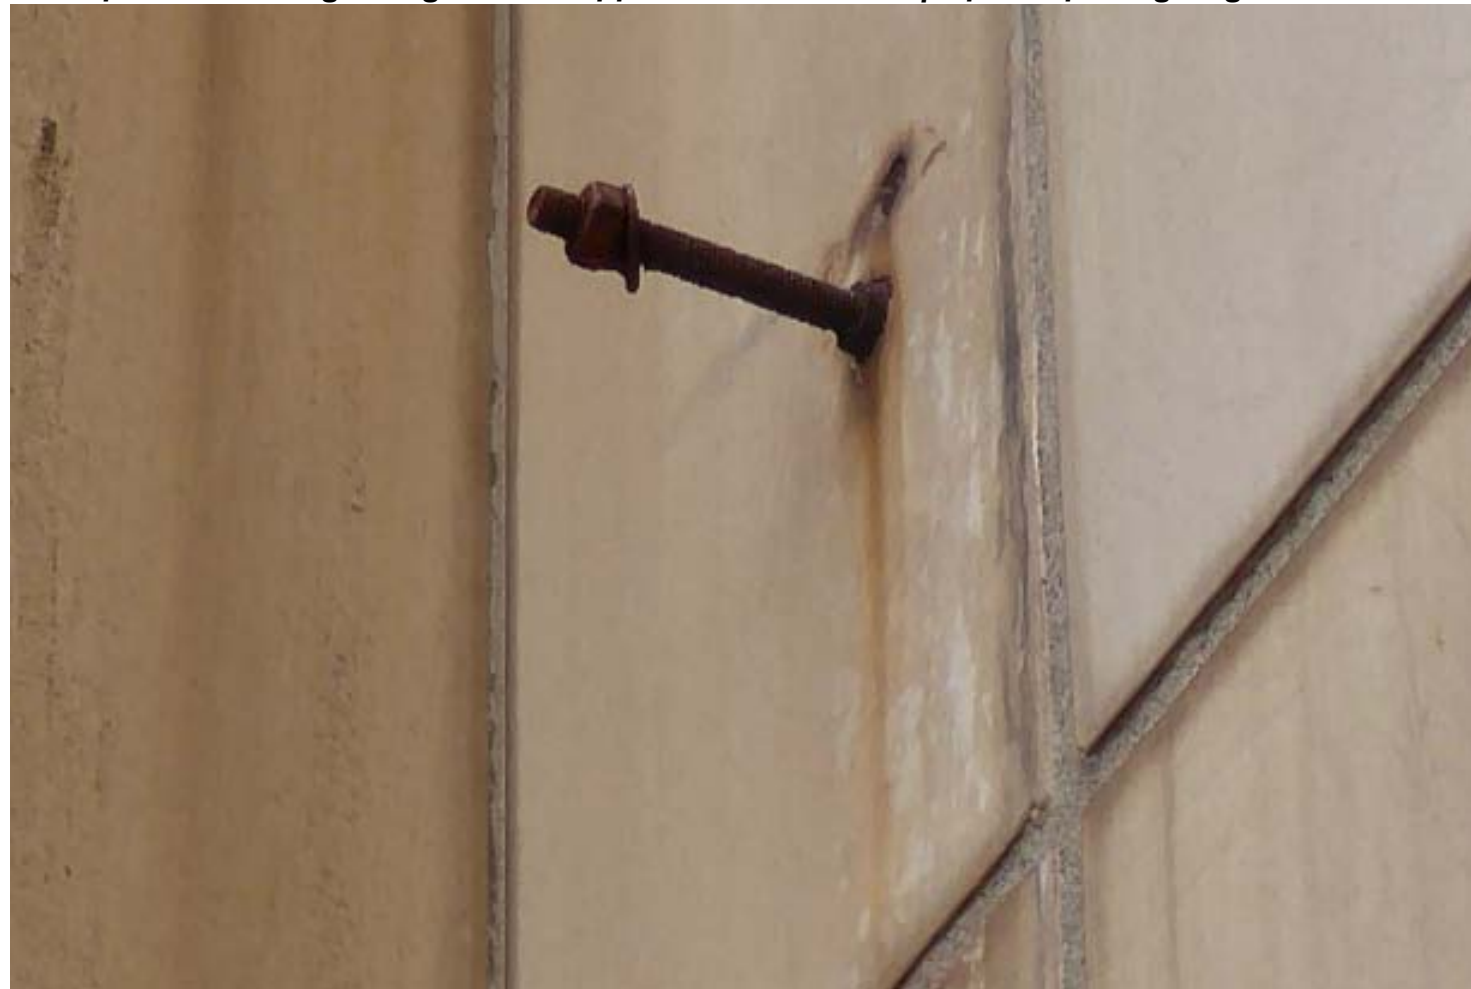
*View of a metal fixing in a faience tiling discolouring the tiles*

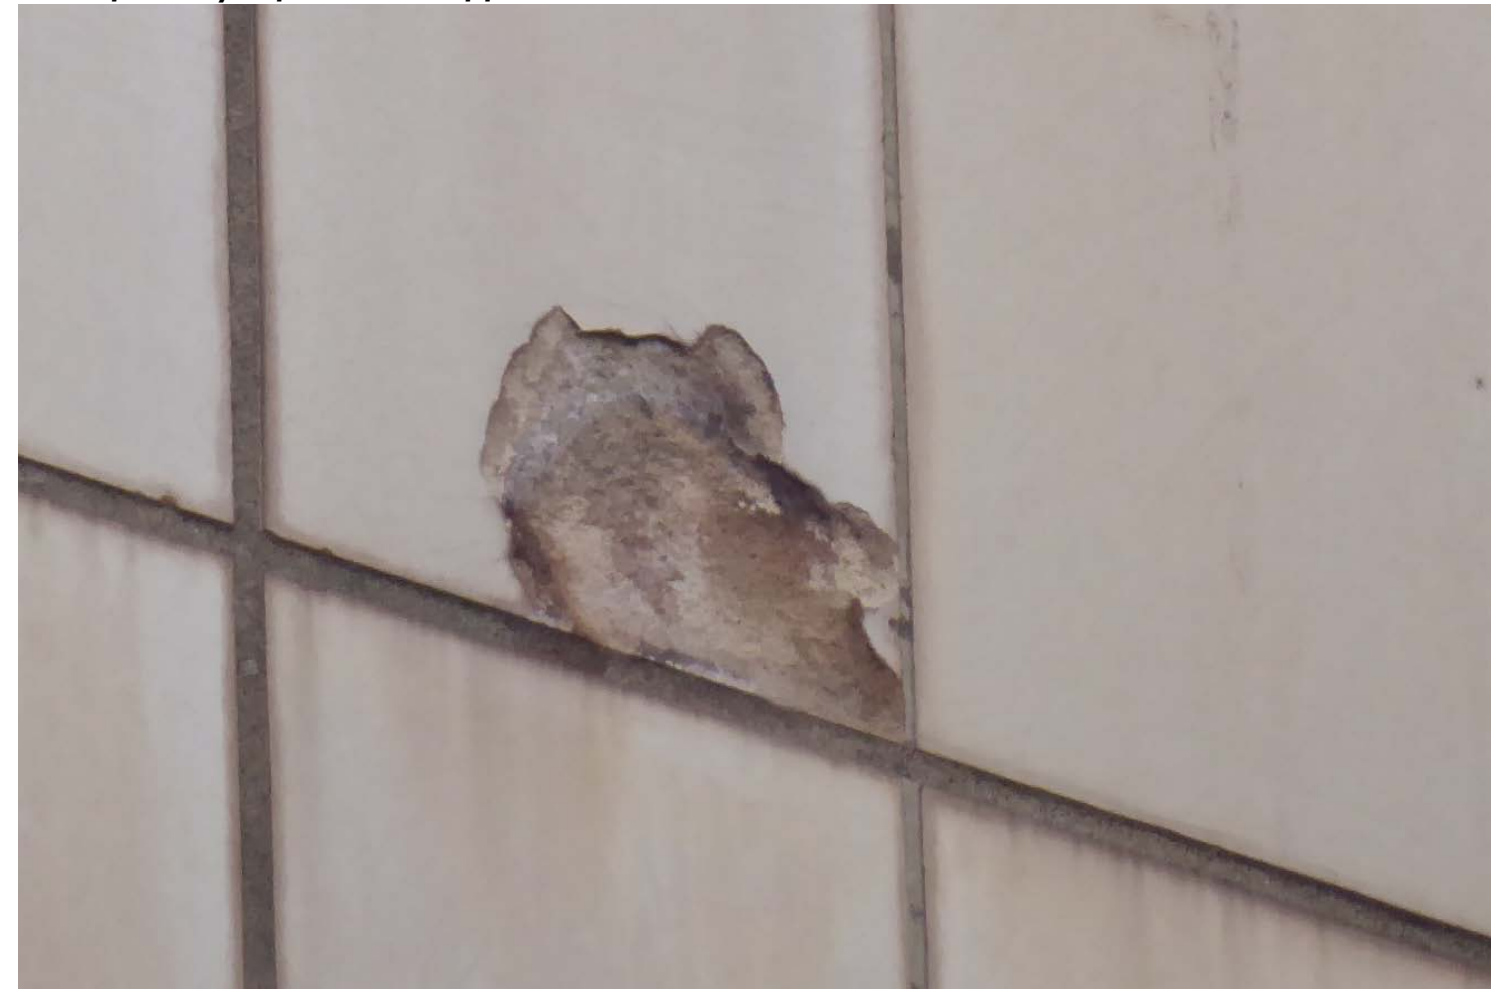
*View of a badly defaced faience tile*

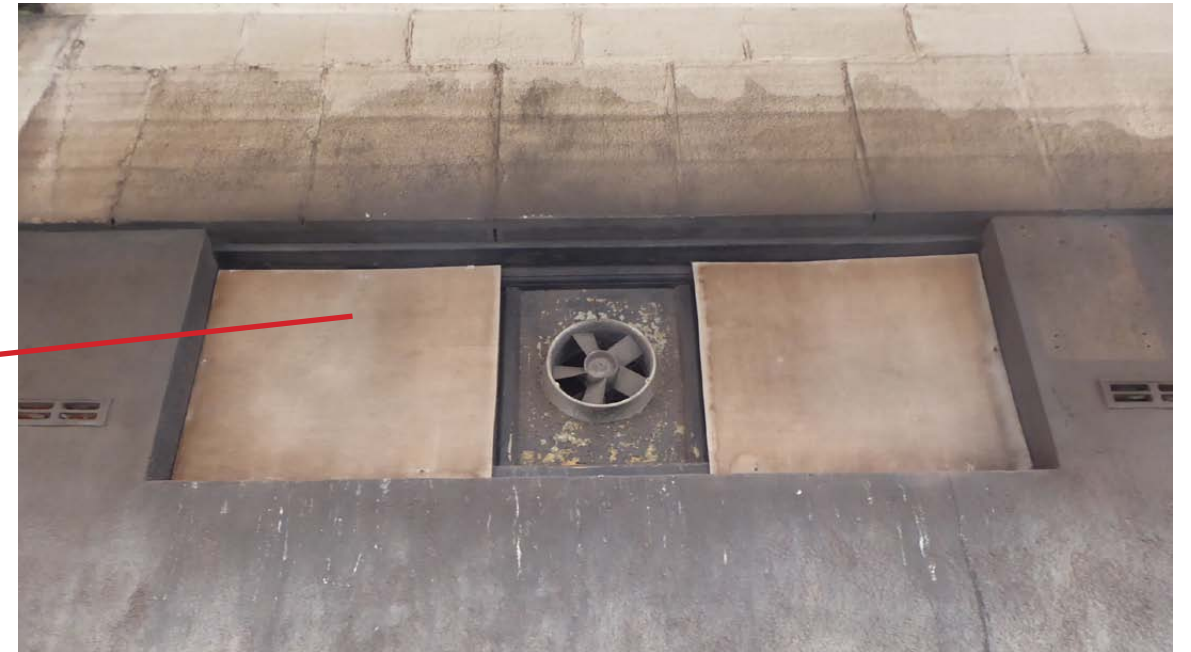
View of part-boarded vent to rear of ground floor to Retail unit

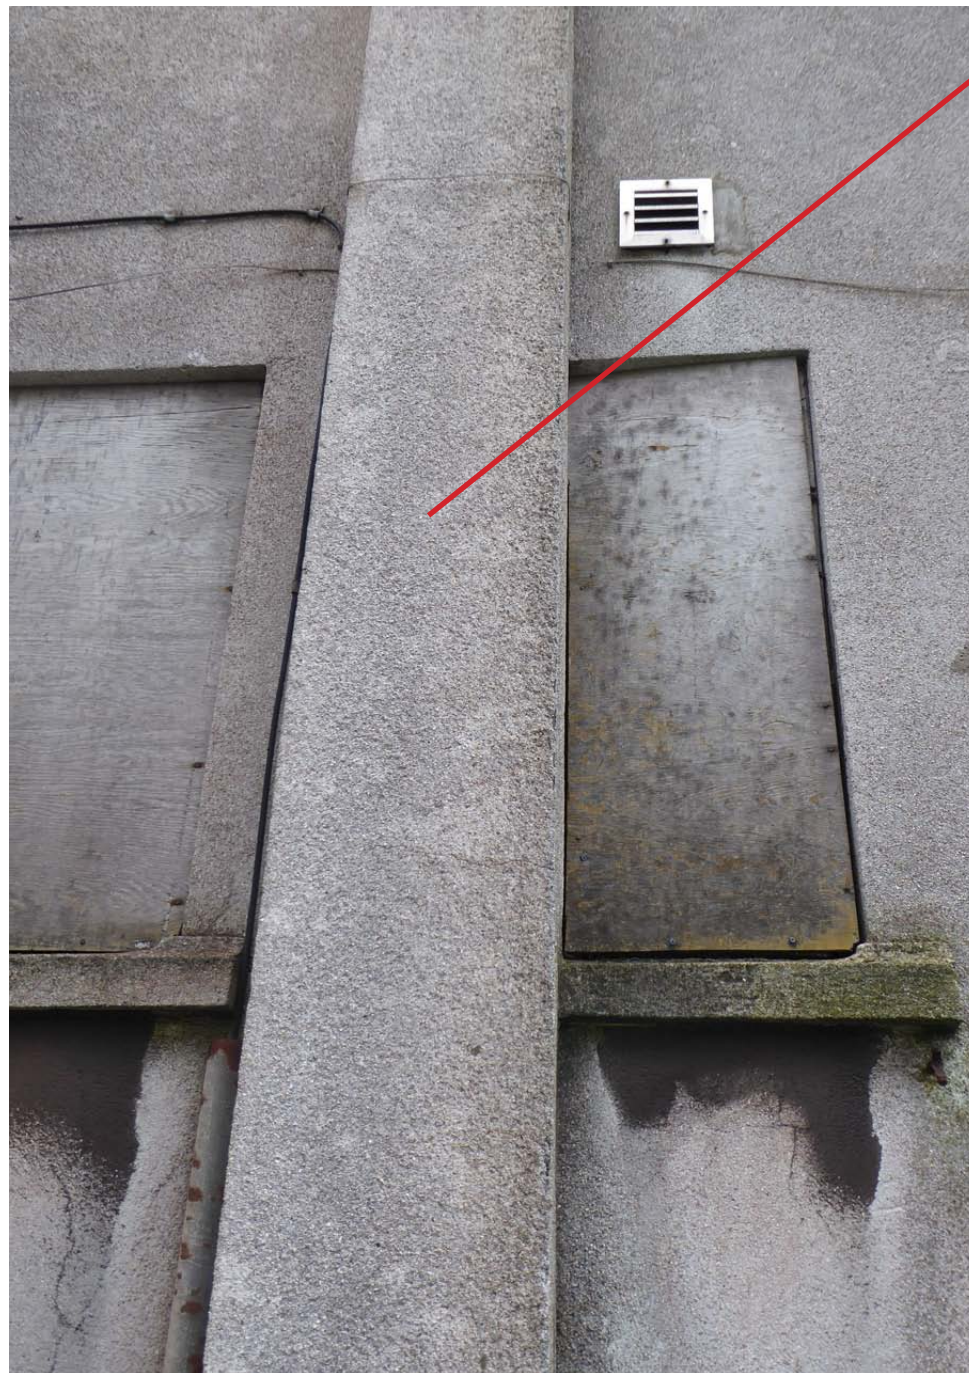
*View of boarded up windows to ground floor to Male Toilets*

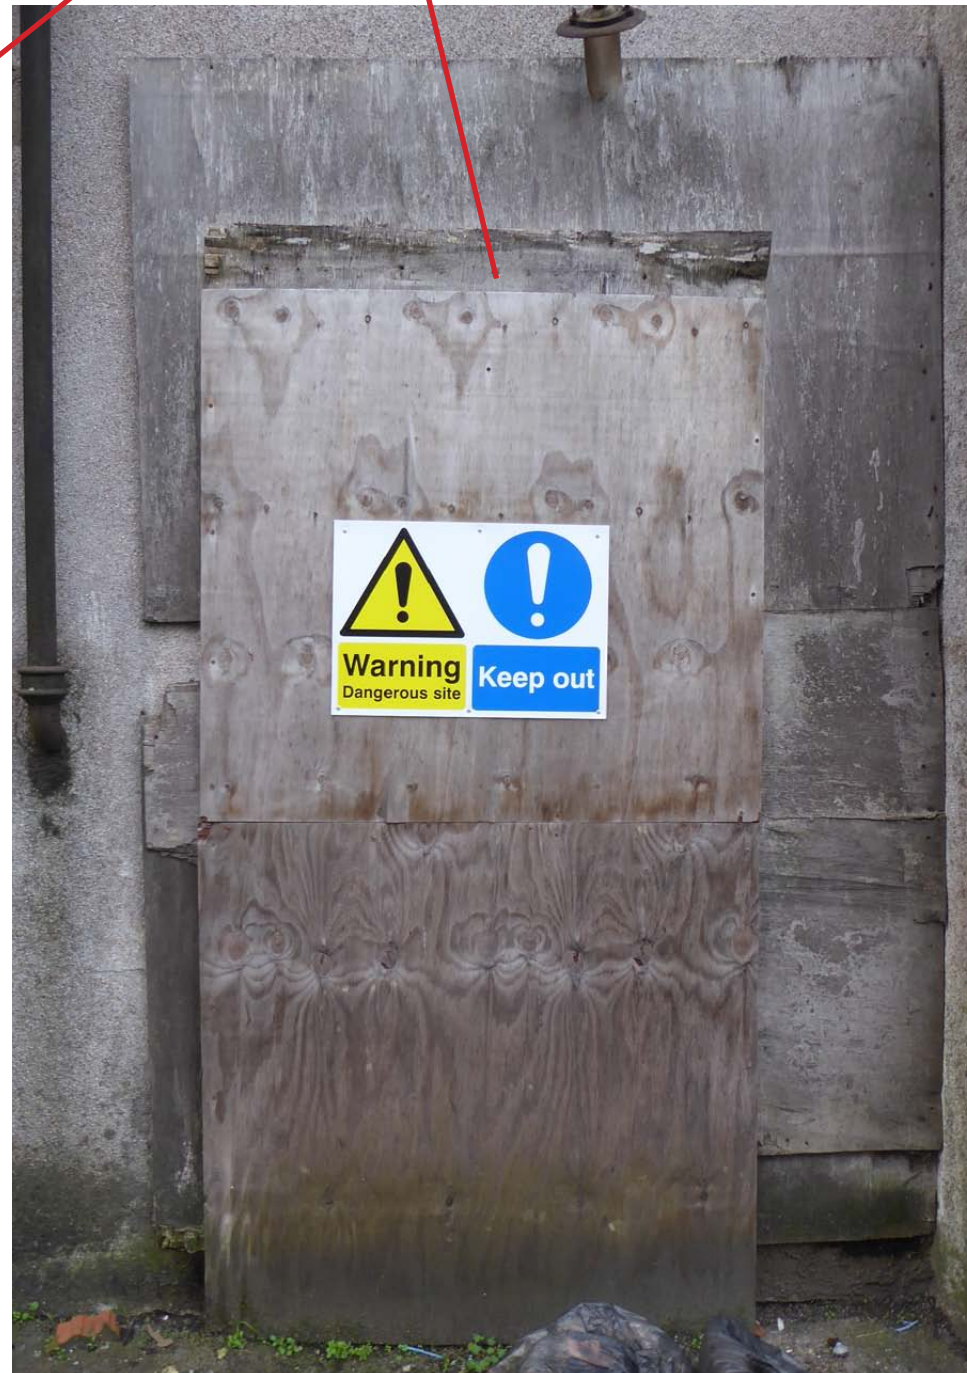
*View of boarded up door to ground floor emergency exit from foyer*

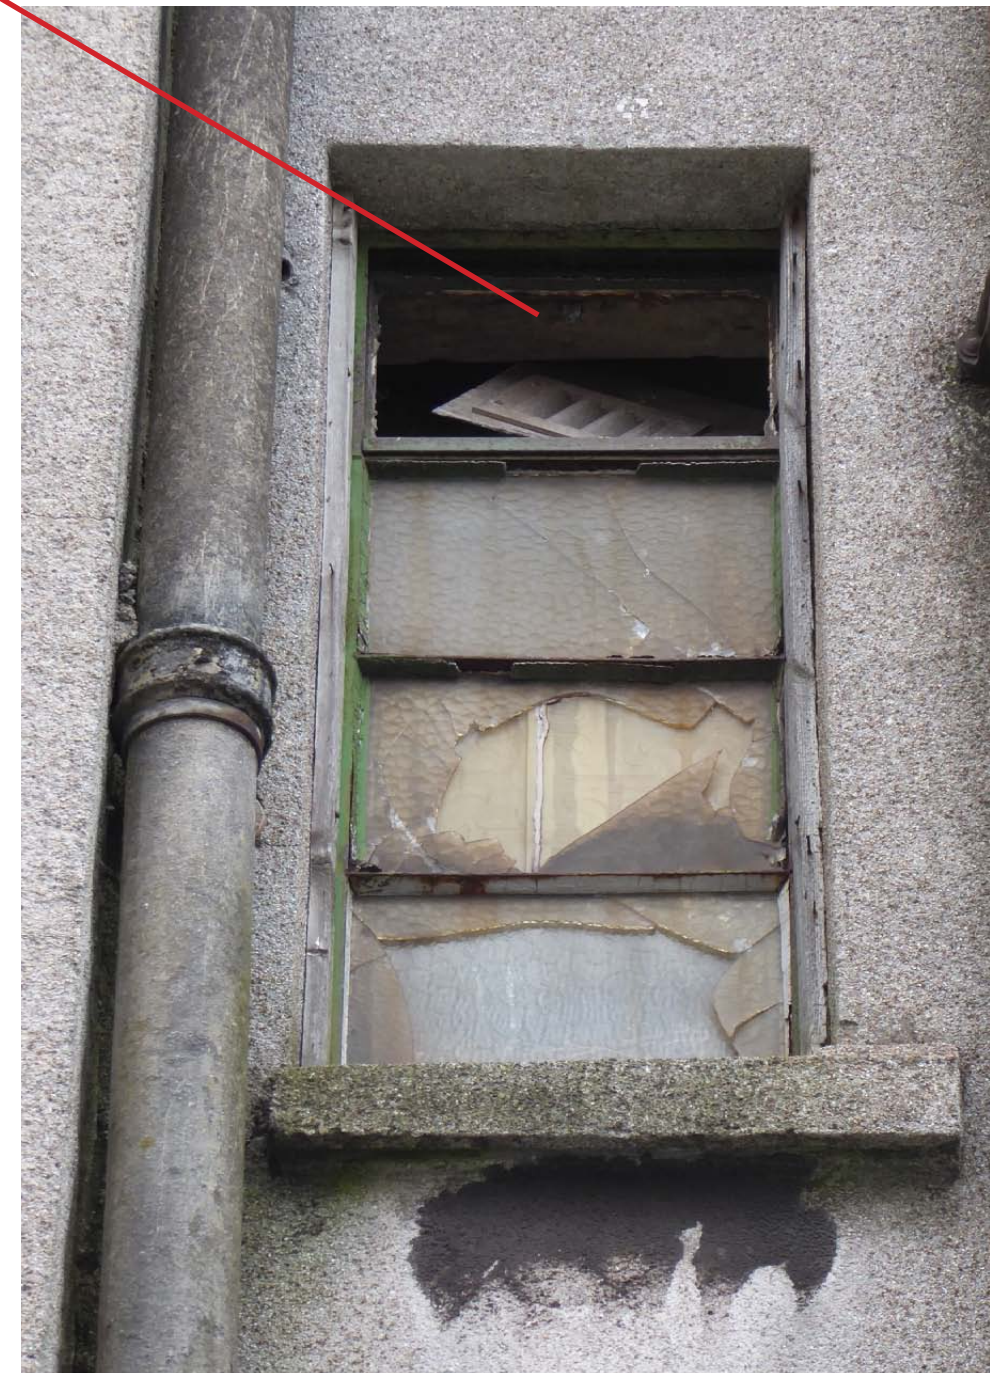
*View to damaged window to first floor toilet*

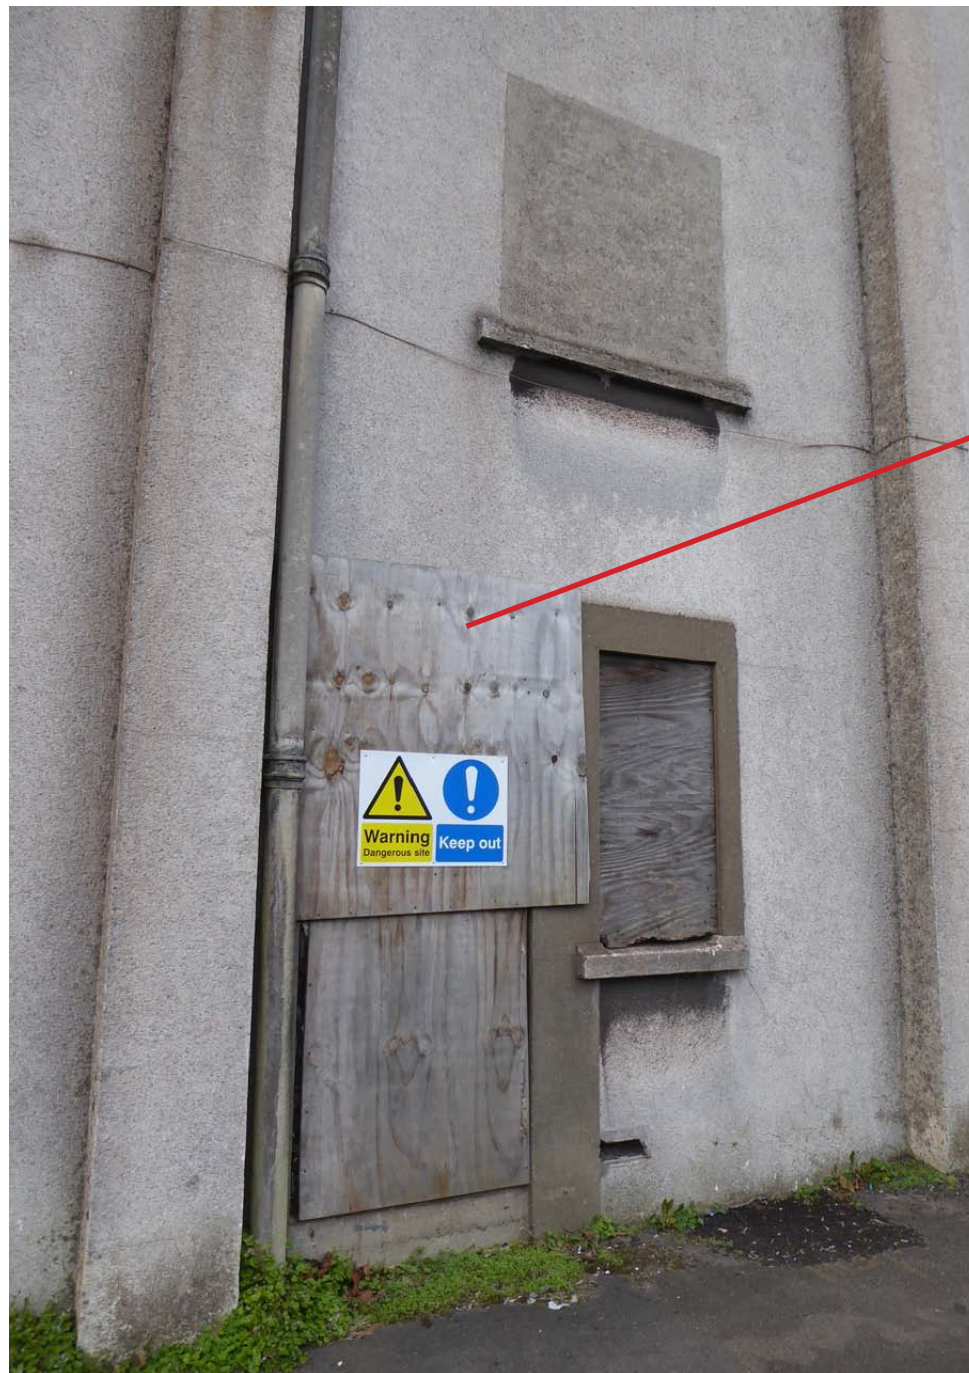
View of blocked / boarded up windows and door to auditorium

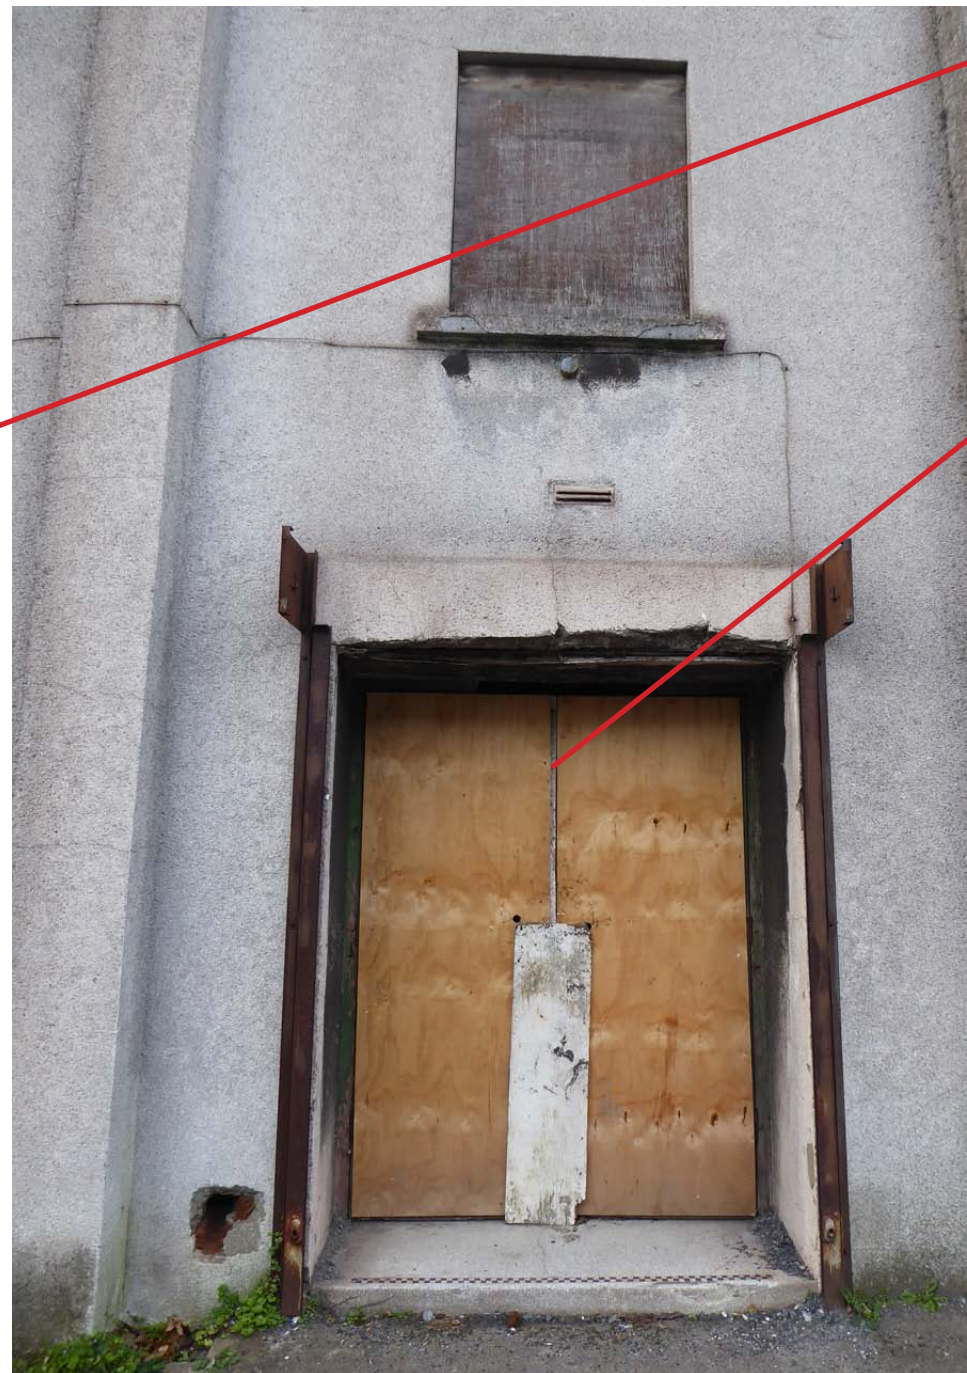
View of boarded up emergency exit door from auditorium

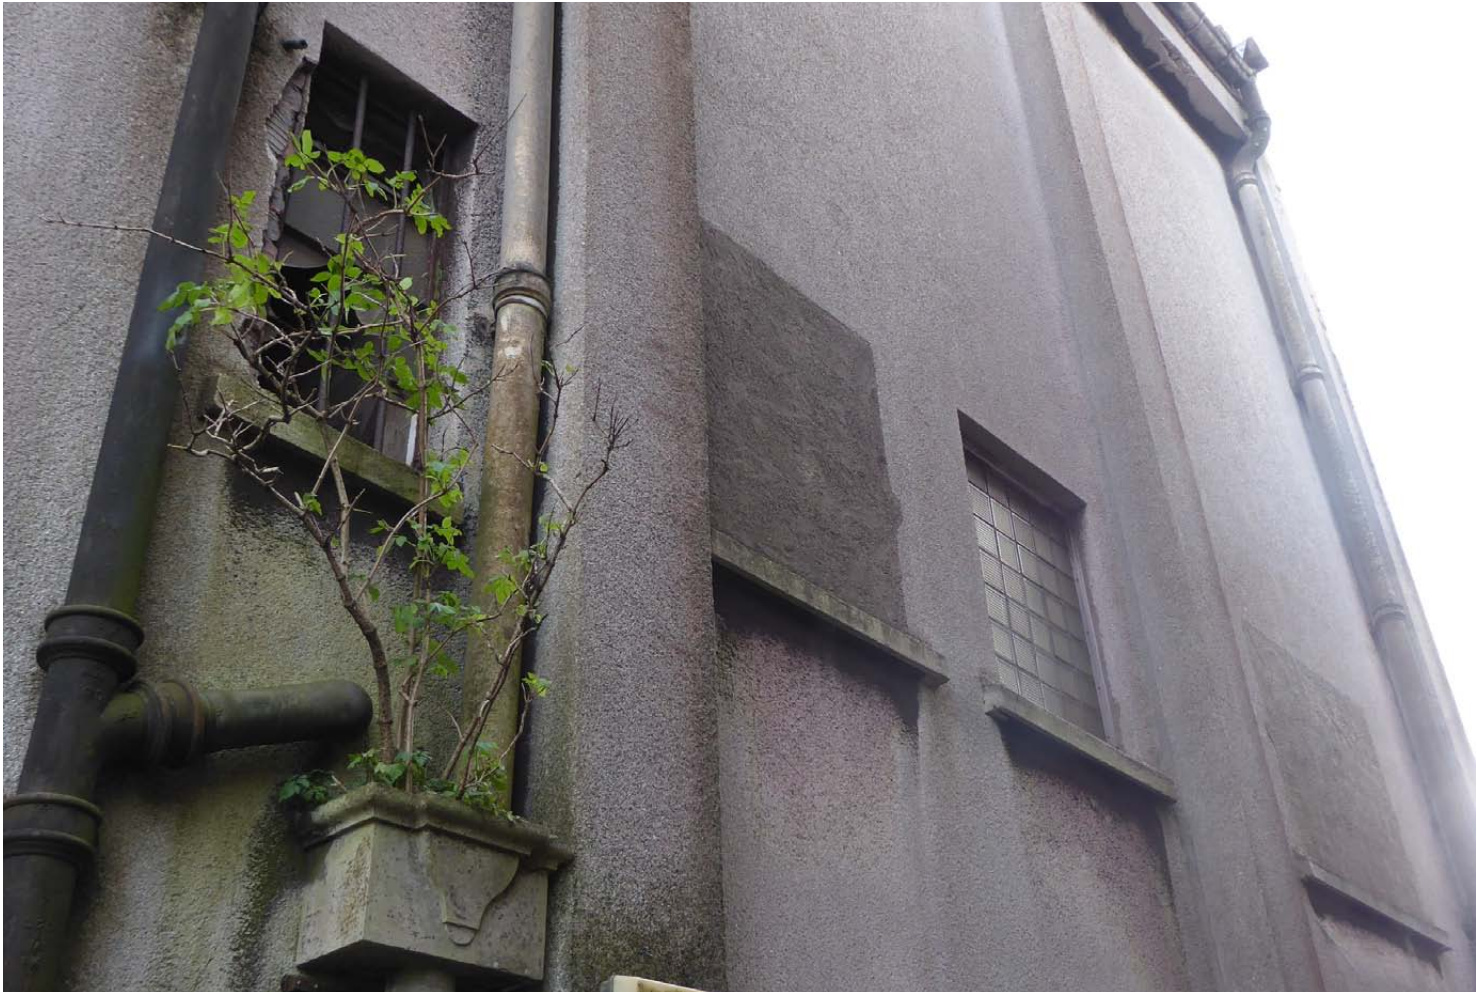
View of the windows and blocked up windows to the upper right hand side of the west side elevation

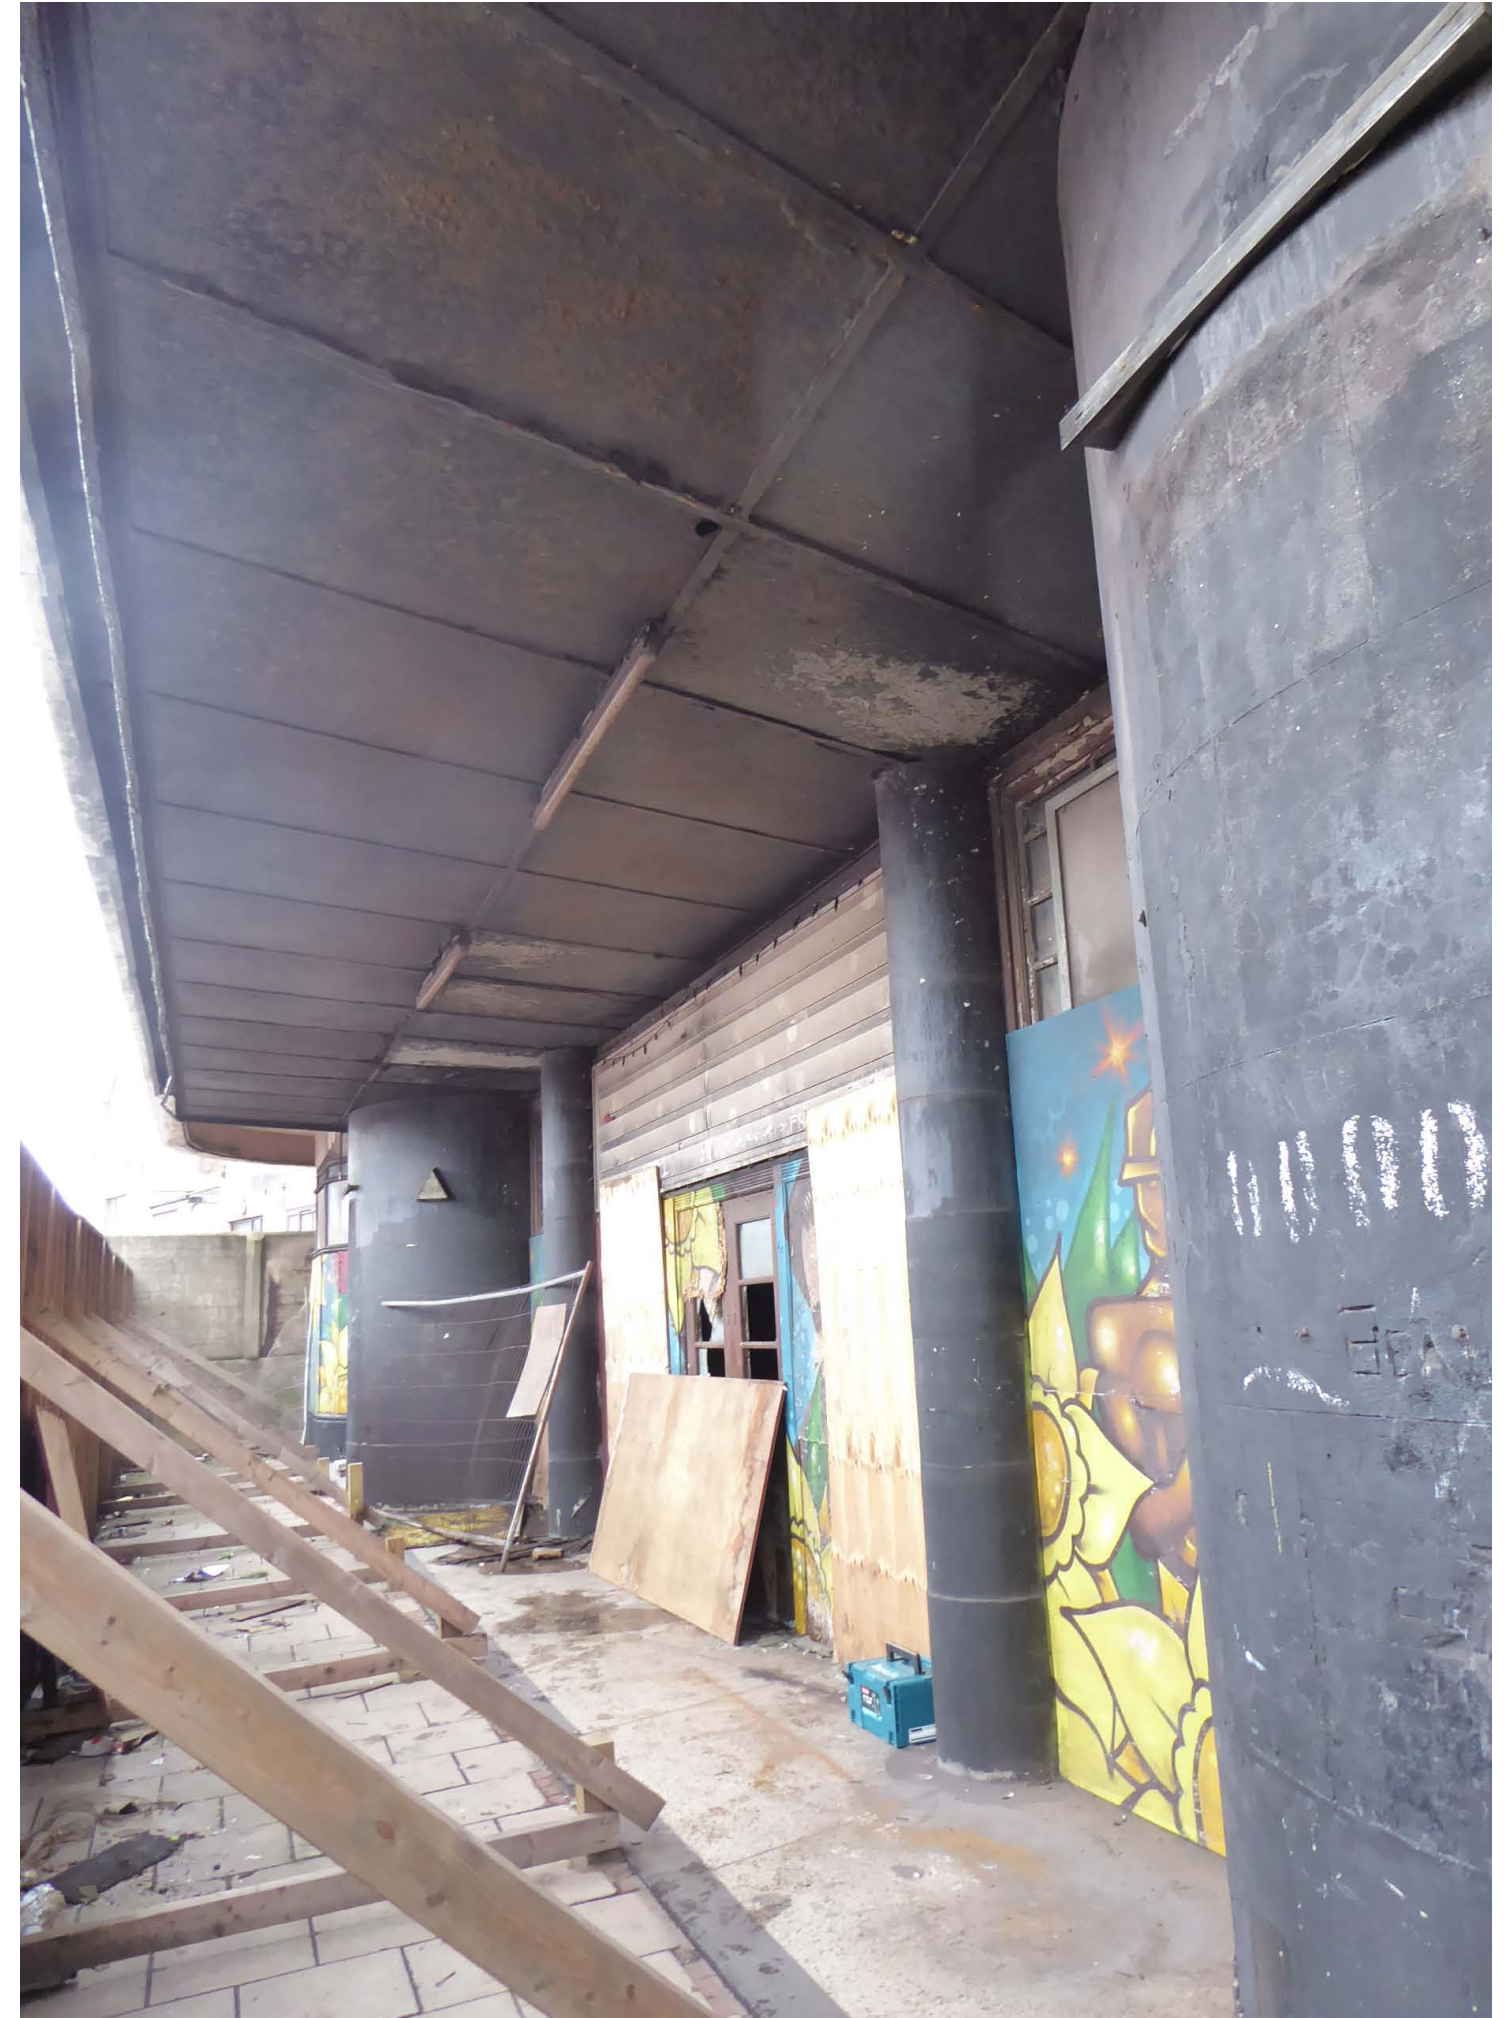
*View of the bank of main entrance boarded up with the metal canopy overhead*
