**Plaza, Port Talbot**

**HISTORIC BUILDING RECORDING**

(385)1902-GWP-A-2A-HBR-P00

Date: 06.01.20

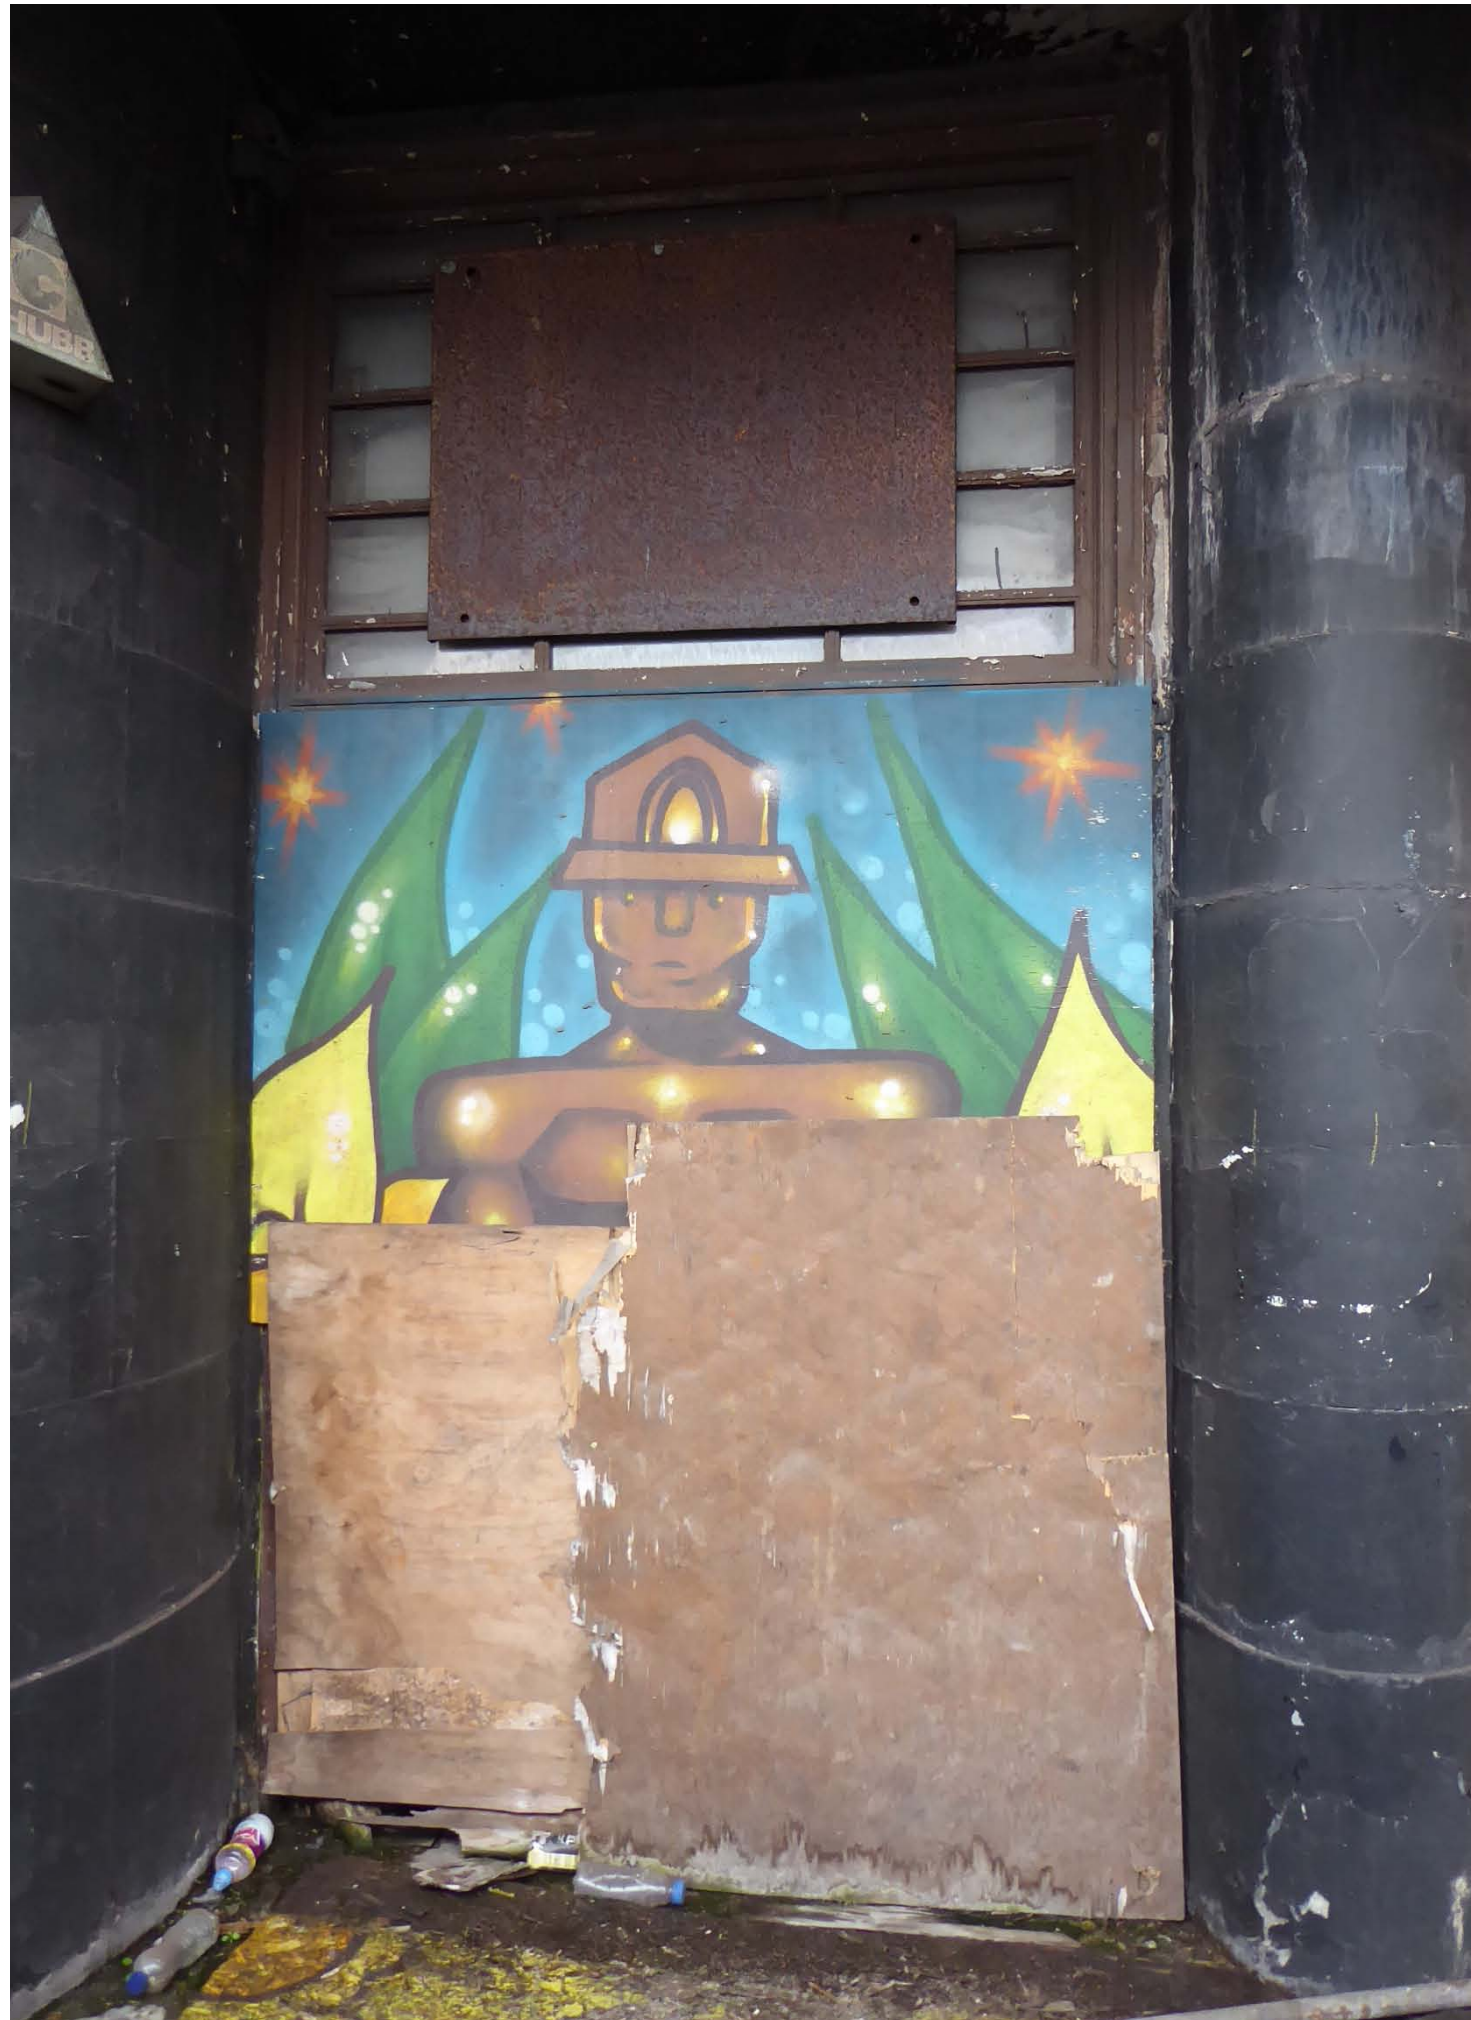
View of boarded up left hand large timber-frame glazed screen to side of bank of entrance doors

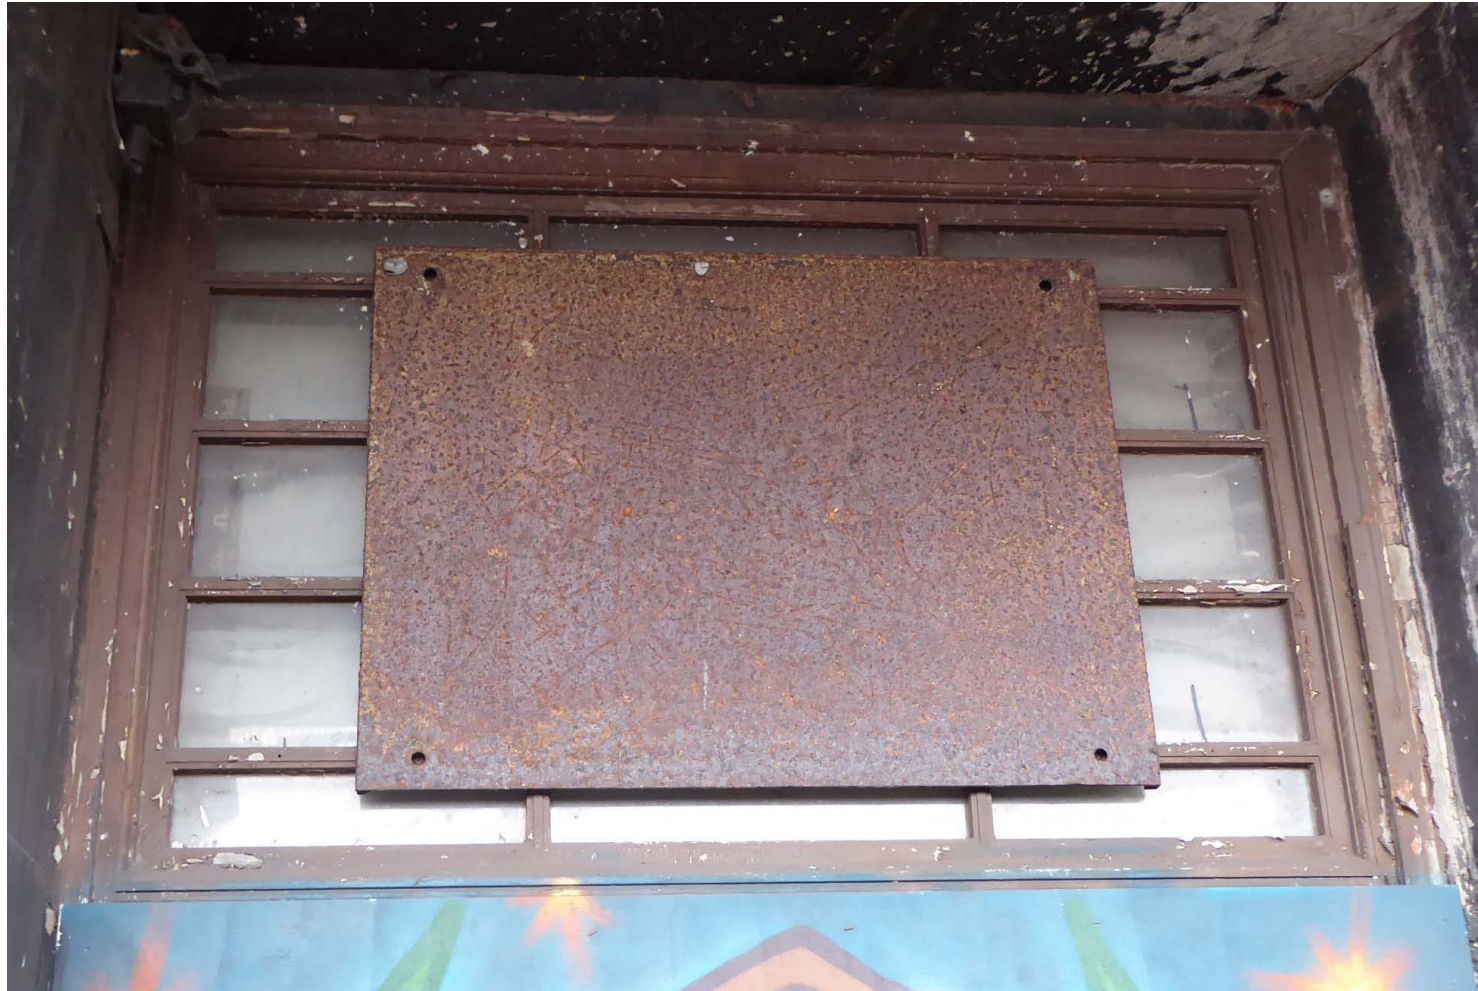
*View of glazed overhead panel above side glazed panel, with metal plate affixed*

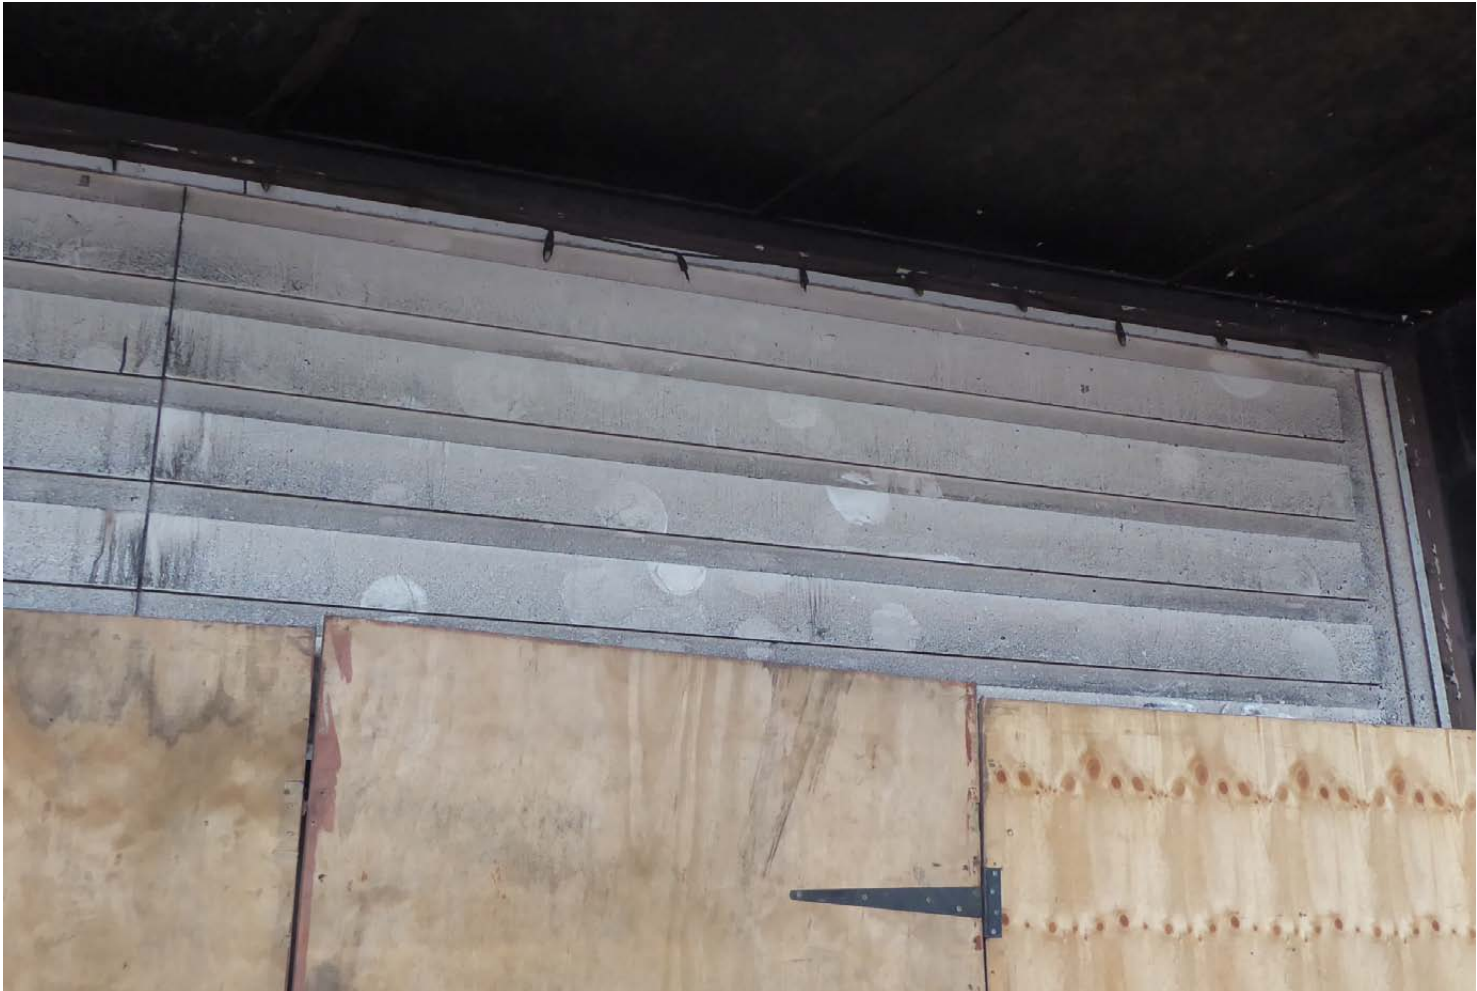
*View of louvres over the top of the bank of main entrance timber doors*

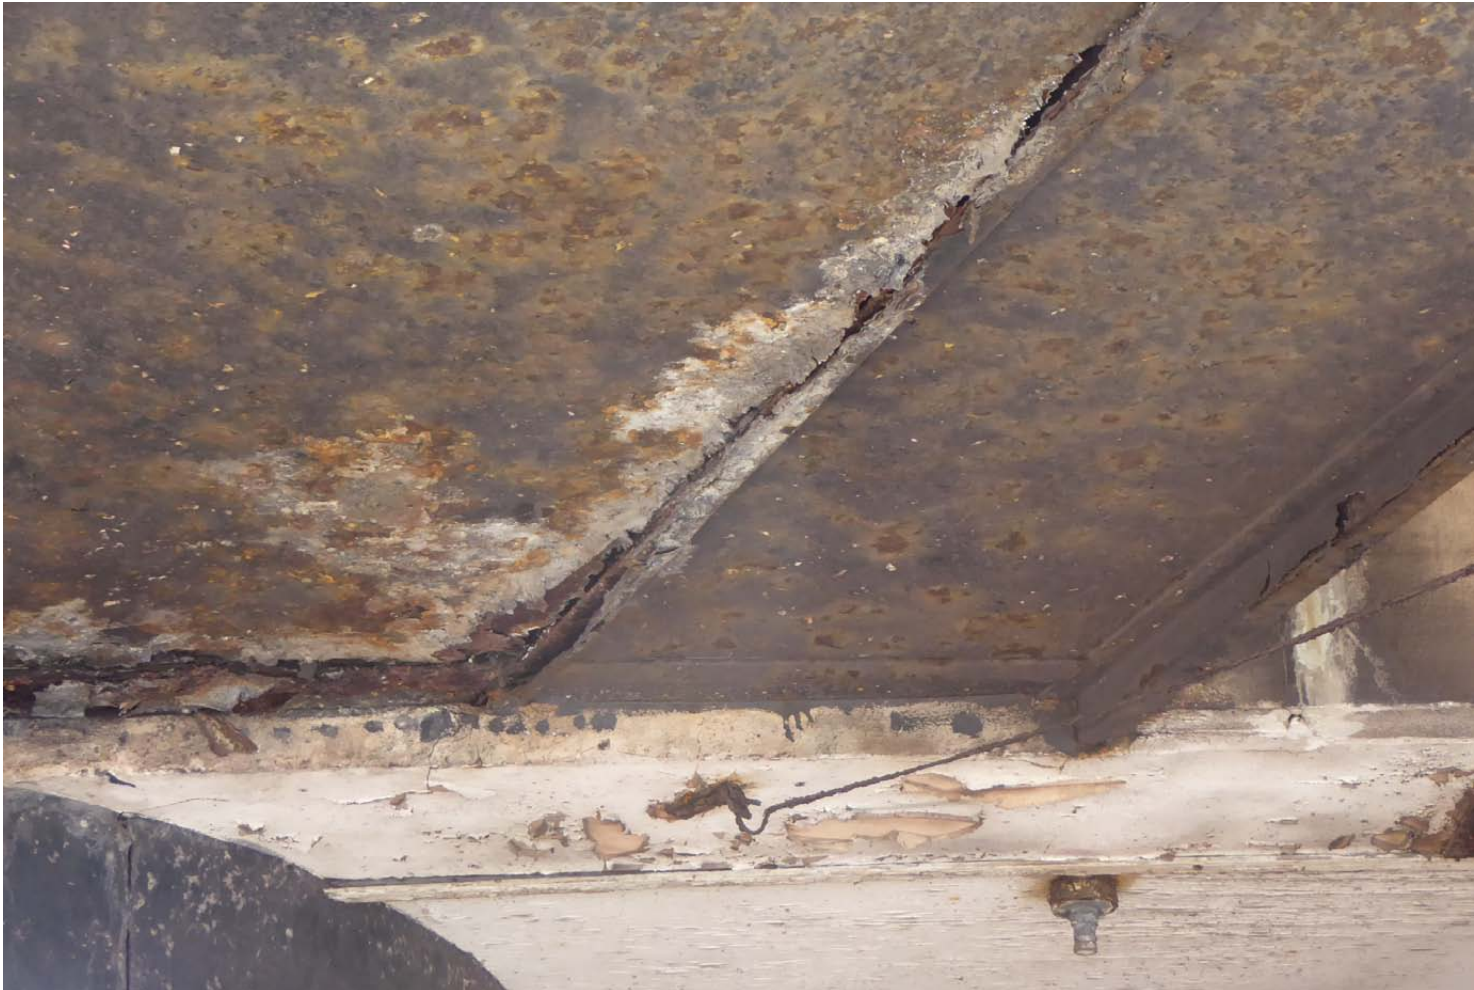
*View of two panels abutting each other where 'T' section support appears to have been lost*

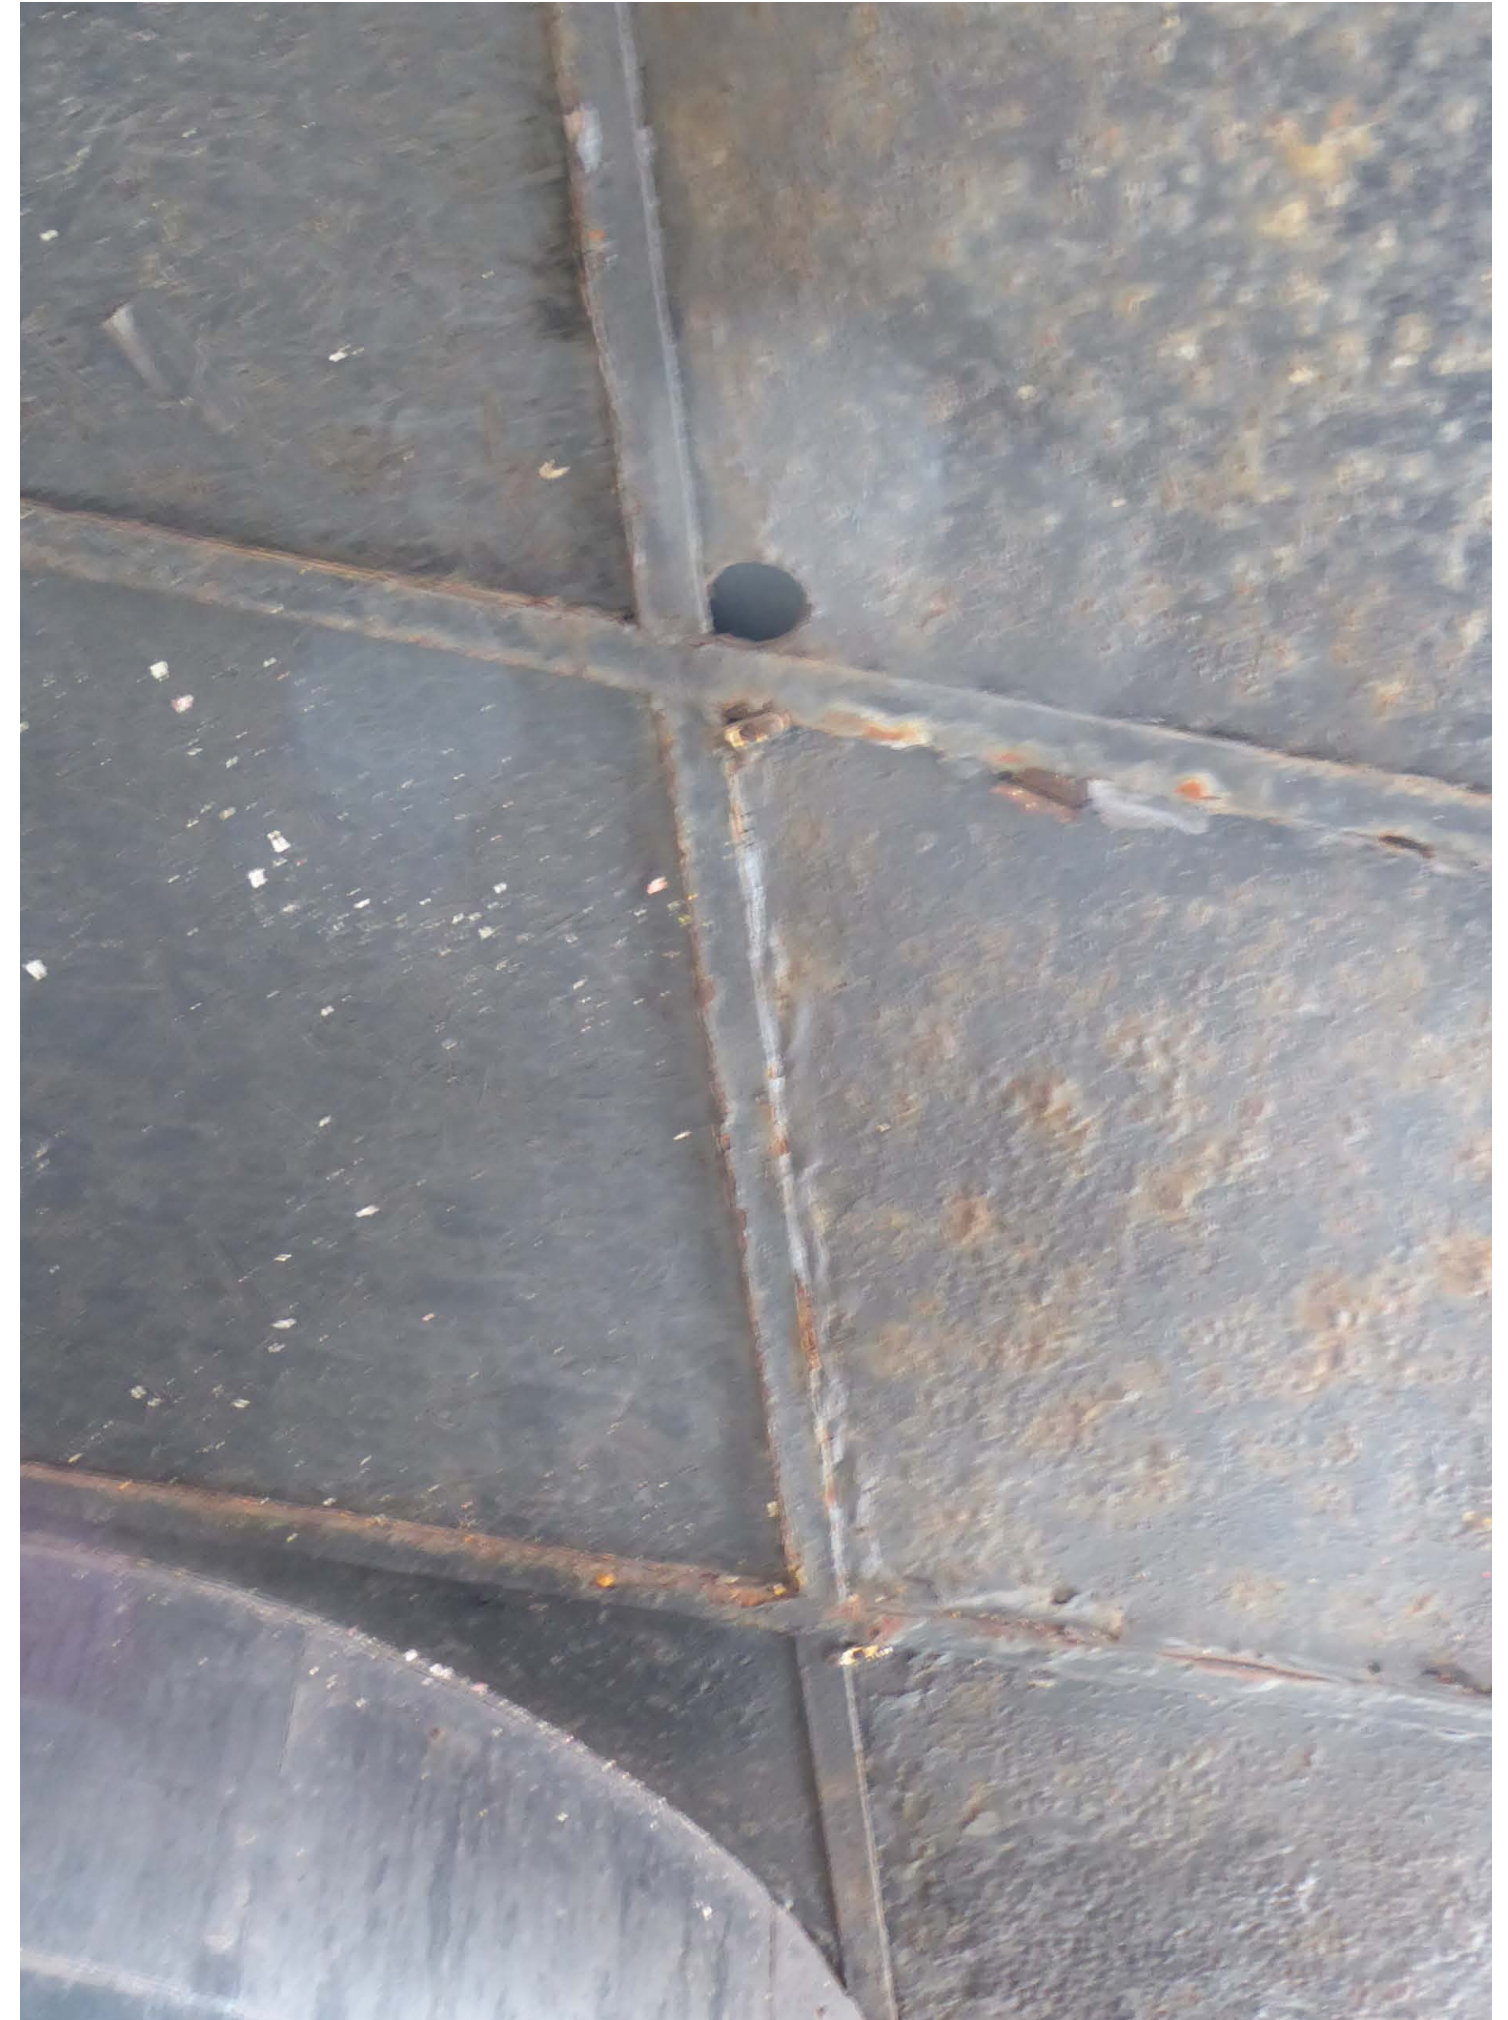
*This photograph show how badly the panels and frame have been corroded*

*Detailed view of panels and frame*

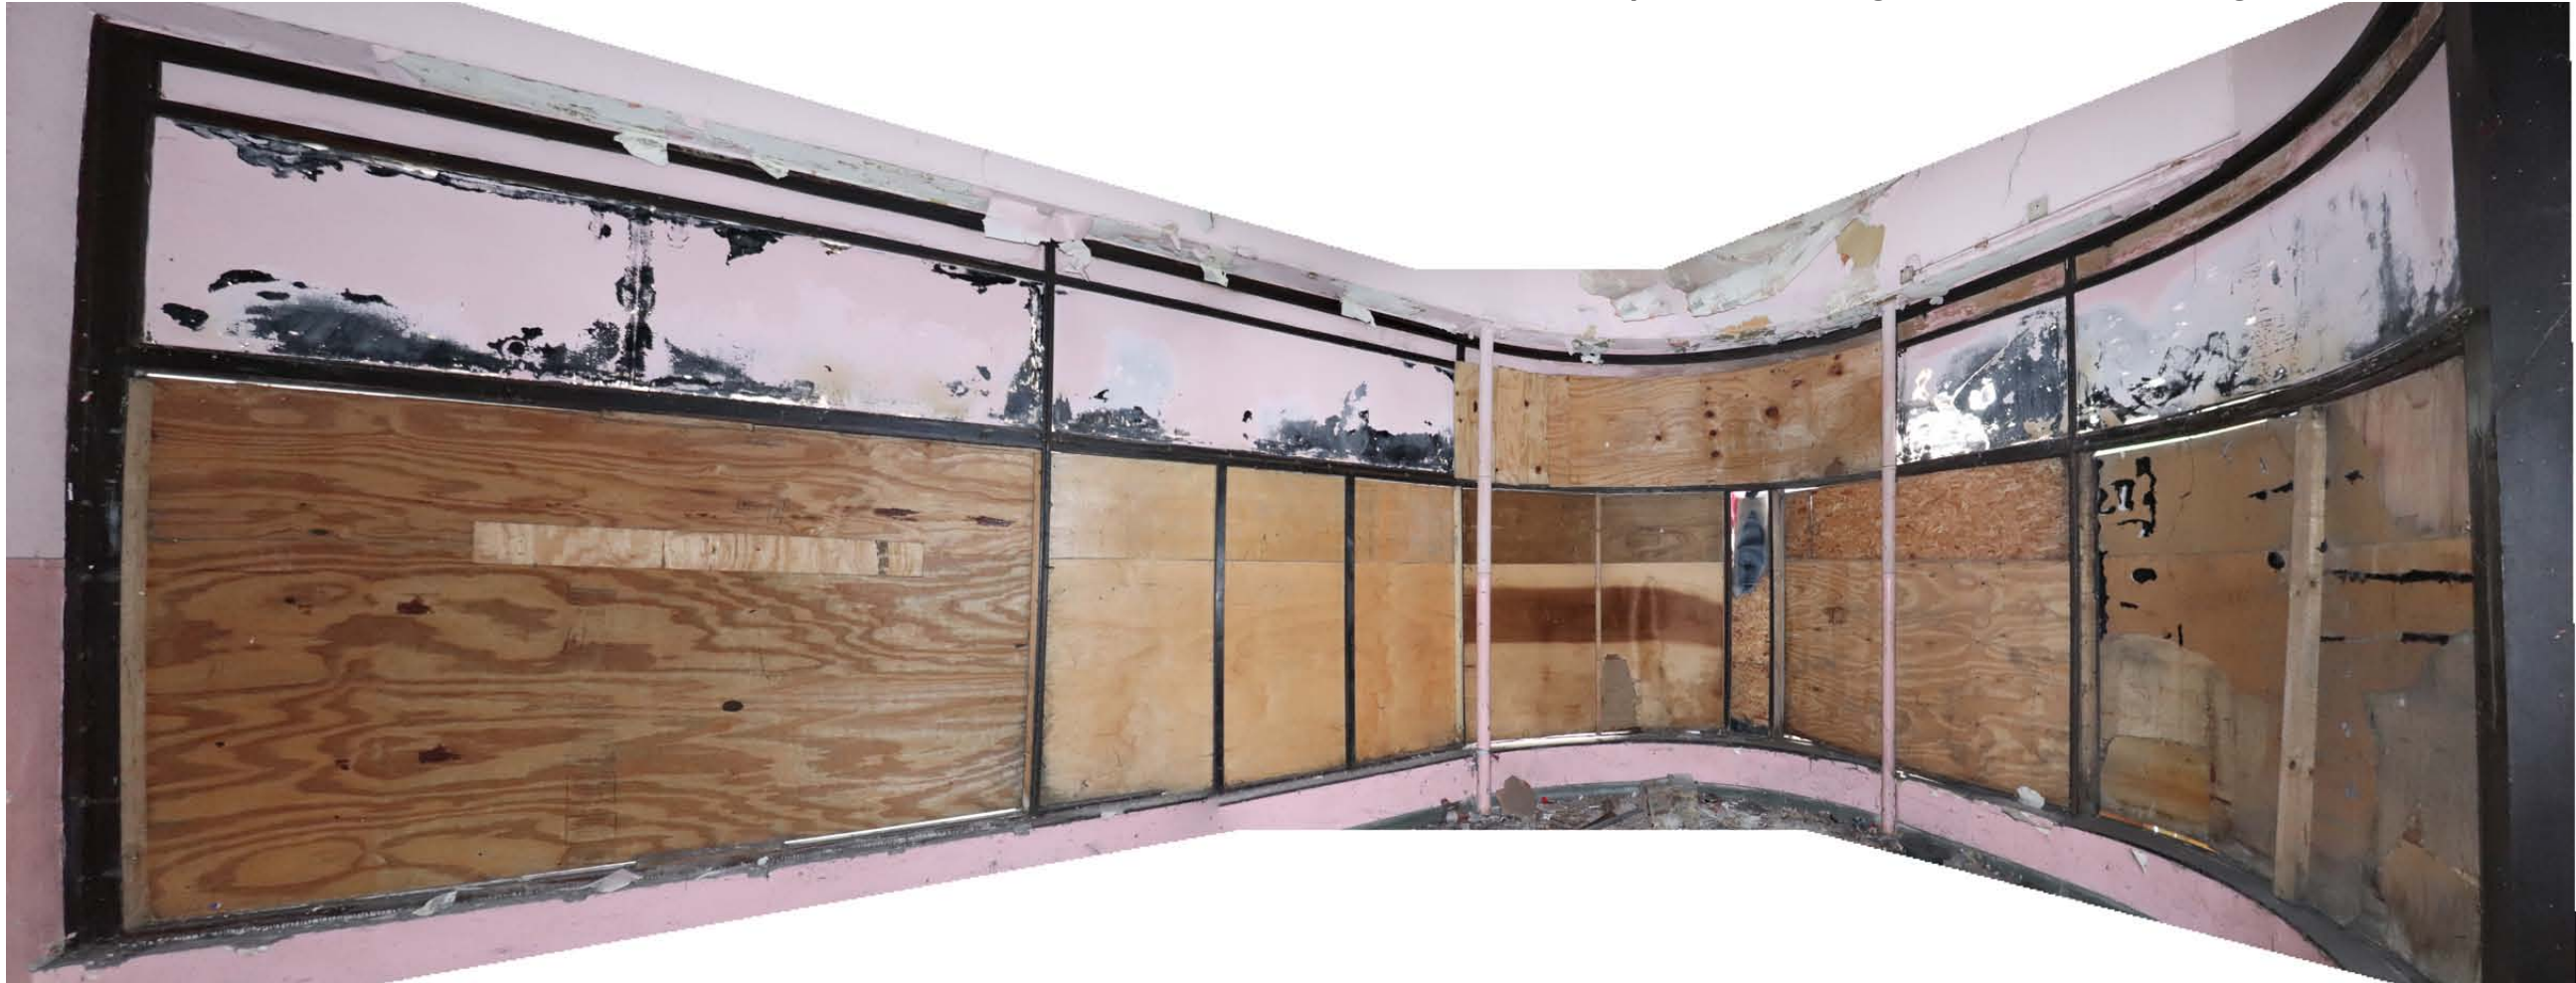
Much of the glazing has been lost or damaged, with some plywood boarding infills and some glass over-painted, however, much, albeit not all, of the slender timber framing remains.

*Panoramic View of Glazing with Curved End and two Steel Columns and full extent of boarded up glazing panes*

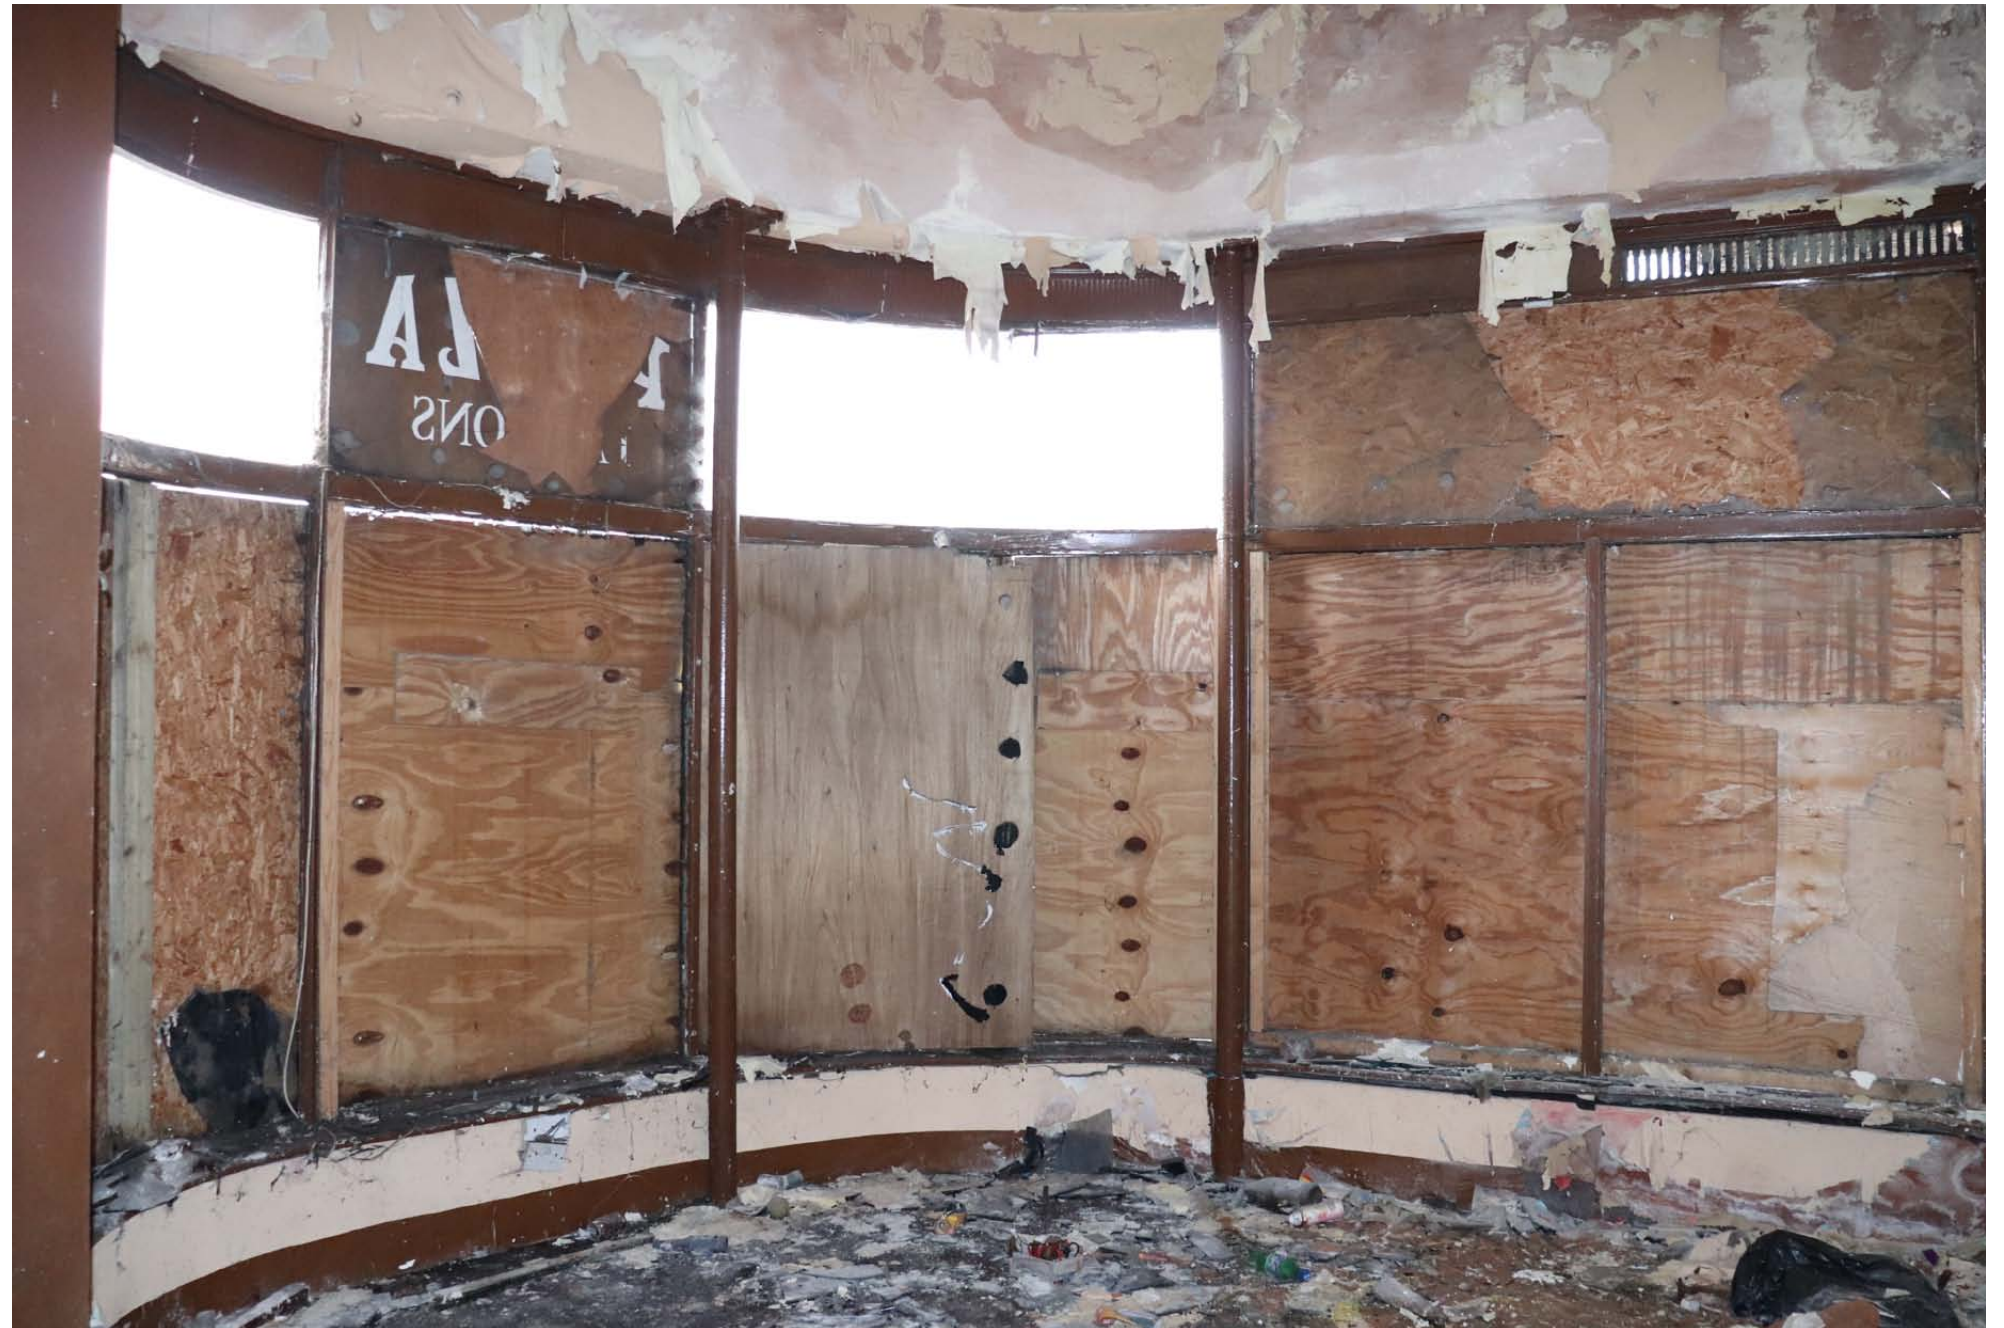
*View of Glazing with Curved End and two Steel Columns and full extent of boarded up glazing panes, timber cill & vented strip to top*

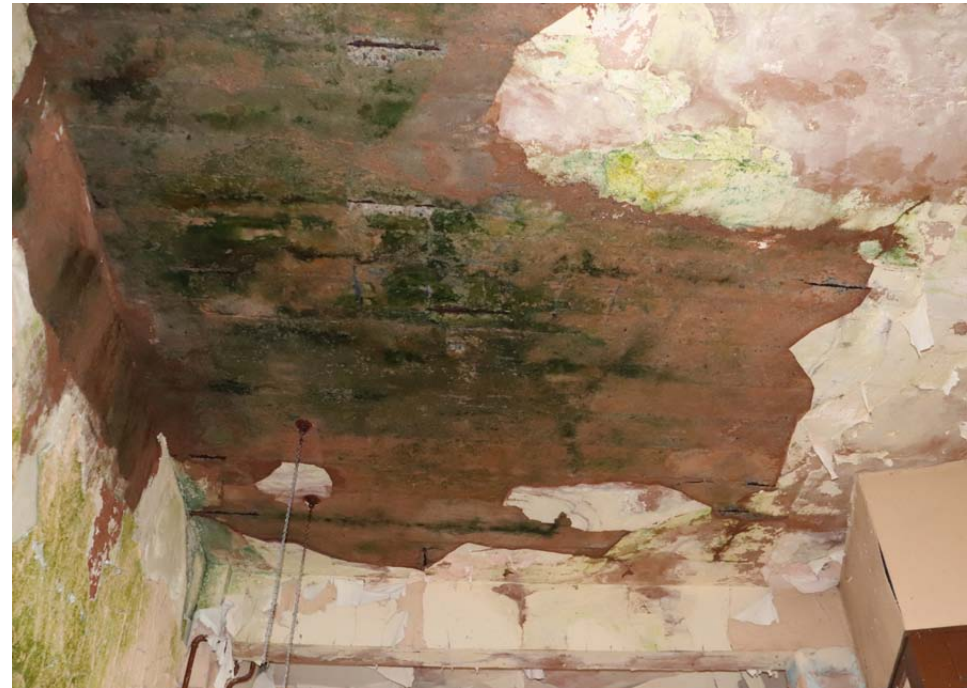
*Extremely damp concrete soffit with paint & plaster all lost*

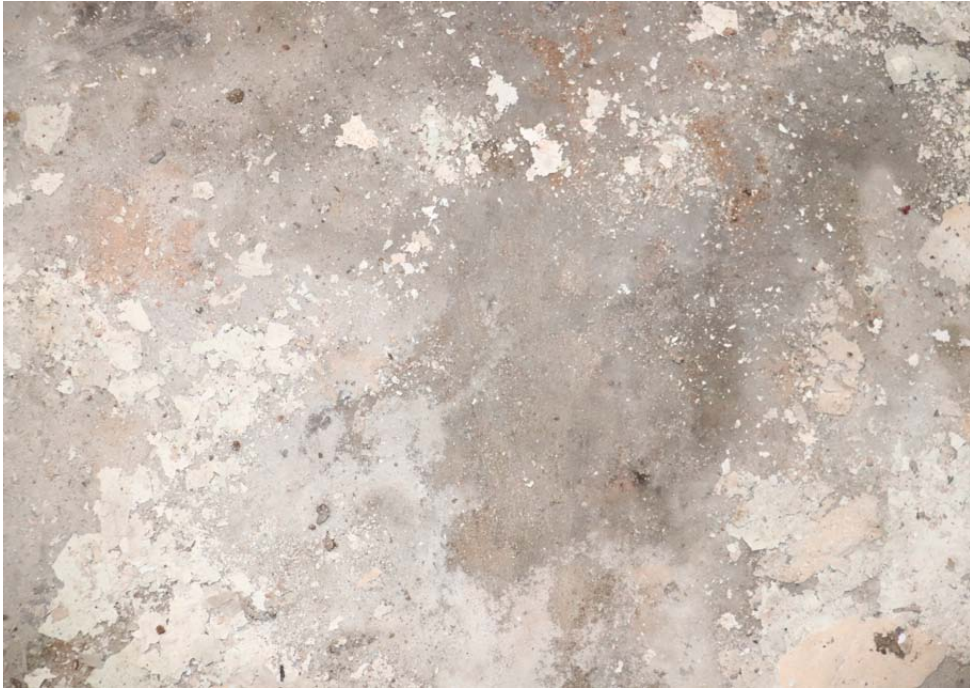
The Flooring appears to be painted concrete, with the paint flaking.

**Flaking Paintwork to Concrete Floor**

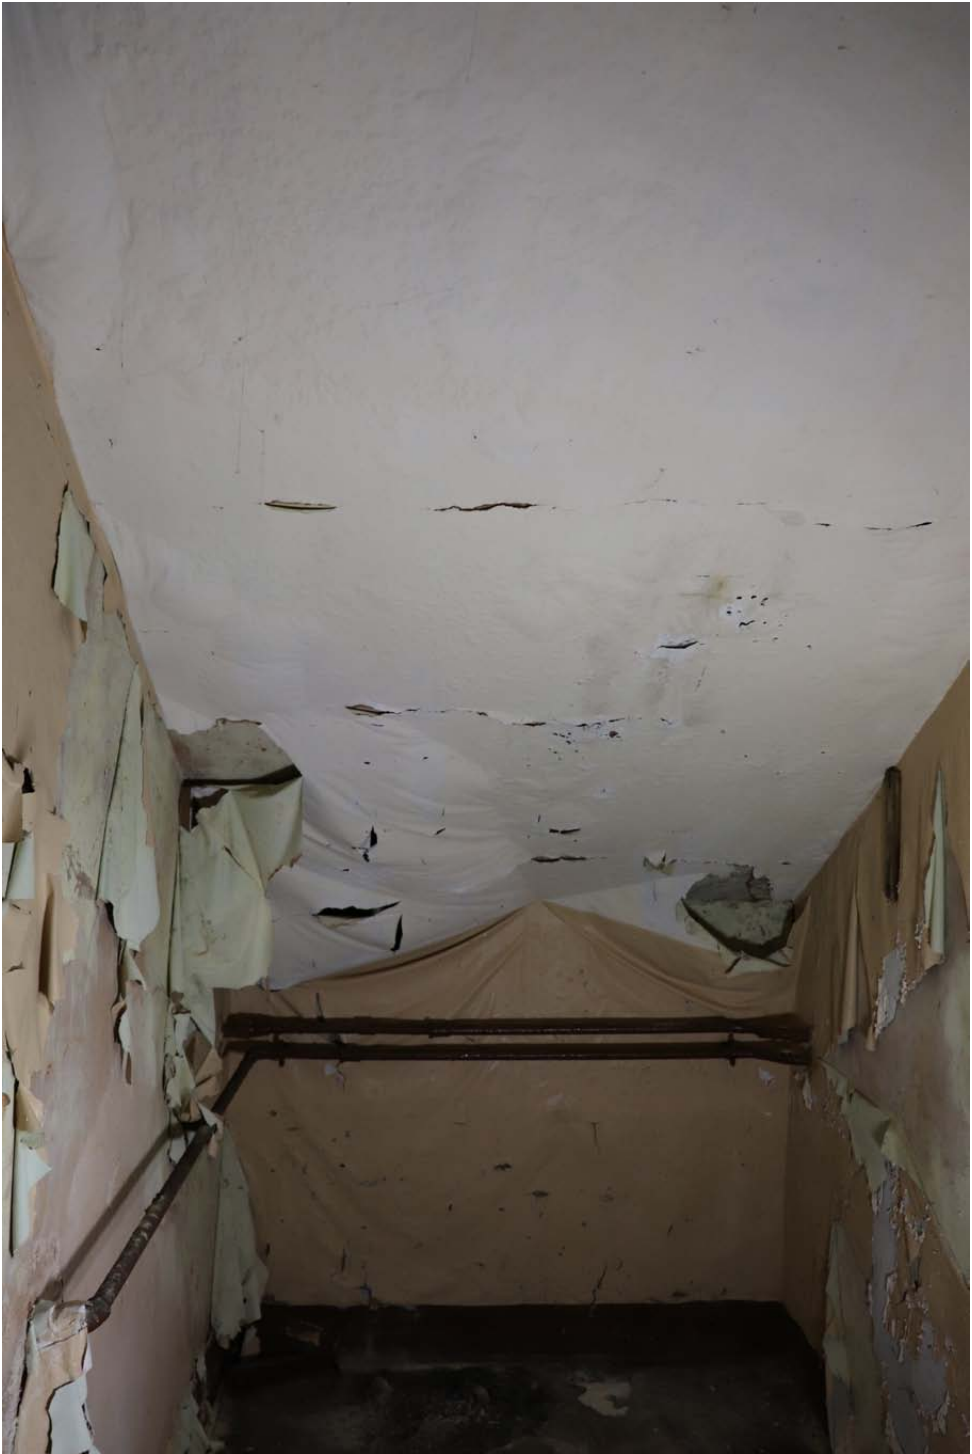
The Walls and Ceiling are painted plaster, which is very badly peeling in most areas.

**Peeling Paint & Plaster to Walls & Ceiling, which is sloping soffit**

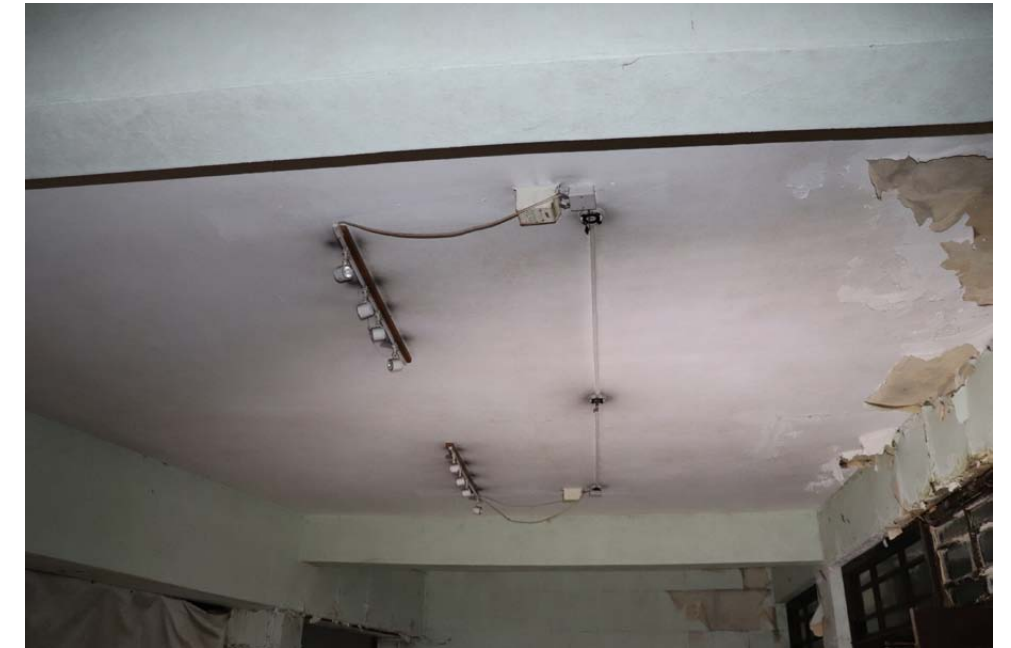
The Ceiling is Painted Plaster, in a better condition than other ceilings, however, still showing signs of damage and damp.

*View of Painted Plastered Ceiling*

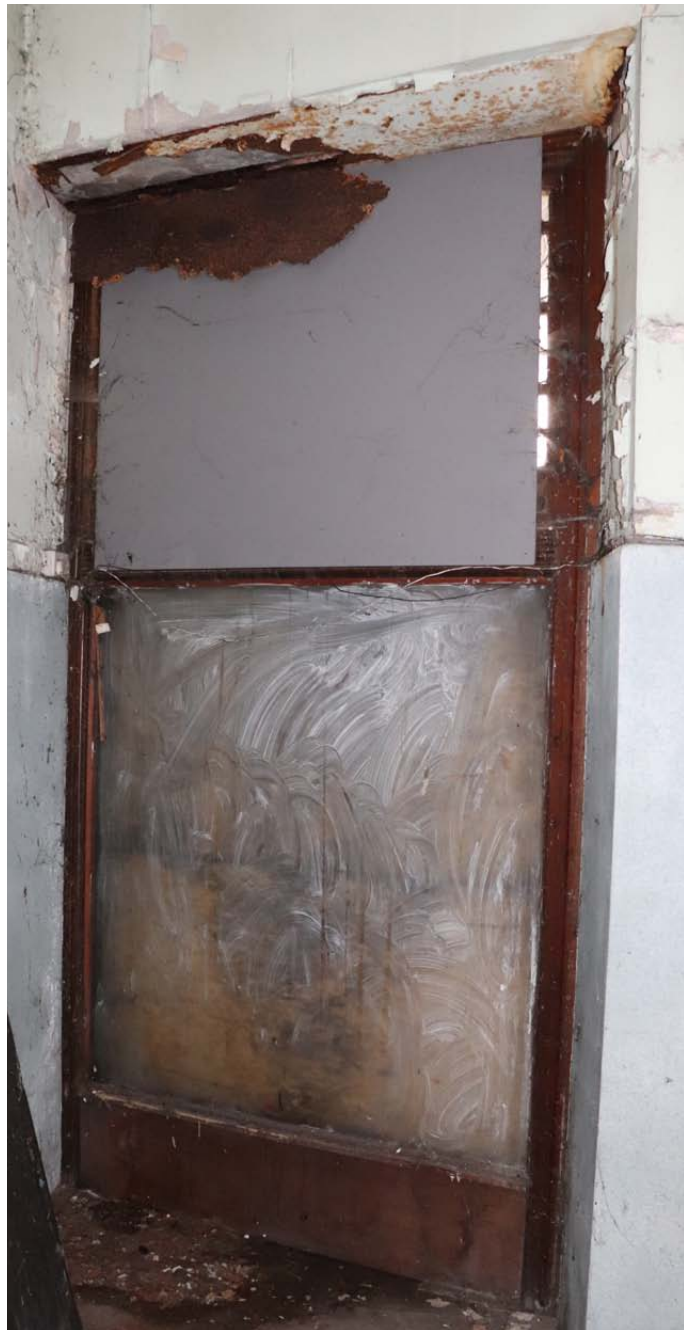
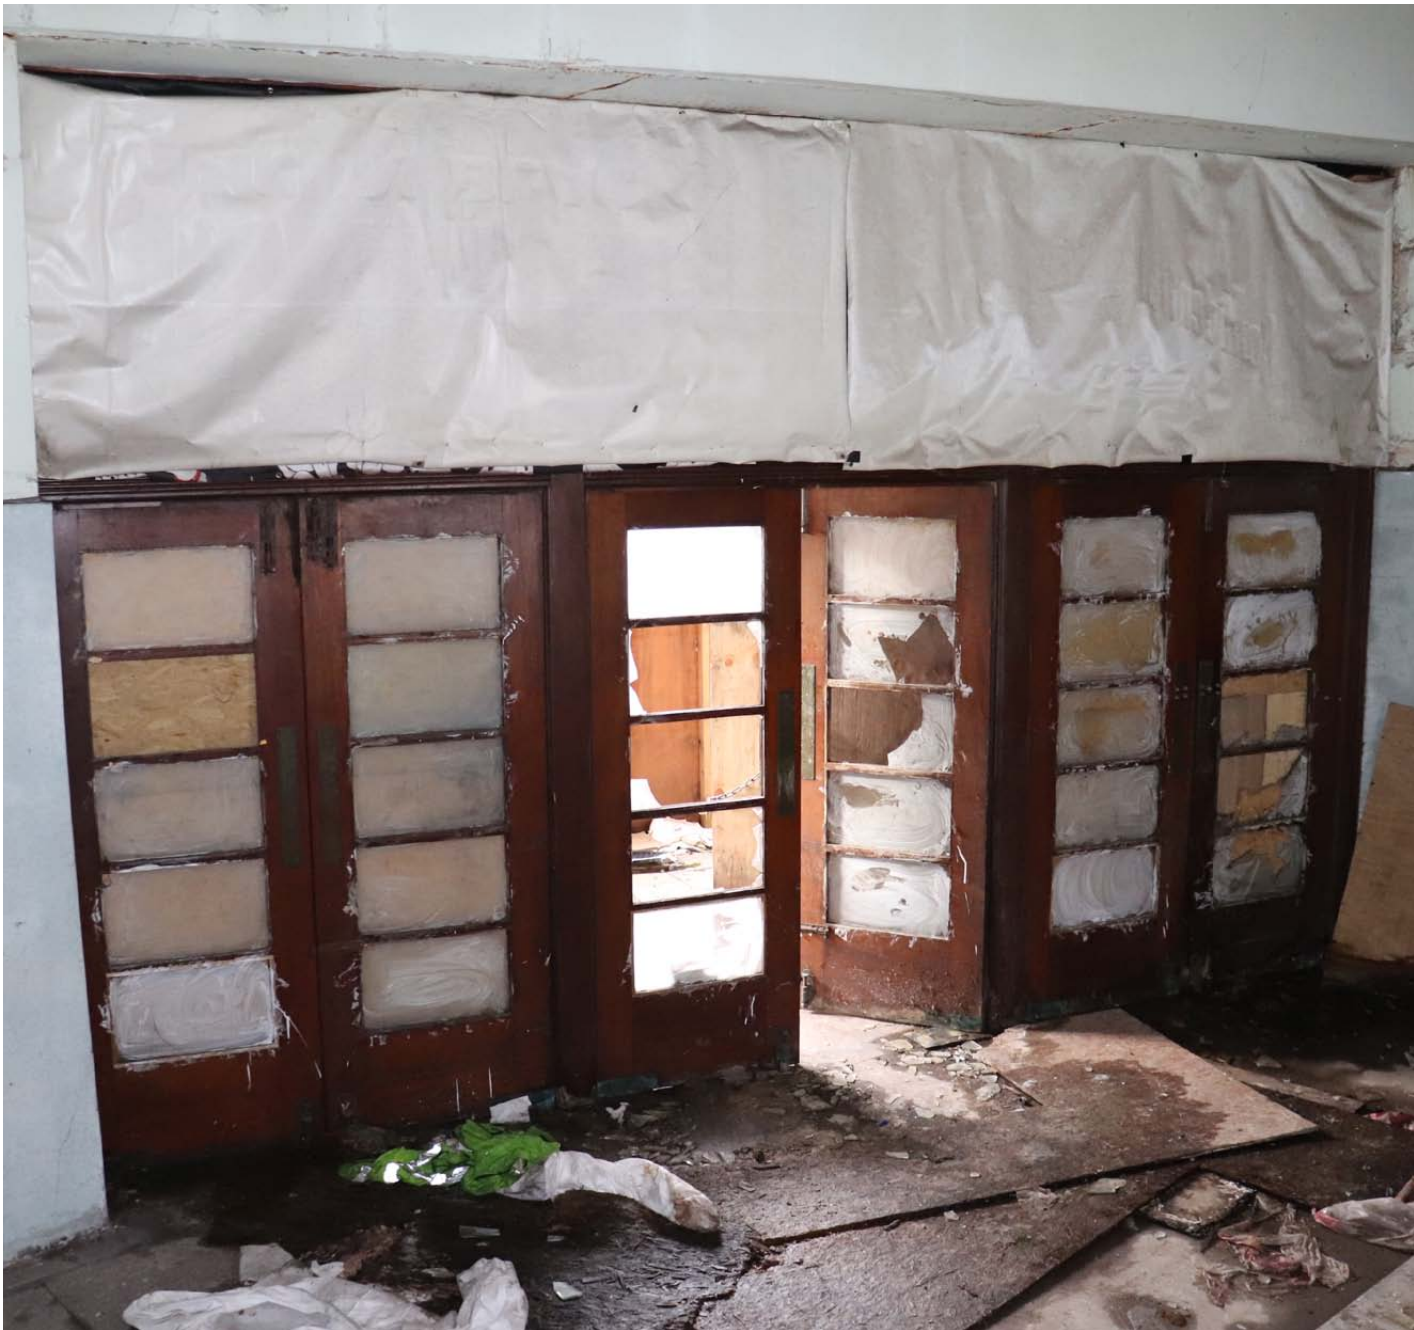
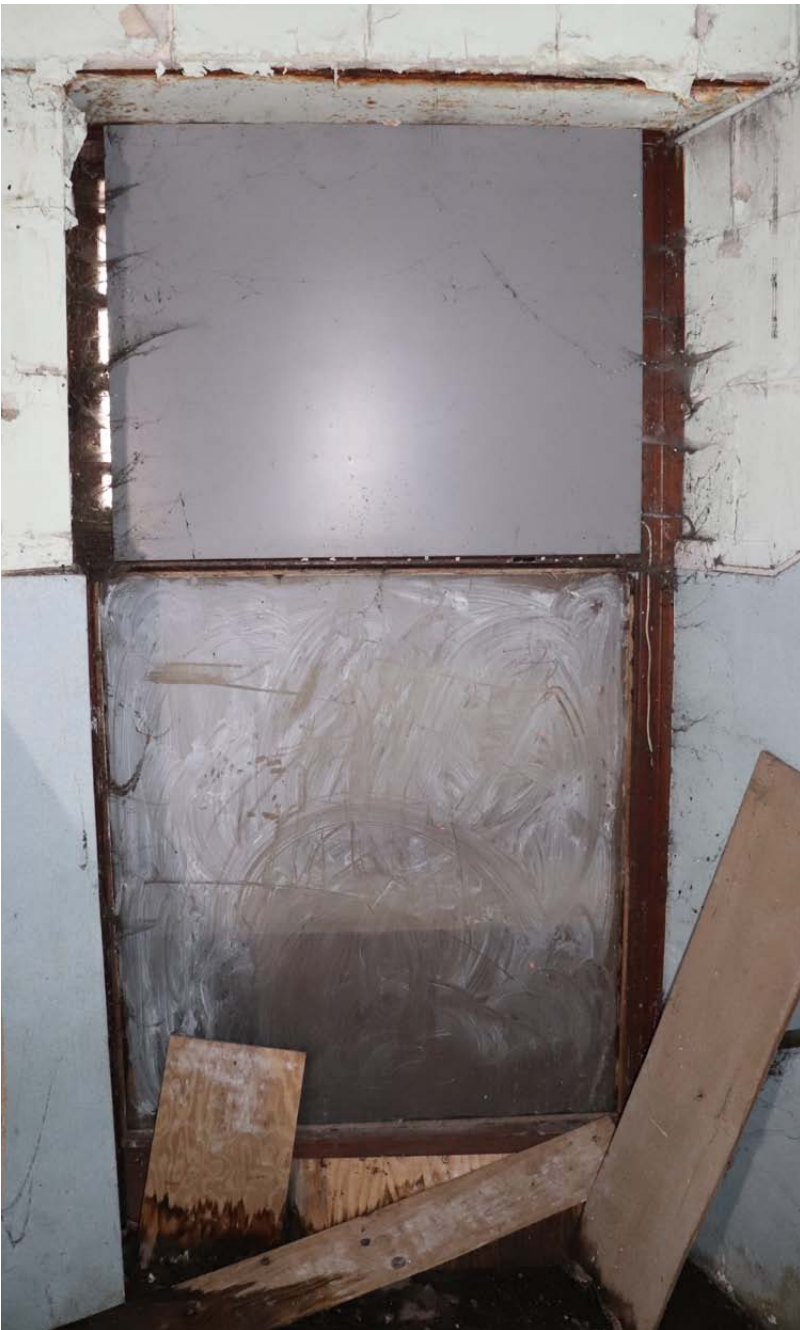
The glass to the doors and side screens is either broken and boarded up or painted out.

The over-panels are also covered up.
