**Plaza, Port Talbot**

**HISTORIC BUILDING RECORDING**

(385)1902-GWP-A-2A-HBR-P00

Date: 06.01.20

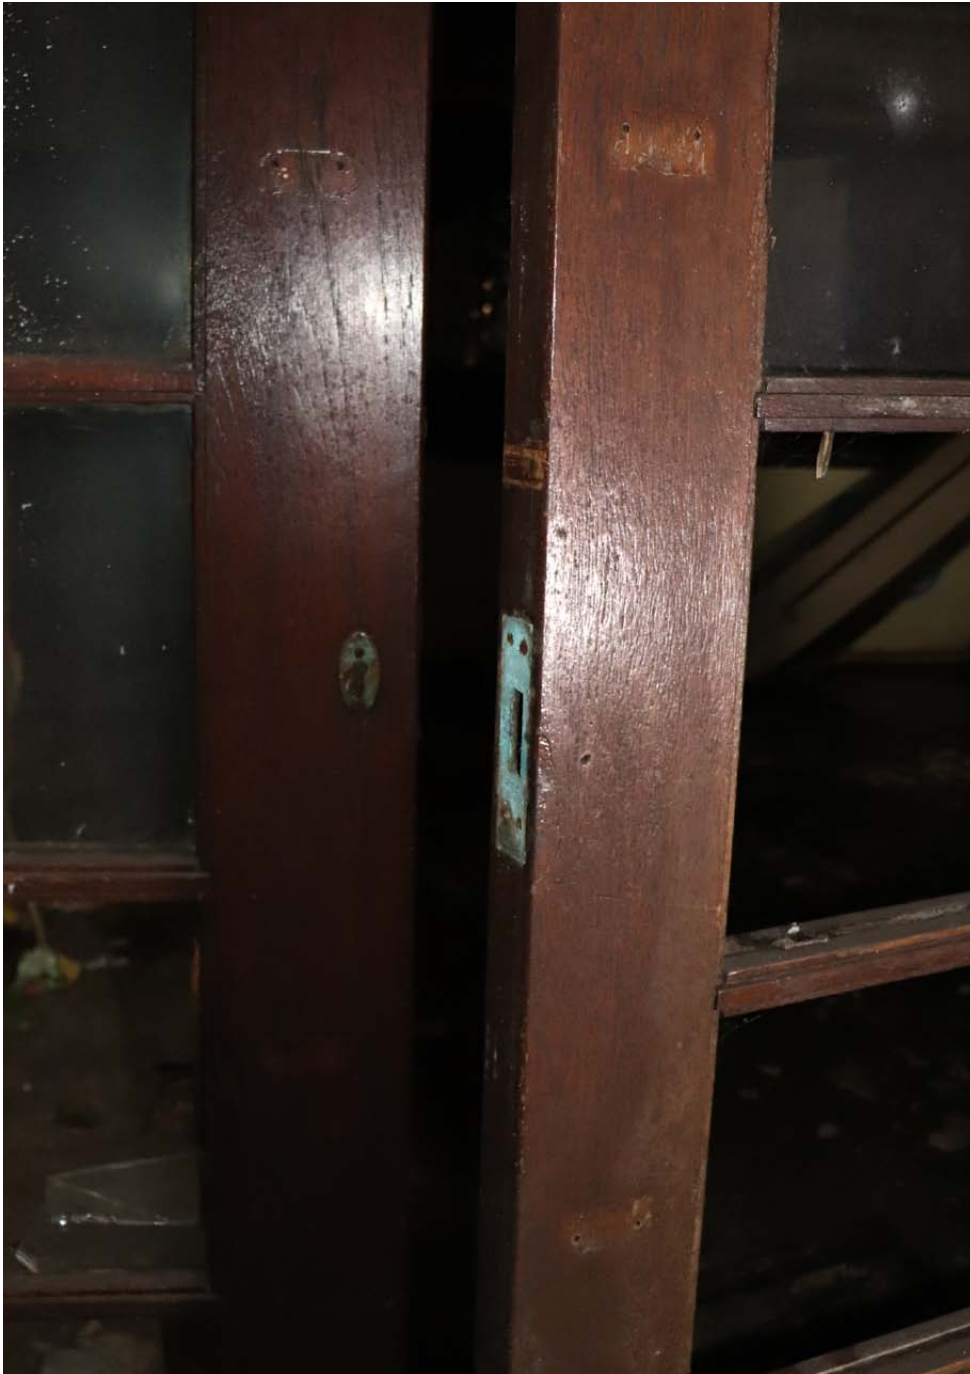
View leading stile of door with holes where handle once was

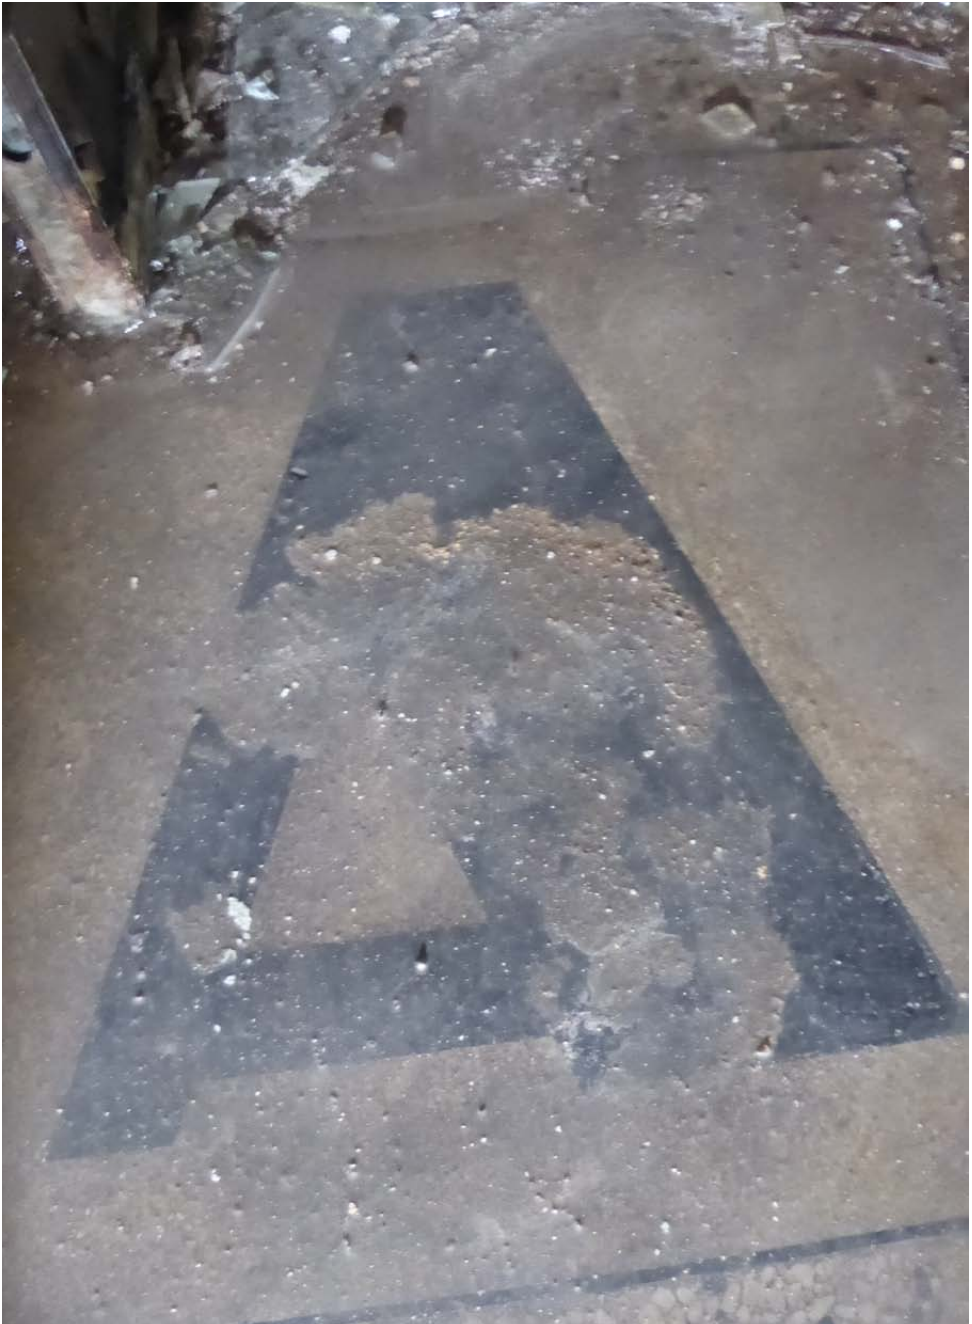
At the top of the steps, just before the bank of doors, painted onto the terrazzo flooring is the word 'PLAZA' in what appears to be 'Broadway' font. It is set within terrazzo of a smaller aggregate and a rectangular box. The final 'A' of the word is in a poor condition, but the other 4no. letters are in a good condition, suggesting that the paint used was extremely robust and long-lasting.

*View of the final 'A' of the 'PLAZA' floor lettering which is damaged*

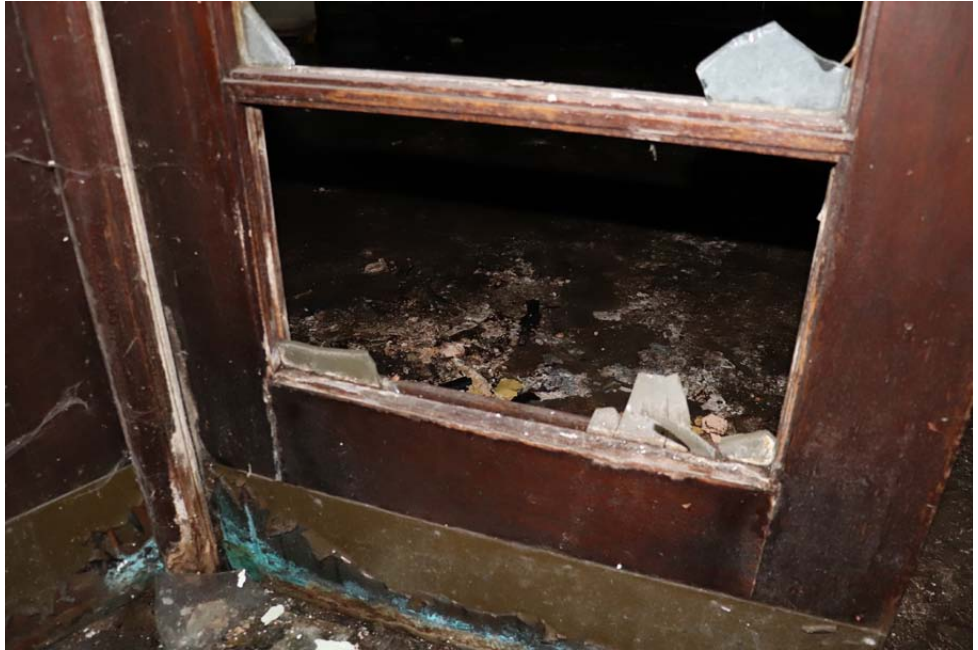
The glazing pattern is of 5no. horizontal panes separated by rebated timber glazing beads. The push plates and kickplates are simple rectangular plates of brass. Much of the glass to the doors is broken.

*View of base of one door with glazing beads and kickplate*

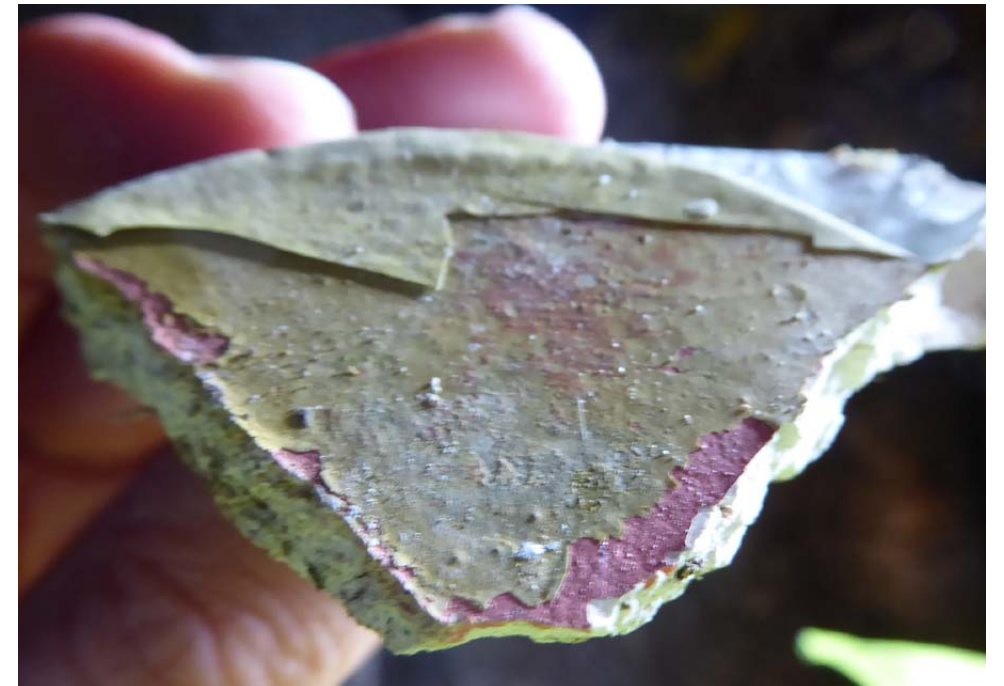
**G8 - Foyer**

On this page is a series of photographs of the chevron profiled frieze (gold / yellow in colour) below the curved coving (white in colour).

Whilst the top two rows of photographs show the frieze principally intact, much of it has been lost throughout the rest of the foyer.

The lower row of photographs shows the profile of the chevron as well as the fact that the gold / yellow paint on the plaster (which appears to comprise two separate coats) appears to have been preceded by a red colour.

Section of chevron plaster with gold / yellow paint preceded by red

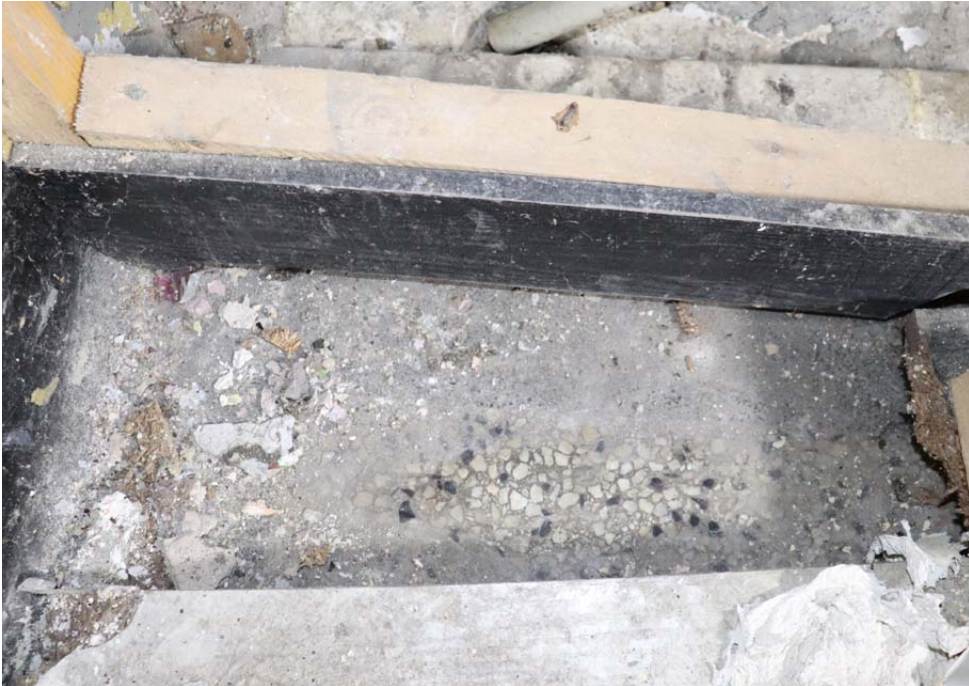
The bottom right photograph shows the grey insitu terrazzo to the Toilets.

*View of grey insitu terrazzo to the toilets*

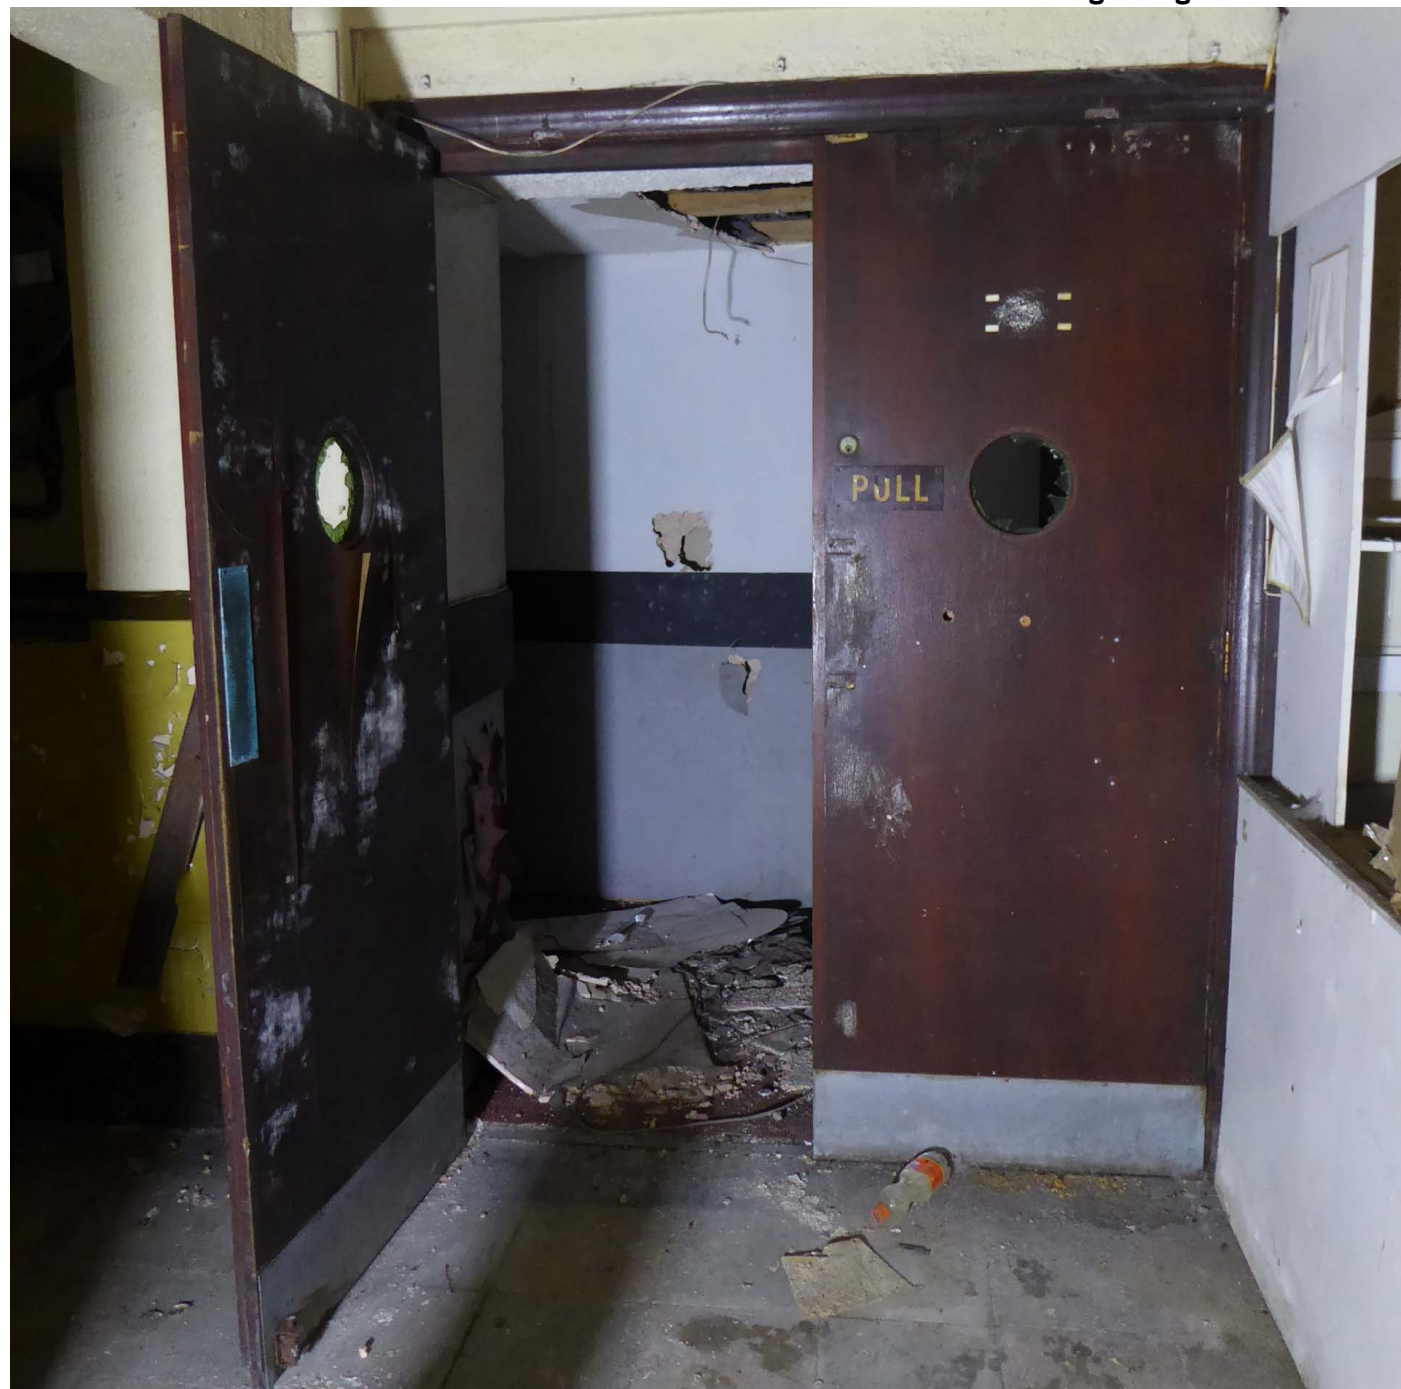
*View of one set of doors - to the west cinema - which is in a reasonable condition*

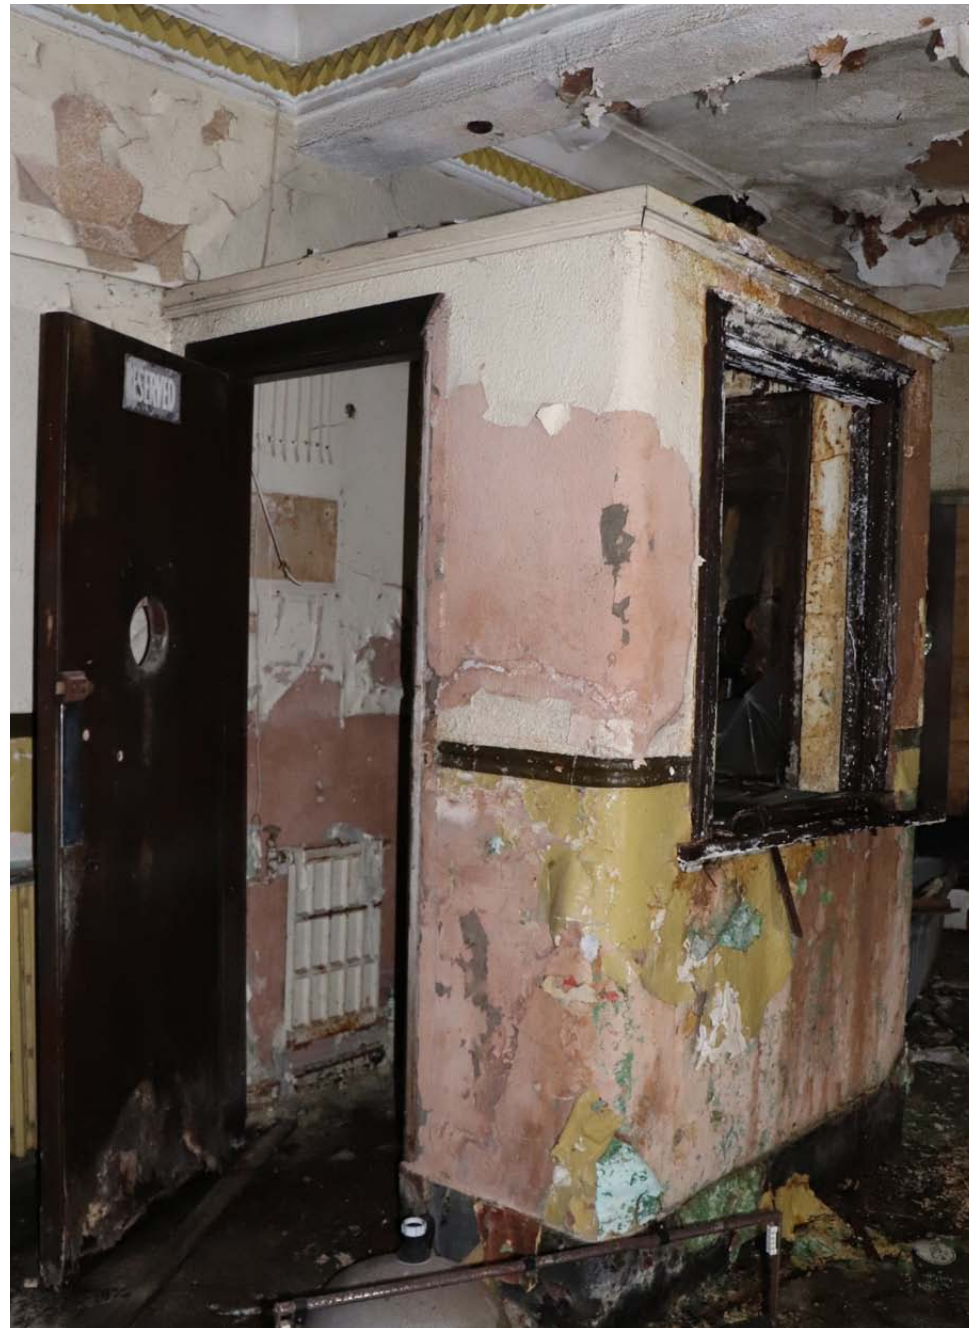
In between the central and right hand doors is a small box office enclosure, which is likely to be original to the building. On this page are photographs of this structure from all sides.

Formed of plastered masonry (treated as the other walls, with a profiled dado) with timber-framed openings to each of three open sides (a door to the west and large window openings to the south and east), it is in a poor condition.

*View of the box office enclosure from the west*

*View of the box office enclosure from the south*

*View of the box office enclosure from the east*

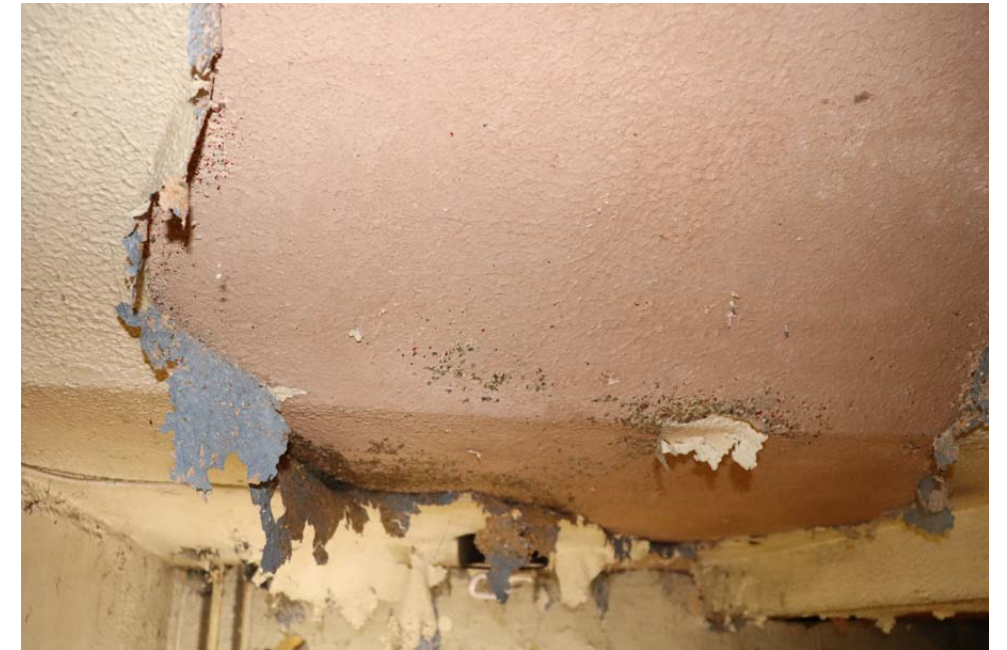
*View of peeling paint to soffit over staircase*

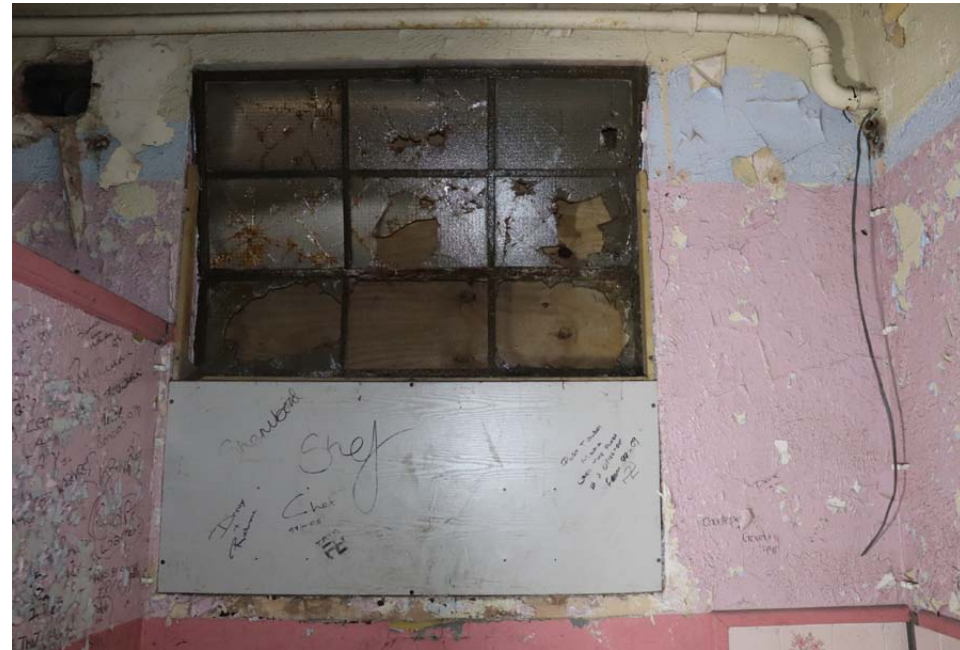
There is a window to the west elevation, with a bottom-hung opener in the top half, with opaque glazing, much of which is broken and boarded up.

**View of the Window to the west elevation**

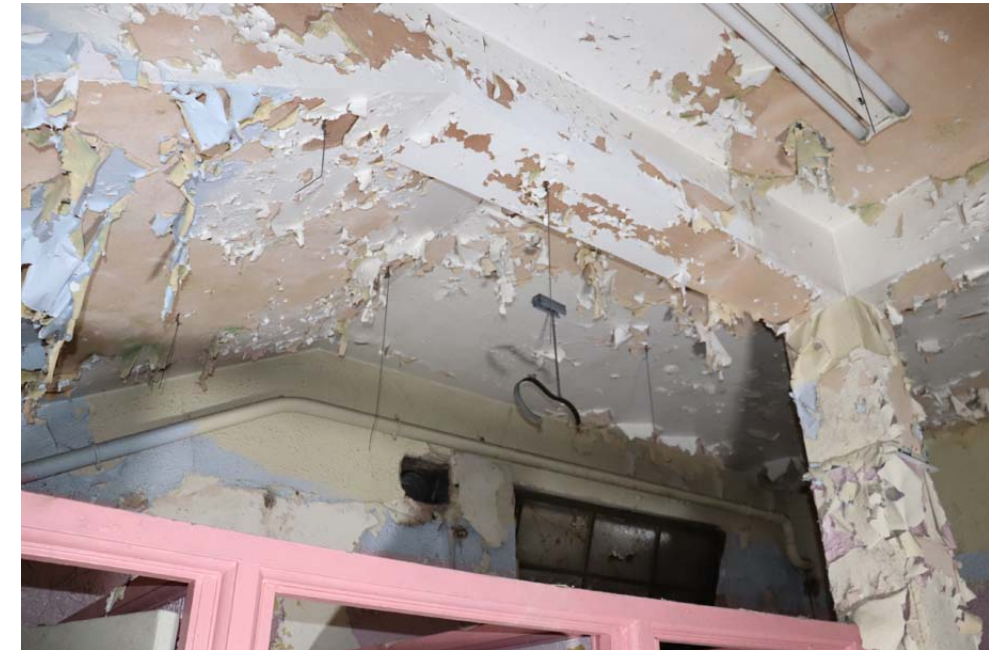
The Wall and Ceiling are painted plaster. The paintwork to all surfaces is badly peeling and there is some damage to the plaster. The lower part of the wall, up to dado, in areas, is papered.

**View of the Ceiling, downstand beam and column**

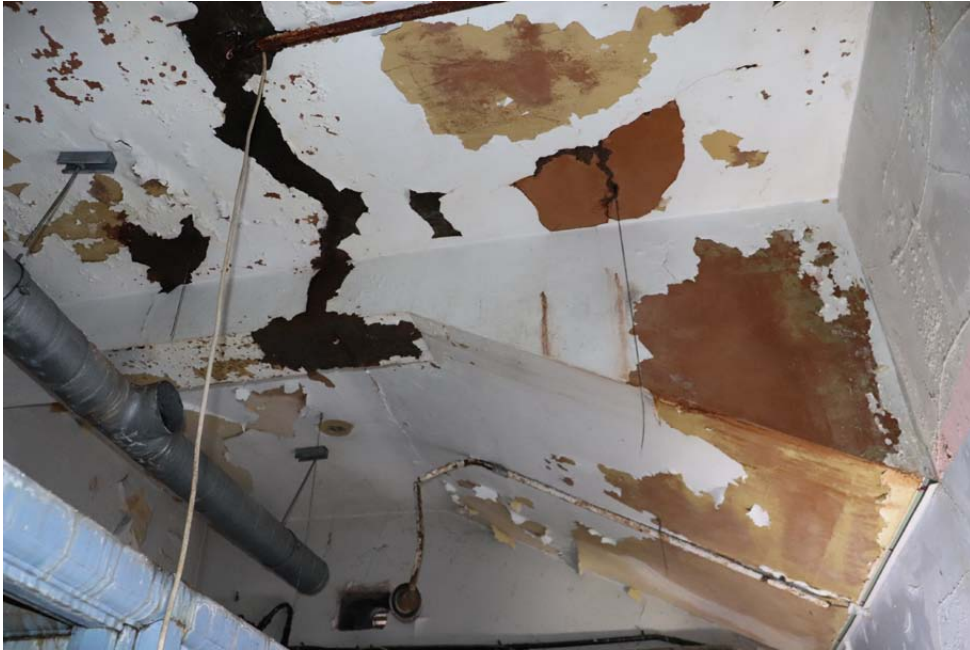
The Wall and Ceiling are painted plaster. The paintwork to all surfaces is badly peeling and there is some damage to the plaster. The lower part of the wall, up to dado, in areas, is papered. The Flooring is insitu grey terrazzo.

*View of the sloping soffit of the staircase within the toilets*

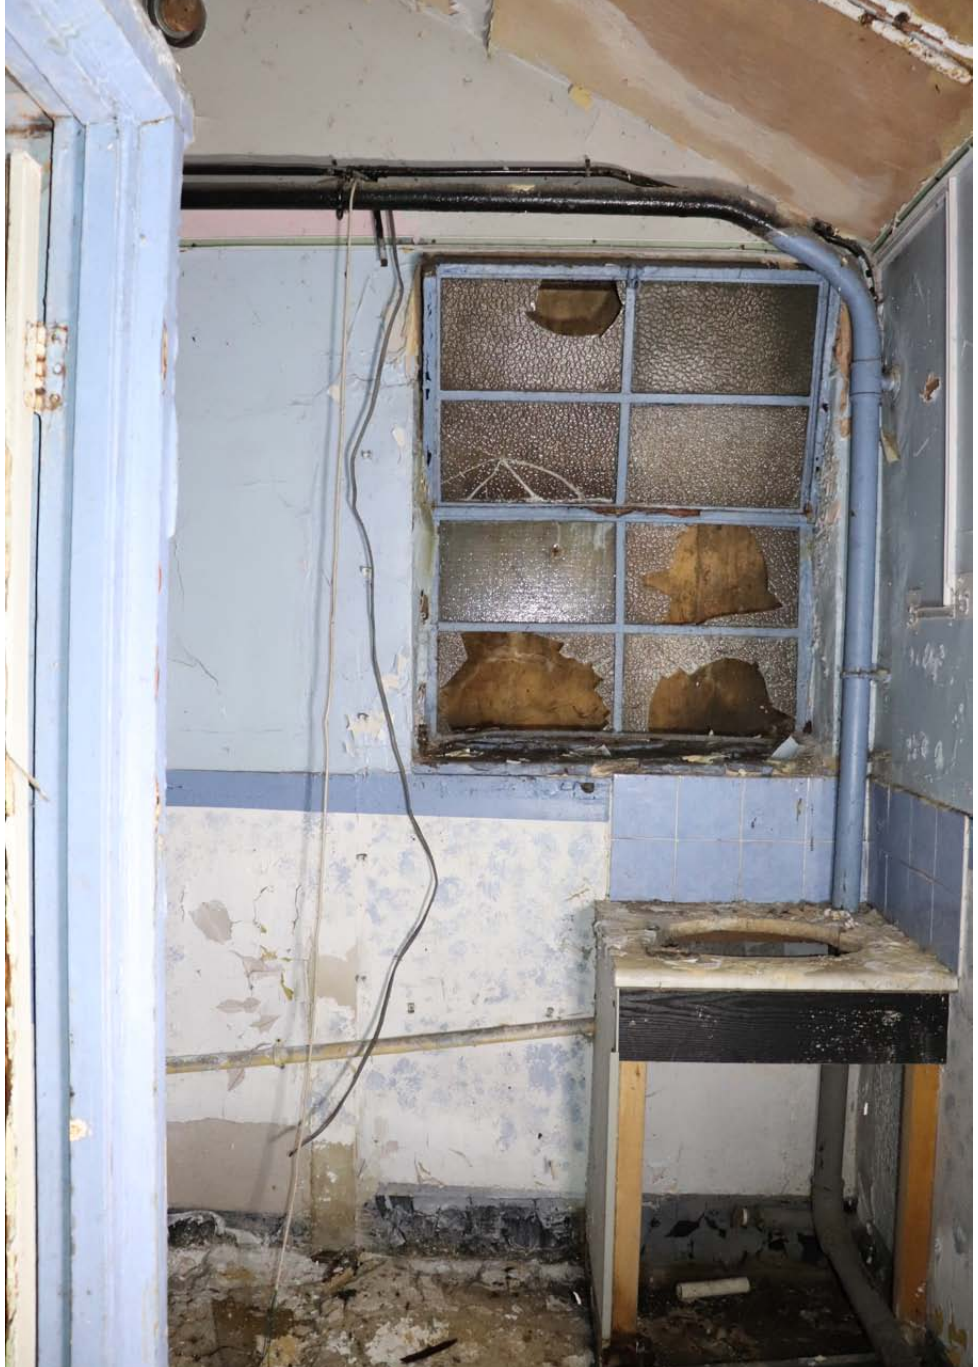
There are 2no. windows to the east elevation (one two panes wide and one one pane wide), with a bottom-hung opener in the top half, of each with opaque glazing, much of which is broken and boarded up.

*View of the larger window to the east elevation*

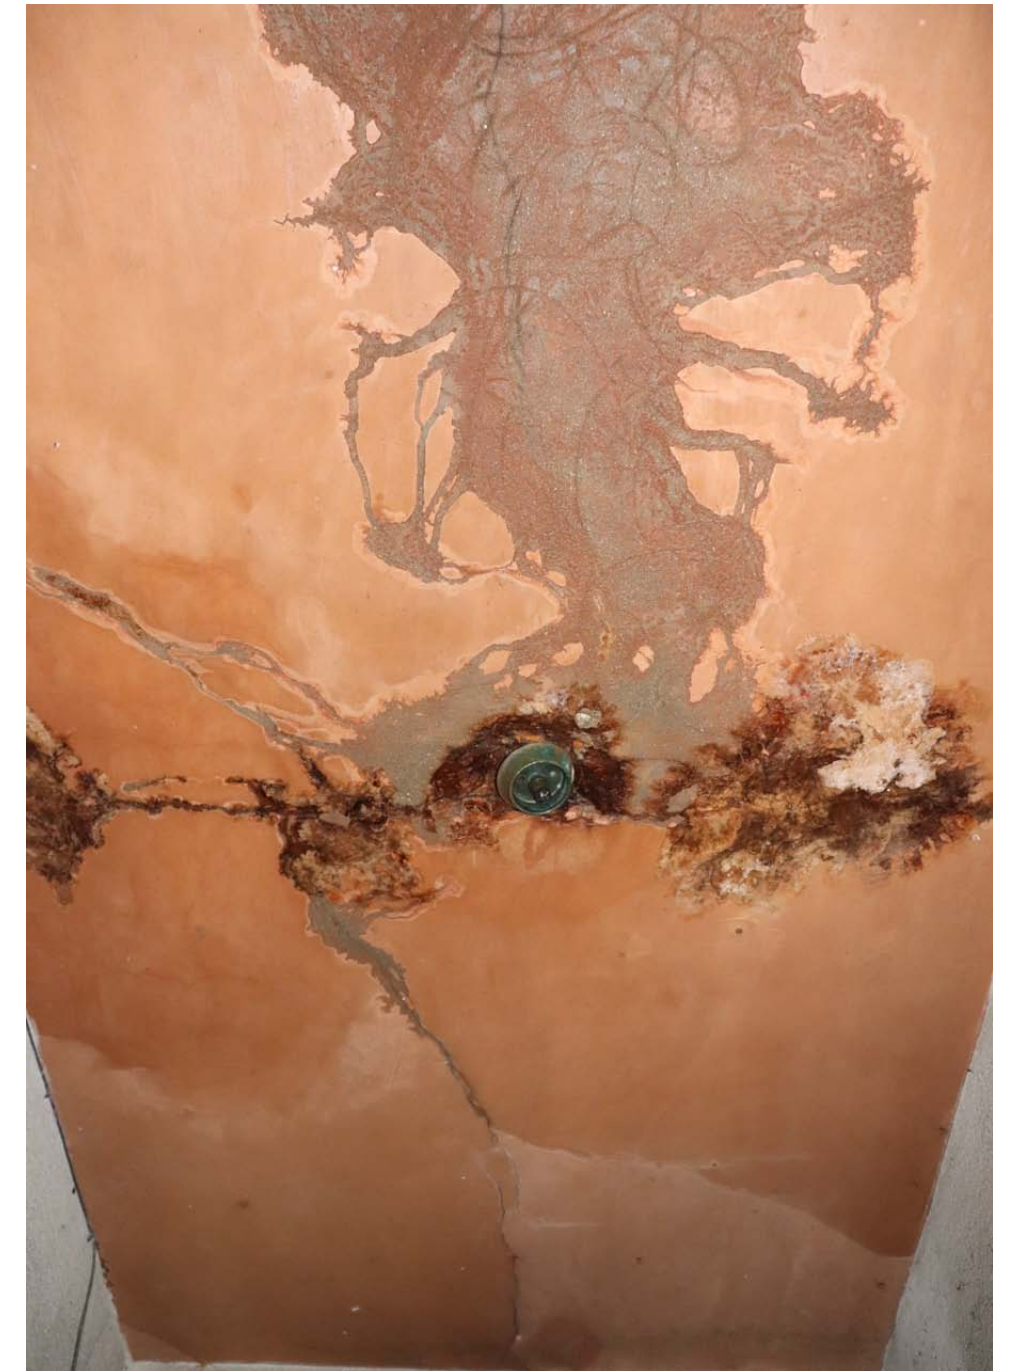
The Walls and Ceiling are painted plaster in a poor condition.

**View of ceiling in poor condition**

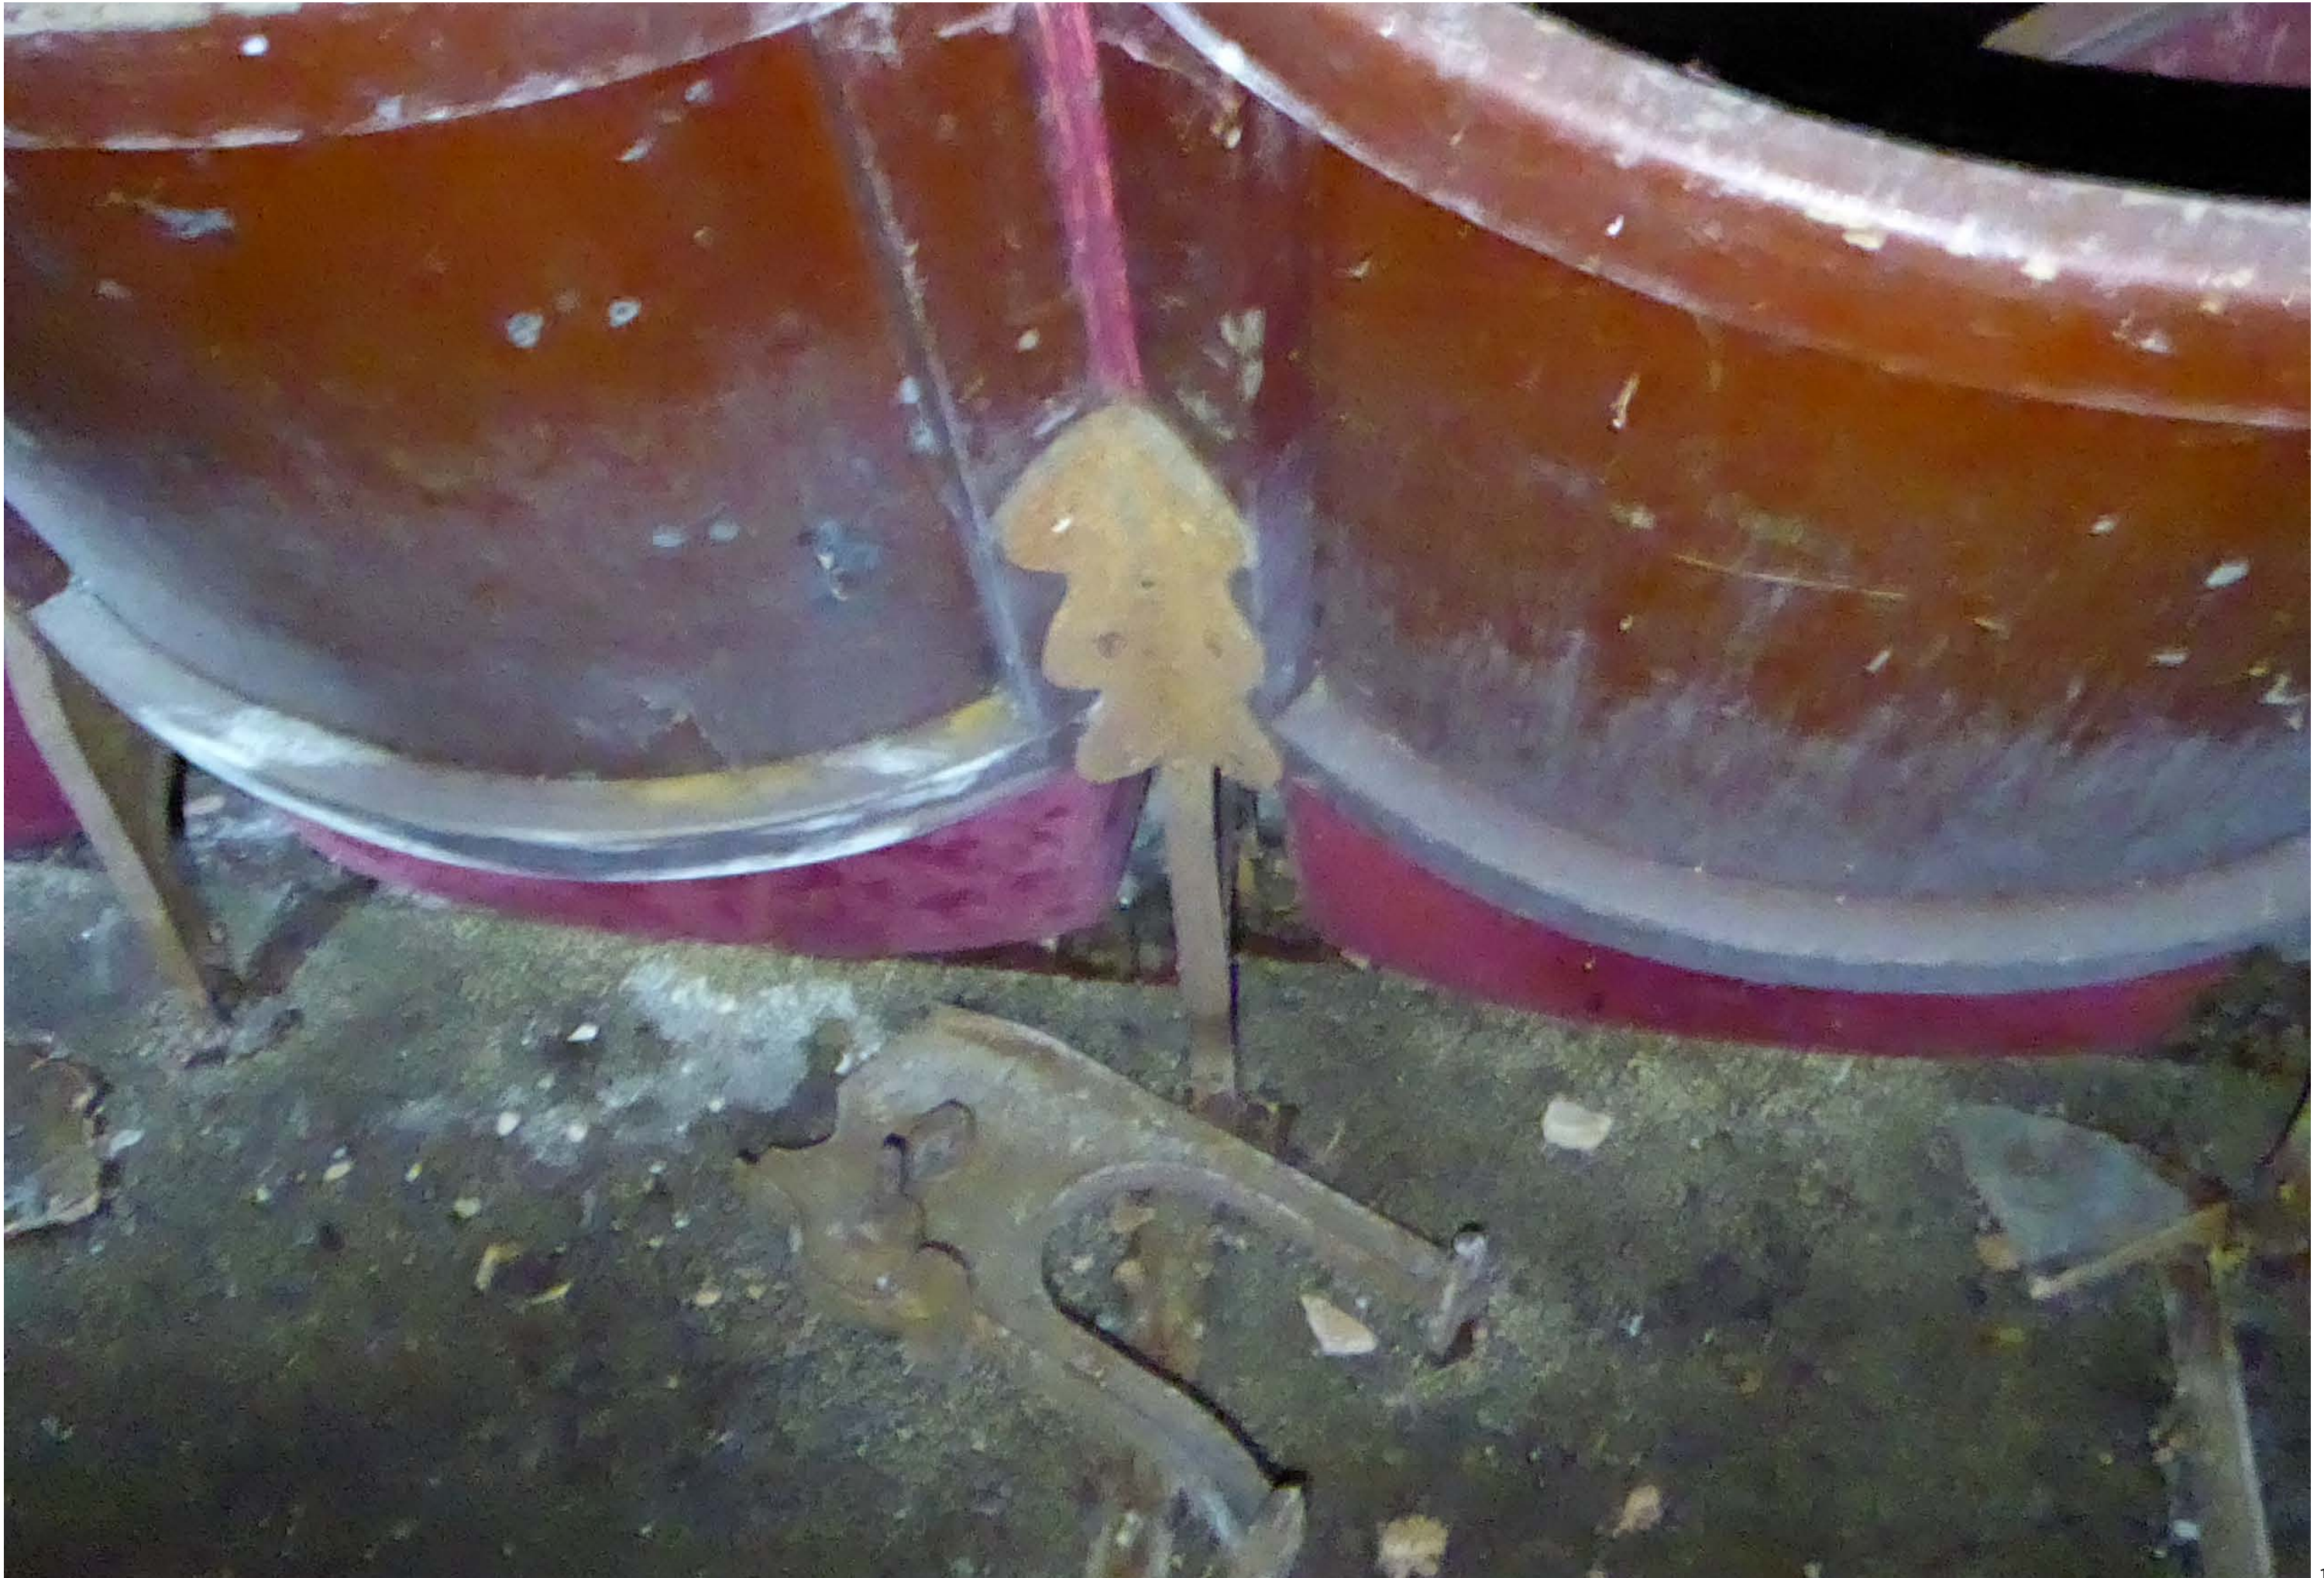
*View of the rear of the seats with their timber curved backs and the metal support in between each seat. The metal stand lying on the floor is a broken version of the stand visible between the seats*

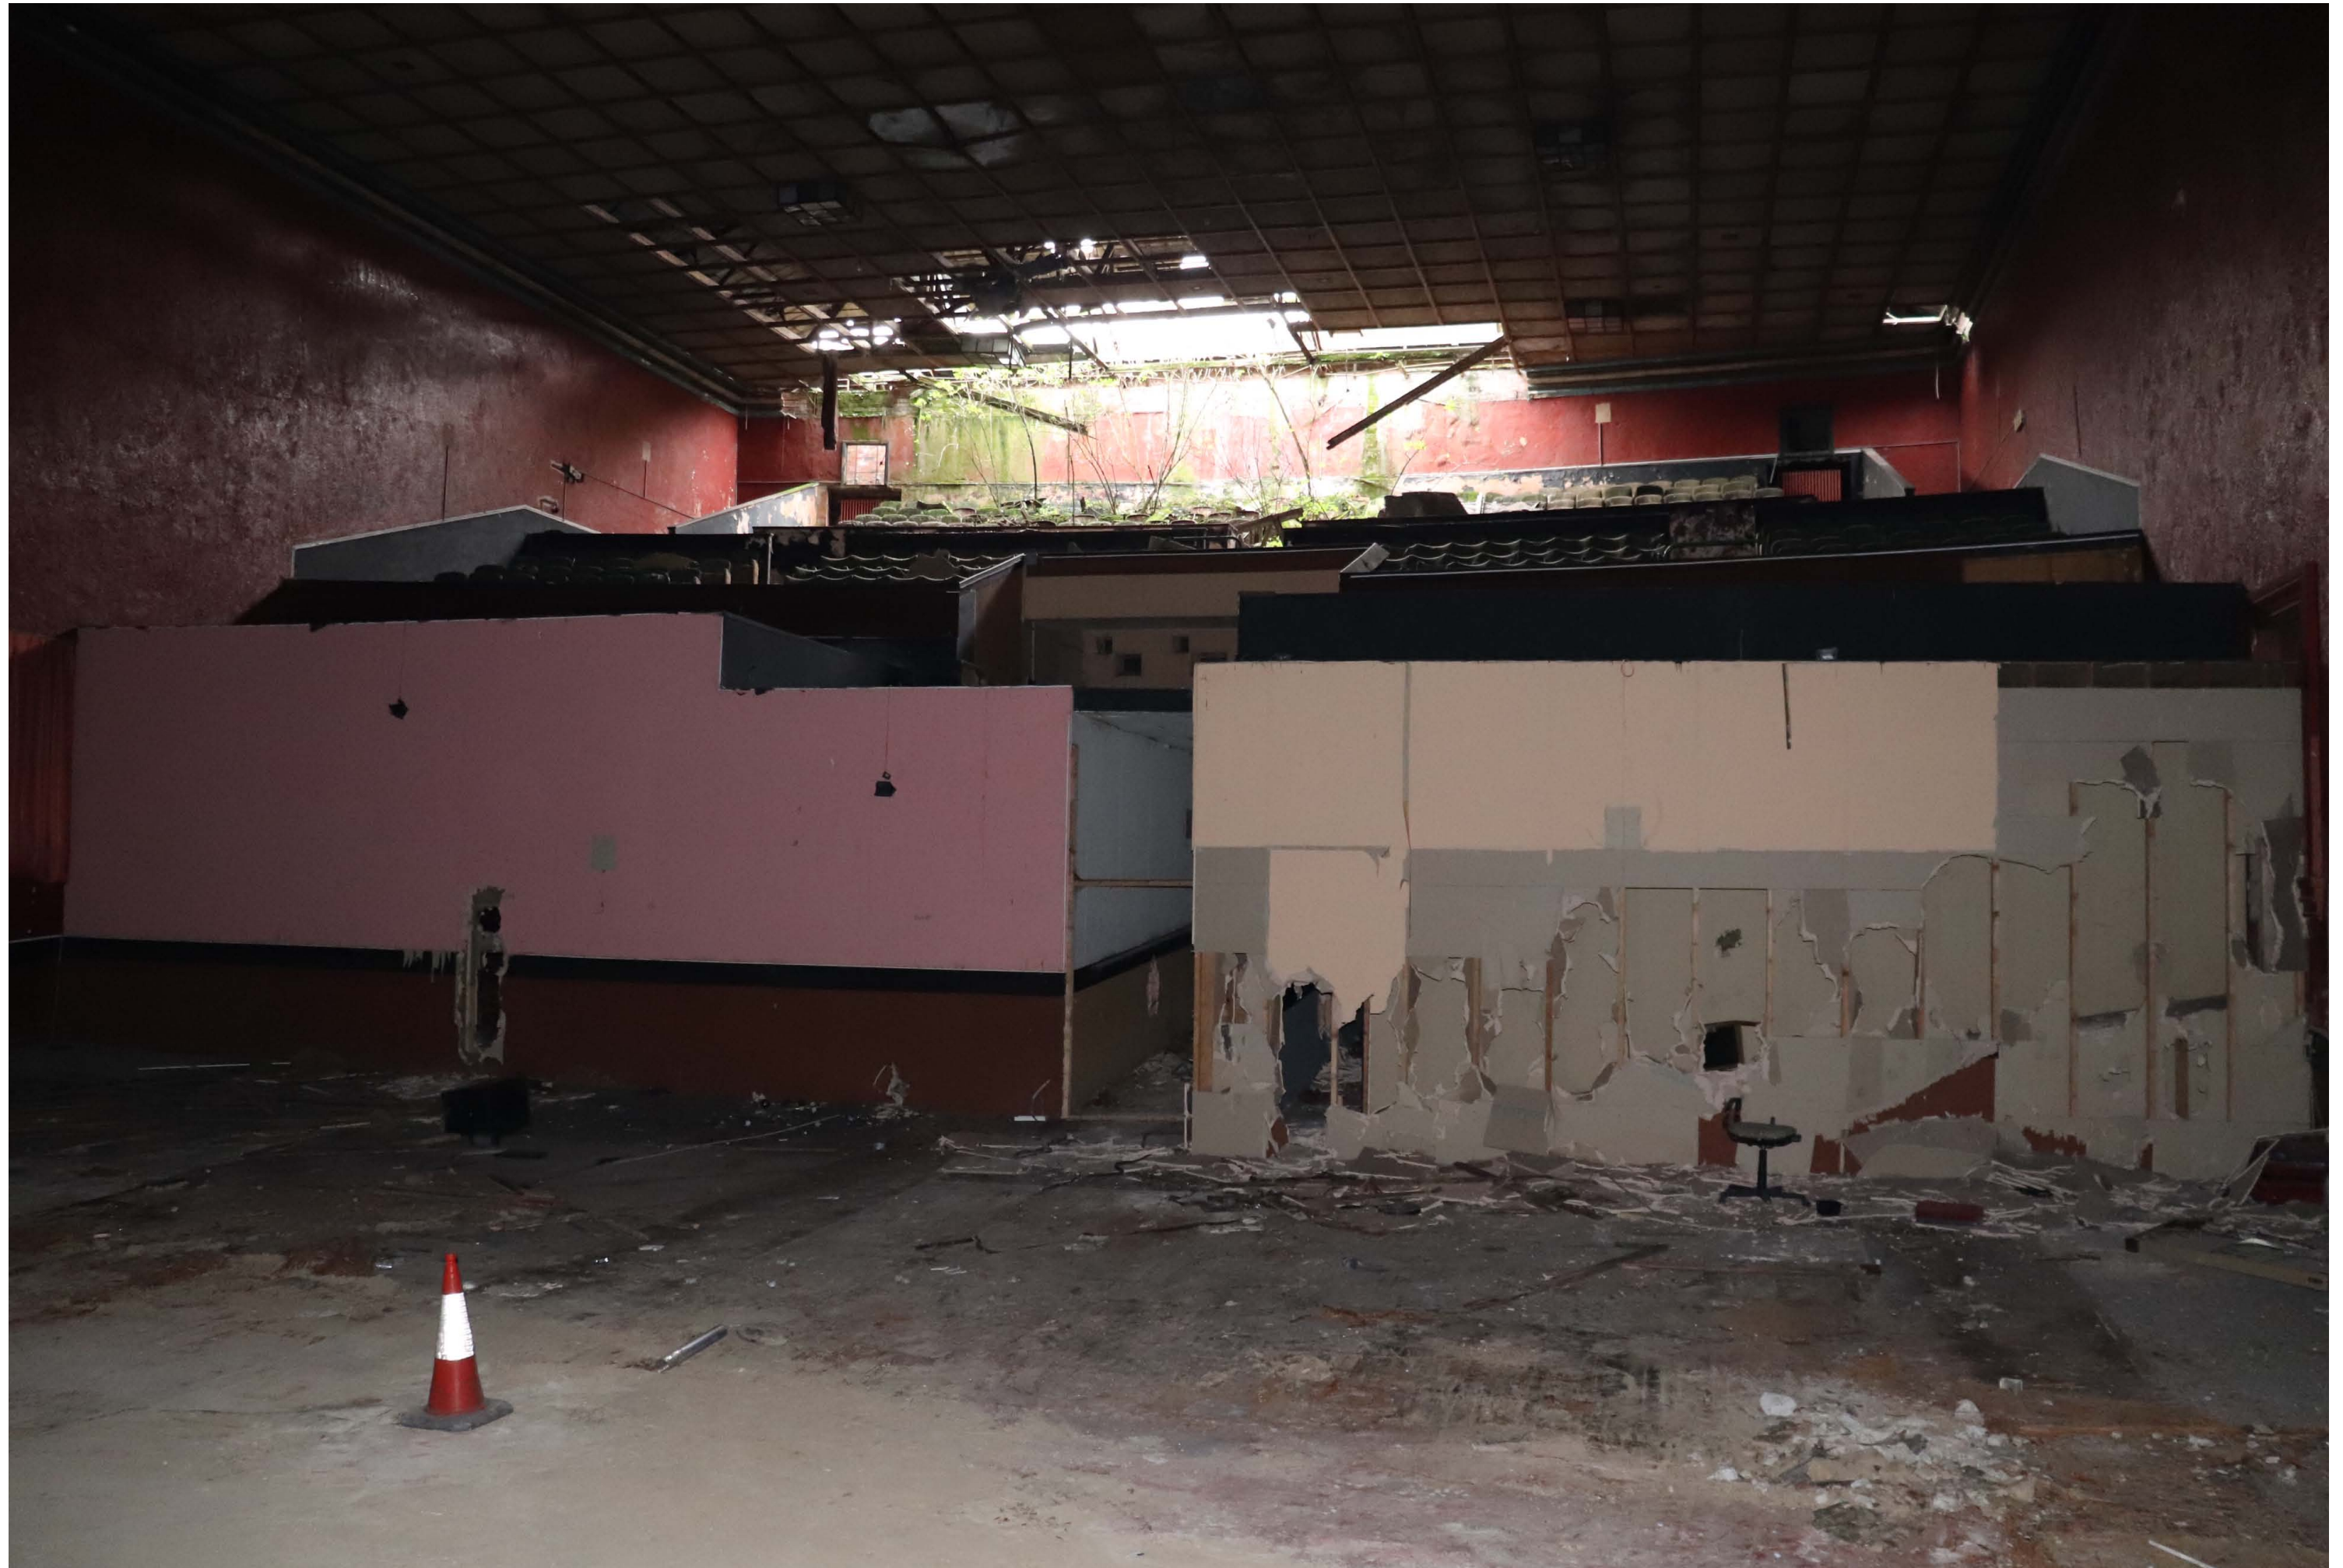
**G17 - Auditorium** - View looking from stage back to Auditorium, with upper balcony seating and large hole in roof at rear, and plasterboard on timber studwork enclosure to both cinemas with central corridor in between both

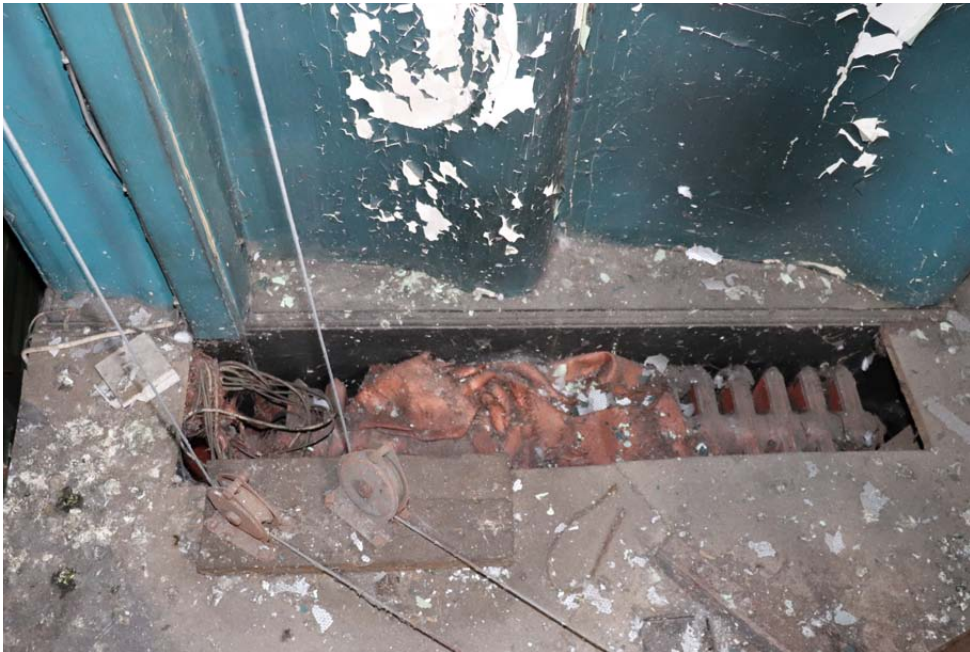
View of recess in stage with cat iron radiator dripped below stage

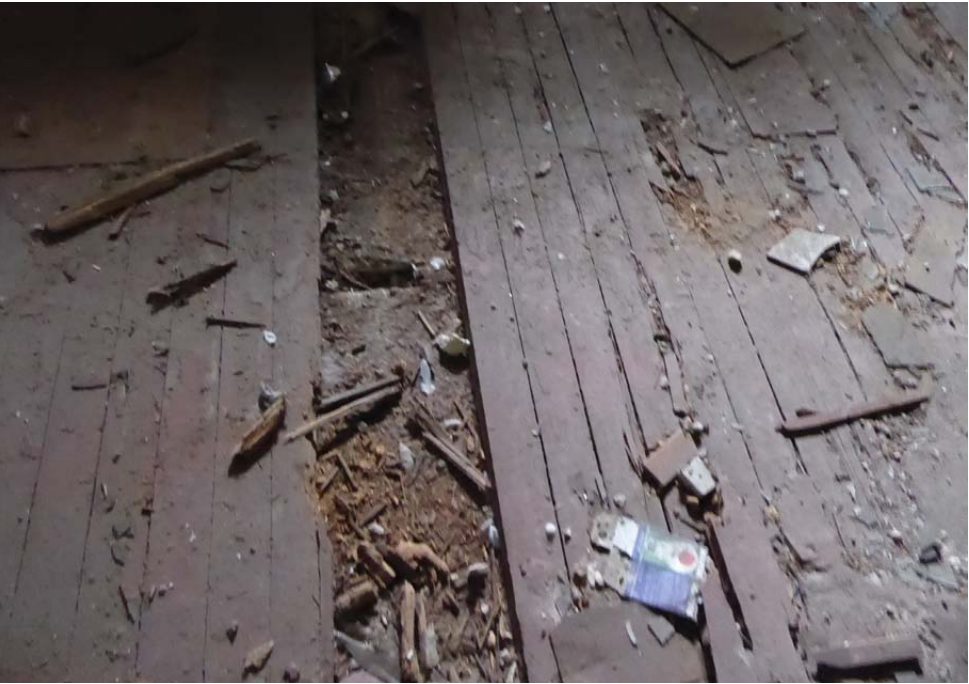
View of timber boarded flooring to auditorium in poor condition
