**Plaza, Port Talbot**

**HISTORIC BUILDING RECORDING**

(385)1902-GWP-A-2A-HBR-P00

Date: 06.01.20

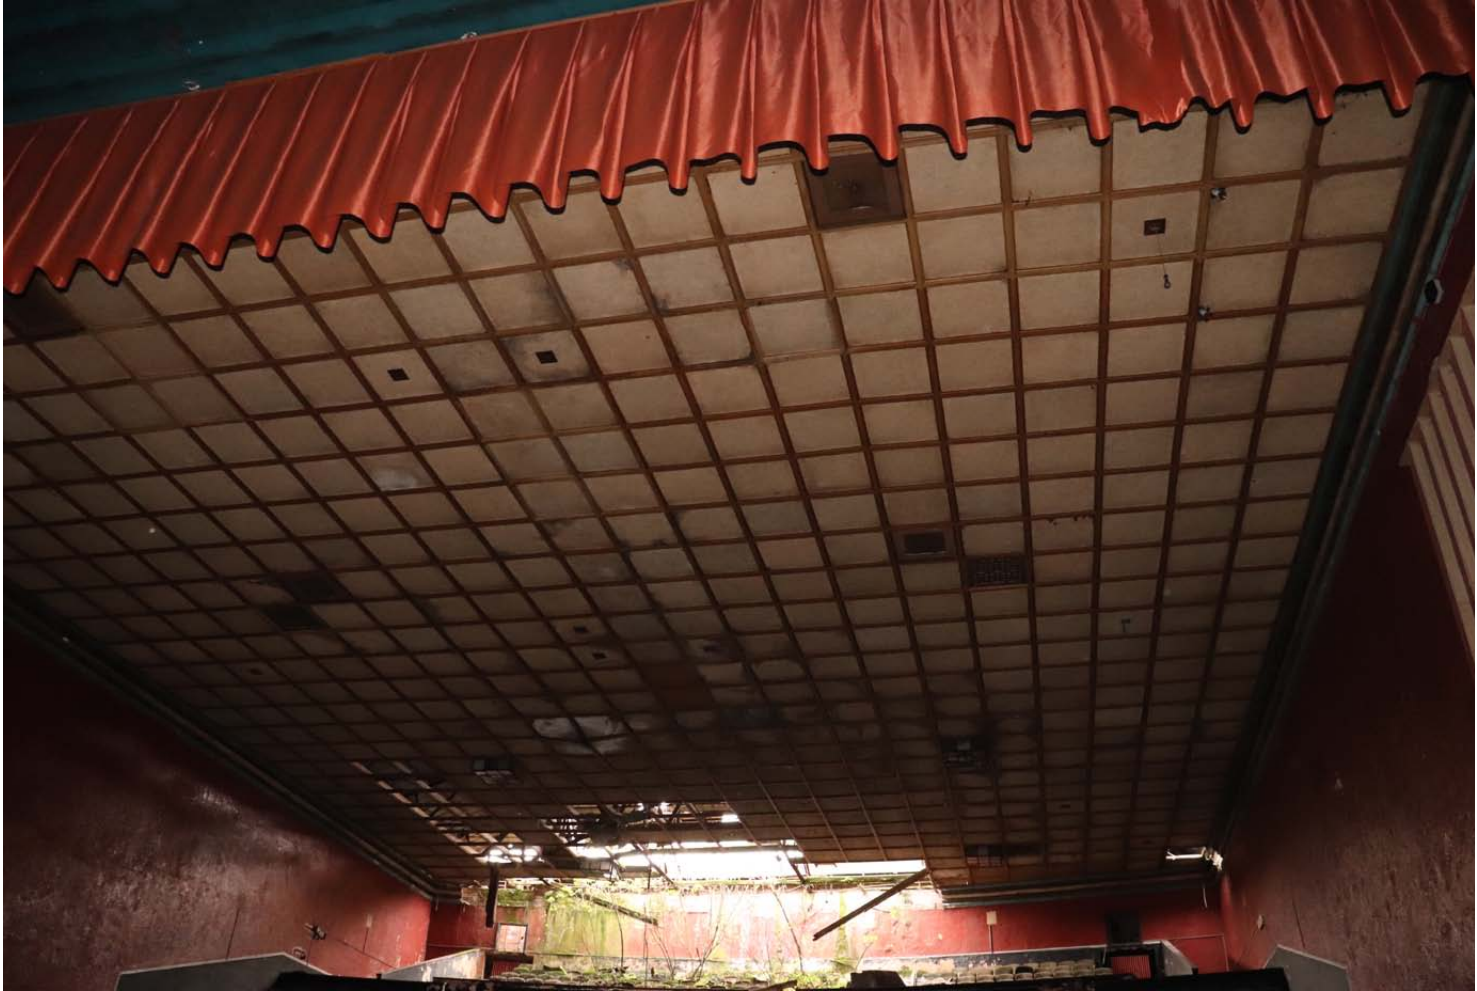
View of ceiling to Auditorium as seen from forestage with hole of roof at far end

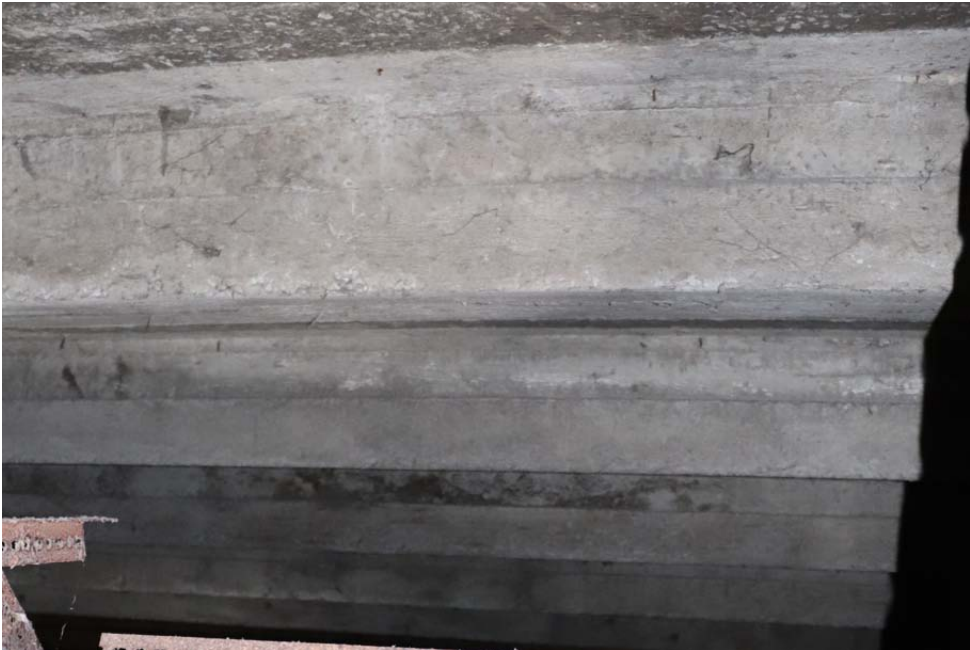
The Walls and Ceilings are of painted plaster, with paintwork in a very poor condition and areas of plaster damage.

*View to void underneath the concrete auditorium balcony seating*

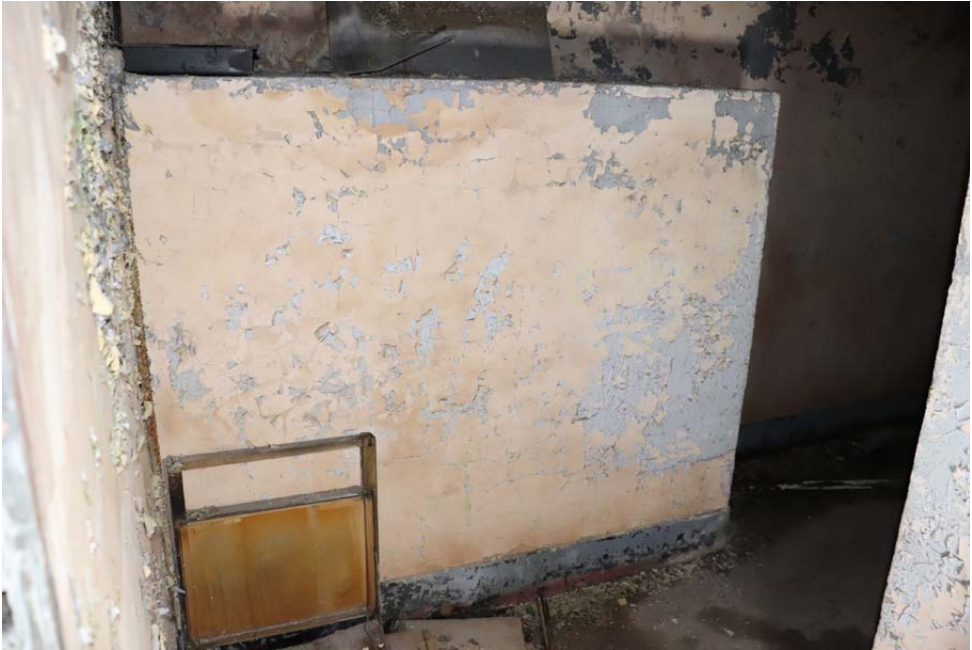
*View of masonry construction providing headroom to the staircase*

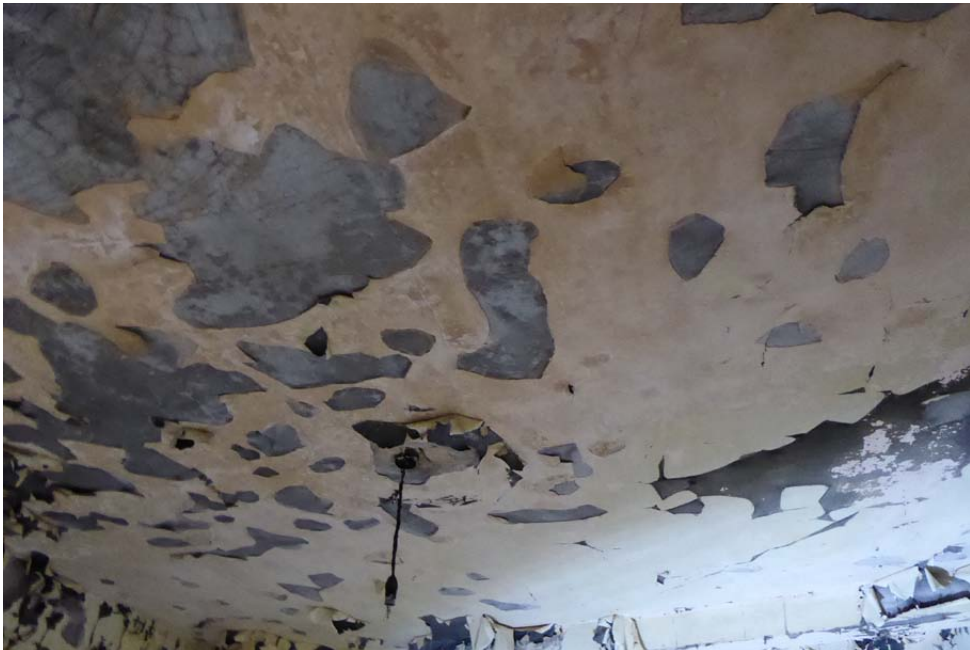
View of peeling paintwork to plastered concrete soffit

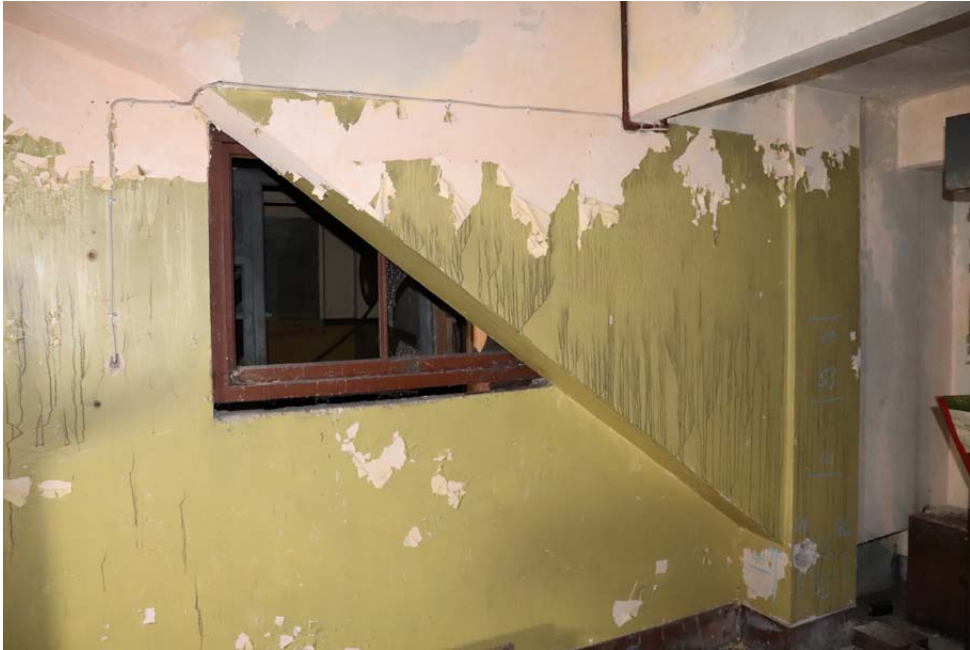
The Walls and Ceilings are of painted plaster, with paintwork in a very poor condition and areas of plaster damage.

West wall to space showing raking concrete ‘beam’ to seating above

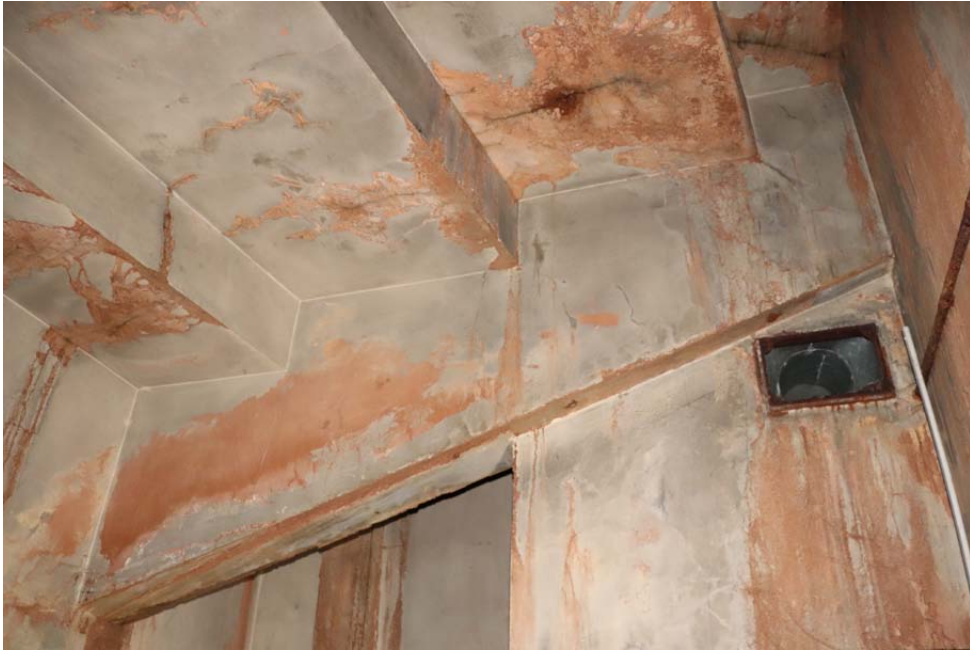
The Walls and Ceilings are of painted plaster, with paintwork in a very poor condition and areas of plaster damage.

*View of soffit showing raking concrete 'beam' and flat seating above*

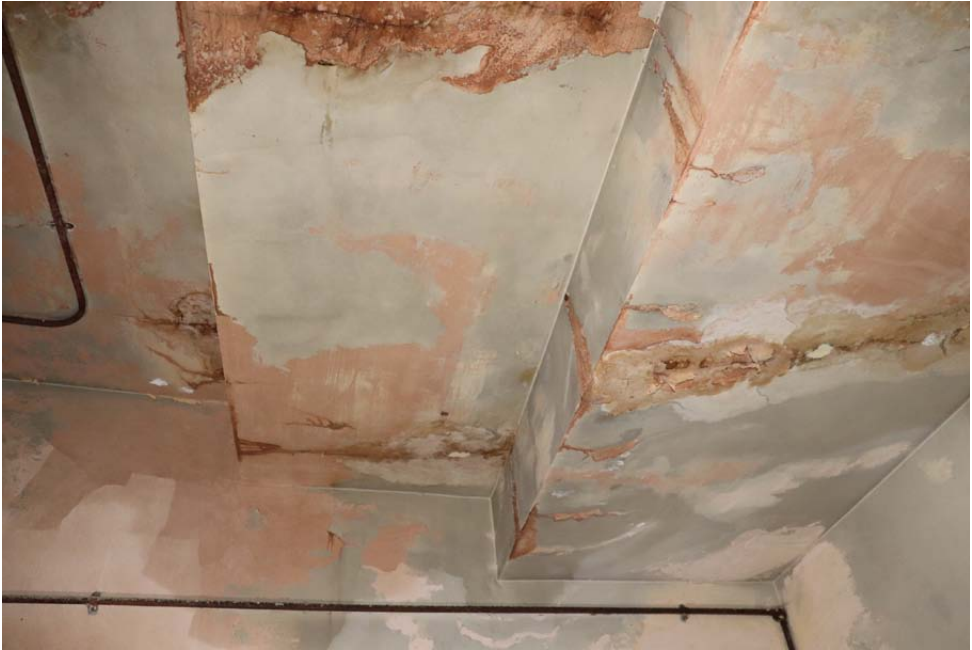
*Further view of soffit showing flat concrete seating above*

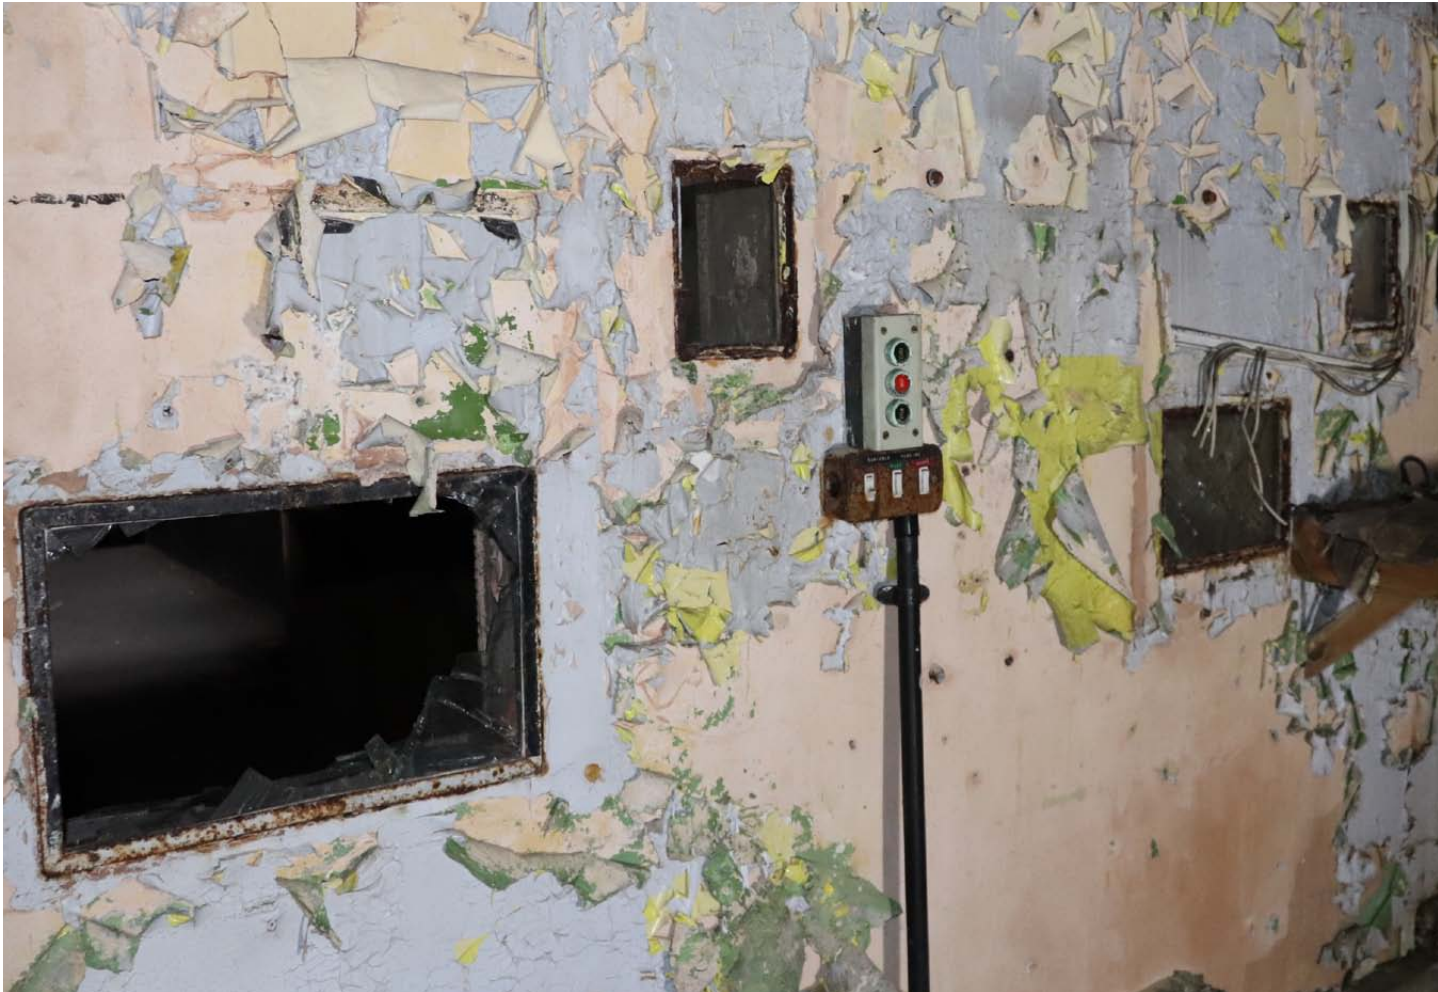
View of glazed projection openings as seen from the left

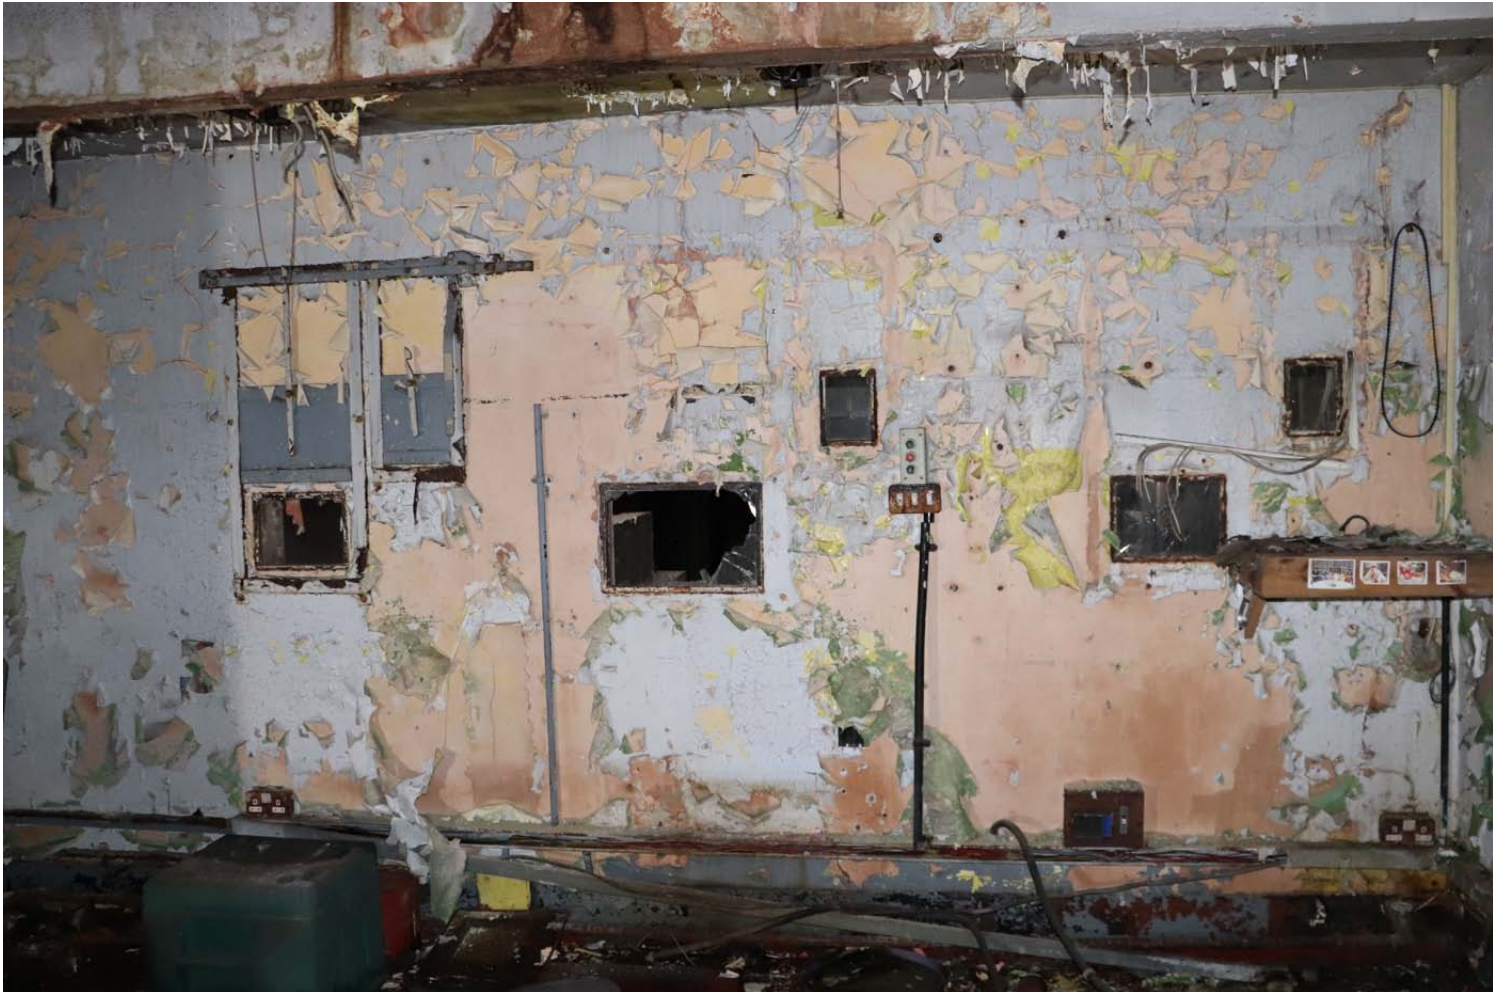
View of glazed projection openings as seen straight on

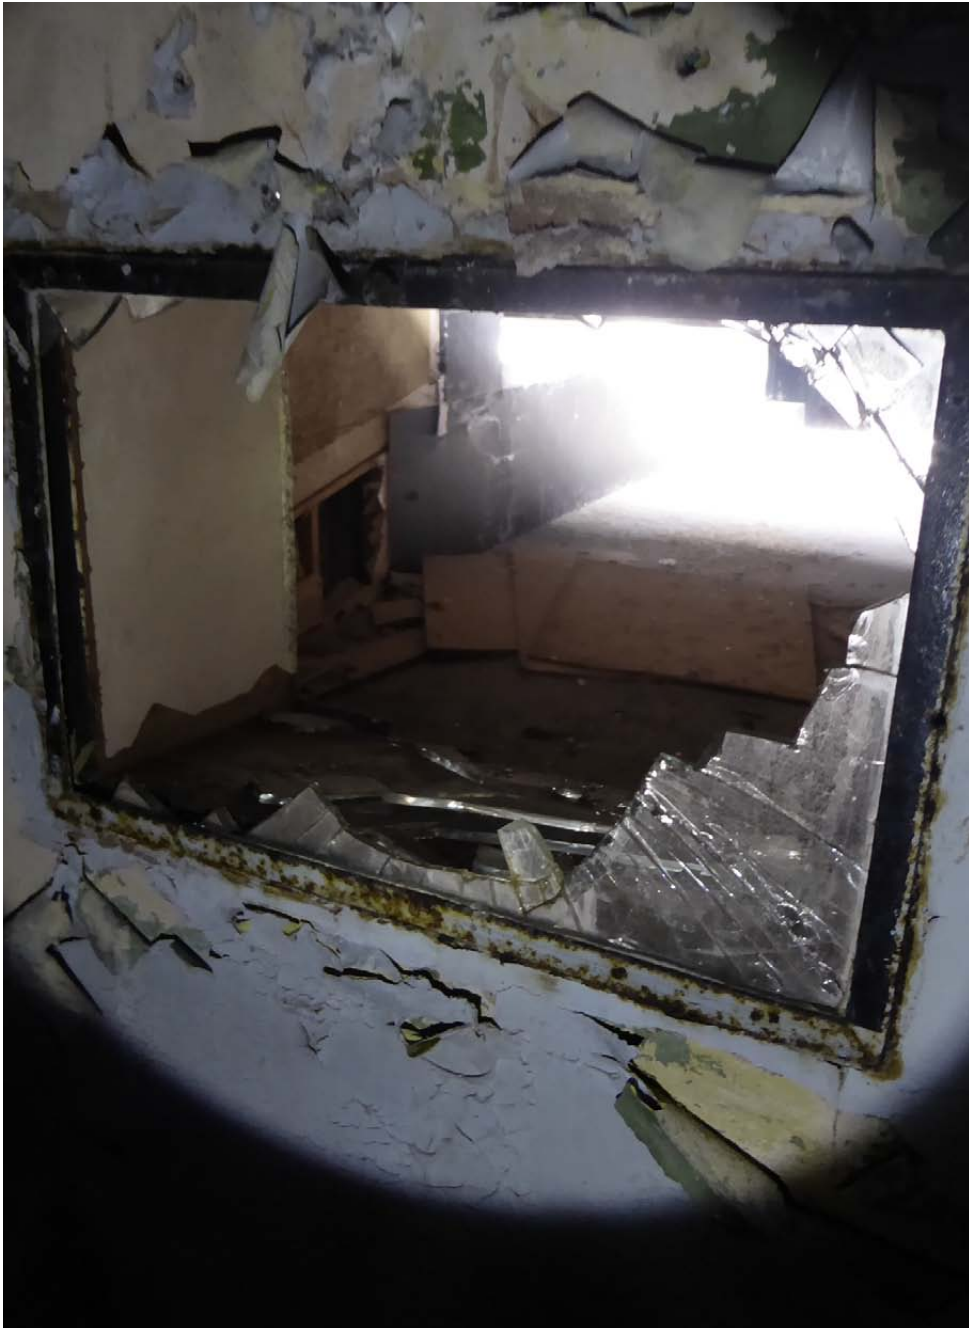
View of one of the projection window with the broken glass

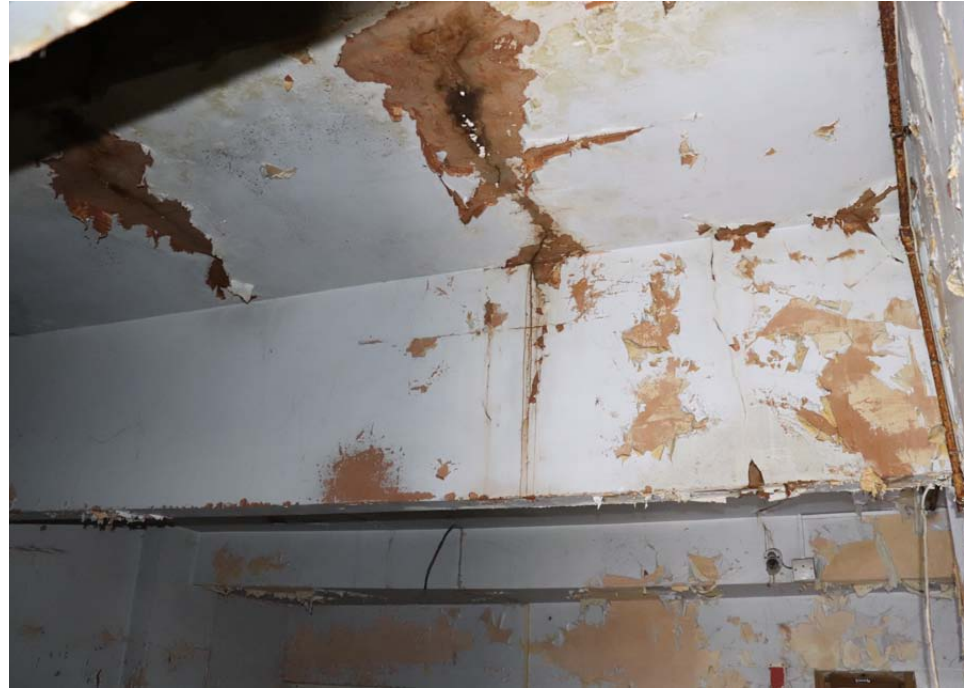
*View of the concrete soffit with spalling concrete & damaged re-bar*

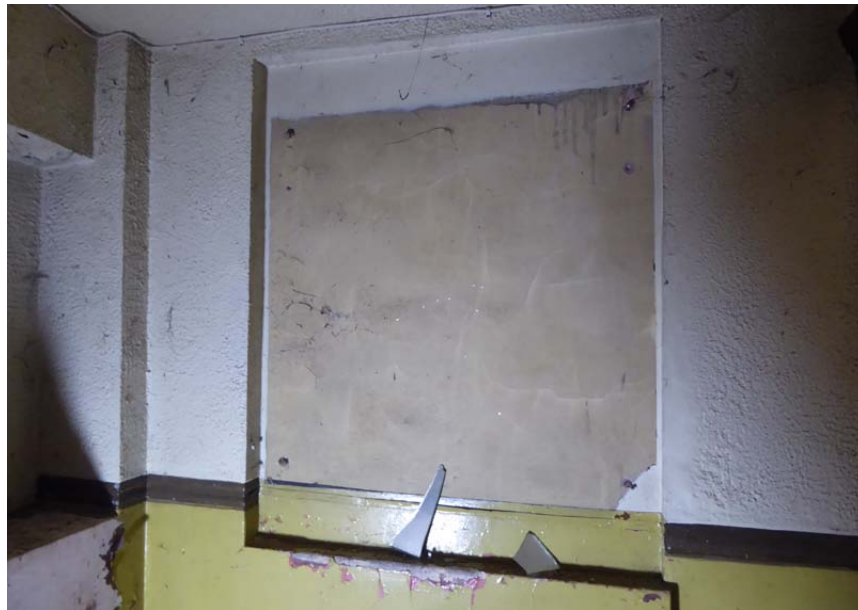
*View of blocked up opening to stair landing*

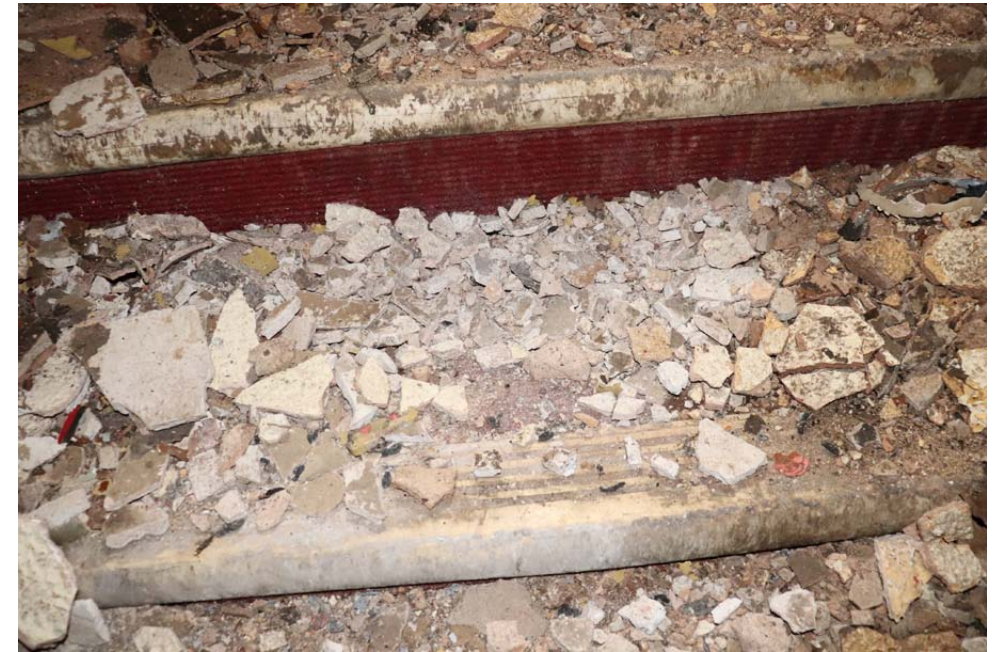
*View of carpeted timber stairs with pvc nosings & debris from above*

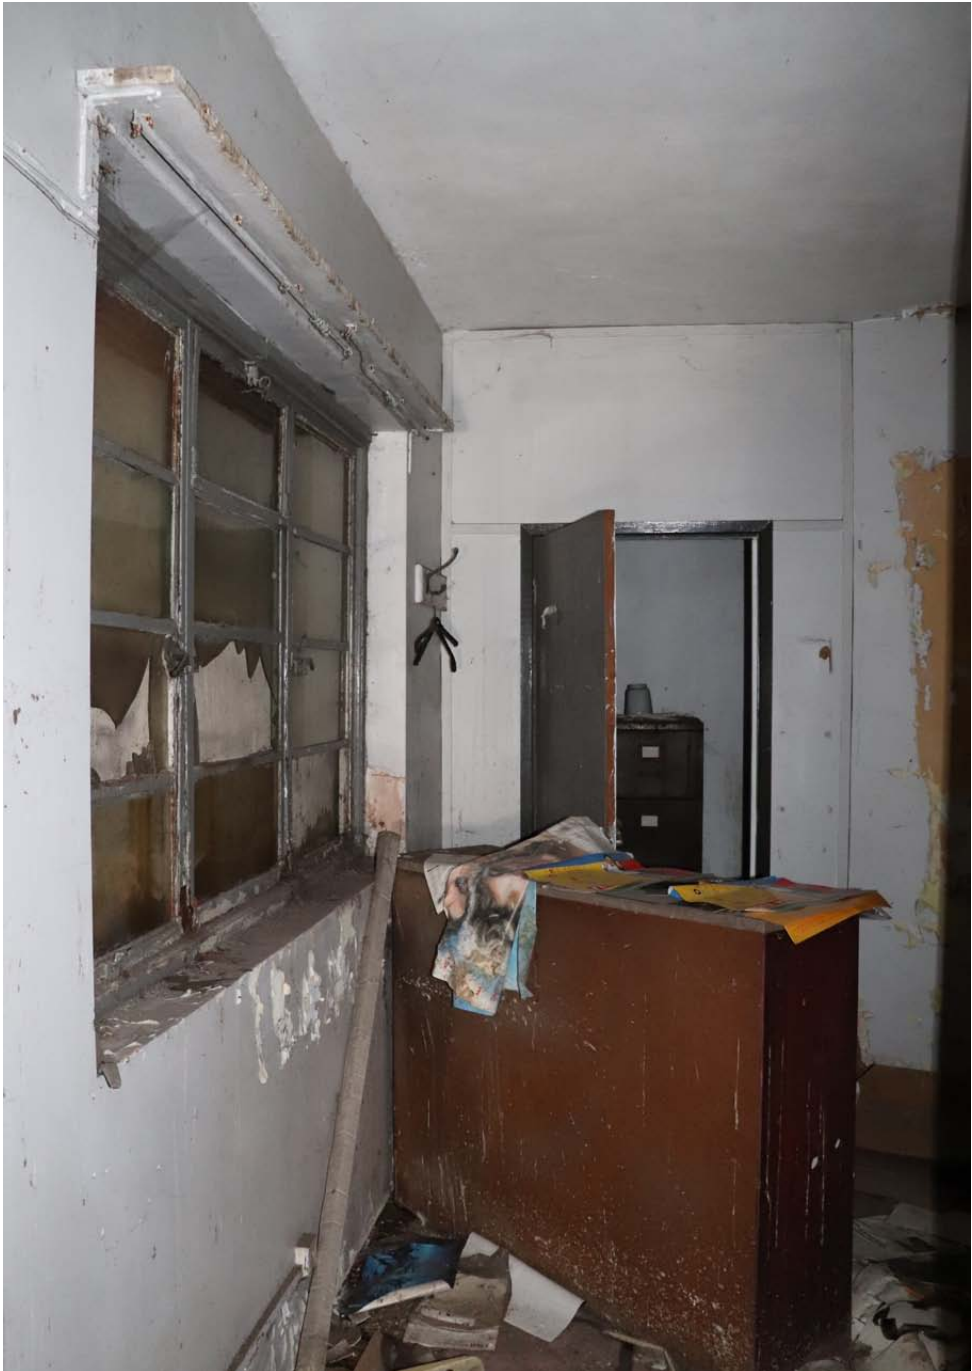
The Walls and Ceilings to the room are of painted plaster, with paintwork in a very poor condition and areas of plaster damage. To the left hand side of the south wall is a rounded apse-like space with a door forming a store room.

*View of room from entrance door with apse-like space at end*

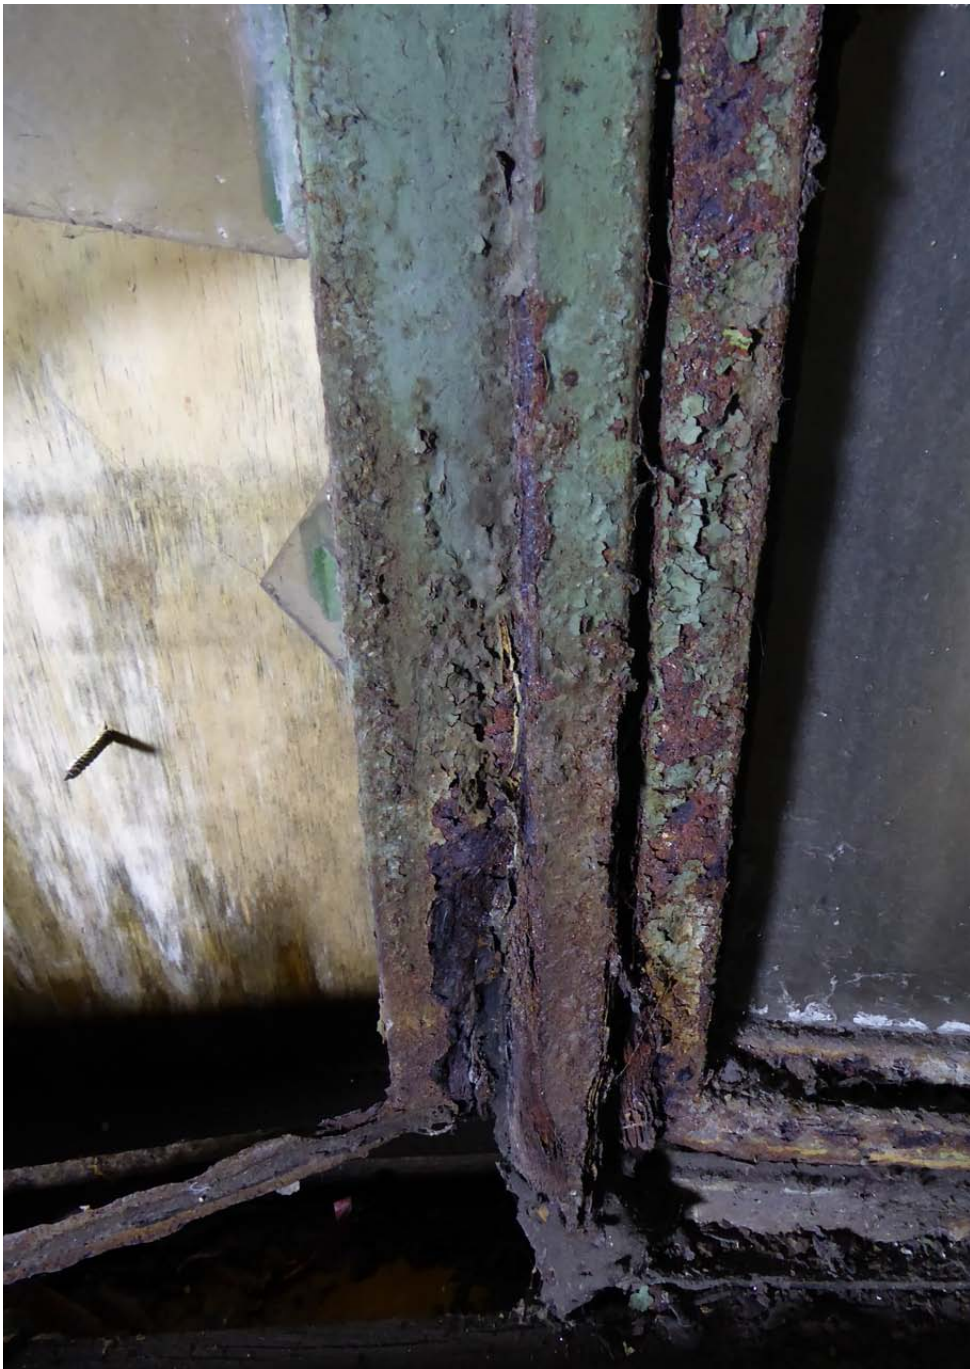
*View of the severe corrosion to the steel section at the mullion*

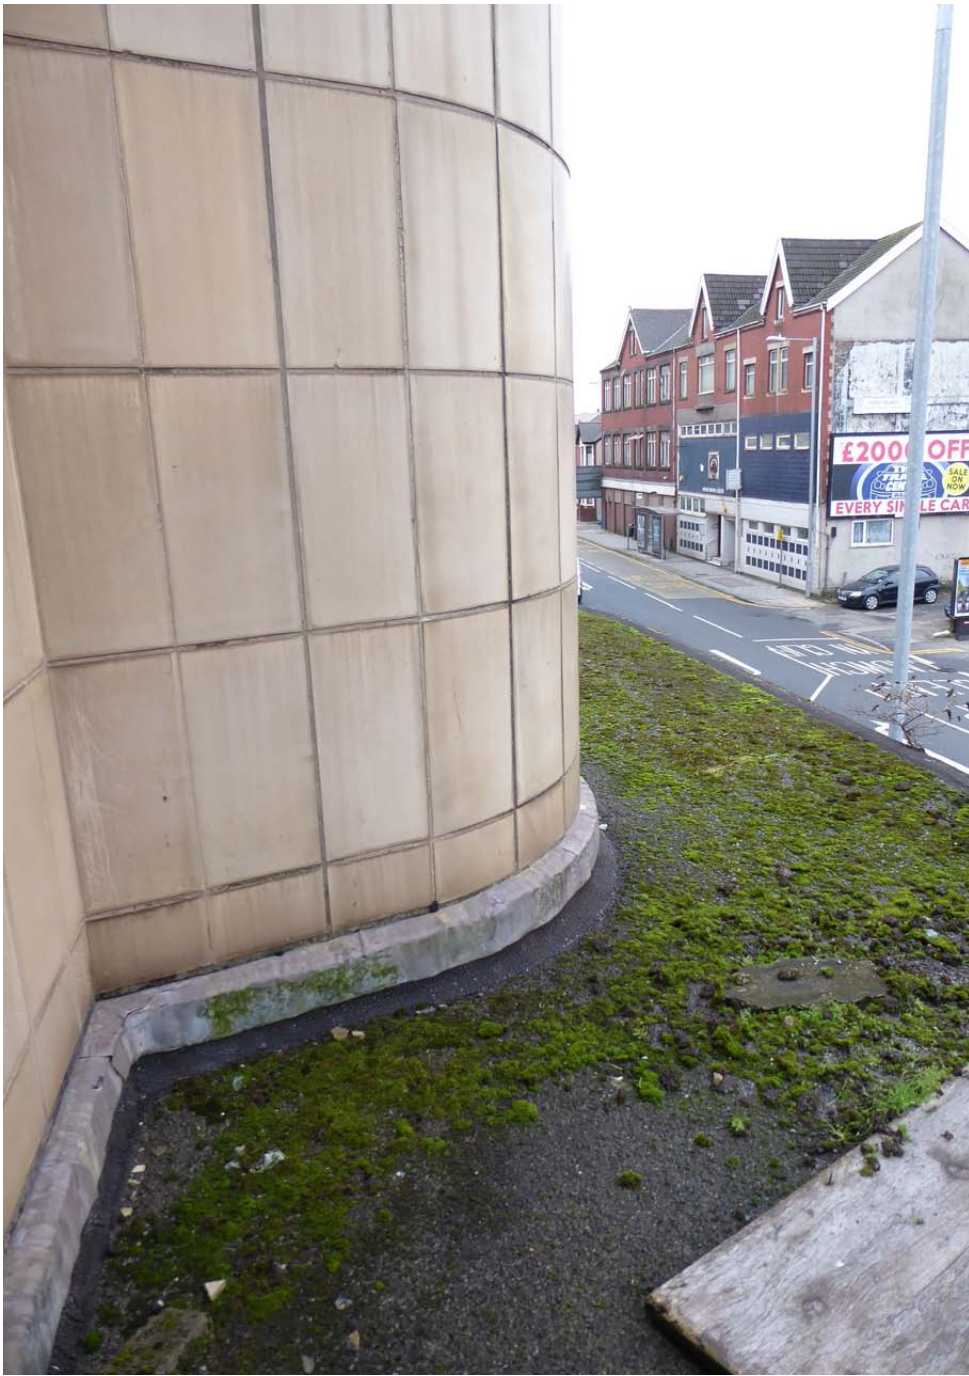
**F14 - Roof to Ground Floor Canopy**

These photographs are of the flat roof area in between and in front of the two round-ended faience-clad forms, which is the canopy over the entrance area. It used to form a balcony, which used to comprise a wrought iron railing, however no longer does.

The finish is asphalt, however, it has developed considerable vegetation over the years and the asphalt is in a poor condition.

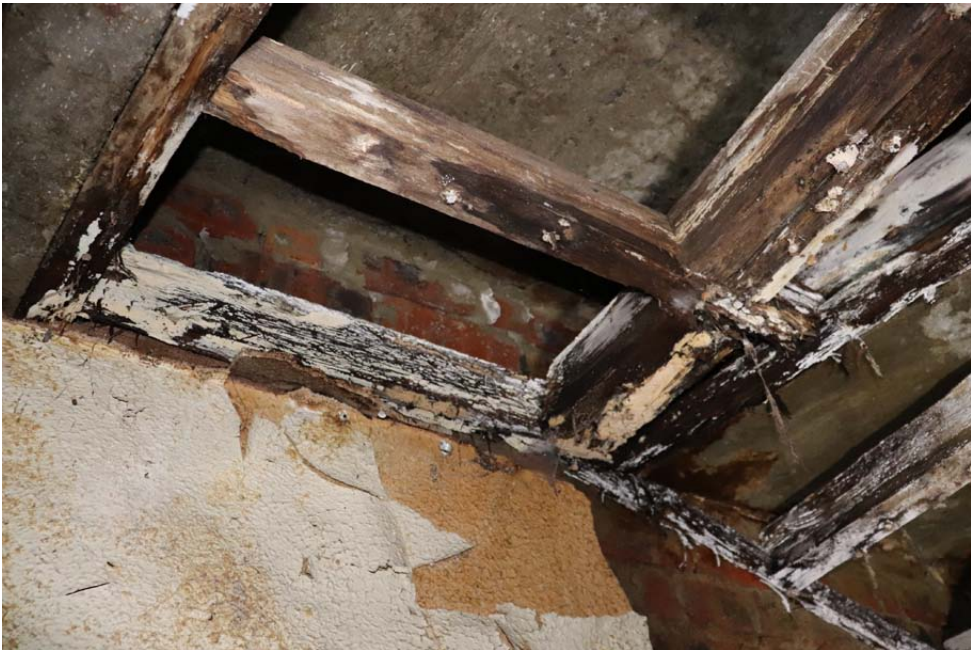
The excessive water ingressing this staircase has resulted in the timber becoming badly rotten with the surface caked in rot spores. The masonry walls have also become saturated, with the plaster falling off.

*View of rot spores caking timber to underside of stairs*

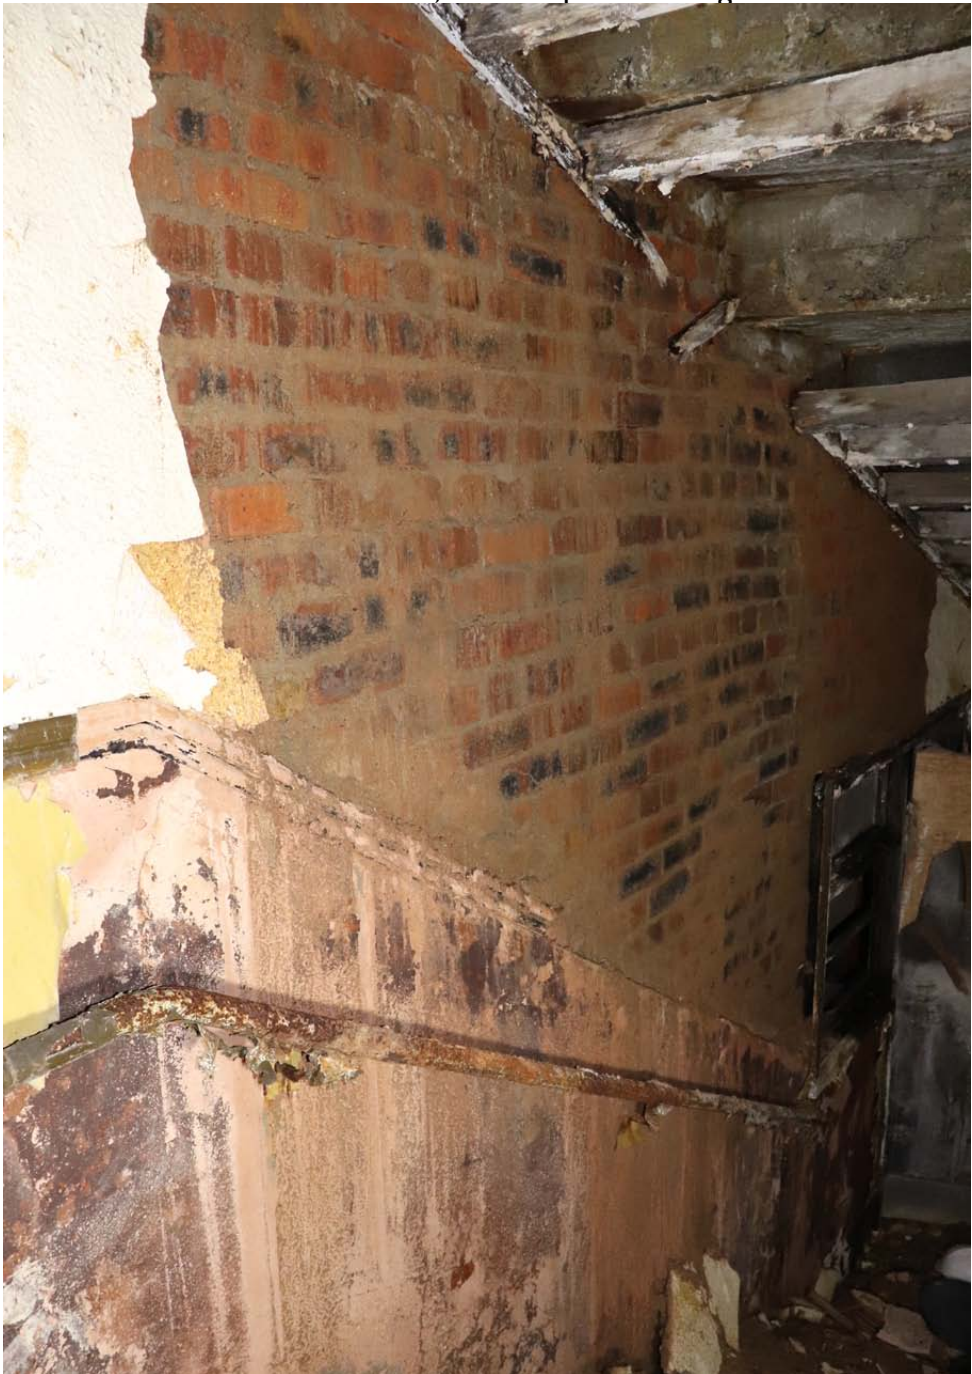
*View of saturated brickwork & lost plaster to inner wall*

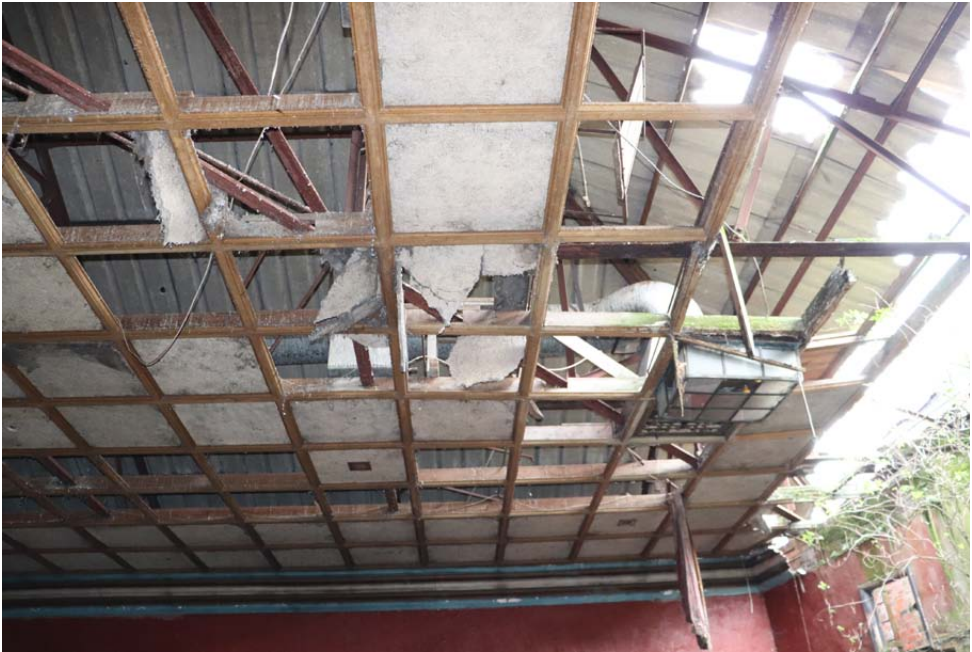
*View of the ceiling looking eastwards with the large hole to the right*

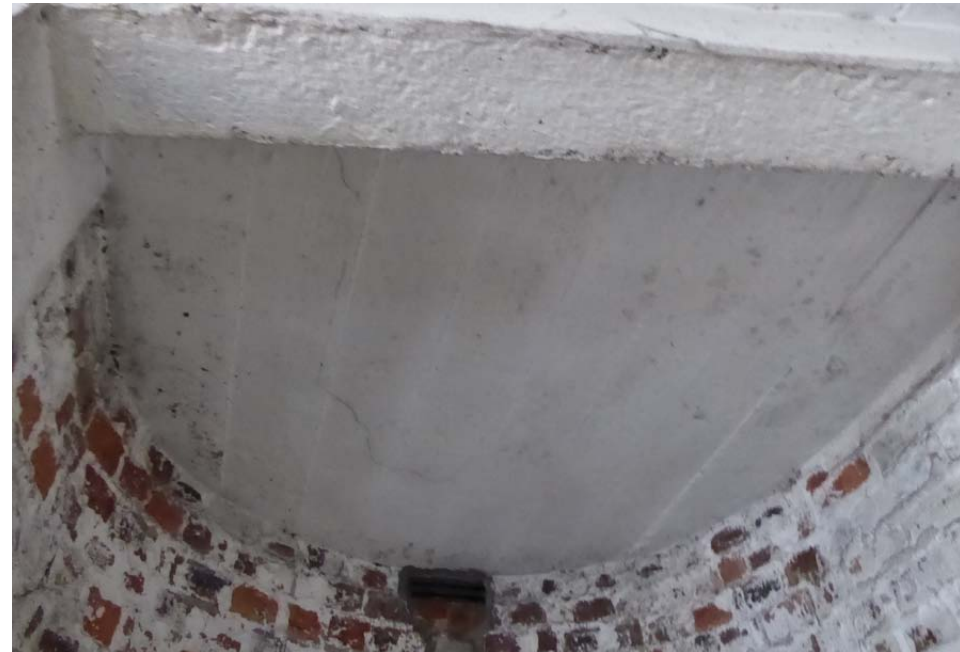
*View of concrete 'lid' to turret, showing small crack*

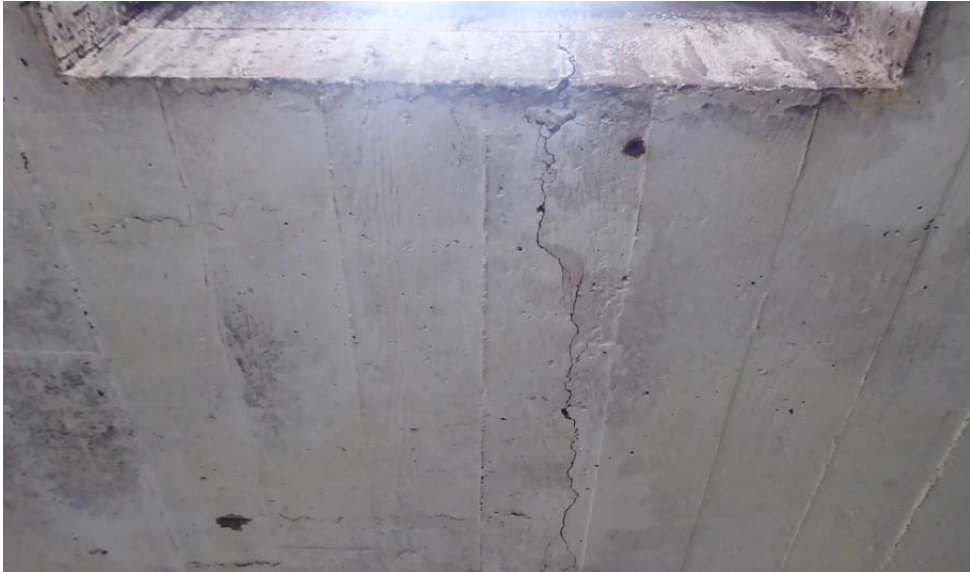
There is a noticeable crack down the concrete soffit

*View of opening in soffit with start of long crack*

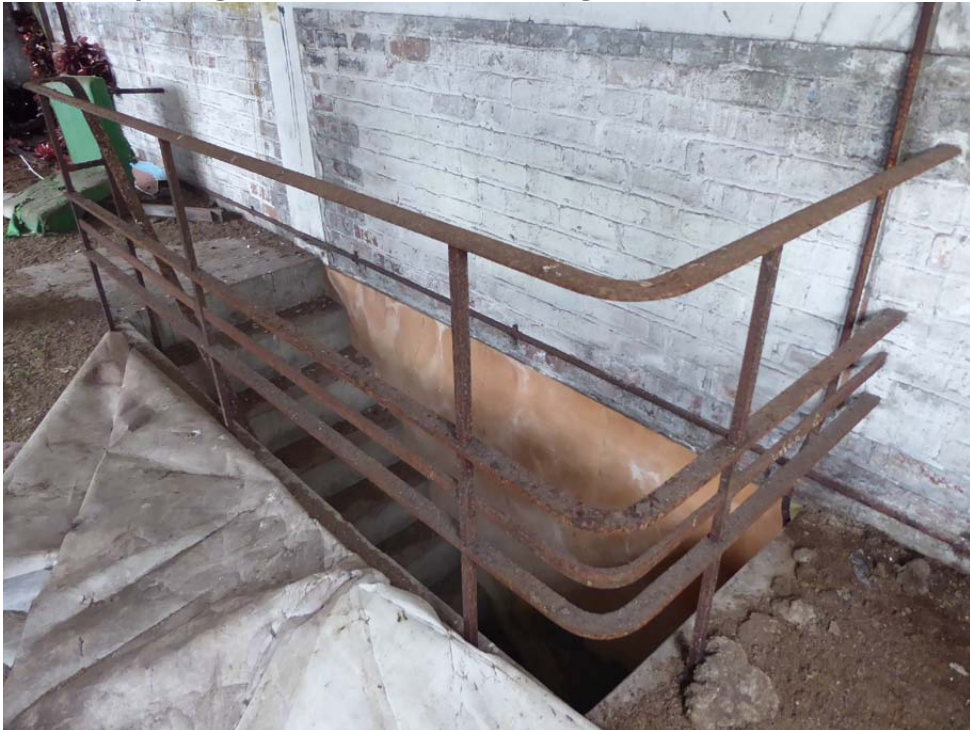
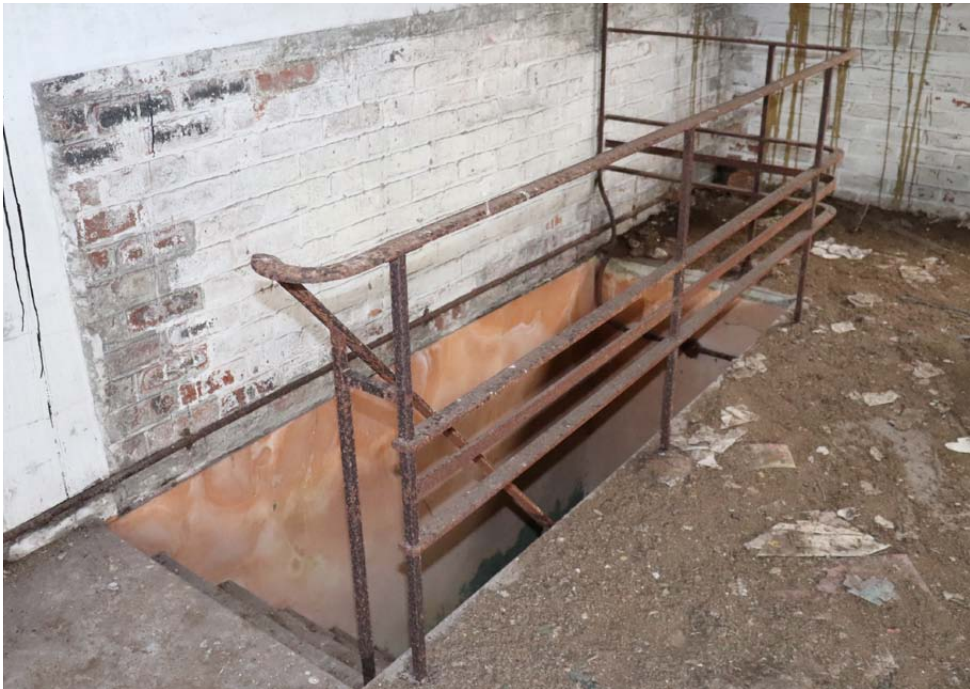
There is a steel guardrail around the stair void, which is Art Deco in style, however, badly corroded.

*View of steel guardrail around stair void, which is Art Deco in style*

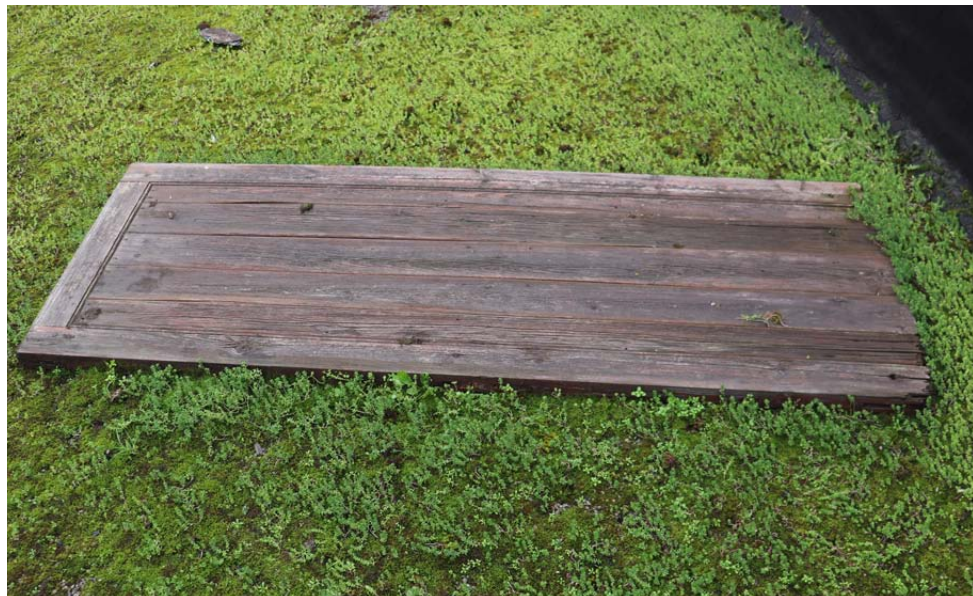
The access used to have a timber door on it, but that has broken away and is lying on the roof.

*View of timber door which used to enclose box construction to ladder*

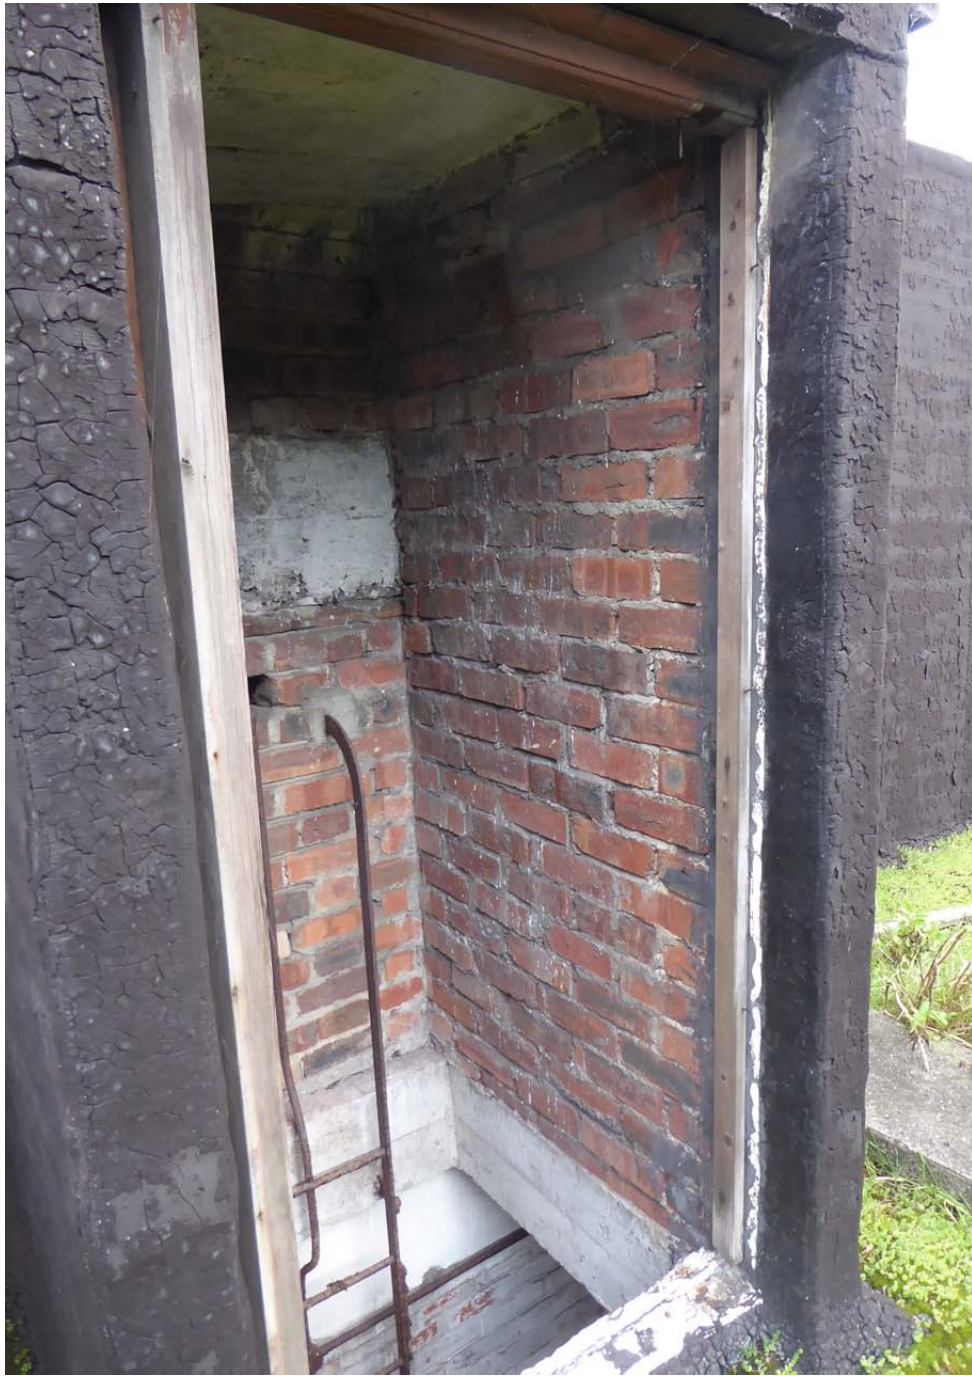
*View of interior of box construction to ladder access*
