**Plaza, Port Talbot**

**HISTORIC BUILDING RECORDING**

(385)1902-GWP-A-2A-HBR-P00

Date: 06.01.20

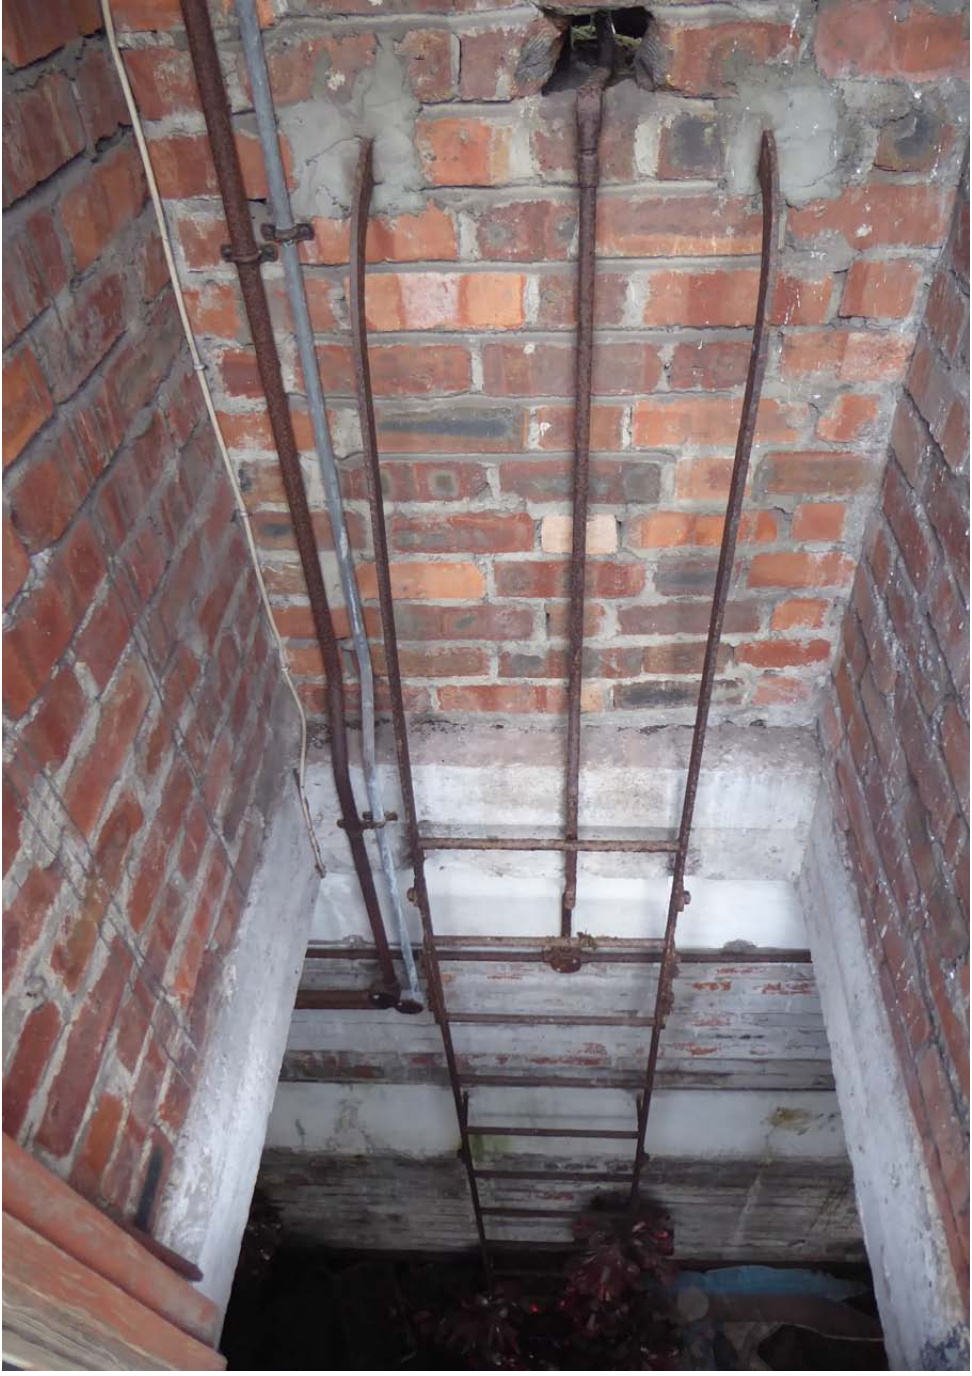
*View of interior of box construction to ladder access, looking down*
