Tidal Lagoon (Swansea Bay) Plc

**Tidal Lagoon Swansea – Onshore GI**

**Ground Investigation Interpretive  
Report (Phase 1)**

March 2017

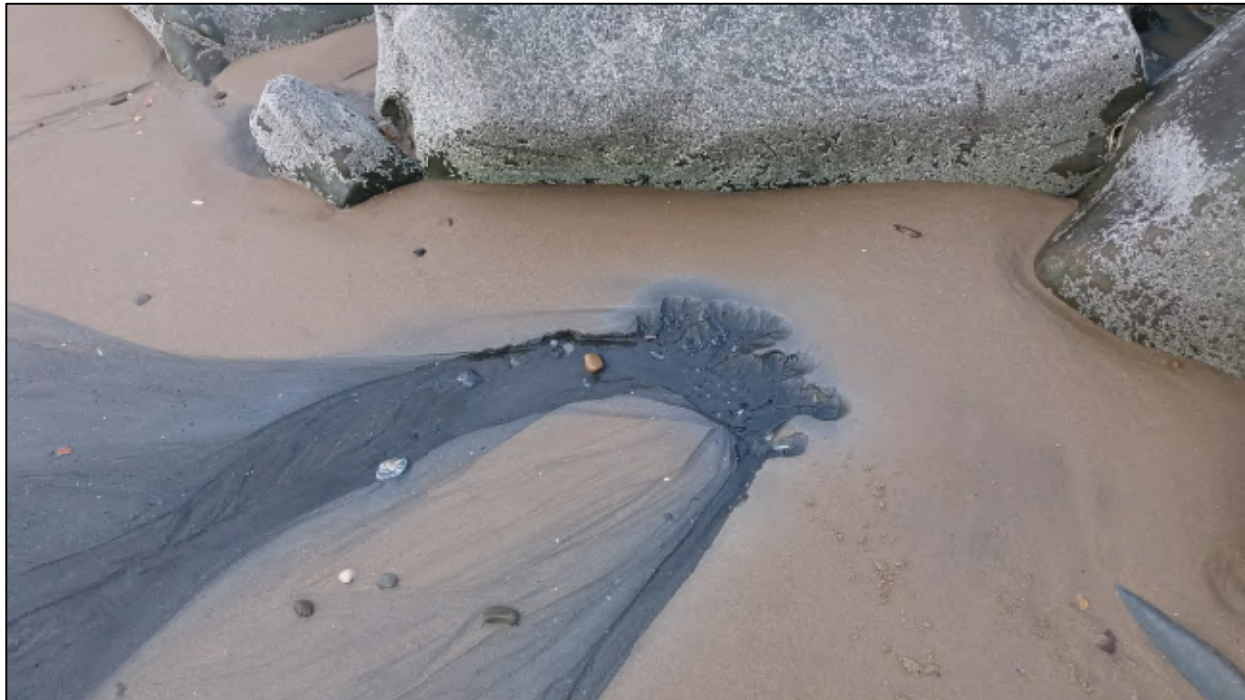
Photo shows discharge of visually contaminated water from the base of the sea wall (SW1)
