Project  
**Cefn Coed Colliery Museum**  
Renovation of two Grade II\* Listed headgear frames

Sheet  
**Building at base of Headframe 1**  
Current condition and works proposed

| Drawing No. | Sheet No. | Revision |
|---|---|---|
| CD-V-C8458.60 | 105B | R0 |

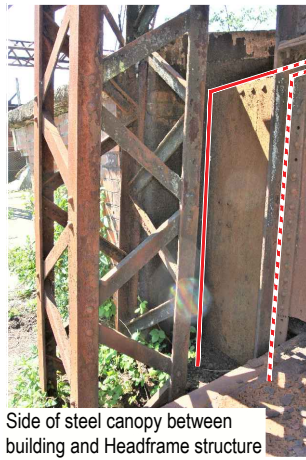
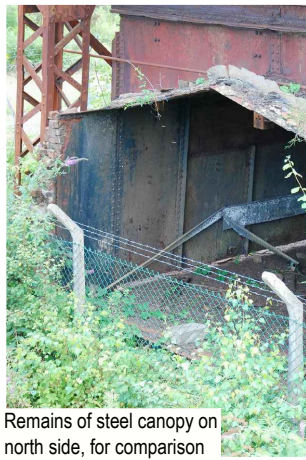
Significant deterioration of the concrete roof has occurred since the survey in April 2018 (and the basis for the Listed Building Consent granted in July 2018): holes have appeared through the slab; widespread loss of concrete across the underside of the slab and beam faces, exposing corroded reinforcing steel. Consequently, it is no longer feasible to repair the roof nor ensure it can safely remain in place whilst adjacent repairs are undertaken.

The concrete roof is of limited architectural or historic significance. It is proposed to remove the concrete roof entirely (it will not be replaced). The adjoining steel canopy will remain and be refurbished. This follows the profile of the roof and, together with the wall remains (see text opposite), will retain sufficient evidence of the form of the building.
