**Cefn Coed Colliery Museum**  
Renovation of two Grade II\* Listed headgear frames

**Building at base of Headframe 1**  
Current condition and works proposed

| Drawing No. | Sheet No. | Revision |
|---|---|---|
| | 105B | R0 |

For Listed Building Consent CD-V-C8458.60

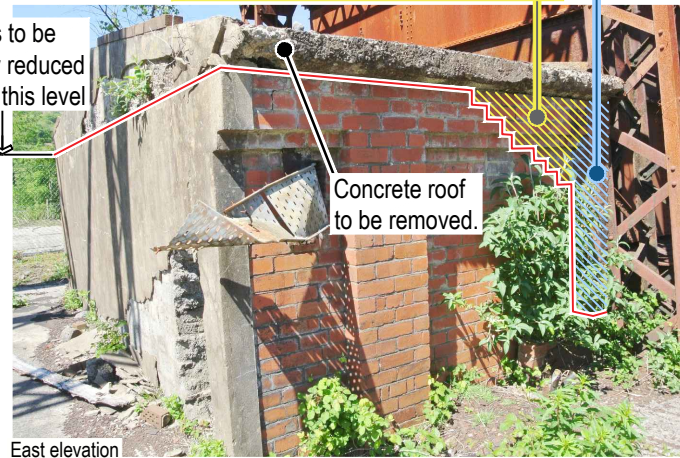
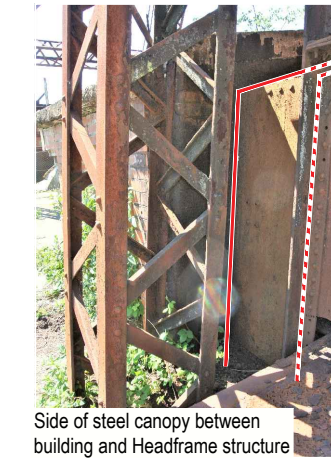
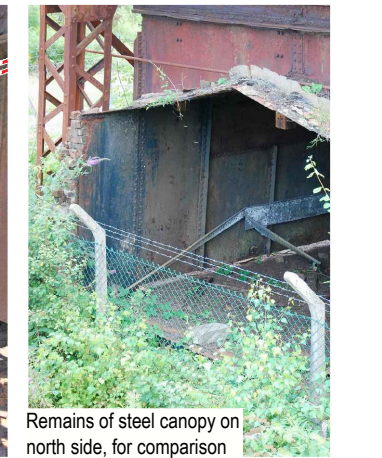
Significant deterioration of the concrete roof has occurred since the survey in April 2018 (and the basis for the Listed Building Consent granted in July 2018): holes have appeared through the slab; widespread loss of concrete across the underside of the slab and beam faces, exposing corroded reinforcing steel. Consequently, it is no longer feasible to repair the roof nor ensure it can safely remain in place whilst adjacent repairs are undertaken.

The current proposals (granted LBC in July 2018) permits some dismantling and modification of the masonry adjacent to the steel lattice girder columns in order to reduce the risk of corrosion and improve access for repairs and future maintenance (i.e. prevent trapping of moisture and debris and permit future applications of protective paint). The masonry was to be reconstructed (albeit modified) because the concrete roof relied upon support from the walls.

As the roof is now to be removed, the modification to the wall can be adjusted to improve the access further: the extents of this is shown on the annotated photographs above (hatched light blue). Consequently, small areas of wall (hatched yellow) have the potential to become unstable, primarily due to the corbel detail or apertures formed crudely in the wall: it is proposed to dismantle these areas to safeguard the stability of the majority of the walls. The pipe which passes through the wall will be retained and supported in-situ.

The concrete roof is of limited architectural or historic significance. It is proposed to remove the concrete roof entirely (it will not be replaced). The adjoining steel canopy will remain and be refurbished. This follows the profile of the roof and, together with the wall remains (see text opposite), will retain sufficient evidence of the form of the building.

This proposal retains significant amount of wall, including evidence of doorways (on the west elevation), and the overall form of the building can be understood. An option to dismantled the middle of the modern blockwork wall would improve visitor access / views through the headframe.
