# THE BARN, TRENACHE FARM, NEATH PRELIMINARY ROOST ASSESSMENT FOR BATS

| <b>TITLE:</b> | Preliminary Roost Assessment for Bats |

| <b>PROJECT REF:</b> | 319-01-01-21 |
| <b>REPORT No.:</b> | 319-01-01.R1 |

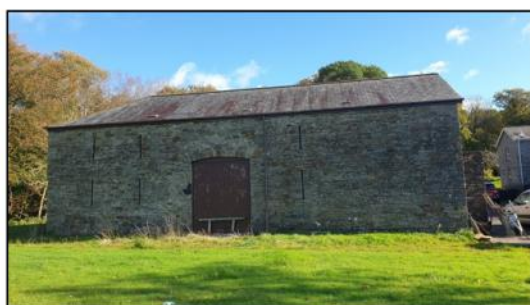
**Figure 3 – Survey Building (W) Aspect**

The building has been constructed with stone which has been bound together with mortar. The masonry was found to be in excellent condition, with no areas identified which allow potential access or egress to the building interior for bats. Similarly, no suitable crevices, gaps or damaged areas of the masonry were identified which could be suitable for crevice-dwelling bats on the exterior of the building.

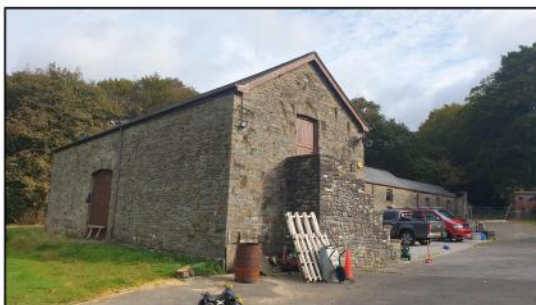
**Figure 7 – Survey Building (S) Aspect**

The surveyed room of the barn does not extend along the whole length of the building. A second internal room is located toward the southern end of the building and is accessible from a well-sealed double wooden door on the eastern side of the building. This room can be further accessed from an external stairway and single wooden door at first-floor level, as visible in Figure 7.

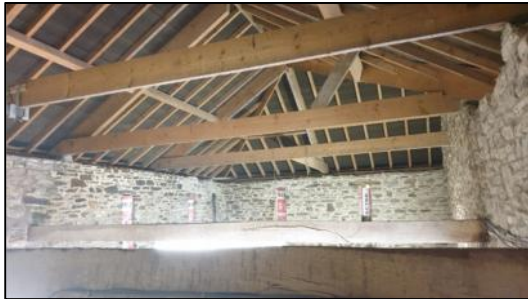
**Figure 13 – Underside of Roof Looking (N)**

The roof felt on the underside of the roof was found to be in generally excellent condition, although a few small tears were recorded which may allow access to a void between the external roof slates and the roof felt from

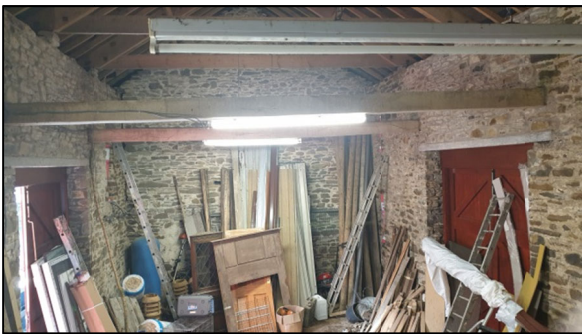
**Photo 3** – Main Barn, looking at (S) Partition Wall

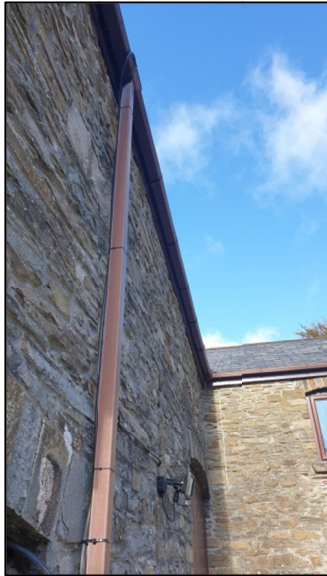
**Photo 9** – Downpipe and Fascia Detail on (E) Elevation of the barn
