**Structural Survey (Inspection)**

**60 Commercial Street  
Ystalyfera  
Swansea  
SA9 2HS**

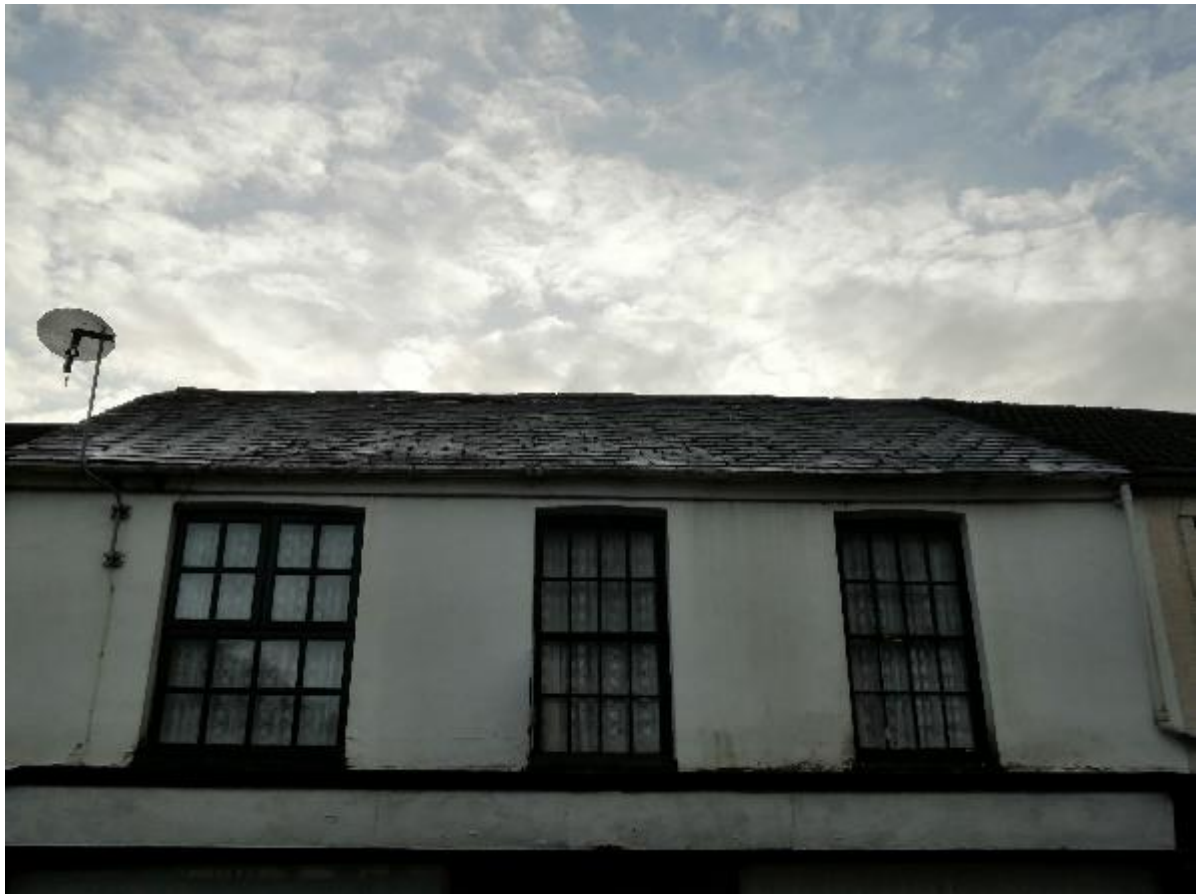
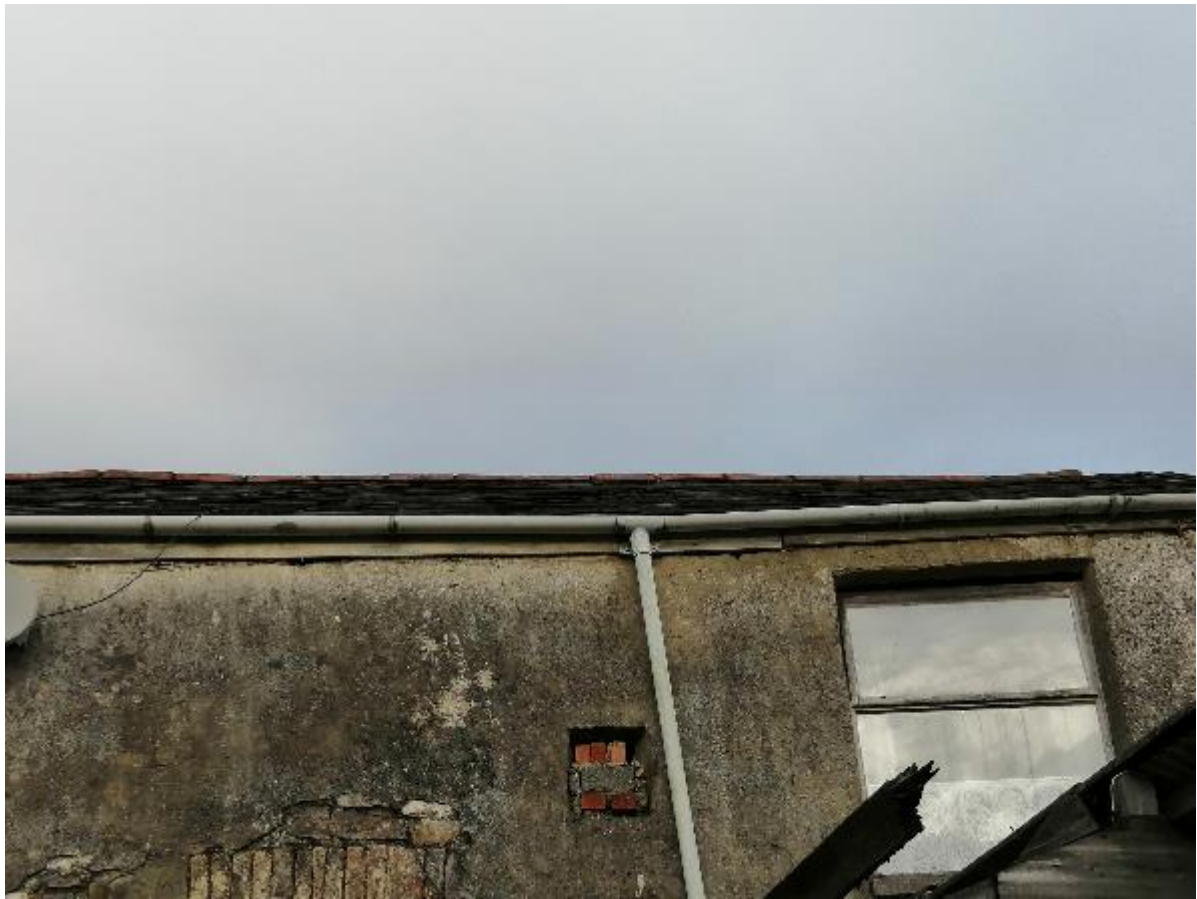
We noted no major undulation, deflection or other distortion to the roof structure of the property, i.e. sagging or leaning of the timber frames to the front or rear elevations – See Photo 1 to 2. However, some sagging was noted to the roof ridge and left hand section of the roof profile – see photo 3 below. This sagging is suspected to be due to the age of the property. This deflection is considered not to be of structural concern and considered to be a characteristic of the property. N.B. further commentary on the condition of the structural timber frameworks follows later in the report, see ‘Internal Condition – Roof Void.’

Photo 1 – Front Roof Profile

Photo 2 – Rear Roof Profile

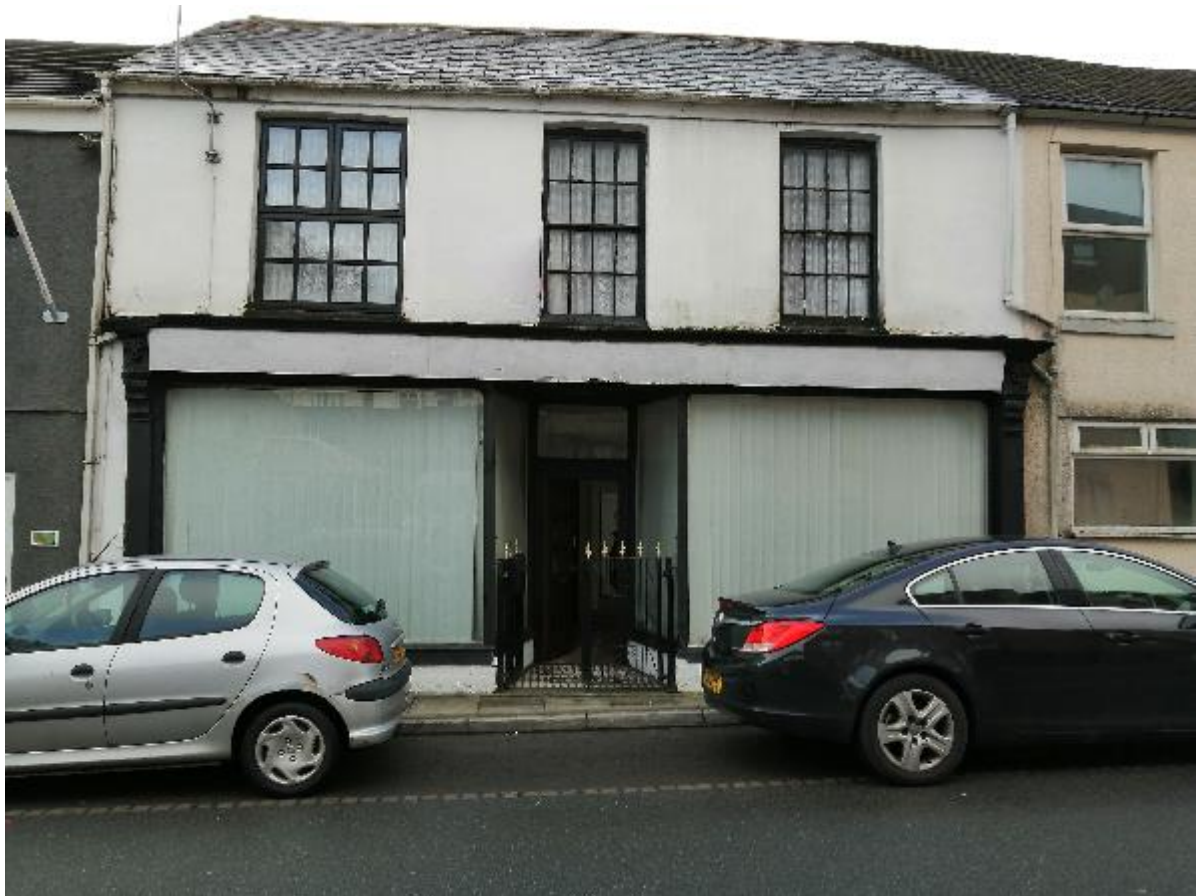
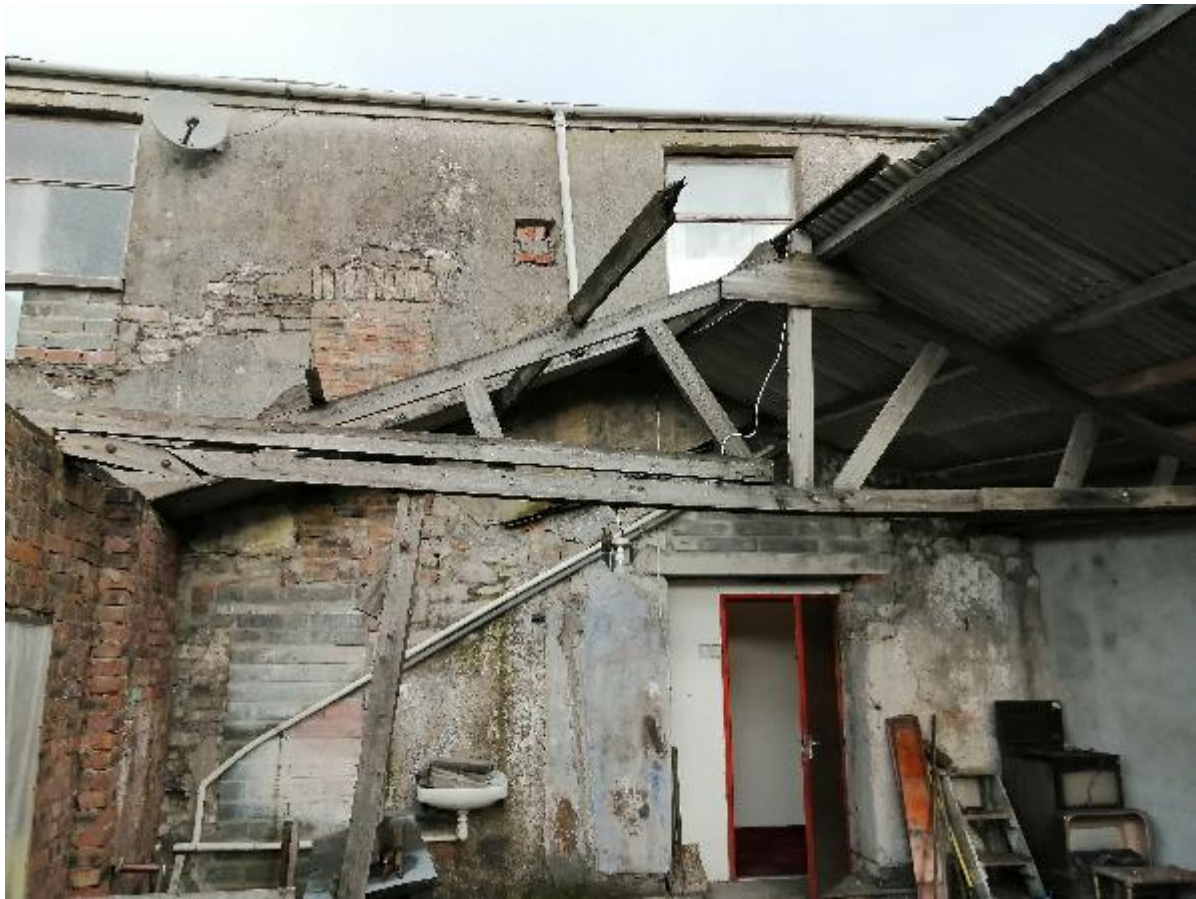
The front and rear / side walls of the property did not indicate any sign of external wall movement, bulging or misalignment of elevations to the property. The vertical and horizontal alignment of the external walls is satisfactory, which suggests the load-bearing wall constructions continue to act compositely and maintain support to the superstructure loading (i.e. roof loading, first floor loading and the load-bearing walls self-weight) – See Photos 5-6.

Photo 5 – Front Wall Elevation

Photo 6 – Rear Wall Elevation

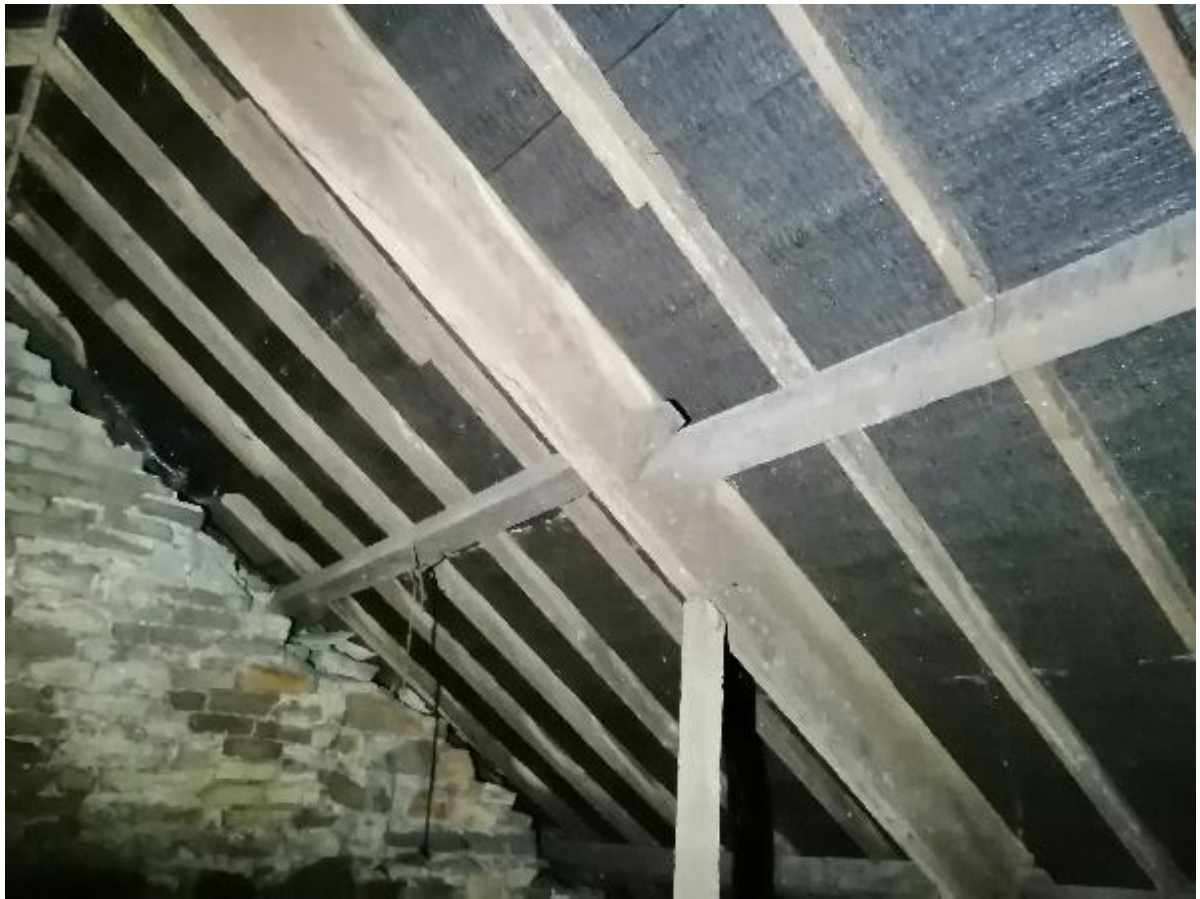
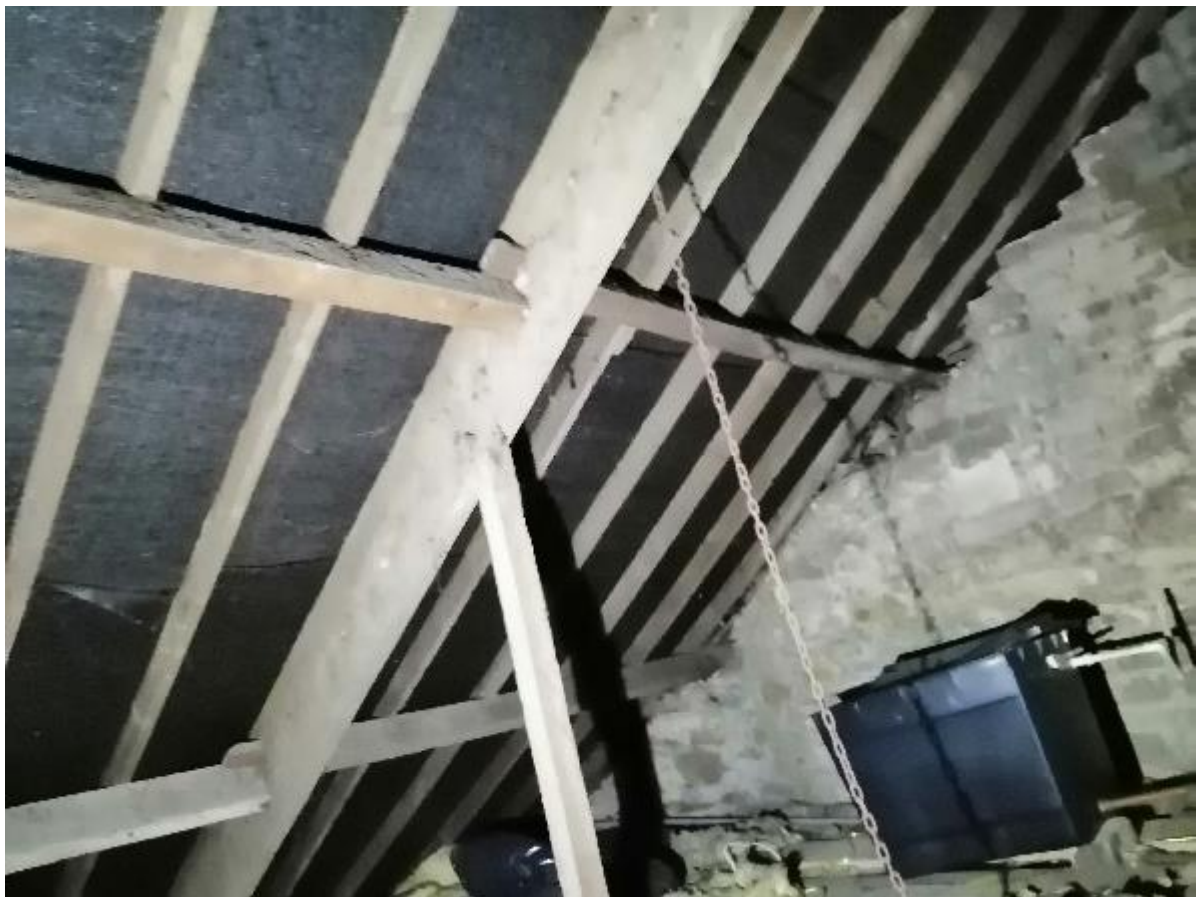
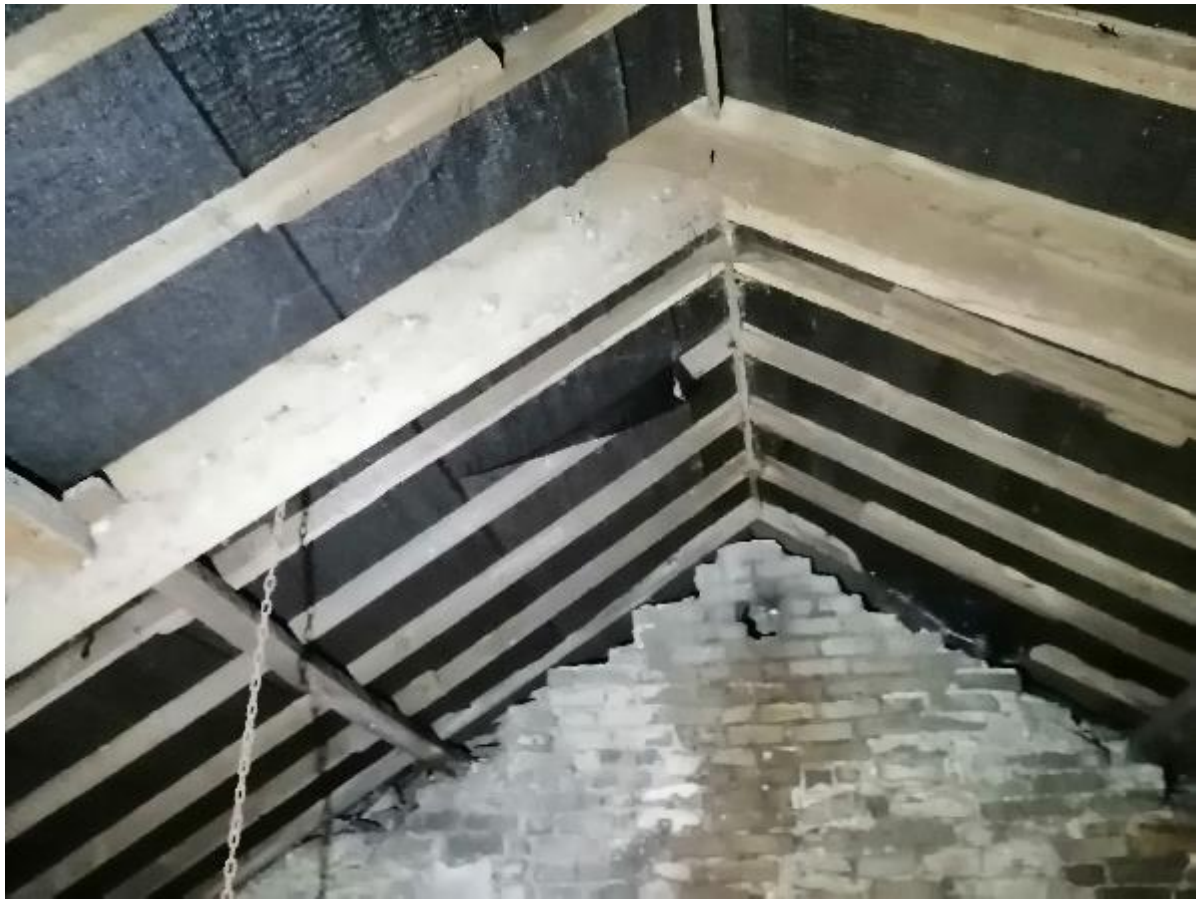
There was limited access to inspect the roof structure to the main property due to lack of runner / floor boarding in the roof space. Our inspection was performed by access adjacent to the loft opening to ensure the safety of our engineer and to prevent any damage to exposed ceilings within the roof void. The layout and configuration of the internal roof structure to the original property can be seen in Photo 11-13.

Photo 11 – Timber Roof Frameworks

Photo 12 – Timber Roof Frameworks

Photo 13 – Timber Roof Frameworks

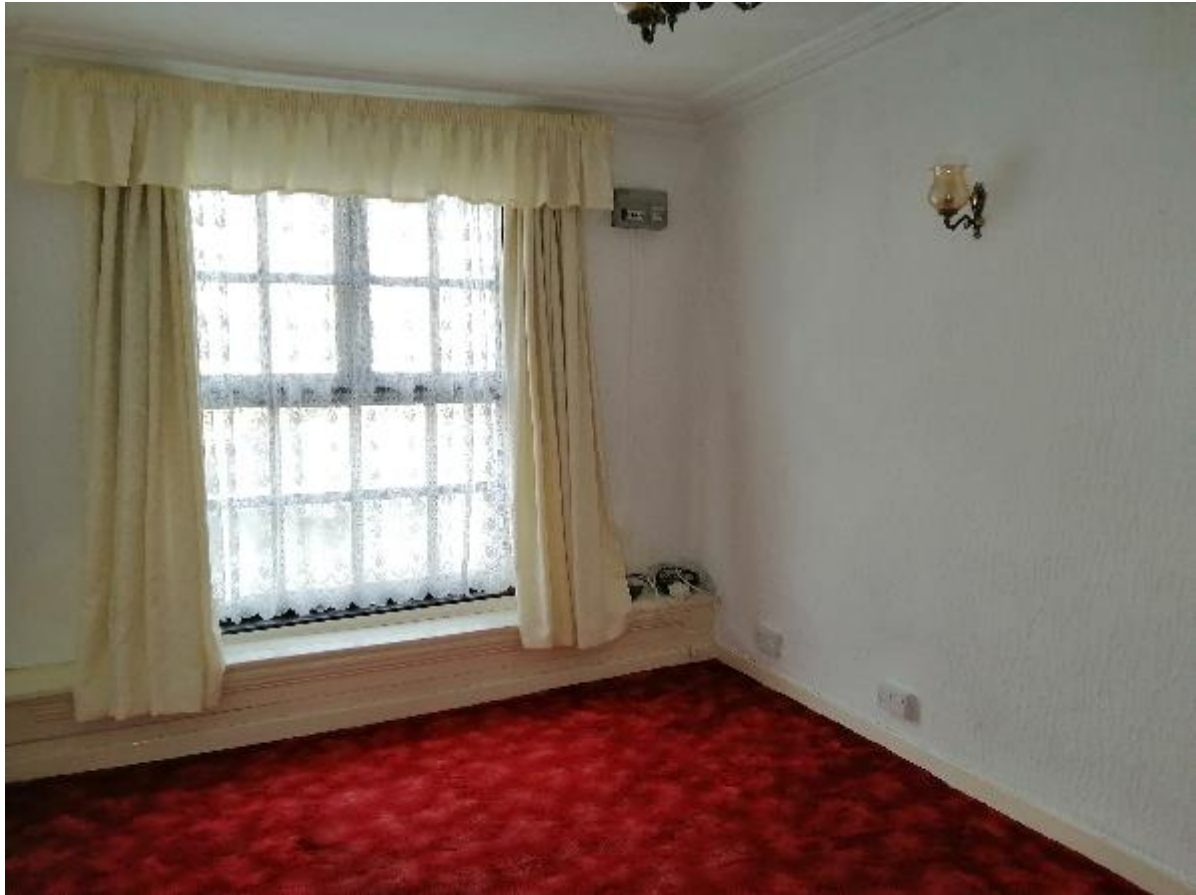
- Some internal plaster finishes are considered substandard and should be replaced.
- The floor to bedroom 1 sagged which indicates there was some flexure to the joists..

Photo 16 – Bedroom 1

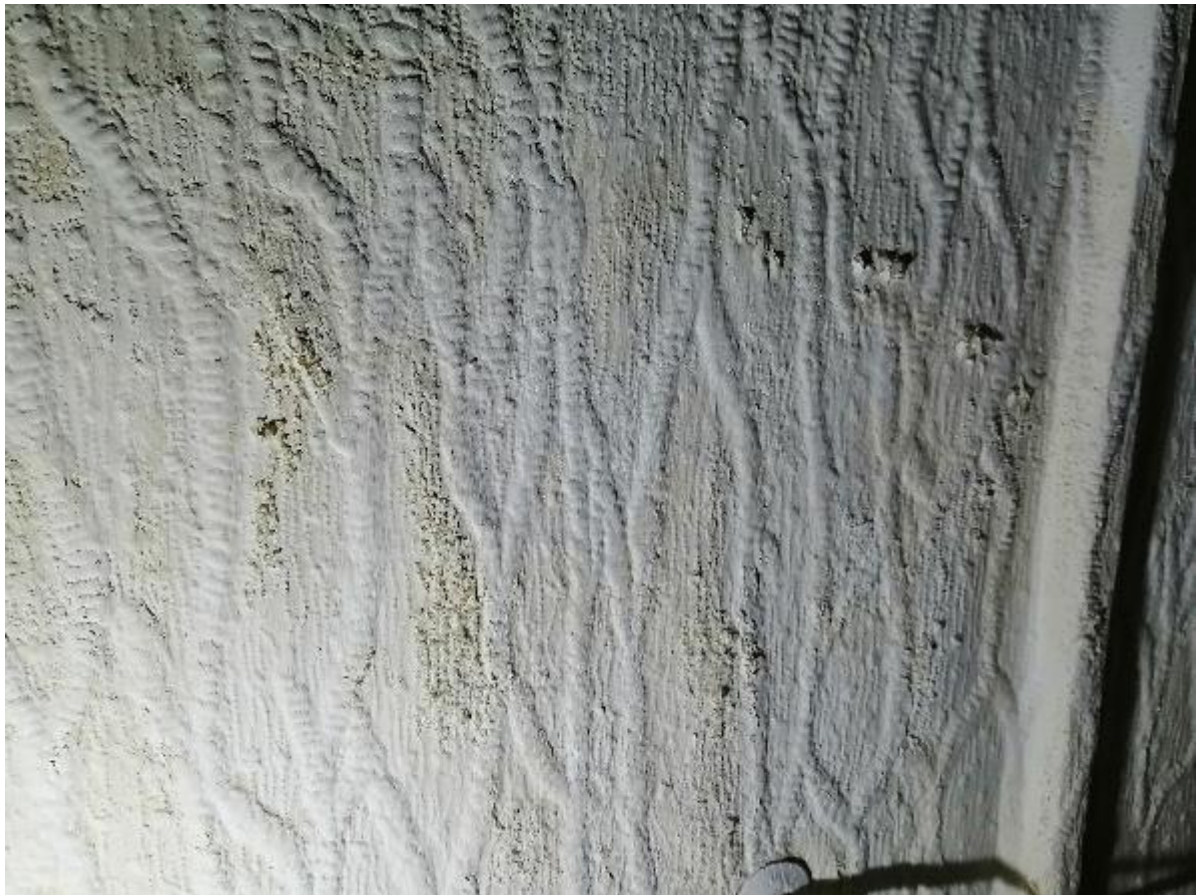
- Penetrating damp was noted to the front wall elevations in bedroom 1 and 3 and penetrating damp was noted to the rear wall elevation on the landing – see photos 36-40. We'd expect that the cause of these areas of penetrating damp is the condition of the external render to the front and rear wall elevation along with the substandard roof drainage.

Photo 37 – Penetrating Damp (Bedroom 1)

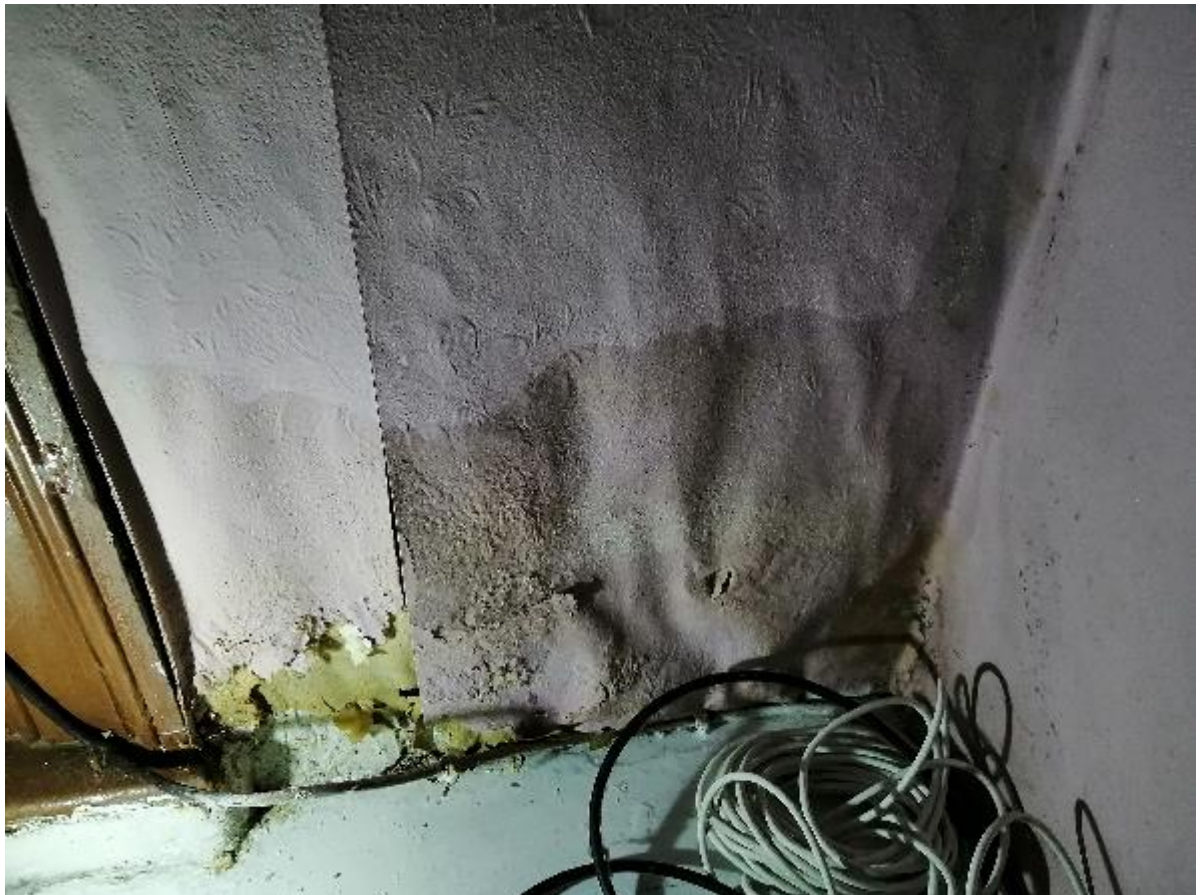
Photo 39 – Penetrating Damp (Bedroom 3)

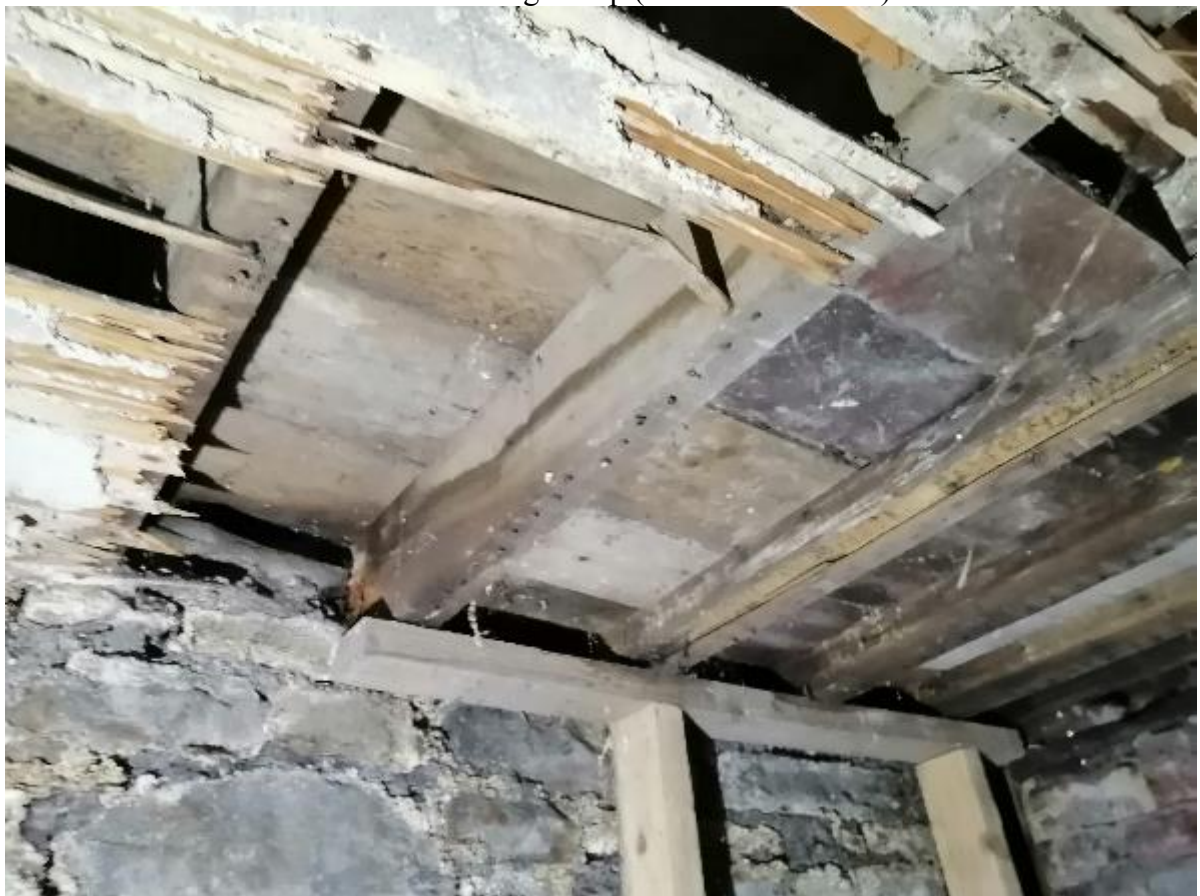
Damp and mould growth were noted to the ground floor boards and joists in basement room 2 and 4 – see photos 64 and 66-69 below. This is expected to be due to the beam ends being supported directly by the solid walls (and so susceptible to moisture attack) and a lack of passive ventilation into the basement. Repairs will be needed - Condition Rating **3** See Section 7.0 Recommendations for guidance on repair works required

Photo 66 – Damp to Ends of Floor Joists (Basement Room 4)

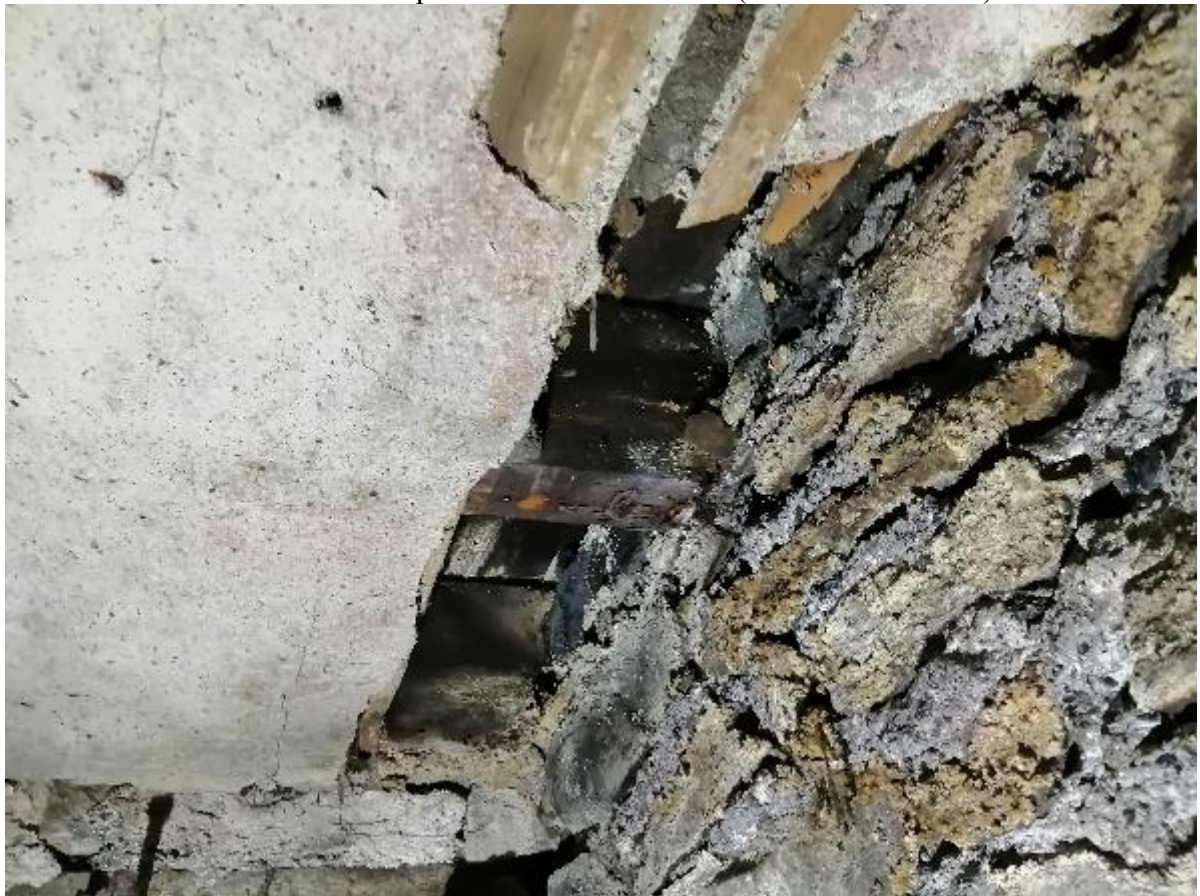
Photo 68 – Damp to Ends of Floor Joists (Basement Room 4)

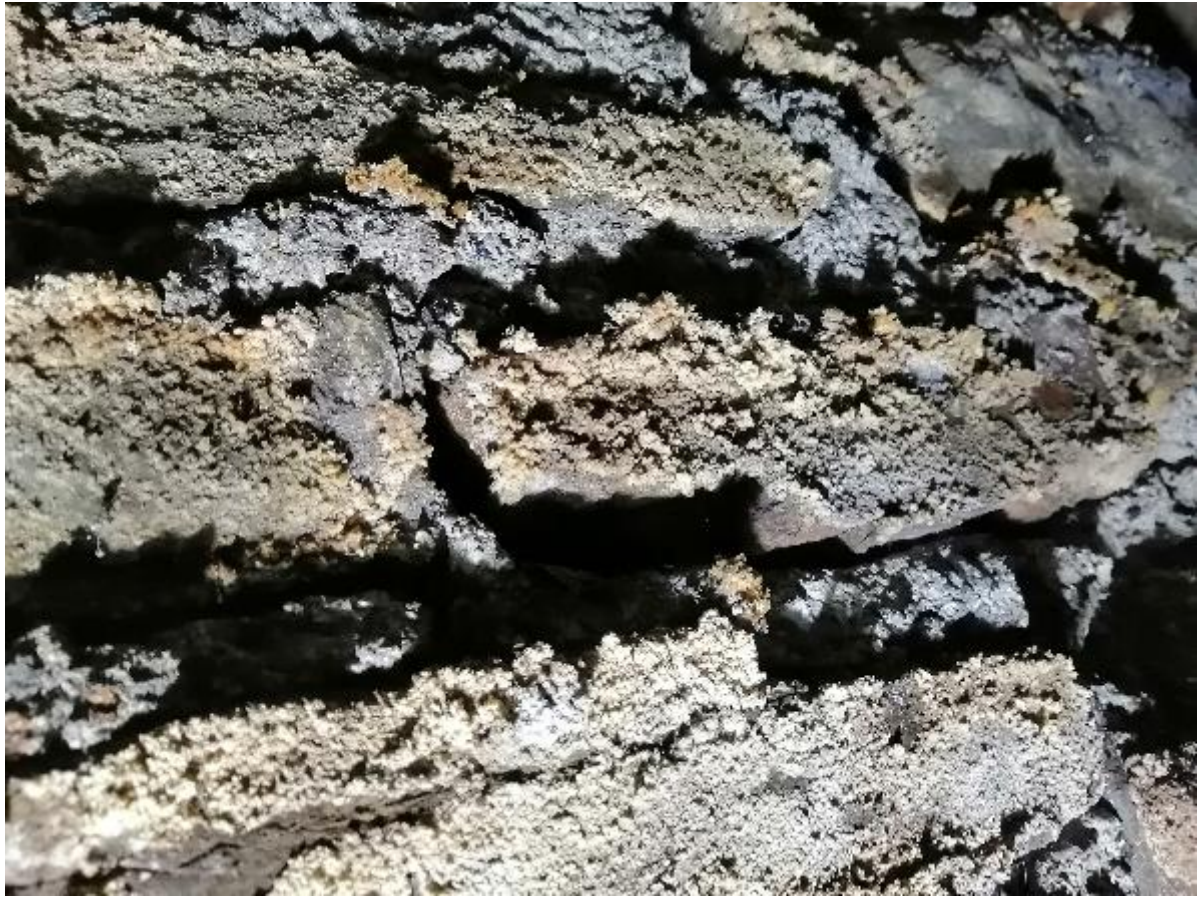
An inspection was undertaken to confirm the presence of damp in the property. Penetrating damp was noted to the internal basement walls (see examples in Photos 70-71 below) along with rising damp (see example in Photo 65 below.) It shall be recognised that solid wall construction as adopted throughout the original property offers less protection against penetrating damp when compared to cavity wall construction. Damp can be more prevalent during winter months and can be exacerbated by cracked or defective external render and mortar joints / pointing. The damp to the basement is exacerbated by the lack of tanking or other internal protection that would otherwise prevent damp migrating into the wall and slabs. Remedial works will be necessary to ensure the basement can remain dry - Condition Rating **3** See Section 7.0 Recommendations for guidance on repair works required.

Photo 71 – Penetrating Damp (Basement Room 4)

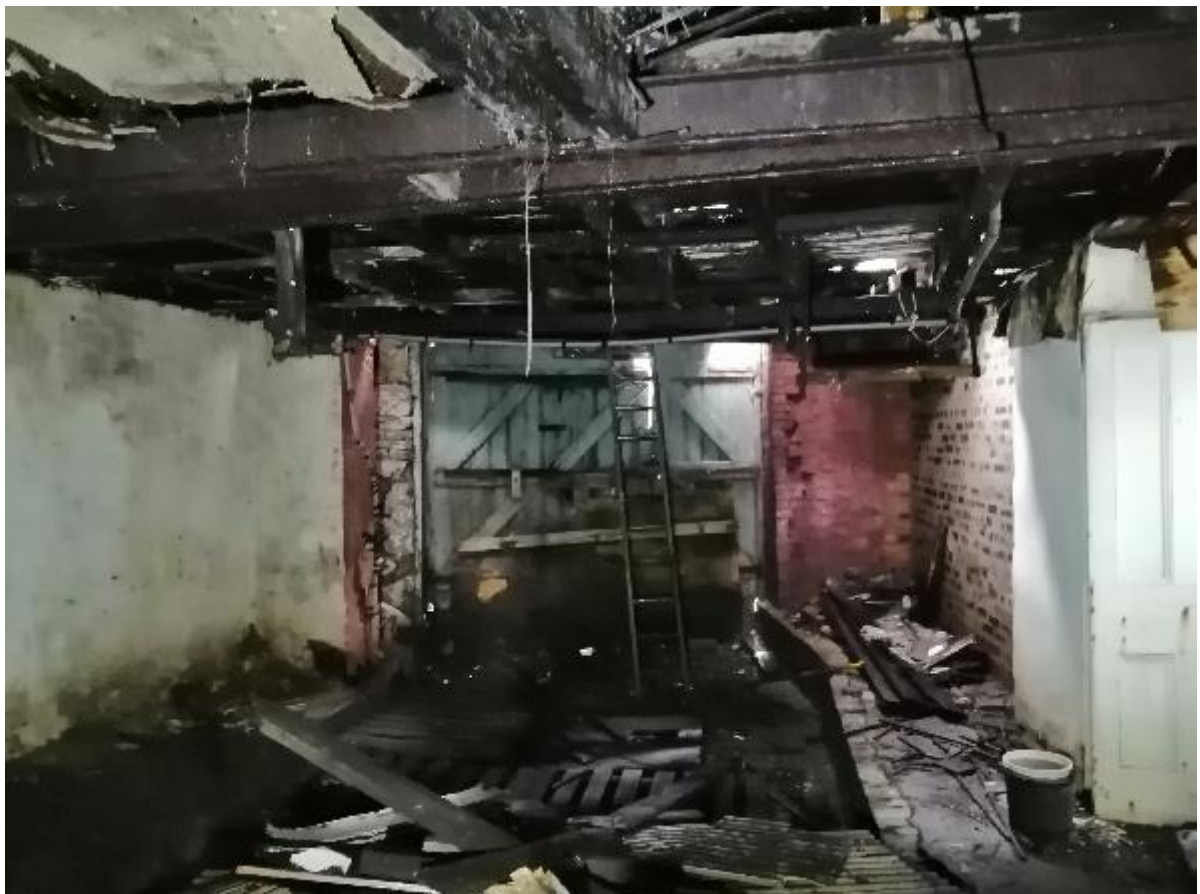
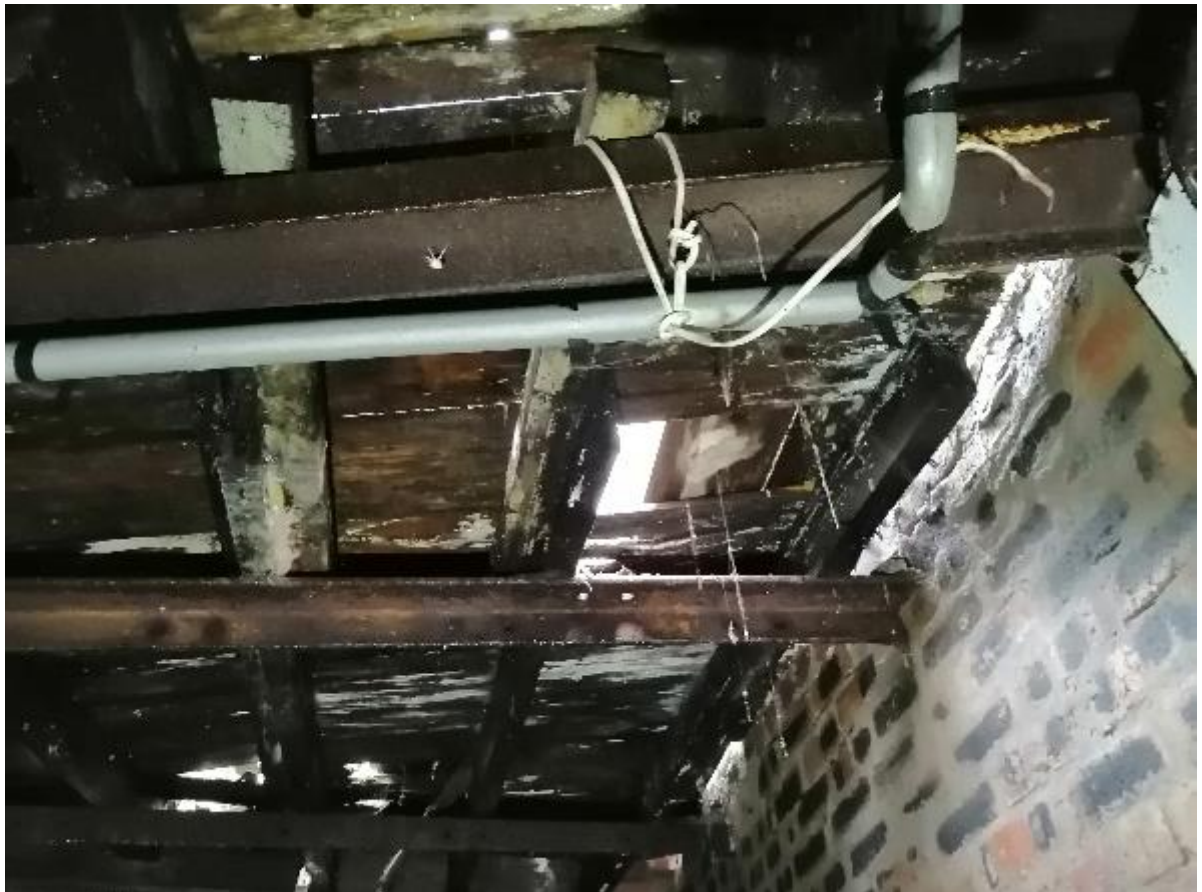
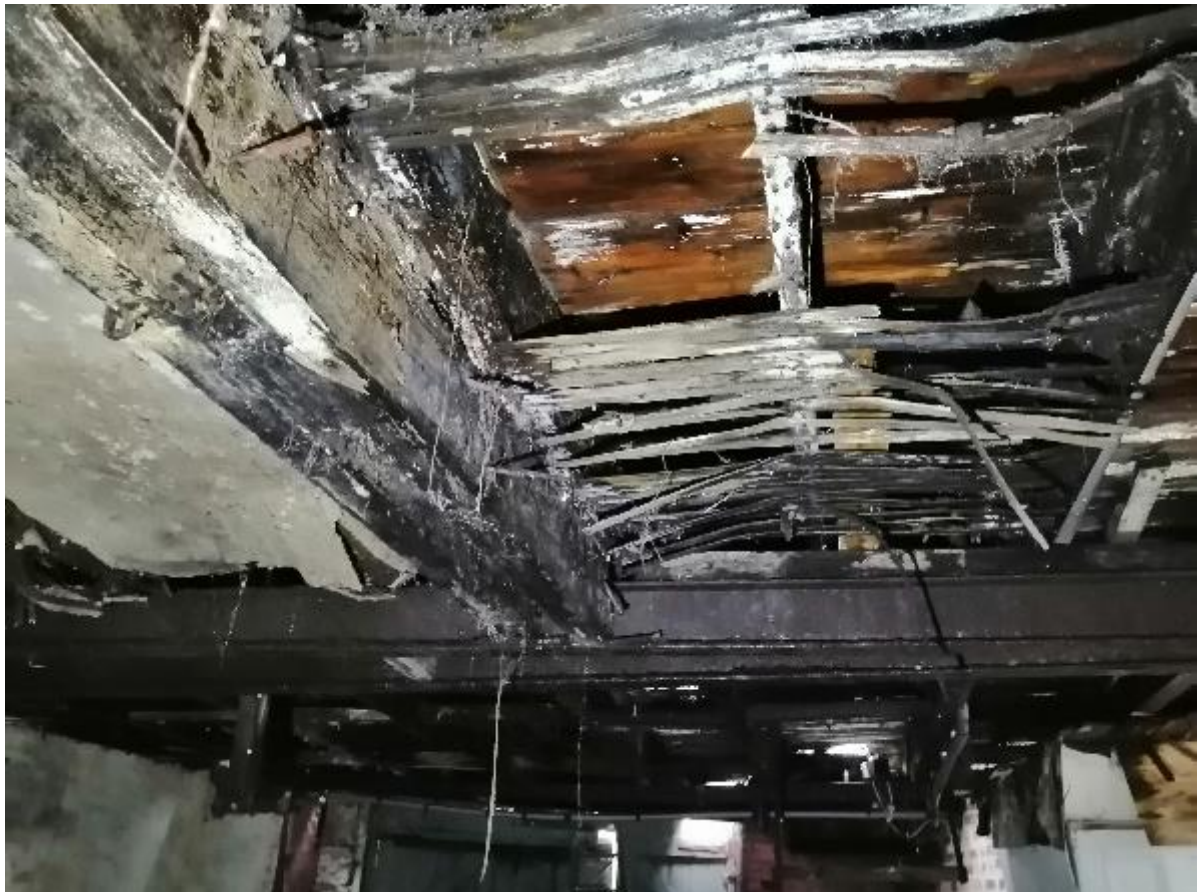
Photo 73 – Timber Structure Basement

Photo 75 – Timber Structure Floor

Photo 77 – Timber Structure Floor

- Penetrating damp was noted to the internal basement walls (see examples in Photos 70-71) along with rising damp (see example in Photo 65).
- The timber structure to the rear is in a significant state of disrepair, is in an unsafe condition and it is recommended that the structure is demolished.
