## Plaza, Port Talbot

### HERITAGE IMPACT STATEMENT

Prepared for: Neath Port Talbot County Borough Council

(385)1902-GWP-Rev 01

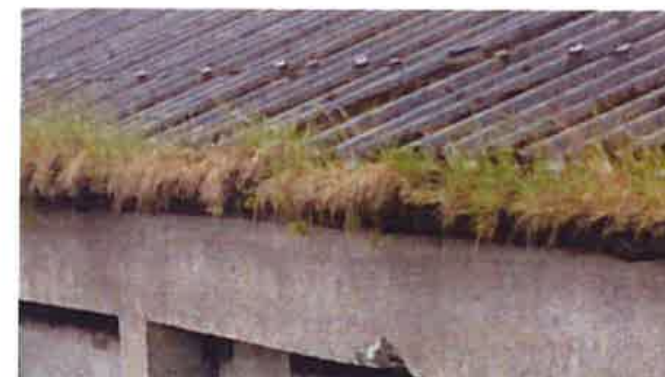
Close up of overgrowth (June 2017)

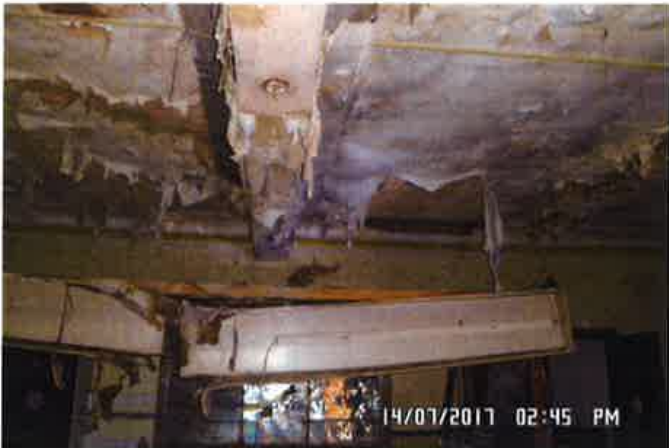
The paintwork to the soffit of the concrete slab, down stand beams and columns are peeling away badly in all locations. There is clearly standing water on the slab above as there are hairline cracks in the soffit with rust staining and damp areas. This area is clearly in a poor state of repair and has deteriorated further since 2012 with the majority of the feature cornicing breaking away from the ceiling. Refer to photographs below:

Foyer area ceiling, July 2017

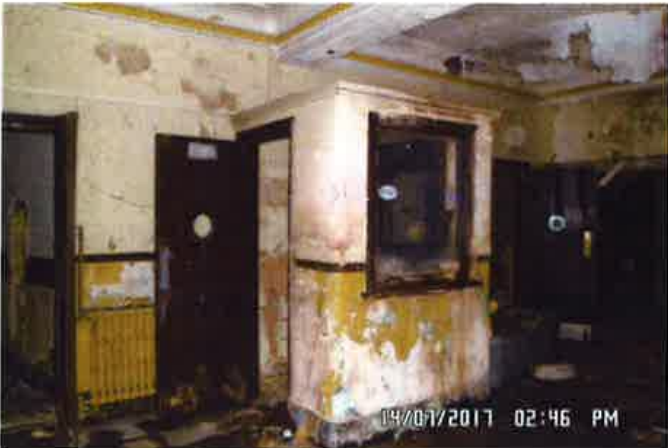
Foyer area ticket booth, July 2017

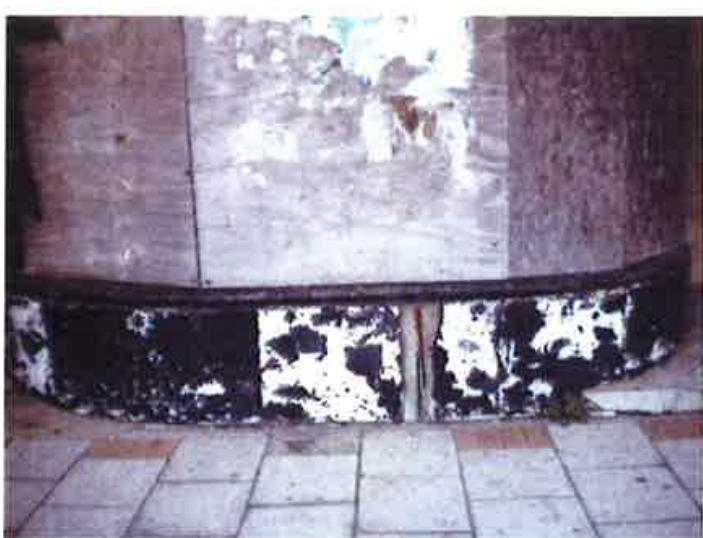
Cladding panels below window 2012

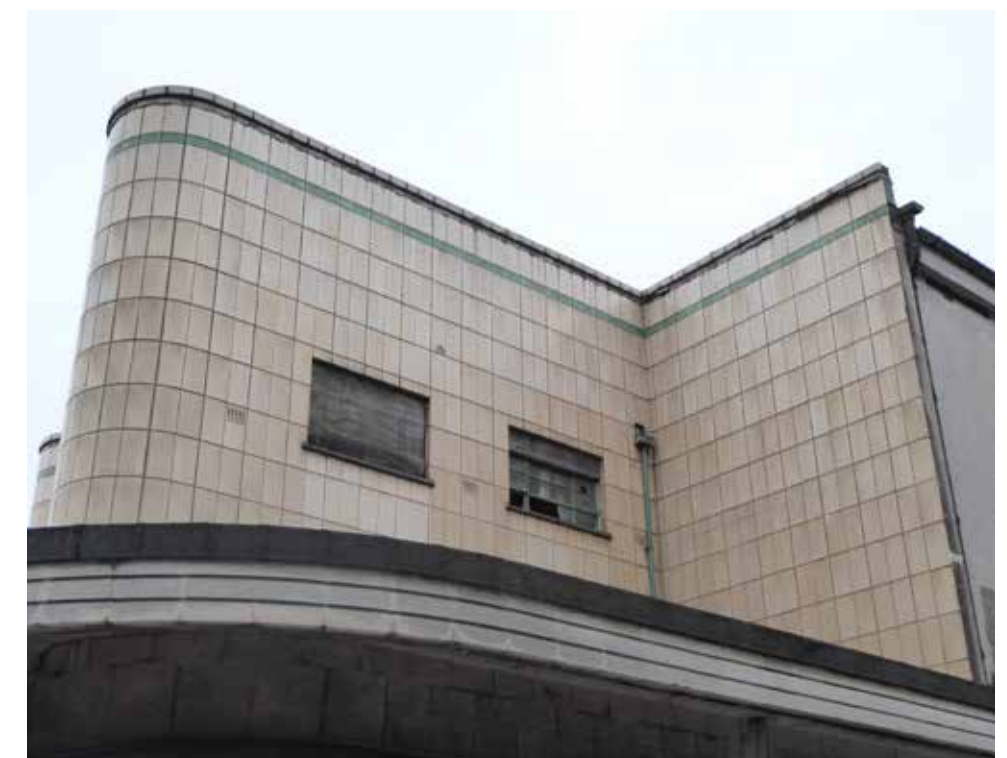
*A recent photo of the Plaza frontage shows that, despite its dereliction, it retains the iconic Art Deco forms, lines & features*
