**BARN OUTBUILDING  
AT  
PLAS FARM  
CILYBEBYLL**

**PROPOSED  
CONVERSION  
TO  
SERVE  
HOLIDAY  
COTTAGES**

**STRUCTURAL SURVEY  
REPORT**

**JULY 2021**

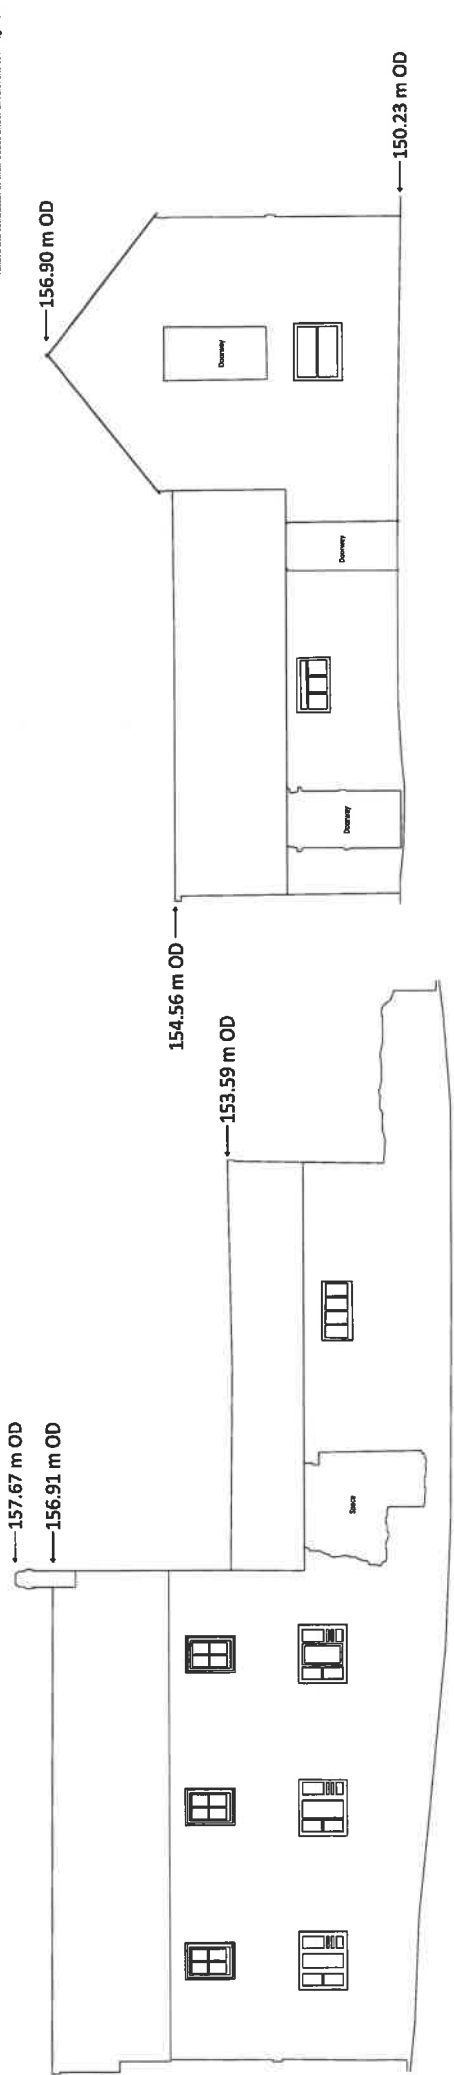
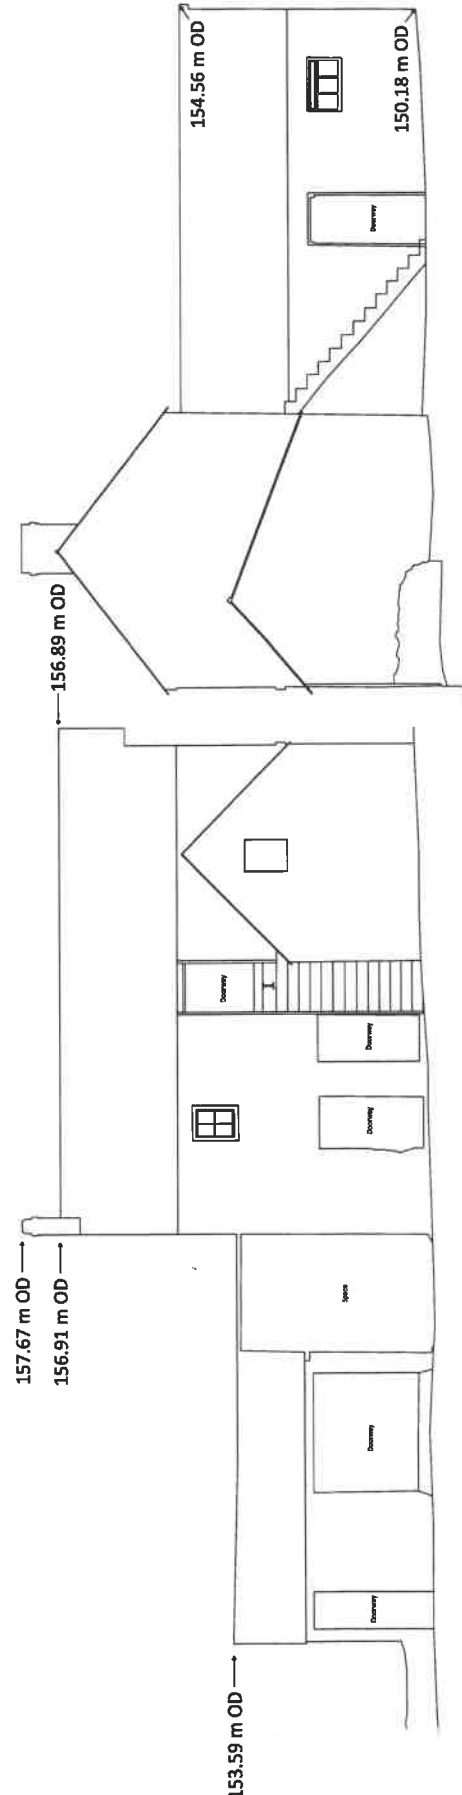
Fig.3

- 4.1** The proposals for the building is to convert and remodel the building to provide a first floor single bed holiday let unit , accessed off an external stairs, with provision of leisure , laundry and reception facilities on the ground floor as shown on RIO Architect's drawings [ fig. 3,4]
