# **Stage 3 Road Safety Audit Report (Post Construction) (FINAL)**

**Aldi Store  
A474 Neath Abbey Road, Neath  
S278 Highway Works  
(Designers response )**

**Project Name:** Aldi Store, A474 Neath Abbey Road, Neath - S278 Highway Works.

**Report Title:** Stage 3 Road Safety Audit (FINAL).

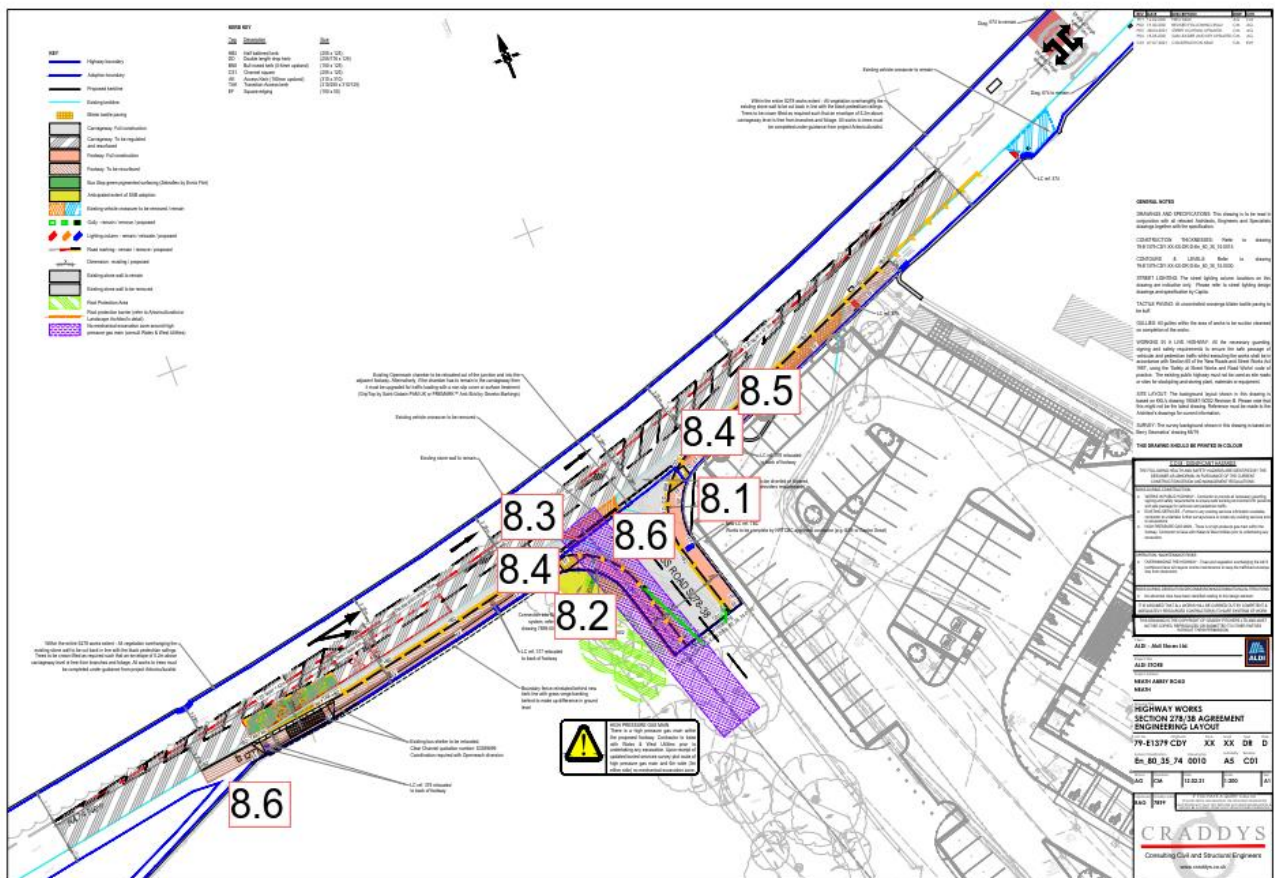
### 13. Appendix B - Identified Road Safety Audit Matters Location Plan

| No. | Item | Comments | Notes |
|---|---|---|---|
| C1.4 | Landscaping | Problems | (8.1) Level difference to rear of footway causing trip hazard.<br>(8.2) Deep hole in verge adjacent to new footway |
| C4.2 | Pedestrians | Problems | (8.3) Tactile paving laid with excessive gradient.<br>(8.4) Insufficient depth of tactile paving installed (Not as detailed)<br>(8.5) Trip hazard on new footway surfacing |
