# BS5837 2012 Arboricultural Implications Assessment

R&J Metals  
The Docks Estate  
Briton Ferry  
Neath  
SA11 2HZ

Report by James Pinder Tech Cert (Arbor A)

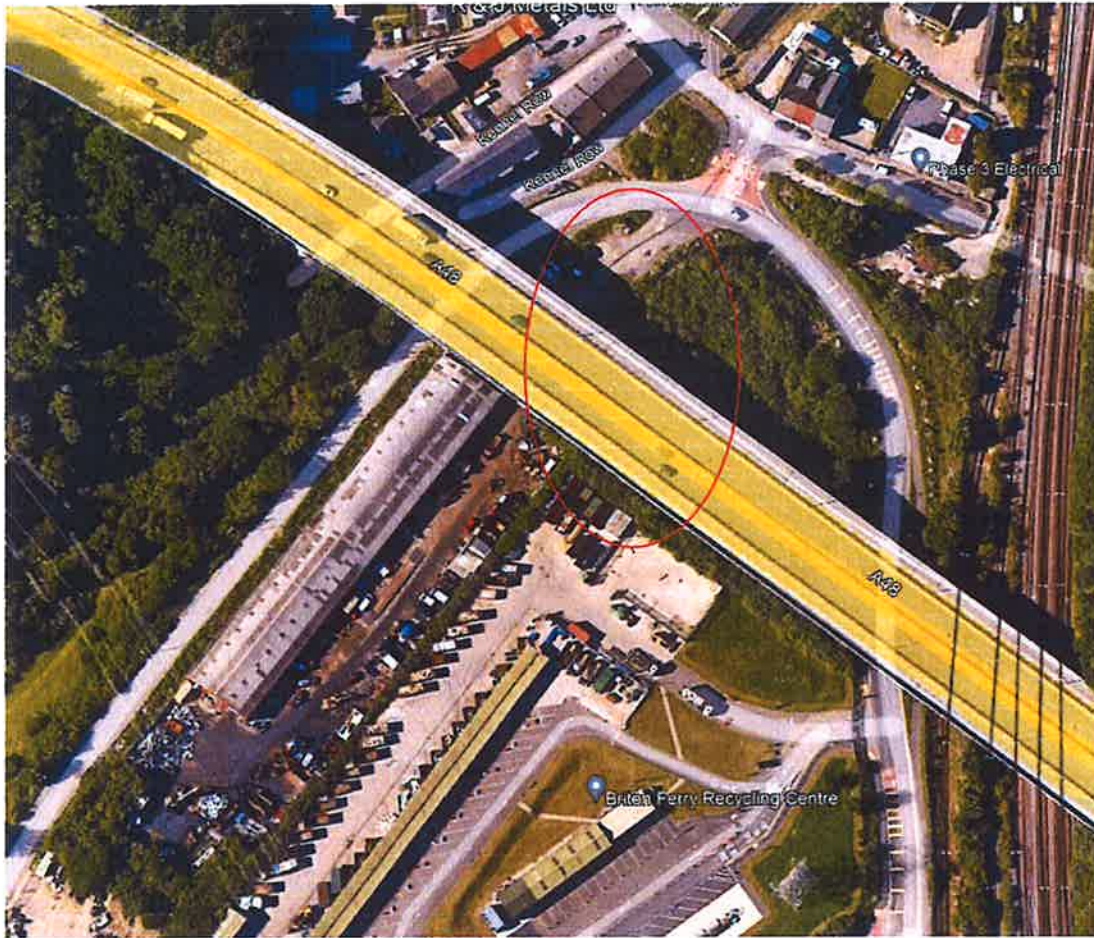
- Site access from Wharf Road.
- Redundant commercial property/land.
- Significant historical clearance and heavy machinery operations on site.
- Low value trees on land.
- Schedule 9 invasive plants.
- Extensive weed growth.

Given no trees worthy of recording within a BS583 2012 survey exist on site or the proposed site boundaries, my suggestion is that the landowner carry out control of Japanese knotweed through chemical control whilst in full leaf summer 2022. Icade herbicide would be a suitable product to use via stem injection of moisture droplet applied. I would also advise that control of remaining weed species is advisable within the proposed site area using Round Up Pro Vantage 480 mixed at suitable rates to control the species present. The initial recommended vegetation controls will enable far easier marking out and site clearance in relation to the proposed project.
