## Tree Assessment 26/10/2022

9 PRINCESS DRIVE, BRYNCOCH - TTS/539

**Paul Hastings**

TENDERLEAF LTD | 19, HEOL Y NANT, RHOS, PONTARDAWE, SA8 3BX

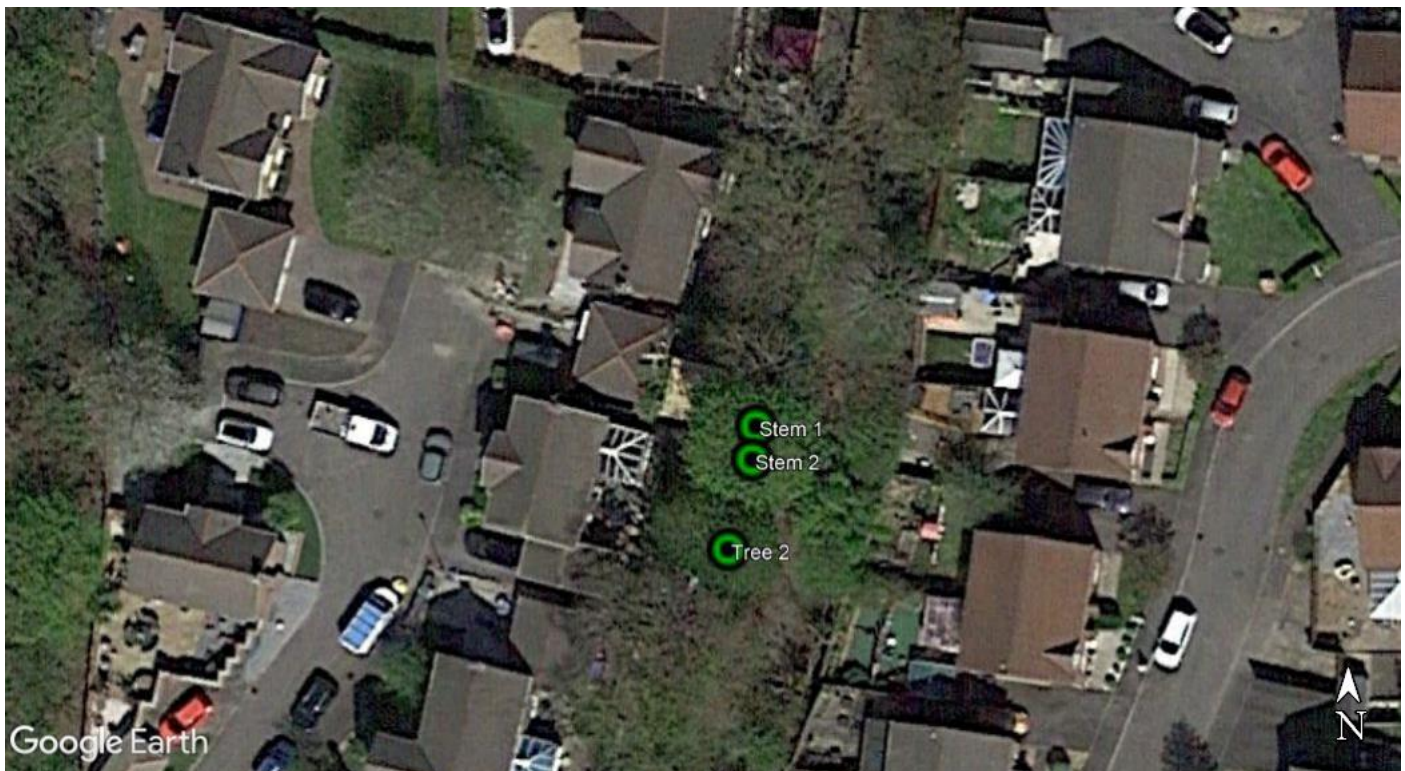
Figure 1

- 4.1 The trees are located on the eastern boundary of the client's property, 9 Princess Drive.
- 4.2 As can be seen from figure 1, the trees lie adjacent to a public footpath.

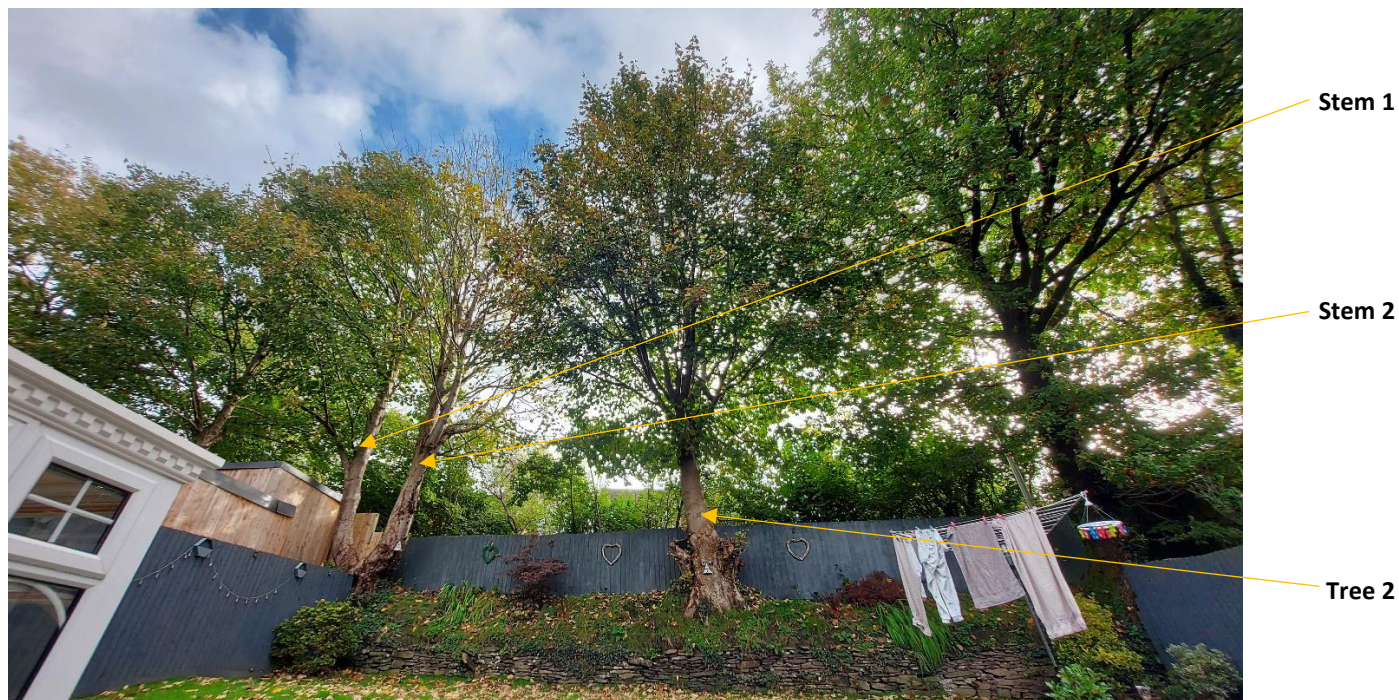
Photo 1 – The view from the owners house up to the trees.
