Land Adjacent Neath Abbey Road  
Abbey Road Industrial Estate,  
Neath.  
SA10 7BR

**Load Assessment on Existing Steel Framed Buildings**

For  
Huw Jenkins

| <b>Date:</b> | 14 <sup>th</sup> November 2022 |

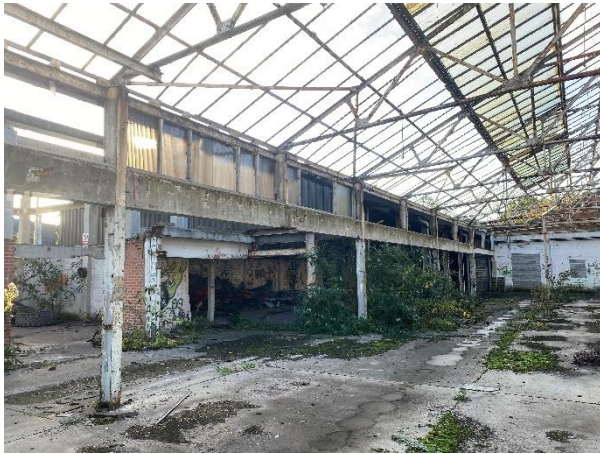
Photo B1 - GA3 - Internal elevation on gridline E

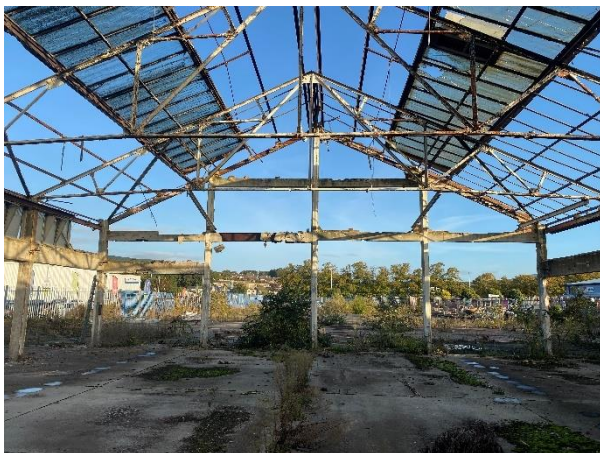
Photo B1 - GA5 - Internal elevation on gridline 1

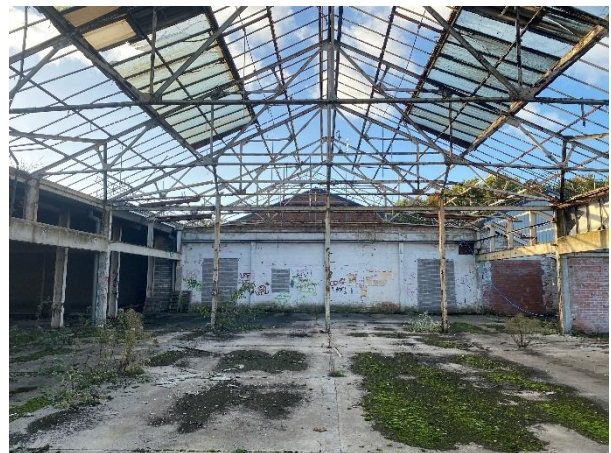
Photo B1 - GA6 - Internal elevation on gridline 10

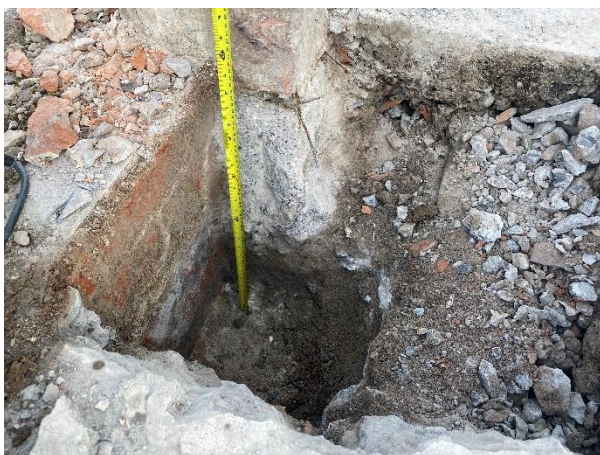
Photo B1 - GA7 - Trial pit to column on gridline A1

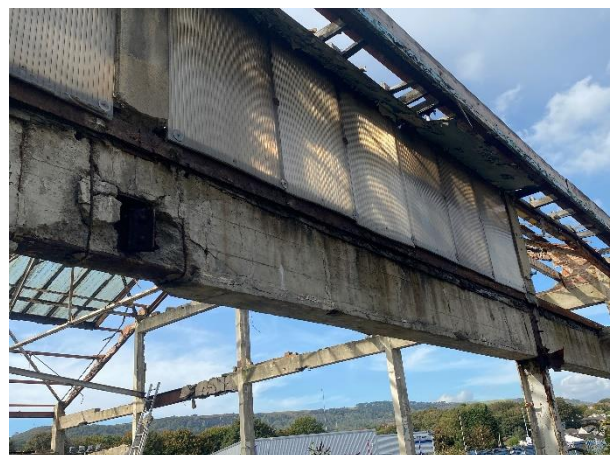
Photo B1 - GA8 - Side wall lights

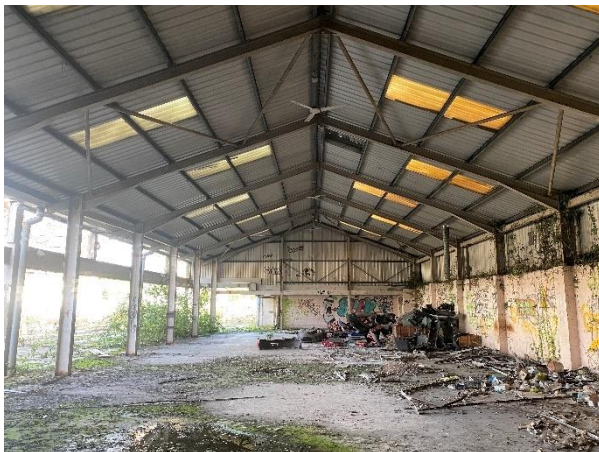
Photo B2-GA1 – Internal elevation on GL4

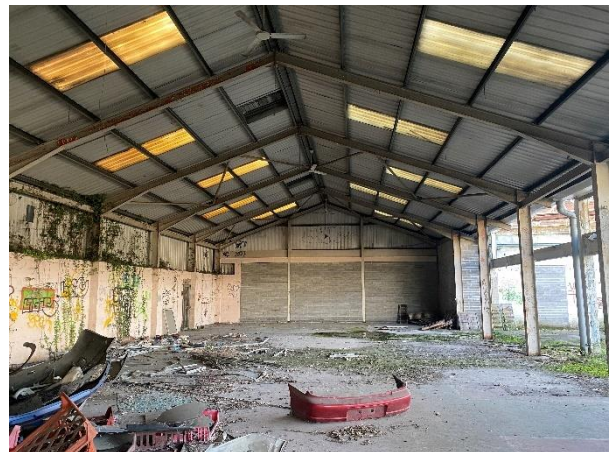
Photo B2-GA2 – Internal elevation on GL11

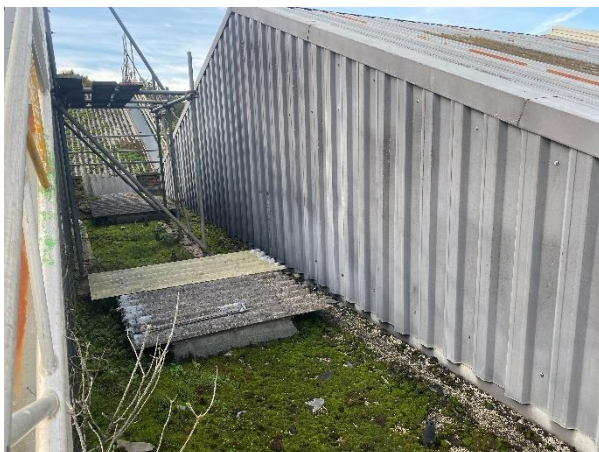
Photo B2-GA3 – External elevation on GL11

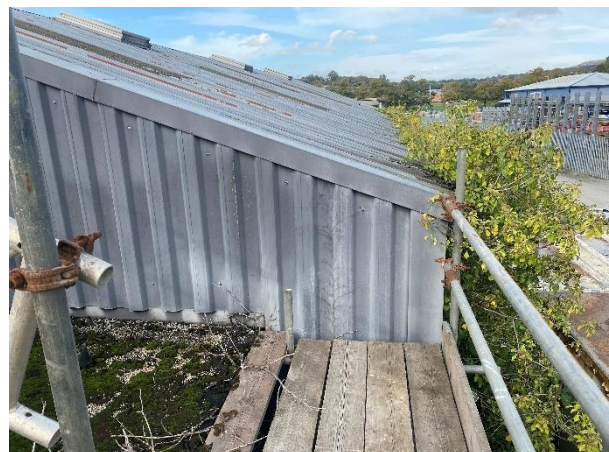
Photo B2-GA4 – External roof along gridline I

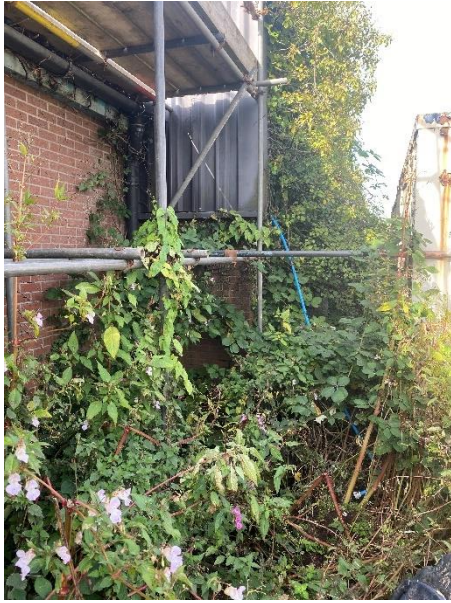
Photo B2-GA5 – External building corner on gridline I/11

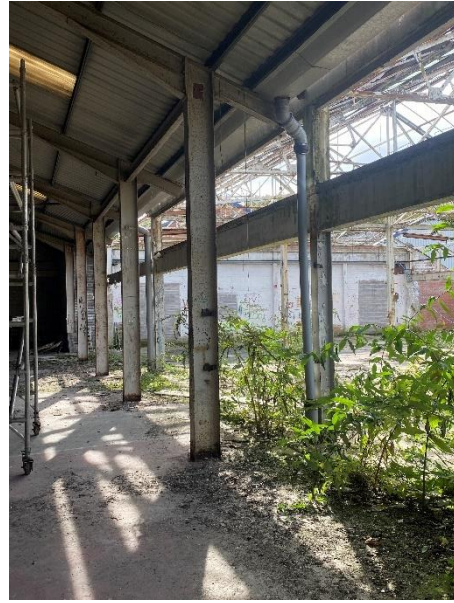
Photo B2-GA6 – Building 1 to building 2 joint arrangements

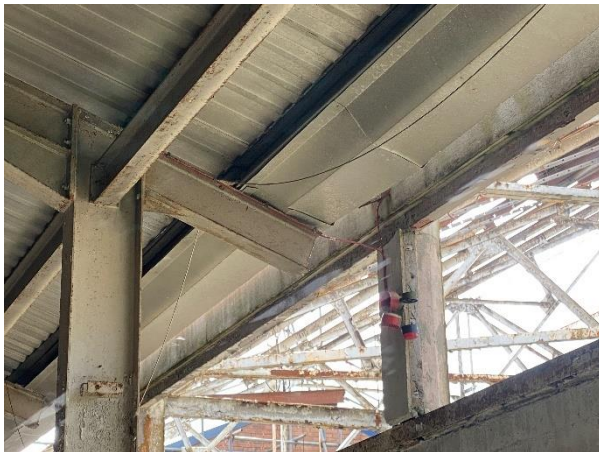
Photo B2-GA7 – Valley gutter along gridline F

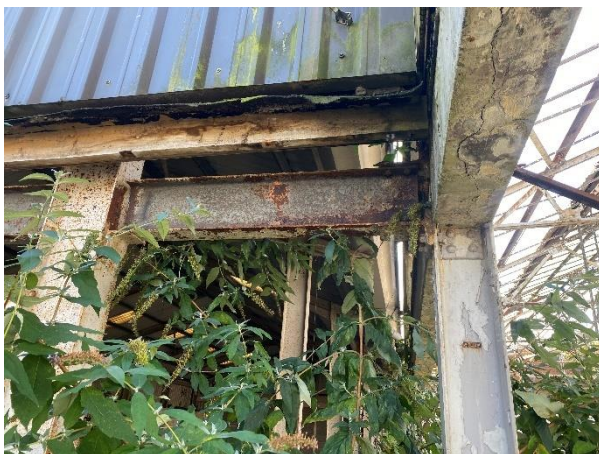
Photo B2-GA9 – Building 1 to building 2 connection on gridline F4

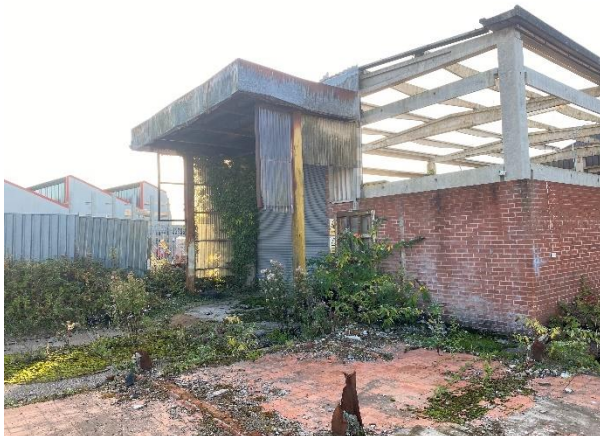
Photo B3-GA1 – Front entrance elevation on gridline 1

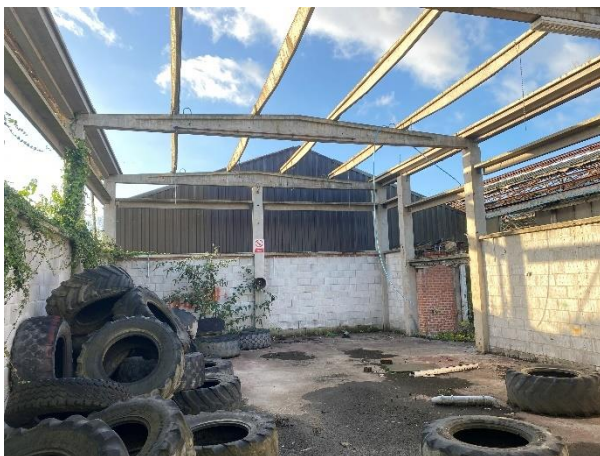
Photo B3-GA5 – Internal elevation on gridline 4

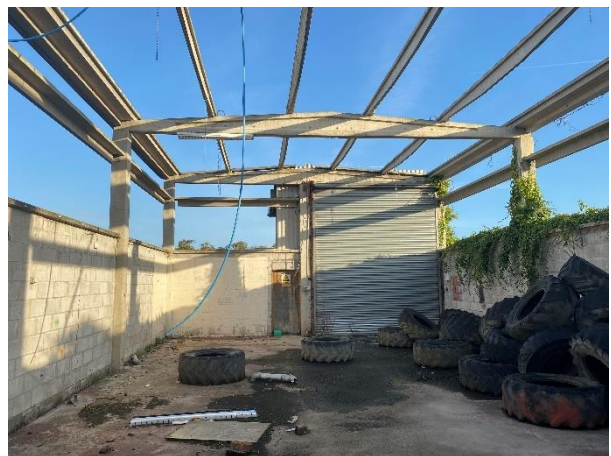
Photo B3-GA6 – Internal elevation on gridline 1

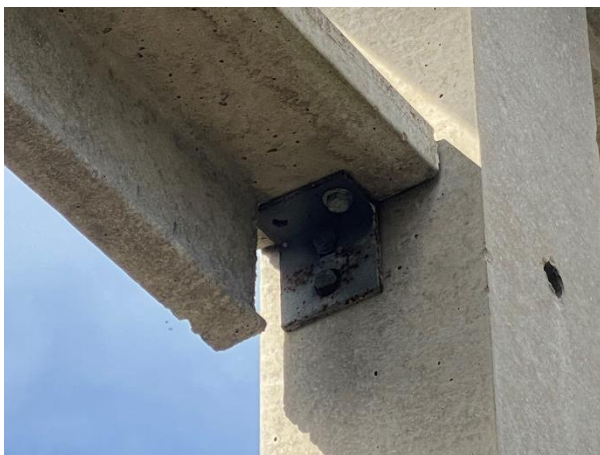
Photo B3-GA7 – Typical cladding rail to column connection

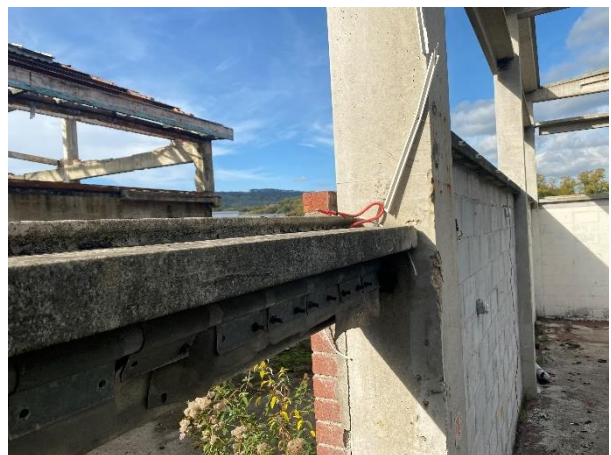
Photo B3-GA8 – Typical cladding rail – note upper concrete rebate/lip for connection of cladding J bolt fixing

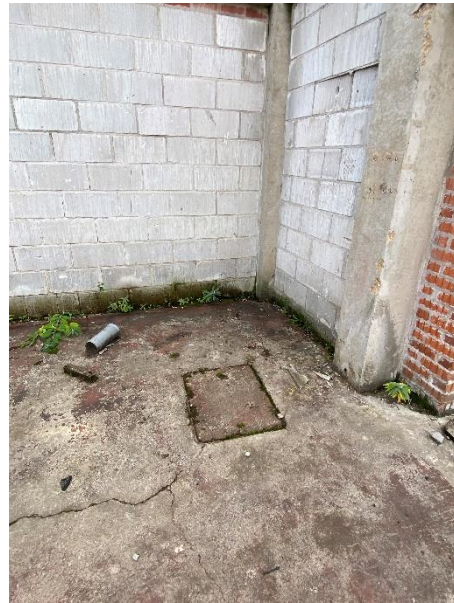
Photo B3-GA10 – Internal manhole

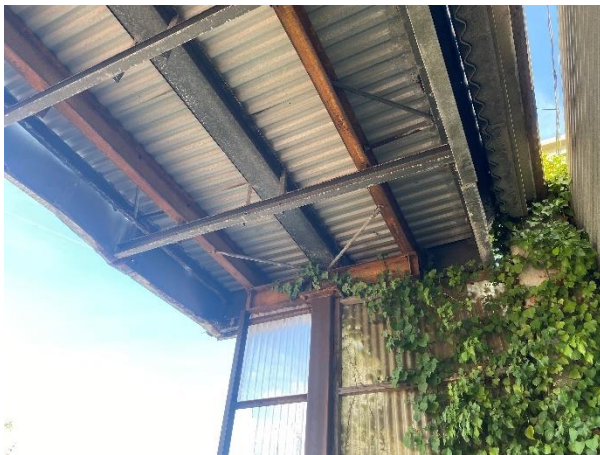
Photo B3-GA11 – Underside of canopy on gridline L
