RHONDDA  
GEOTECHNICAL  
SERVICES

COAL MINING RISK ASSESSMENT  
PRE-PLANNING ENQ. Q2022/0111  
NEATH PORT TALBOT C.B.C.  
RESIDENTIAL UNITS  
BRYNMORGAN VILLA CARE HOME  
LOWER BRYNMORGAN BRIDGE  
UPPER CWMTWARCH  
SWANSEA  
SA9 2XG  
16/10/2022

## **COAL MINING RISK ASSESSMENT**

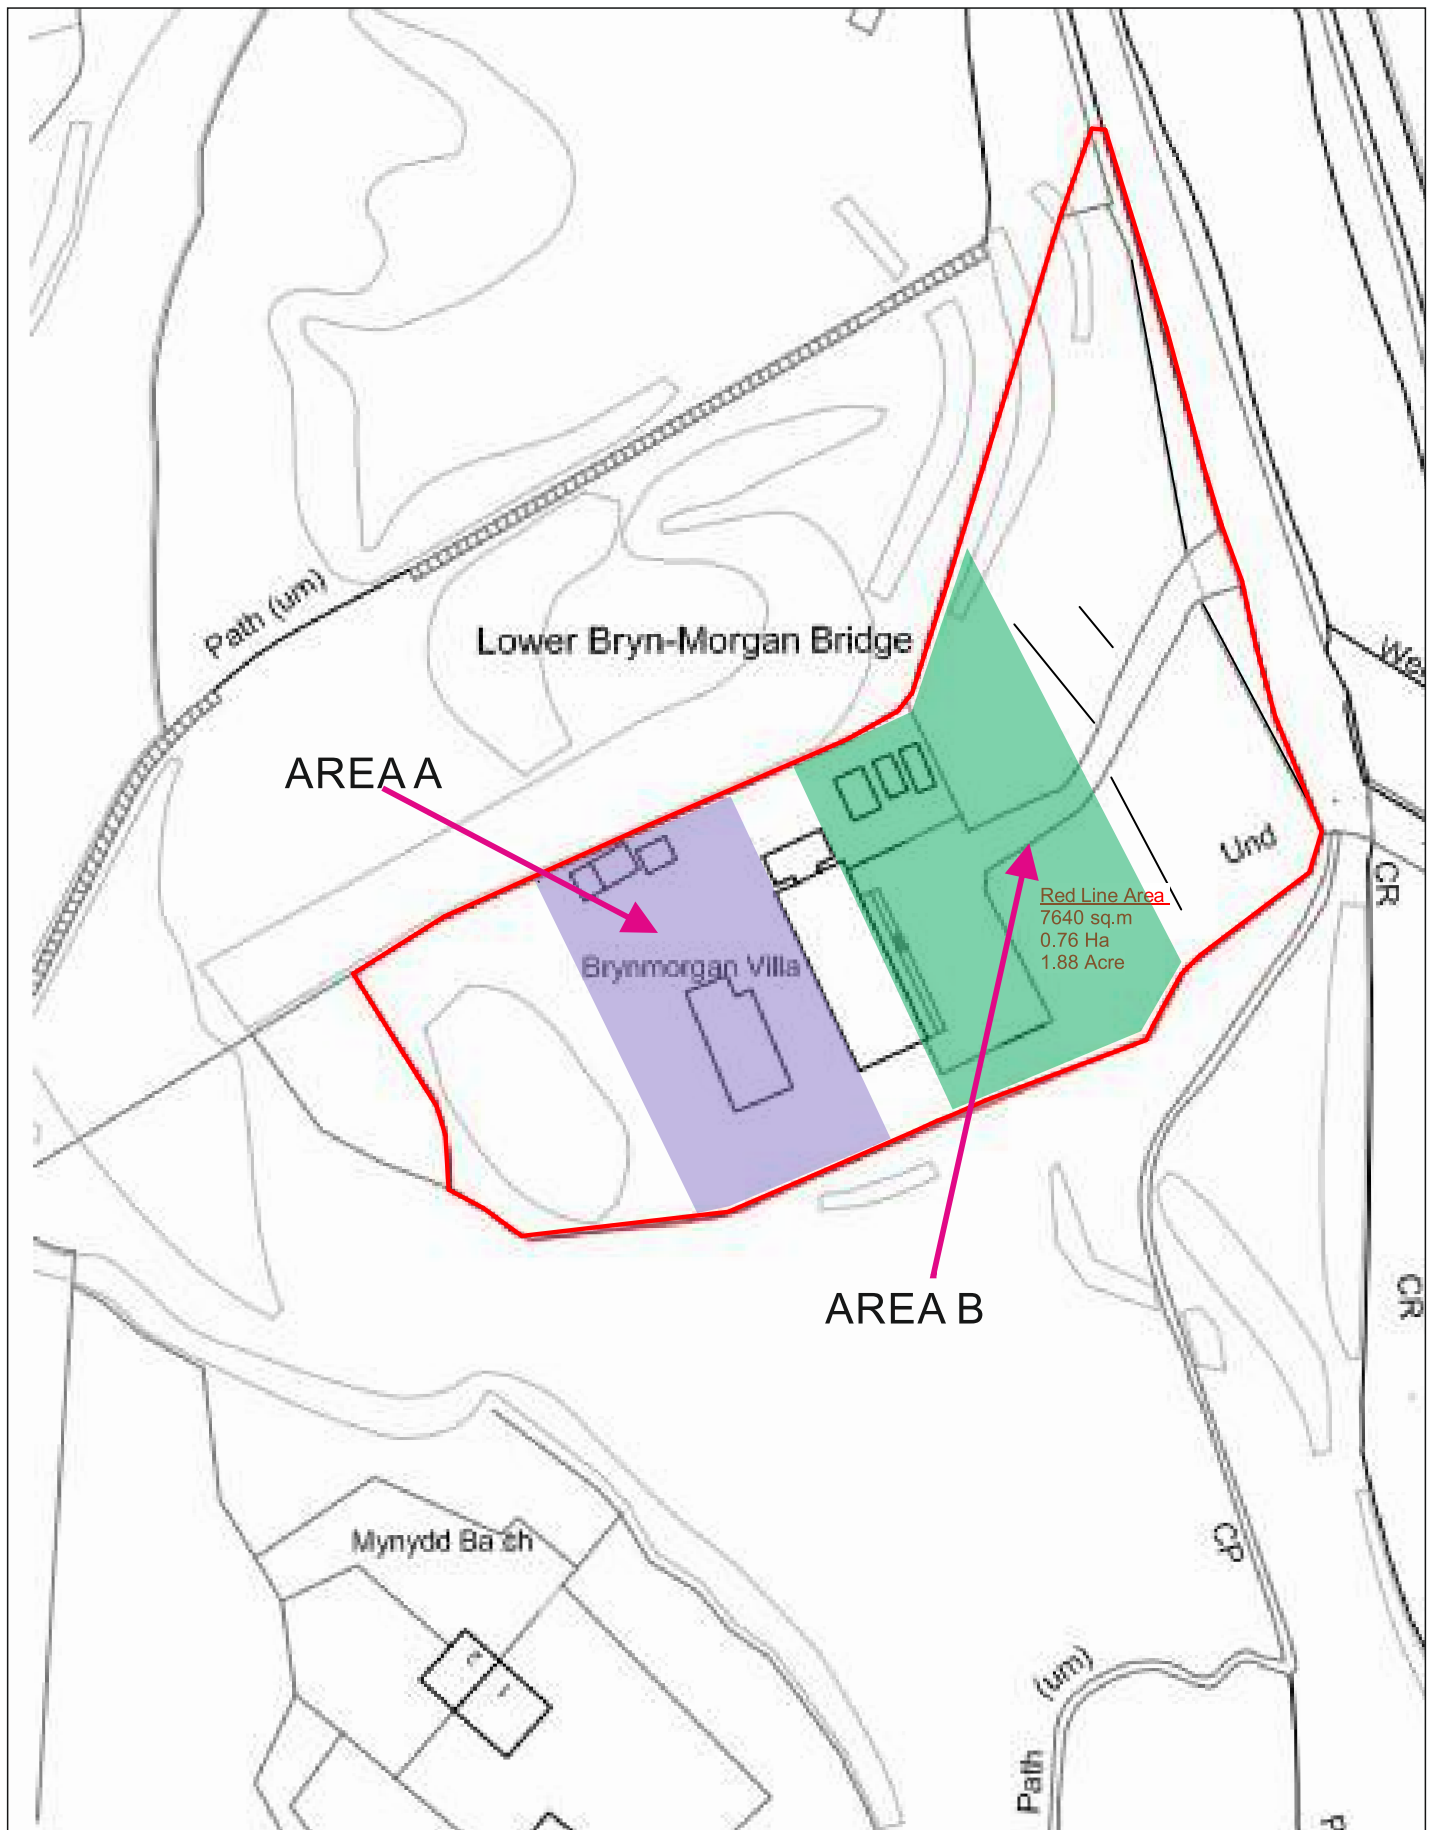
FIGURE 2  
LAND OWNERSHIP BOUNDARY IS OUTLINED IN RED.  
TWO POTENTIAL DEVELOPMENT AREAS ARE HIGHLIGHTED.

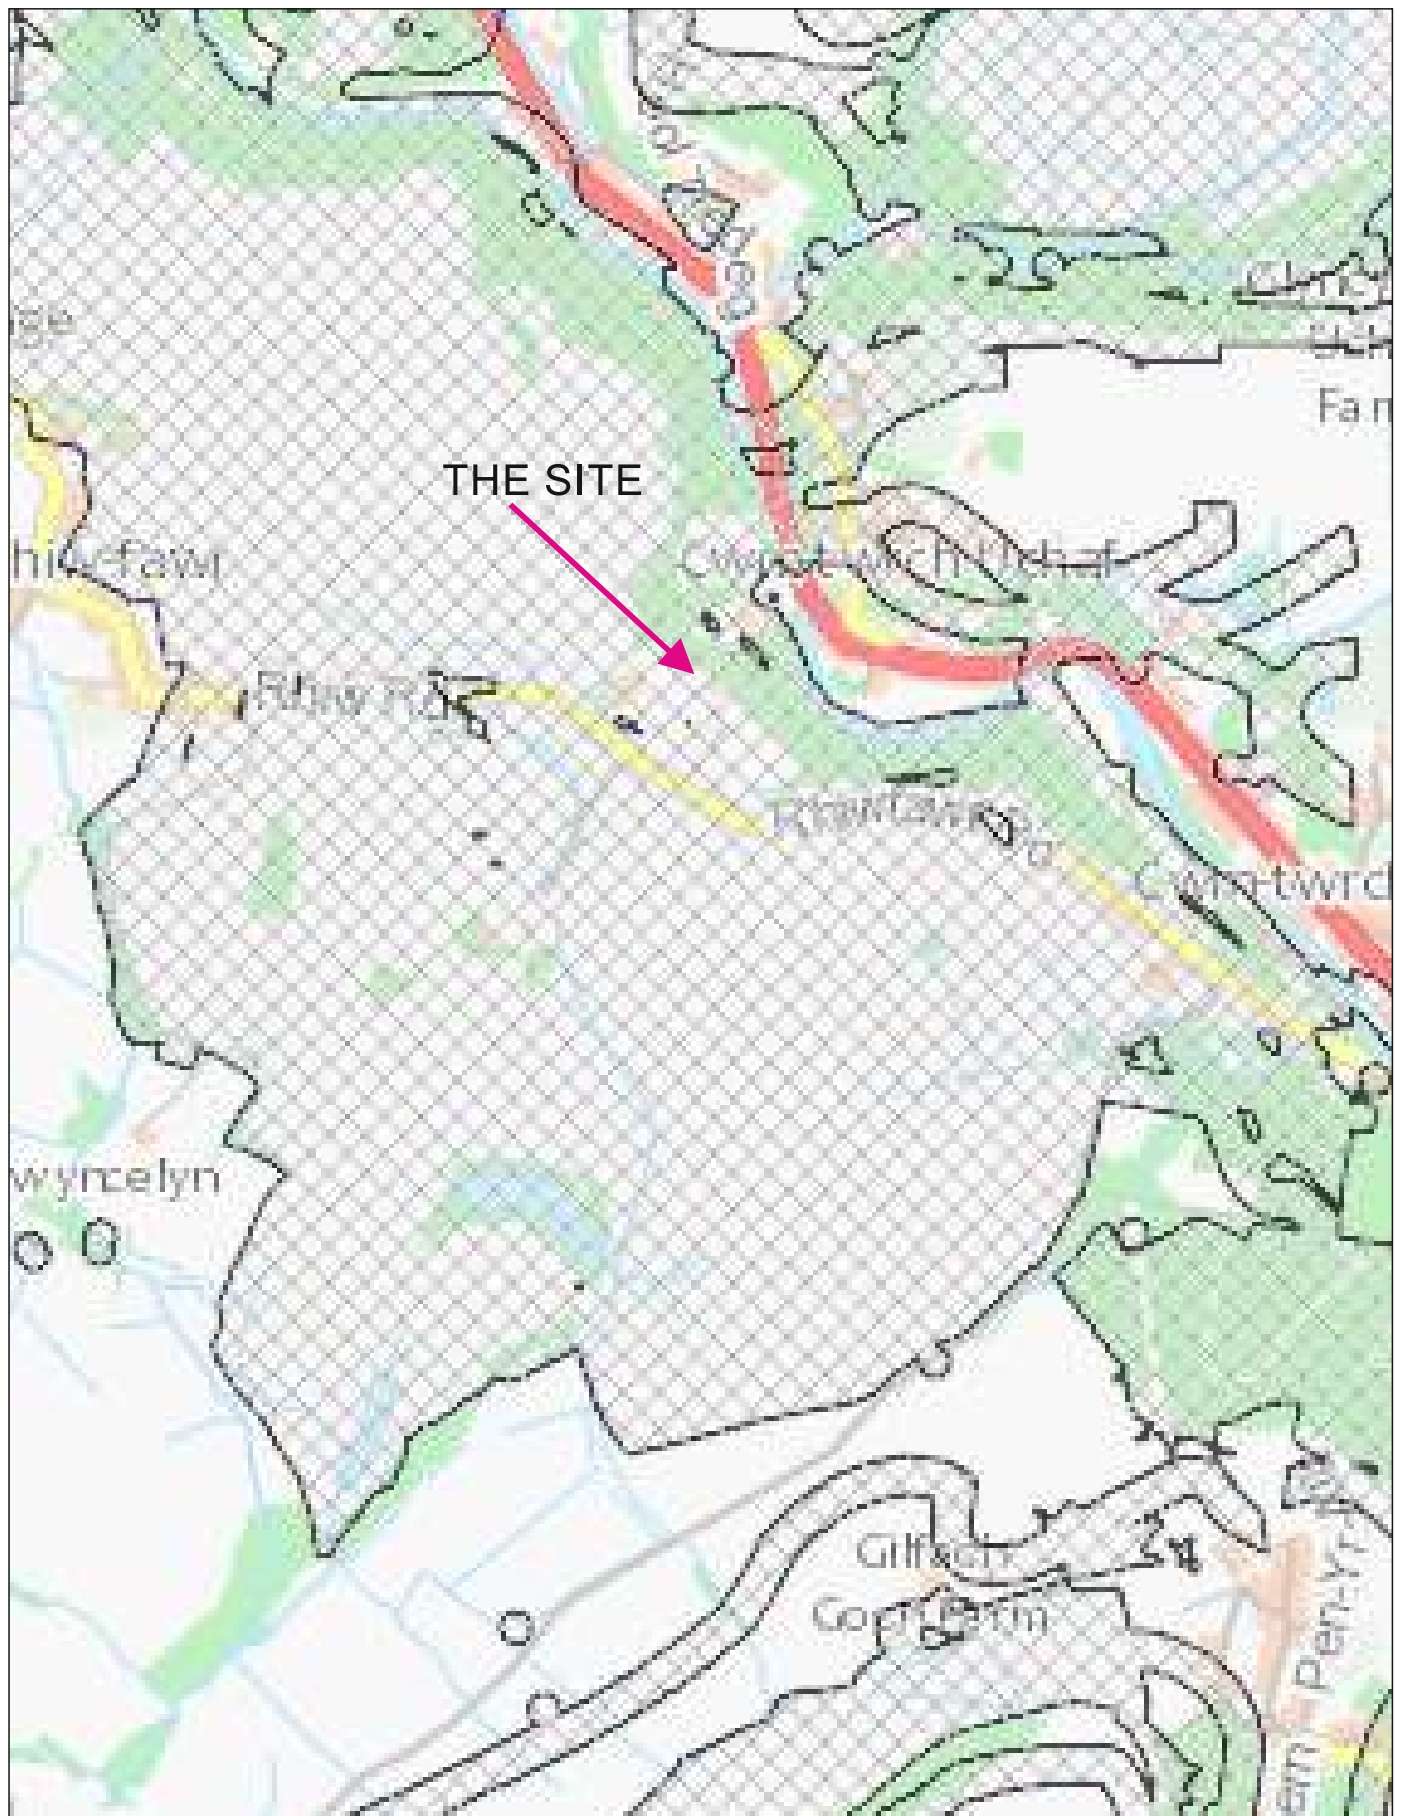
2b) The C.A. interactive viewer contains a vast amount of information from various sources, particularly on the mining data window. Much of this is not contained within a Consultants Report for reasons unknown. An extract from the planning window can be seen in Figure 4. Development High Risk Areas are hatched in grey. The site lies in a very large area of development high risk.

FIGURE 4  
COAL AUTHORITY INTERACTIVE VIEWER, PLANNING WINDOW.  
GREY HATCHED AREAS ARE DEVELOPMENT HIGH RISK.

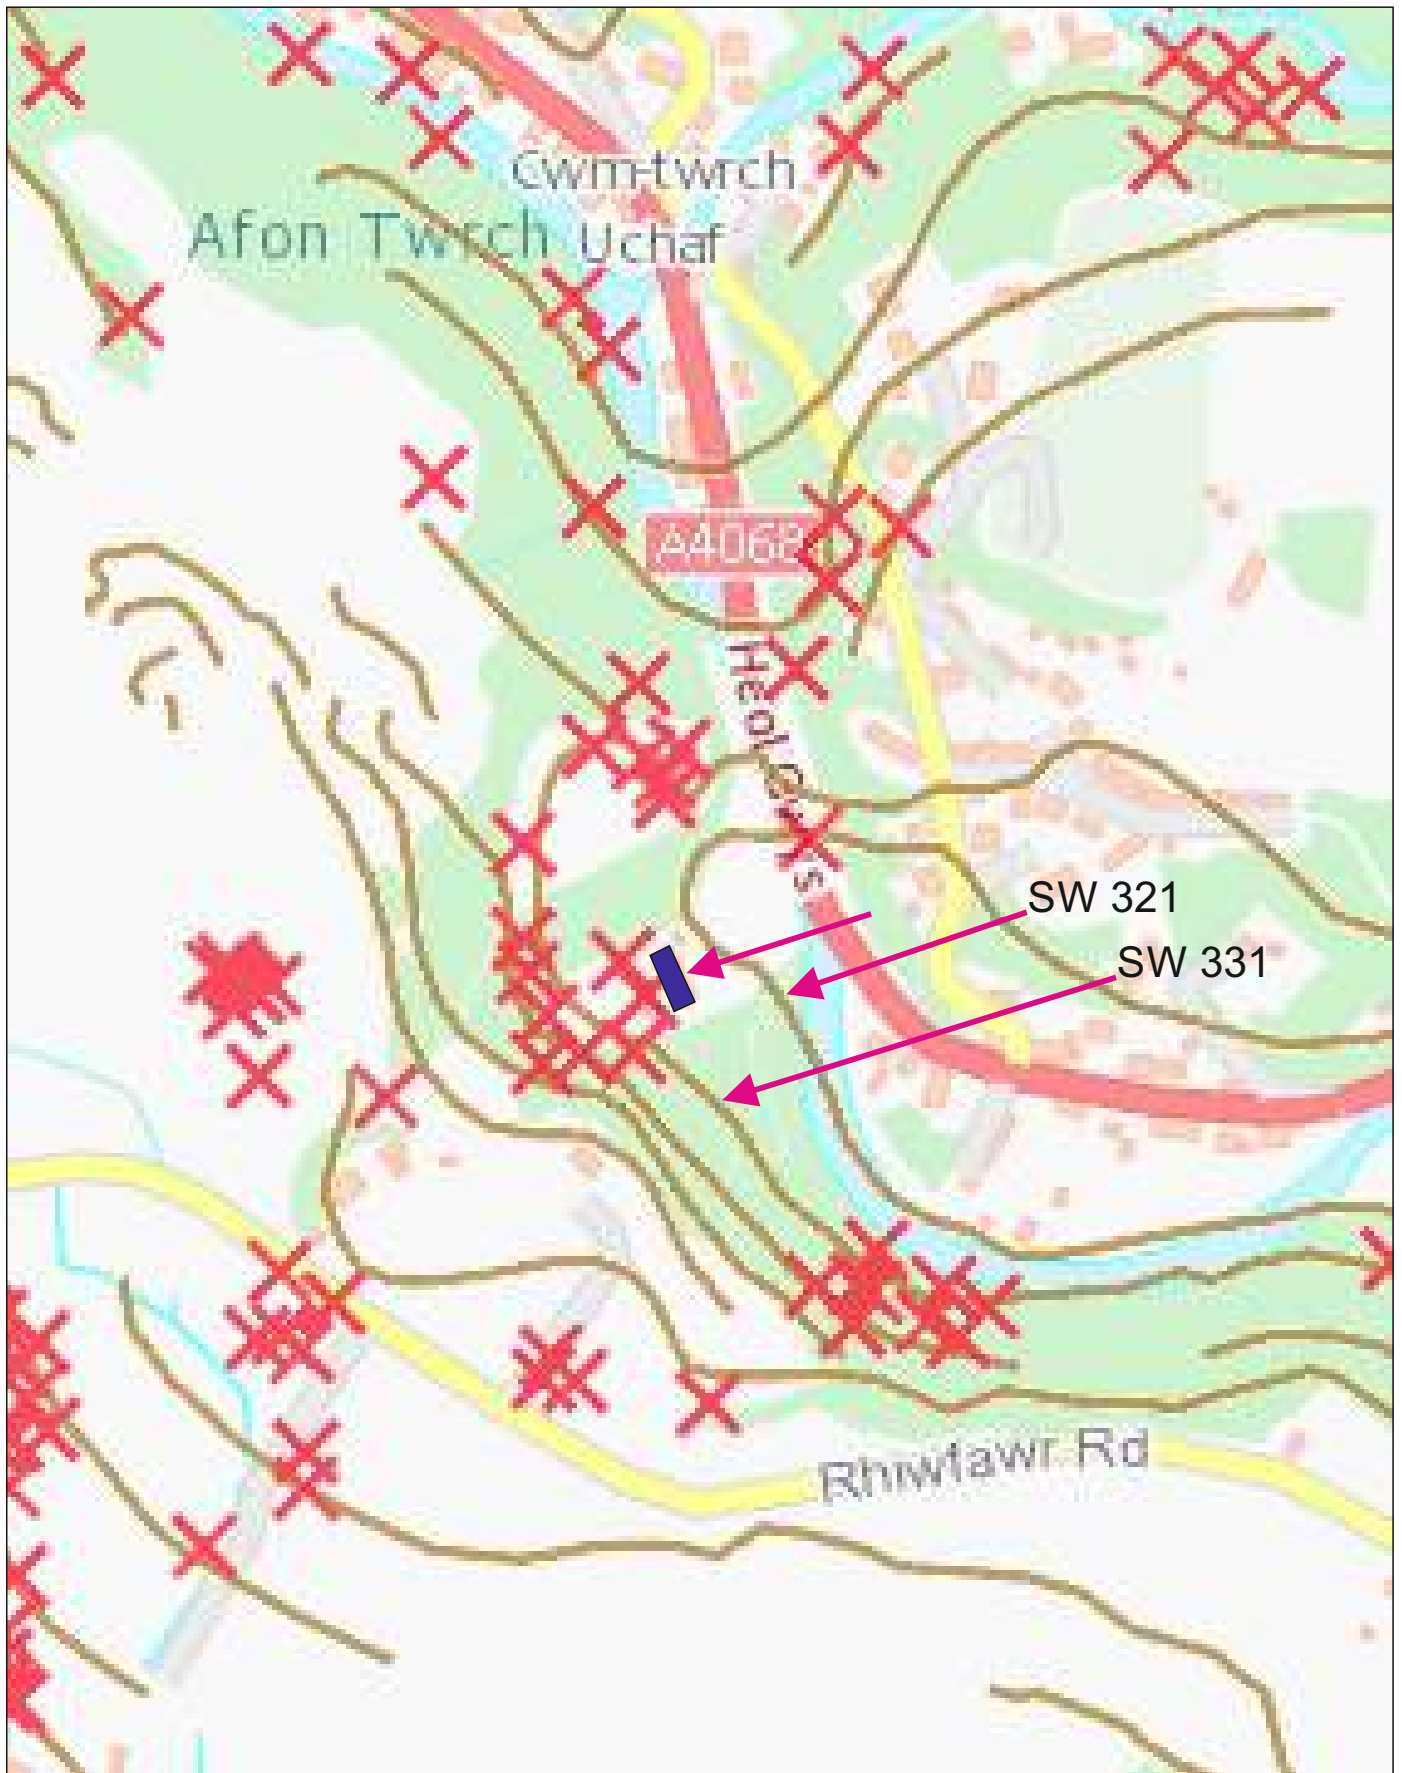
FIGURE 5

In order to fully understand why a site has a high-risk status it is informative to study the Coal Mining Data window. This window is far superior to the planning window as it is at a larger scale. There are multiple datasets which can be turned on and off. An extract from the Mining Data Window is reproduced as Figure 5 overleaf. For clarity only two sets of data are turned on in Figure 5- seam outcrops and mine entries. The brown lines are coal seam outcrops. The two nearest outcrops east and west of the existing building (highlighted) are numbered with their seam codes SW0321 and SW0331. The C.A. seam directory shows these to be the Lower Nine Foot Bottom Leaf and the Middle Nine Foot Top Leaf respectively. From the seam numbers ascending to the west it can be deduced that the strata may be dipping to the west, or that the ascending order could be caused by topography alone. Neither dips or topography are shown on the viewer.

C.A.VIEWER, MINING DATA WINDOW. RED CROSSES ARE MINE ENTRIES, BROWN LINES ARE SEAM OUTCROPS. THE MAIN RESIDENTIAL BUILDING IS HIGHLIGHTED

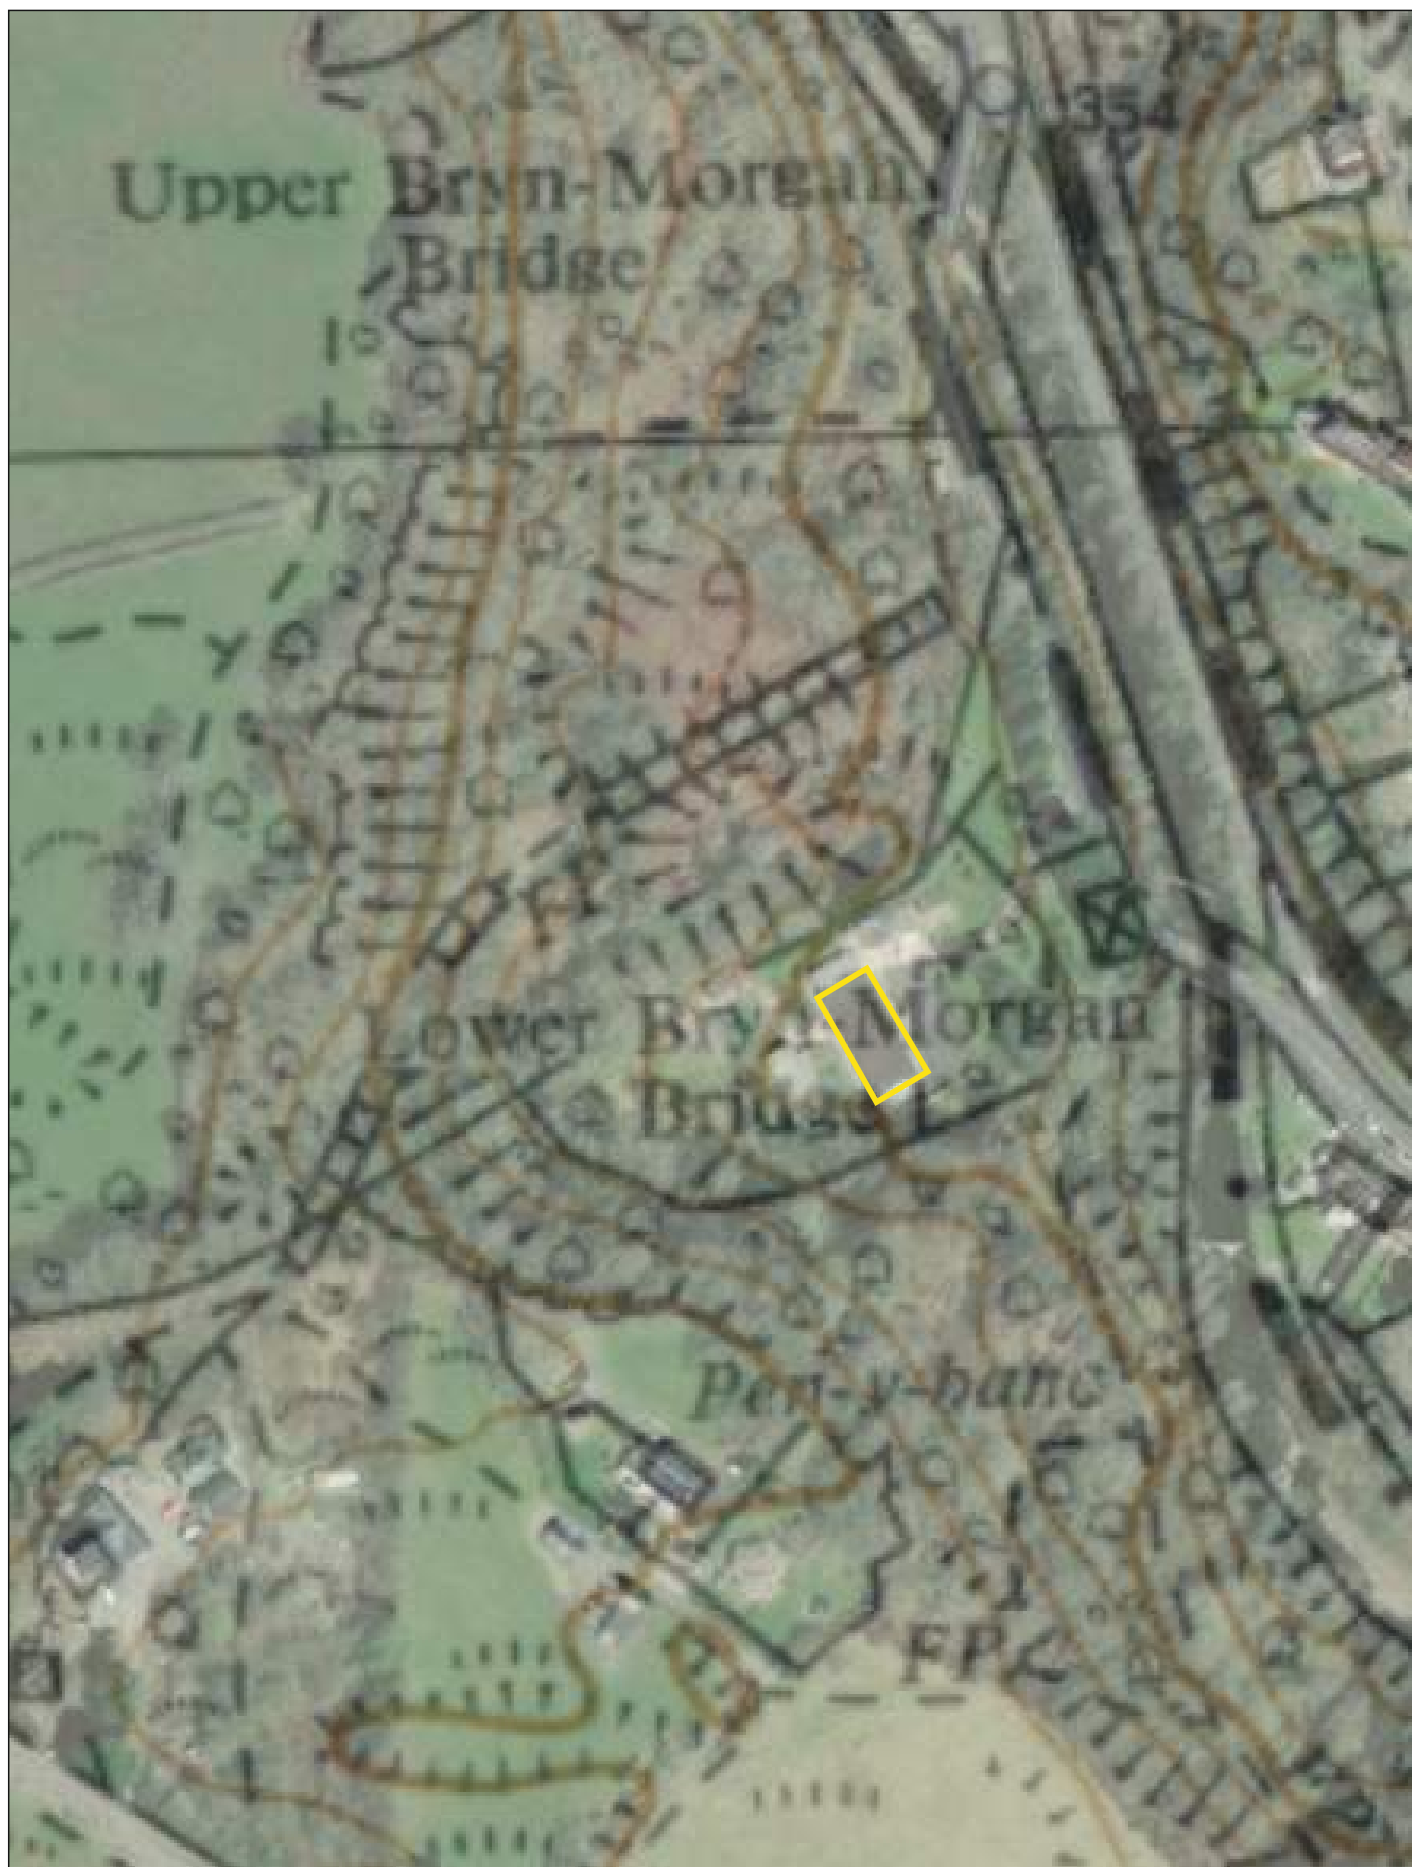
FIGURE 6A

1964 NATIONAL GRID O.S. GEOREFERENCED ON A RECENT AERIAL PHOTOGRAPH. BRYNMORGAN VILLA IS HIGHLIGHTED

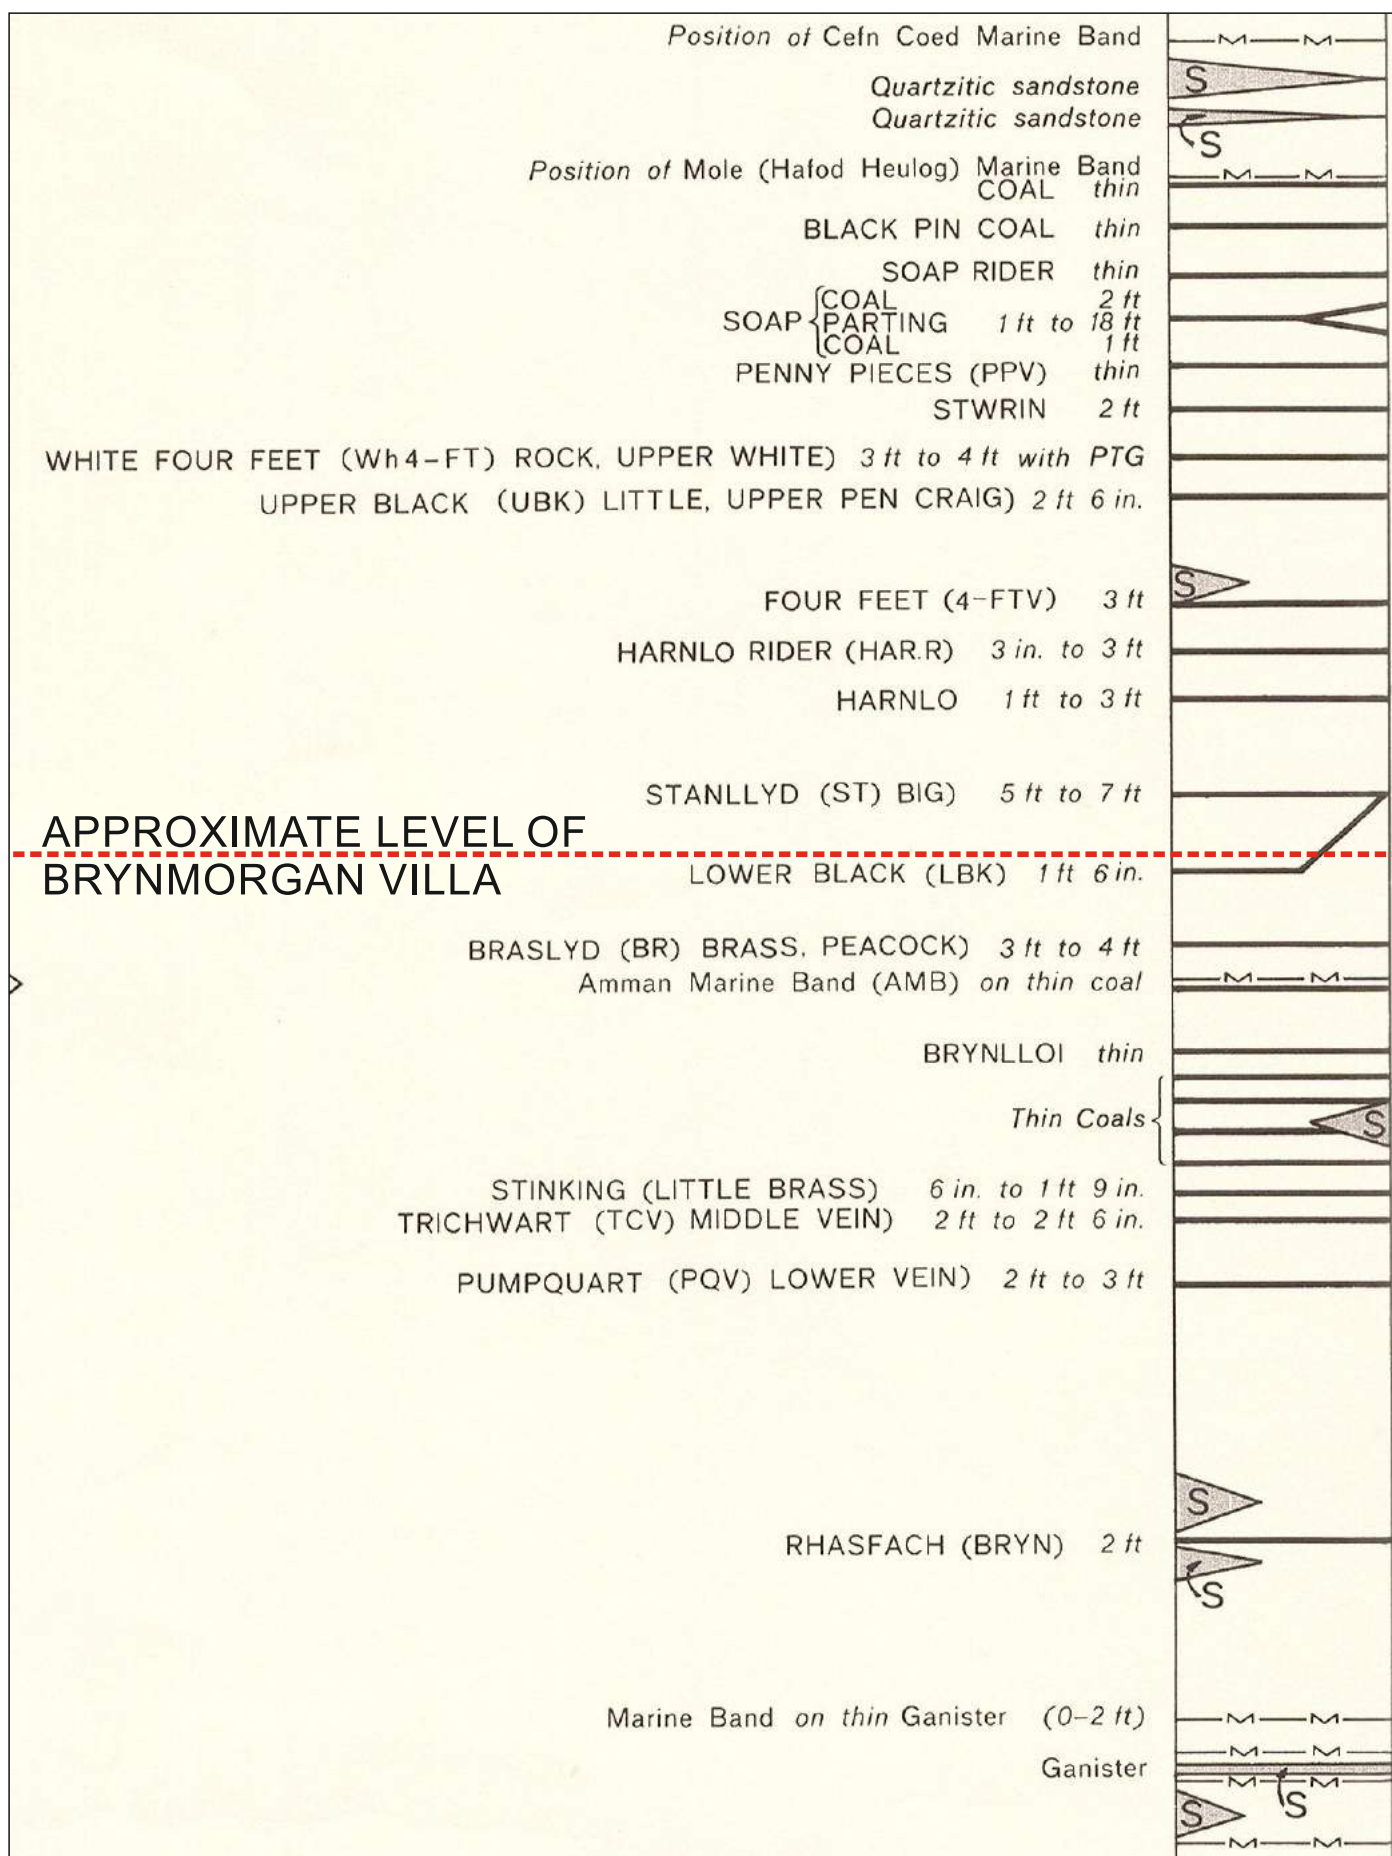
**FIGURE 7**

All three seam outcrops are west of, and higher than the existing building and so do not underlie it. There is no seam outcrop shown east of the building as in Figures 3 and 5. This is not unusual, as the Geological Survey usually only shows the main seams for clarity. Referring back to Figure 7, the approximate level of the existing building is shown. There is a split off the Stanllyd called the Lower Black which probably underlies the existing building. This may well correspond to the outcrop shown in Figures 3 and 5. The seam is shown to be 1'6" thick. This is at the lower end of workable thickness. It should be borne in mind that this is an average over the entire 25 km<sup>2</sup> map sheet and may vary considerably both upward and downward.

SECTION OF THE STRATIGRAPHIC COLUMN FROM SN 71SE.  
THE APPROXIMATE LEVEL OF BRYNMORGAN VILLA IS SHOWN.

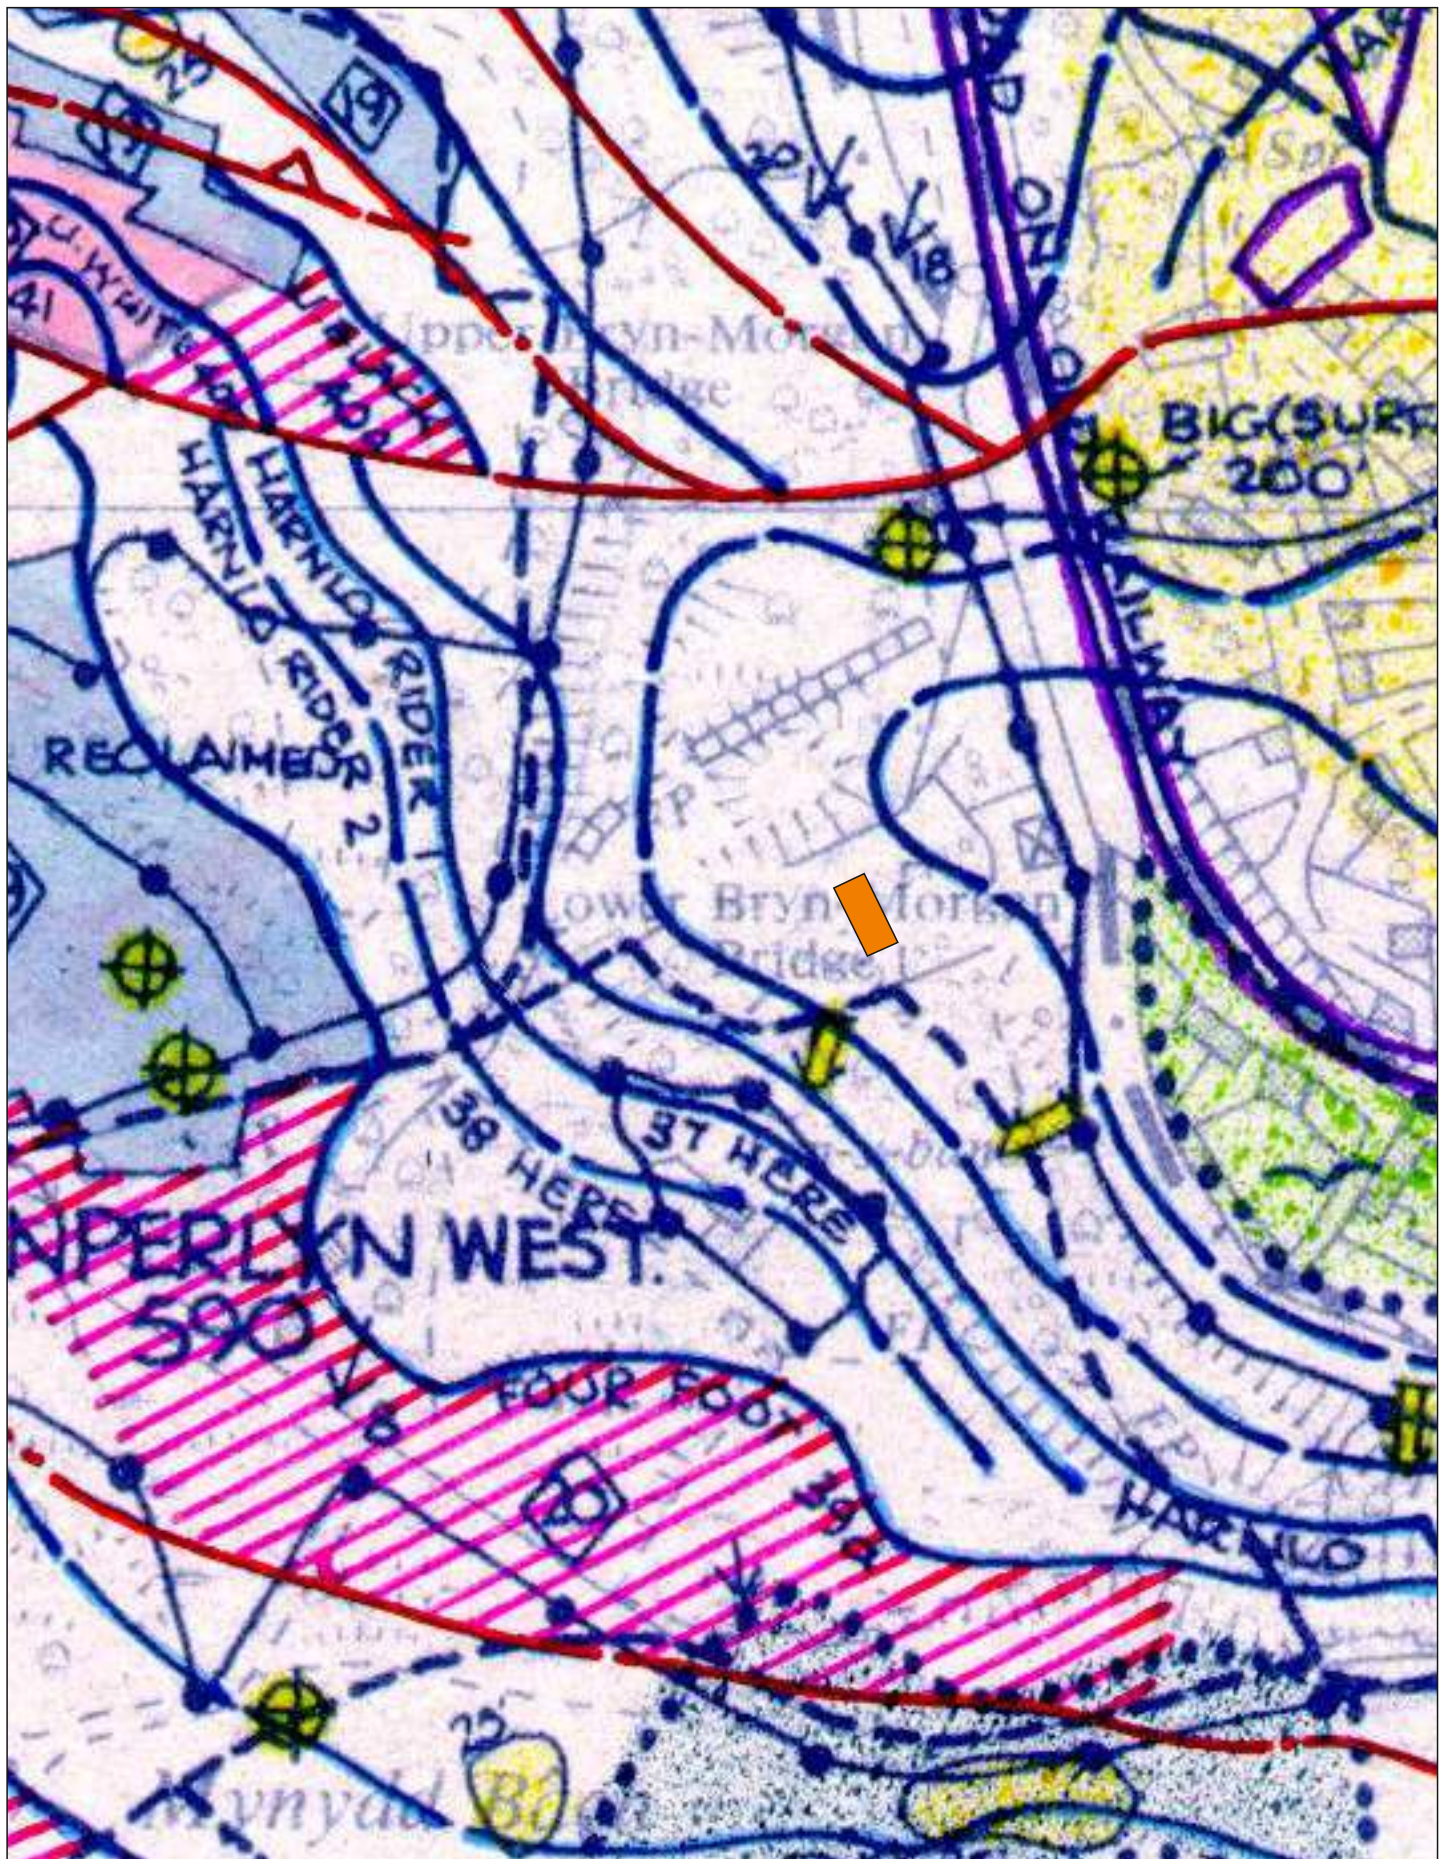
The primary source for the C.A. Interactive Viewer is the British Coal Rationalised Development Plan. This itself drew heavily on the Geological Survey with additional information from N.C.B/B.C. opencast records. Figure 8 is a section of Development Plan 07/D/SN/71SE. The existing building is highlighted, and the outcrop pattern is identical to the Interactive Viewer. The second outcrop, east of the building is identified as Seam 32. In the stratigraphic column in Figure 9, this is indeed the Lower Black. The complicated splitting of the Big Seam into its components is well illustrated. The thickness of the Lower Black is given as 6"-48" (0.15m-1.22m). This is certainly a good workable thickness at the higher end.

FIGURE 8  
EXTRACT OF BRITISH COAL DEVELOPMENT PLAN 07/D/SN/71 SE.  
BRYNMORGAN VILLA IS HIGHLIGHTED IN ORANGE.

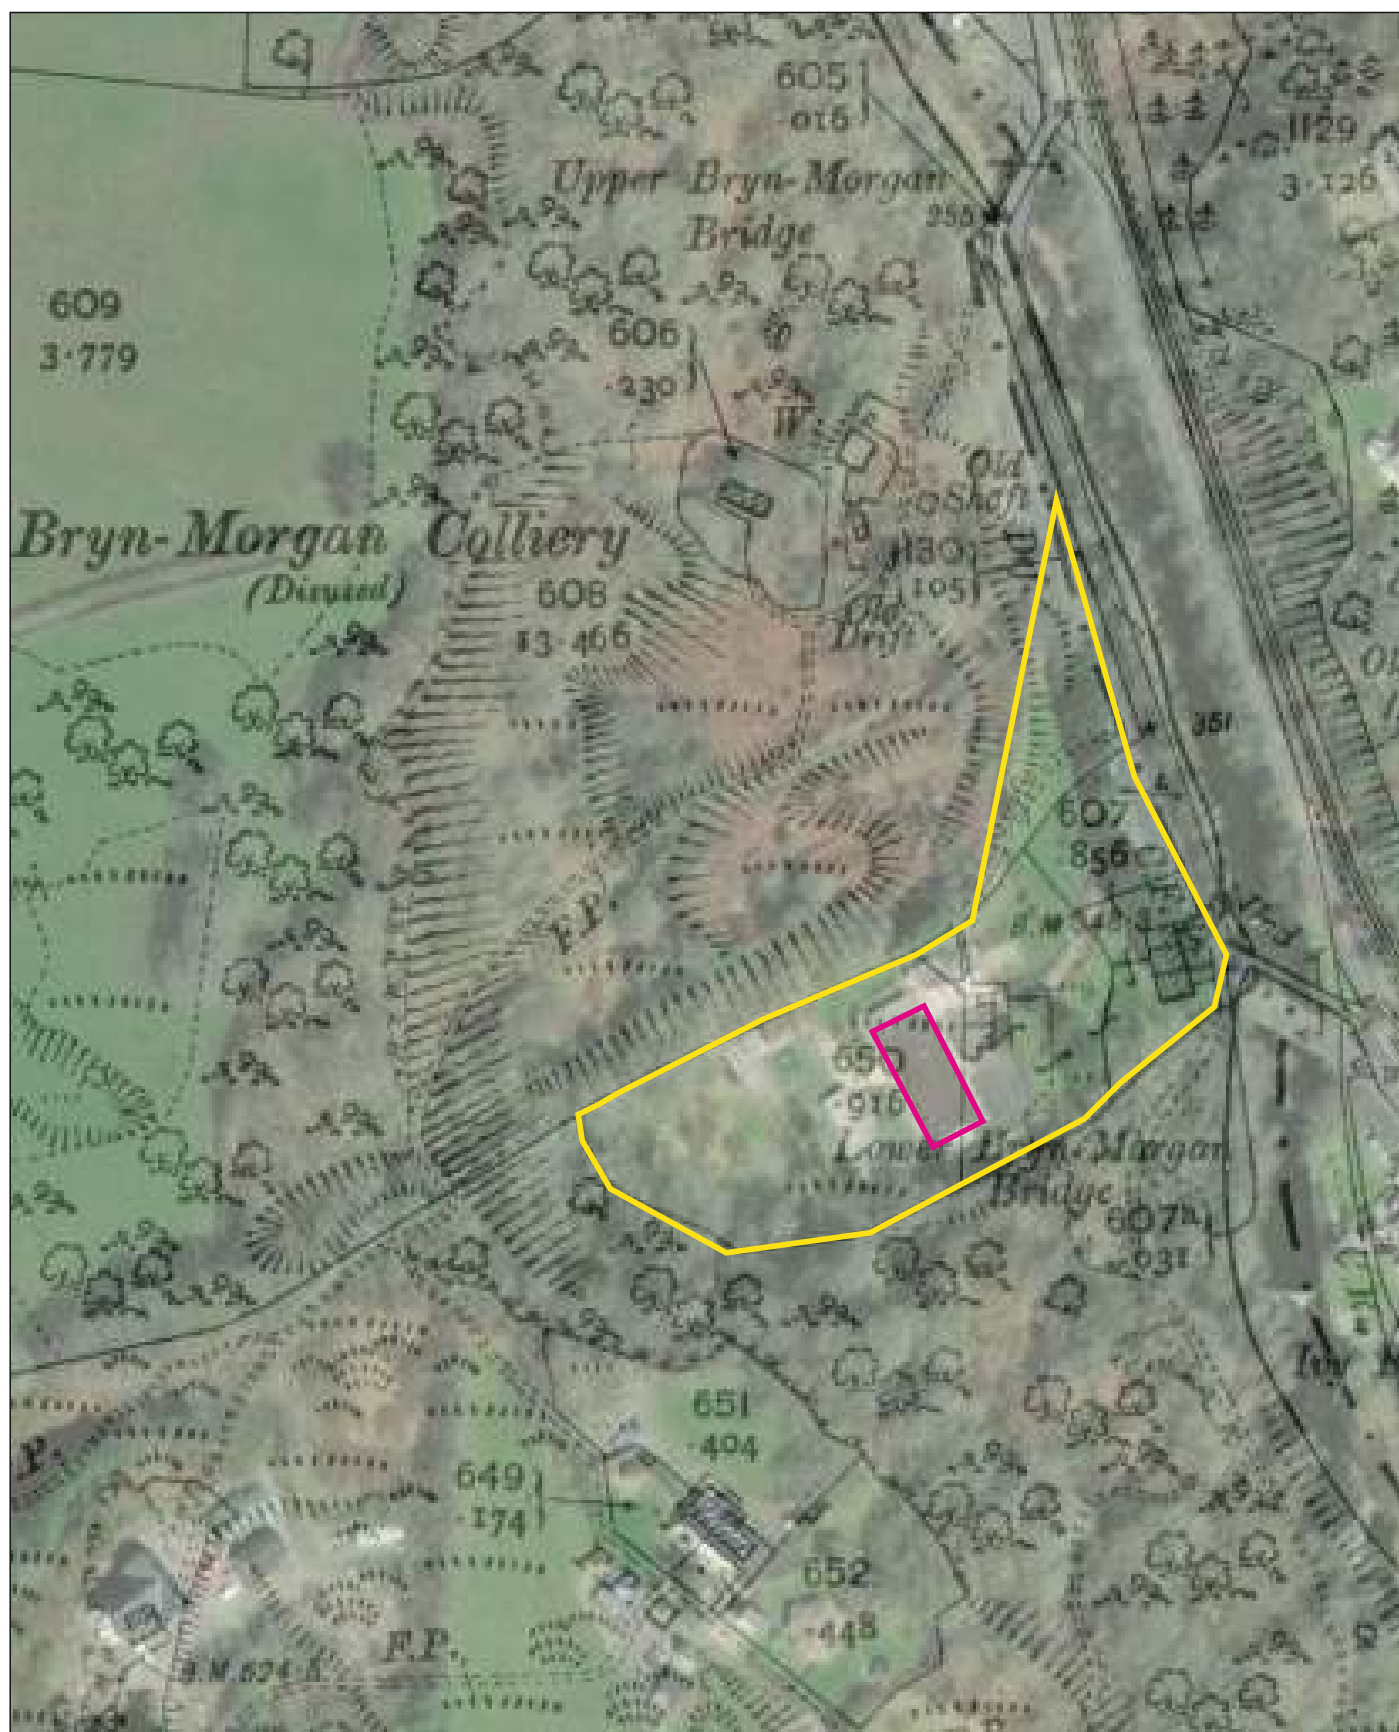
FIGURE 10

2f) Historical Ordnance Survey maps can prove invaluable in looking for evidence of coal mining activity. Since the first County Series maps were produced in the 1870's nearly all mining features have been recorded, even if they were considered "old" at that time. This is particularly true of the 1:1250 and 1:2500 scale maps. They are a useful additional source to the geological material. Levels are frequently labelled and spoil heaps shown. The older maps show many coal mining features, but nothing in the immediate vicinity of the site. For this reason are not reproduced here Figure 10 is the 1903 1:2500 O.S. georeferenced onto a modern aerial photo. The spoil heap from the disused Brynmorgan Colliery reaches to the current northern site boundary.

1903 1:2500 O.S. GEOREFERENCED ON A MODERN AERIAL PHOTO.  
BRYNMORGAN VILLA IS HIGHLIGHTED.
