| Location | Neath Leisure Centre, Neath. |
| Title | Preliminary Bat Roost Assessment and Bat Activity Surveys and Assessment |
| Report Date | October 2022 |

## Neath Leisure Centre Bat Survey Report

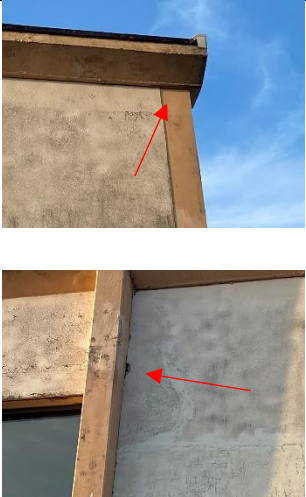
| SOUTH (S1) | SE uppermost corner of main concrete rendered building. Small slit to base of soffit, slit midway (peeling paint?) and small crack in wall below soffit. | |

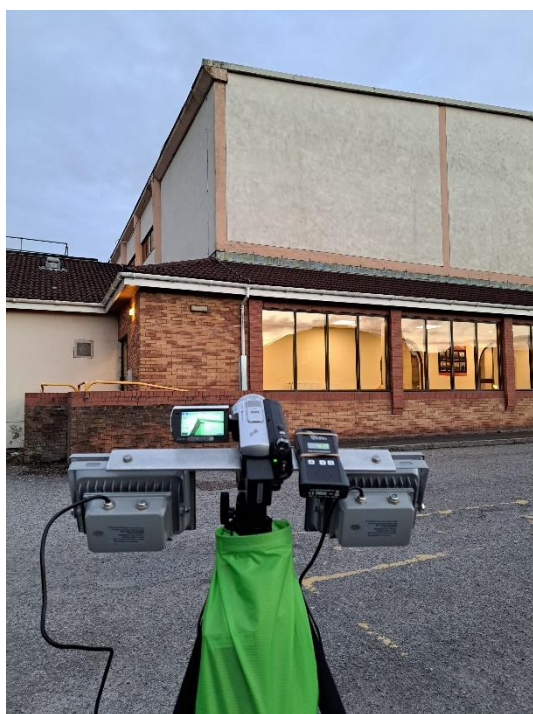
**Figure 9: Infra red camera deployed at W1 19th August 2022**

| Location | Survey | Results | Observations |
|---|---|---|---|
| W1<br>Surveyor 2<br>Infra red video camera C1 | 19/08/22 - Dusk | <p>No bats were seen to emerge or enter W1.</p> <p>No bats were recorded emerging or entering W1 on the Infra red video camera.</p> | <p>Common pipistrelle and Noctule (very faint) were recorded on the EM but no bats were seen in the vicinity of the building.</p> |
