| CLIENT | GCRE Ltd |
| PROJECT | Global Centre for Rail Excellence (GCRE) |
| TITLE | Washery - CLAH Walkover Land Use Plan |

**Photograph Location Plan**

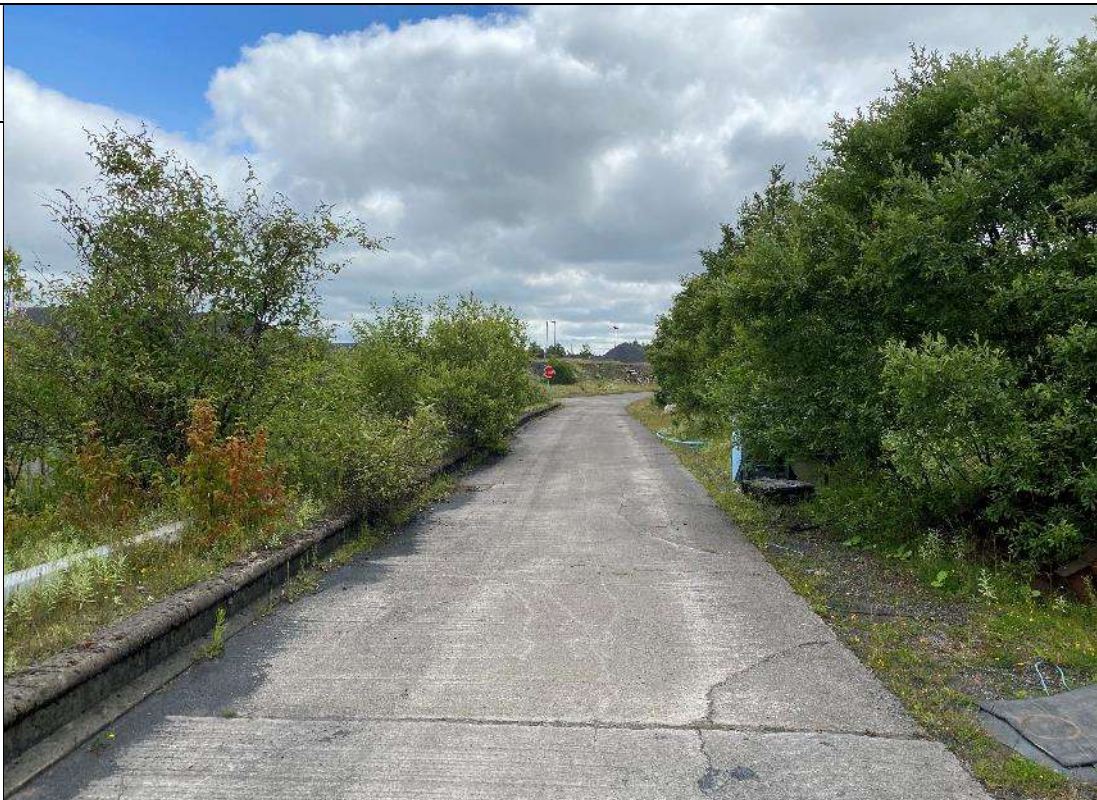
| <b>Access road and surrounds</b><br><br>The photograph aspect is east. | | |

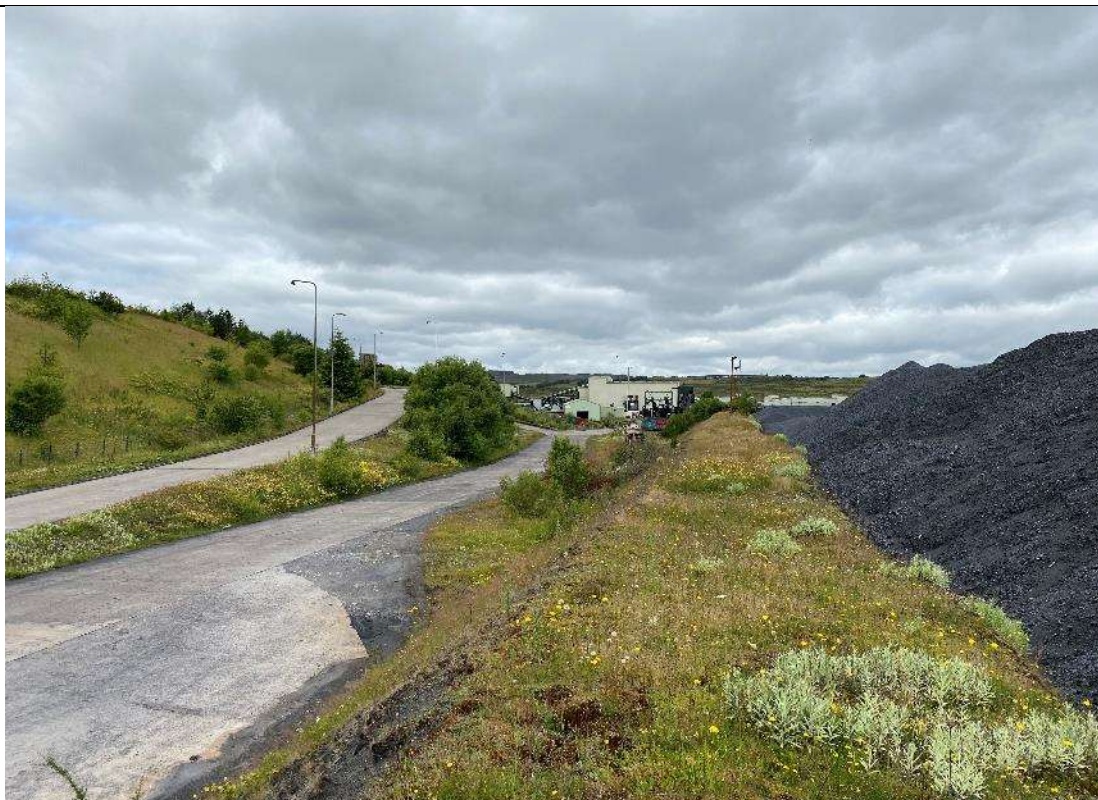
| <b>Coal stockpile (004)</b><br><br>View of retaining bund and stockpile of crushed and washed coal.<br><br>The photograph aspect is west. | | |

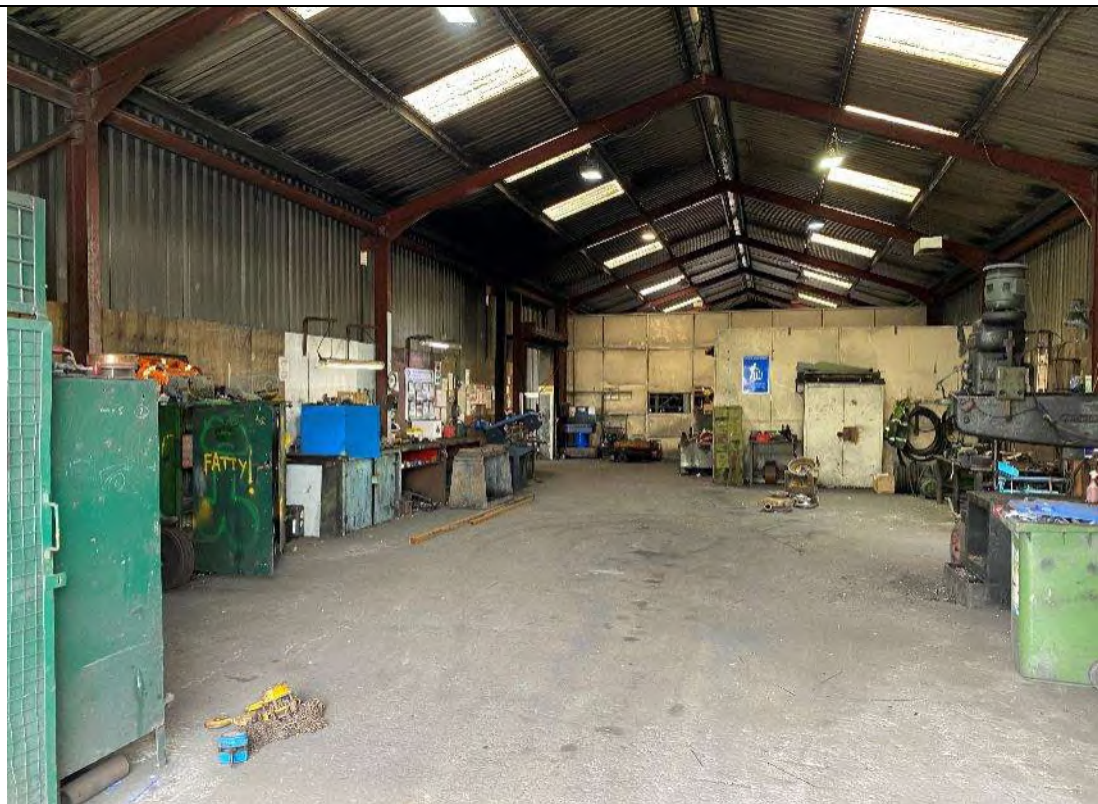
**Photo No.**  
19

**Workshop (010)**

View into western wing.

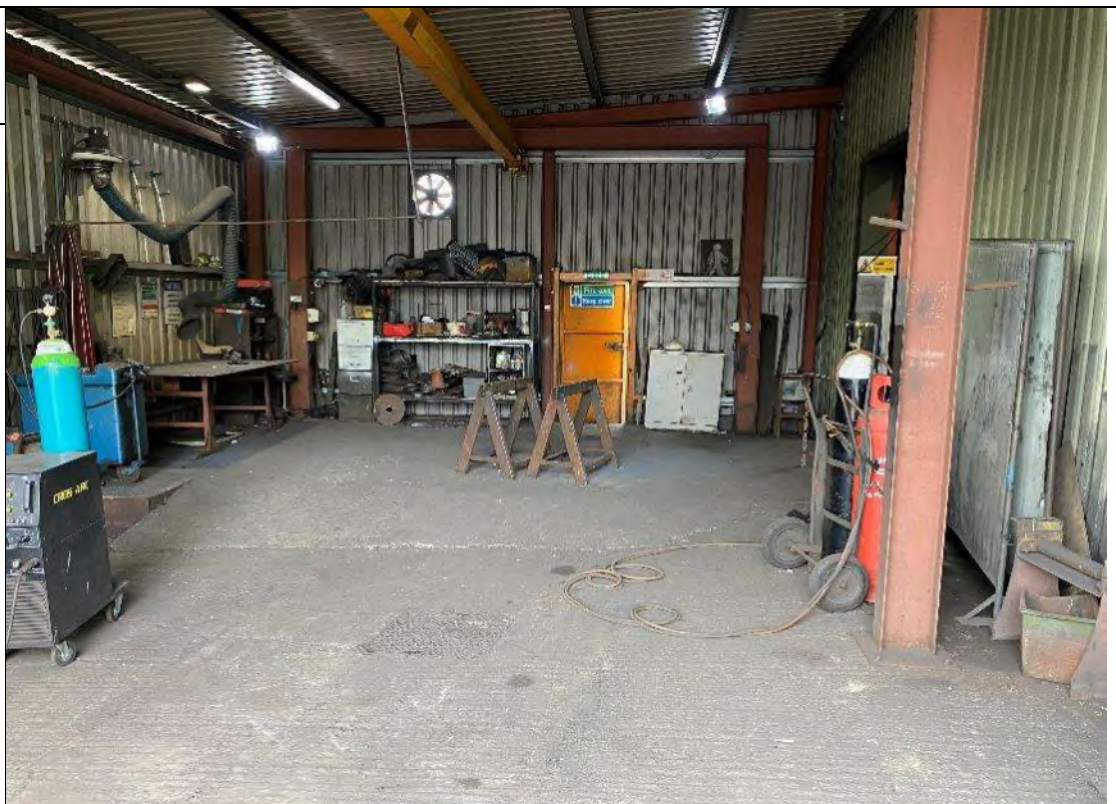
**Photo No.**  
20

**Workshop (010)**

View into northern wing, area used for welding / hot work.

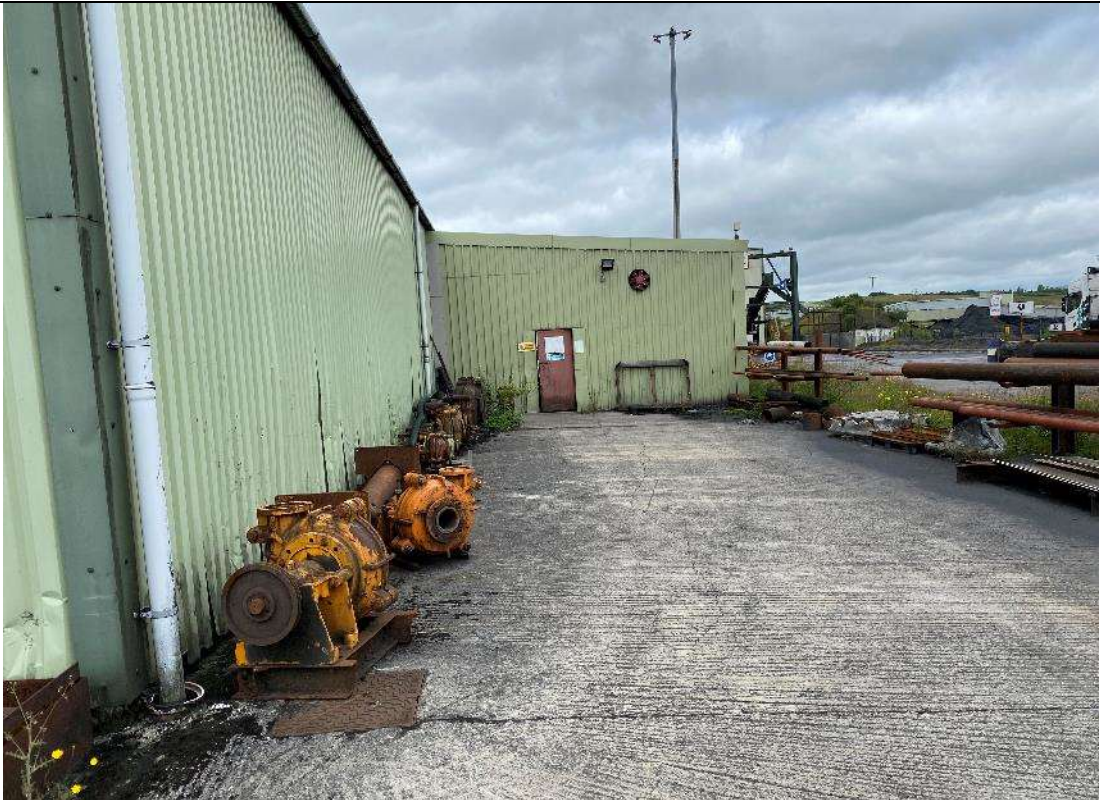
| <p><b>Exterior of Workshop (010)</b></p> <p>View of concrete slab and machine parts stored on concrete.</p> <p>Aspect to west.</p> | | |

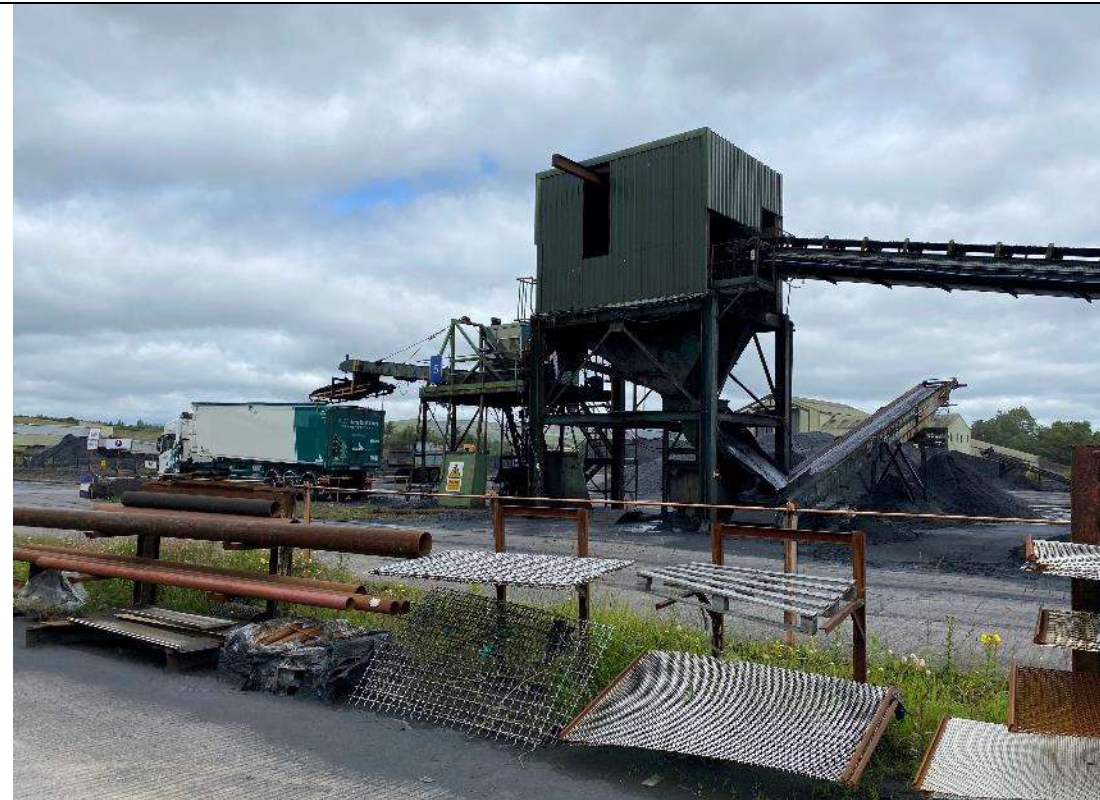
| <p><b>Washery Structure (017)</b></p> <p>View of screening equipment (017) from Workshop (010)</p> <p>Photo aspect is north.</p> | | |

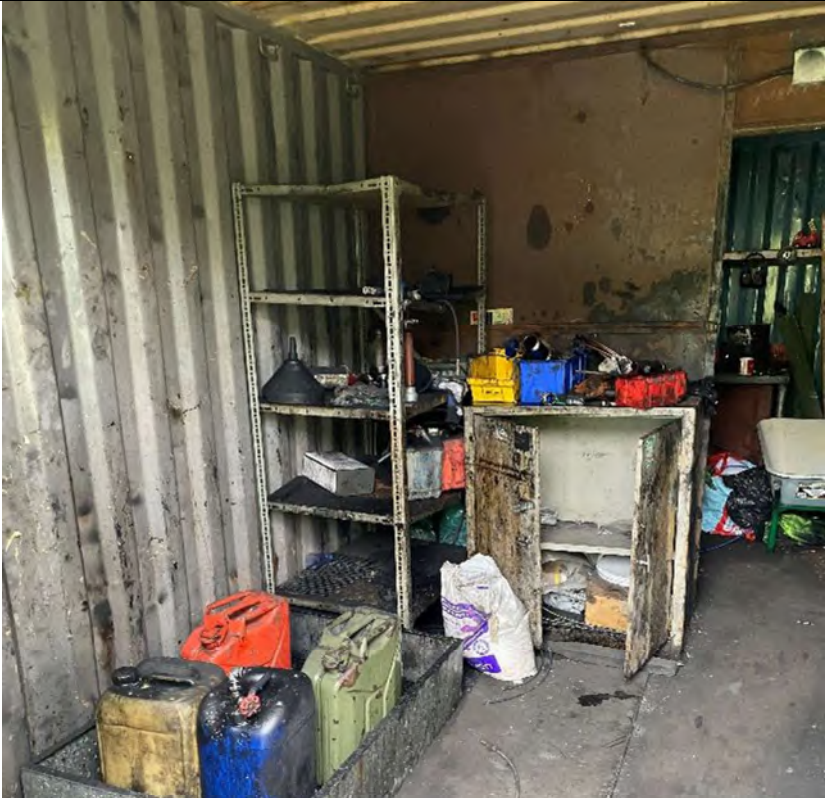
| <b>Shipping Container (011)</b><br><br>Contents of shipping container, used to store oil and fuel containers. | | |

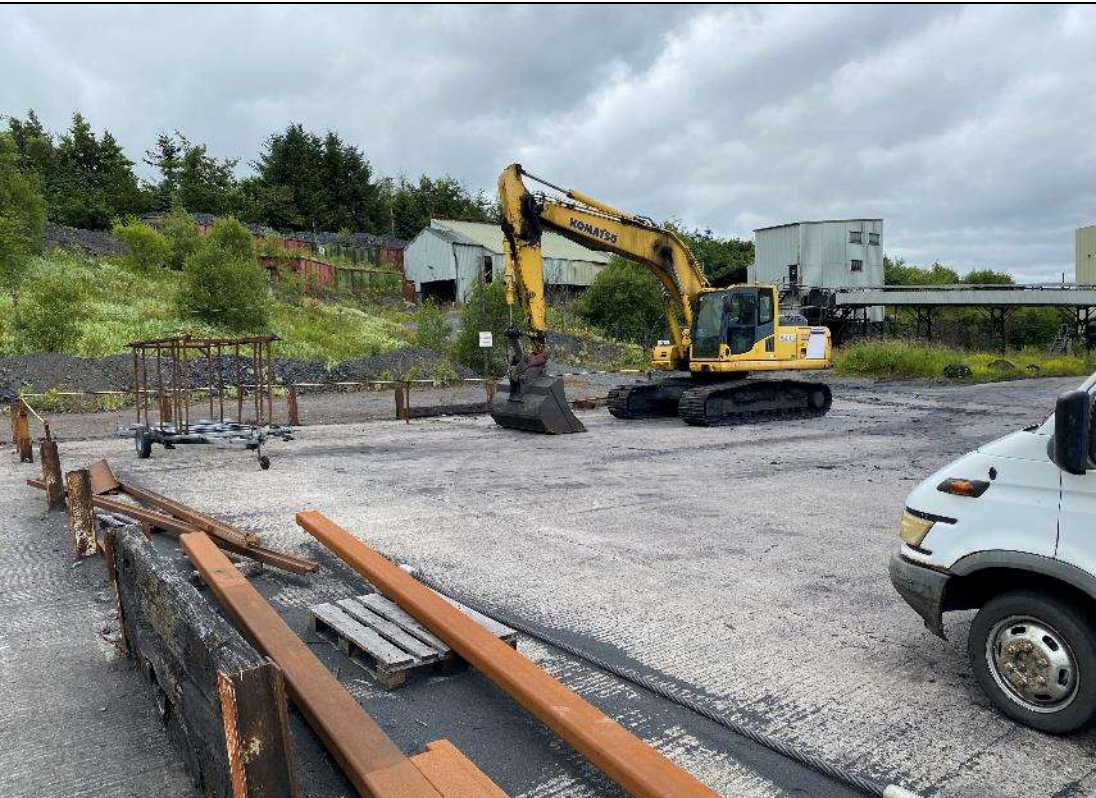
| <b>Washery</b><br><br>View of yard area to west of workshop.<br><br>Photo aspect is west. | | |

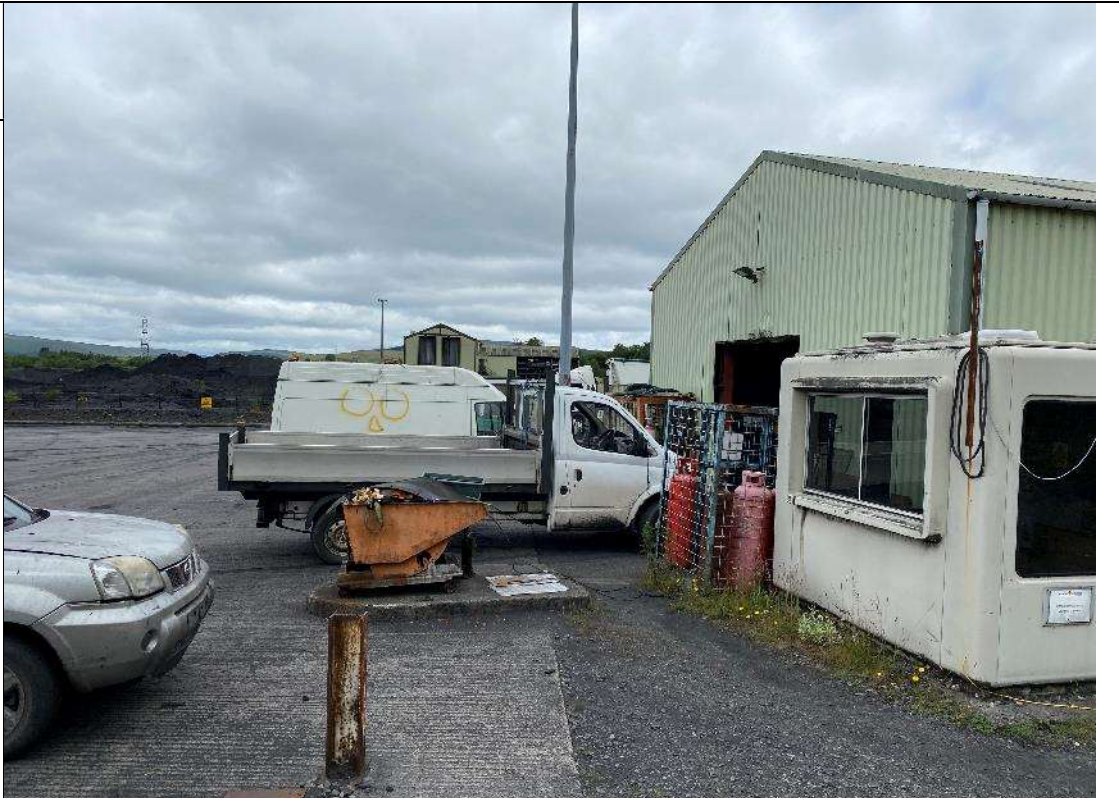
| <b>Washery</b><br><br>View of exterior of workshop.<br><br>Photo aspect is north. | | |

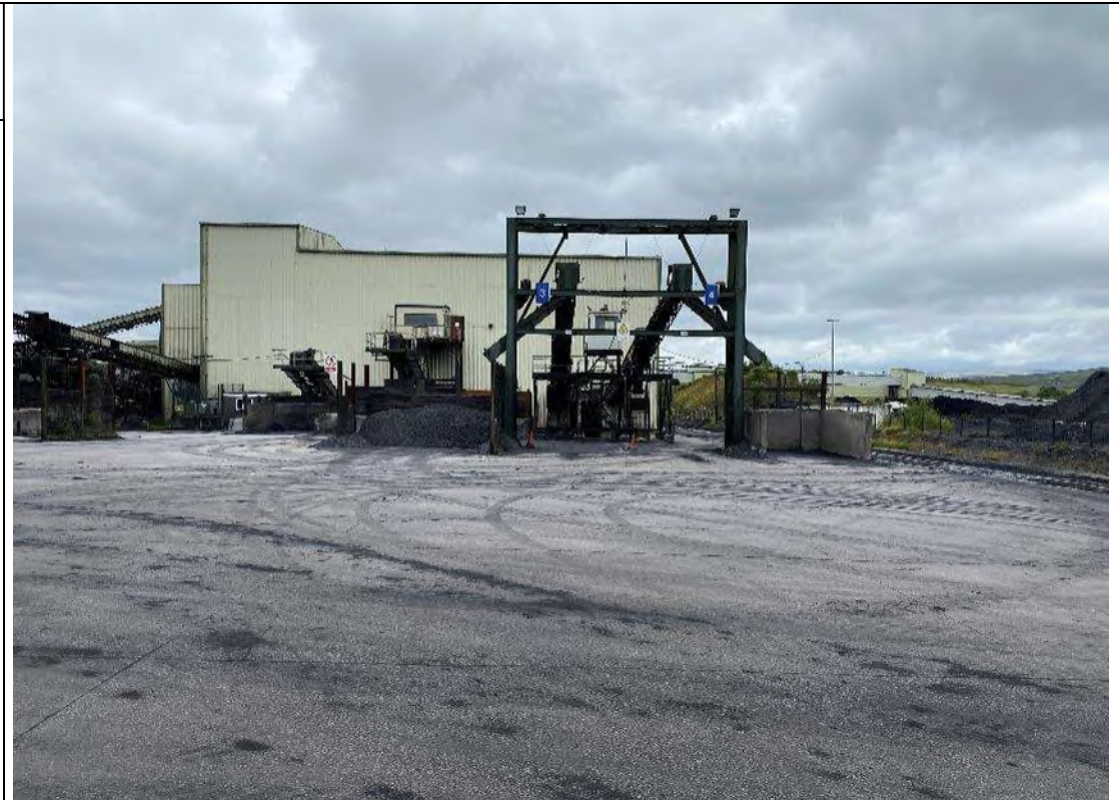
| <b>Washery (014)</b><br><br>View of washery building (014) and yard.<br><br>The photograph aspect is north-west. | | |

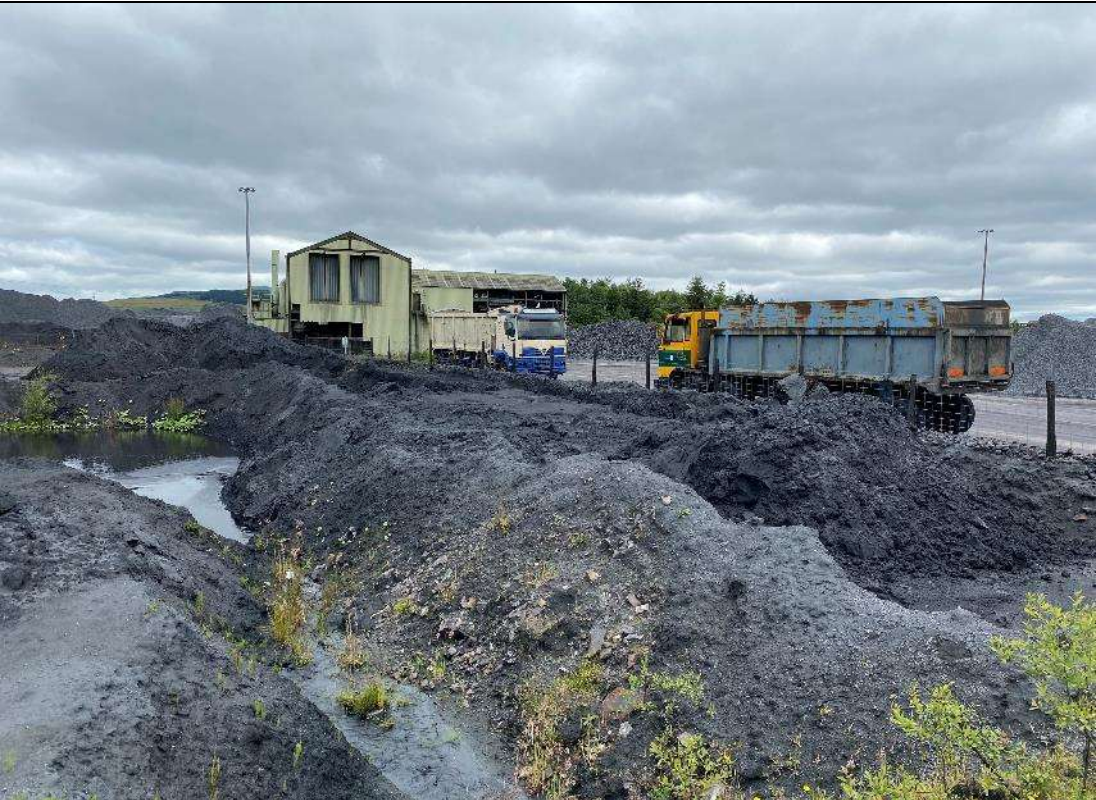
| <b>Washery</b><br><br>Stockpiled coal and lagoons (015).<br><br>The photograph aspect is north. | | |

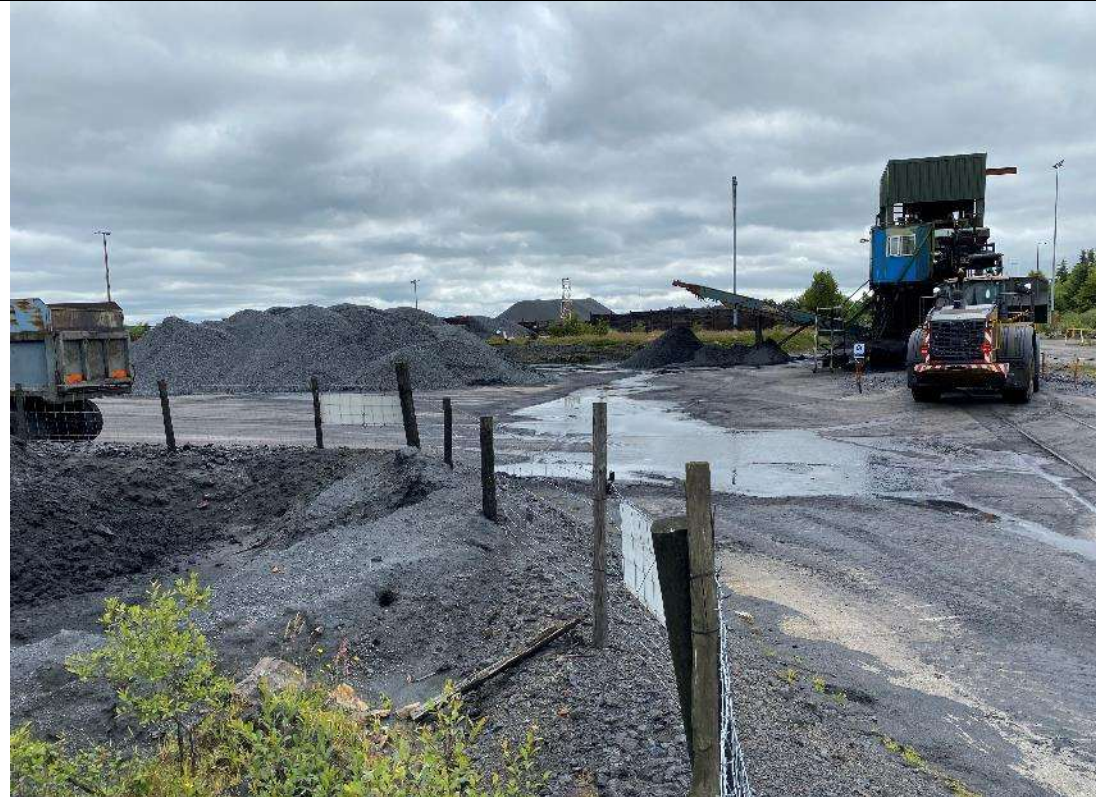
| <b>Washery</b><br><br>View of screening machinery (017) and stockpiled coal (016).<br><br>The photograph aspect is east. | | |

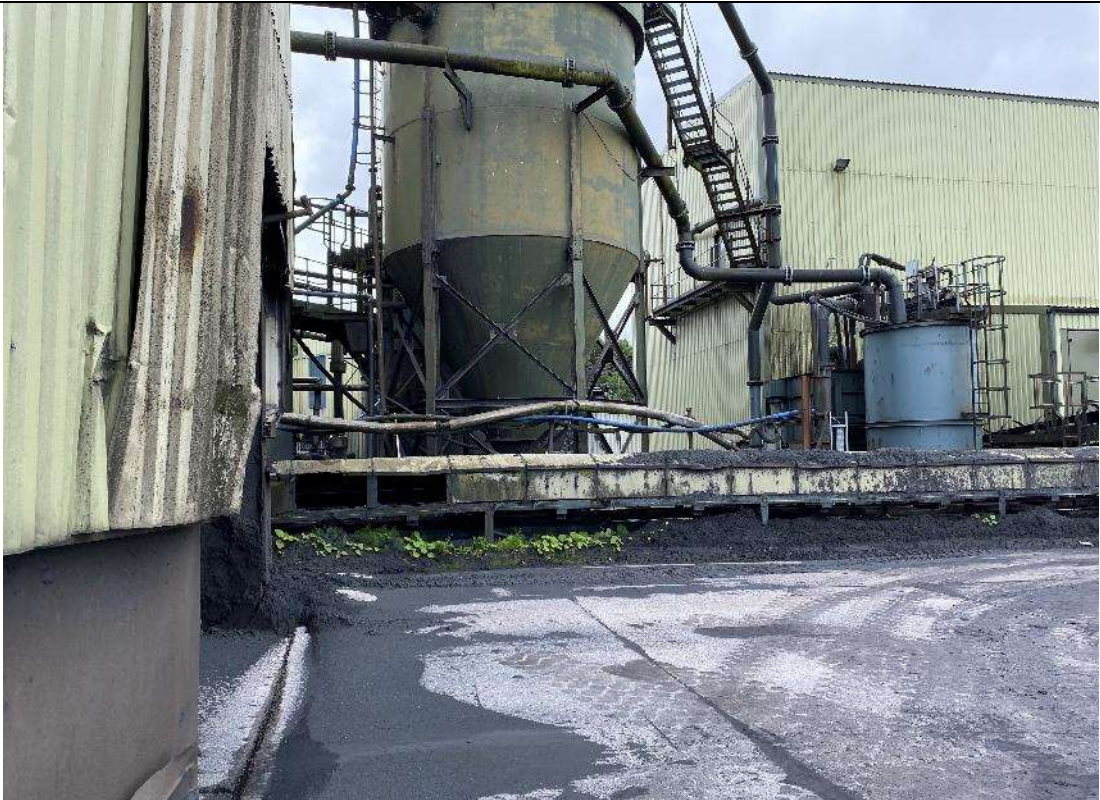
| <p><b>Washery Structure (018)</b></p> <p>View of AST tanks, believed to hold water.</p> <p>The photograph aspect is south.</p> | | |

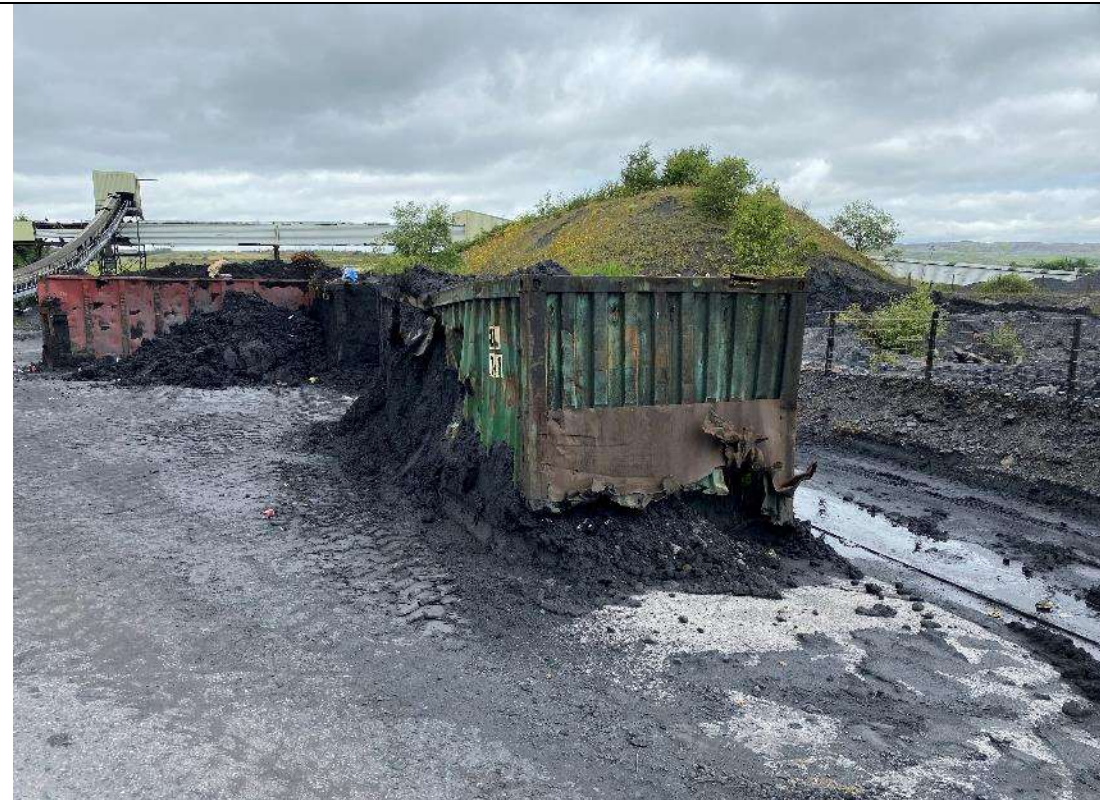
| <p><b>Washery Structure (019)</b></p> <p>View of skips / shipping containers holding waste coal.</p> <p>The photograph aspect is west.</p> | | |

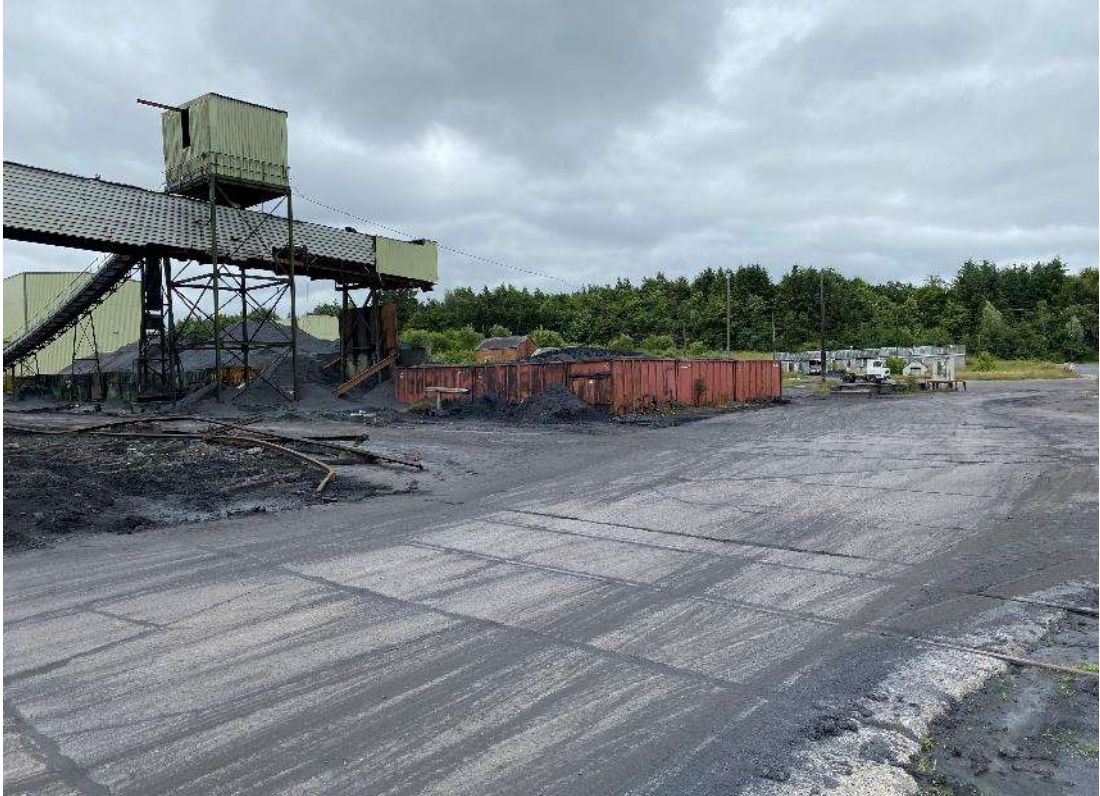
| <b>Washery Structures</b><br><br>View of conveyor belt from building 014 connecting with additional conveyor. Railway tracks (021) crossing concrete road way in foreground.<br><br>The photograph aspect is east. | | |

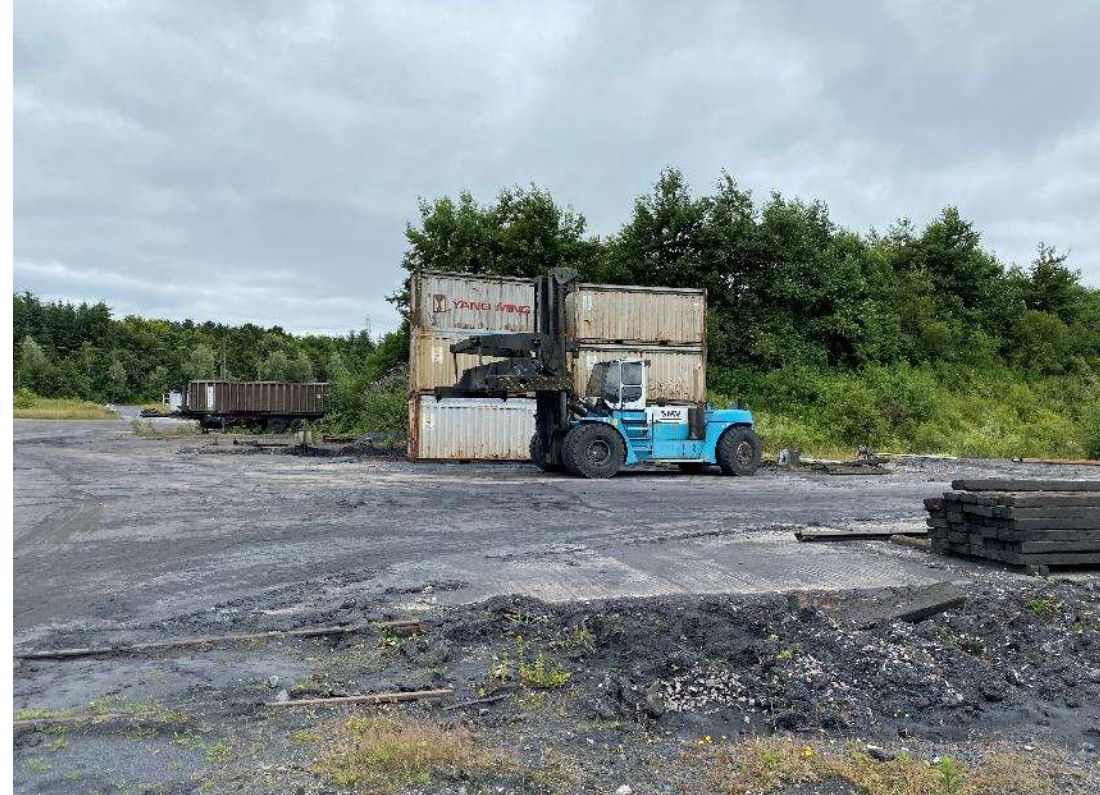
| <b>Washery Area (023)</b><br><br>View of unknown stockpile (023) and shipping container storage. Railway land in foreground.<br><br>The photograph aspect is south. | | |

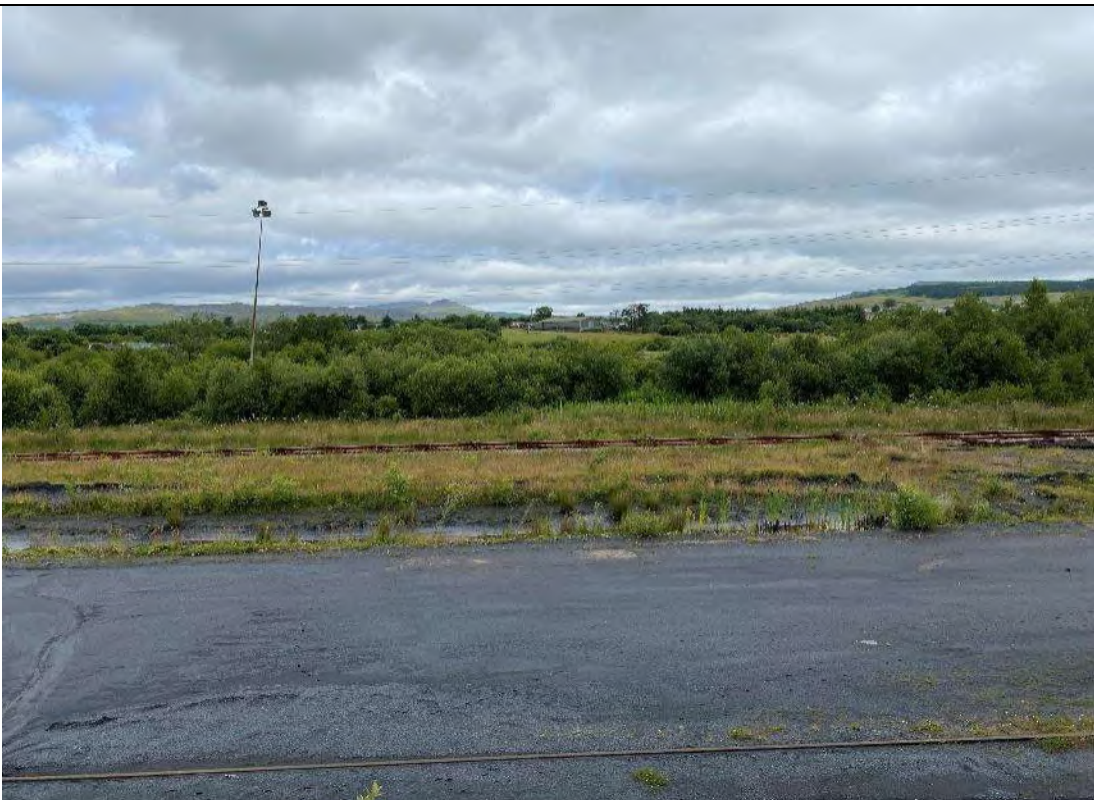
| <b>Retaining wall (025)</b><br><br>View of the northern portion of Washery site. Railway tracks and railway land present.<br><br>The photograph aspect is north. | | |

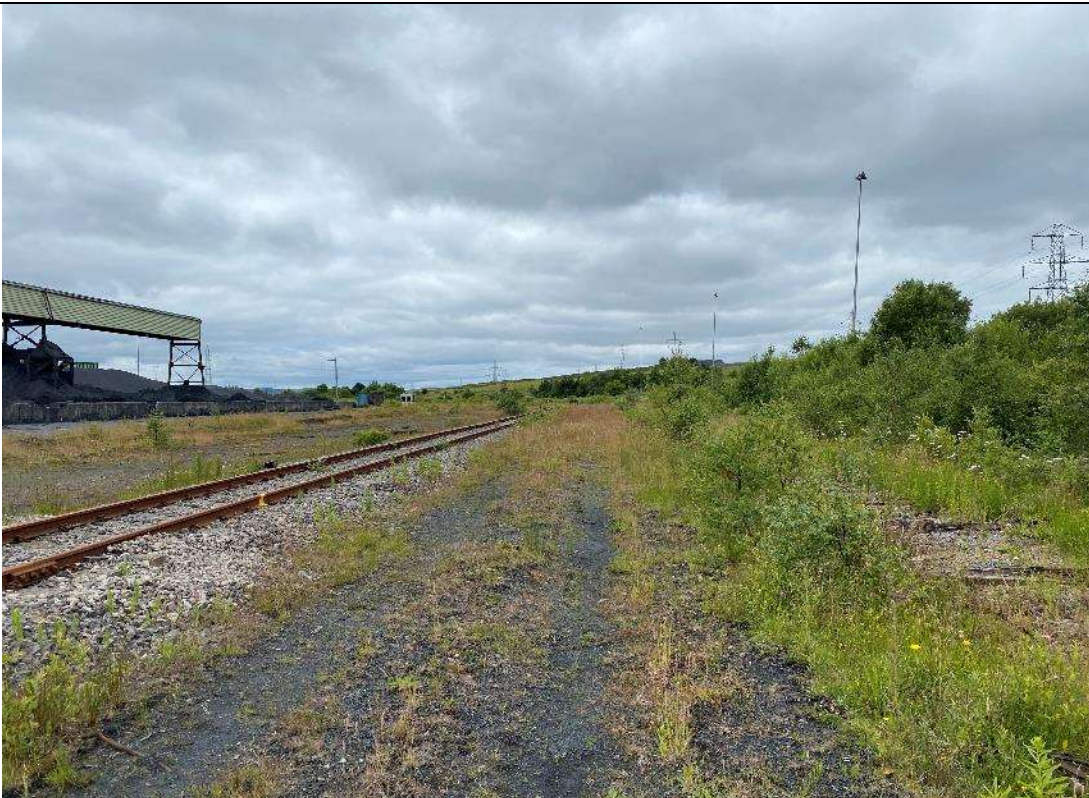
| <b>Railway Land (023)</b><br><br>View of railway sidings, two tracks currently present, with relict evidence of two unused tracks.<br><br>The photograph aspect is west. | | |

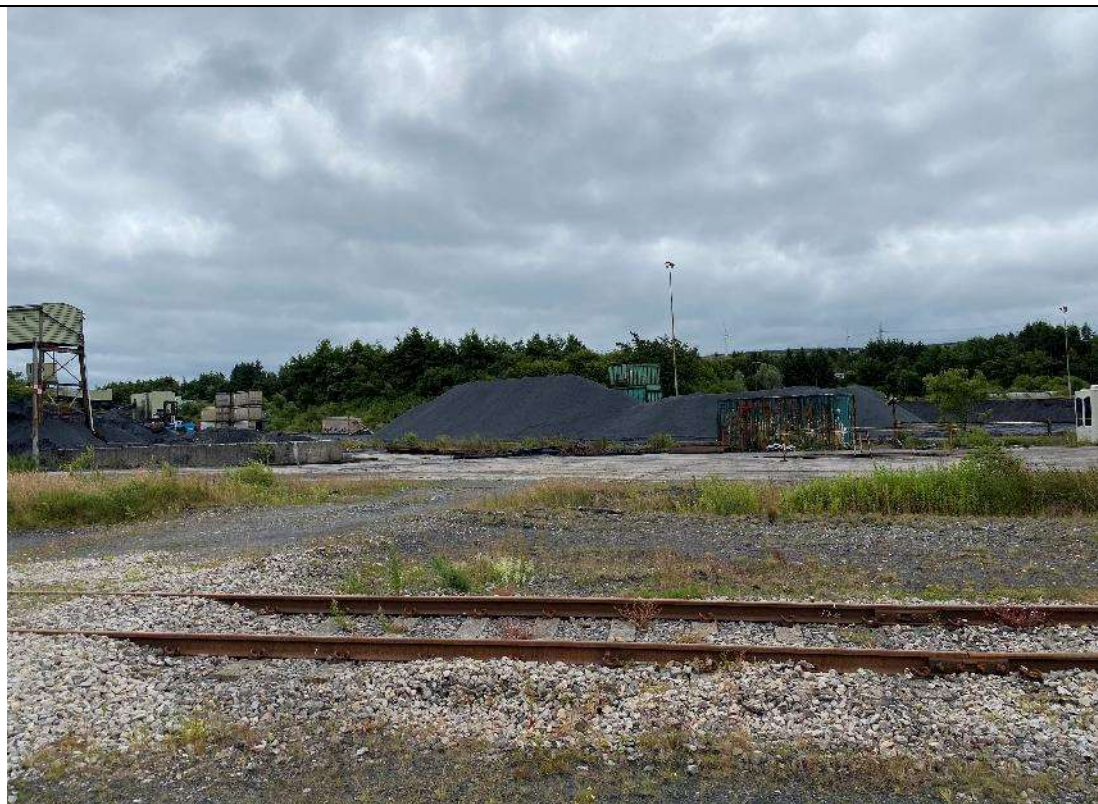
**Client Name: Global Centre of  
Rail Excellence**
**Site: GCRE (Onllywyn Washery)**
**Project No.  
5209796**
**Photo No.**  
49

**Stockpile (023)**

View south across  
washery from railway  
land.

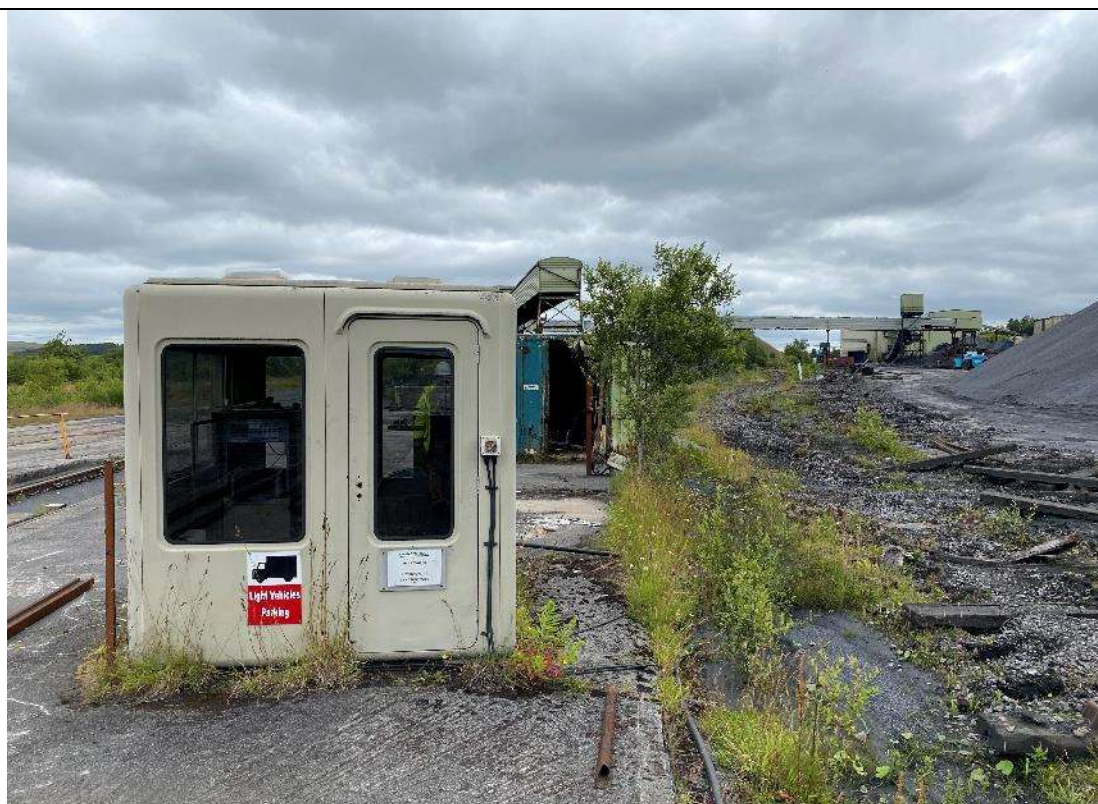
**Photo No.**  
50

**Electricity substation /  
control room on  
railway land (024)**

View of prefabricated  
cabin holding electrical  
equipment.

Former railway tracks to  
right running up to  
building 014.

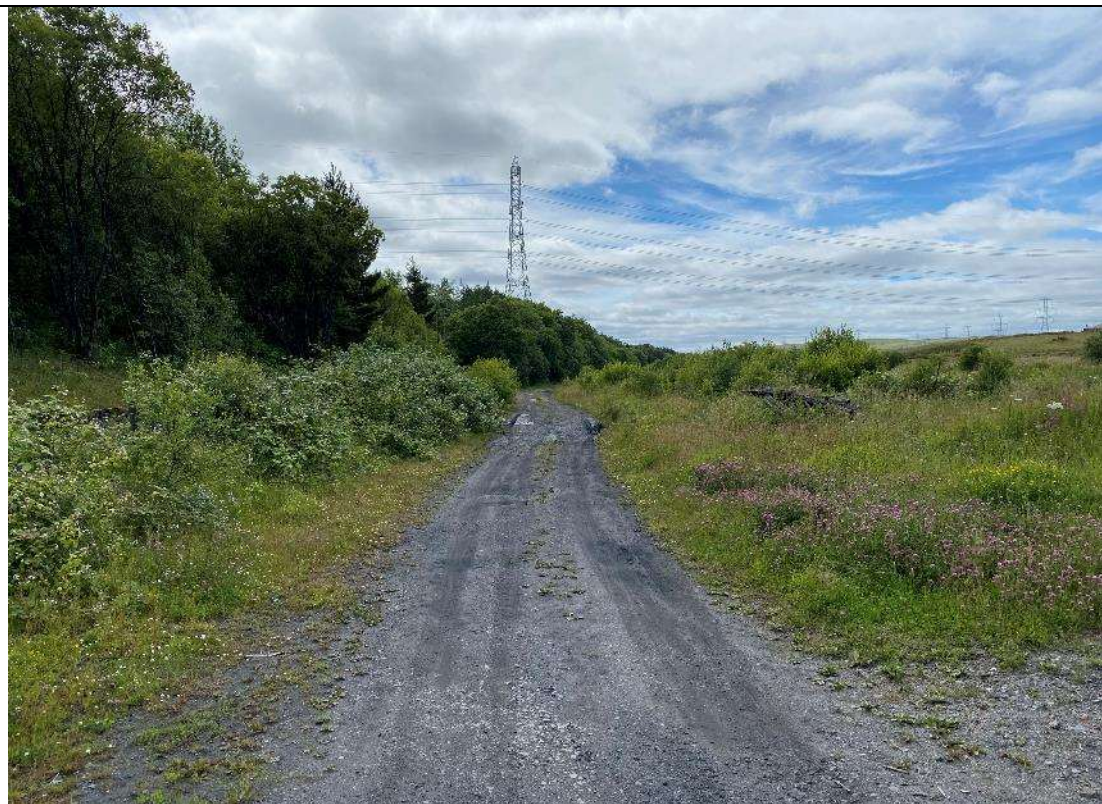
| <b>Photo No.</b><br>67 | <b>Date:</b><br>6 July 2022 |

| <b>Haul Road to Main Site</b><br><br>View of haul road connecting Main Site to Washery.<br><br>The photograph aspect is west. | |

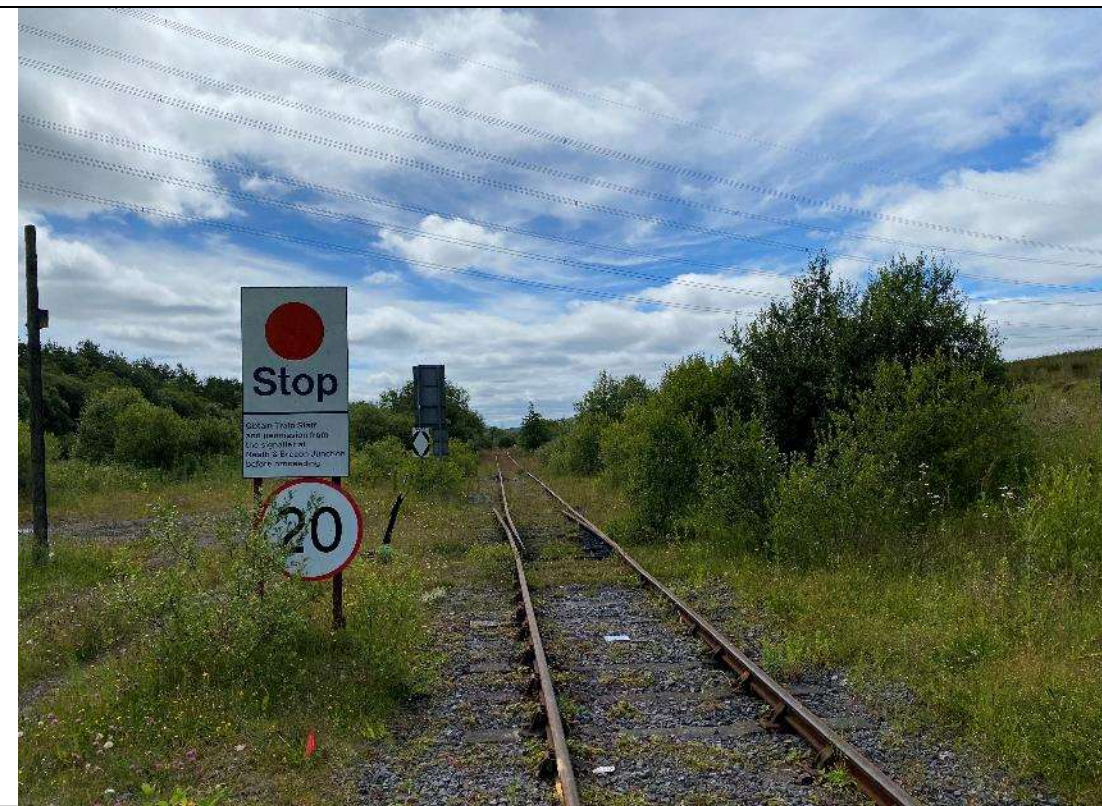
| <b>Photo No.</b><br>68 | <b>Date:</b><br>6 July 2022 |

| <b>Site Boundary</b><br><br>View of point sites railway land ends and Network Rail owned Railway starts.<br><br>The photograph aspect is west. | |
