**Client Name: Global Centre of Rail Excellence**

**Site: GCRE (Onllywyn Washery)**

**Project No. 5209796**

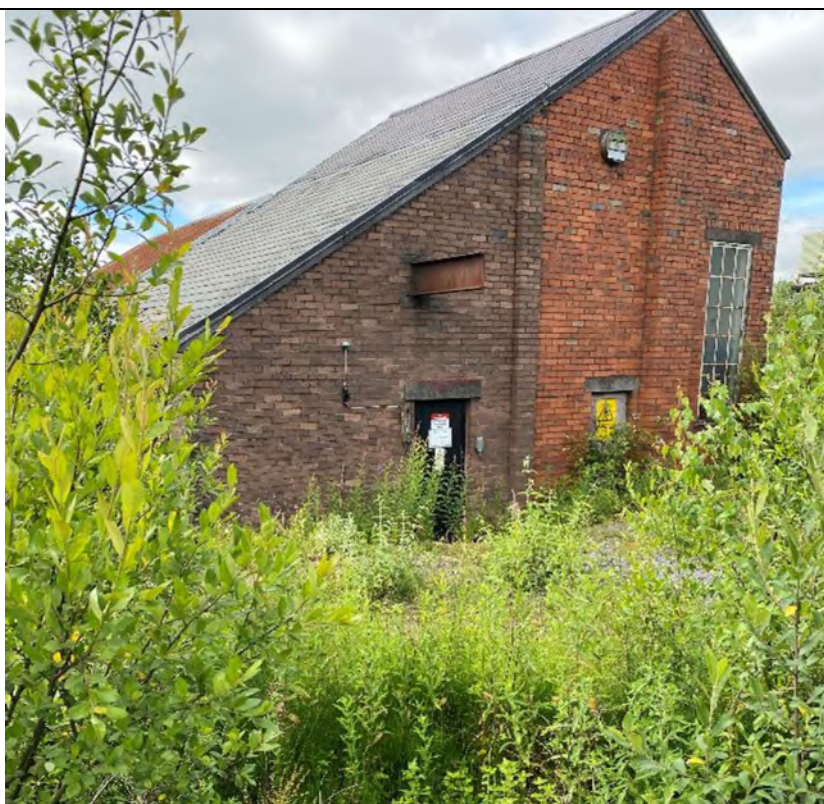
| <b>Photo No.</b><br>75 | <b>Date:</b><br>7 July 2022 | |

| <b>Electrical Substation<br/>(043)</b><br><br>View of substation.<br><br>The photograph aspect<br>is north-west. | | |

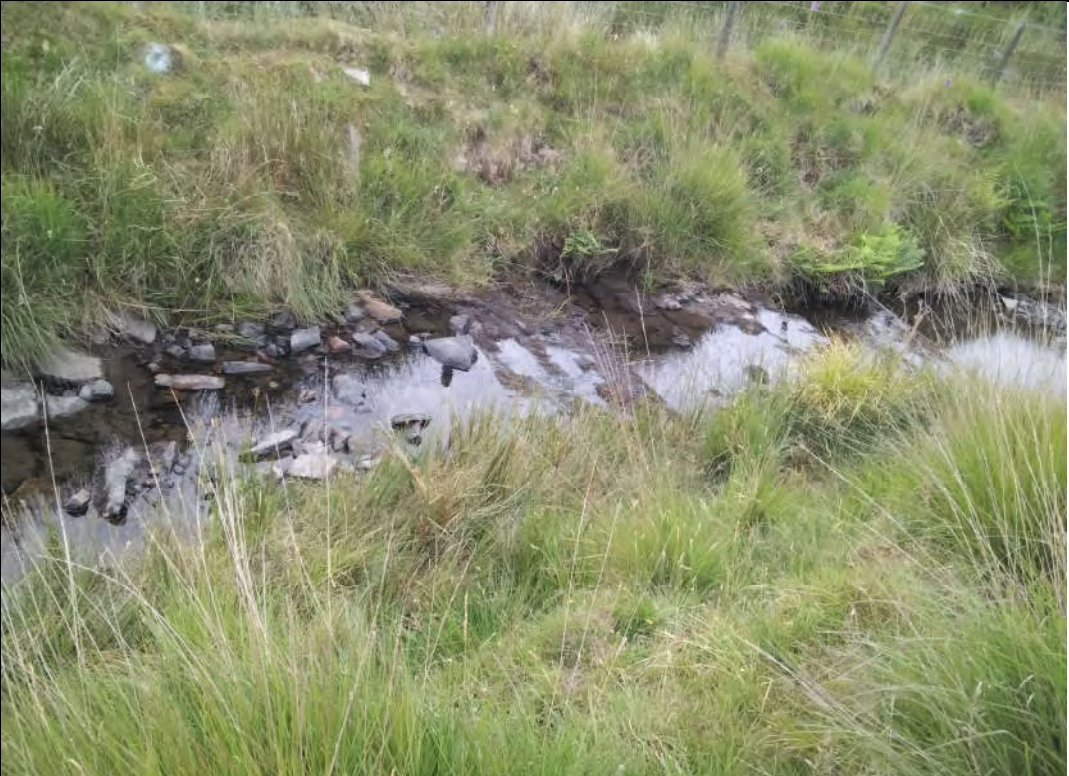
| Photo No. | Date: | |
|---|---|---|
| <b>Surface Water Feature SW-10 CE:</b><br>Surface Water Course (Stream), collecting water from all other discharge drains. Not lined, probably natural. Approximate measurements 0.5m wide, 2.5cm depth. Average speed 0.008m/s, DO 102.5, ORP123.9, Cond 1225.1, pH 8.38, T 19.69. | | |

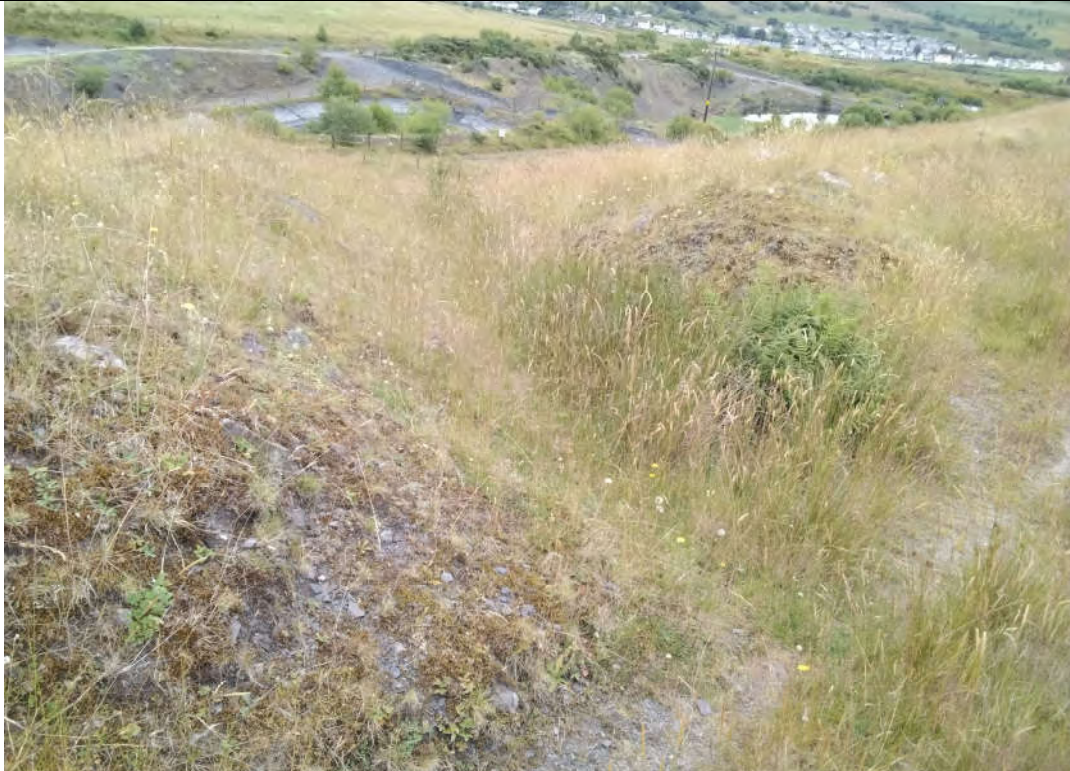
| Photo No. | Date: | |
|---|---|---|
| <b>A Surface Water Feature SW-21 CE:</b><br>Surface Water Course (Minor ditch), collecting runoff/drainage from restoration area. Not lined. Dry at the time. Approximate measurements 3m wide, 0.5m depth. | | |

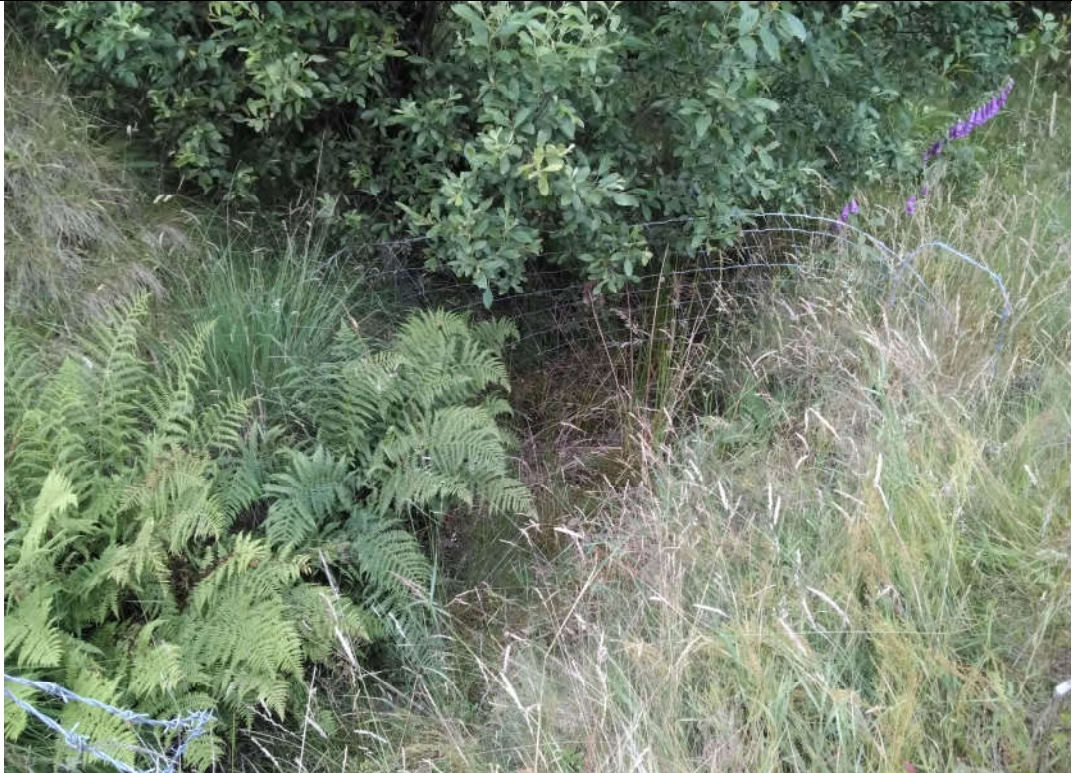
| <b>Photo No.</b><br>SW-23 CE | <b>Date:</b><br>12 July<br>2022 | |

| <b>A Surface Water<br/>Feature SW-23 CE:</b><br>Surface Water Course<br>(Minor ditch), collecting<br>runoff/drainage from<br>pastoral areas. Not likely<br>to be lined. Dry at the<br>time. Approximate<br>measurements 1.5m<br>wide, 0.5m depth. | | |

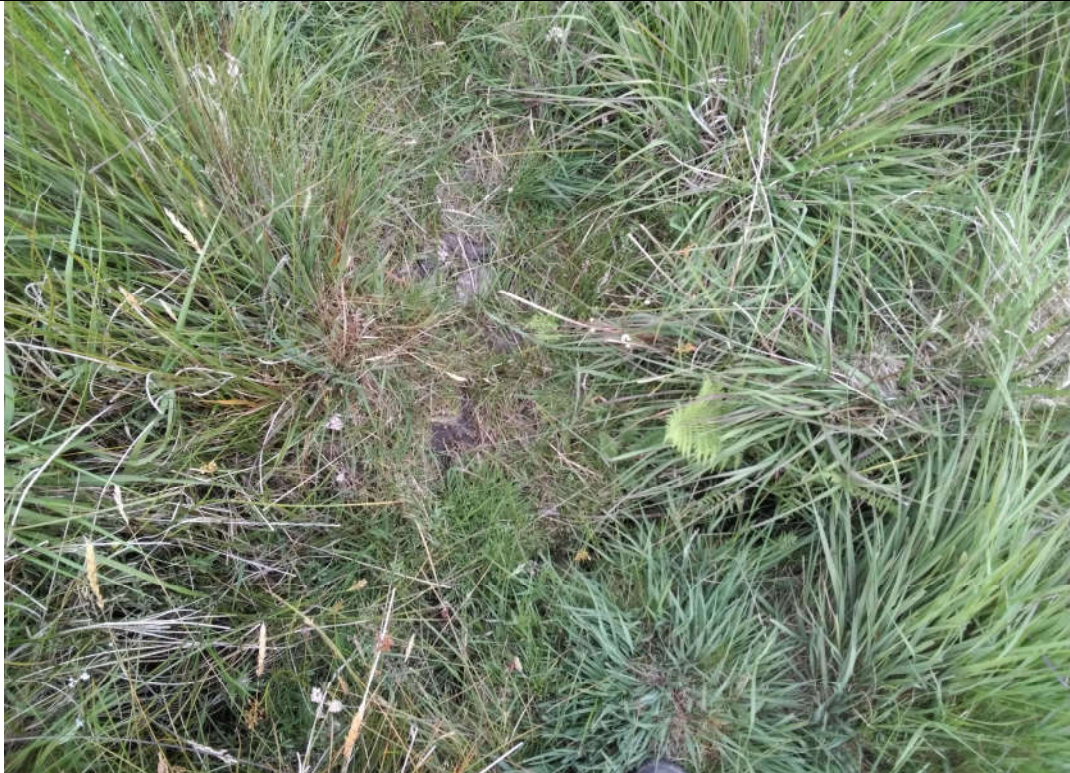
| Photo No. | Date: | |
|---|---|---|
| <b>Surface Water Feature<br/>SW-33 CE:</b><br>Surface Water (minor<br>ditch), land drainage<br>from adjacent areas, dry<br>at the time, no likely to<br>be lined. Approximate<br>measurements 1m wide<br>by 0.5 depth. | | |

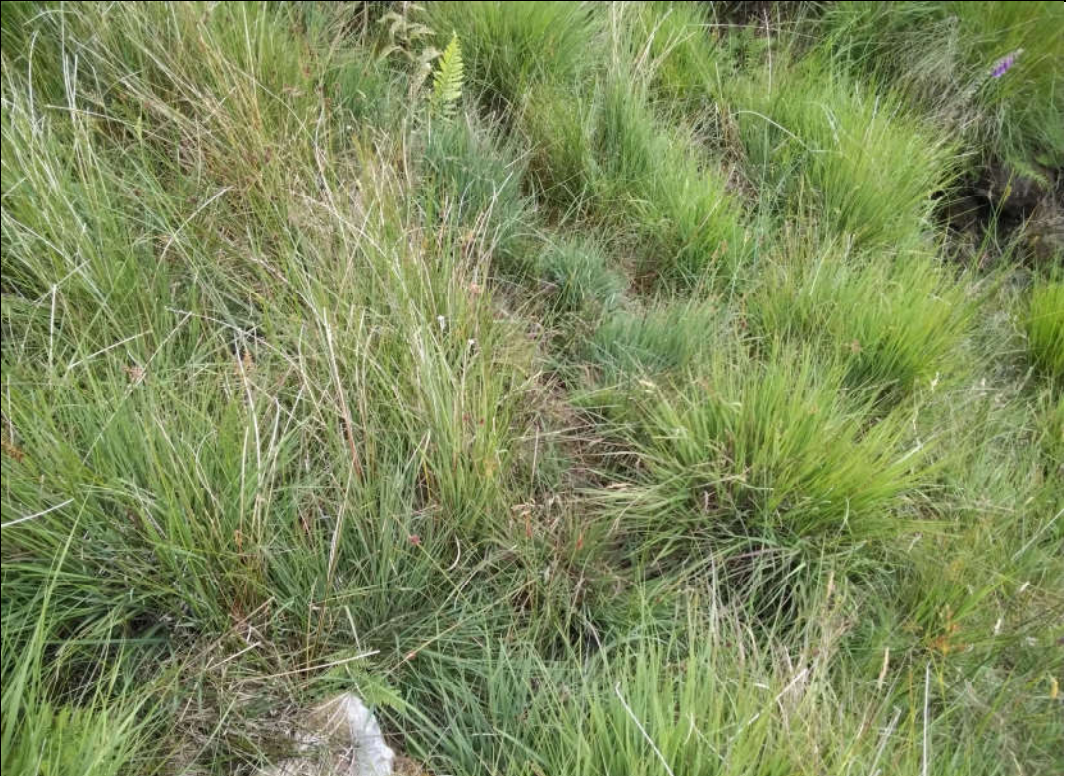
| Photo No. | Date: | |
|---|---|---|
| SW-34 CE | 12 July 2022 | |

| Photo No. | Date: | |
|---|---|---|
| <b>Surface Water Feature SW-34 CE:</b><br>Surface Water (minor ditch), land drainage from adjacent areas, dry at the time, no likely to be lined. Approximate measurements 1m wide by 0.5 depth. | | |

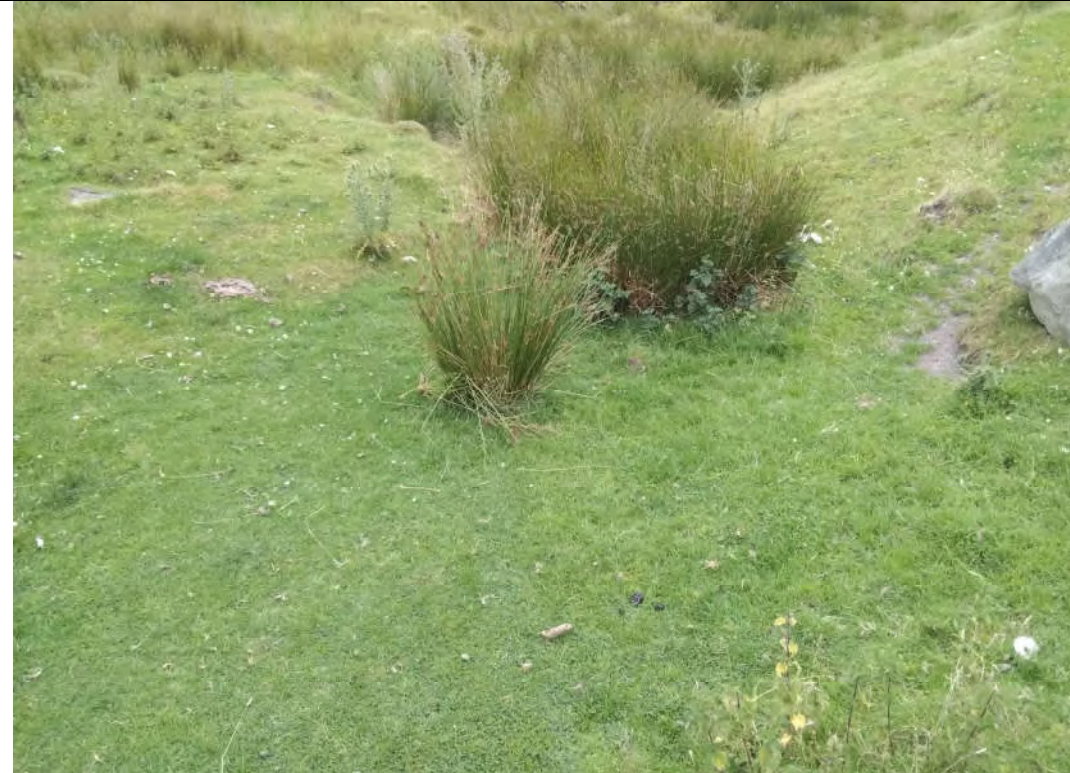
| Photo No. | Date: | |
|---|---|---|
| SW-39 CE | 12 July 2022 | |

| Photo No. | Date: | |
|---|---|---|
| <b>Surface Water Feature SW-39 CE:</b><br>Surface Water (minor ditch), land drainage/runoff from adjacent areas, dry/no flow, no likely to be lined. | | |

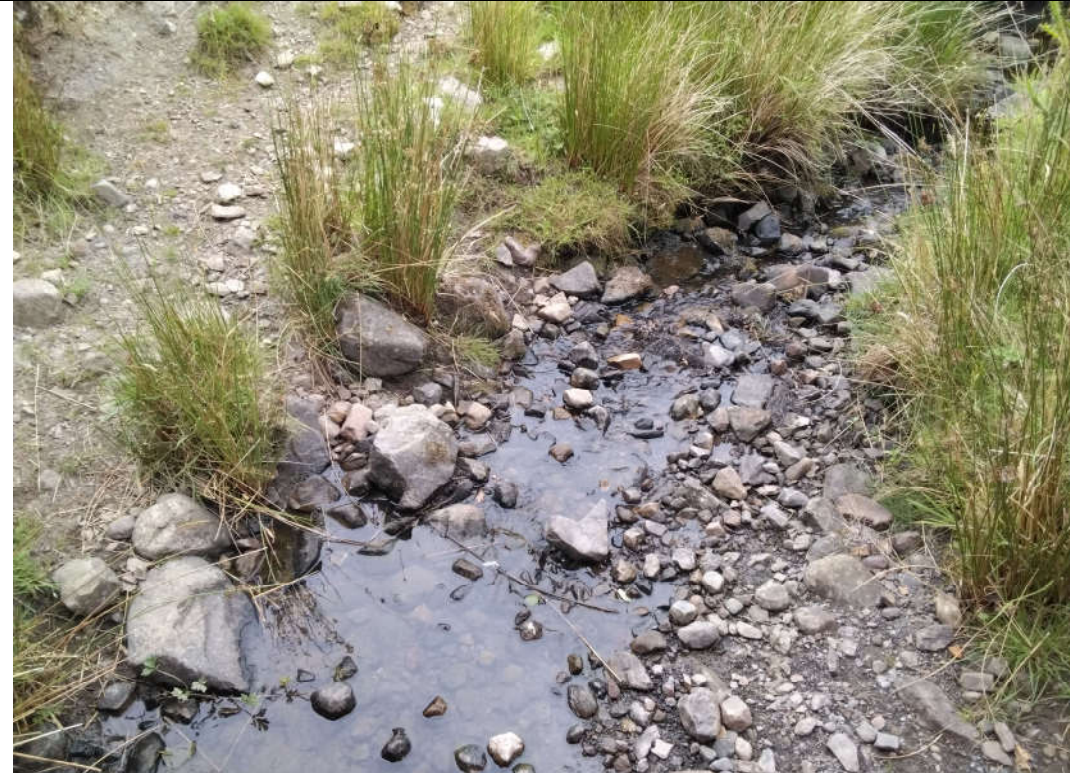
| Photo No. | Date: | |
|---|---|---|
| <b>Surface Water Feature<br/>SW-43 CE:</b><br>Surface Water Course (Stream), collecting water from all other discharge drains, rainfall, runoff. Not lined, probably natural. Approximate measurements 75cm wide, 2cm depth. Average speed 0.013m/s, no readings taken | | |

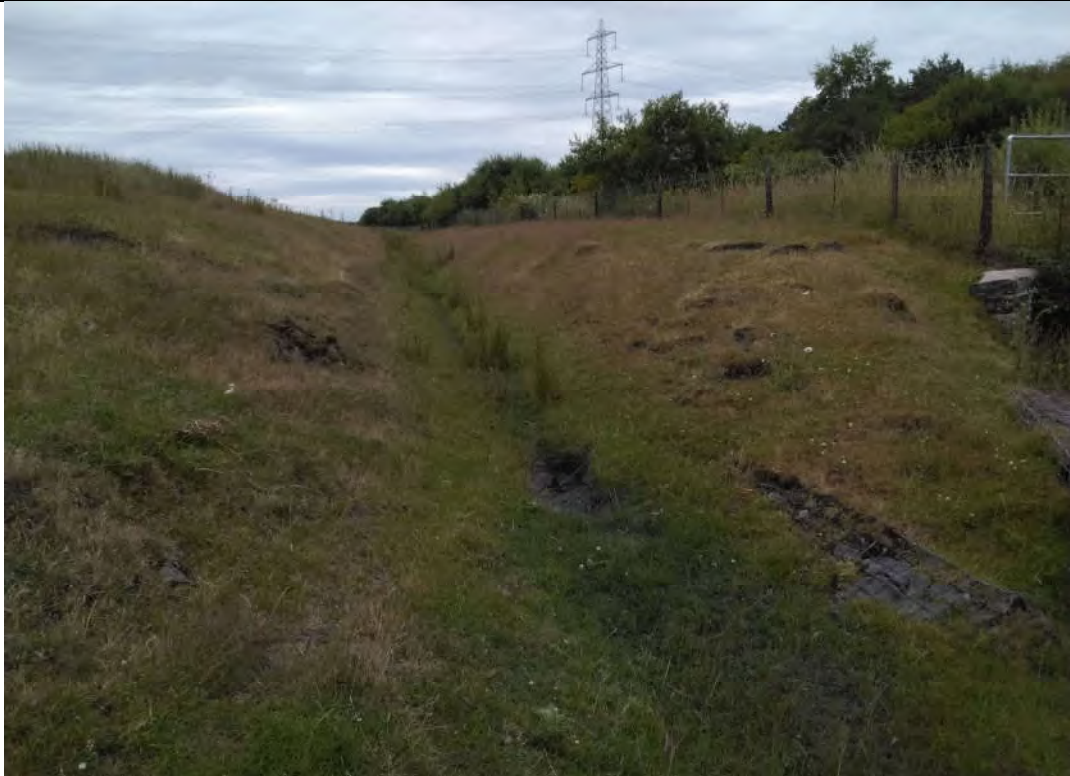
| Photo No.<br>SW-46 CE | Date:<br>12 July<br>2022 | |
|---|---|---|
| <b>Surface Water Feature SW-46 CE:</b><br>Surface Water (minor ditch), land drainage/runoff from adjacent restored and pastoral areas, dry/no flow, no likely to be lined. Approximate measurements 2m wide by 1m depth | | |

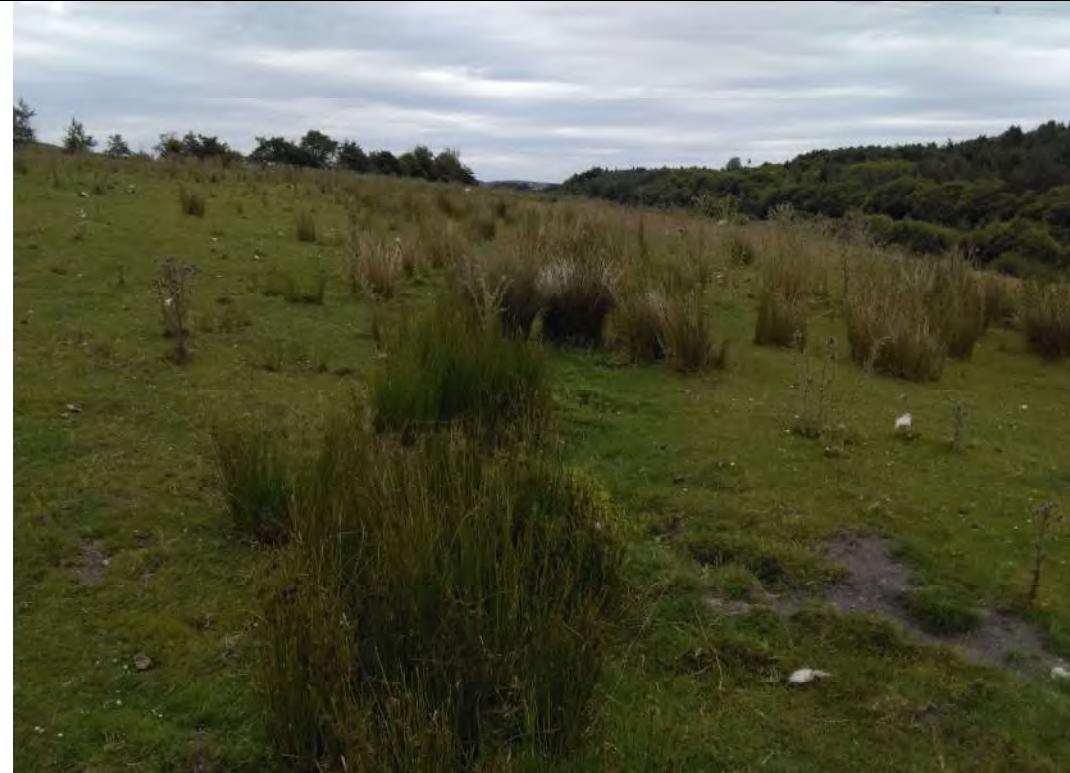
| Photo No.<br>SW-47 CE | Date:<br>12 July<br>2022 | |

| Photo No.<br>SW-47 CE | Date:<br>12 July<br>2022 | |
|---|---|---|
| <b>Surface Water Feature SW-47 CE:</b><br>Surface Water (minor ditch), land drainage/runoff from adjacent restored and pastoral areas, dry/no flow, no likely to be lined. | | |

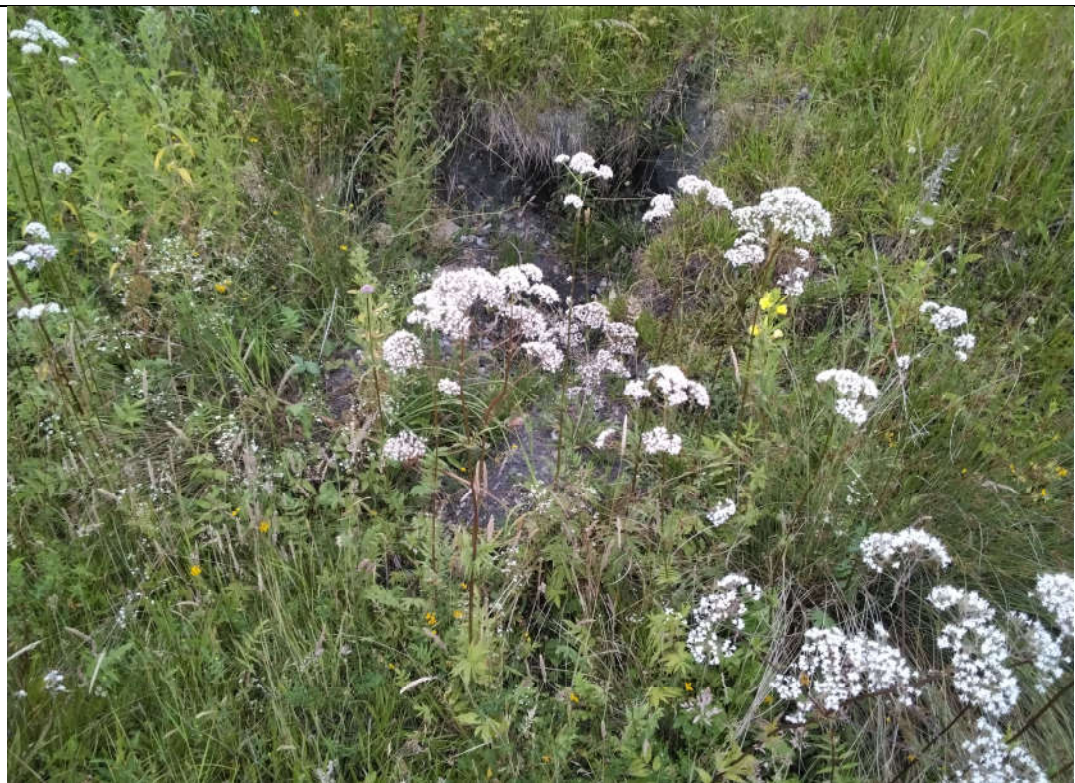
**Surface Water Feature SW-55 CE:**

Surface Water (minor ditch), land drainage/runoff from adjacent restored and pastoral areas, dry, no likely to be lined.

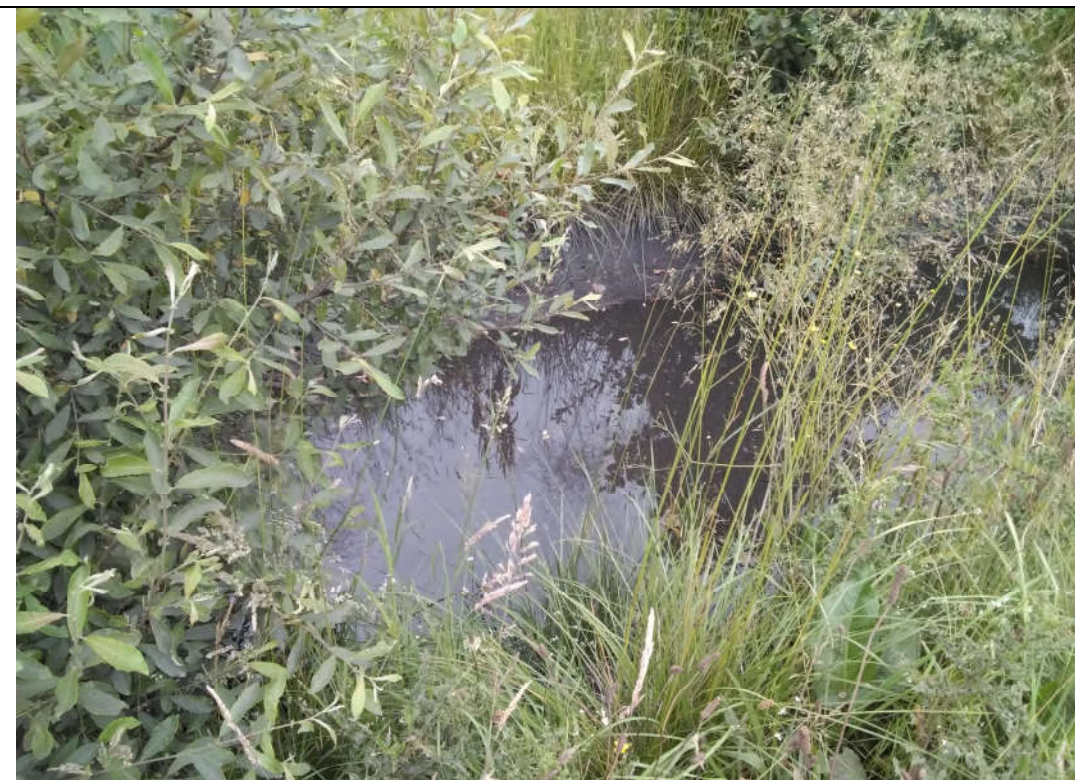
**Photo No.**  
SW-56 CE

**Surface Water Feature SW-56 CE:**

Surface Water (minor ditch), land drainage/runoff from adjacent restored and pastoral areas, water in the ditch but not apparent flow, no likely to be lined.

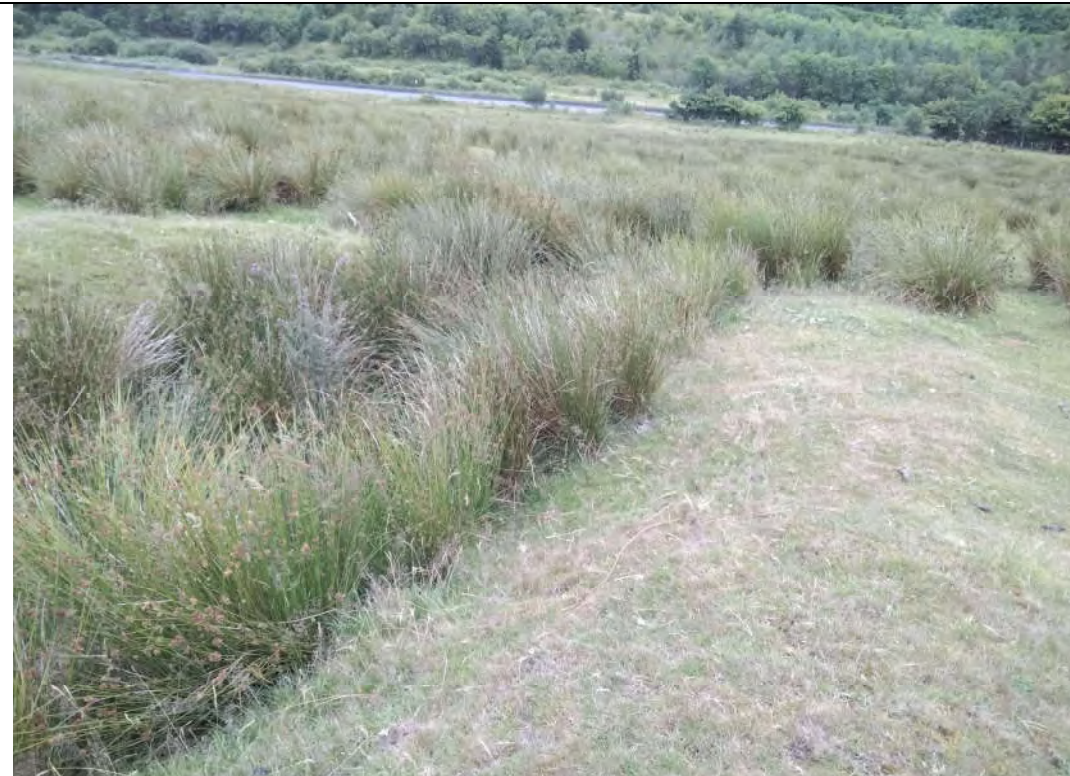
| Photo No. | Date: | |
|---|---|---|
| SW-59 CE | 12 July 2022 | |

| Photo No. | Date: | |
|---|---|---|
| <b>Surface Water Feature SW-59 CE:</b><br>Surface Water (minor ditch), land drainage/runoff from adjacent restored and pastoral areas, dry, no likely to be lined. | | |

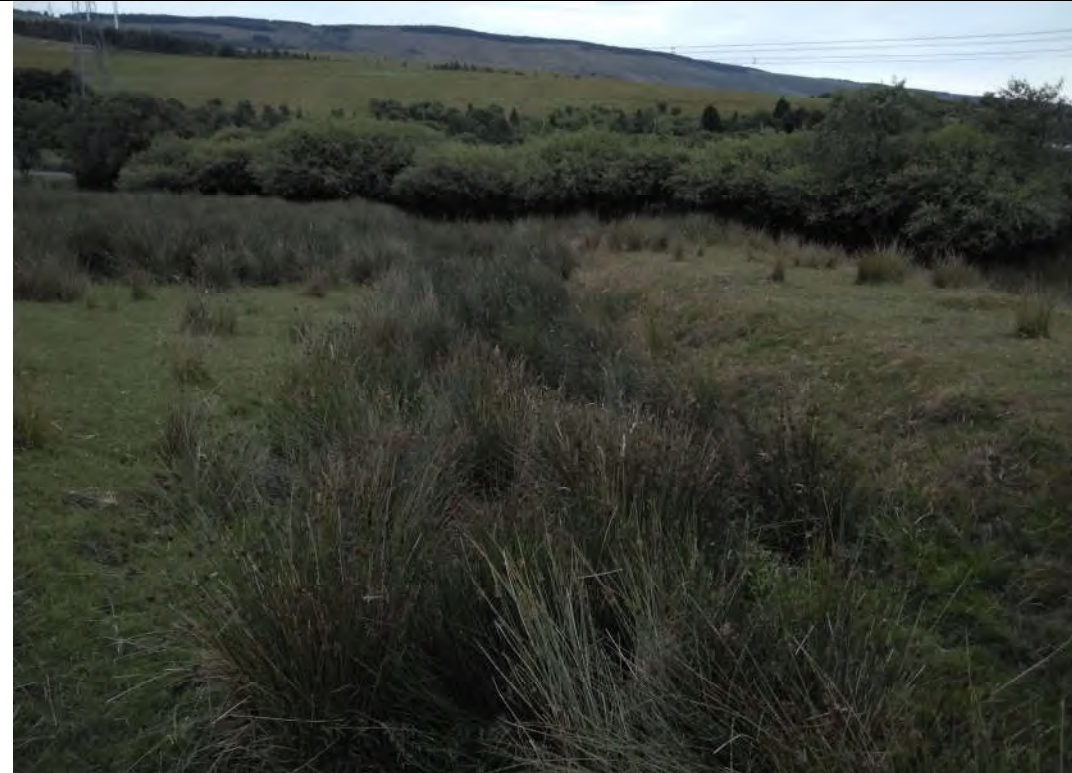
| Photo No. | Date: | |
|---|---|---|
| SW-64 CE | 12 July 2022 | |

| Photo No. | Date: | |
|---|---|---|
| <b>Surface Water Feature SW-64 CE:</b><br>Surface Water (minor ditch), land drainage/runoff from adjacent restored and pastoral areas, dry, no likely to be lined. | | |

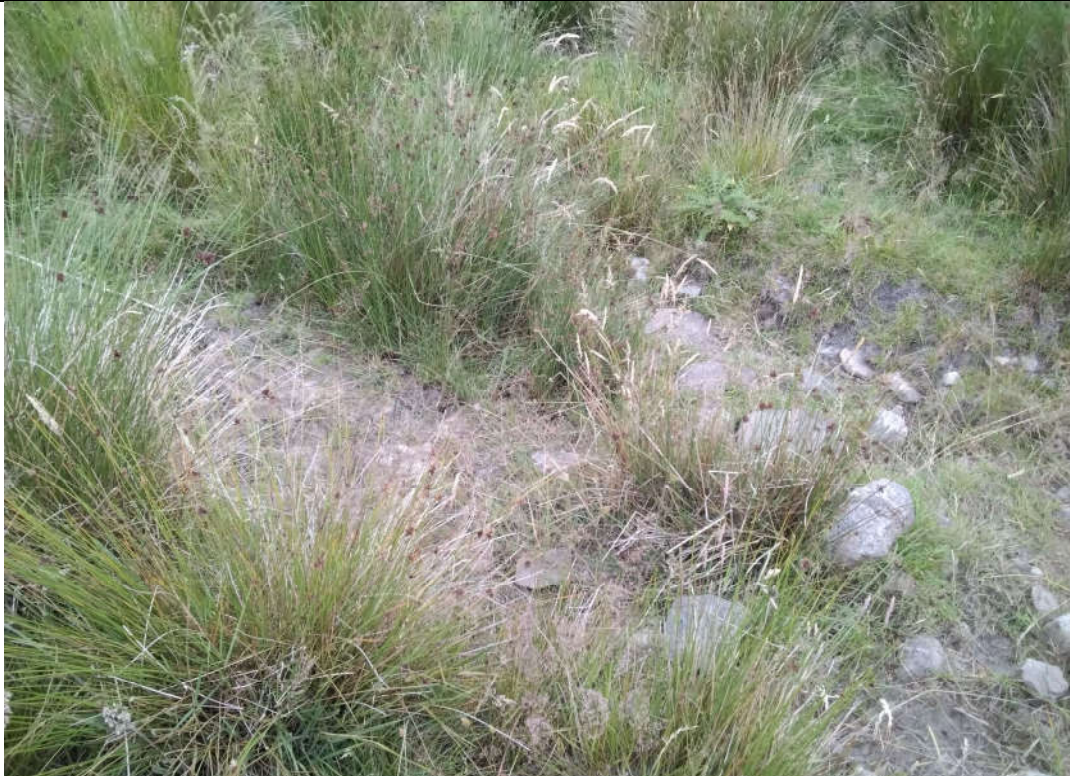
| Photo No. | Date: | |
|---|---|---|
| SW-66 CE | 12 July 2022 | |

| Photo No. | Date: | |
|---|---|---|
| <b>Surface Water Feature SW-66 CE:</b><br>Surface Water (minor ditch), land drainage/runoff from adjacent restored and pastoral areas, dry, no likely to be lined. | | |

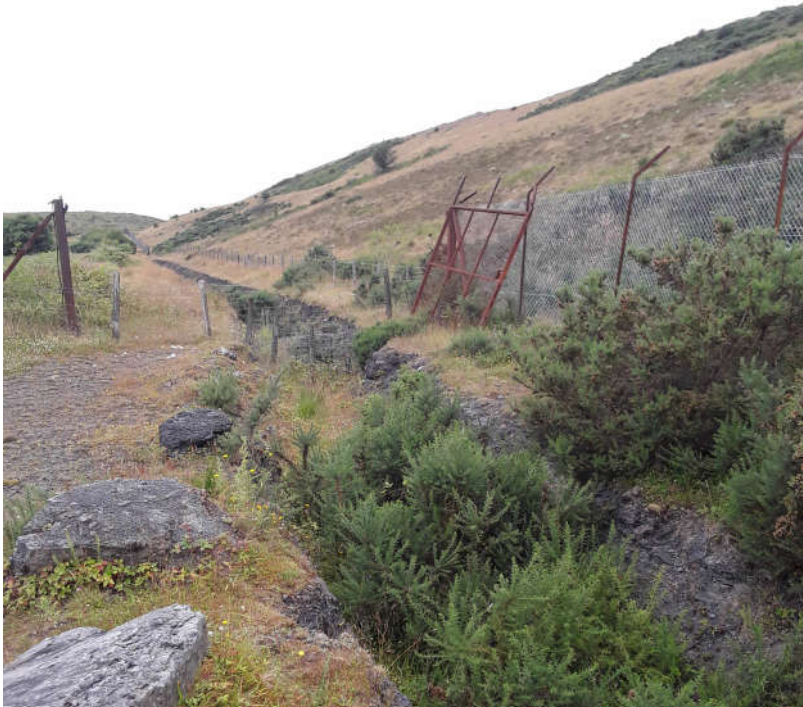
| <b>Photo No.</b><br>SW-13 DP | <b>Date:</b><br>12 July 2022 | |

| <b>Surface Water Feature SW-13 DP:</b><br>Continuation of SW03 ditch.<br>Photo aspect is west. | | |

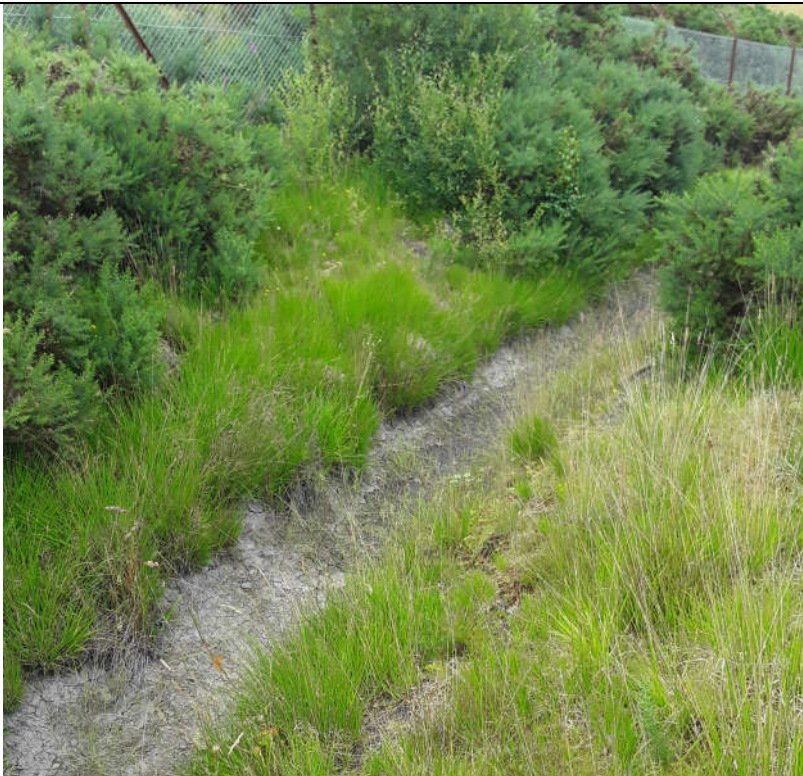
| <b>Photo No.</b><br>SW-14 DP | <b>Date:</b><br>12 July 2022 | |

| <b>Surface Water Feature SW-14 DP:</b><br>Continuation of SW14 ditch.<br>Photo aspect is east. | | |
