**Client Name:** Global Centre of Rail Excellence

**Site:** GCRE (Main Site)

**Project No.**  
5209796

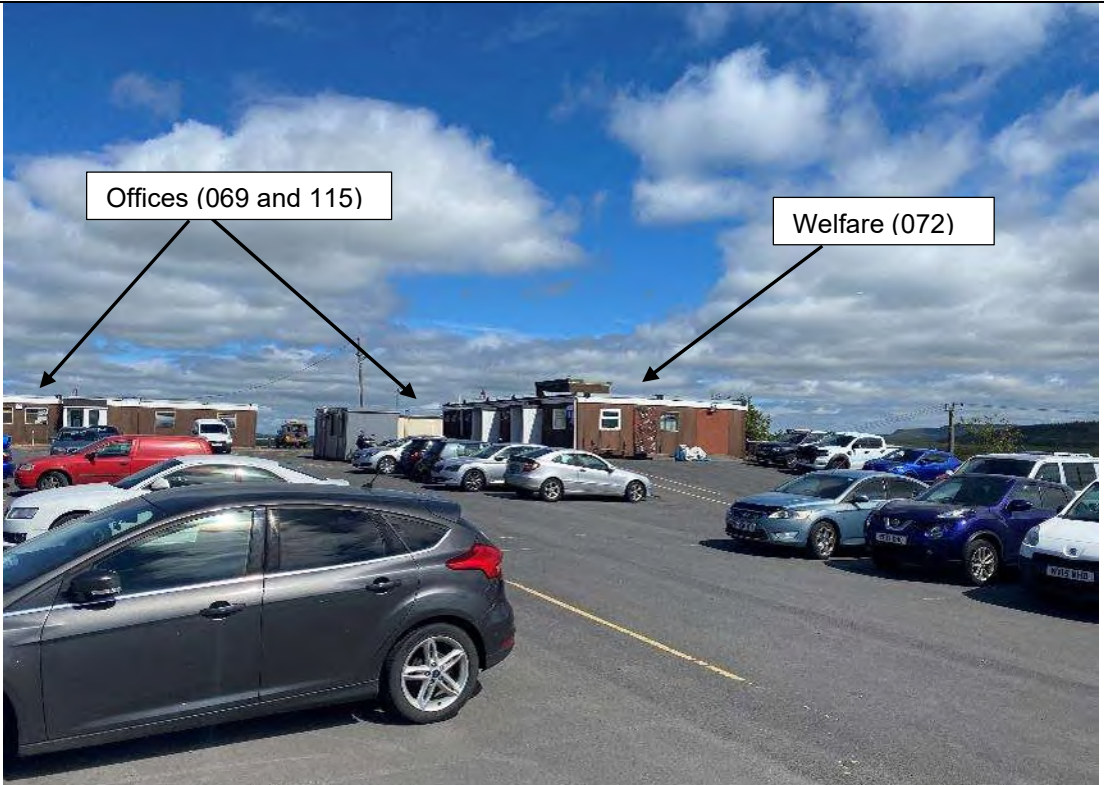
| <p><b>Car Park (067)</b></p> <p>View across car park (067) towards welfare block (072) and offices (069 and 115).</p> <p>The photograph aspect is south-east.</p> | | |

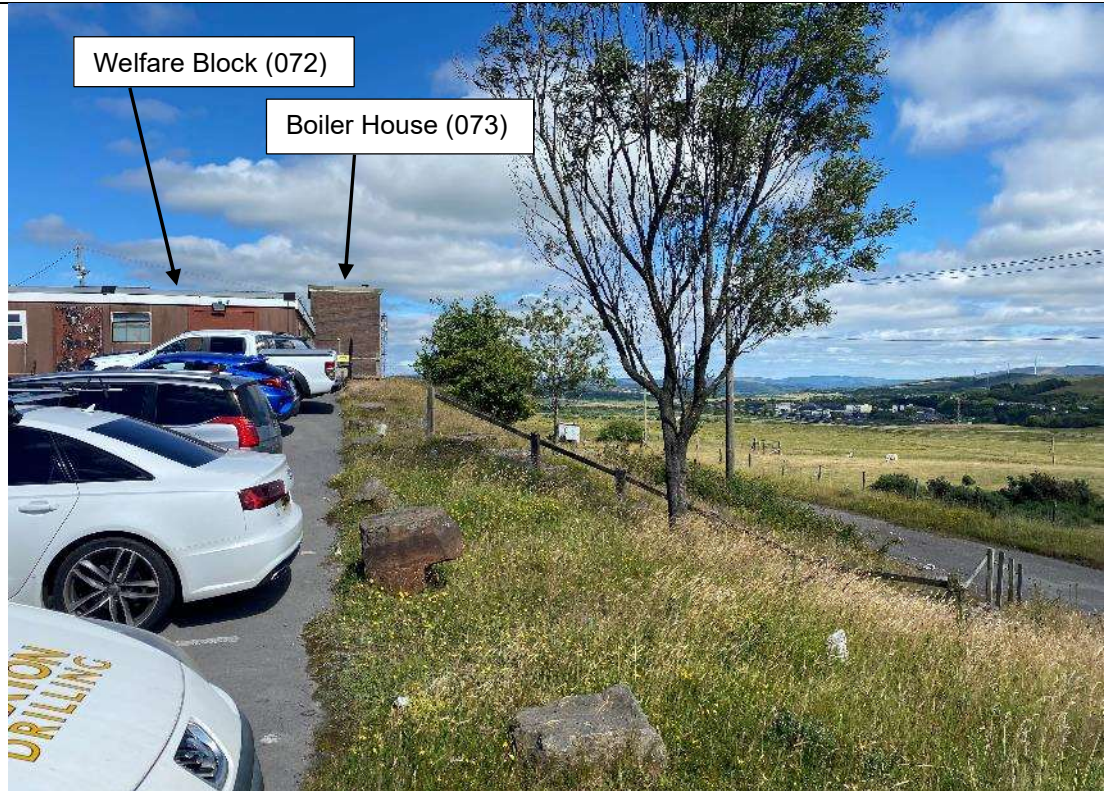
| <p><b>Car Park (067)</b></p> <p>View along boundary of car park towards welfare block (072)</p> <p>Car park and offices on area built up to produce level surface, approximately 5 m above land to south, with slope that drops at 1:3</p> <p>The photograph aspect is east.</p> | | |

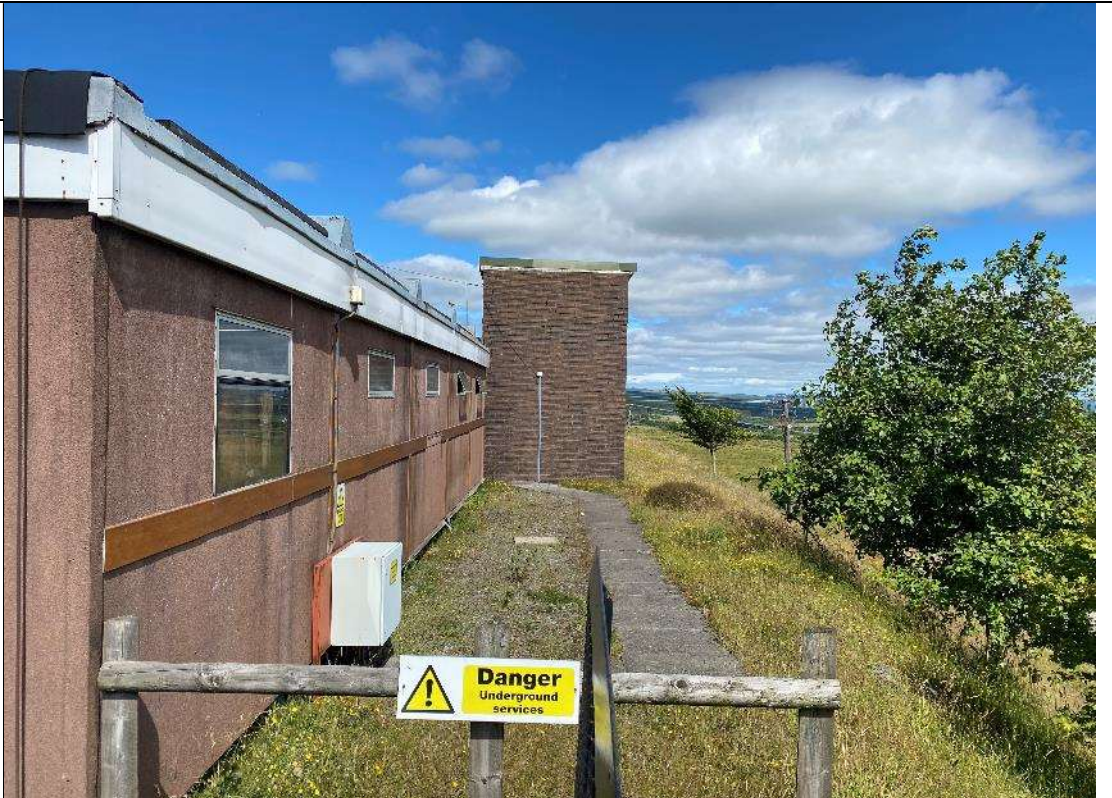
| <p><b>Office (071)</b></p> <p>Rear of office blocks (072 and 070).</p> <p>The photograph aspect is north.</p> | | |

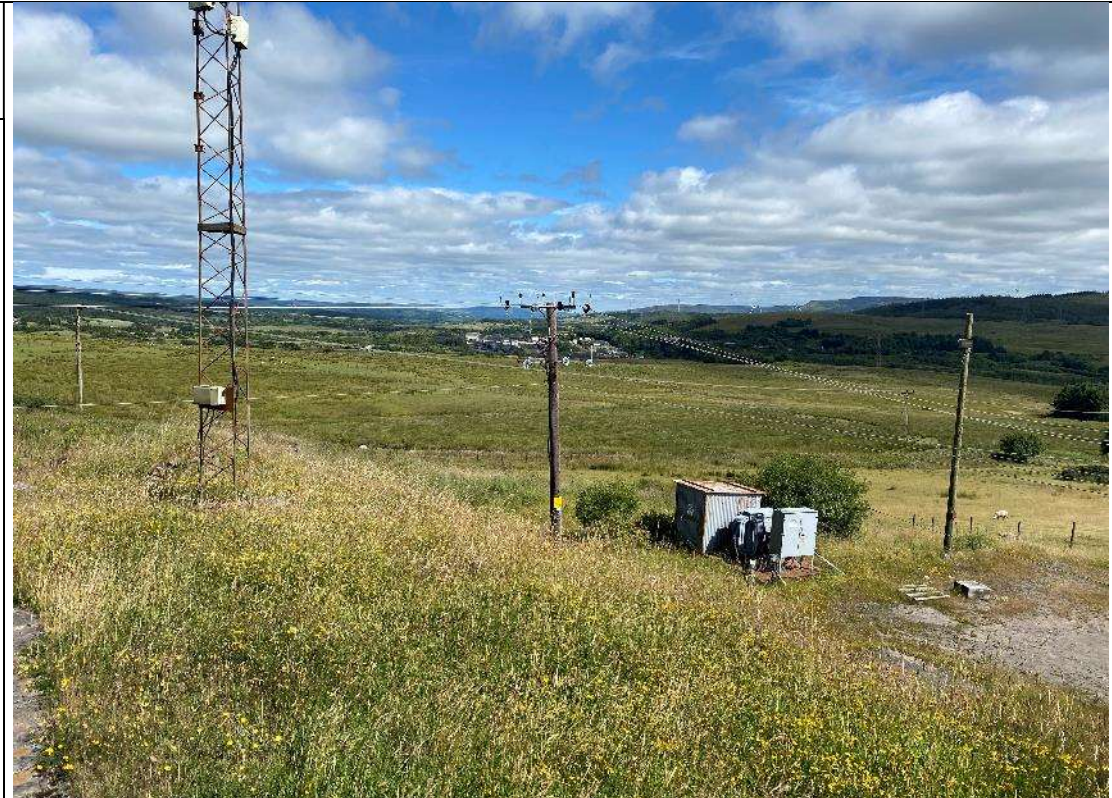
| <p><b>Electrical Substation (064)</b></p> <p>Electrical substation (064) visible to right and communications mast / overhead electrical supply also visible.</p> <p>View aspected to south-east.</p> | | |

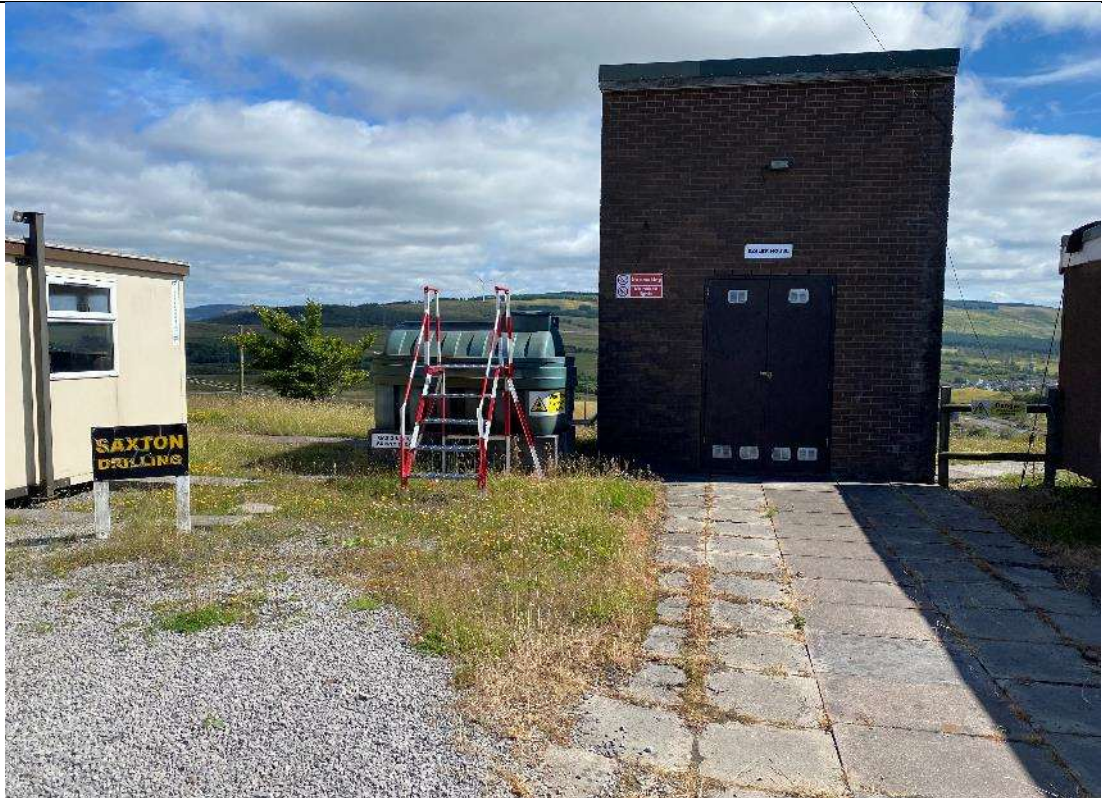
| <b>Boiler House (073) and AST (074)</b><br><br>View of boiler house (073) and gas-oil AST (074) located to left. Boiler house supplies warm water to Welfare Unit (072). Portacabin signed as being used by Saxton Drilling (115) to left.<br><br>The photograph aspect is east. | | |

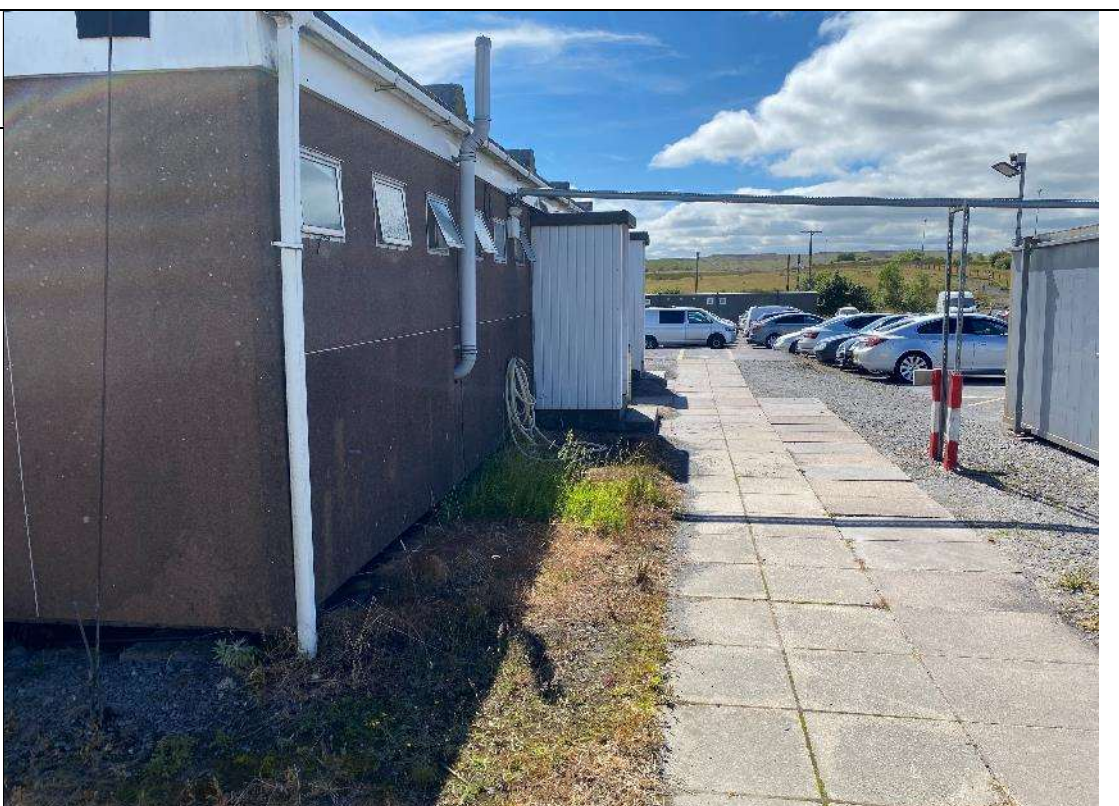
| <b>Welfare block (072)</b><br><br>Welfare block view of front and made ground at car park / office area.<br><br>The photograph aspect is west. | | |

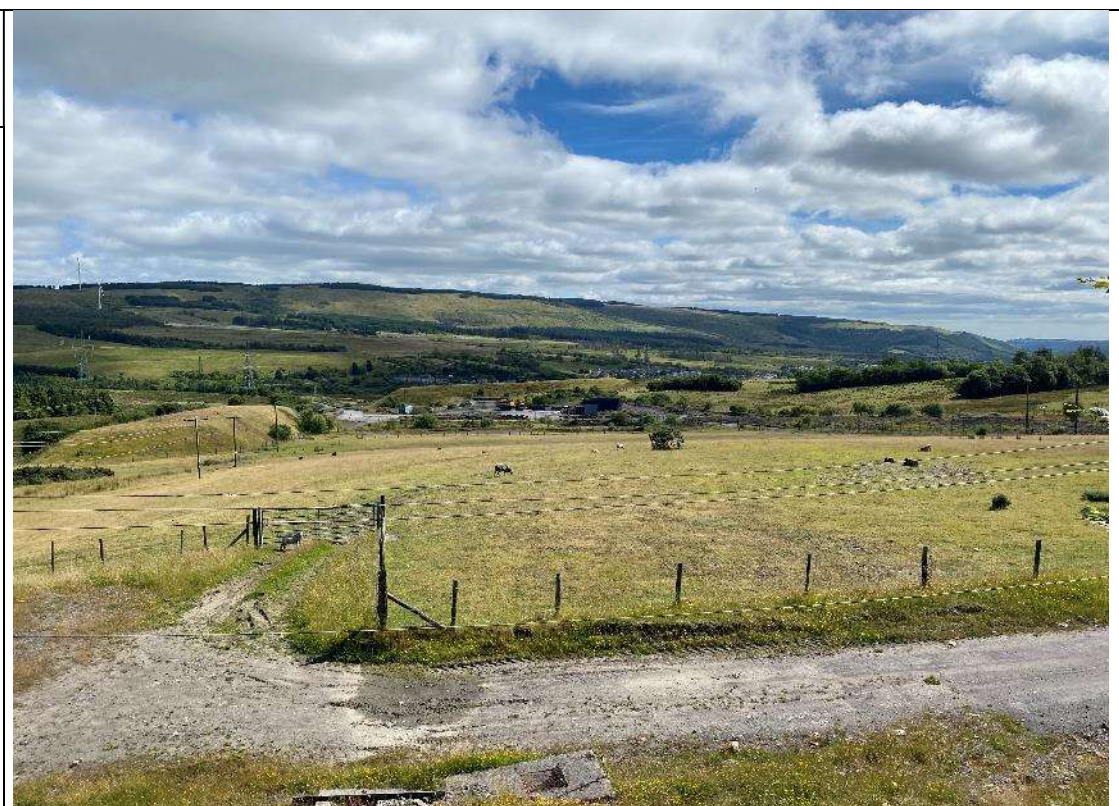
| <b>Southern Main Site</b><br><br>View of south from car parking area towards wheel wash (062), several bunds (116) of unknown made ground visible.<br><br>The photograph aspect is south. | | |

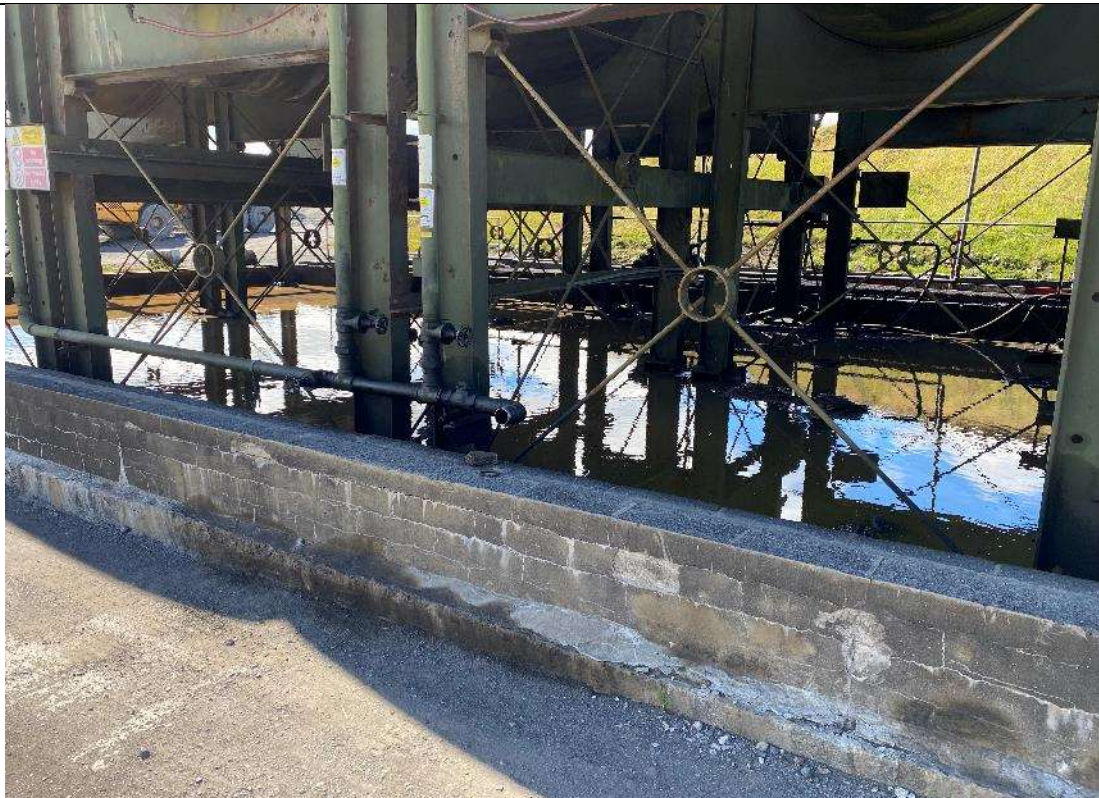
| <b>Diesel AST (056)</b><br><br>Diesel AST Containment bund and filling pipework.<br><br>The photograph aspect is north-west. | | |

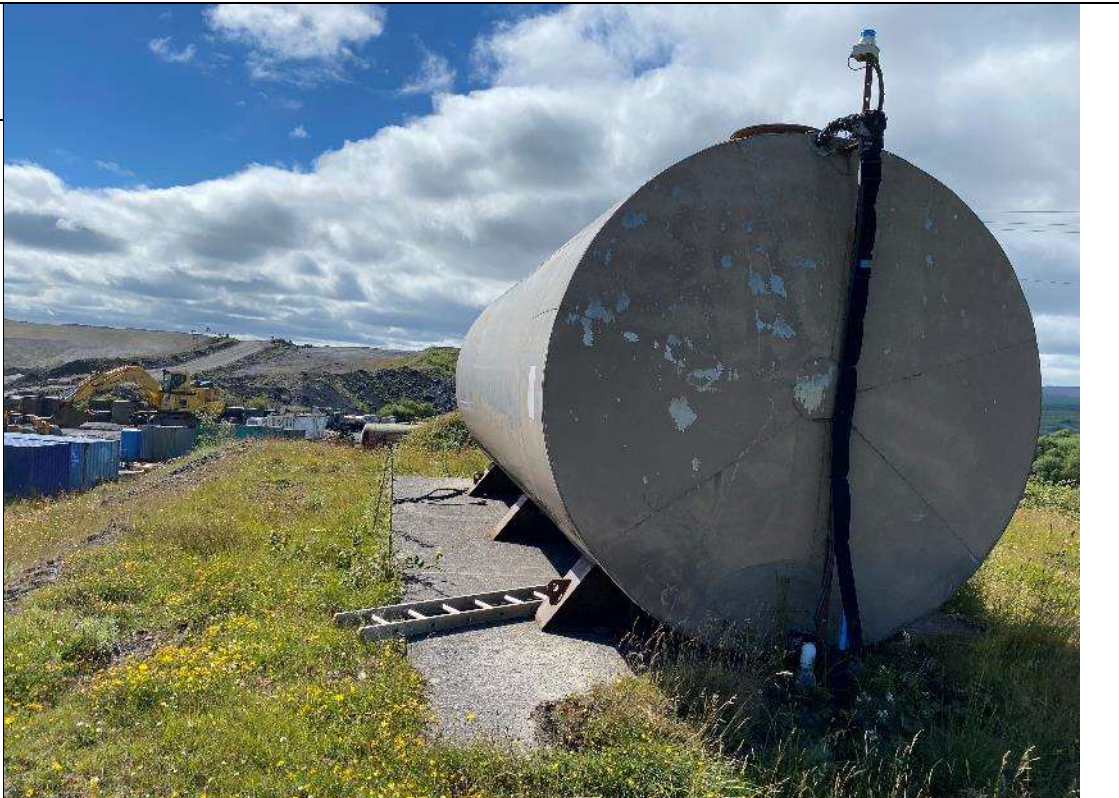
| <b>Water AST (055)</b><br><br>View of water AST located on bund above repair garage (057) and scrap yard (060) area<br><br>The photograph aspect is west. | | |

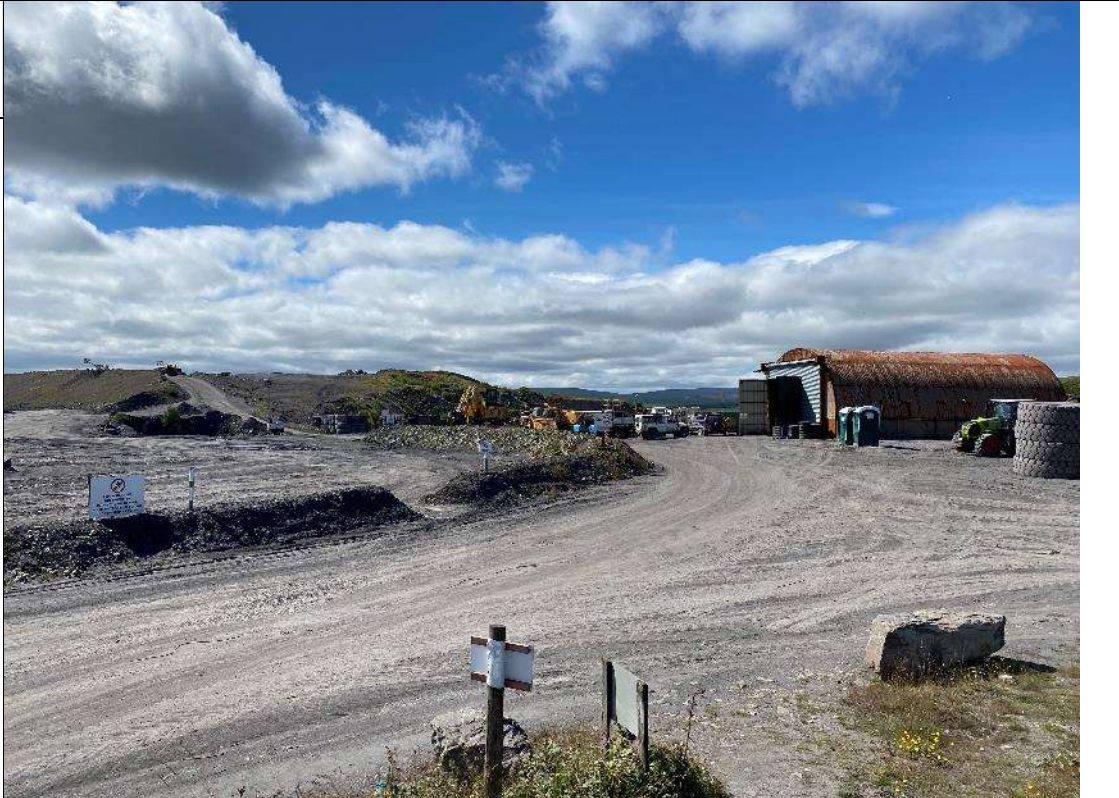
| <b>Plant Parking (068),<br/>repair garage (057) and<br/>Open Cast Restoration<br/>Area</b><br><br>View of Plant Parking to<br>left, then Vehicle Repair<br>Garage to right.<br><br>The photograph aspect<br>is north. | | |

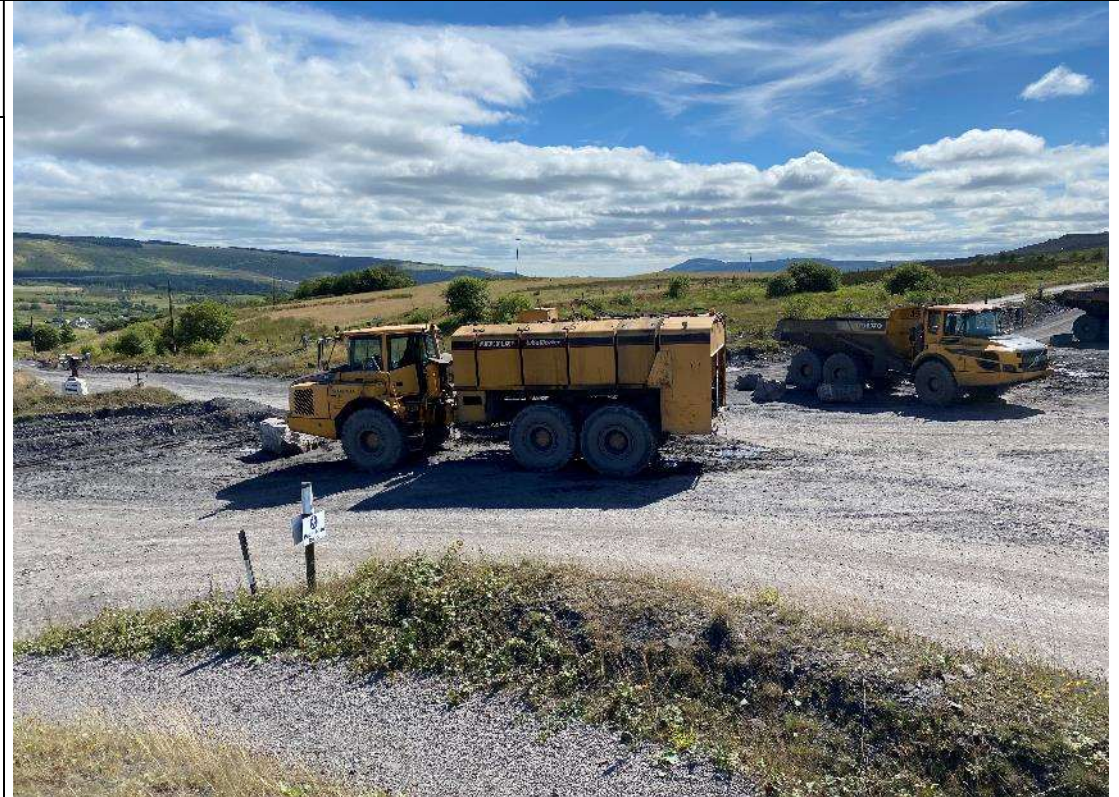
| <b>Site access track and<br/>Plant Yard (068)</b><br><br>View across south-west<br>of site with plant<br>travelling south to<br>Washery Area. | | |

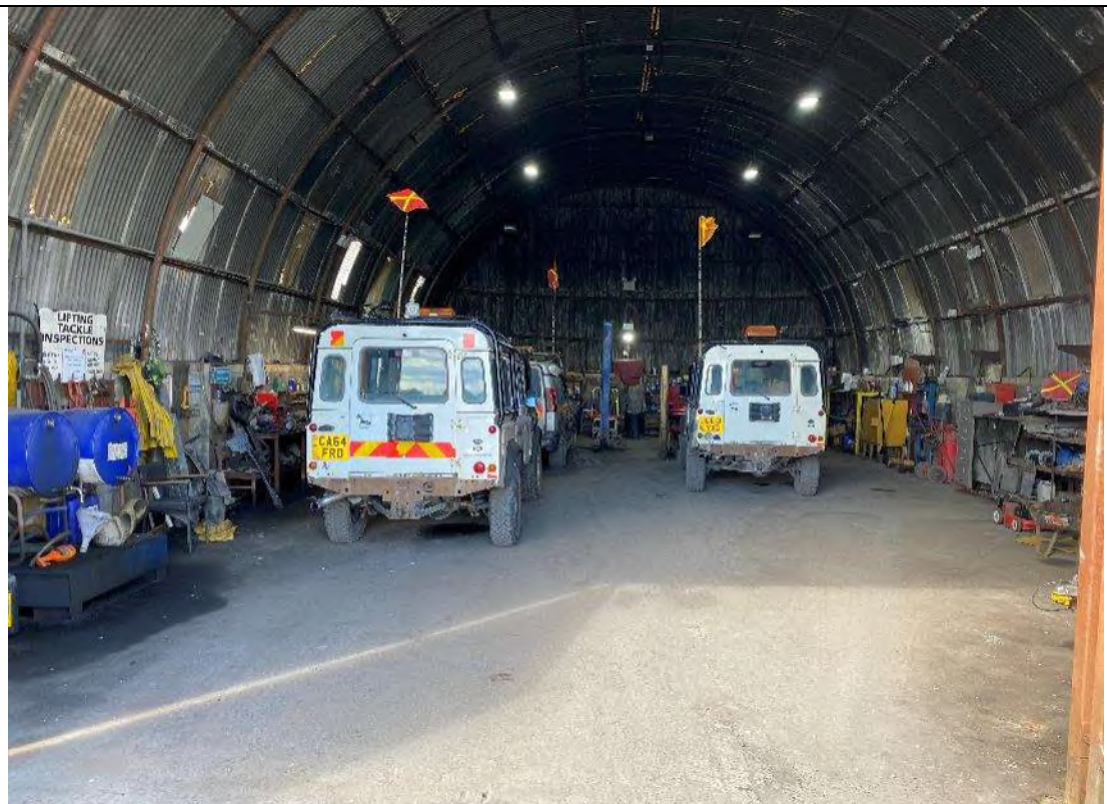
| <b>Photo No.</b><br>105 | <b>Date:</b><br>6 July 2022 |

| <b>Interior of Repair<br/>Garage (057)</b> | |
| View of repair garage.<br><br>The photograph aspect<br>is north. | |

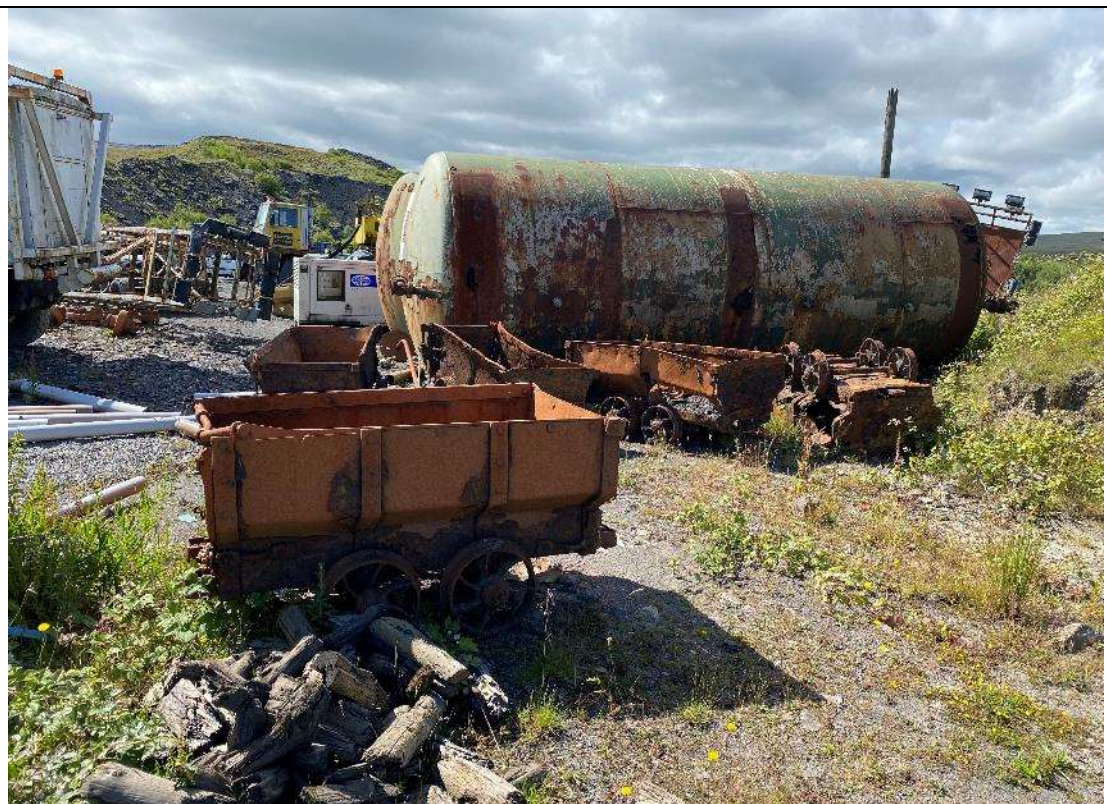
| <b>Photo No.</b><br>106 | <b>Date:</b><br>6 July 2022 |

| <b>Scrap Yard (060)</b> | |
| View of scrap yard area<br>to west of vehicle repair<br>garage. Former AST,<br>generators, plant,<br>present. Wood in<br>foreground consists of<br>props from excavated<br>mine levels. | |

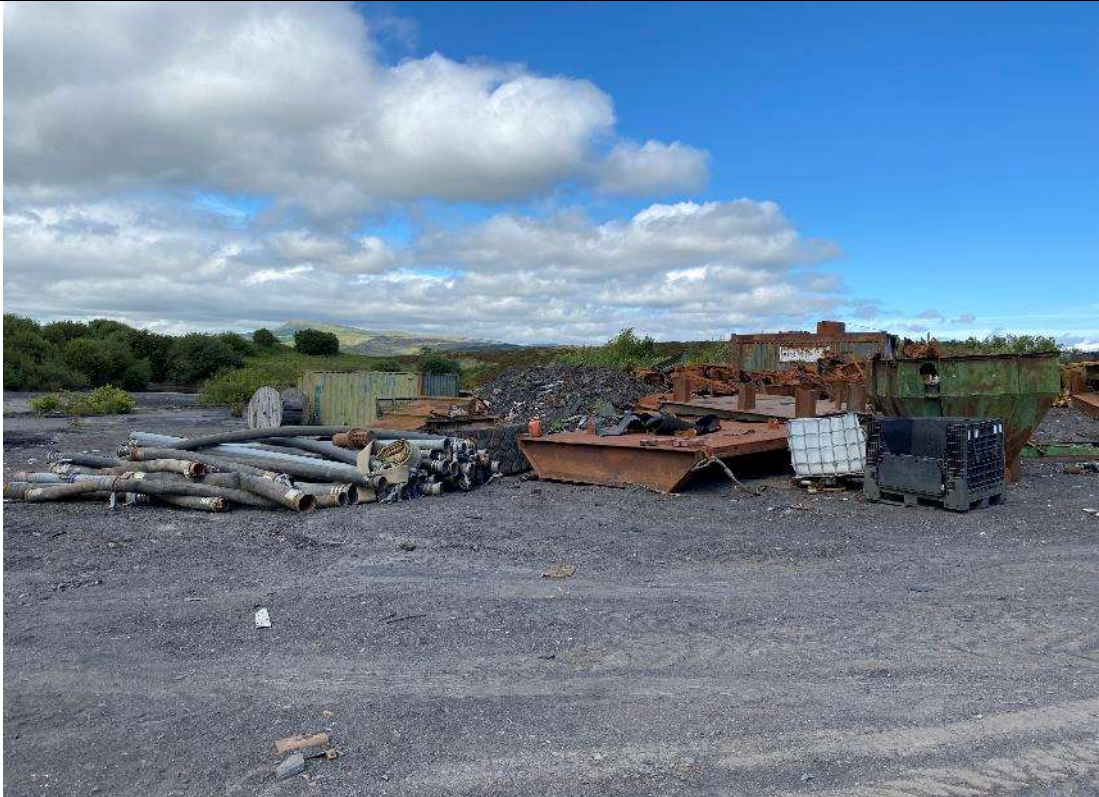
| <b>Scrap Yard (060) Area</b><br><br>View of pump parts stored in scrap yard area.<br><br>Photograph aspect is south-west. | | |

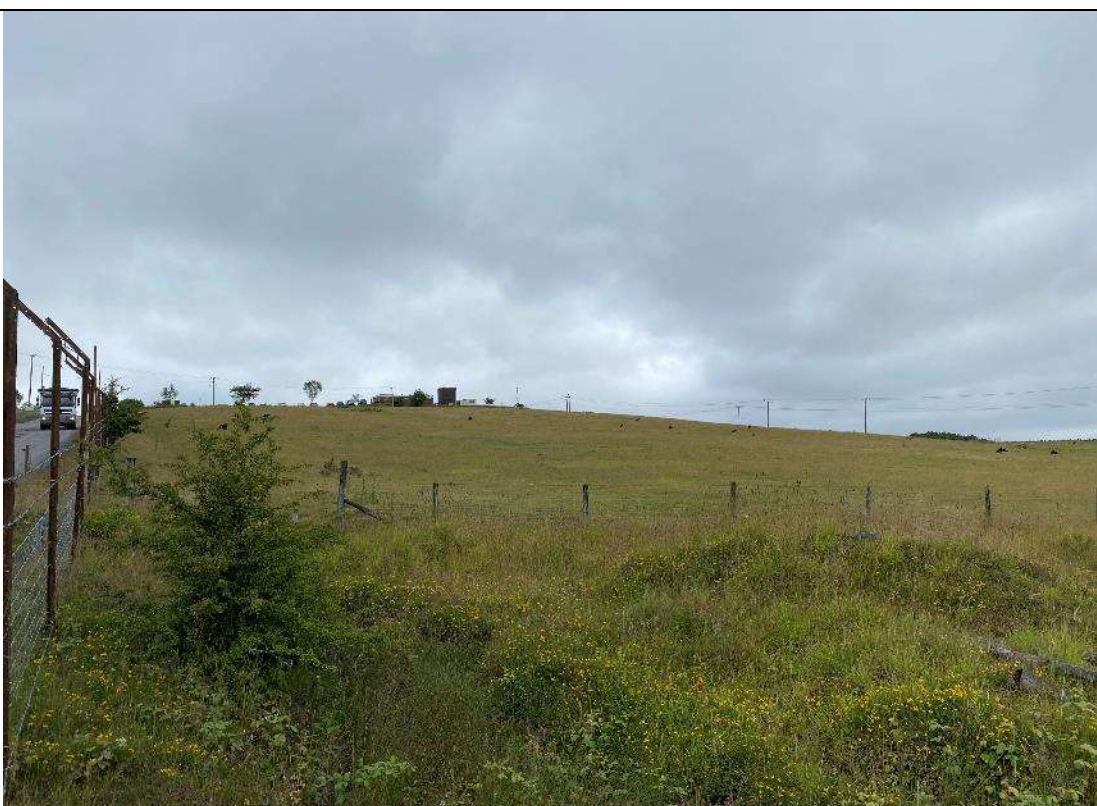
| <b>Main Site</b><br><br>View towards car park / office area with haul road running to washery to left. Field used for sheep pasturage to right.<br><br>Photograph aspect is north. | | |

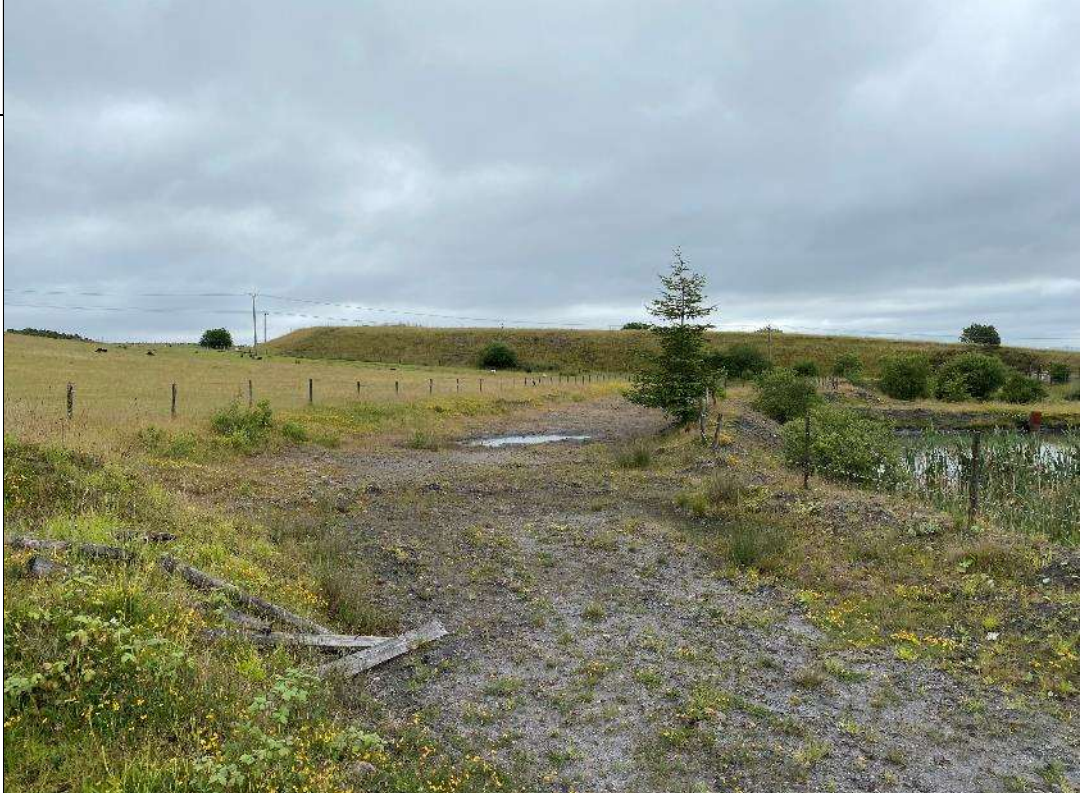
| <b>View of southern Main Site</b><br><br>View across southern part of Main Site.<br><br>Photo aspected to east. | | |

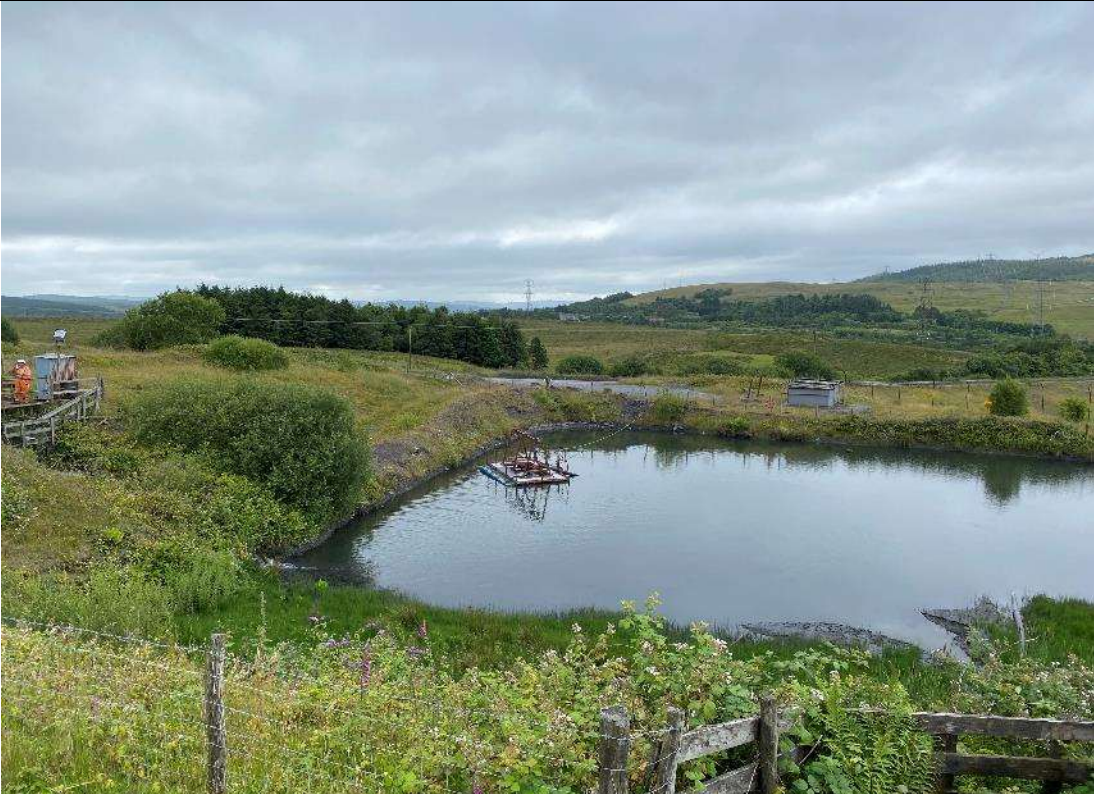
| <p><b>Lagoon Area (078)</b></p> <p>View of lagoon area (078), access road, stockpiles beyond and area used for farming.</p> <p>Photo aspect is south-east.</p> | | |

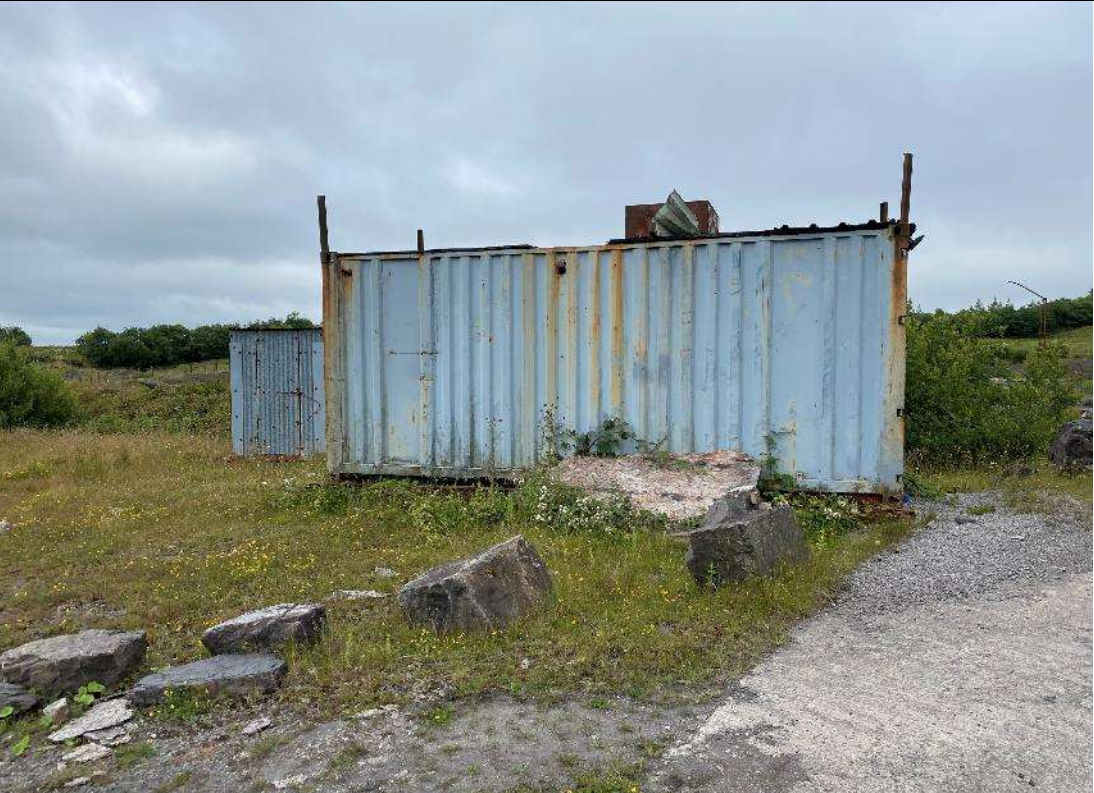
| <p><b>Exterior of Workshop (119)</b></p> <p>View of shipping container (119) and metal shed (120) holding electrical equipment associated with wheel wash and lagoon areas.</p> <p>Photo aspect is west.</p> | | |

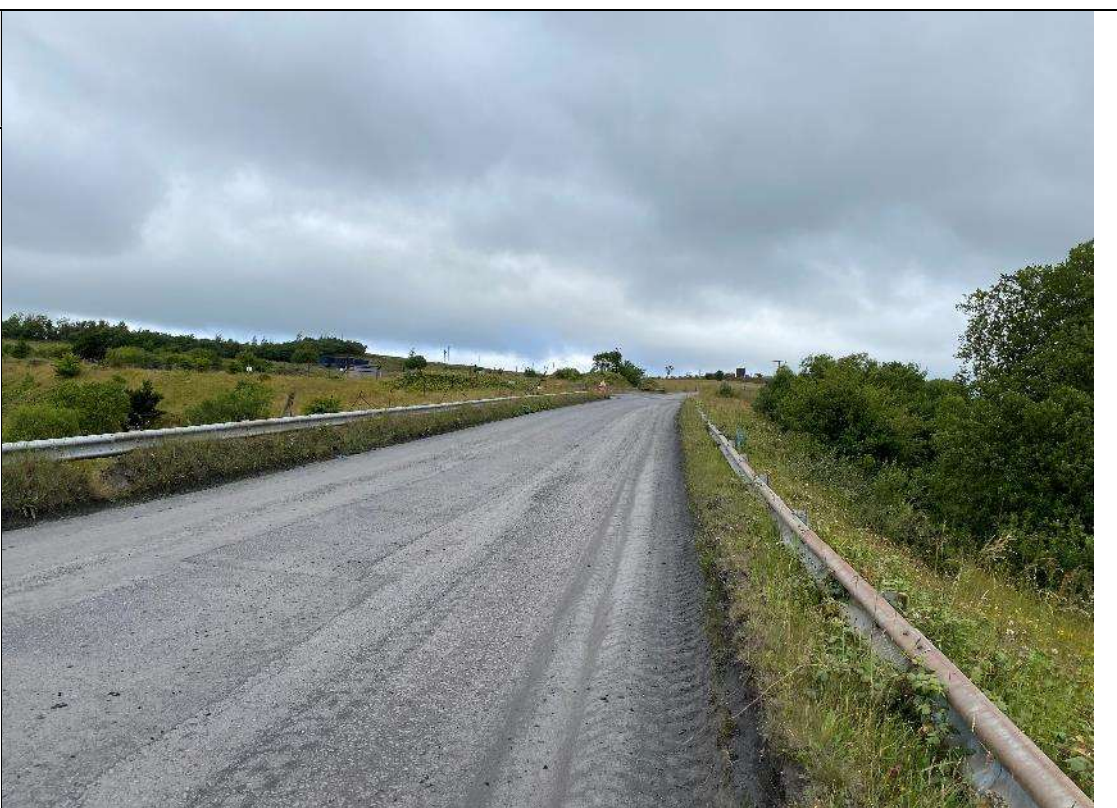
| <p><b>Haul Road</b></p> <p>Haul road area connecting Main Site to Washery with area used for farming to left.</p> <p>Aspect to south.</p> | | |

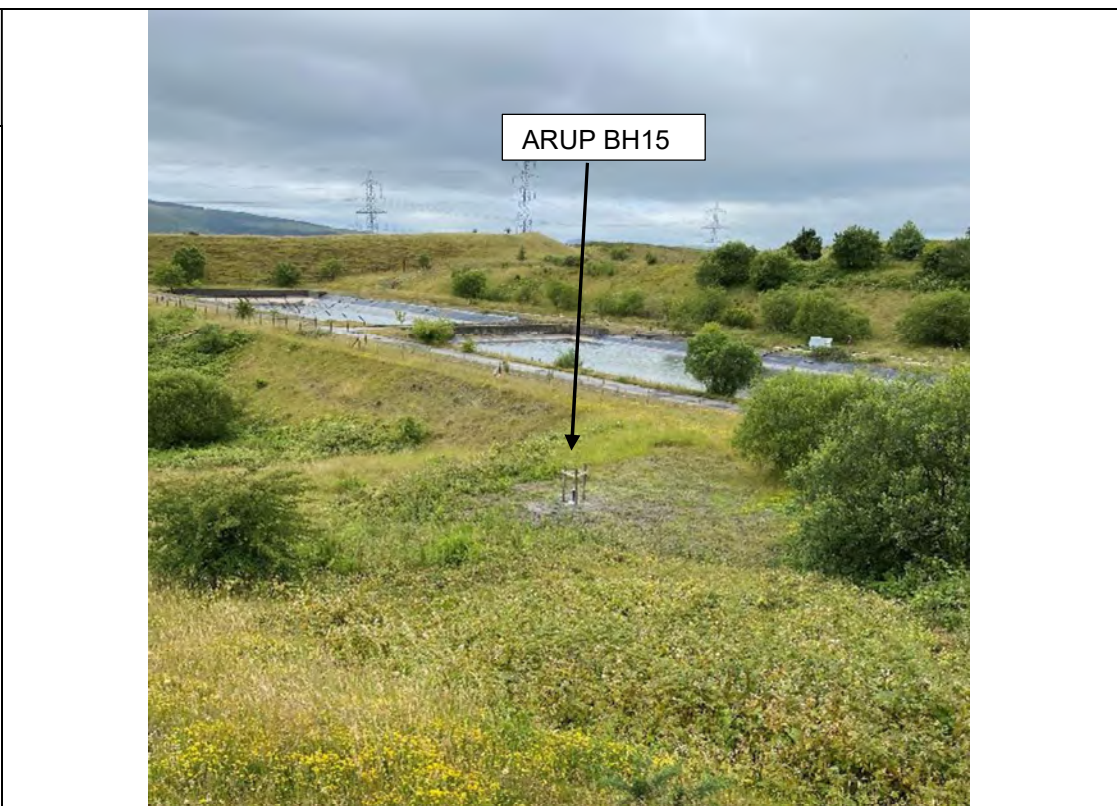
| <p><b>Washery</b></p> <p>View of lagoon 079 with stockpiles / bunds built to enable lagoons to hold water in distance. Borehole BH15 from Arup GI in foreground.</p> <p>Photo aspect is south-west.</p> | | |

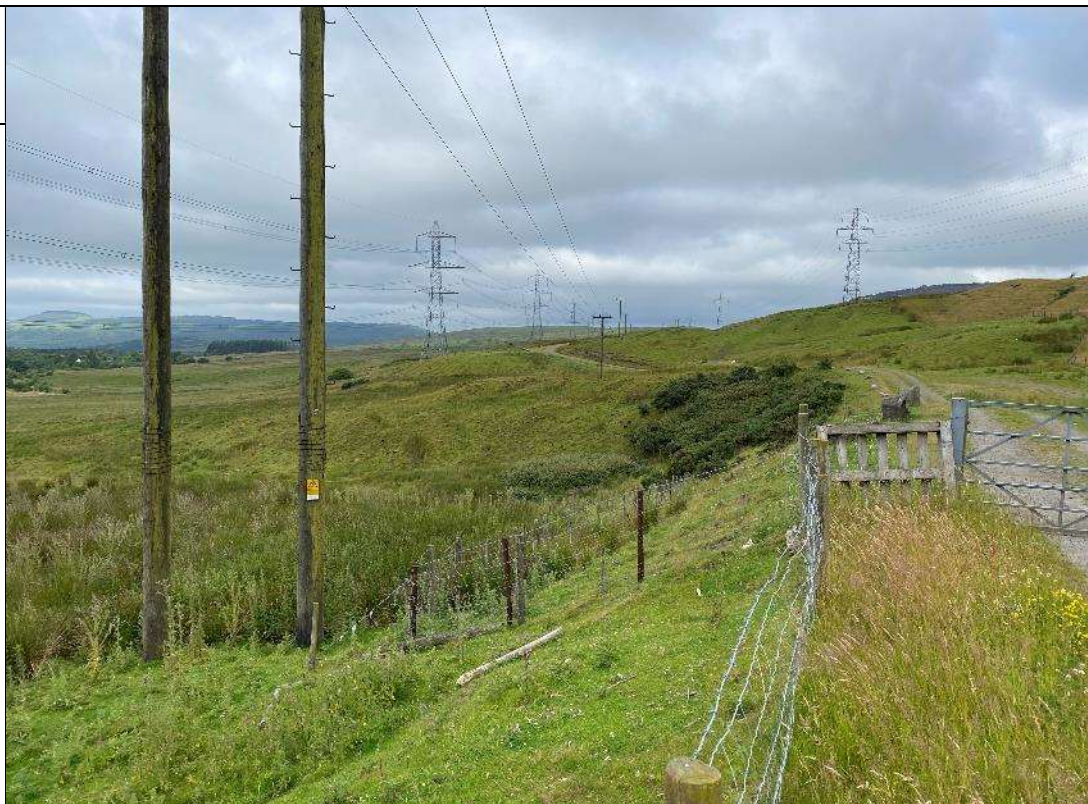
**Washery**

View of access road  
running across south of  
main site.

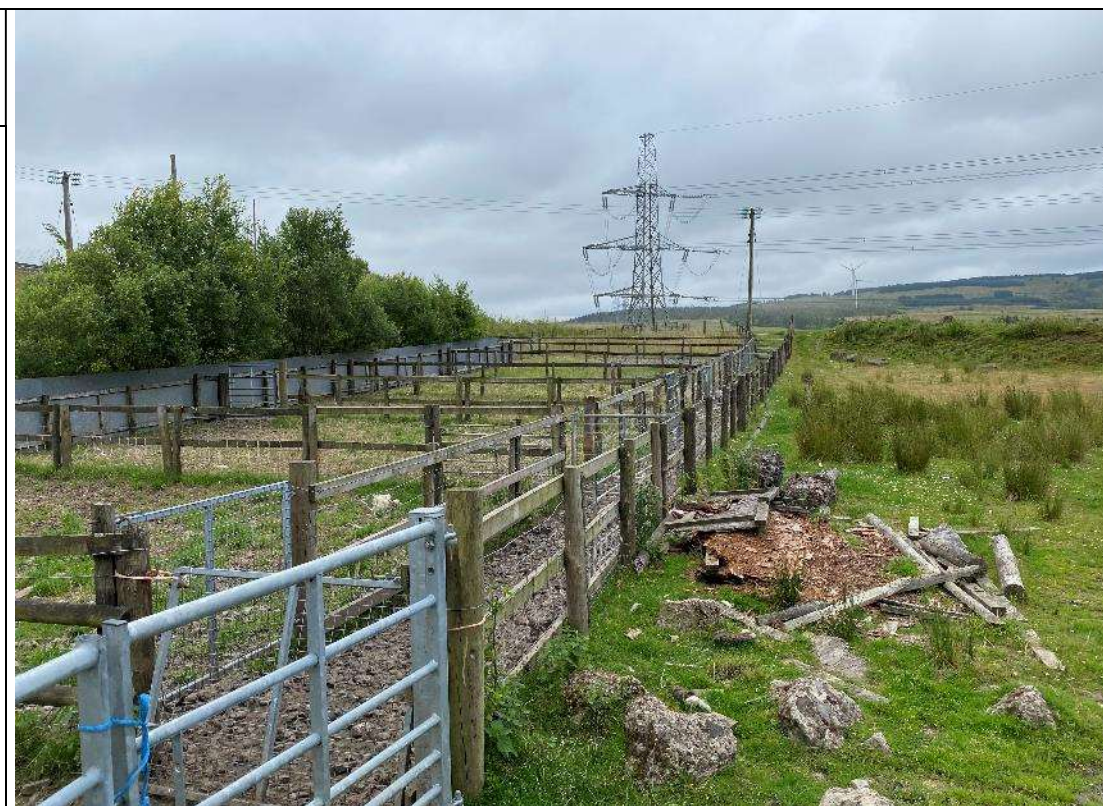
**Photo No.**  
118

**Sheep Pens (092)**

View of area used for  
holding sheep / cattle.

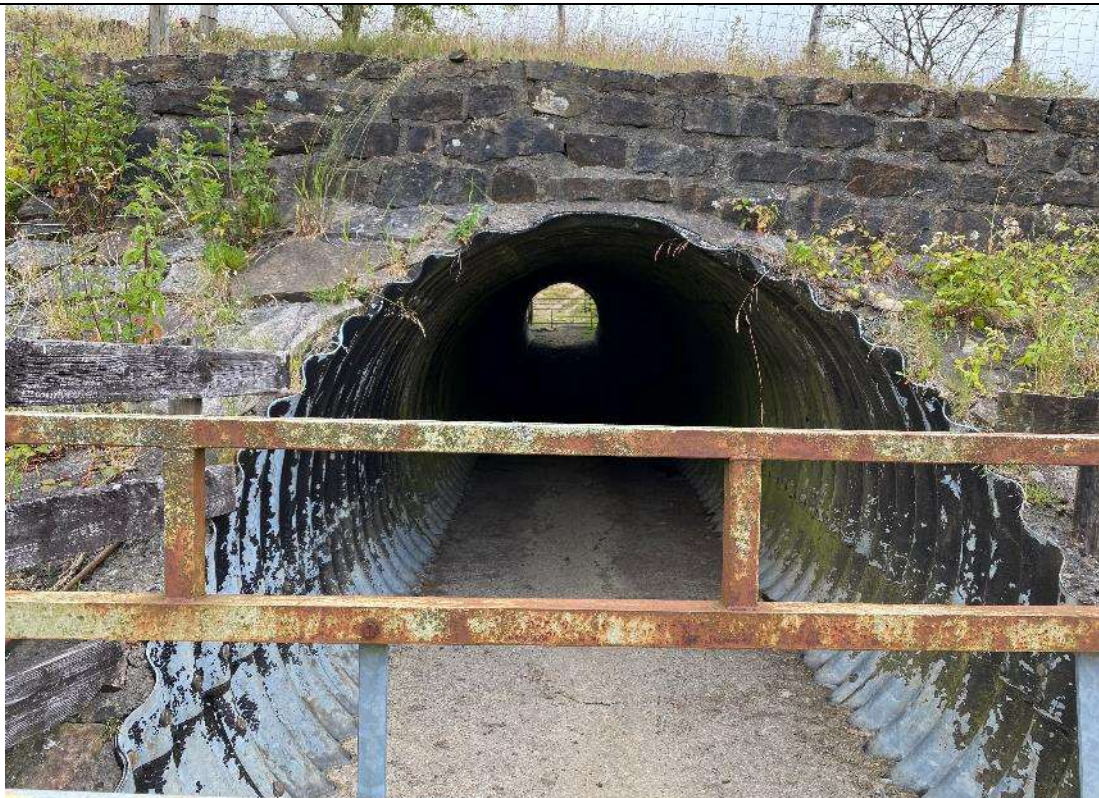
| <b>Tunnel</b><br><br>Tunnel crossing below haul road, intended to allow farmer to access both sides without livestock interacting with plant.<br><br>The photograph aspect is east. | | |

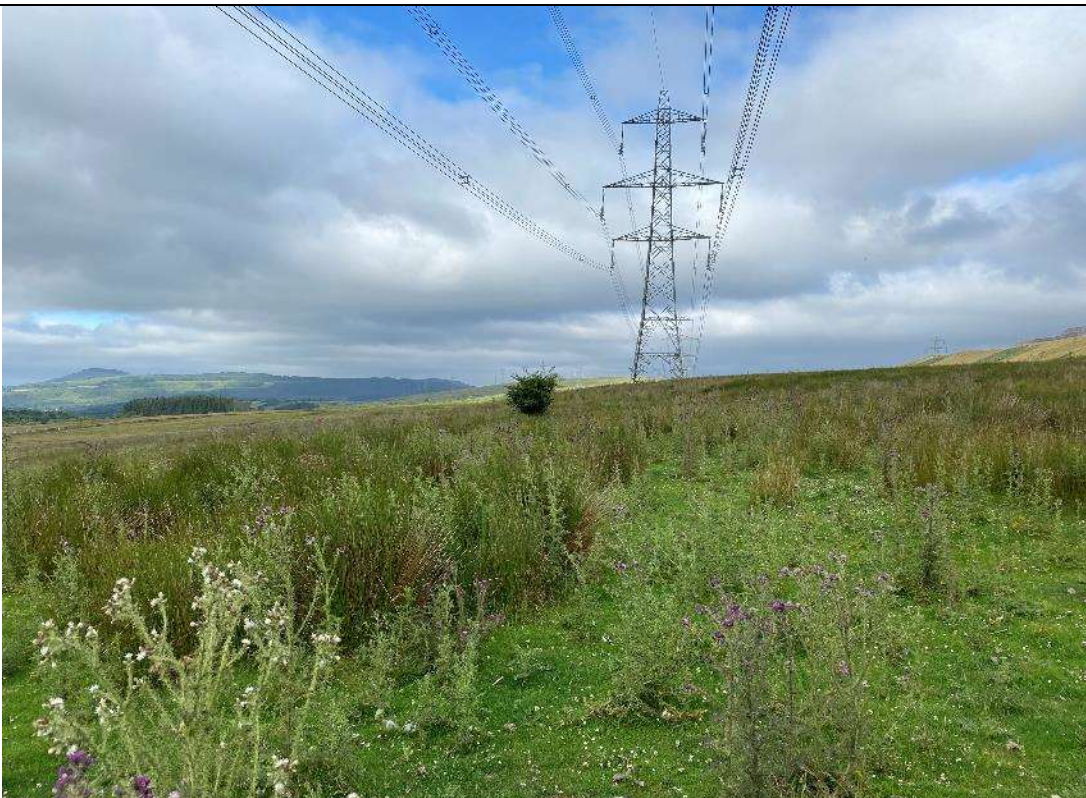
| <b>Washery</b><br><br>View of south of site, electricity pylons visible and water course in foreground).<br><br>The photograph aspect is south-west. | | |

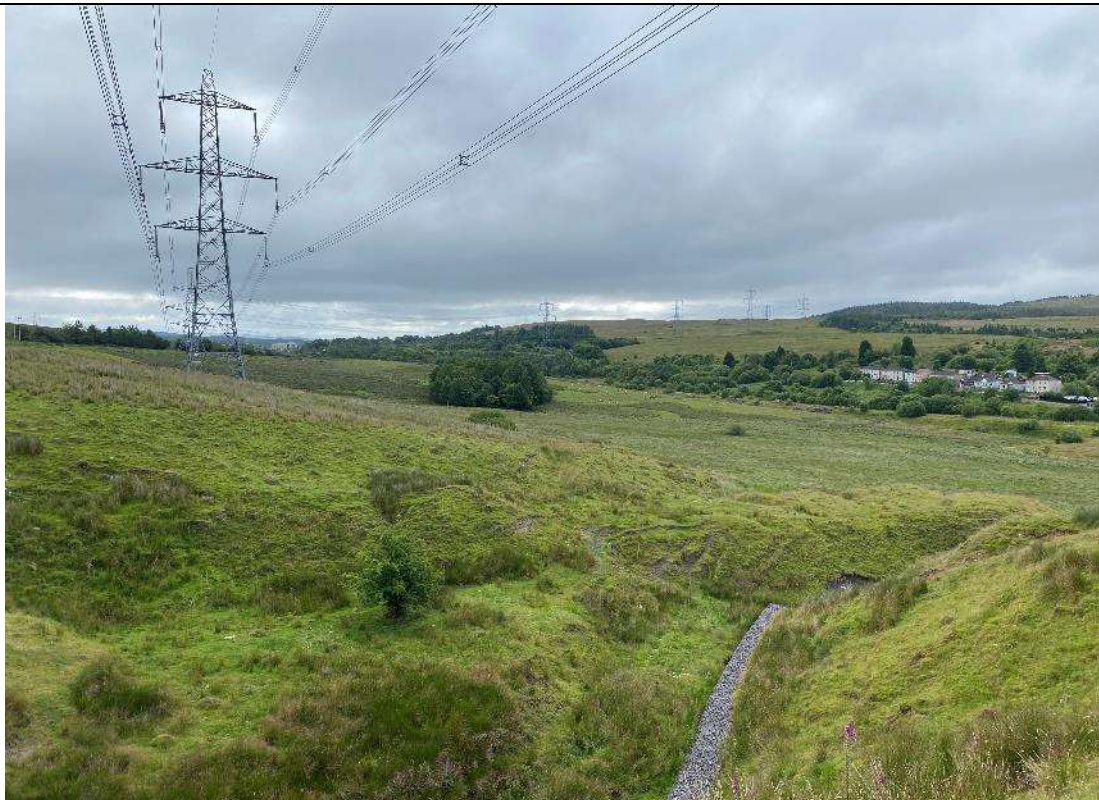
| <b>Southern Main Site</b><br><br>View of southern Main Site.<br><br>The photograph aspect is south-east. | | |
