**Client Name:** Global Centre of Rail Excellence

**Site:** GCRE (Main Site)

**Project No.**  
5209796

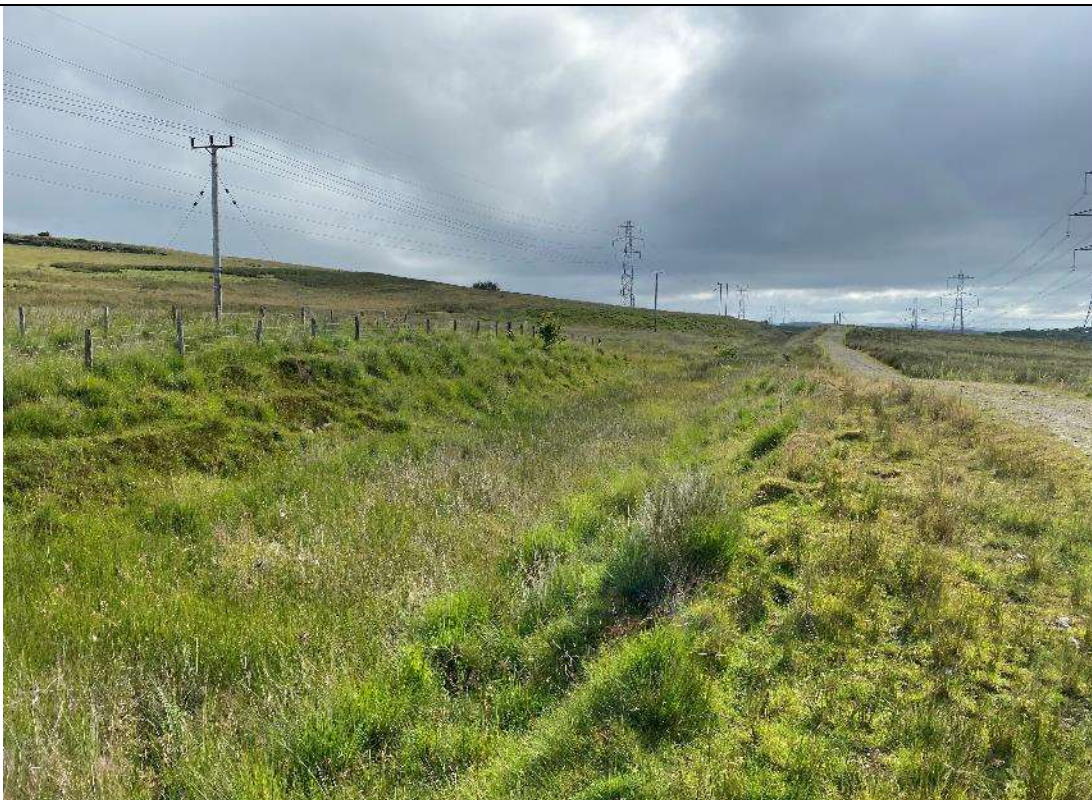
| <b>Main Site</b><br><br>View of ancient monument looking to east. | | |

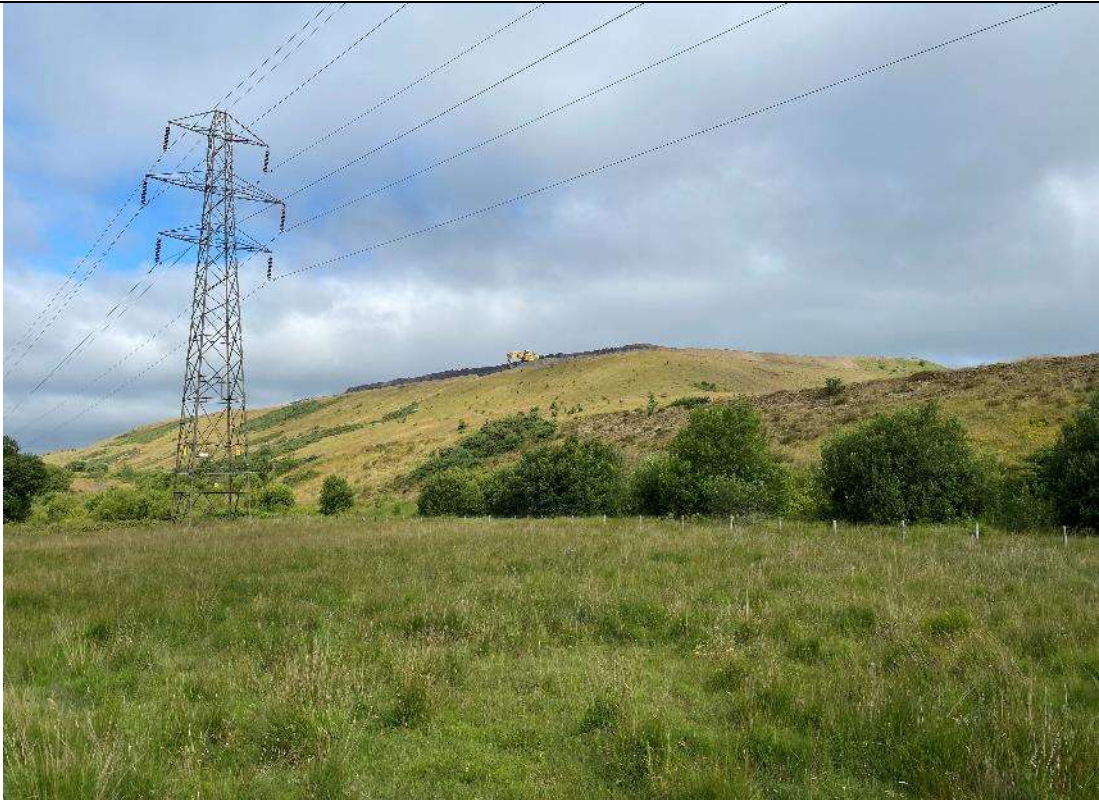
| <p><b>Stockpiled Overburden</b></p> <p>View of Over burden stockpile from south of site.</p> <p>Aspect to north-west.</p> | | |

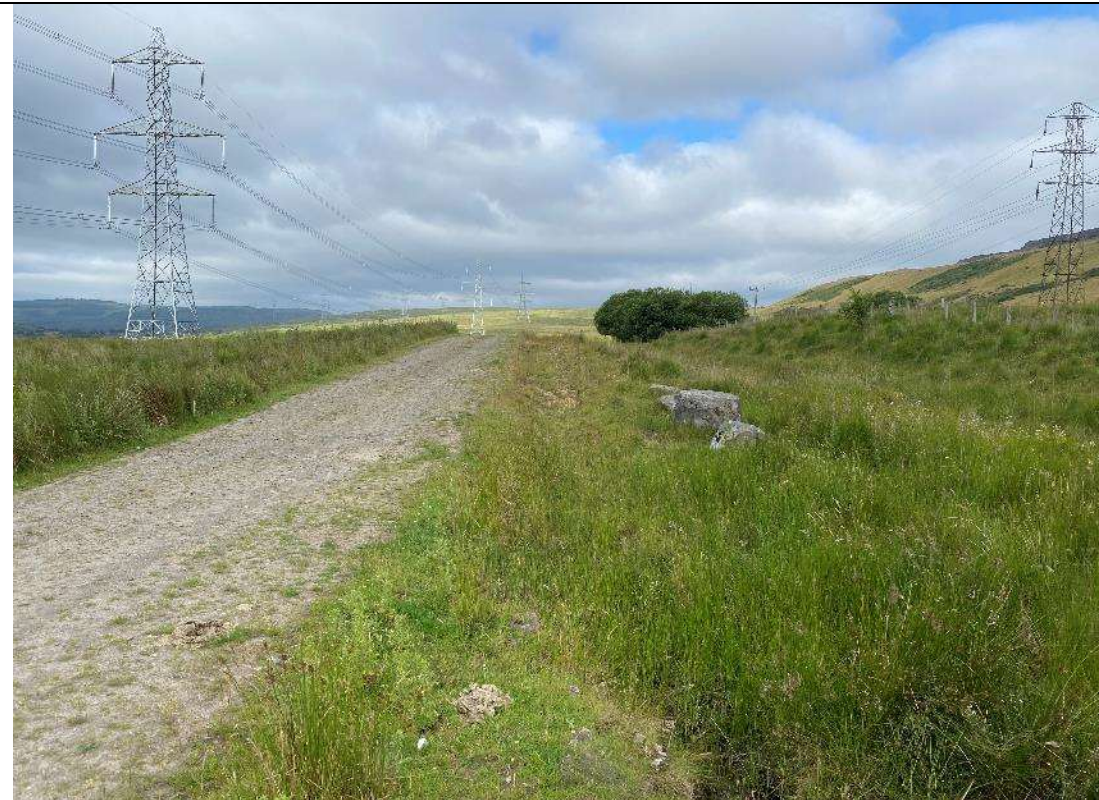
| <p><b>Washery Structure (014)</b></p> <p>View access road running west to east along southern portion of site, ancient monument to right.</p> <p>Aspect to west.</p> | | |

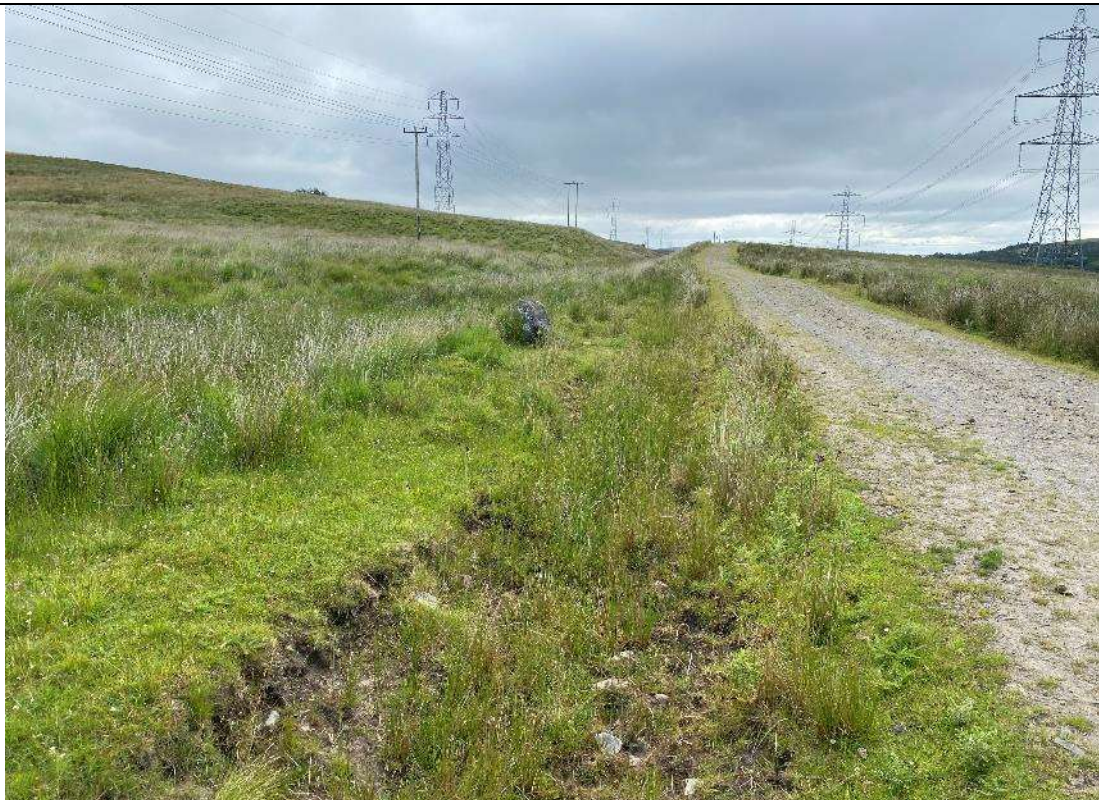
| <b>Main Site</b><br><br>View of access road and ancient monument to left.<br><br>The photograph aspect is east. | | |

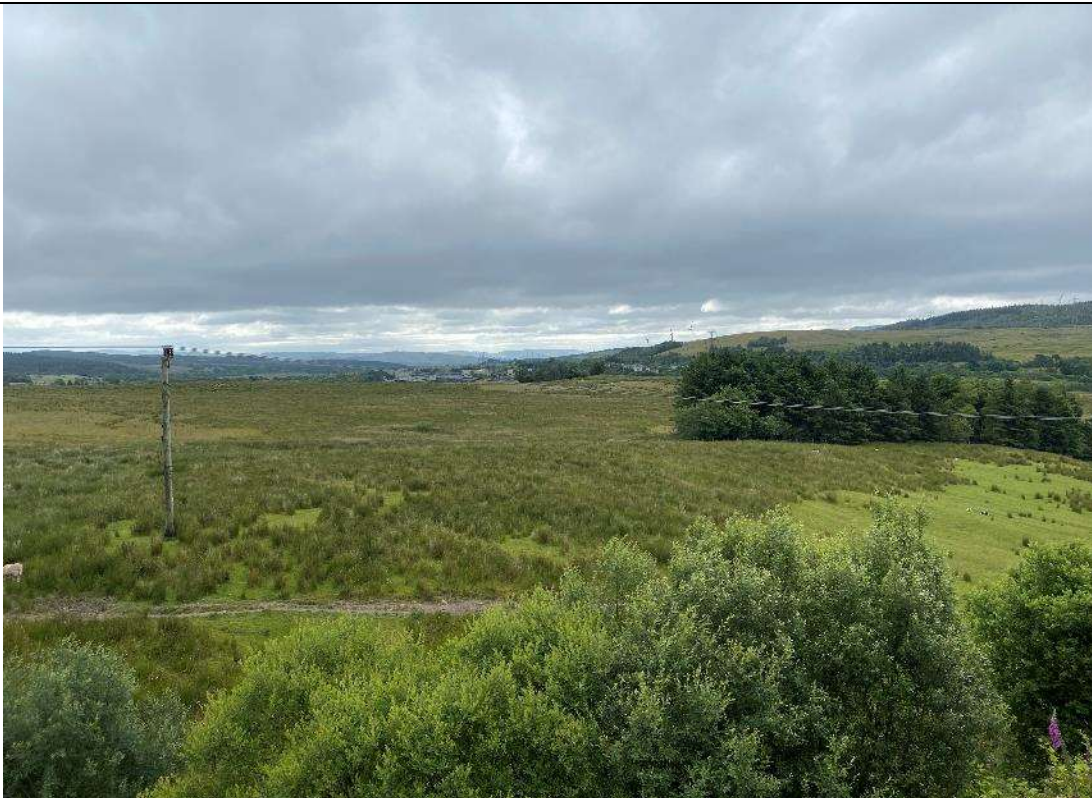
| <b>Main Site</b><br><br>View of southern site,<br>area used for farming.<br>Former area of colliery<br>land.<br><br>The photograph aspect<br>is south. | | |

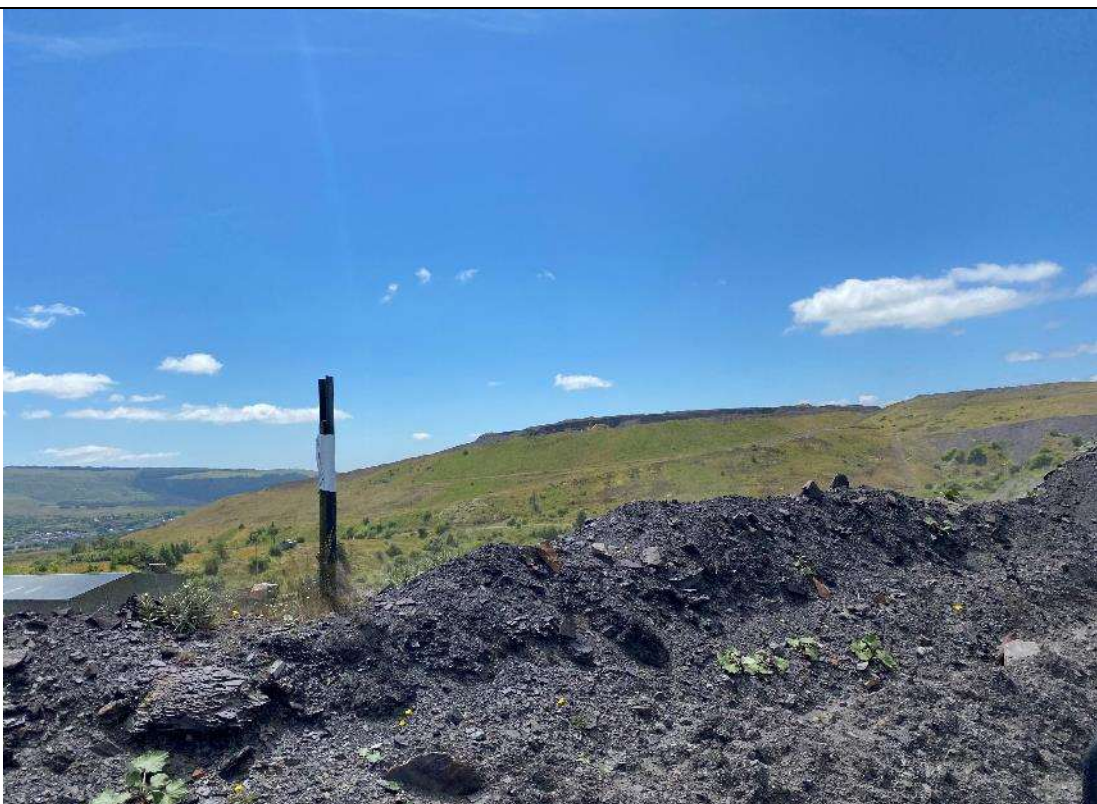
| <b>Southern Site</b><br><br>View from active restoration area.<br><br>The photograph aspect is south-west. | | |

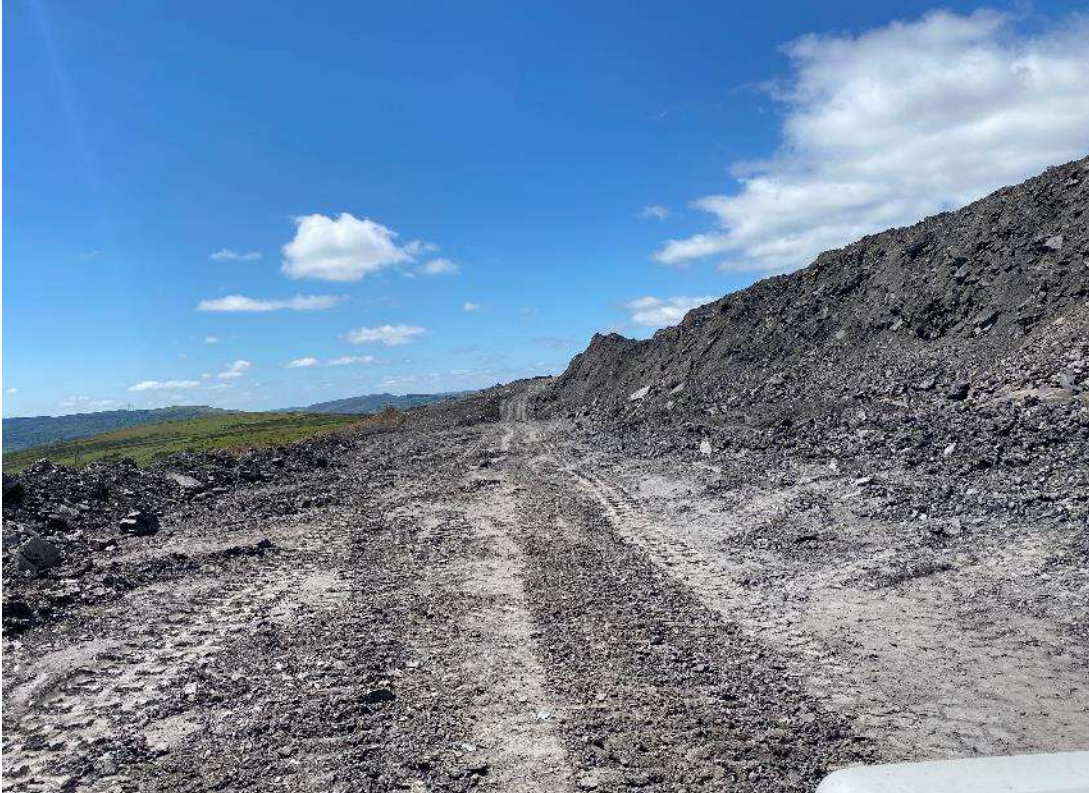
| <b>Washery (014)</b><br><br>View of restoration area.<br><br>The photograph aspect is west. | | |

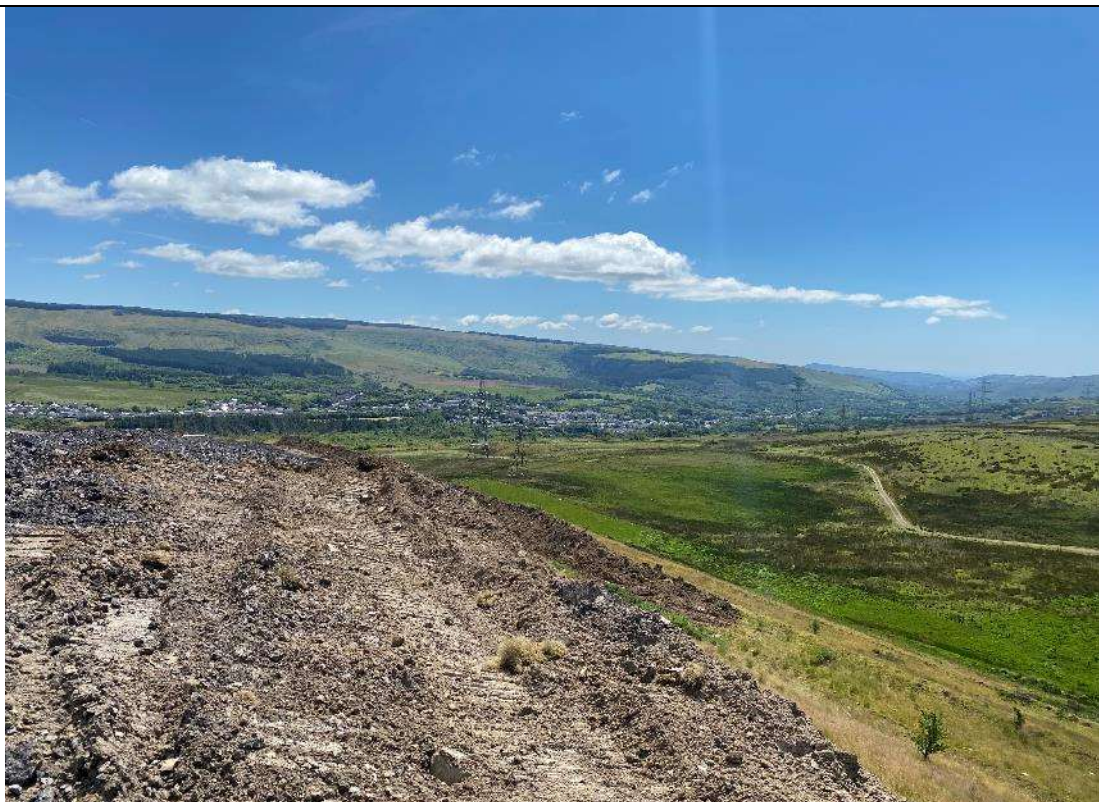
| <b>Restoration Area</b><br><br>View southern portion of site from restoration area. Overburden present in foreground.<br><br>The photograph aspect is east. | | |

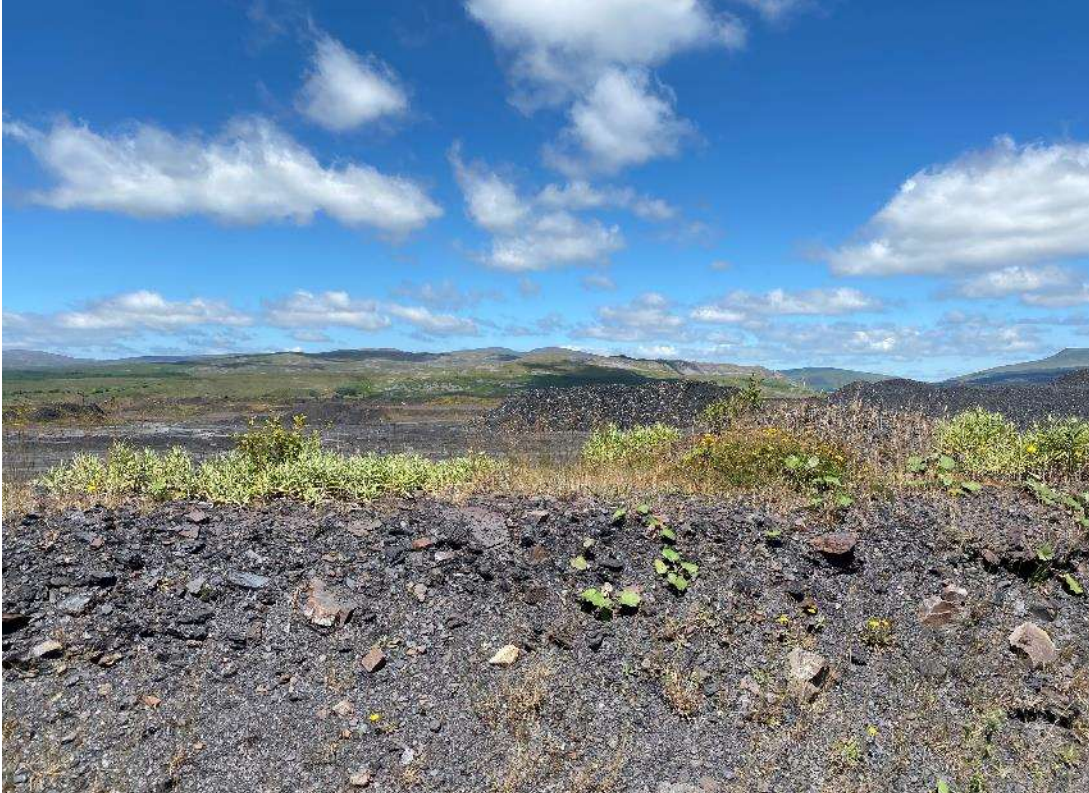
| <b>Restoration Area</b><br><br>View of stockpile holding coal and wood from props formerly contained in coal levels.<br><br>The photograph aspect is north. | | |

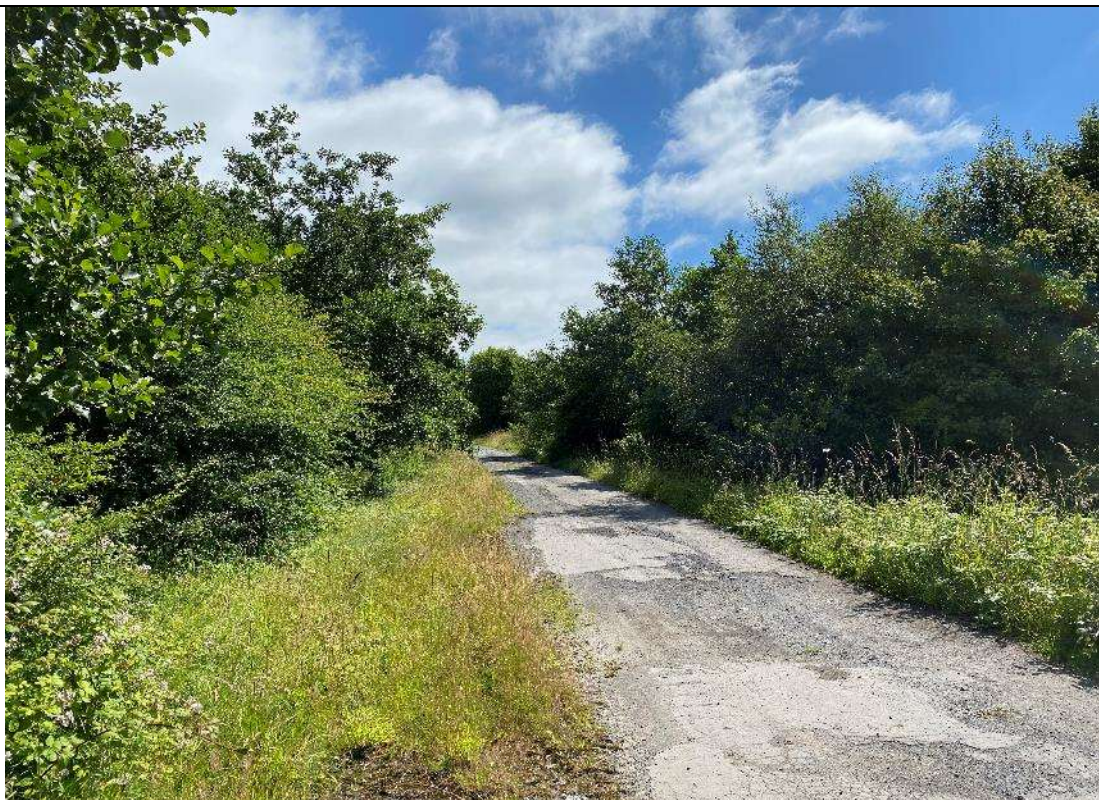
| <b>Railway Land (024)</b><br><br>View of access track in<br>norther area of washery,<br>area of open cast activity<br>did not extend to right of<br>road.<br><br>Land rises steeply to left<br>and is heavily vegetated.<br><br>The photograph aspect<br>is west. | | |

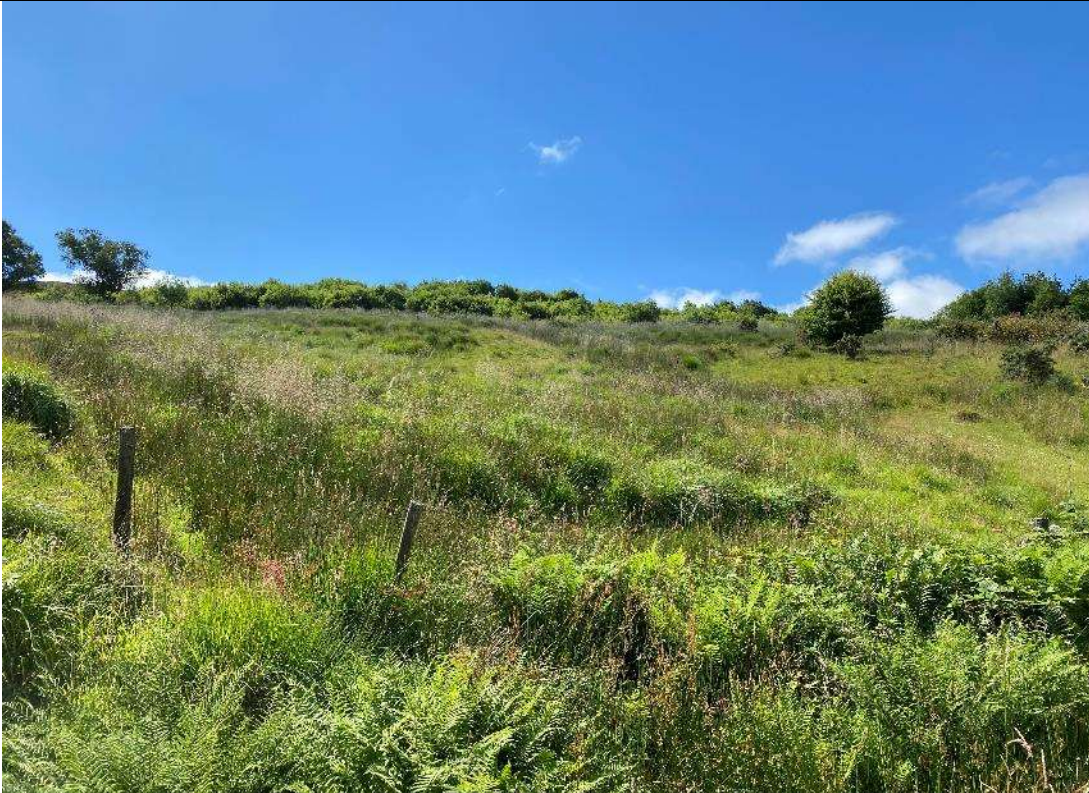
| <b>Northern site</b><br><br>View of hillside rising to south from access road.<br><br>The photograph aspect is south. | | |

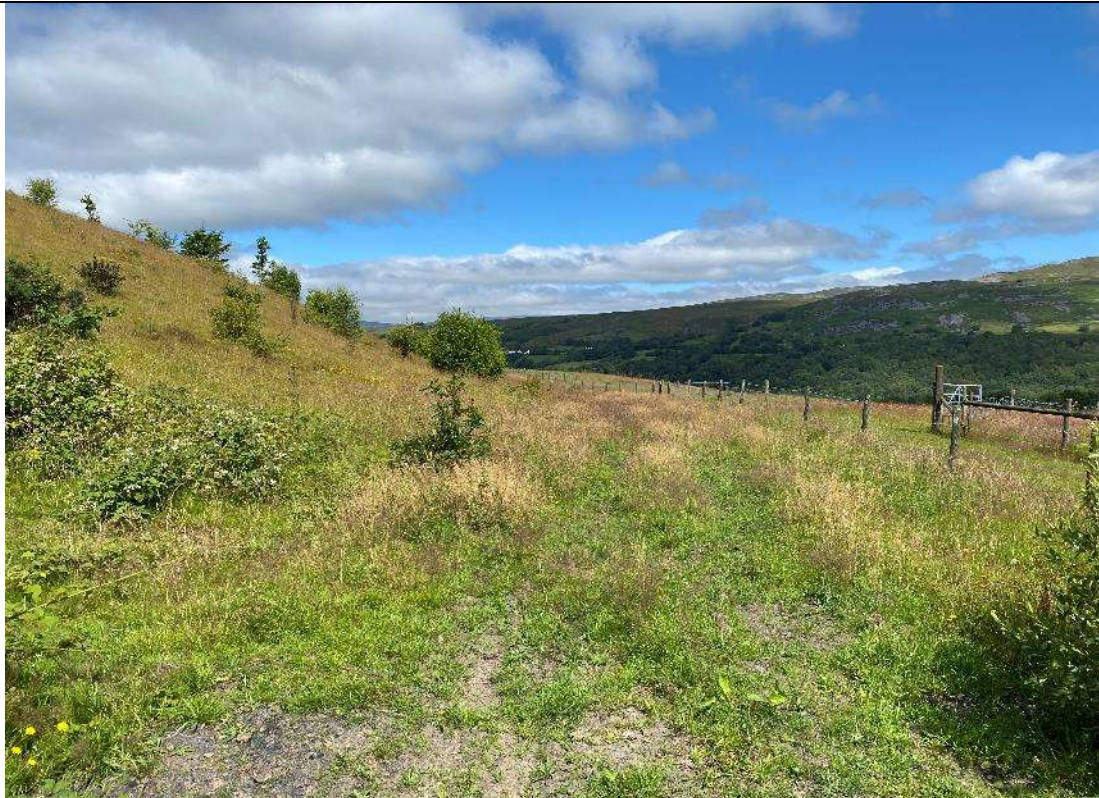
| <b>Photo No.</b><br>135 | <b>Date:</b><br>7 July 2022 | |

| <b>Retaining wall (025)</b><br><br>View of boundary between open cast areas restoration and former Aber Craf Colliery land. Currently used as grazing.<br><br>The photograph aspect is west. | | |

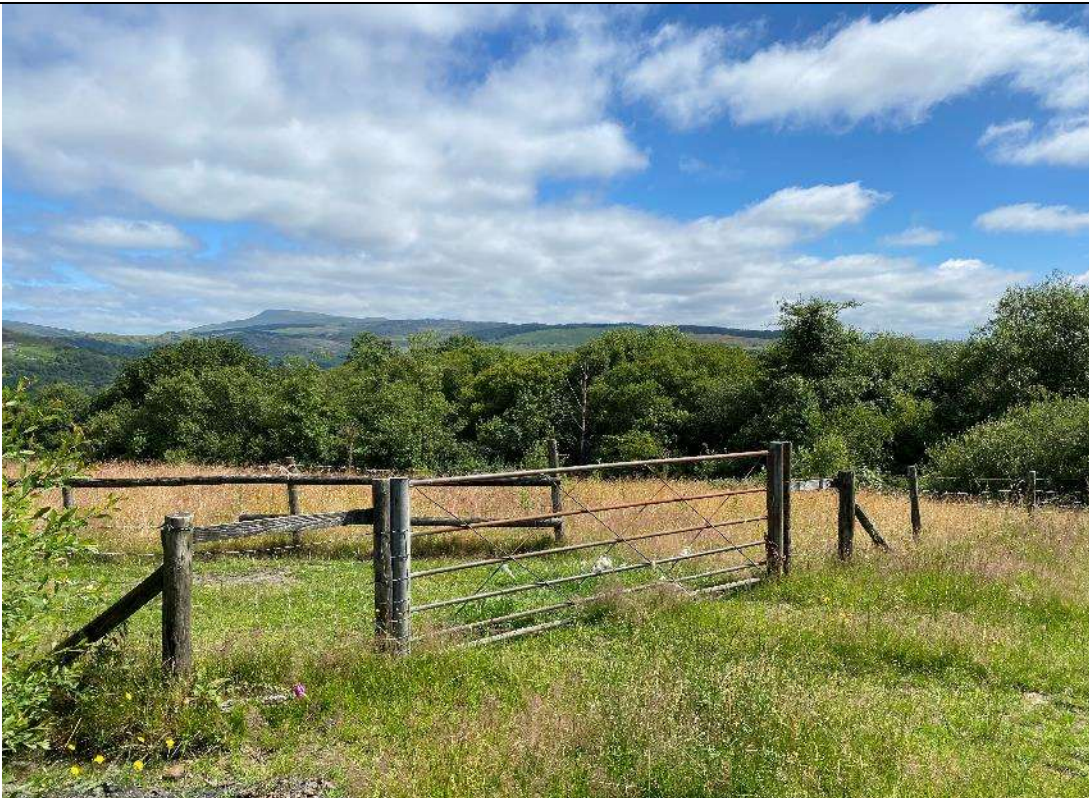
| <b>Photo No.</b><br>136 | <b>Date:</b><br>7 July 2022 | |

| <b>Norther Site.</b><br><br>View of farm land area<br>on north of site.<br><br>The photograph aspect<br>is north. | | |

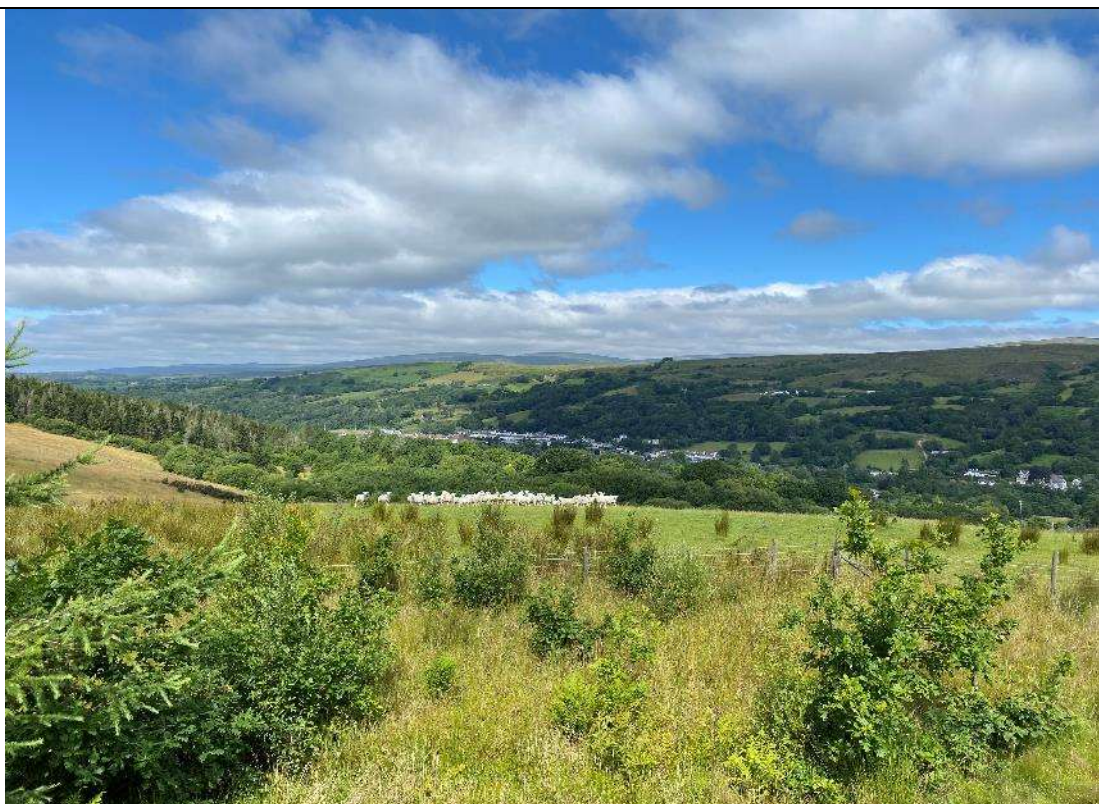
| <b>Photo No.</b><br>137 | <b>Date:</b><br>7 July 2022 | |

| <b>Offsite View</b><br><br>View of northern site and land offsite.<br><br>The photograph aspect is north. | | |

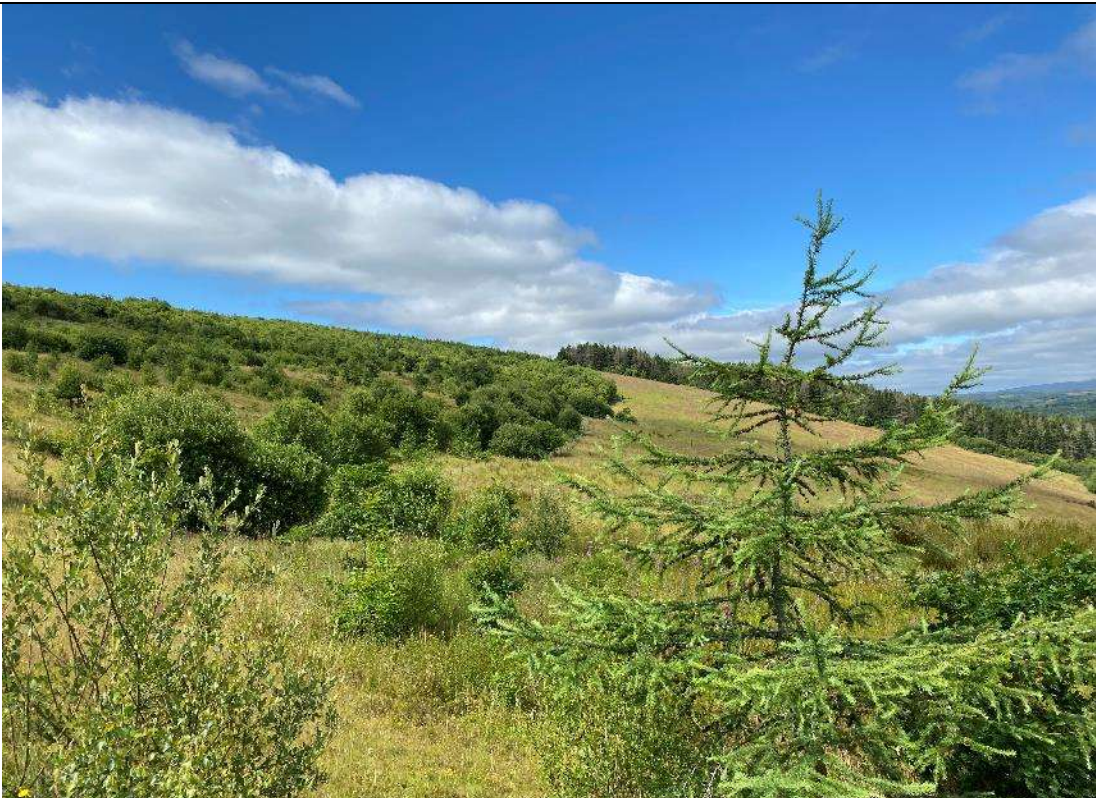
| <b>Photo No.</b><br>138 | <b>Date:</b><br>7 July 2022 | |

| <b>Norther Main Site</b><br><br>View restored area of open cast mining in north of site.<br><br>The photograph aspect is south. | | |

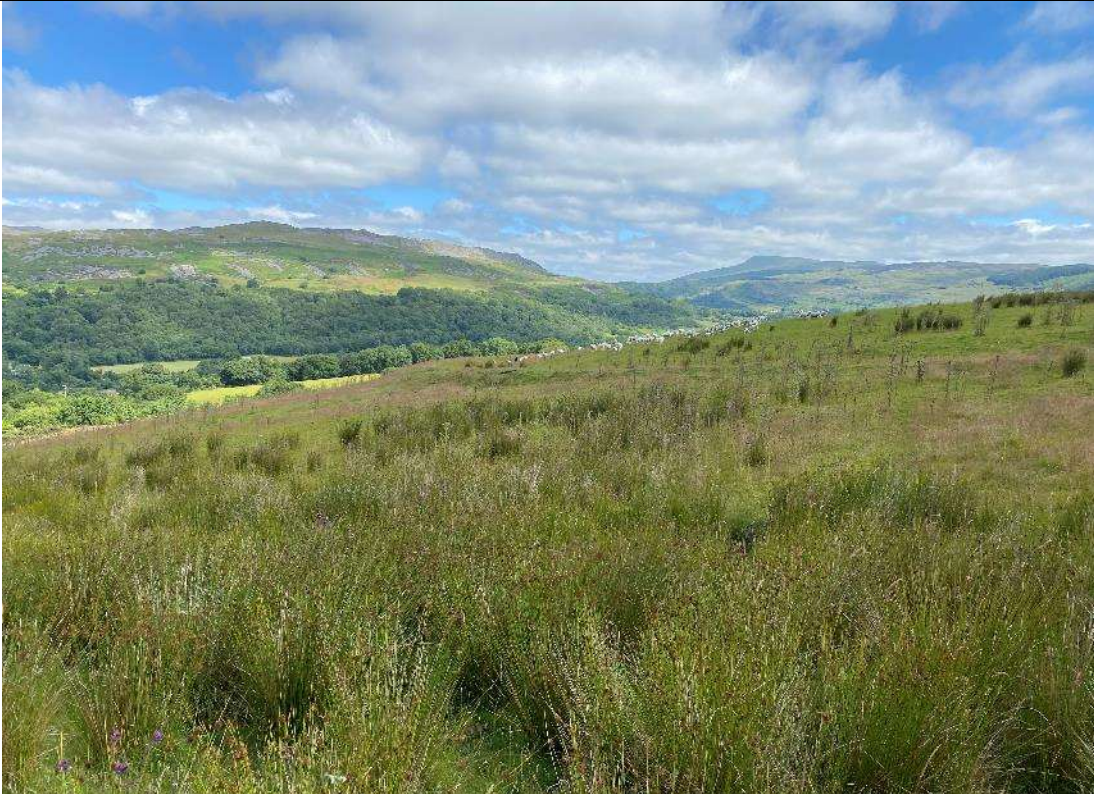
| <b>Photo No.</b><br>139 | <b>Date:</b><br>7 July 2022 | |

| <b>Relict Colliery Structure</b><br><br>View of topographic change associated with former colliery use.<br><br>The photograph aspect is north. | | |

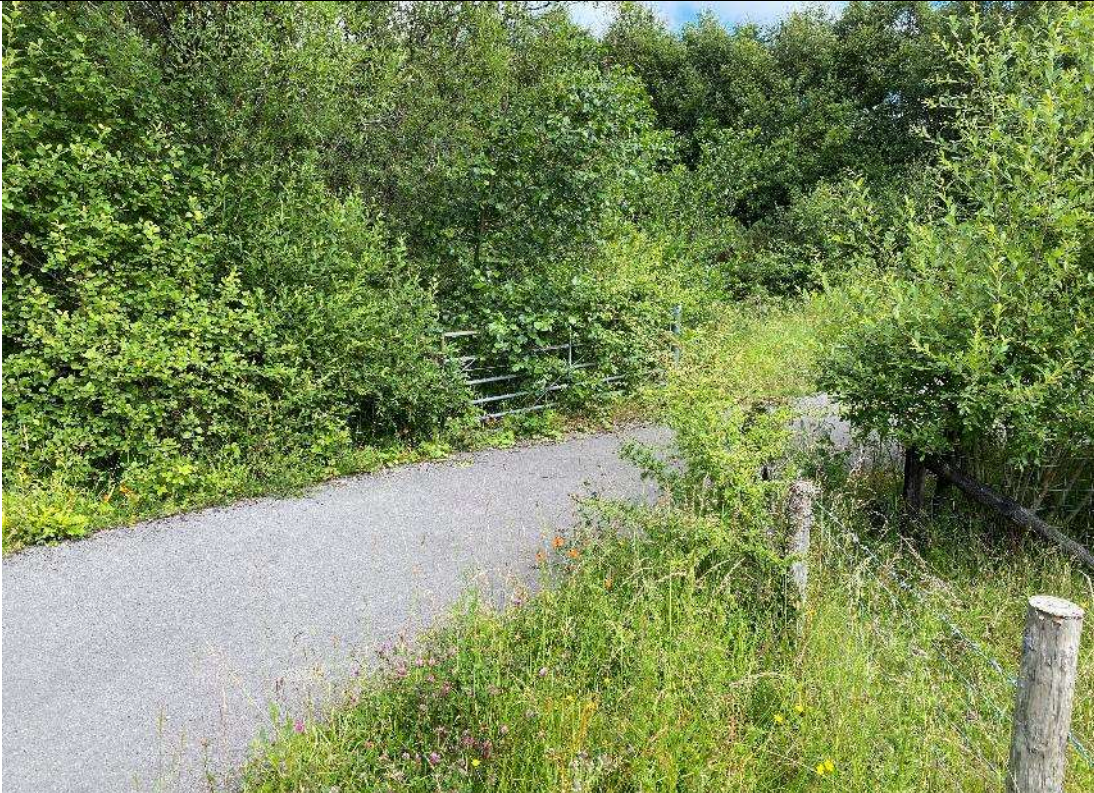
| <b>Photo No.</b><br>140 | <b>Date:</b><br>7 July 2022 | |

| <b>Access Road</b><br><br>View of asphalt track in north of site.<br><br>The photograph aspect is west. | | |

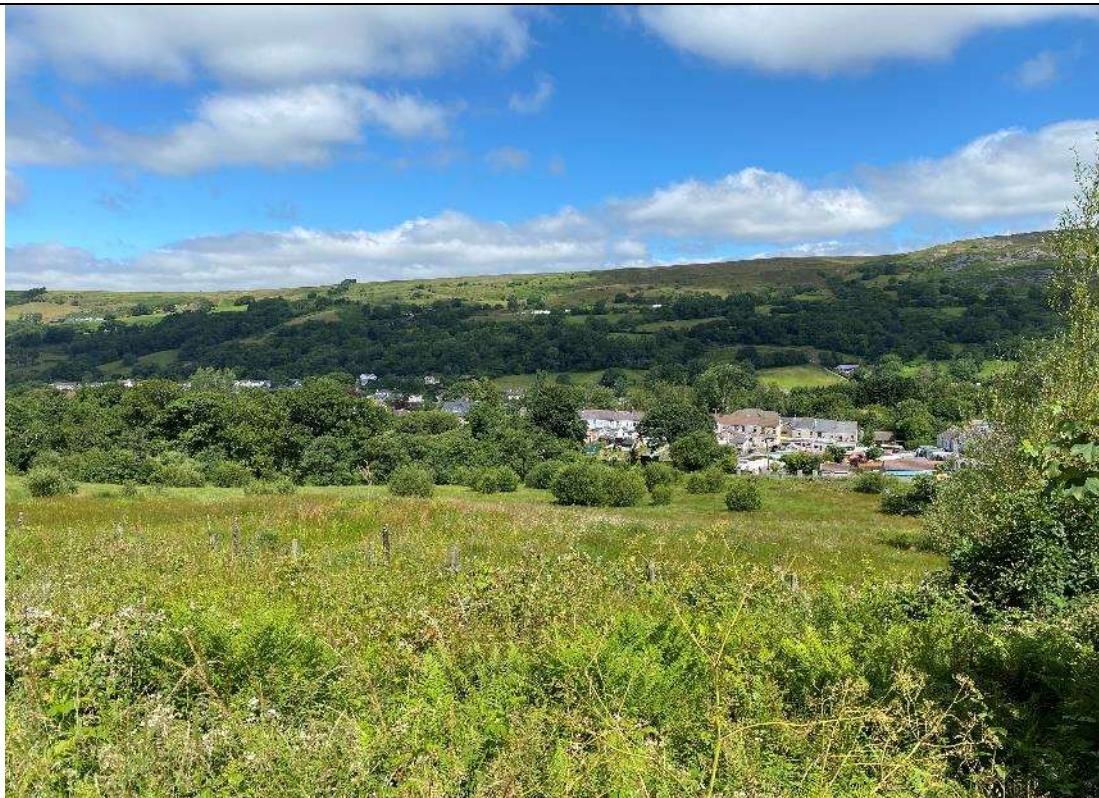
| <b>Photo No.</b><br>141 | <b>Date:</b><br>7 July 2022 | |

| <b>Lagoons (025)</b><br><br>View of residential land off-site to north.<br><br>The photograph aspect is north. | | |

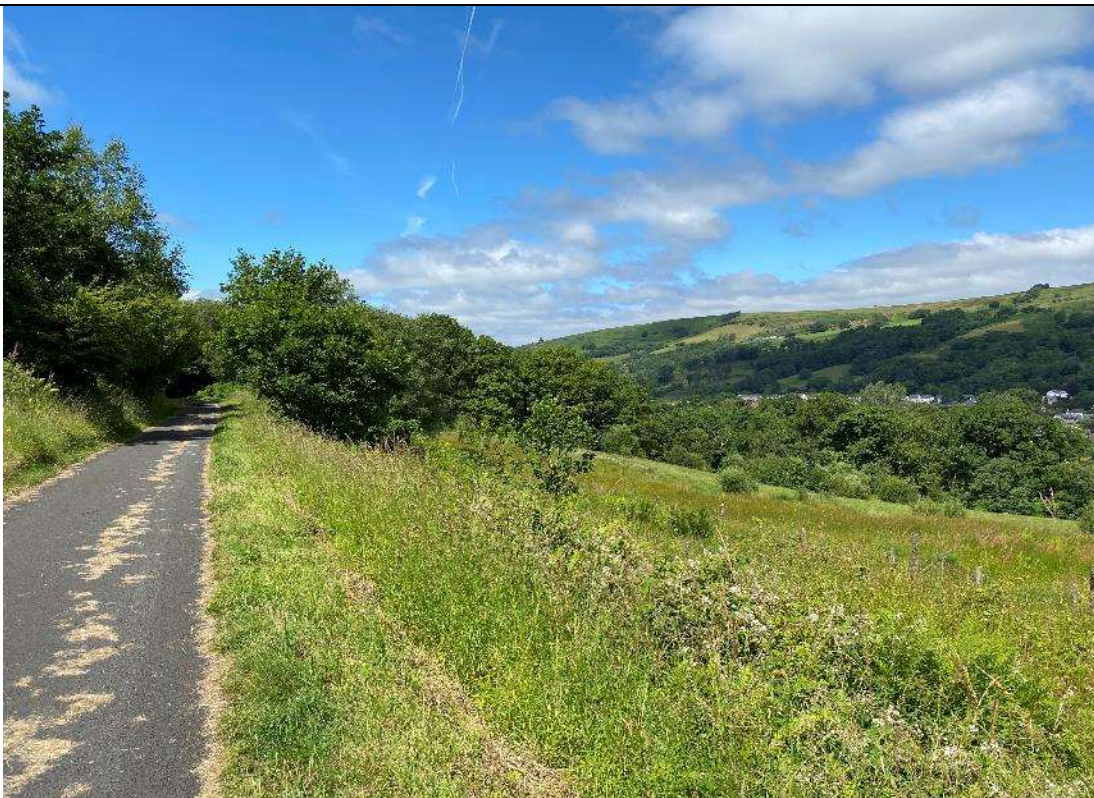
| <b>Photo No.</b><br>142 | <b>Date:</b><br>7 July 2022 | |

| <b>Railway Land (023)</b><br><br>View former railway embankment running along sites norther boundary.<br><br>The photograph aspect is west. | | |

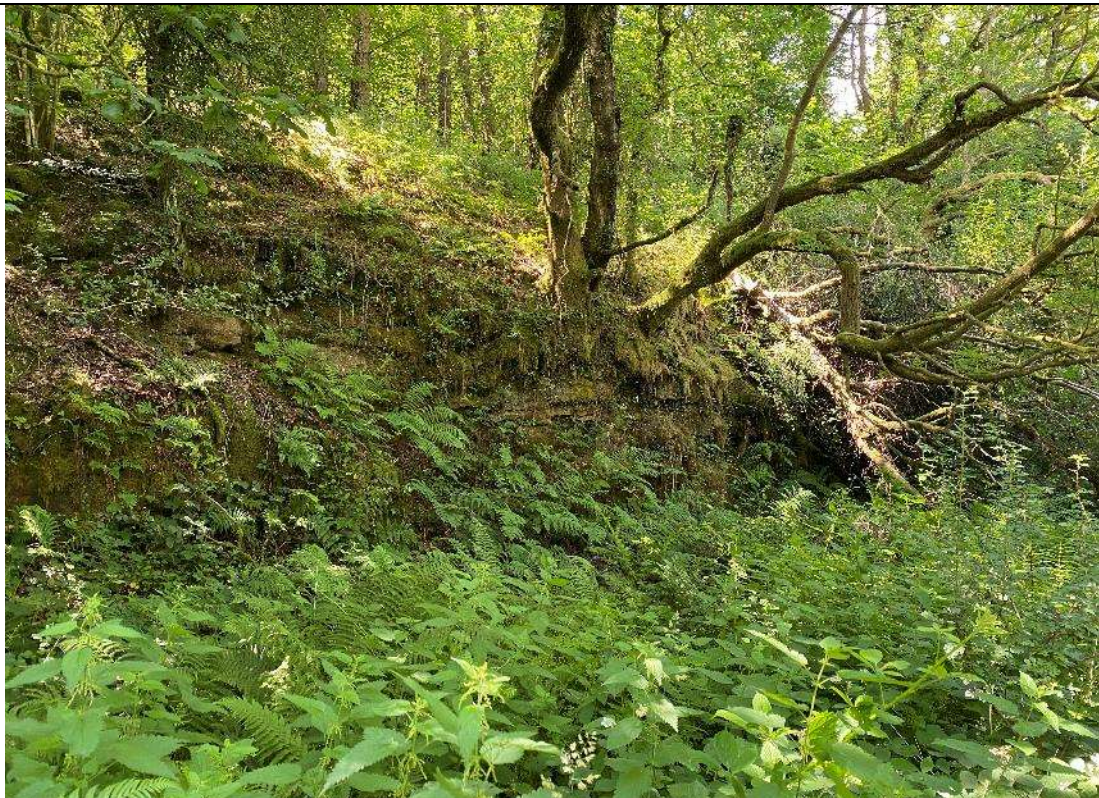
| <b>Photo No.</b><br>143 | <b>Date:</b><br>6 July 2022 | |

| <b>Plant Crossing</b><br><br>View excavation into bedrock on northern boundary of site.<br><br>The photograph aspect is south-west. | | |

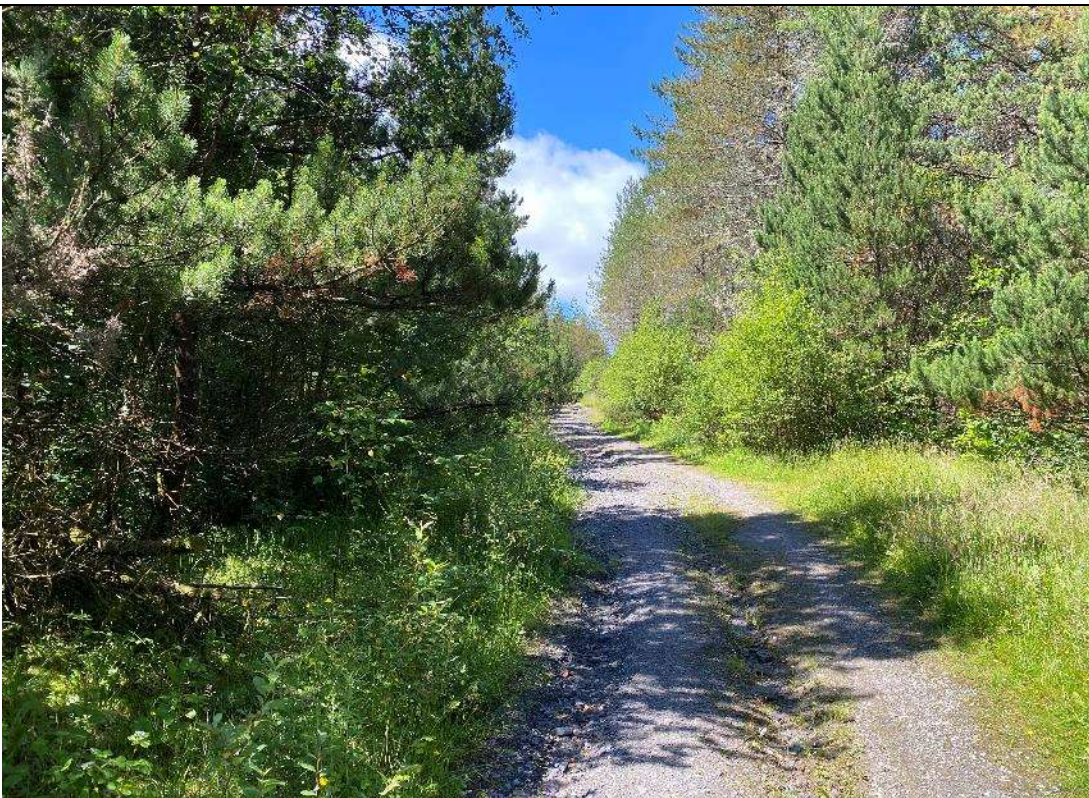
| <b>Photo No.</b><br>144 | <b>Date:</b><br>7 July 2022 | |

| <b>Loading bays (026)</b><br><br>View of access track through wood land in north of site. Woods to left and right thick and difficult to navigate in.<br><br>The photograph aspect is south-west. | | |

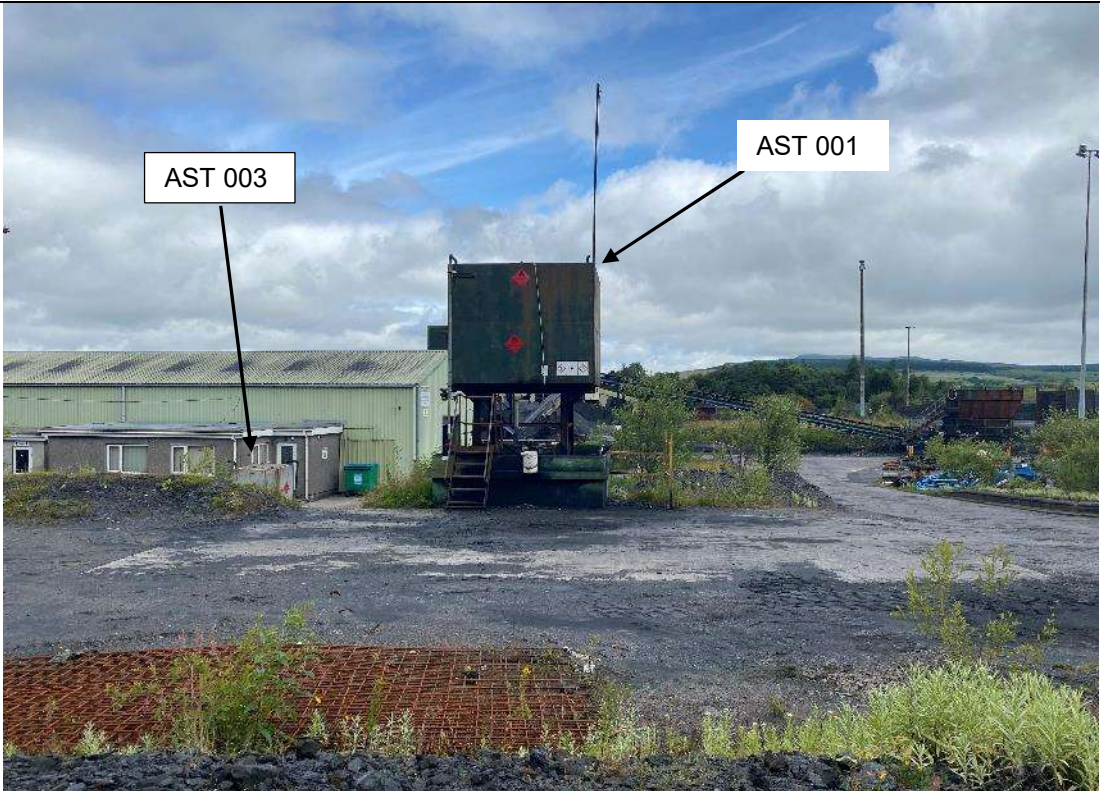
| <b>Photo No.</b><br>1 | <b>Date:</b><br>6 July 2022 | |

| <b>Fuel Storage (001 and 003)</b><br><br>View of ca. 4,000 litre diesel AST (001) in centre of picture, ca. 1,000 litre diesel AST (003) to left.<br><br>The photograph shows concrete access road in fore ground<br><br>The photograph aspect is north. | | |

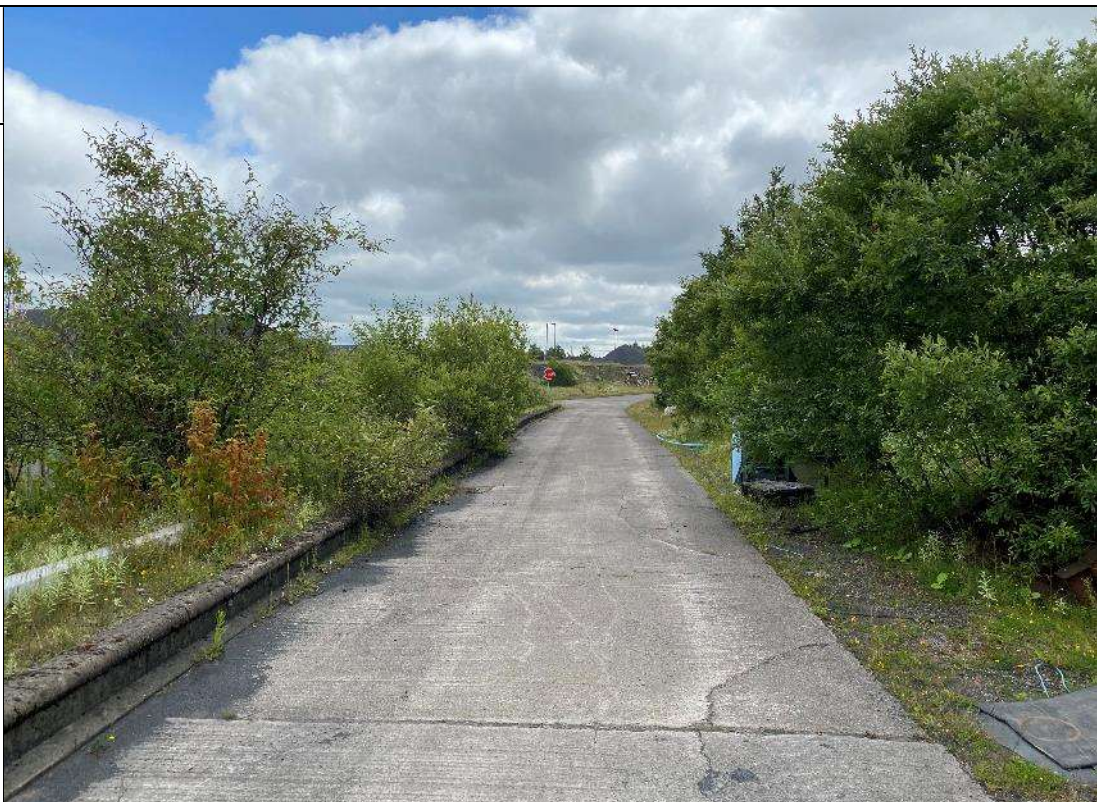
| <b>Photo No.</b><br>7 | <b>Date:</b><br>6 July 2022 | |

| <b>Access road and surrounds</b><br><br>The photograph aspect is east. | | |

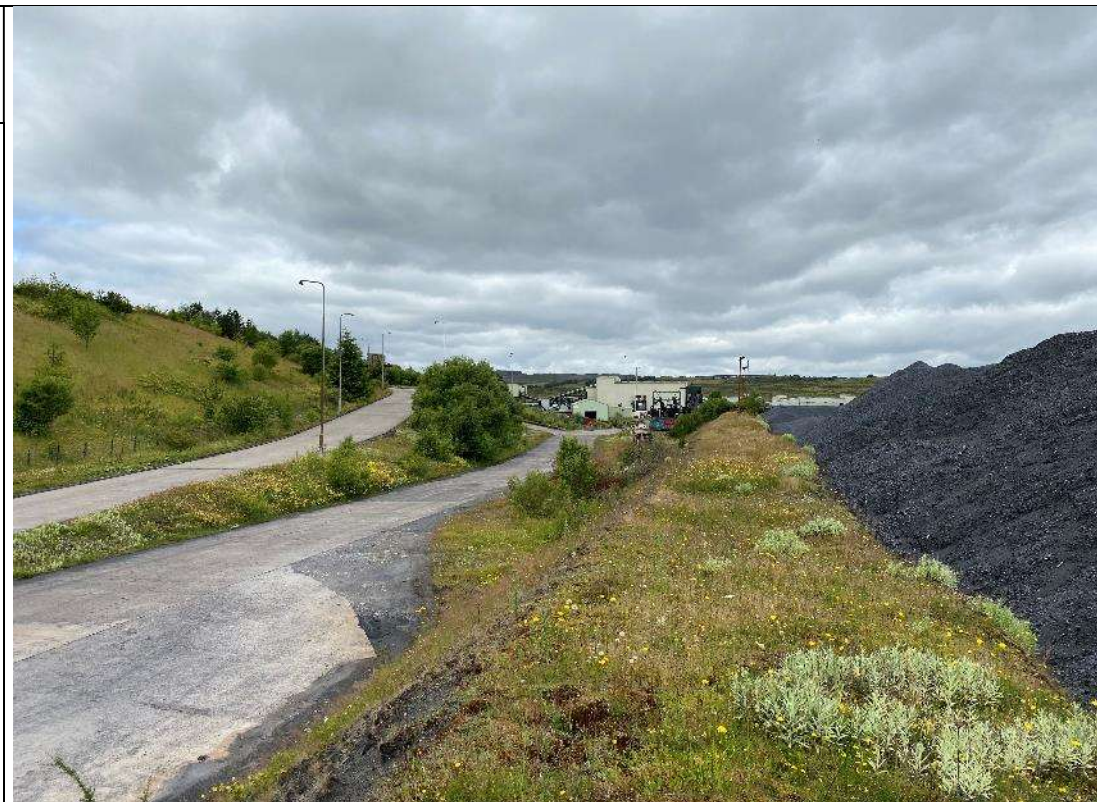
| <b>Photo No.</b><br>8 | <b>Date:</b><br>6 July 2022 | |

| <b>Coal stockpile (004)</b><br><br>View of retaining bund and stockpile of crushed and washed coal.<br><br>The photograph aspect is west. | | |
