**Client Name:** Global Centre of Rail Excellence

**Site:** GCRE (Onllywyn Washery)

**Project No.**  
5209796

Washery - CLAH Walkover Photograph Location Plan

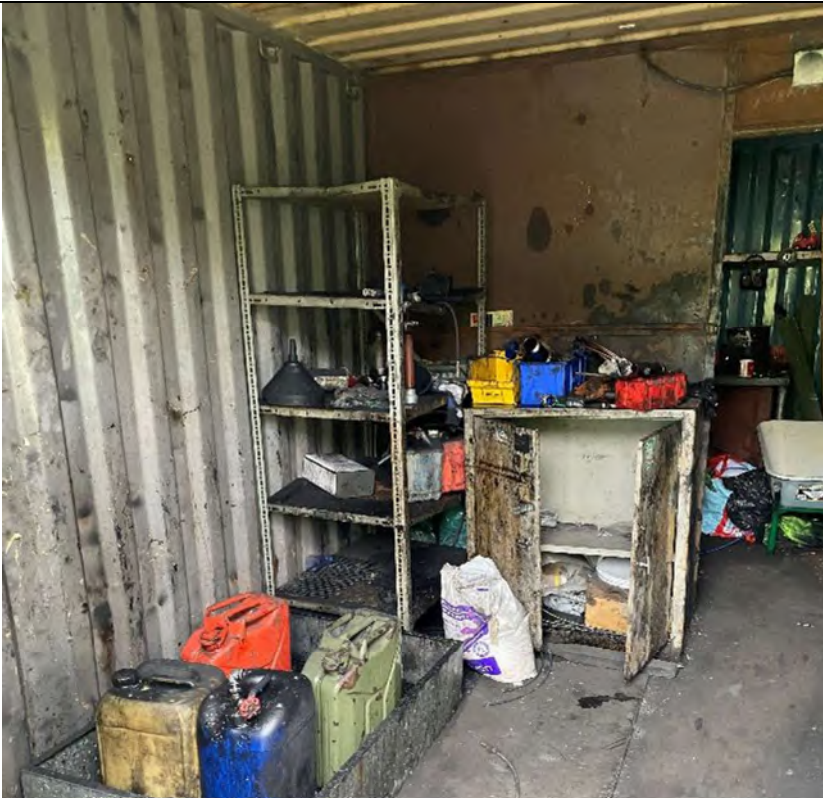
| <p><b>Photo No.</b><br/>25</p> | <p><b>Date:</b><br/>6 July 2022</p> | |

| <p><b>Shipping Container (011)</b></p> <p>Contents of shipping container, used to store oil and fuel containers.</p> | | |

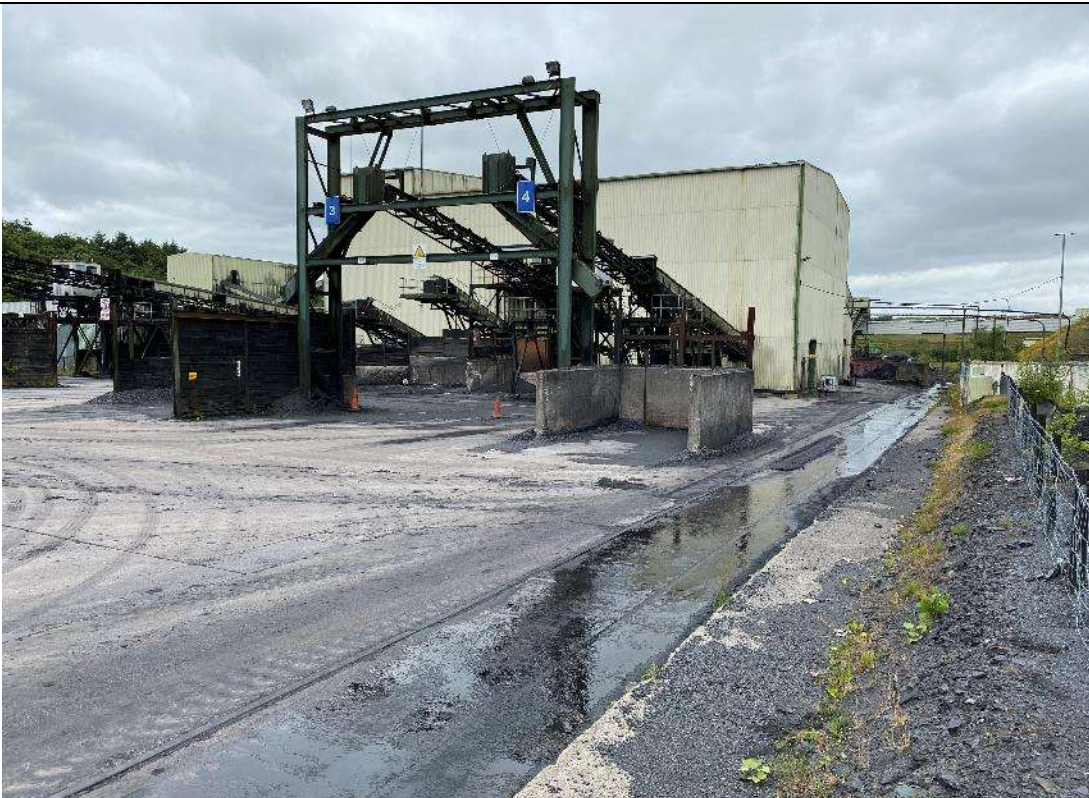
| <b>Photo No.</b><br>32 | <b>Date:</b><br>6 July 2022 |

| <b>Washery (014)</b><br><br>View of washery structure (014), surface water running off to west on road in foreground. Empty shipping container to right labelled as having held "autowash".<br><br>The photograph aspect is west. | |

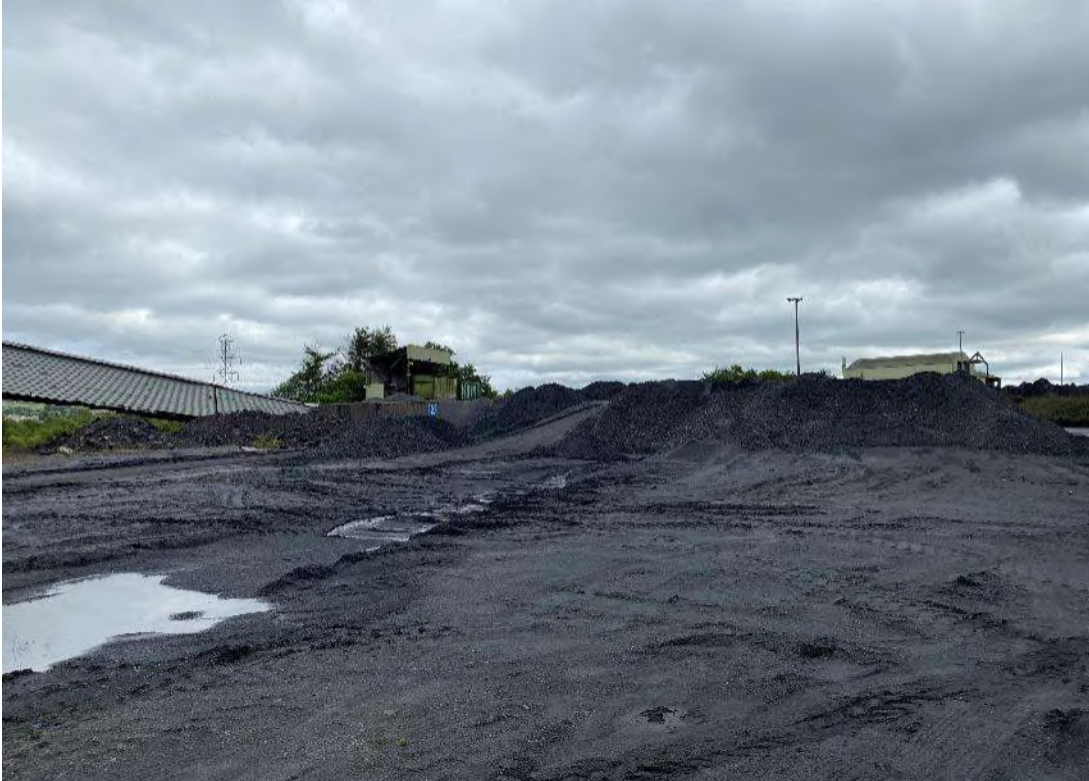
| <b>Photo No.</b><br>42 | <b>Date:</b><br>6 July 2022 | |

| <b>Stockpiles (022)</b><br><br>View of coal stockpile adjacent to base of conveyor belt.<br><br>The photograph aspect is north-east. | | |

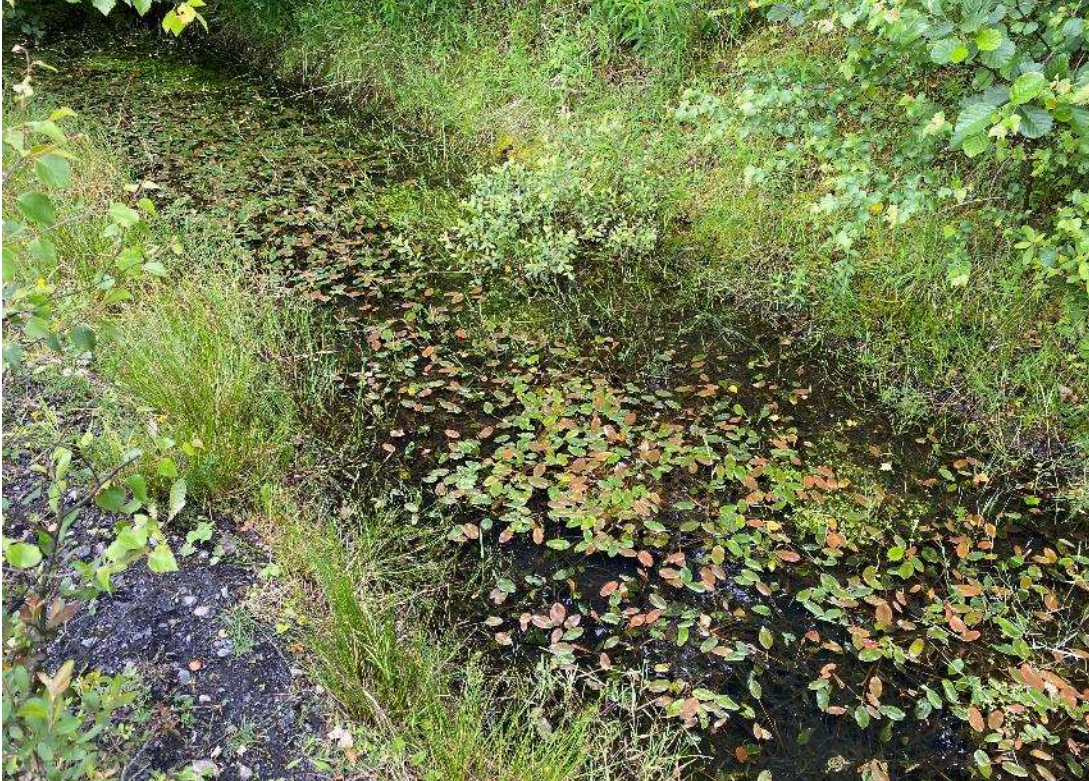
| <b>Photo No.</b><br>46 | <b>Date:</b><br>6 July 2022 | |

| <b>Drain at base of slope<br/>in area of railway land.</b><br><br>The photograph aspect<br>is east. | | |
