**Structural Survey (Inspection)**

**Moose Hall  
Castle Street  
Neath  
SA11 3LU**

Structural Surveys UK were commissioned to undertake a Full Structural Survey (Inspection) to a residential property at Moose Hall, Castle Street in Neath.

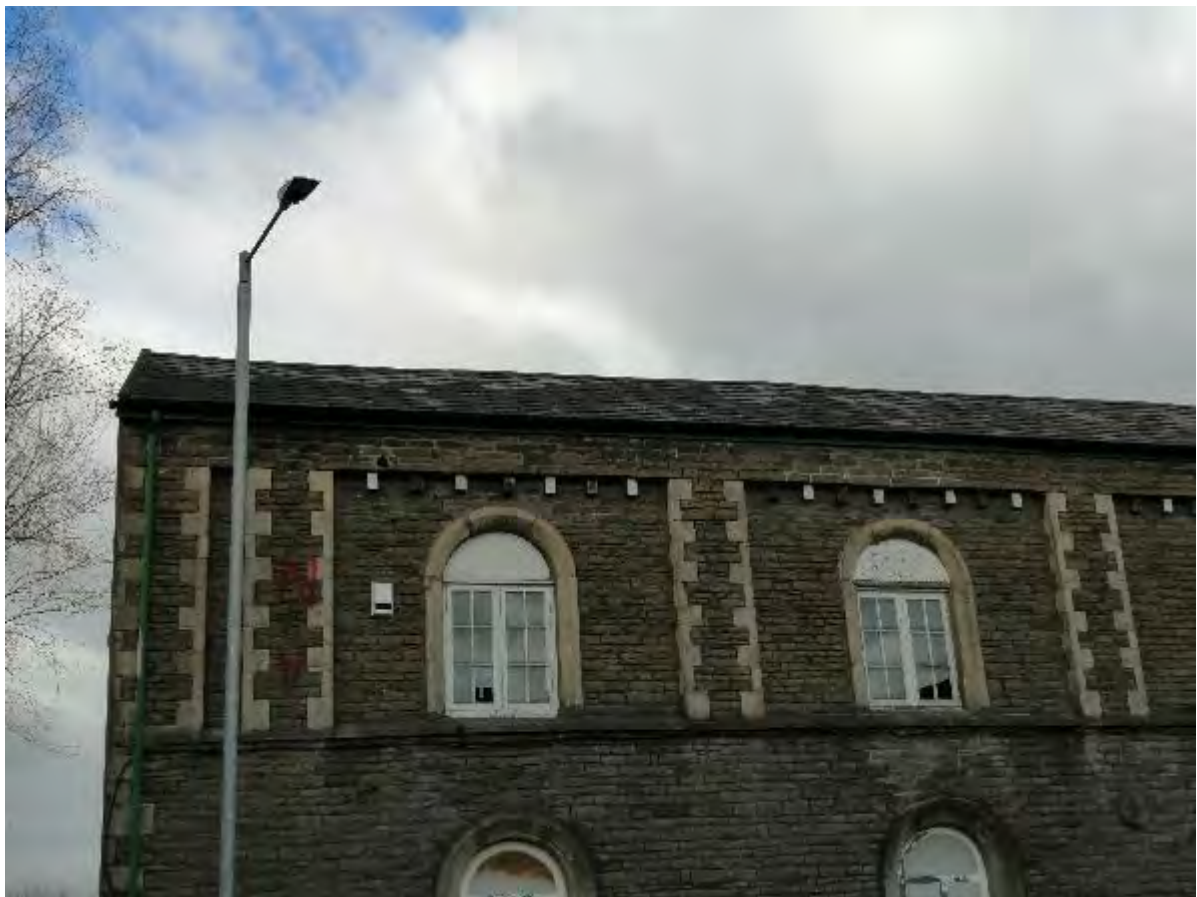
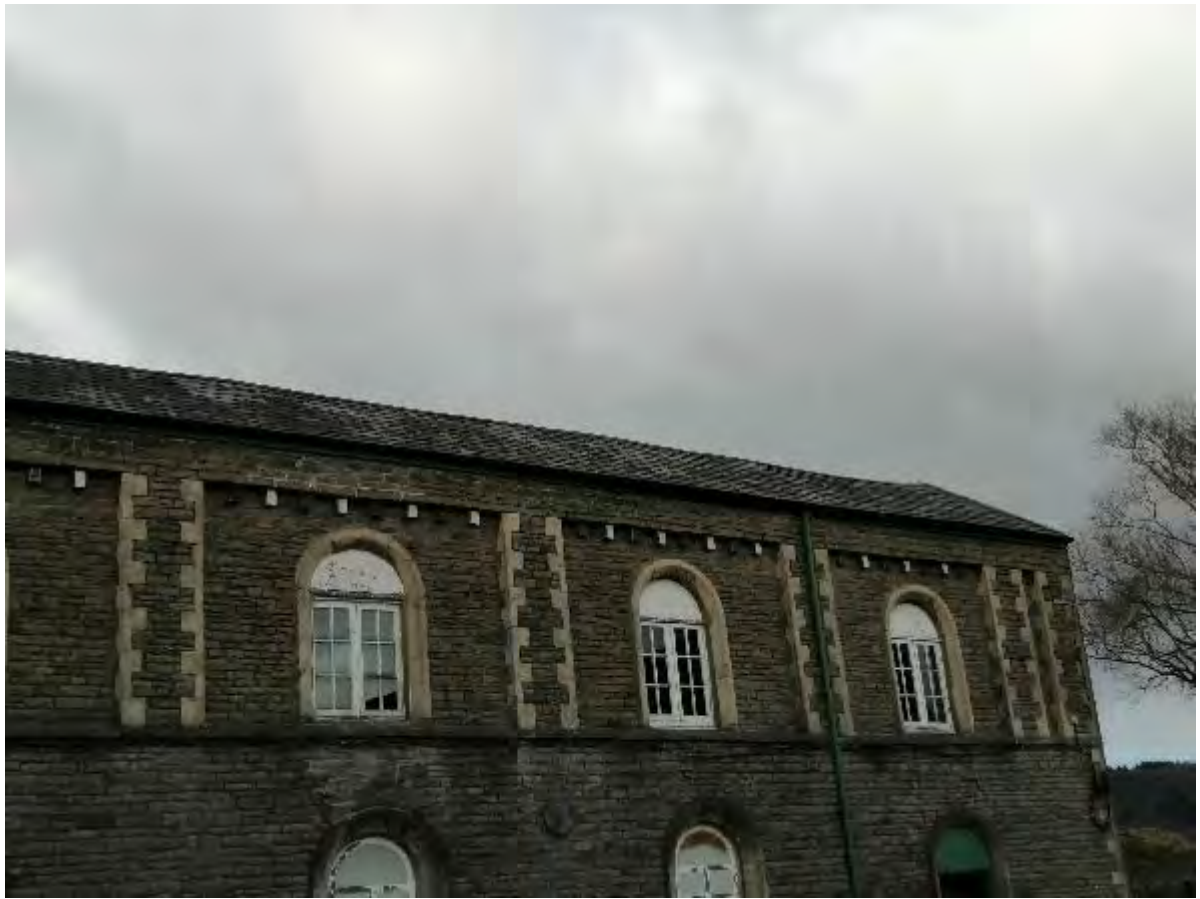
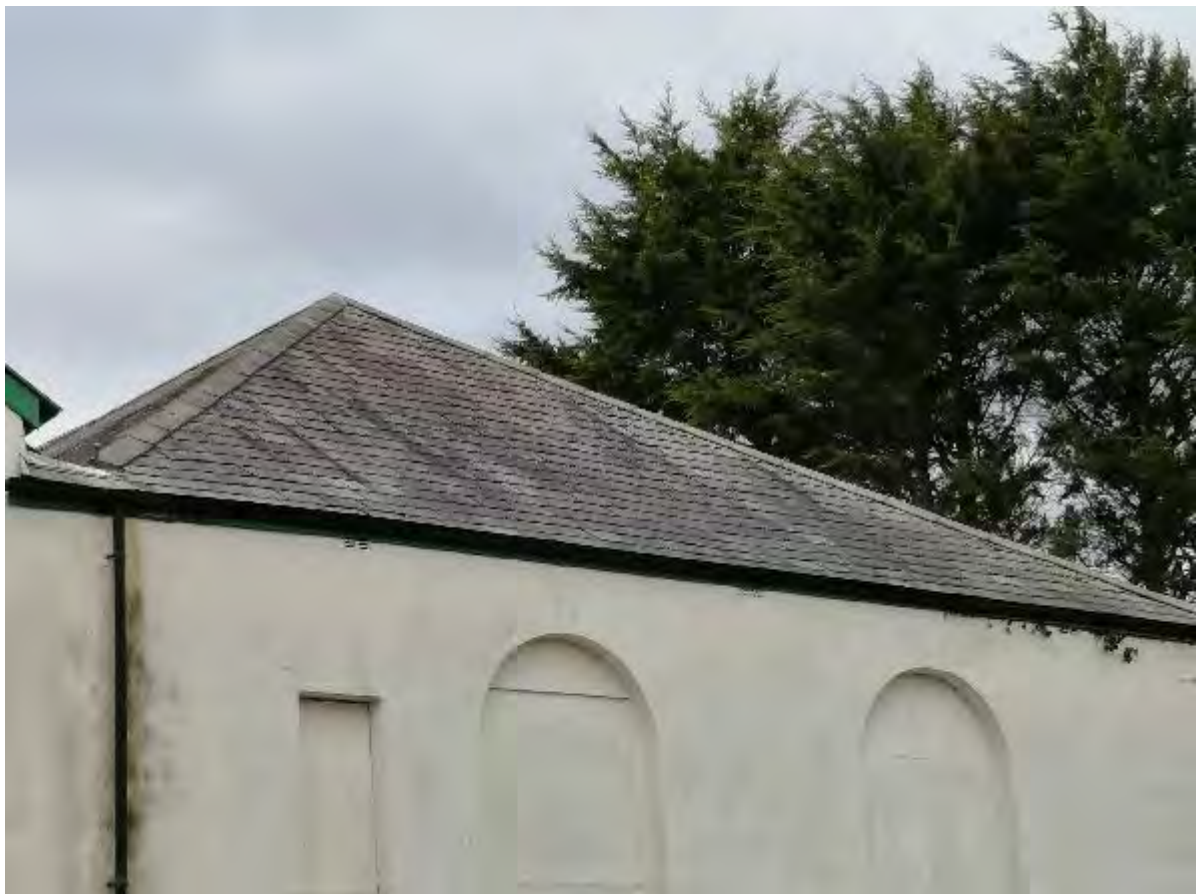
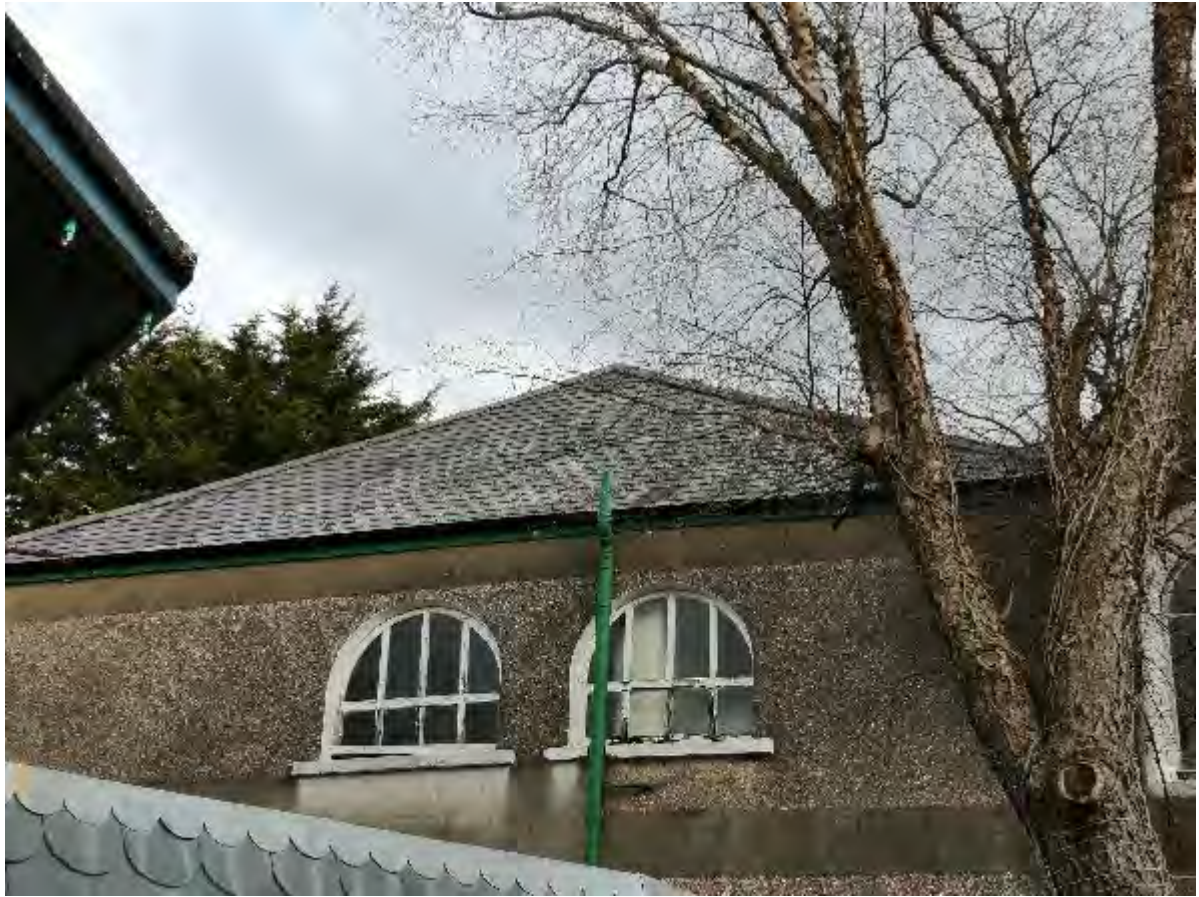
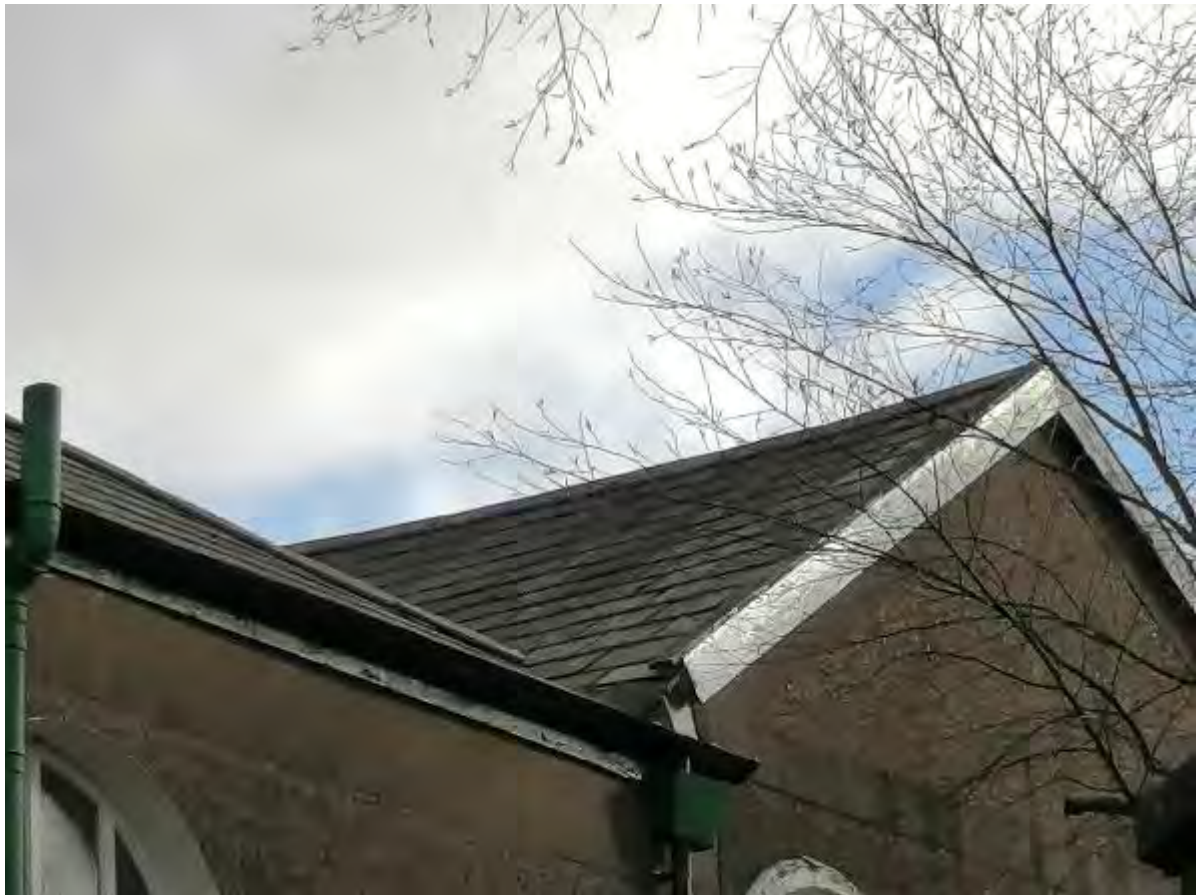
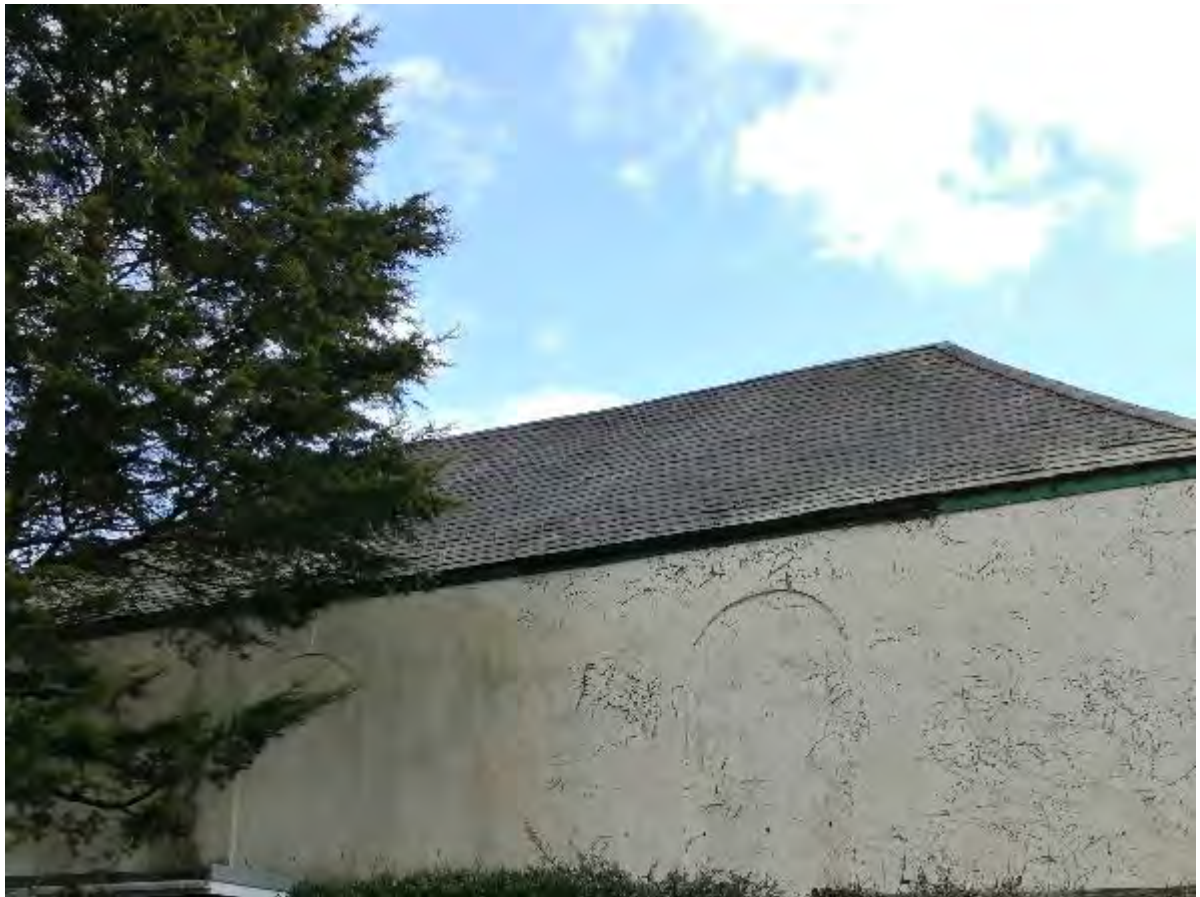
We noted no major undulation, deflection or other distortion to the roof structure of the property, i.e. sagging or leaning of the timber frames to the front or rear elevations – See Photo 1 to 10. Minor sagging was noted to the front roof profile – see photo 20 below. The alignment of the roof profile was satisfactory and did not raise concerns regards the integrity of the structural timber frameworks beneath (when inspected externally).

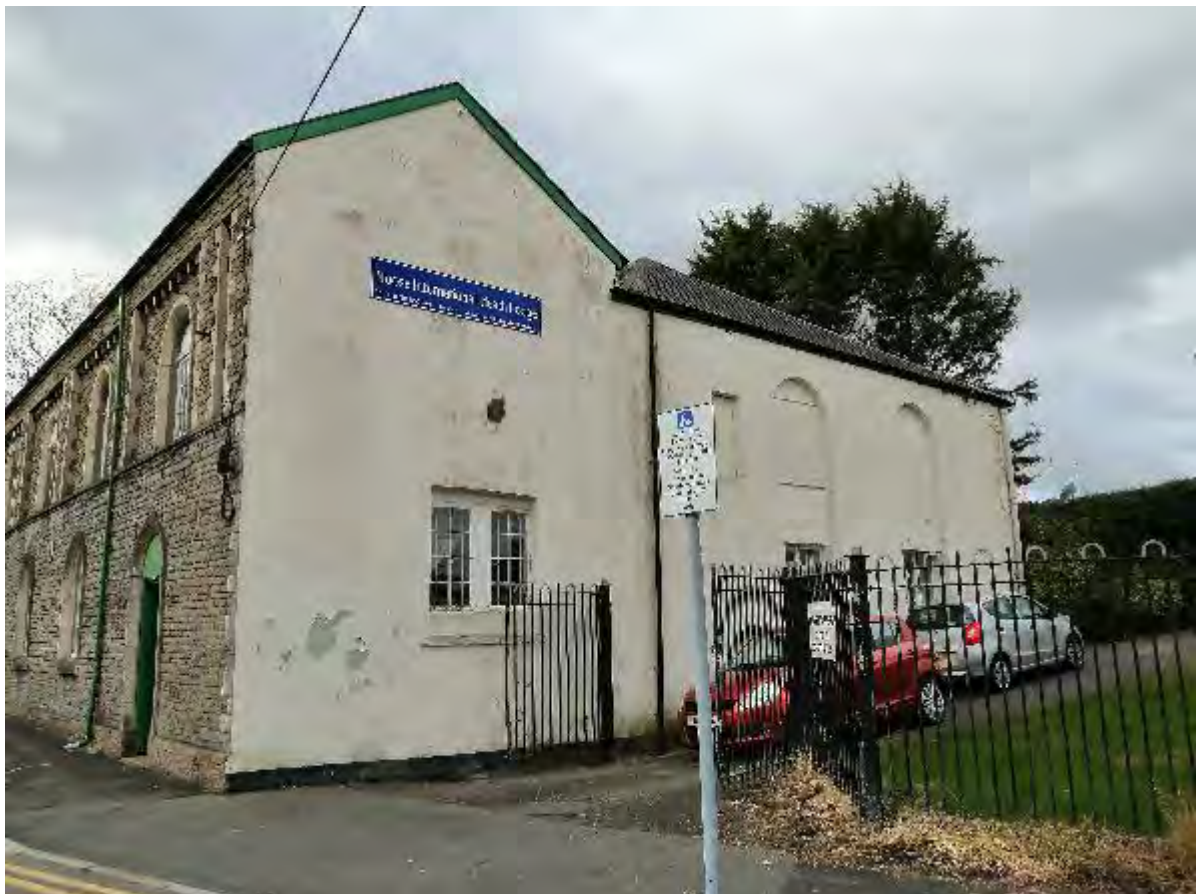
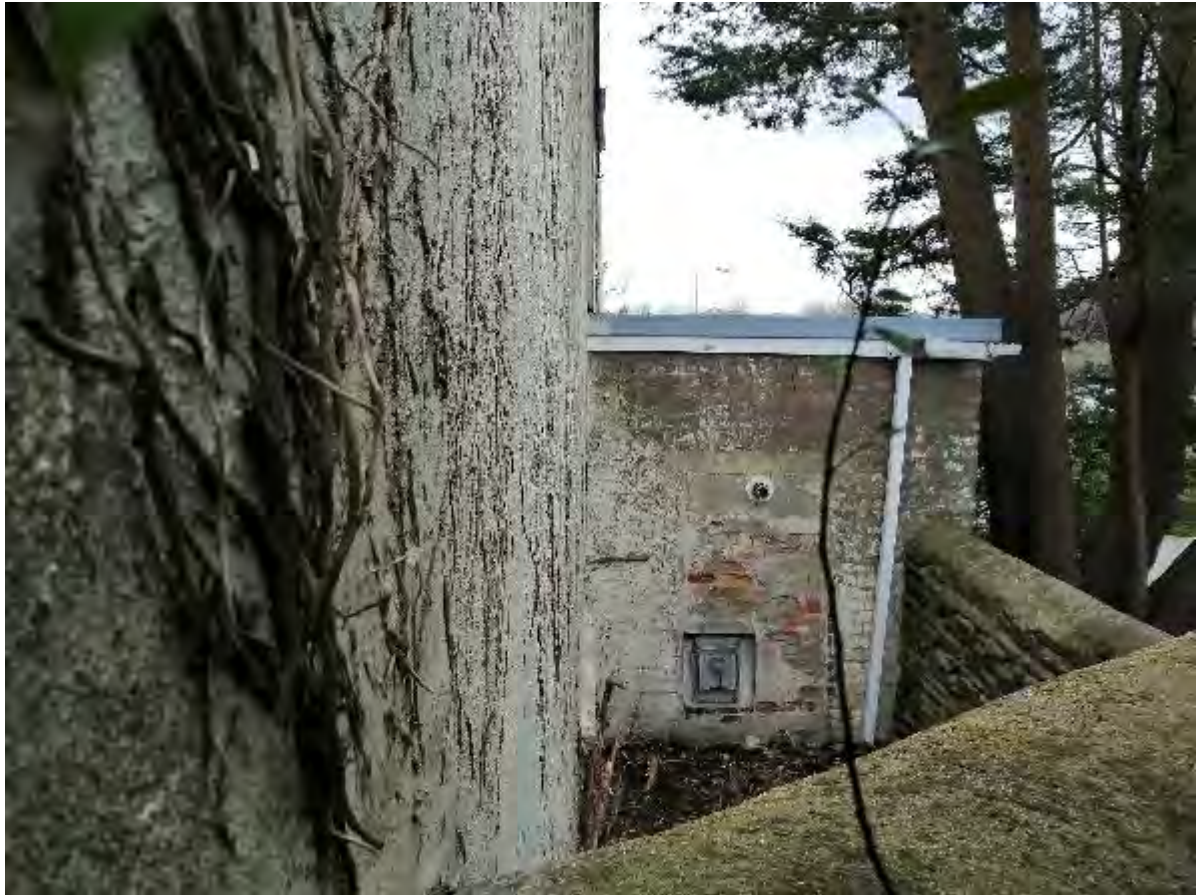
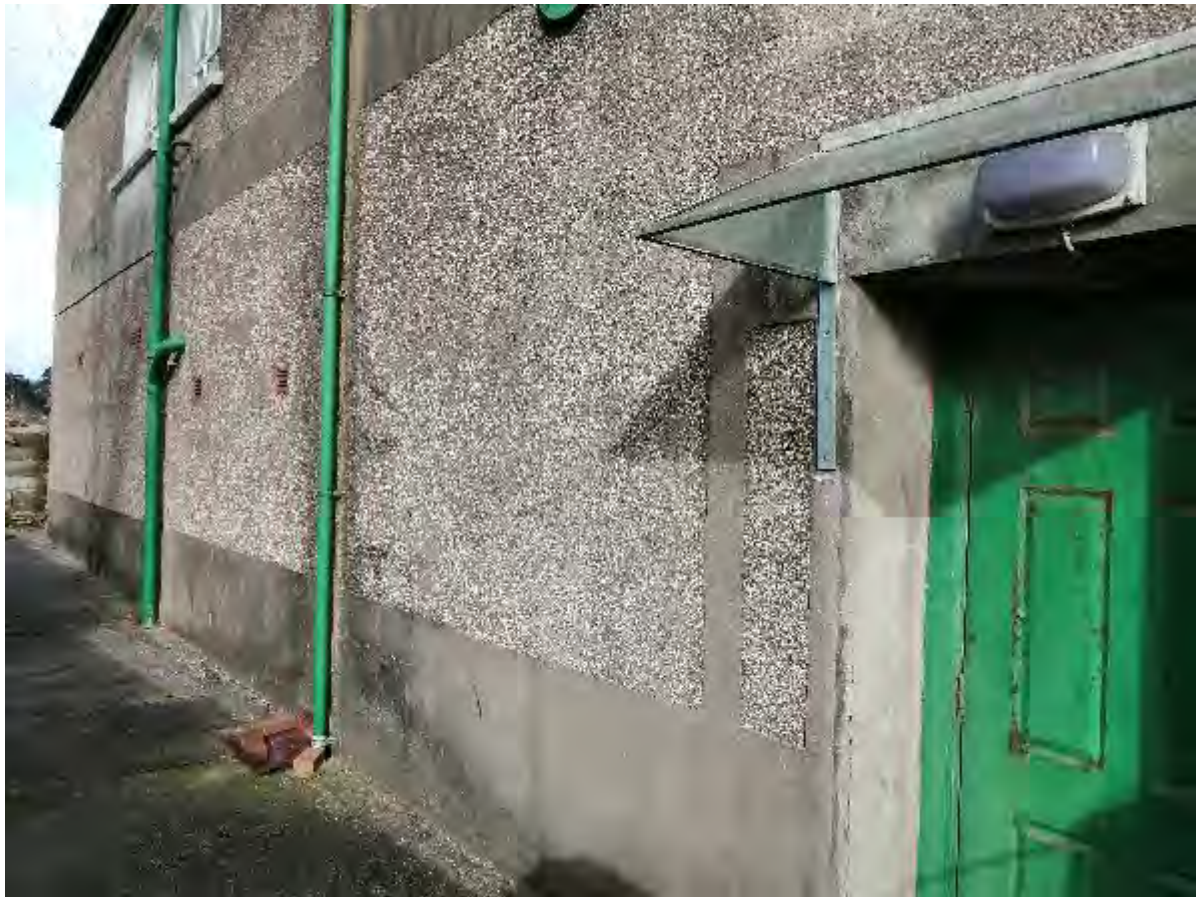
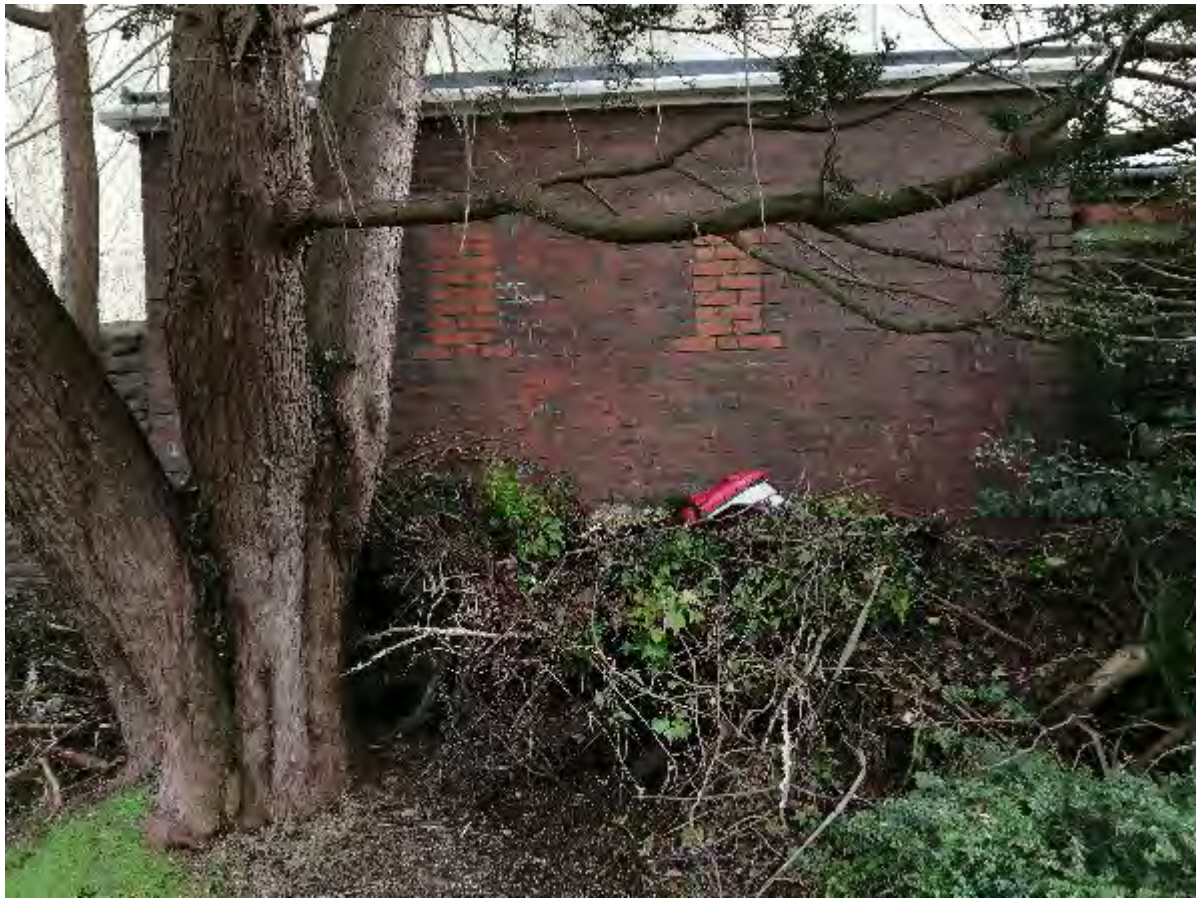
The vertical and horizontal alignment of the external walls is satisfactory, which suggests the load-bearing wall constructions continue to maintain support to the superstructure loading (i.e. roof loading, first floor loading and the load-bearing walls self-weight) – See Photos 7-11.

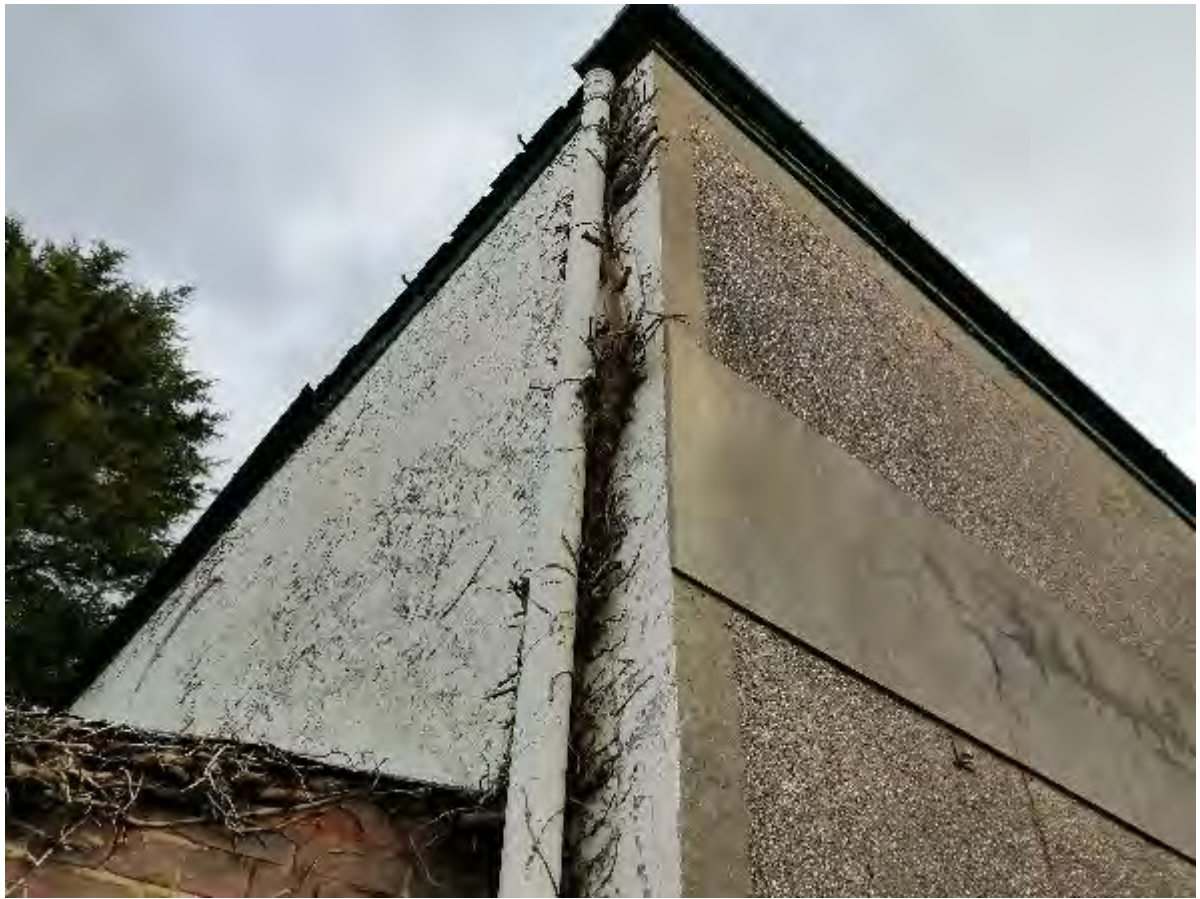
Photo 31 – Vegetation Growth (Rear Wall Elevation)

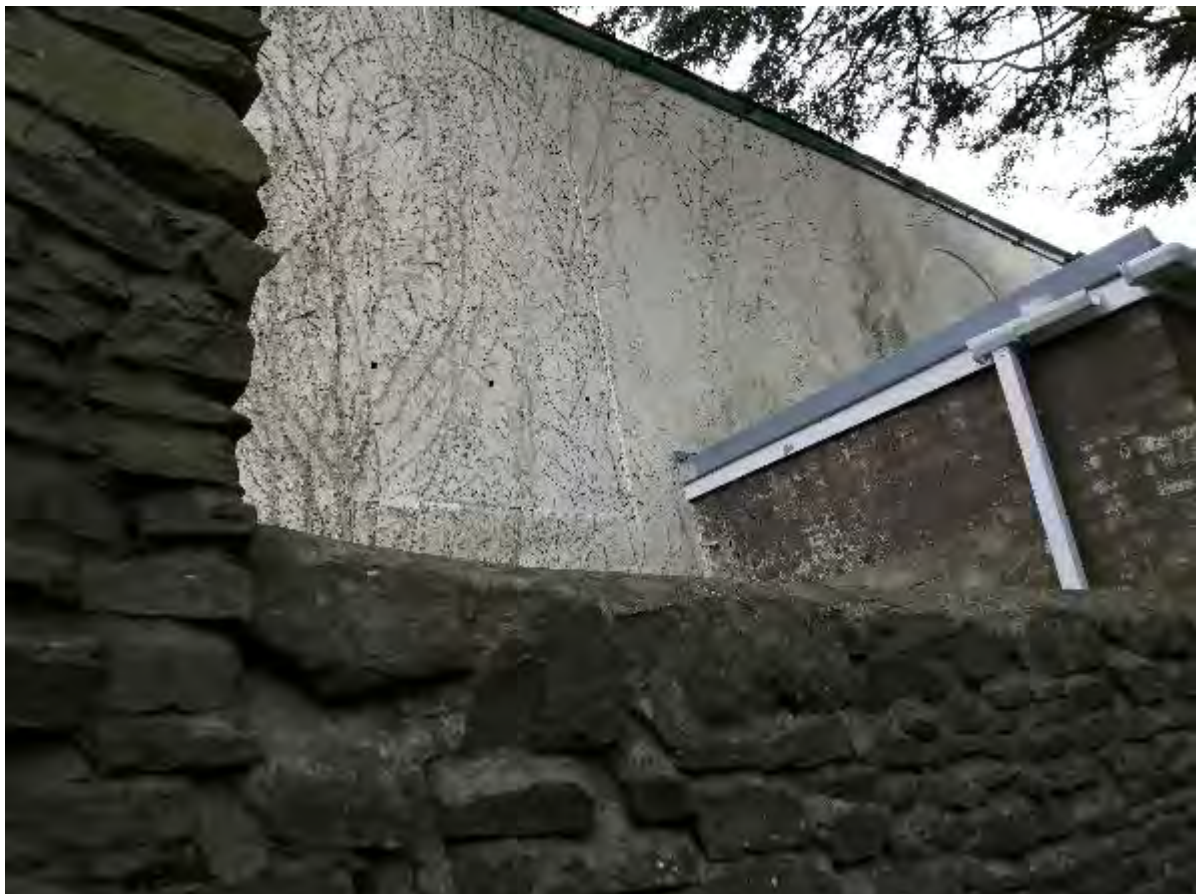
Photo 32 – Vegetation Growth (Rear Wall Elevation)

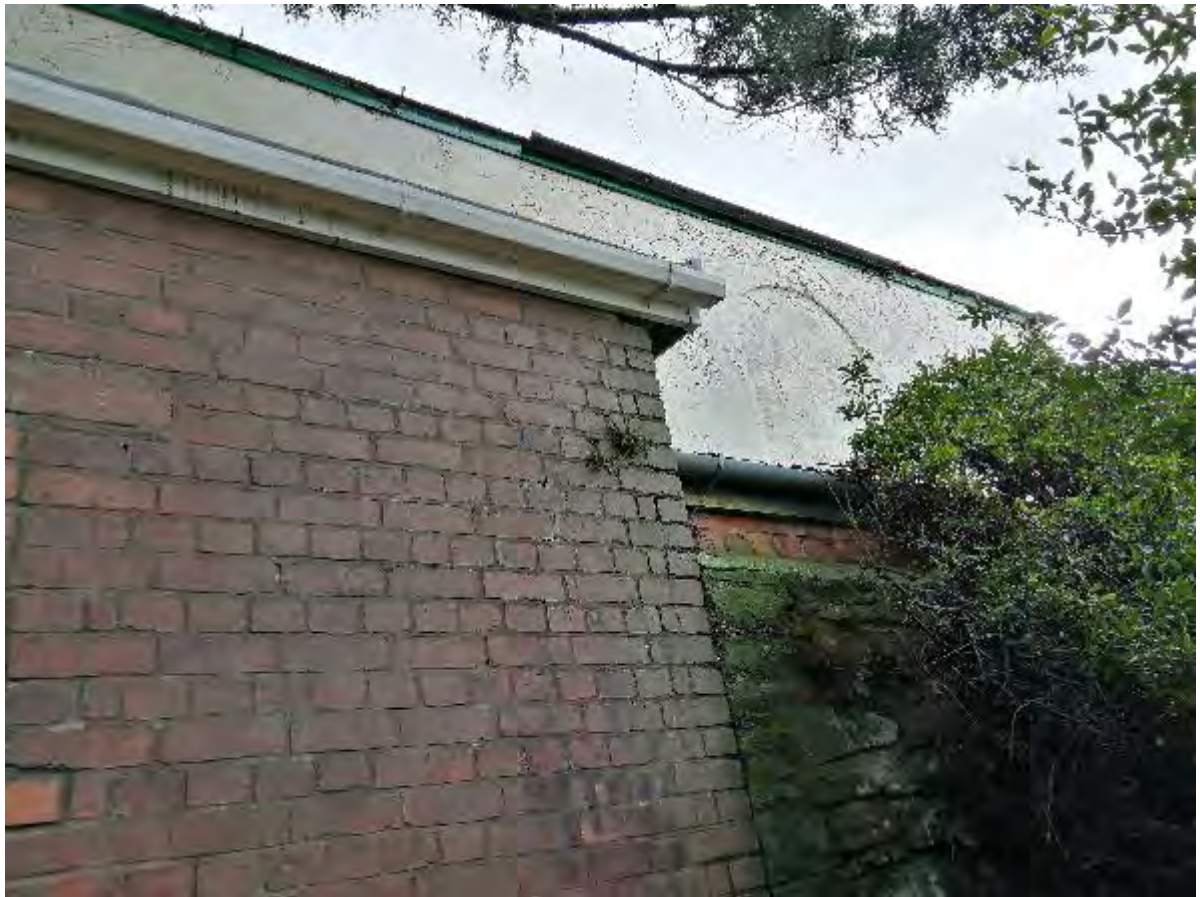
Photo 33 – Vegetation Growth (Rear Wall Elevation)
