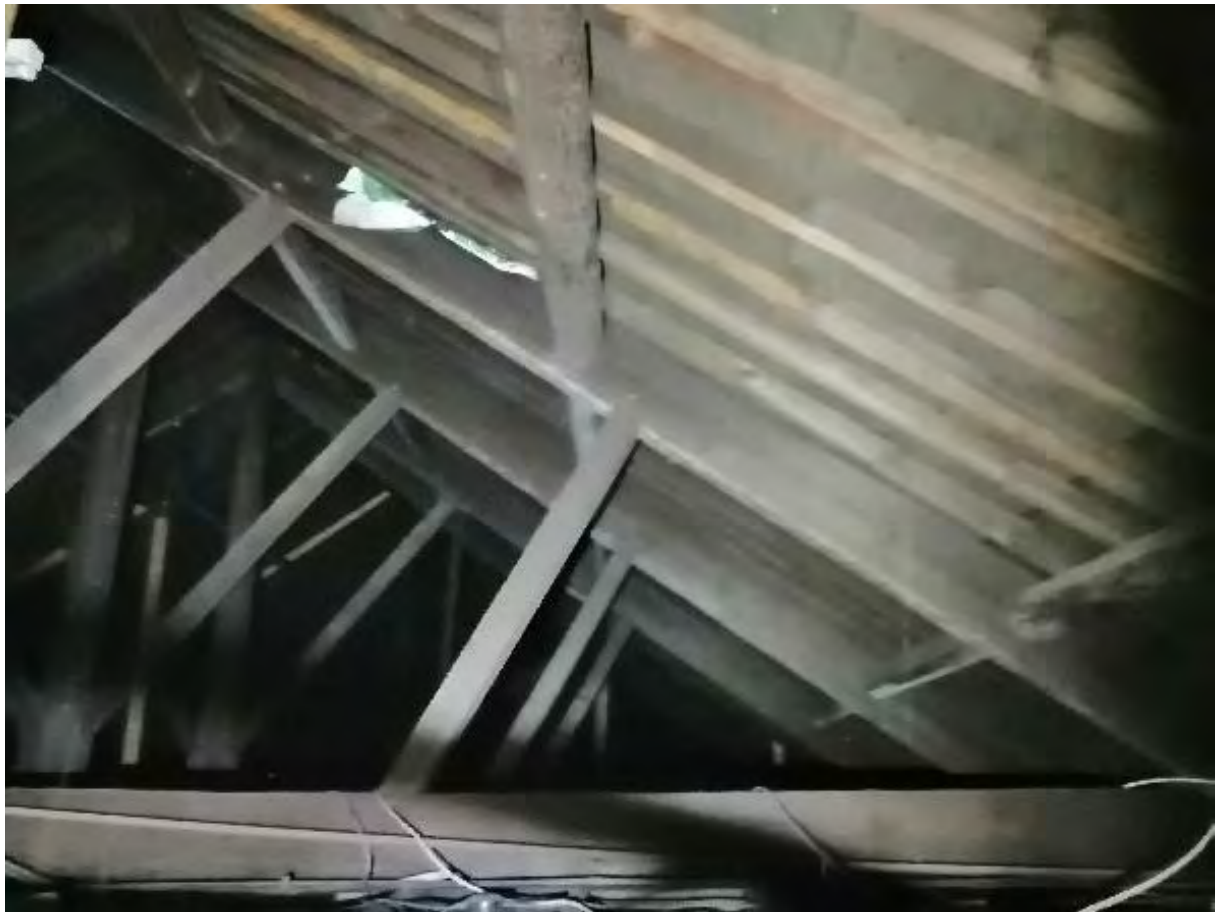
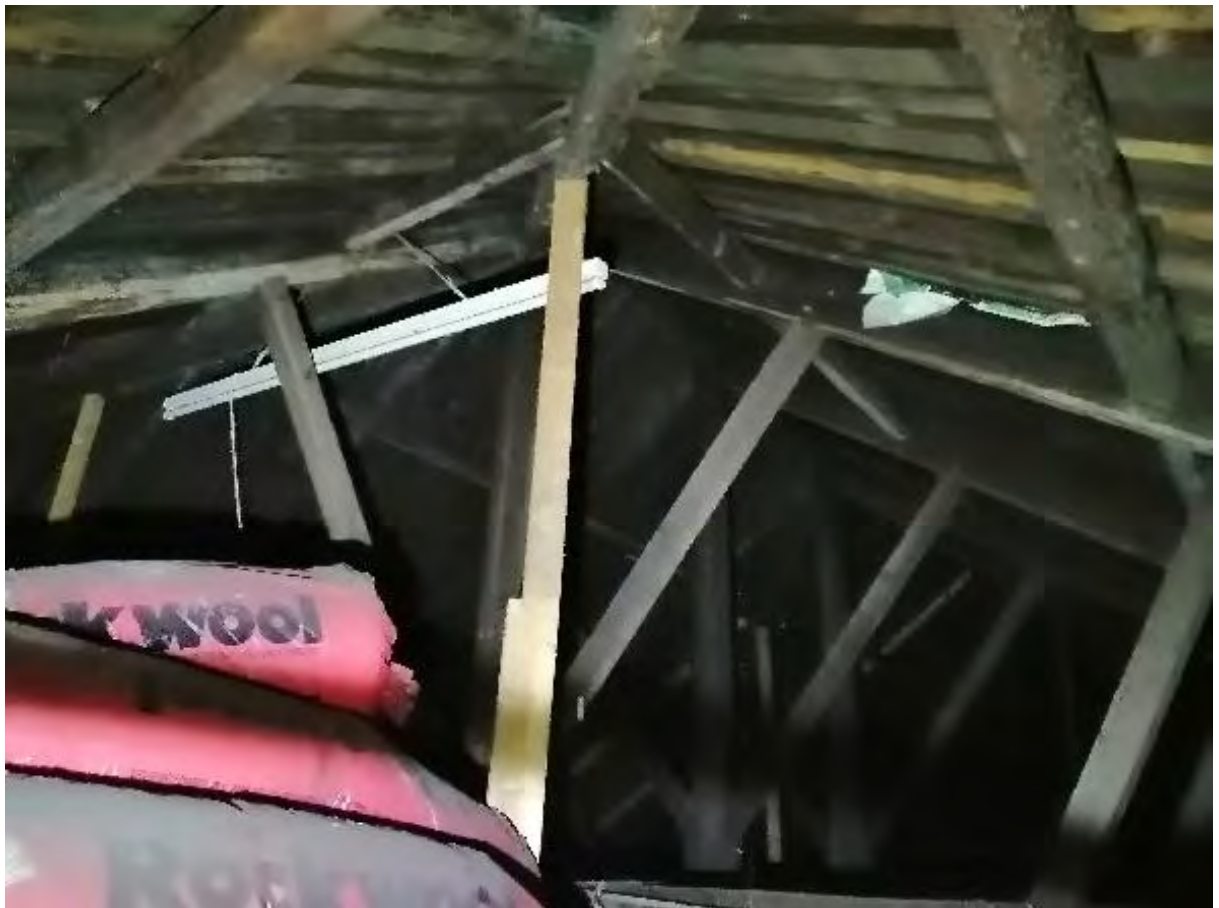
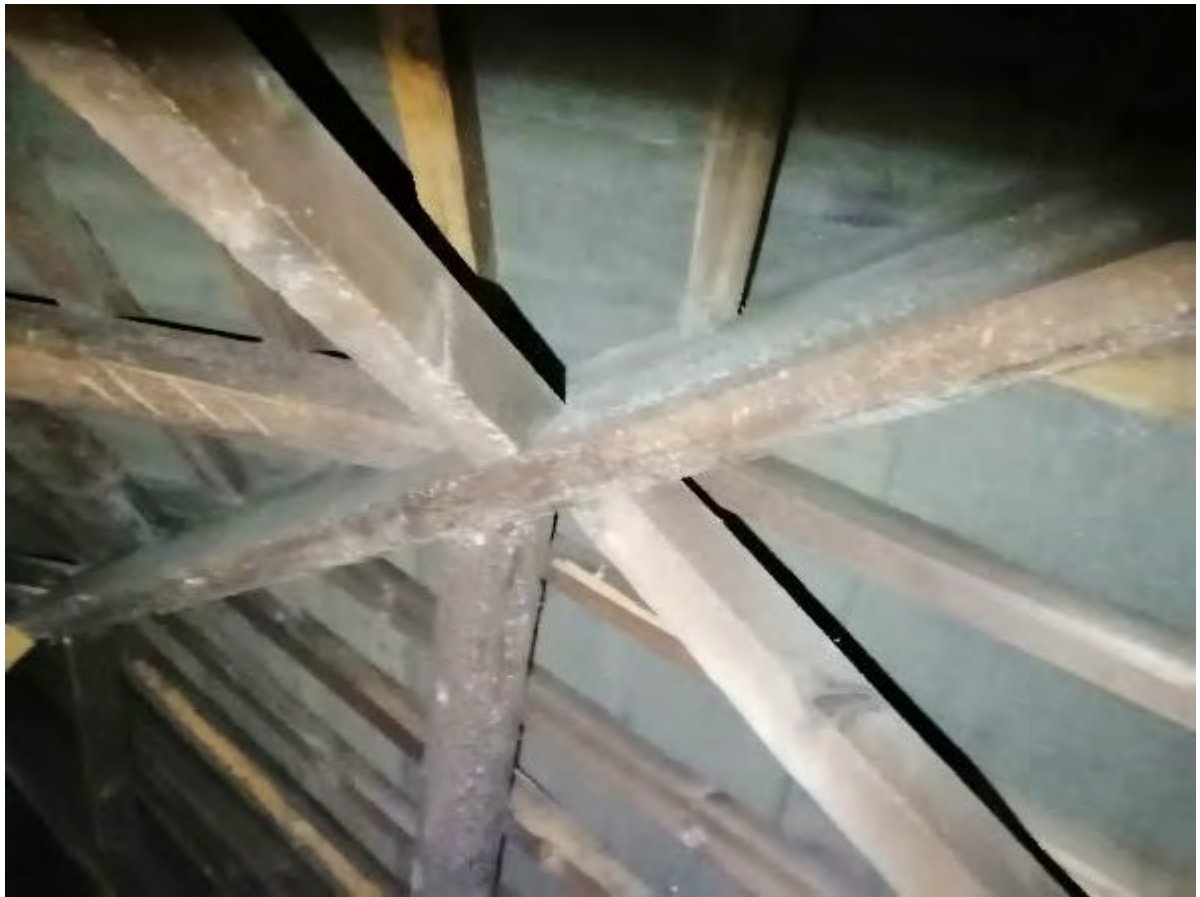
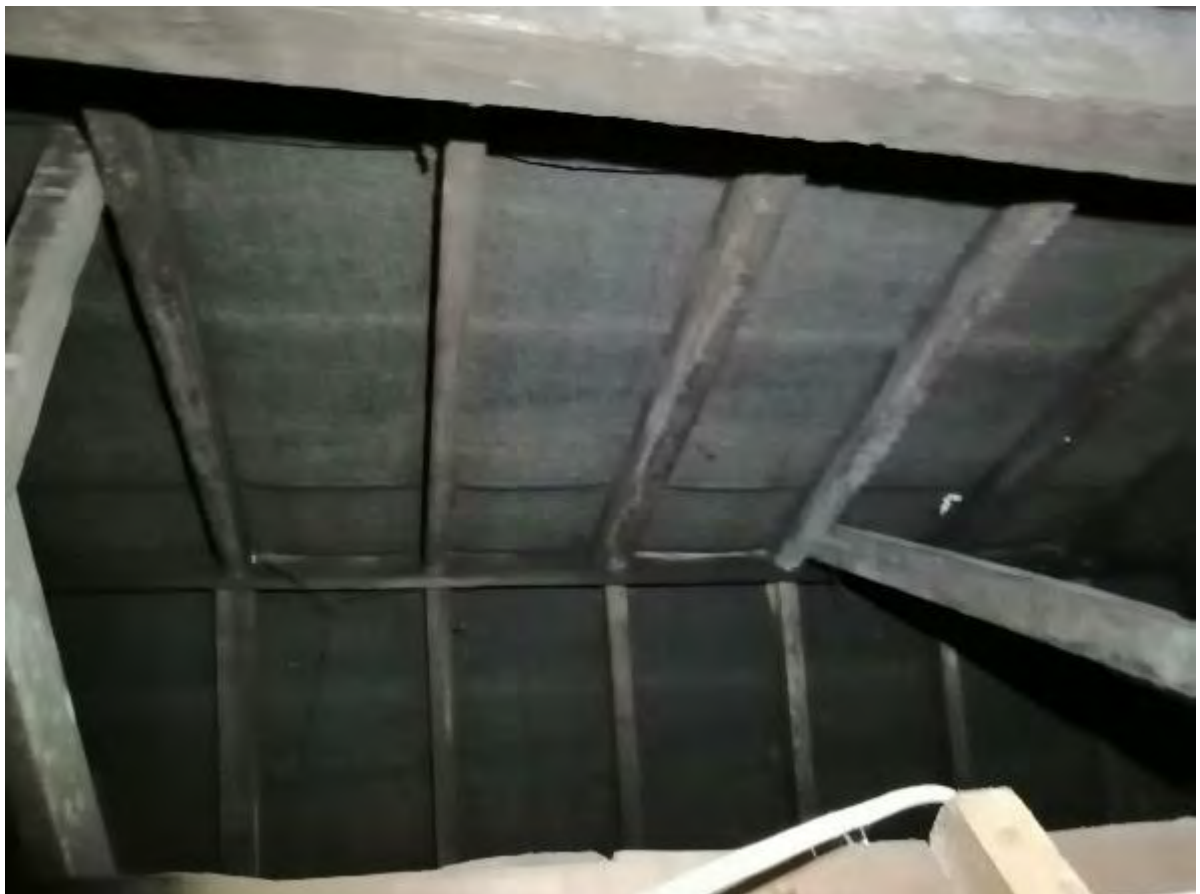
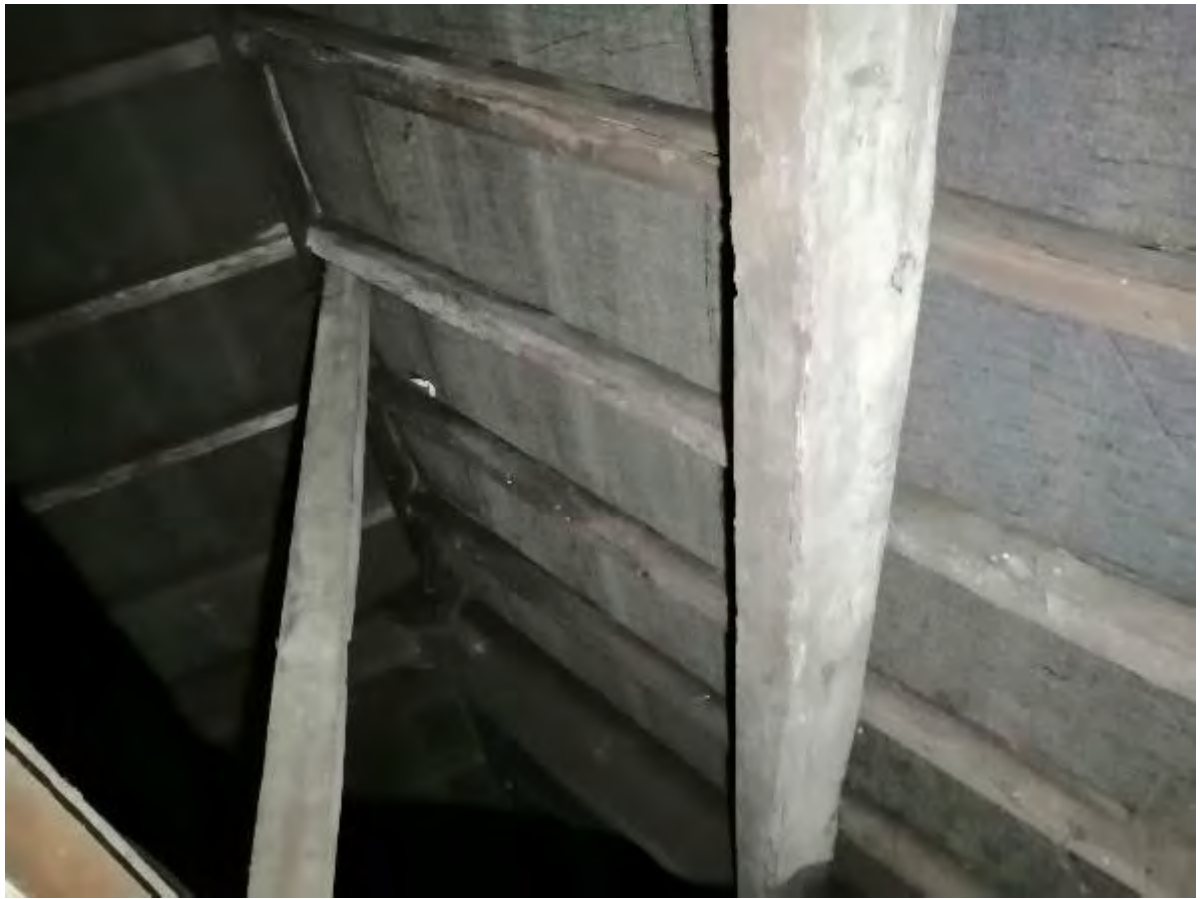
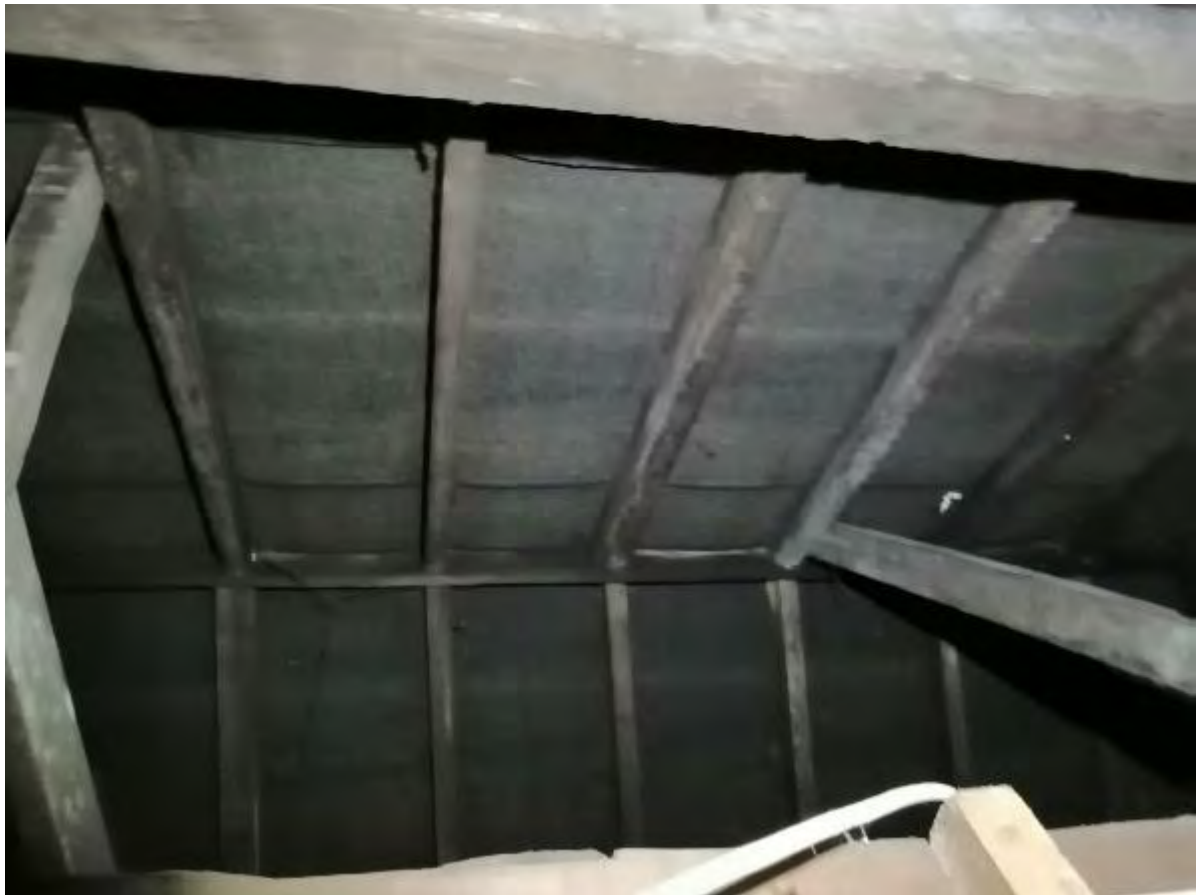
There was limited access to inspect the roof structure due to lack of runner / floor boarding in the roof space. Our inspection was performed by access adjacent to the loft openings to ensure the safety of our engineer and also to prevent any damage to exposed ceilings within the roof void. The layout and configuration of the internal roof structure can be seen in Photos 89-94.

The layout of the principal structural members is suitably configured to support the external roof coverings (tiles) as well as external loading (snow and wind).

There was no obvious indication of distress or misalignment of the structural timber members, i.e. noticeable deflection, bending or torsional (twisting) effects that would otherwise suggest potential issues with the structural integrity of the roof. The majority of the timber frameworks have water markings / apparent surface rot across their surface areas. This would be expected as the building would not have had roofing felt present when it was first built and so would have been susceptible to wind driven rain migrating beneath the roof tiles. Also, following the installation of roofing felt when the roof tiles were previously changed, there was no provision for passive ventilation and so the roof timber frameworks will have been subject to condensation build up within the roof void space, which can encourage dry rot to develop. We'd recommend that the roof timber frameworks are suitably treated to negate any further deterioration - Condition Rating **2** See Section 7.0 Recommendations for guidance on repair works required.

Overall, the strength and stiffness properties of the structural timber frameworks appears to remain adequate and the condition of the structural timbers is as one would expect for a property of this type and age, although treatment should be carried out as noted above.

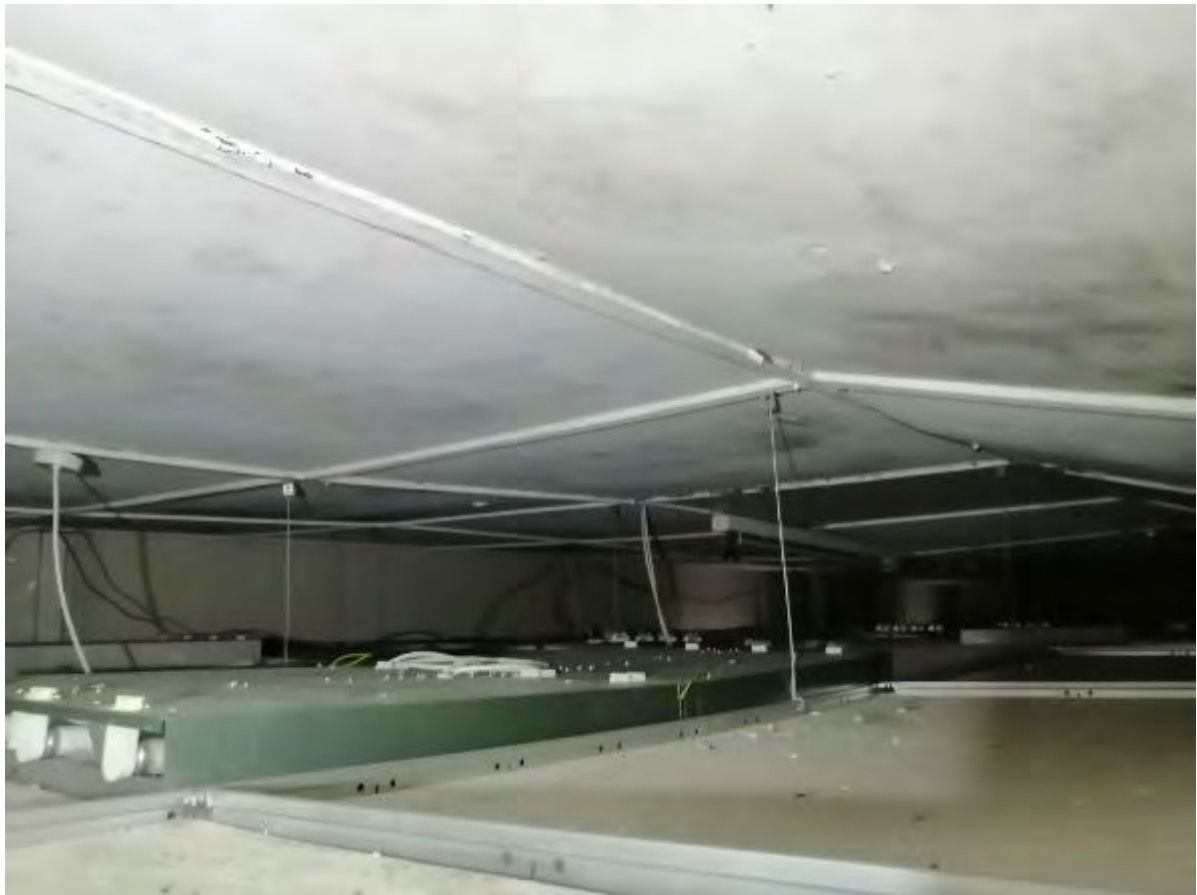
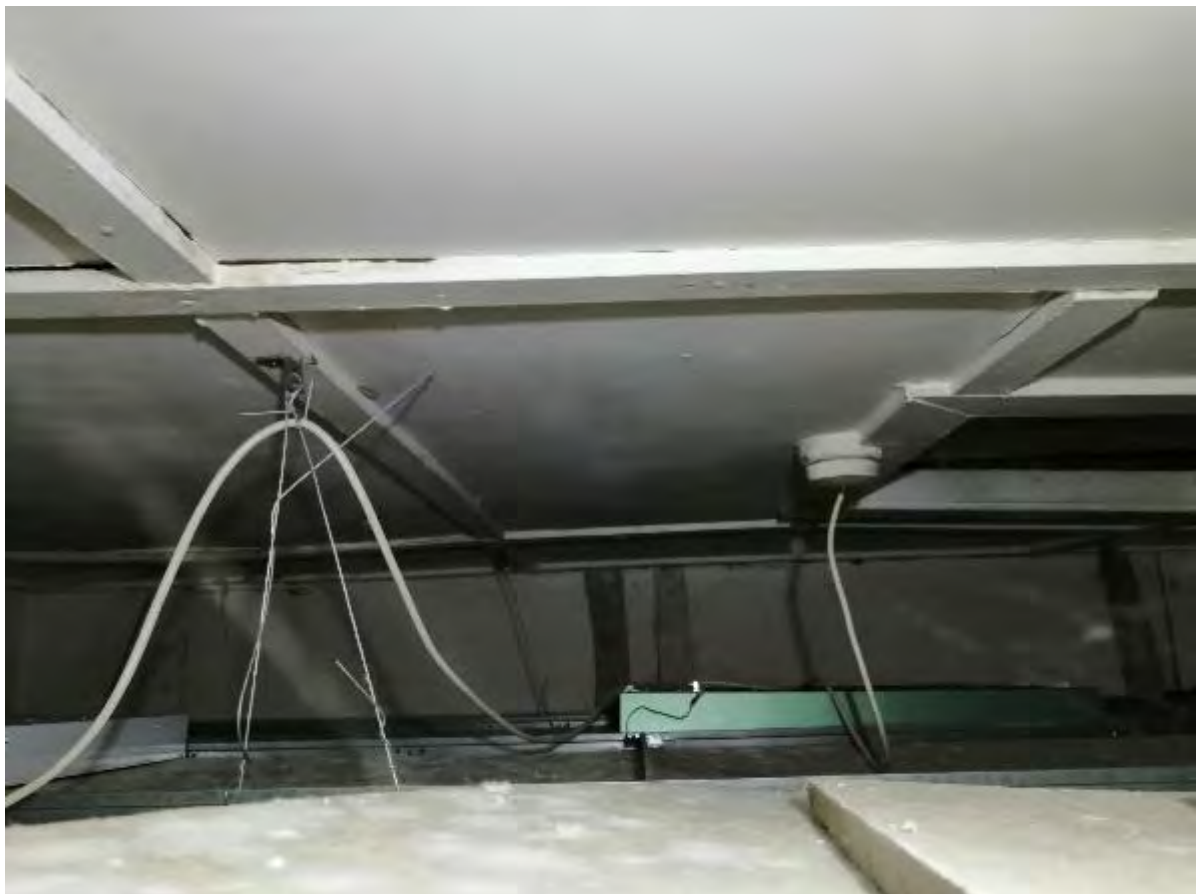
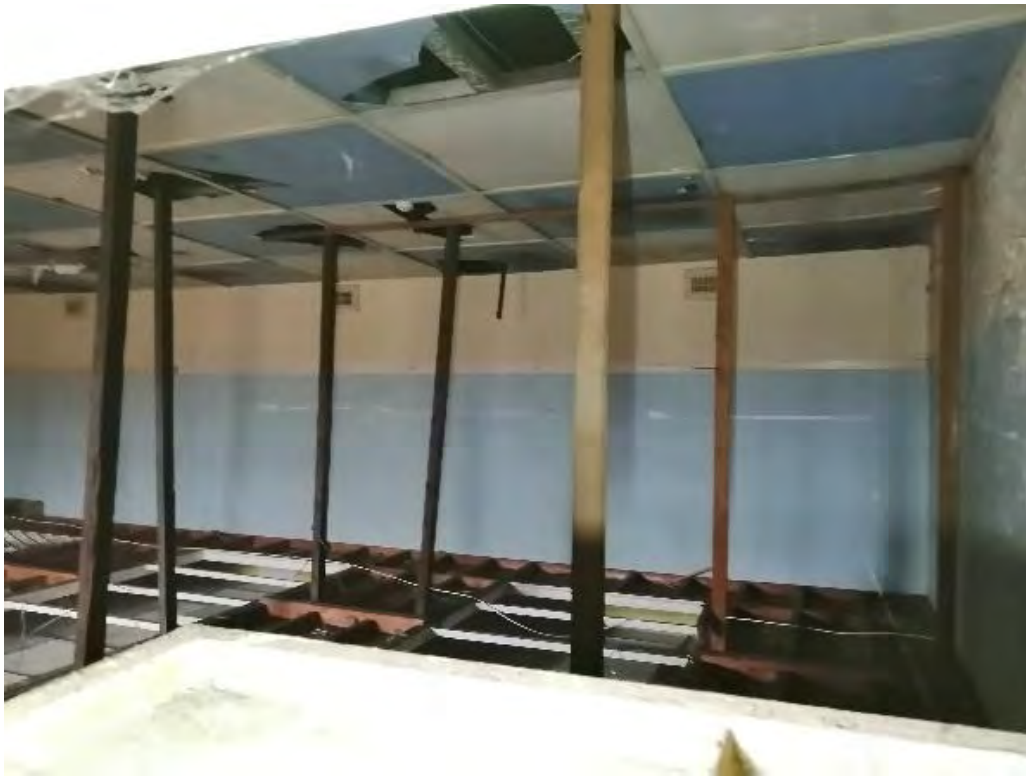
No deflection or distortion to the ceiling finishes were evident to the first floor rooms. This would suggest the horizontal timber roof beams above (which provide support to the ceiling finishes) are satisfactory from a structural perspective, continue to perform as intended and that sagging / deflection is not a concern. N.B. a number of rooms have false ceilings present and so further inspection of the void above was conducted where possible. We noted ceiling cracks to the rear room – see photos 102-112 below. These cracks are expected to be caused by minor flexure of the ceiling joists due to loading of the attic space. The cracking is considered not to be of structural concern and can be remediated through general maintenance and decoration - N.B. we recommend that all internal ceiling finishes are replaced - Condition Rating **2** See Section 7.0 Recommendations for guidance on repair works required.

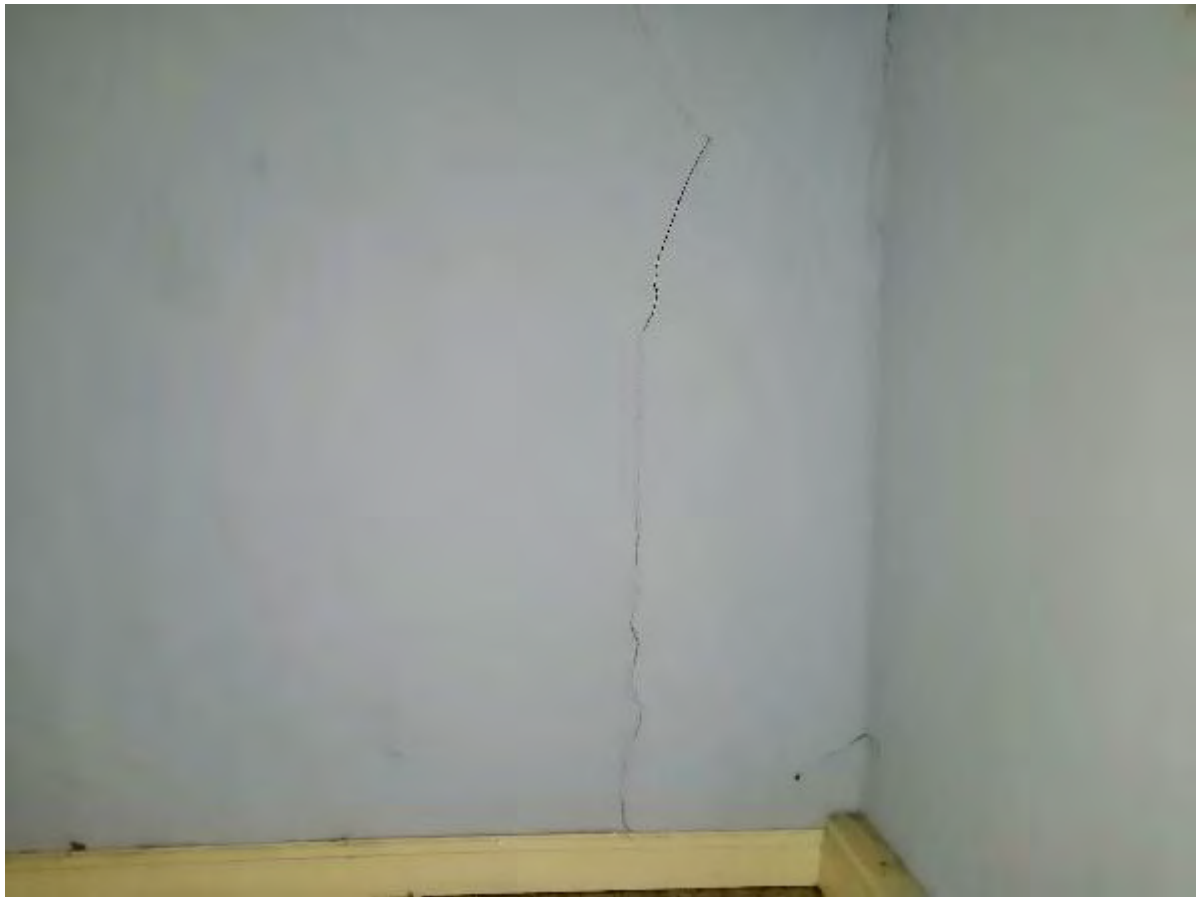
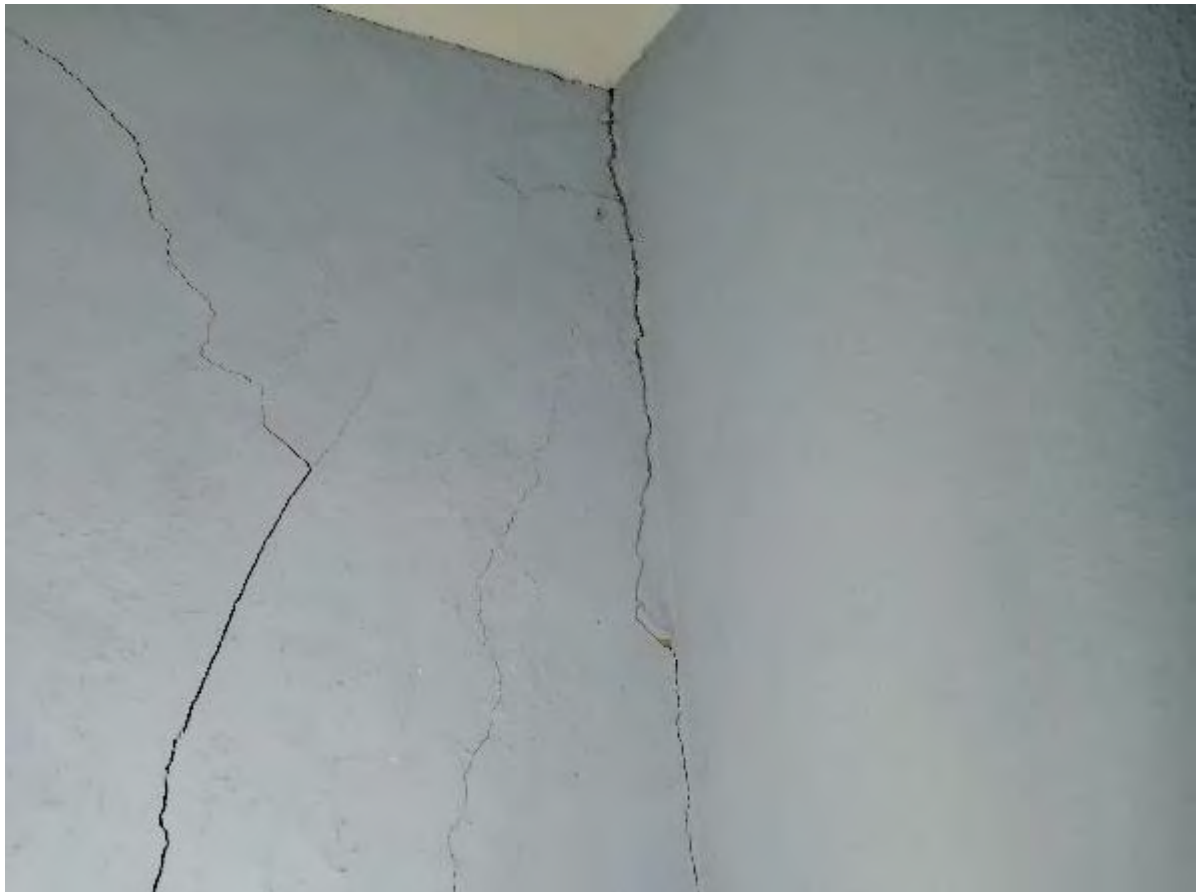
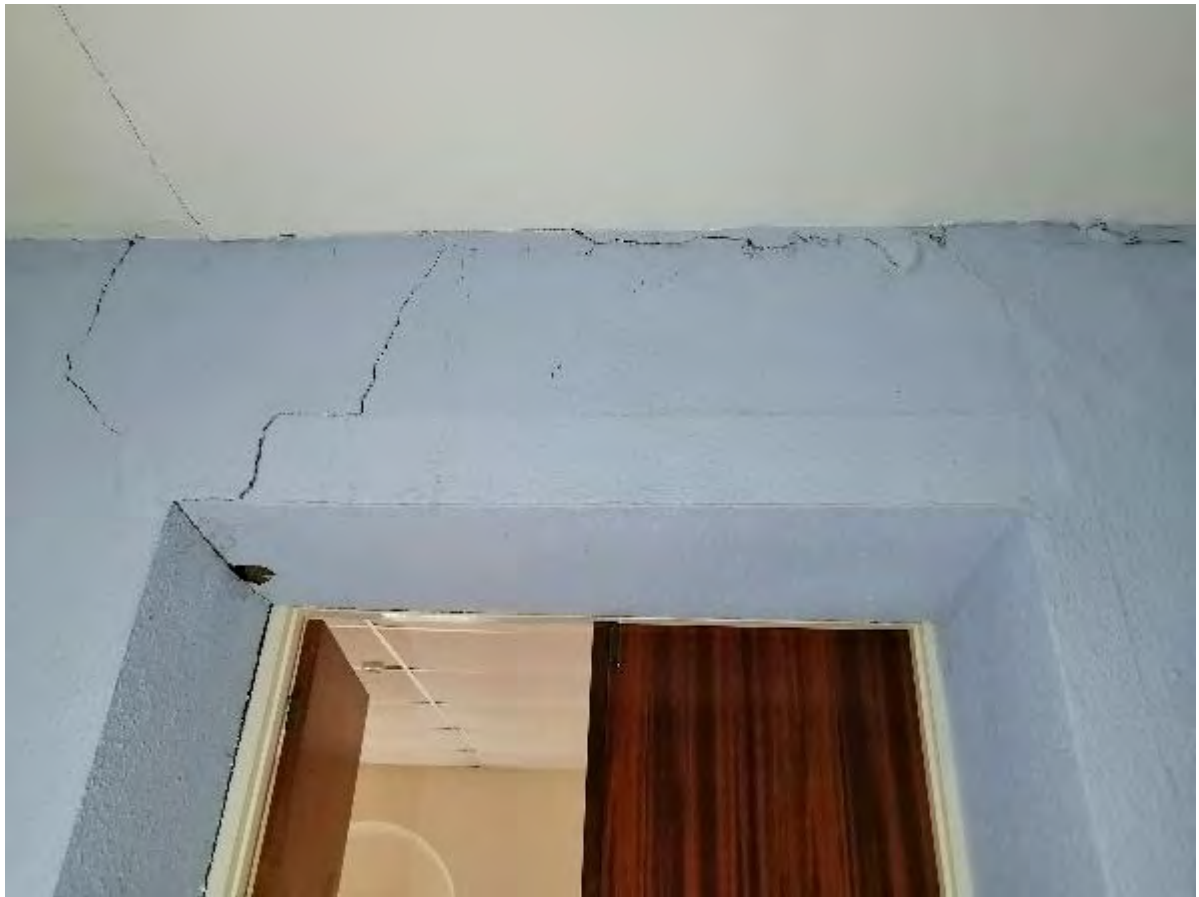
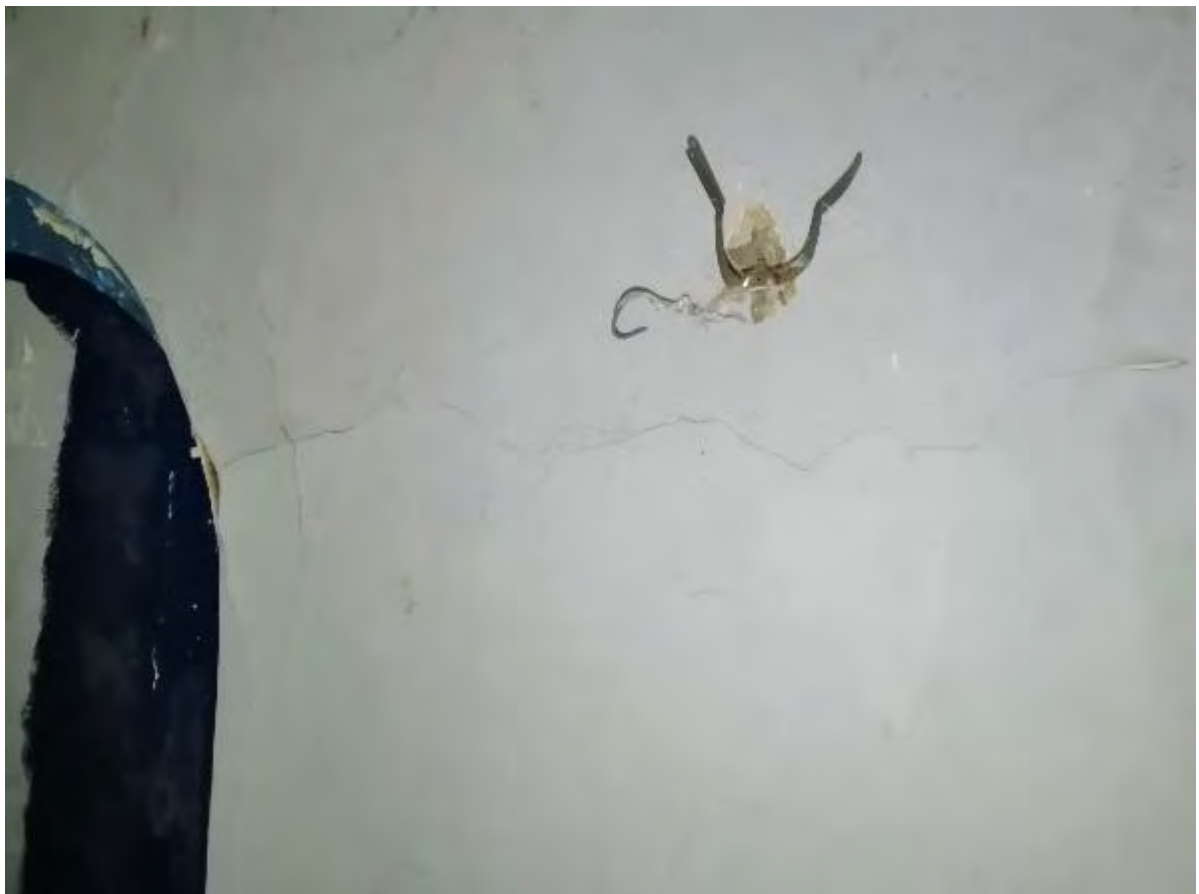
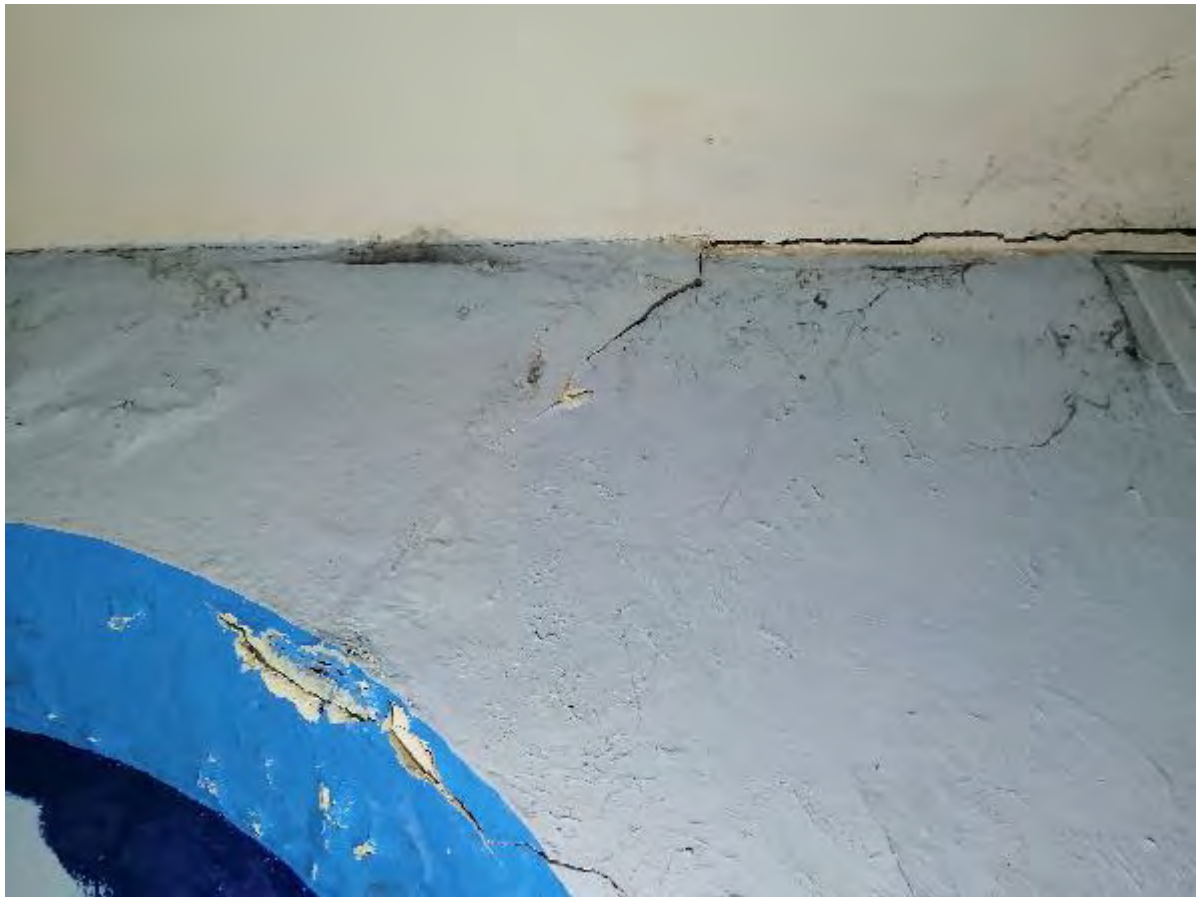
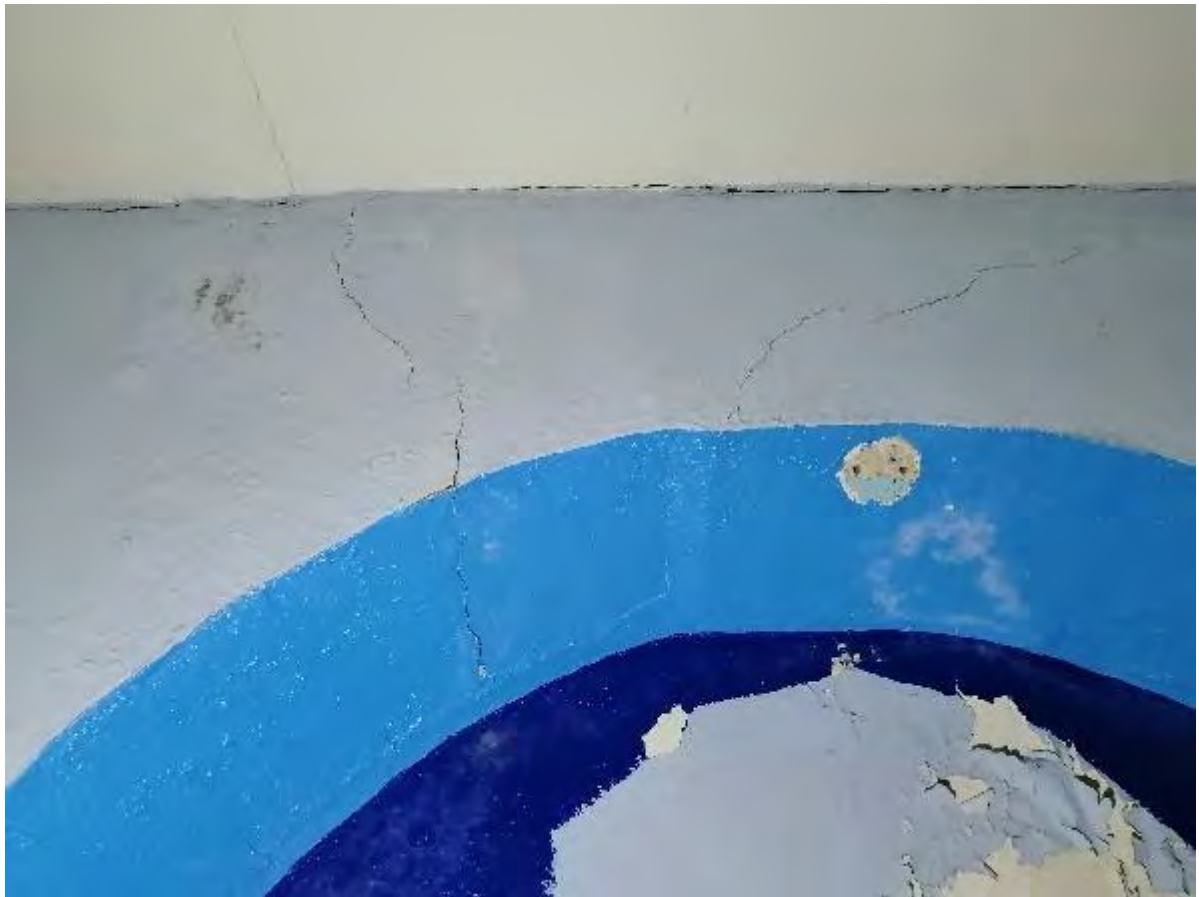
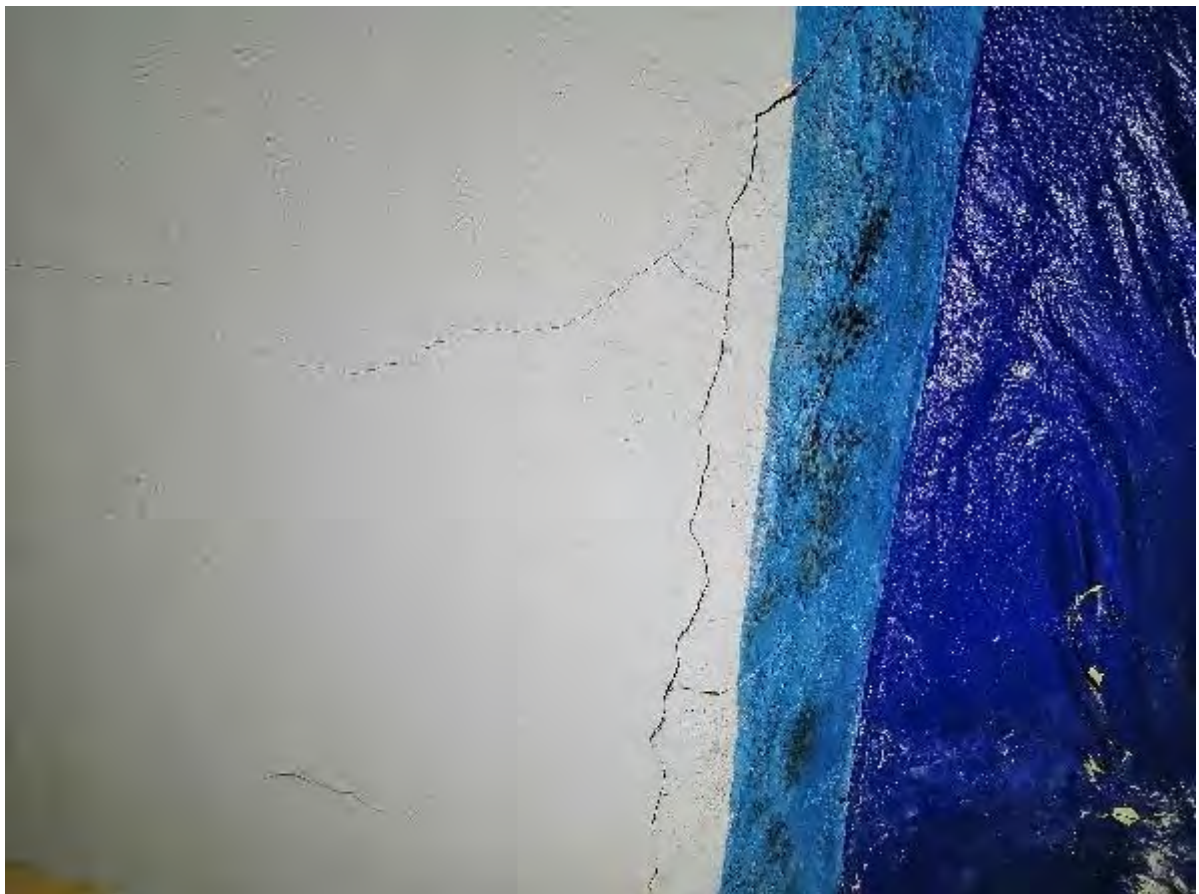
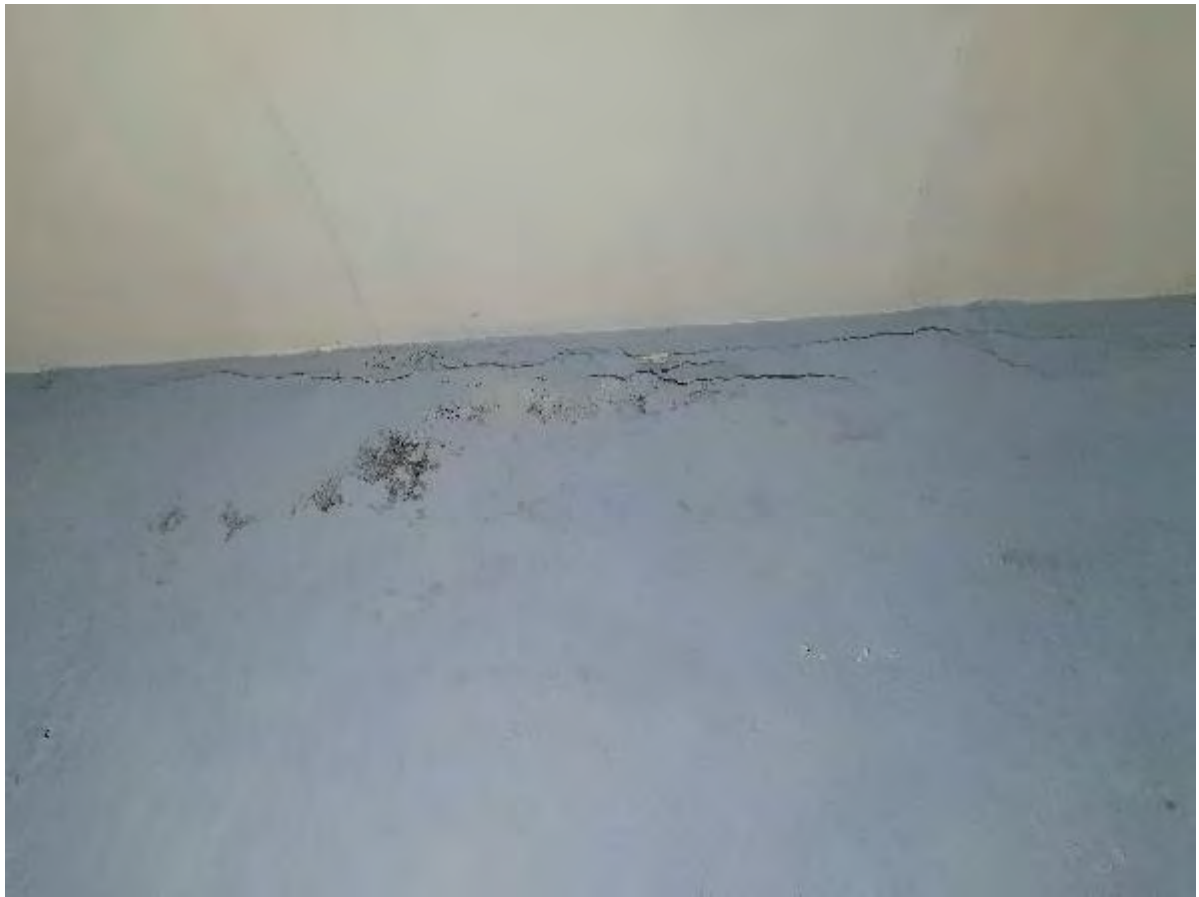
Internal cracking (damage category 1 to 2) to plaster finishes were noted to the rear room, front room 1, staircase and male toilets – see photos 113-121, 124, 126, 128, 130 and 132-138 below. Further cracking (damage category 1 to 2) was noted to the wall plaster above the external wall archways in the front room 1 – see photos 127, 129 and 131. Also, cracking (damage category 1 to 2) was noted around the archway infill in the rear room and front room 1 – see photos 122 and 125 below. These cracks are low grade in nature and expected to be confined to the non-structural plaster finishes only. There is no obvious loss of structural support or failure of the wall panel at these locations. Notwithstanding this, the internal wall finishes should be removed to check the integrity of the load-bearing wall face beneath and to conduct the necessary repairs where necessary- Condition Rating **2** See Section 7.0 Recommendations for guidance on repair works required.

Photo 113 – Wall Plaster Crack (Rear Room)

Photo 114 – Wall Plaster Crack (Rear Room)

Photo 115 – Wall Plaster Crack (Rear Room)

Photo 116 – Wall Plaster Crack (Rear Room)

Photo 117 – Wall Plaster Crack (Rear Room)

Photo 119 – Wall Plaster Crack (Rear Room)

Photo 120 – Wall Plaster Crack (Rear Room)

Photo 121 – Wall Plaster Crack (Rear Room)

- Internal cracking (damage category 1 to 2) to plaster finishes were noted to the rear room, front room 1, staircase and male toilets – see photos 113-121, 124, 126, 128, 130 and 132-138. Further cracking (damage category 1 to 2) was noted to the wall plaster above the external wall archways in the front room 1 – see photos 127, 129 and 131. Also, cracking (damage category 1 to 2) was noted around the archway infill in the rear room and front room 1 – see photos 122 and 125. Further Internal cracking (damage category 1-2) to plaster finishes were noted to corridor 1, 2, female toilets, front room 2, side room 1, utility room 1 and fire exit room – see photos 185-186, 188-190, 193-196, 202 and 214-218. The internal wall finishes should be removed to check the integrity of the load-bearing wall face beneath and to conduct the necessary repairs where necessary

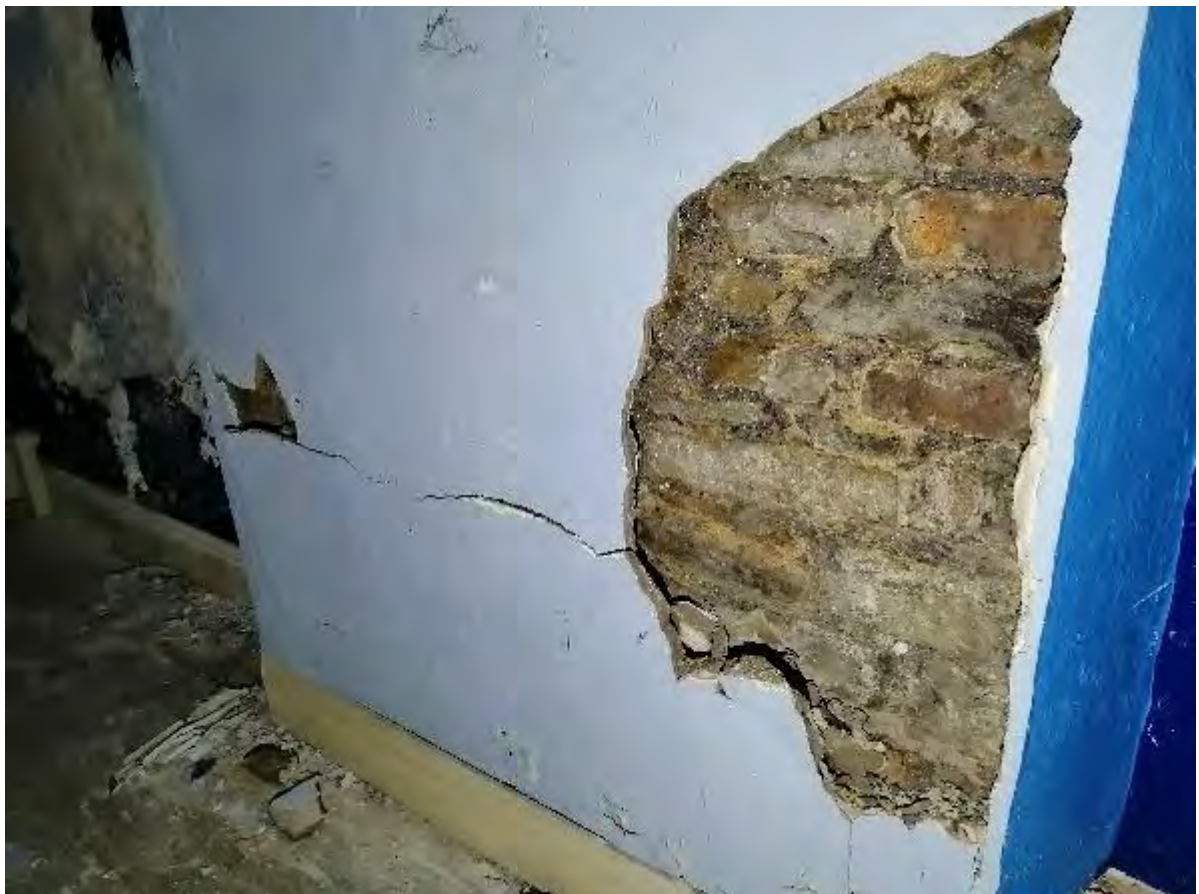
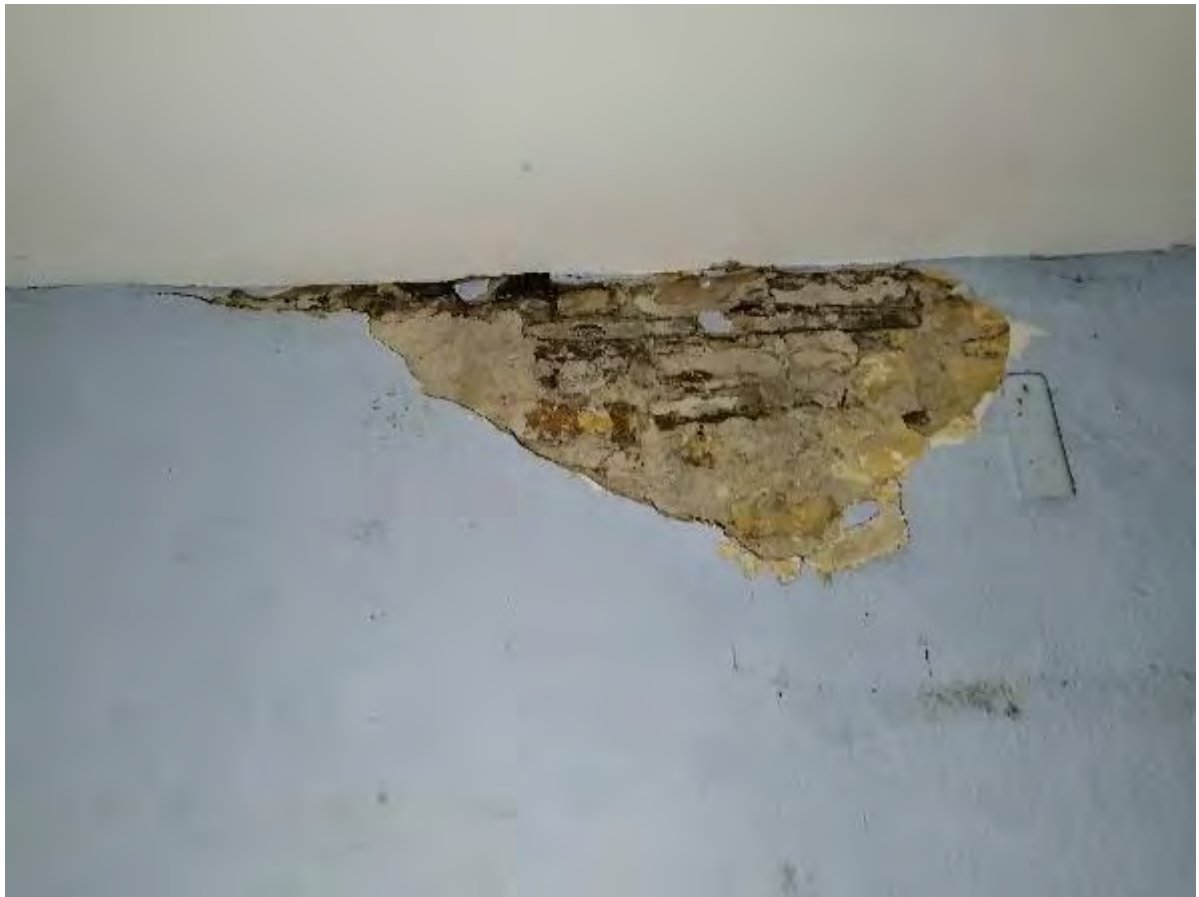
Areas of detached plaster were noted to the rear room, front room 1 and staircase – see photos 114, 188, 120, 123-124 and 135 below. These areas of detached plaster are expected to be caused by penetrating damp to the walls in these areas. Condition Rating **2** See Section 7.0 Recommendations for guidance on repair works required.

Photo 118 – Detached Wall Plaster (Rear Room)

Photo 123 – Detached Wall Plaster (Rear Room)

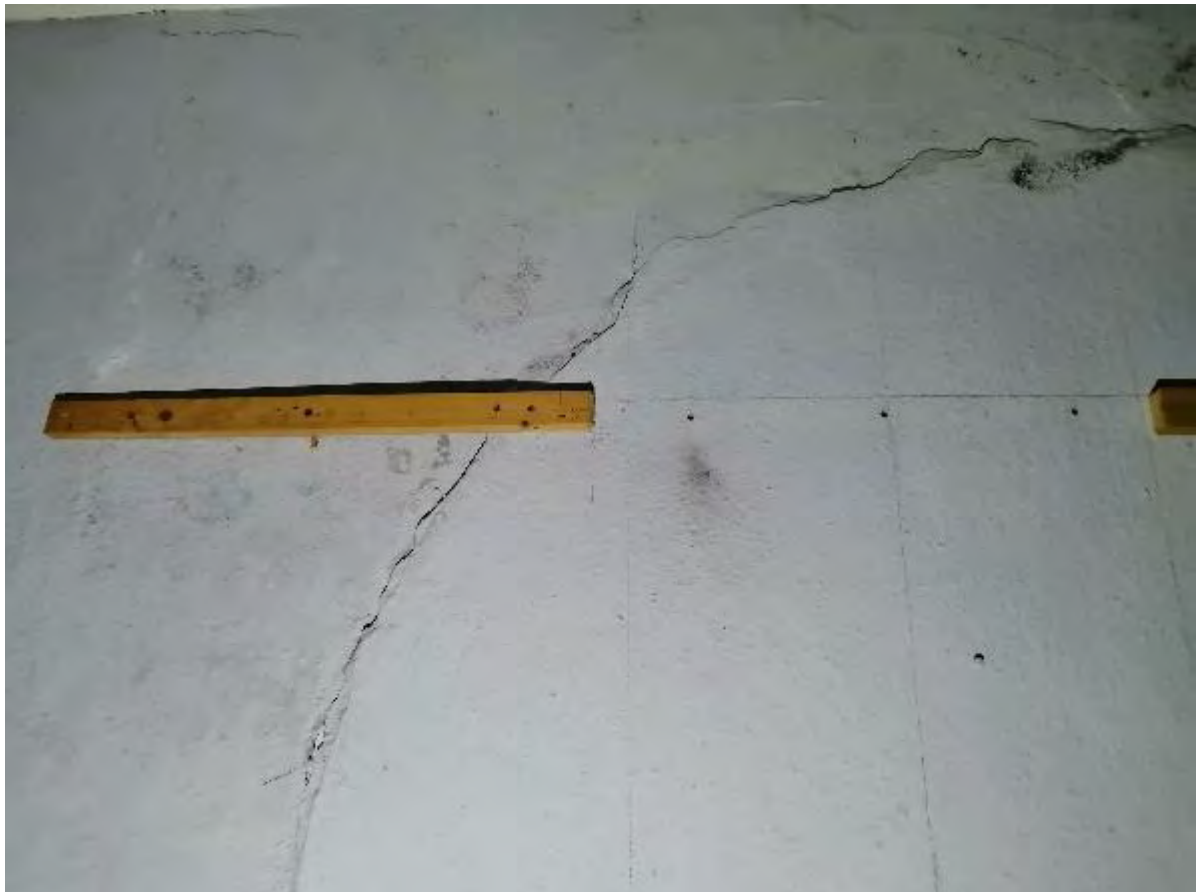
Photo 122 – Cracking Around Archway Infill (Rear Room)
