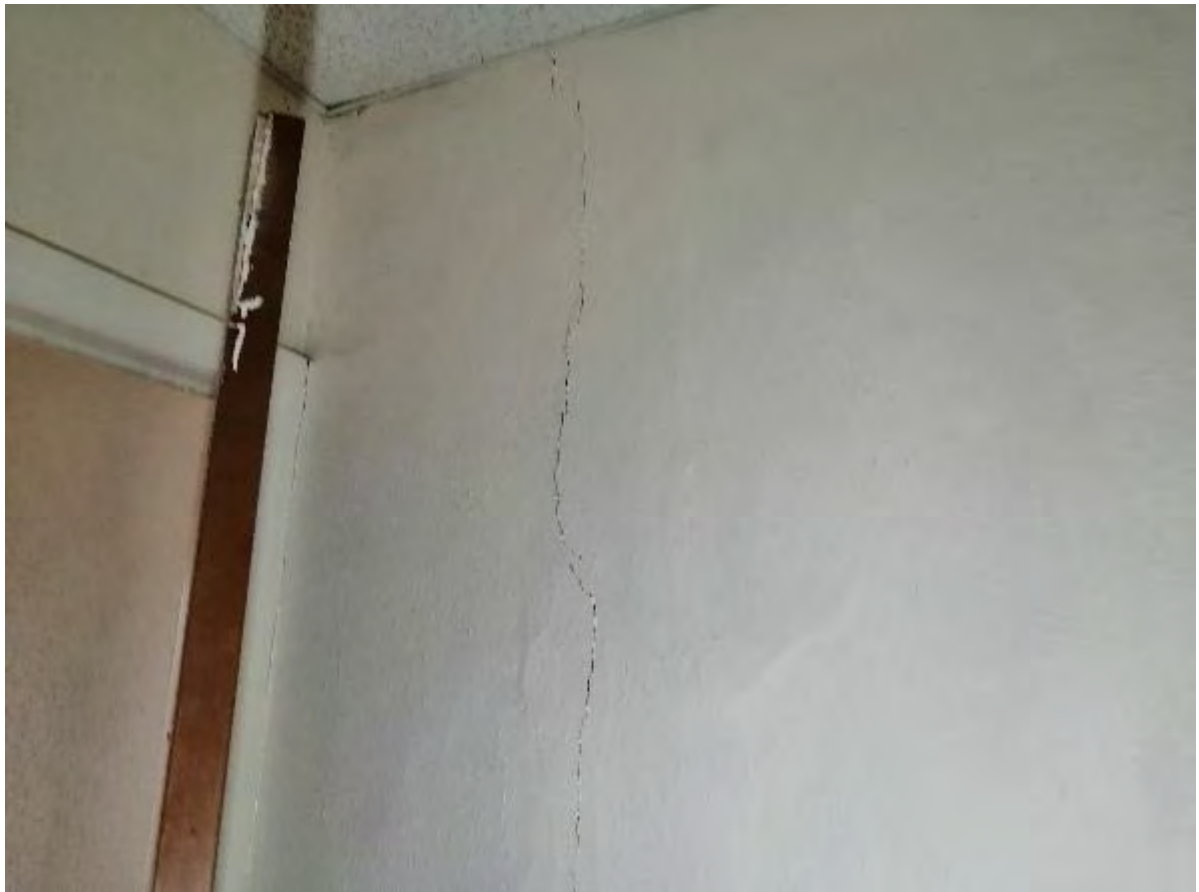
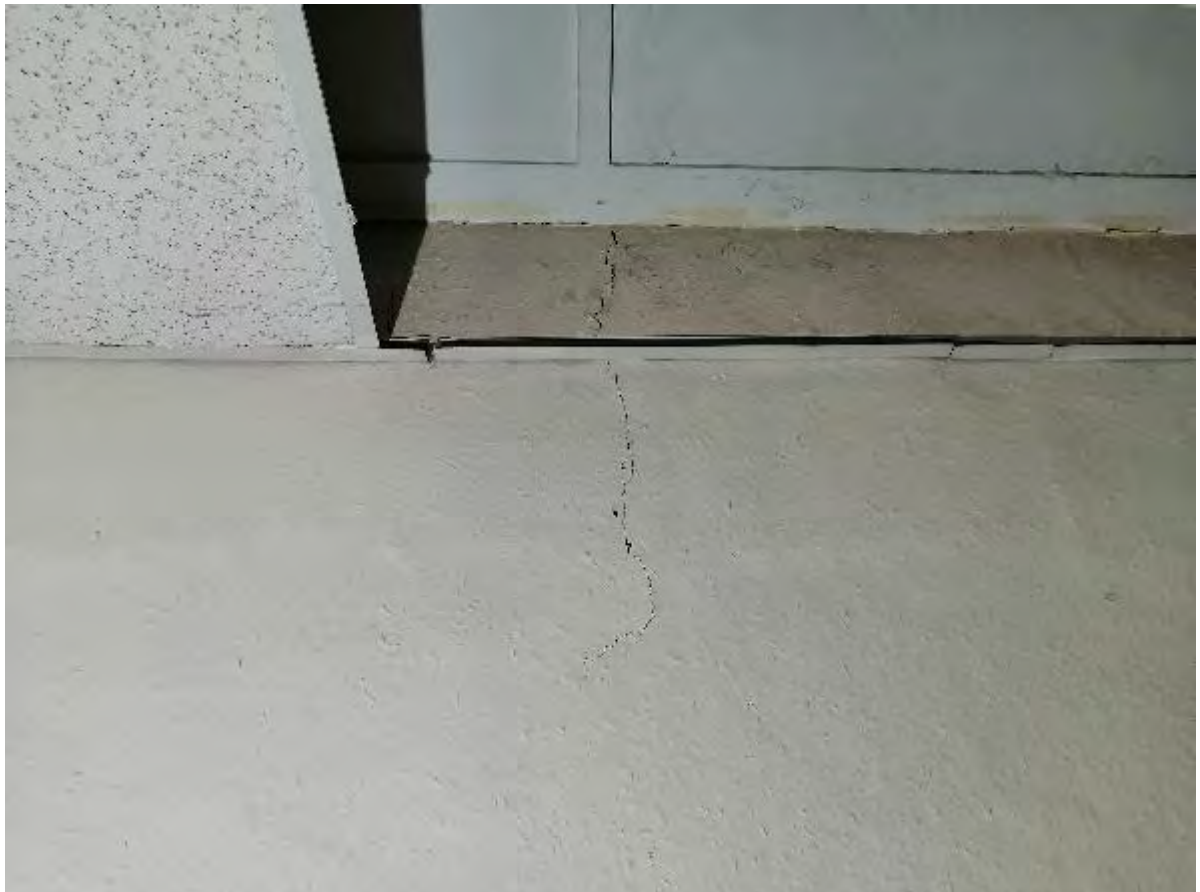
Internal cracking (damage category 1 to 2) to plaster finishes were noted to the rear room, front room 1, staircase and male toilets – see photos 113-121, 124, 126, 128, 130 and 132-138 below. Further cracking (damage category 1 to 2) was noted to the wall plaster above the external wall archways in the front room 1 – see photos 127, 129 and 131. Also, cracking (damage category 1 to 2) was noted around the archway infill in the rear room and front room 1 – see photos 122 and 125 below. These cracks are low grade in nature and expected to be confined to the non-structural plaster finishes only. There is no obvious loss of structural support or failure of the wall panel at these locations. Notwithstanding this, the internal wall finishes should be removed to check the integrity of the load-bearing wall face beneath and to conduct the necessary repairs where necessary- Condition Rating **2** See Section 7.0 Recommendations for guidance on repair works required.

Photo 124 – Wall Plaster Crack (Front Room 1)

Photo 126 – Wall Plaster Crack (Front Room 1)

- Internal cracking (damage category 1 to 2) to plaster finishes were noted to the rear room, front room 1, staircase and male toilets – see photos 113-121, 124, 126, 128, 130 and 132-138. Further cracking (damage category 1 to 2) was noted to the wall plaster above the external wall archways in the front room 1 – see photos 127, 129 and 131. Also, cracking (damage category 1 to 2) was noted around the archway infill in the rear room and front room 1 – see photos 122 and 125. Further Internal cracking (damage category 1-2) to plaster finishes were noted to corridor 1, 2, female toilets, front room 2, side room 1, utility room 1 and fire exit room – see photos 185-186, 188-190, 193-196, 202 and 214-218. The internal wall finishes should be removed to check the integrity of the load-bearing wall face beneath and to conduct the necessary repairs where necessary

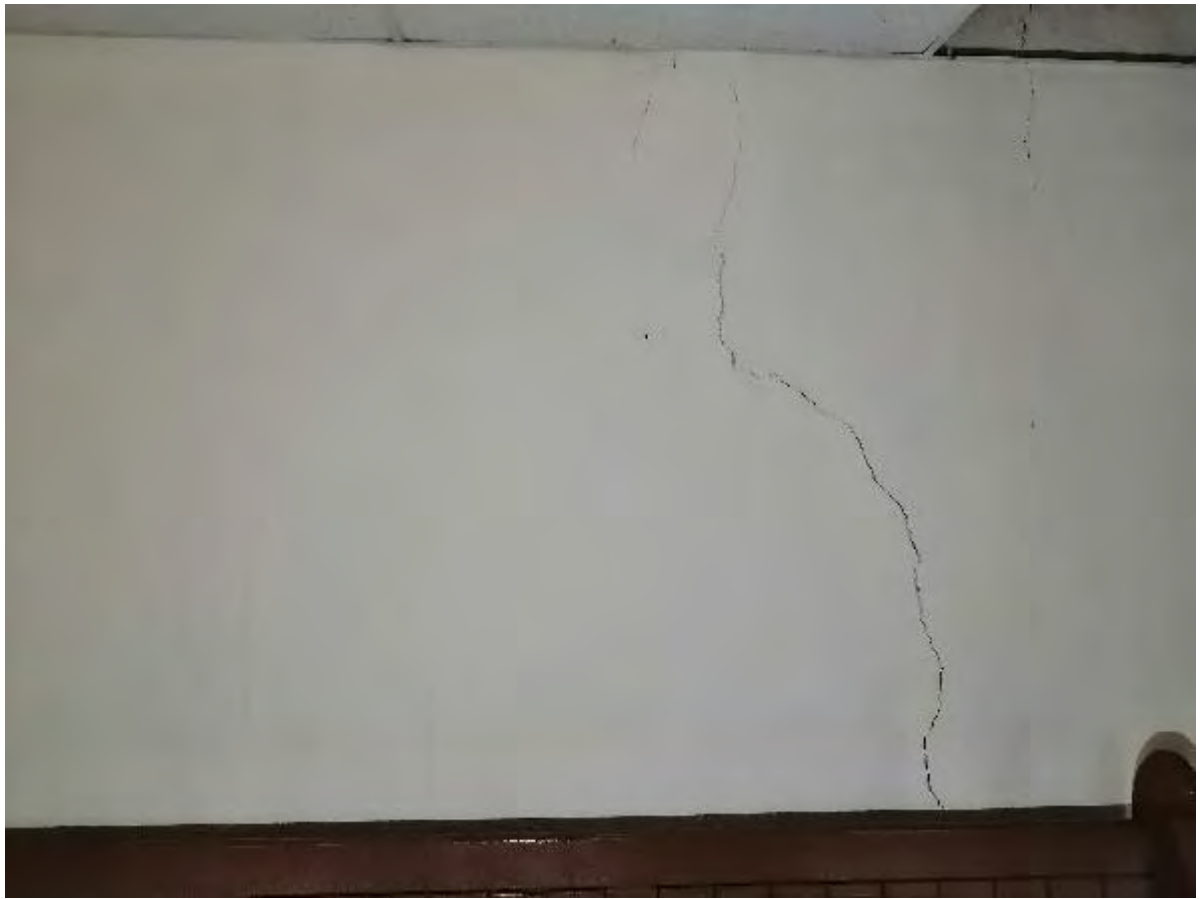
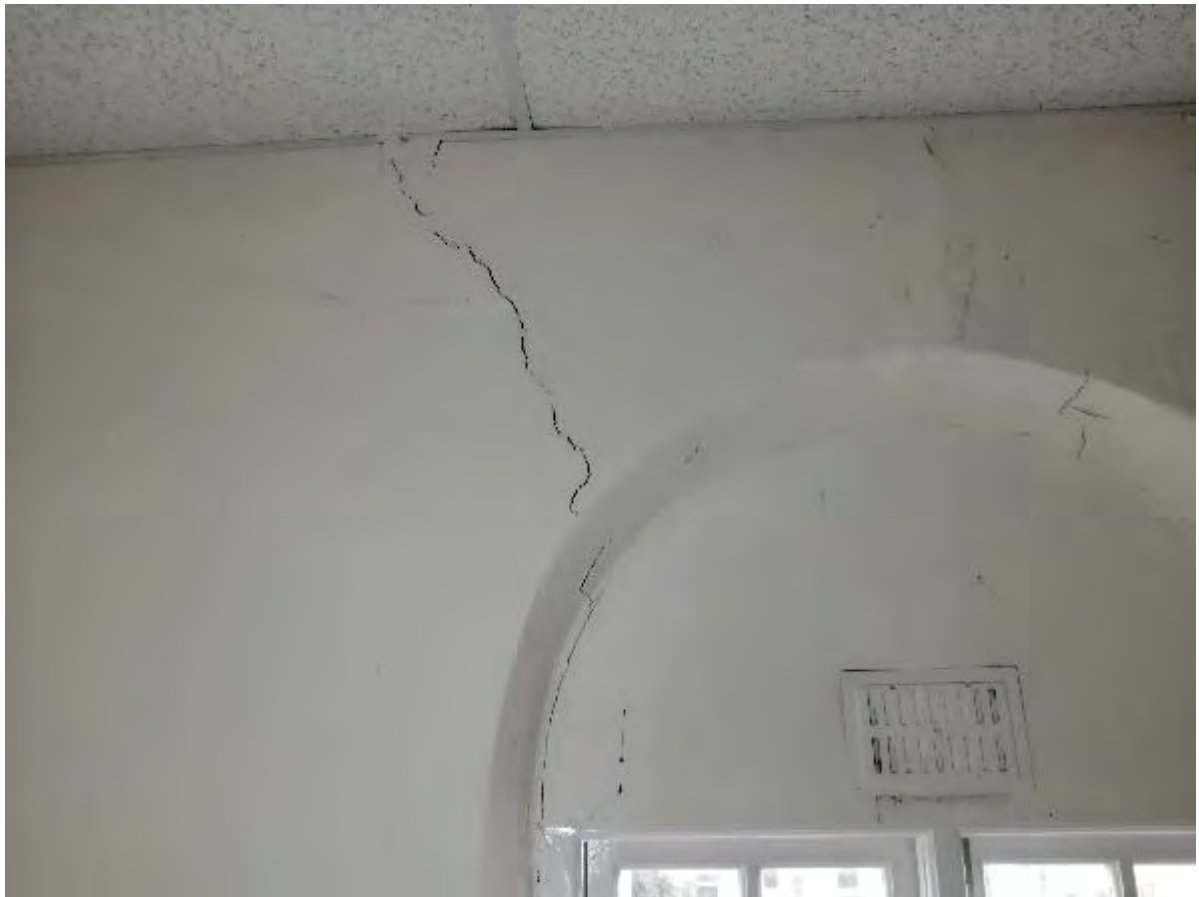
Photo 125 – Cracking Around and Above Archway Infill (Front Room 1)

Photo 127 – Wall Crack Above Archway (Front Room 1)

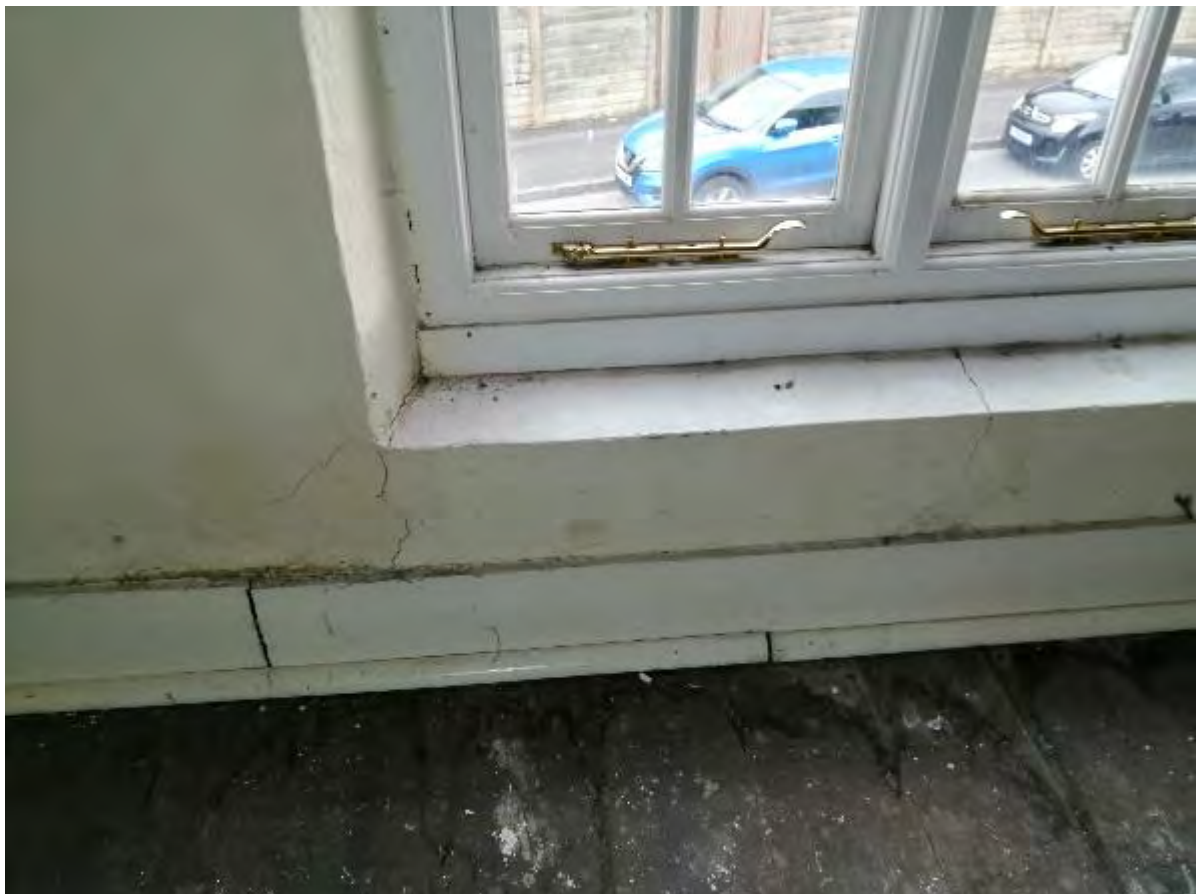
Photo 128 – Wall Plaster Crack (Front Room 1)

31). Internal cracking (damage category 1 to 2) to plaster finishes were noted to the rear room, front room 1, staircase and male toilets – see photos 113-121, 124, 126, 128, 130 and 132-138. Further cracking (damage category 1 to 2) was noted to the wall plaster above the external wall archways in the front room 1 – see photos 127, 129 and 131. Also, cracking (damage category 1 to 2) was noted around the archway infill in the rear room and front room 1 – see photos 122 and 125. Further Internal cracking (damage category 1-2) to plaster finishes were noted to corridor 1, 2, female toilets, front room 2, side room 1, utility room 1 and fire exit room – see photos 185-186, 188-190, 193-196, 202 and 214-218.

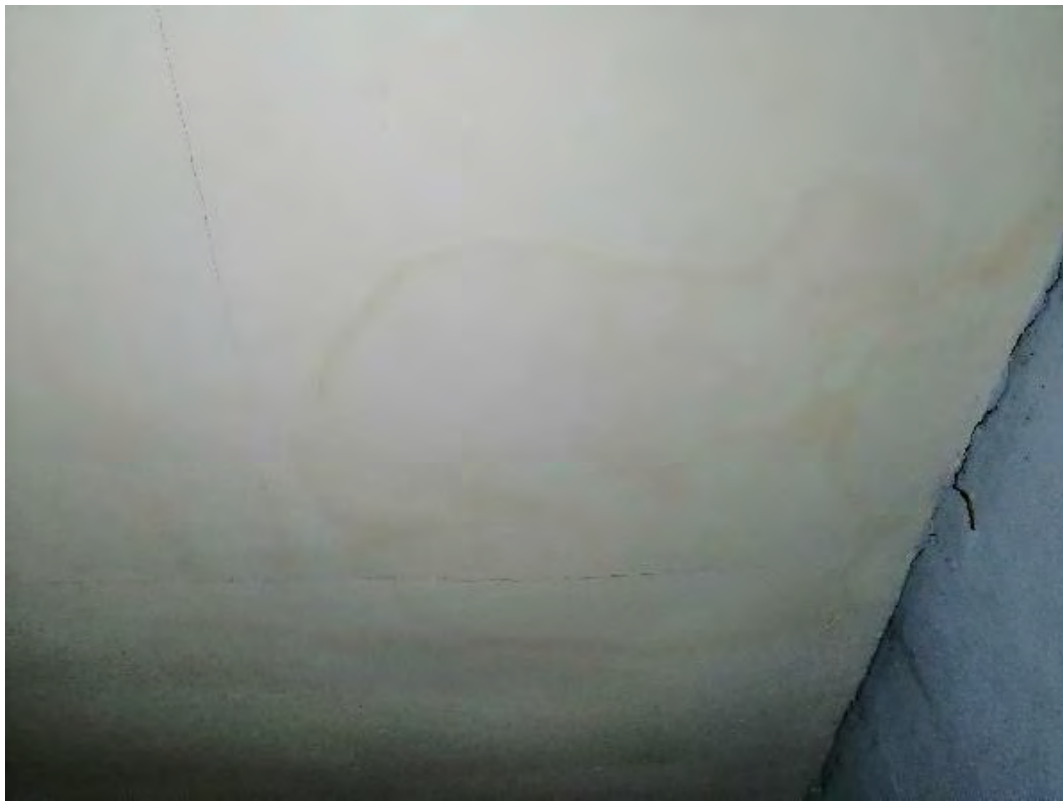
Photo 139 – Penetrating Damp (Rear Room)

Penetrating damp was noted to the ceiling of the rear room – see photo 139 below. Due to the limited access to the roof void we were unable to confirm the cause of the penetrating damp at this location. It is recommended that further investigation is undertaken within the roof void (following safe access provisions) to confirm the cause of this penetrating damp and undertake suitable remedial works where necessary. Condition Rating **3** See Section 7.0 Recommendations for guidance on repair works required.

- Penetrating damp was noted to the ceiling of the rear room – see photo 139. Due to the limited access to the roof void we were unable to confirm the cause of the penetrating damp at this location.

2). Penetrating damp was noted to the ceiling of the rear room – see photo 139. Due to the limited access to the roof void we were unable to confirm the cause of the penetrating damp at this location.

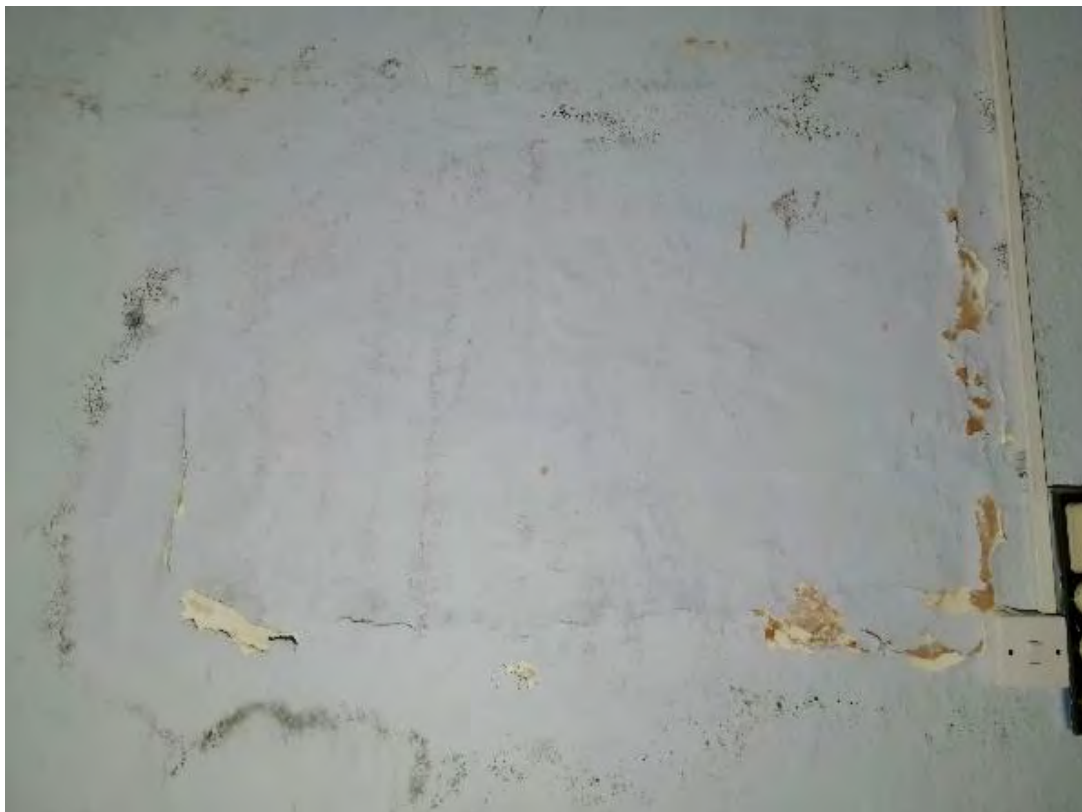
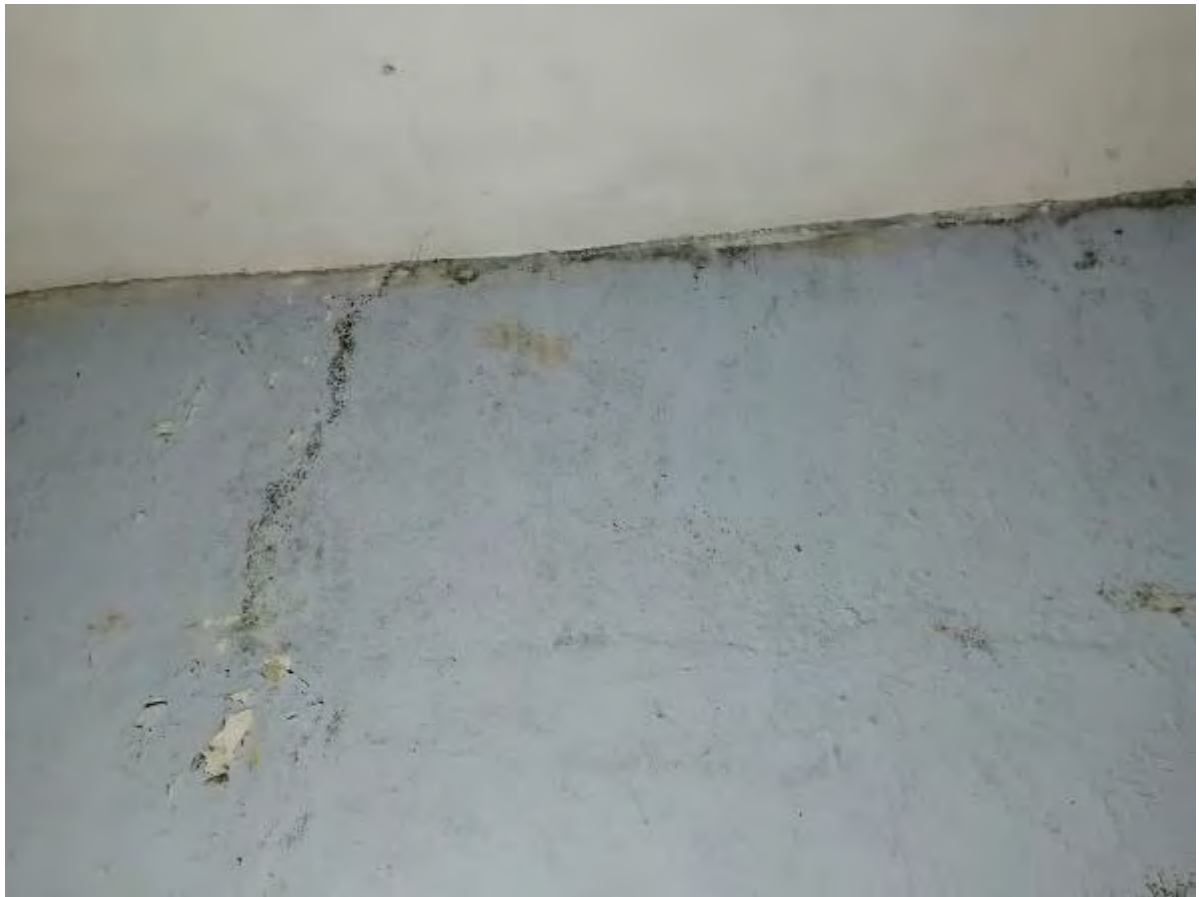
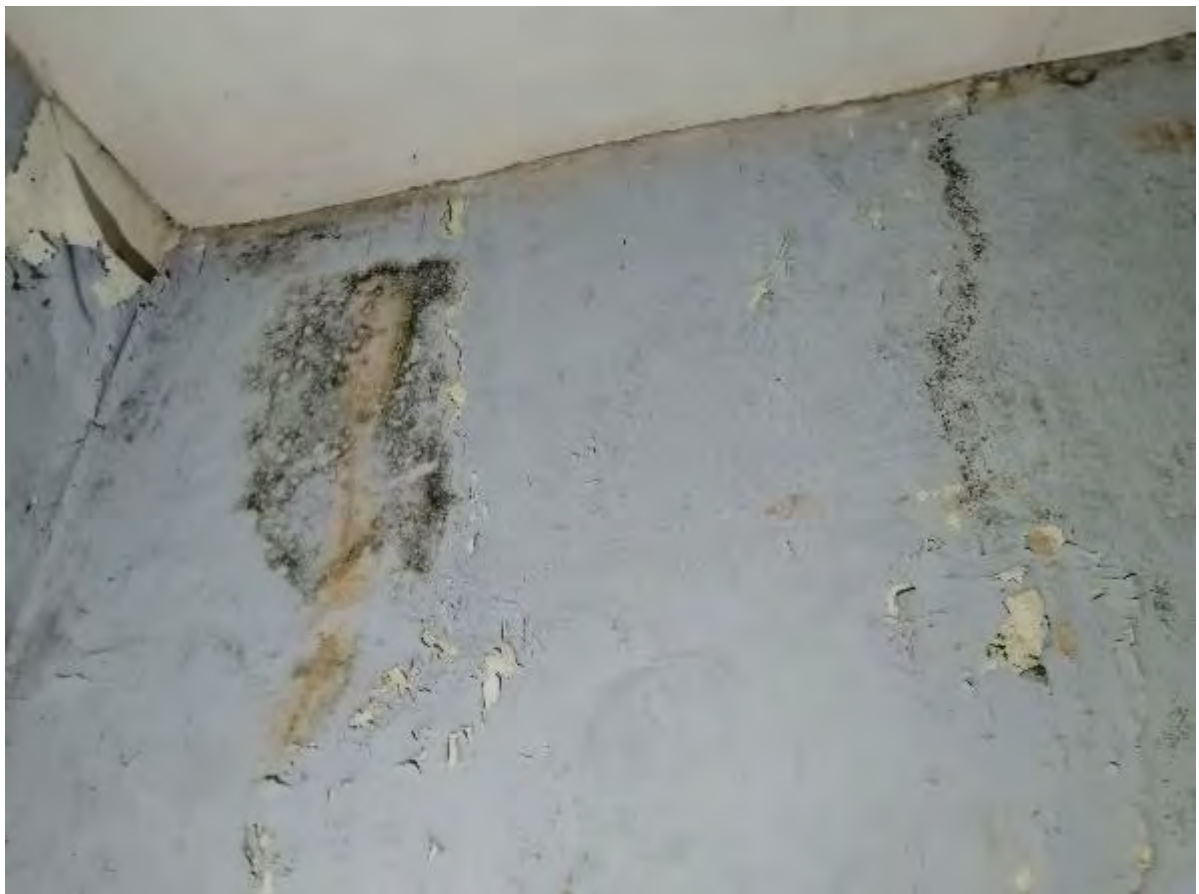
Penetrating damp was noted to the internal wall between the original building and front extension within the rear room – see photos 140-142 below. It is suspected that the damp is caused by issues / defects to the roof valley between the original and front roof profile. However, due to the limited access to the roof void and limited visibility of the external roof profile at this section of roof we were unable to confirm the cause of the penetrating damp at this location. It is recommended that further investigation is undertaken within the roof void and at high level to the roof valley to confirm the cause of this penetrating damp and undertake suitable remedial works where necessary. Condition Rating **3** See Section 7.0 Recommendations for guidance on repair works required.

Photo 140 – Penetrating Damp (Rear Room)

Photo 141 – Penetrating Damp (Rear Room)

Photo 142 – Penetrating Damp (Rear Room)
