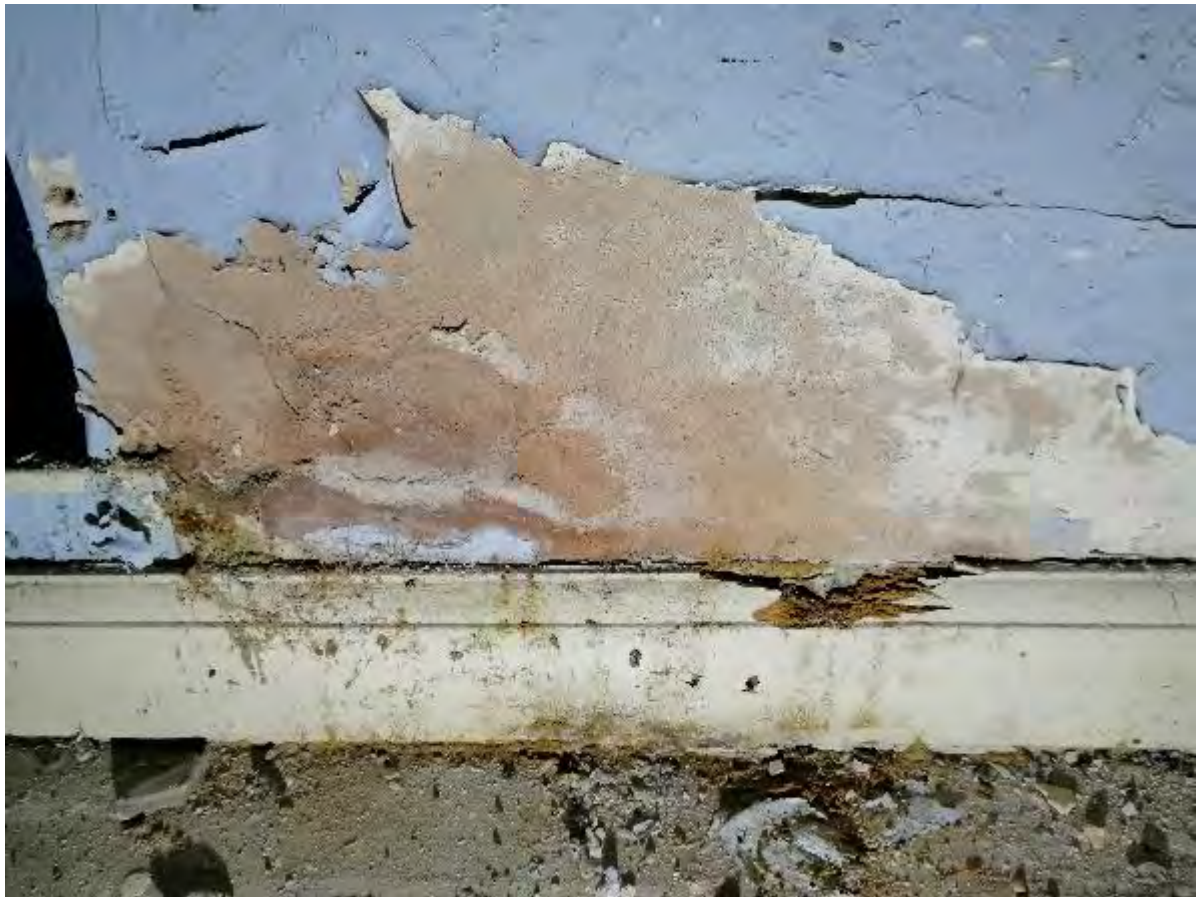
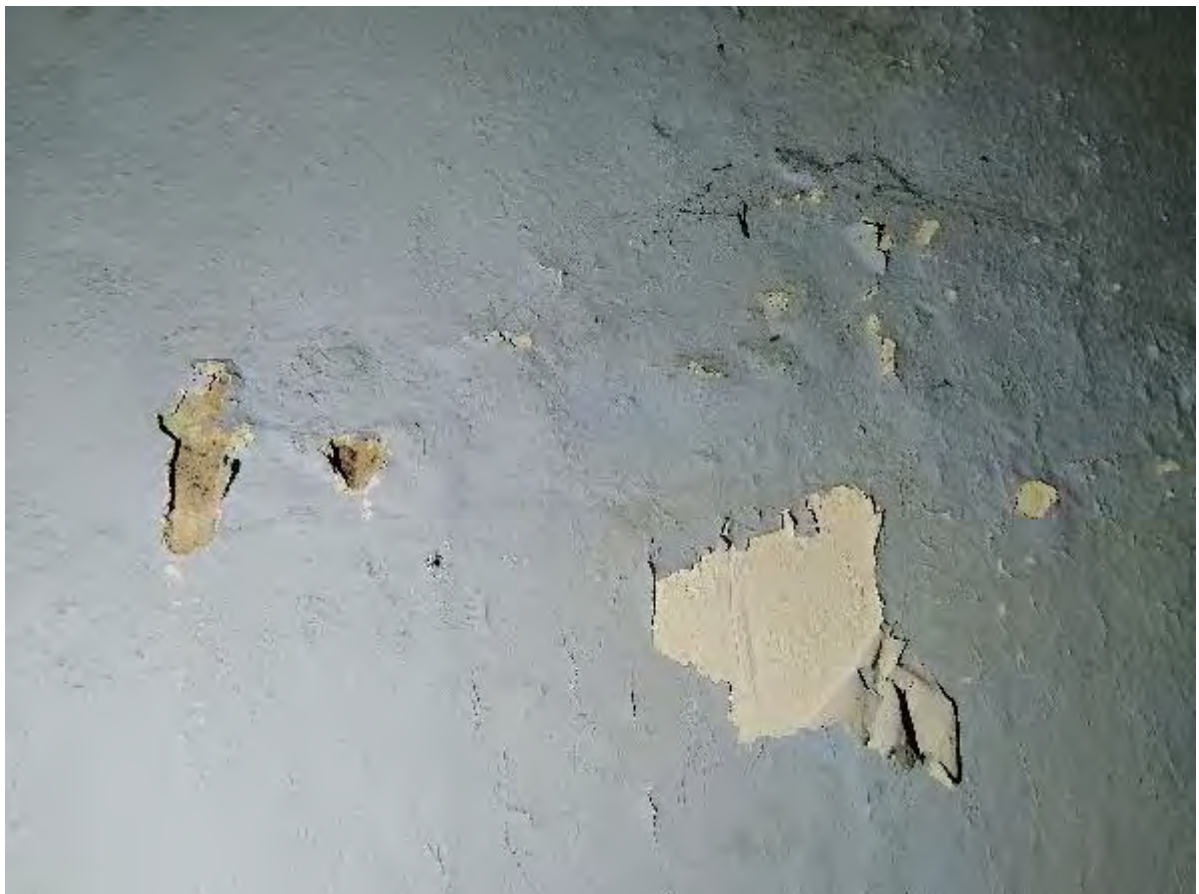
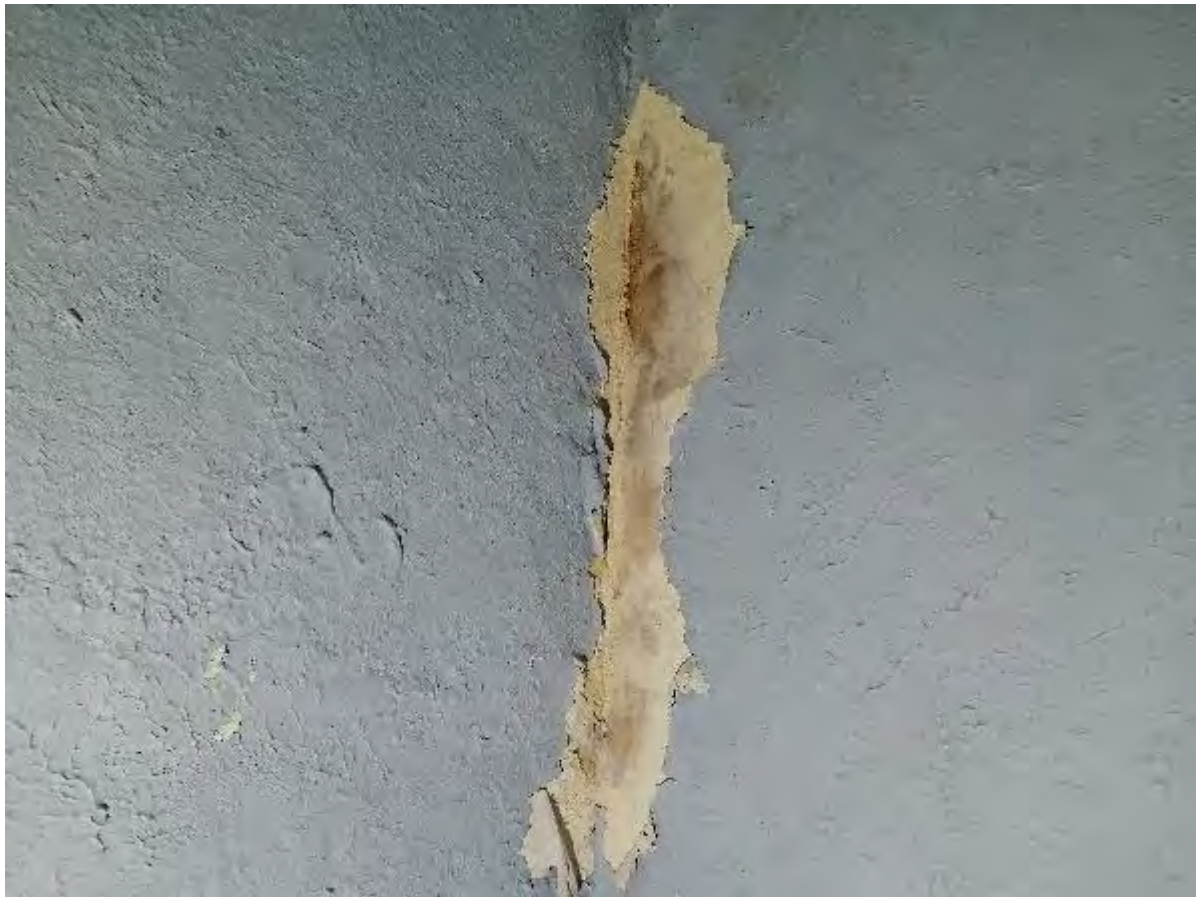
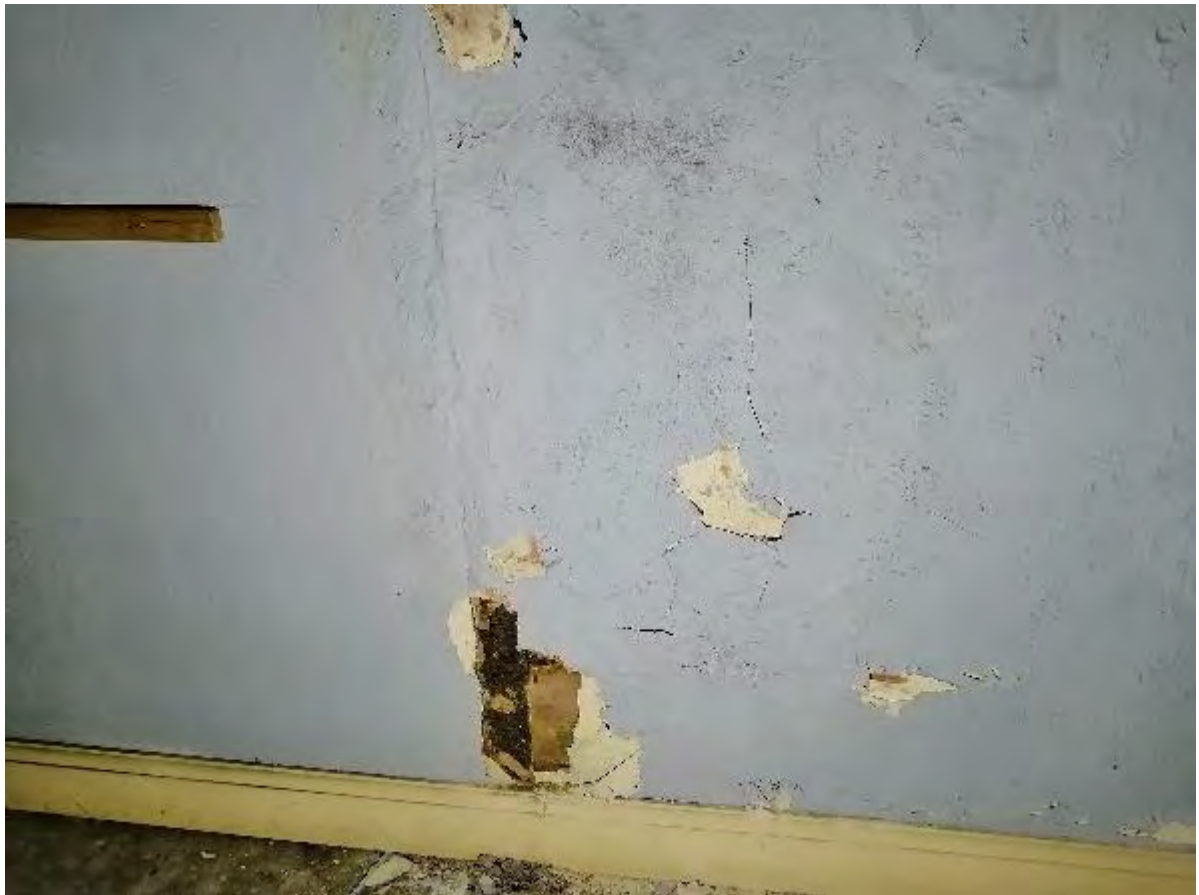
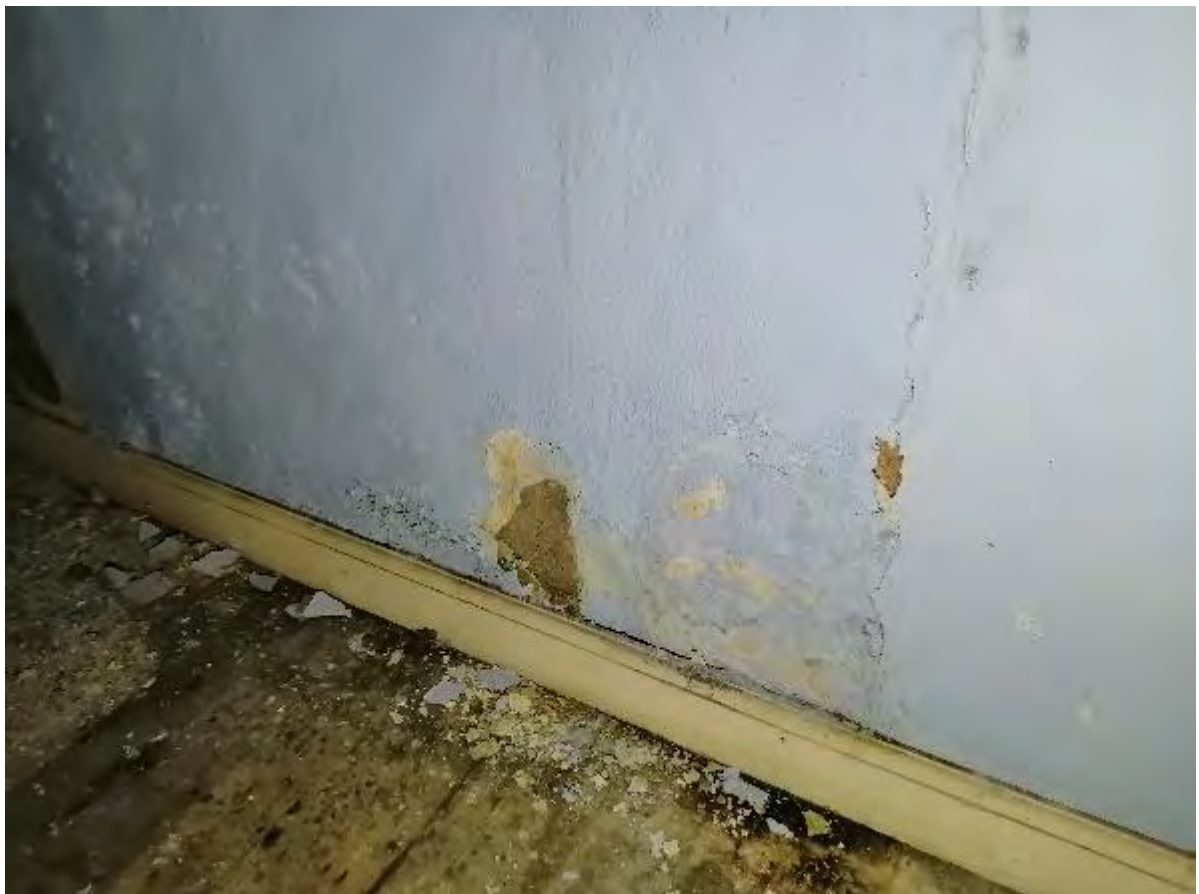
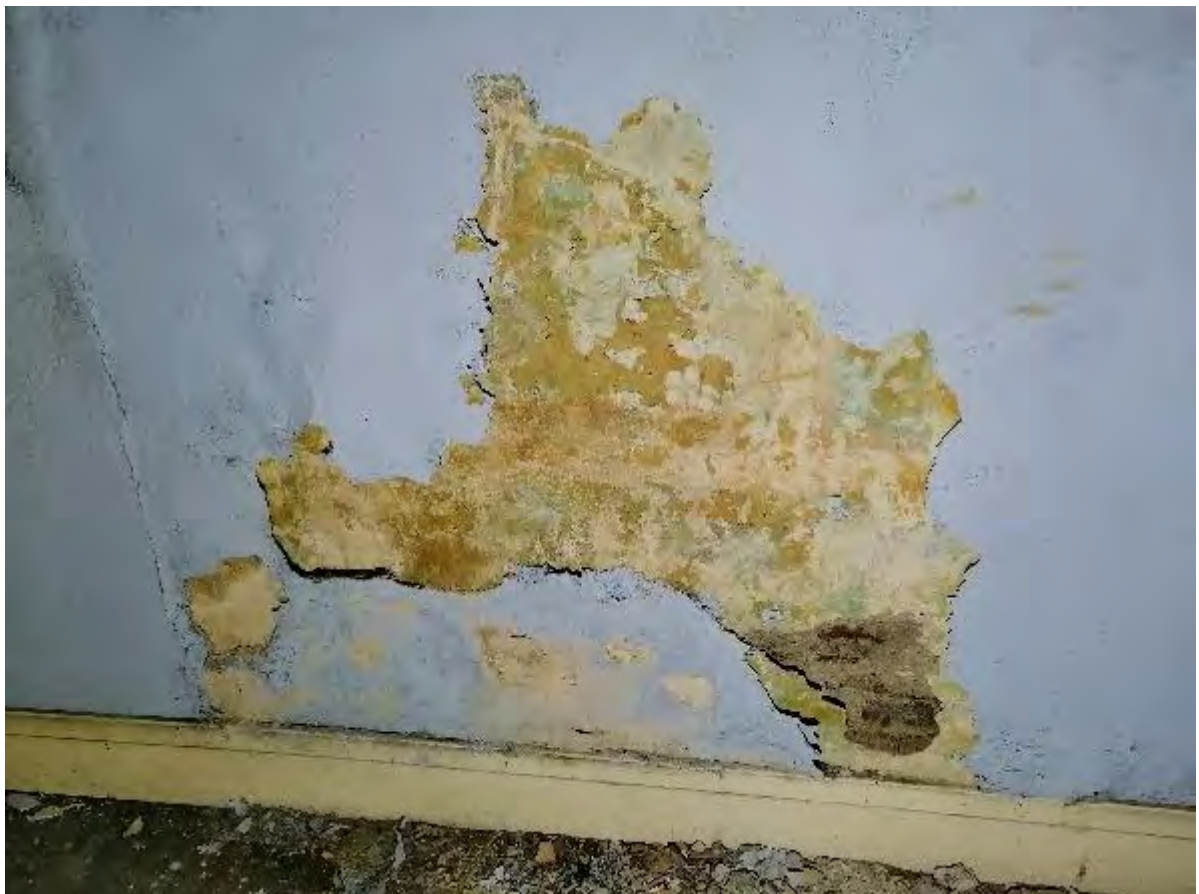
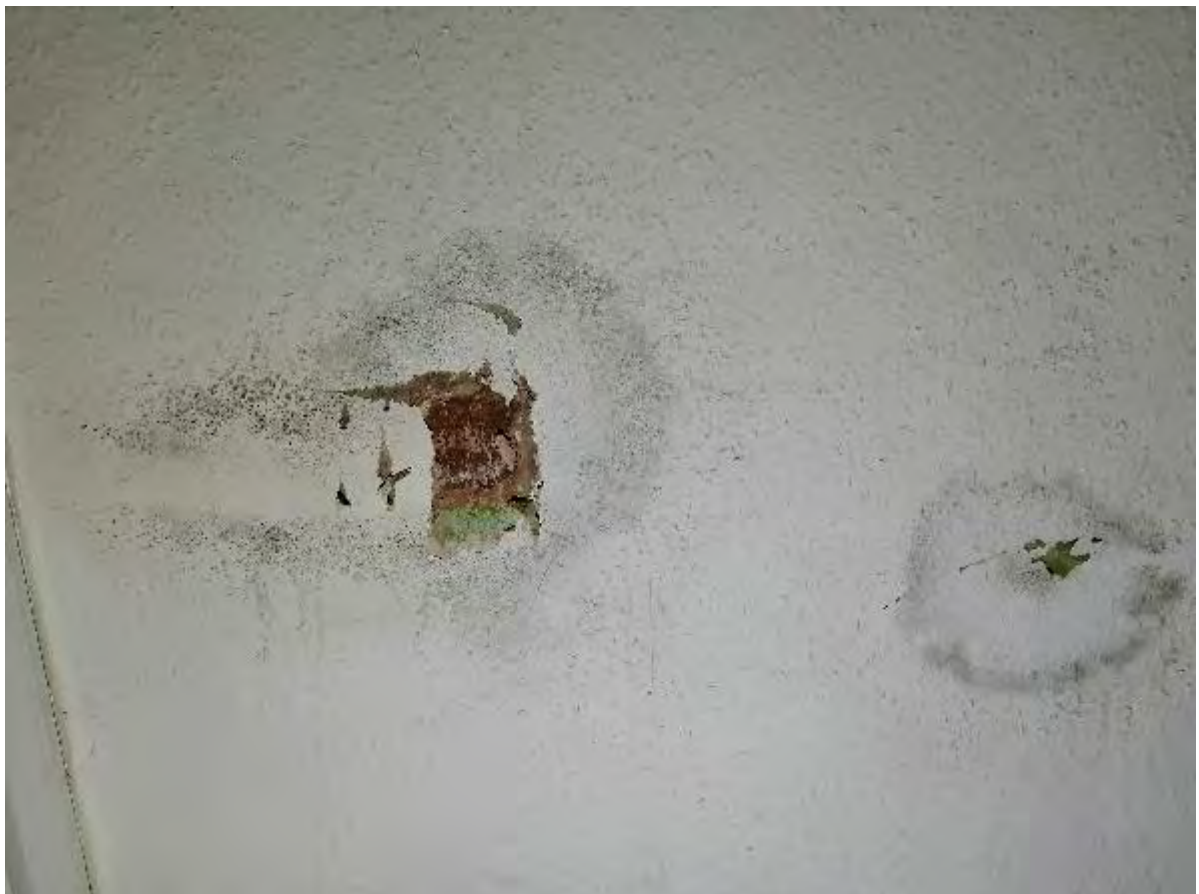
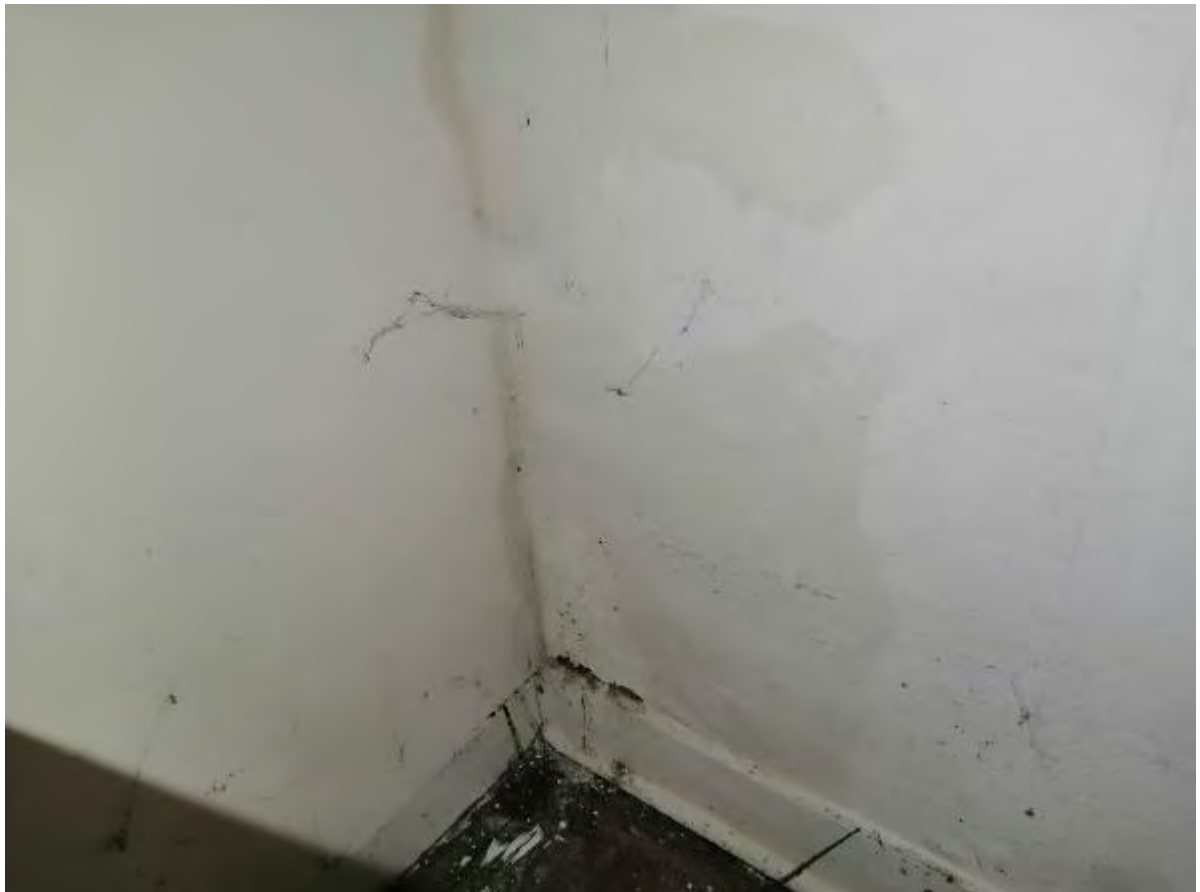
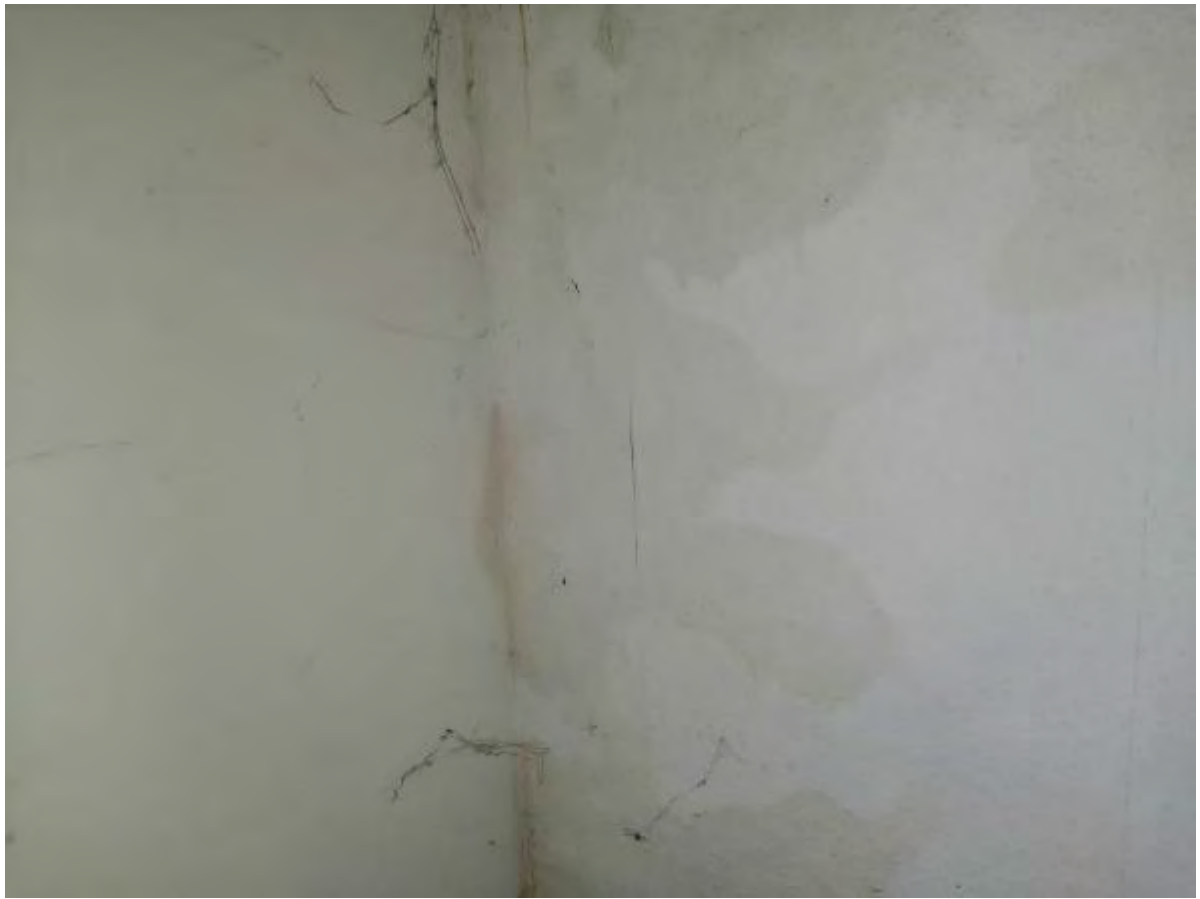
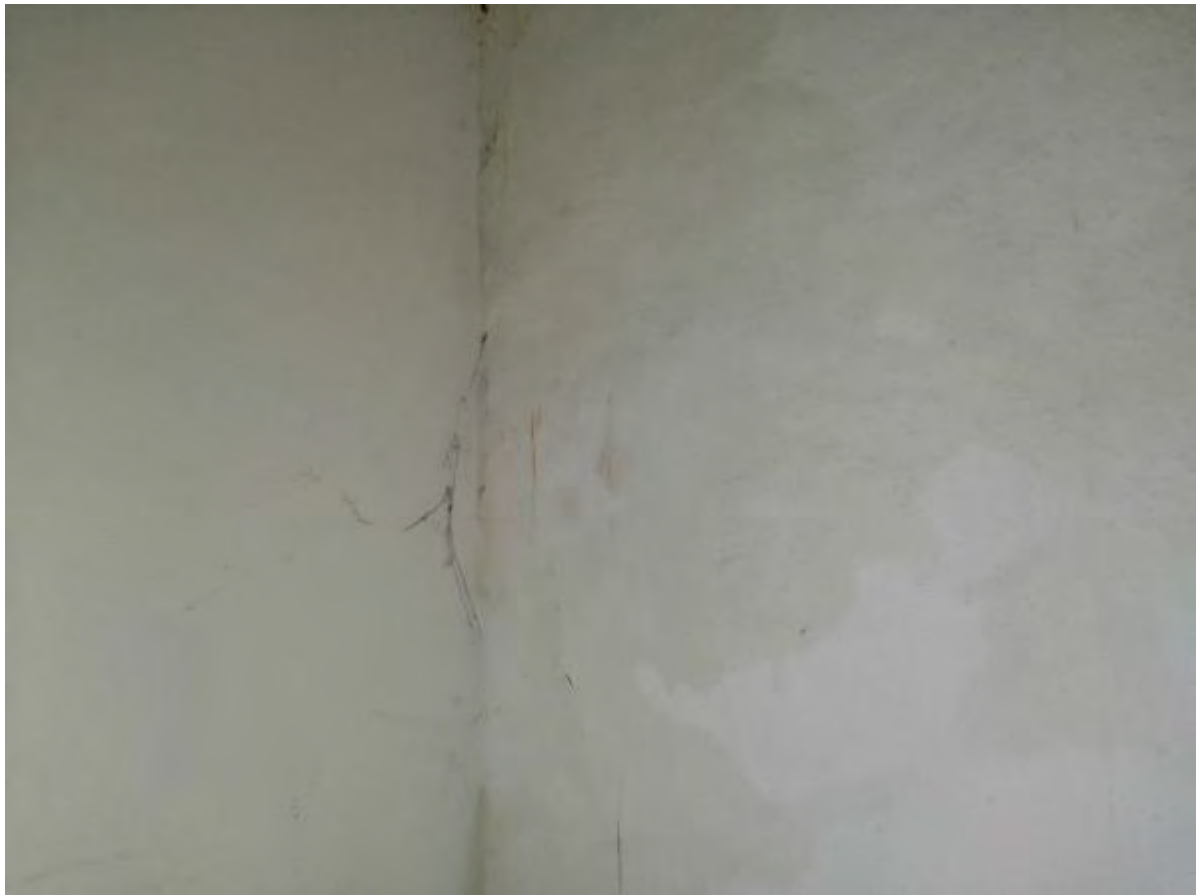
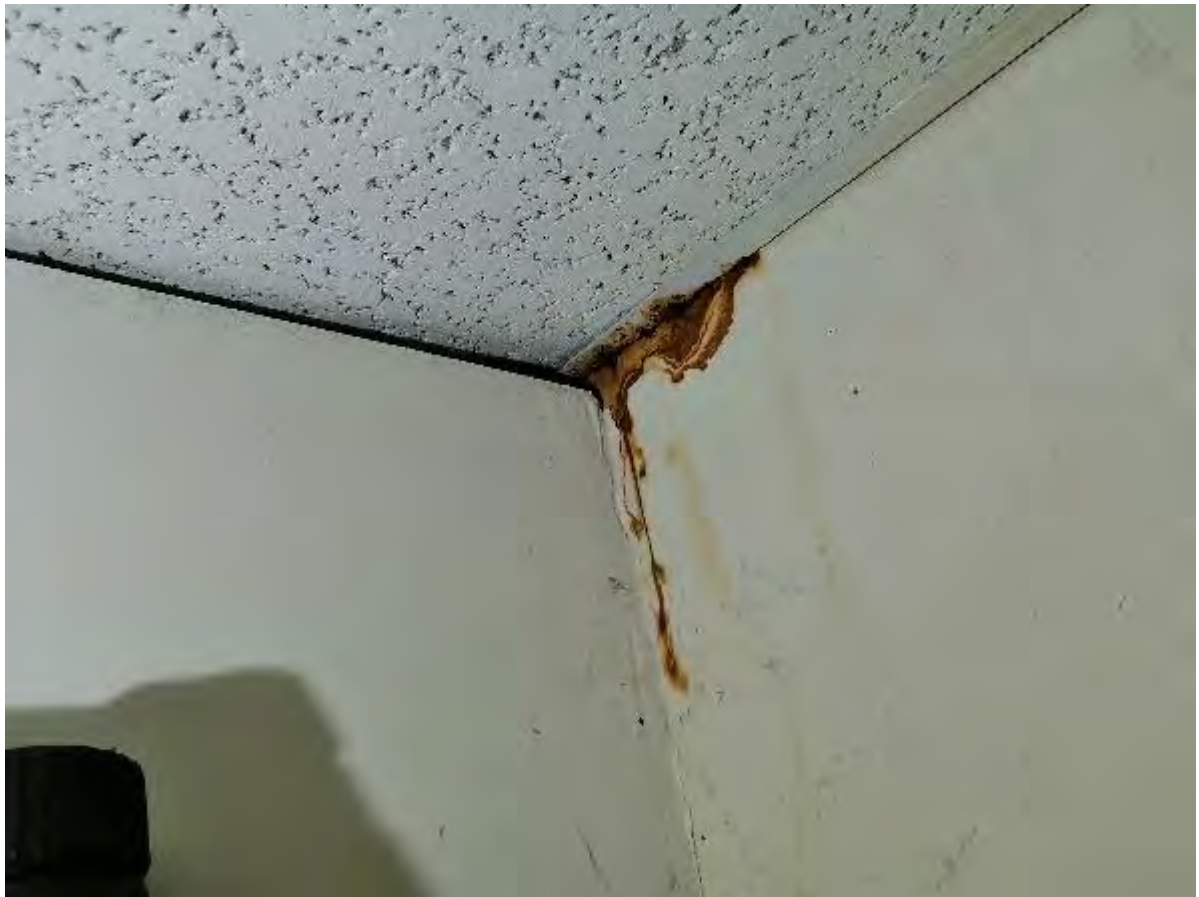
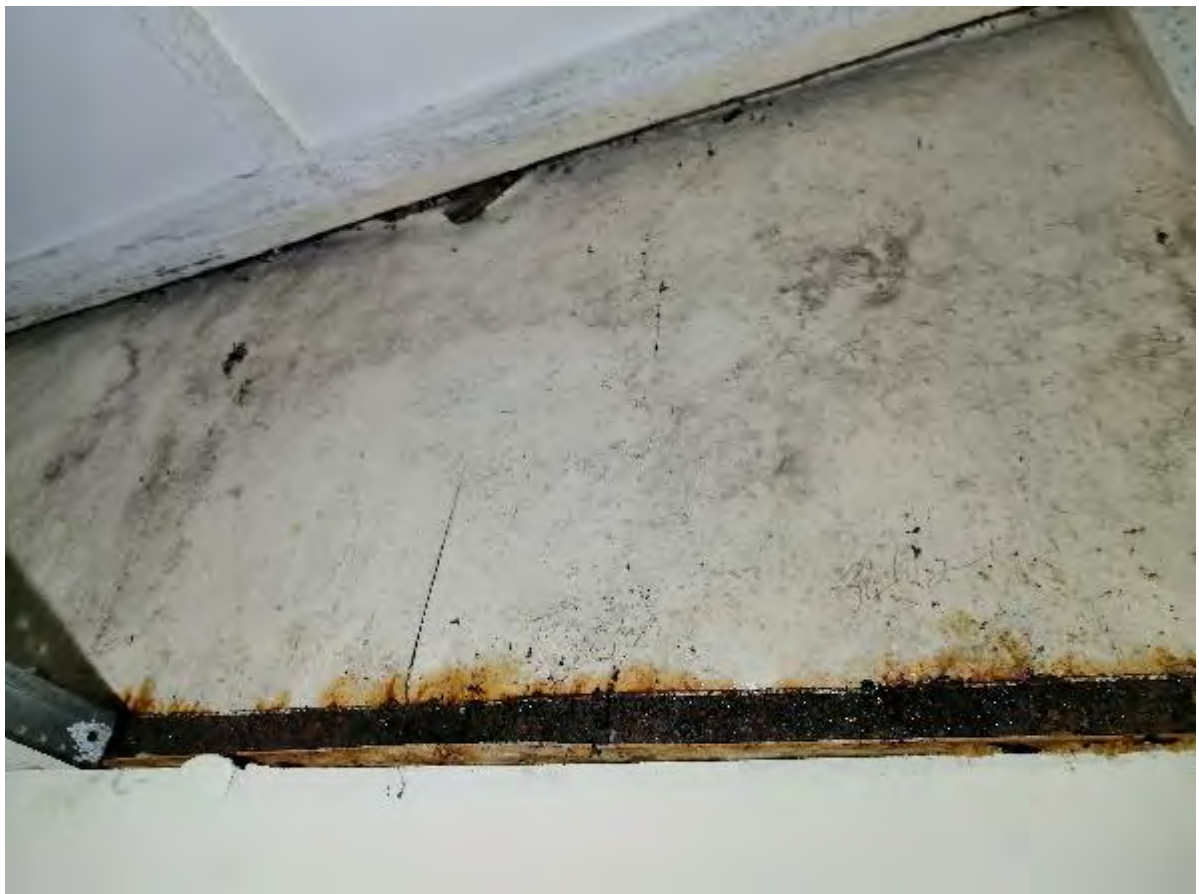
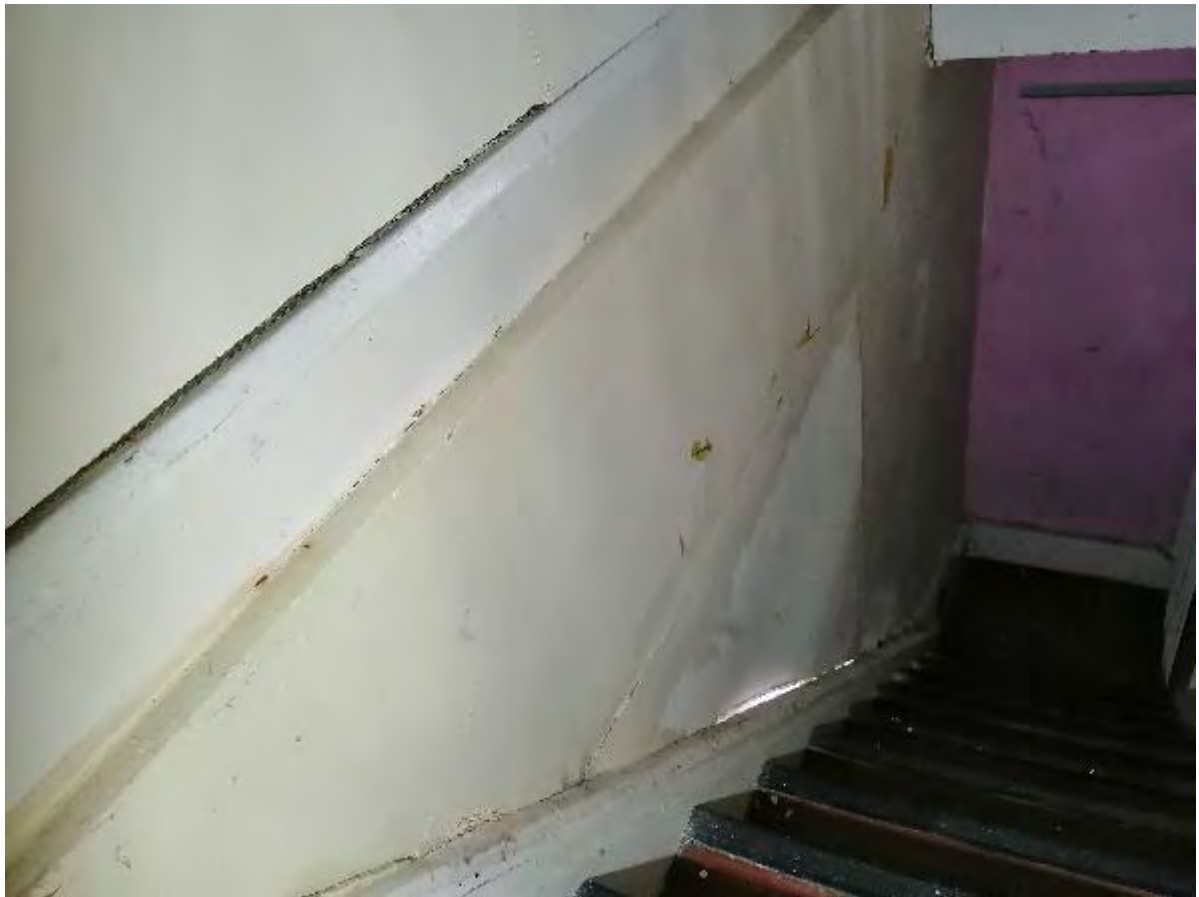
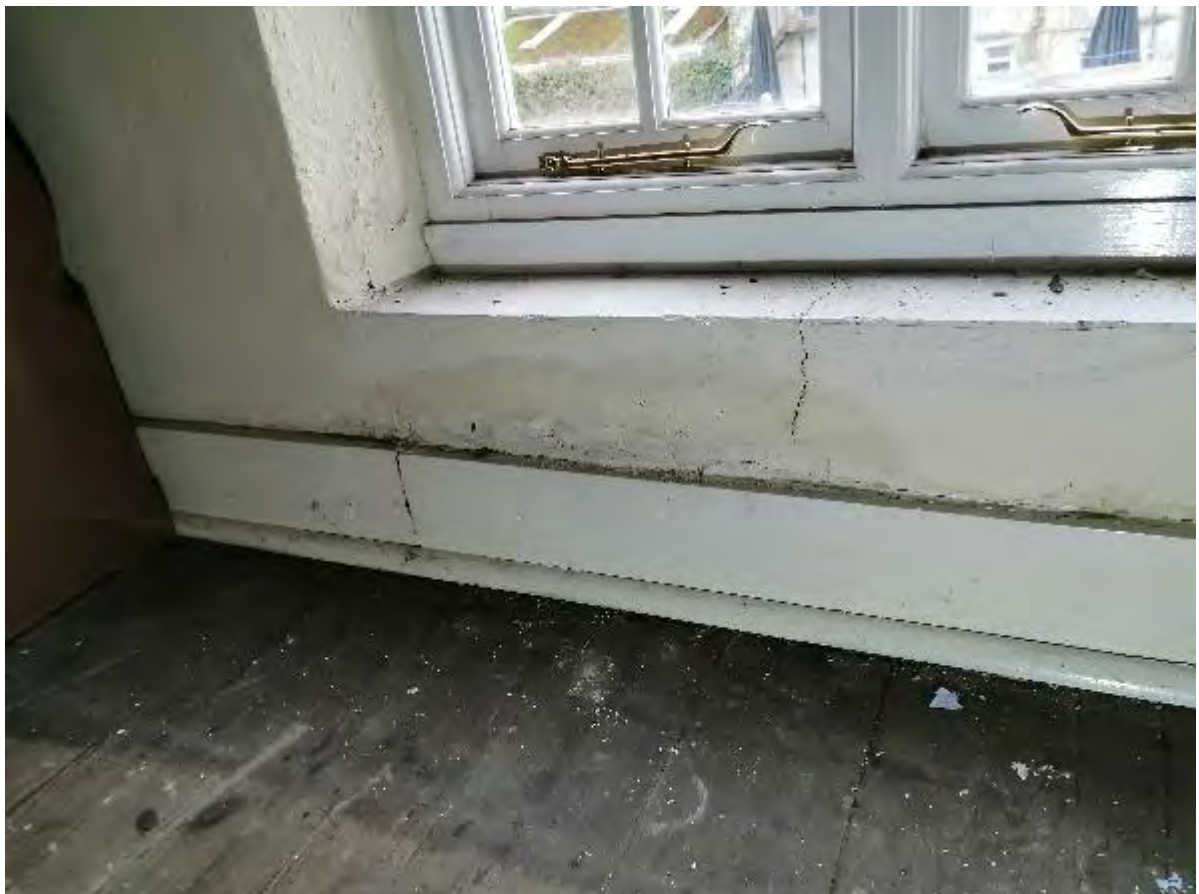
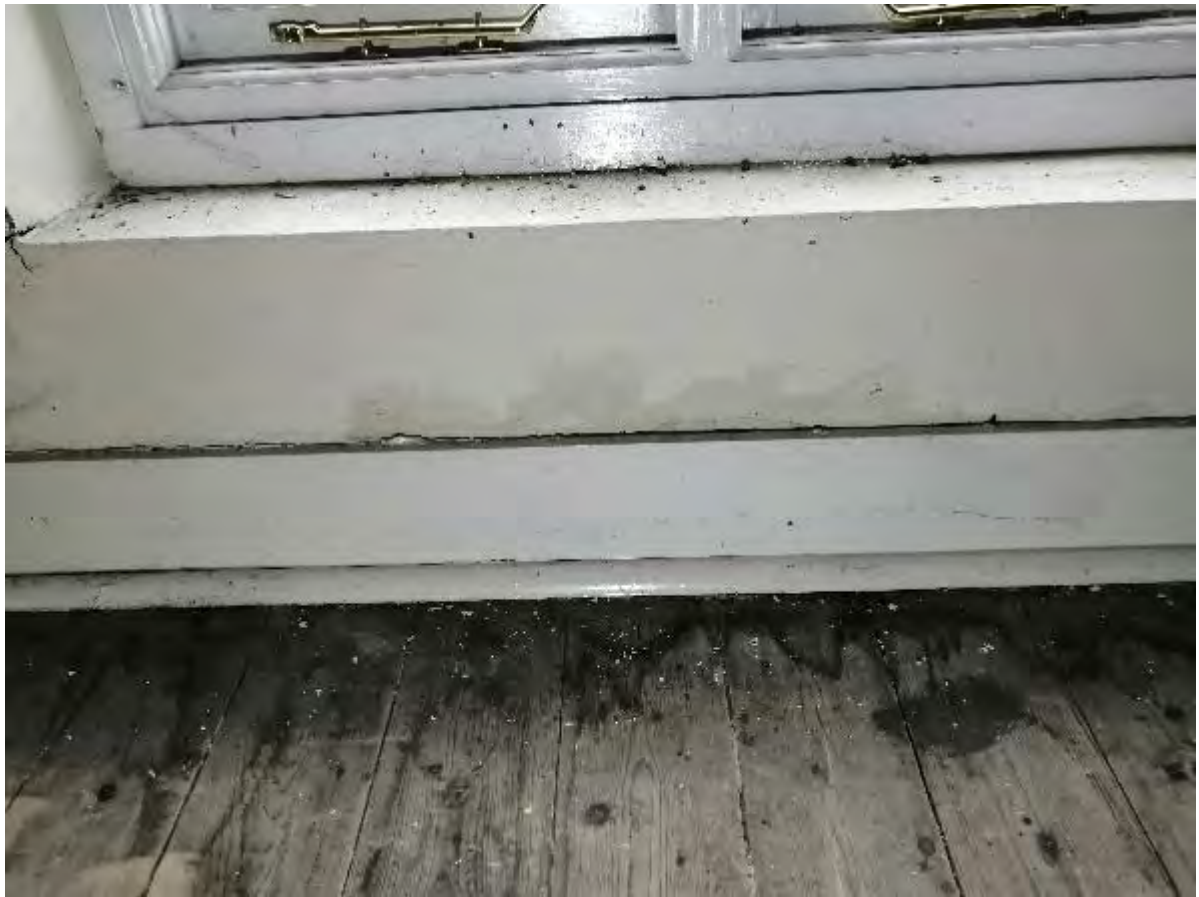
An inspection was undertaken to confirm the presence of damp in the property. Penetrating damp was noted to the external walls of the rear room, front room 1, staircase and male toilets – see photos 143-144, 147-148, 150, 152, 154, 156-163, 165 and 167-168 below. These areas of penetrating damp are expected to be caused by cracking of the external render and stonework mortar joints / pointing. Also, the type of render being cementitious based entraps moisture and prevents the solid wall from suitably ‘breathing’ - Condition Rating **3** See Section 7.0 Recommendations for guidance on repair works required.

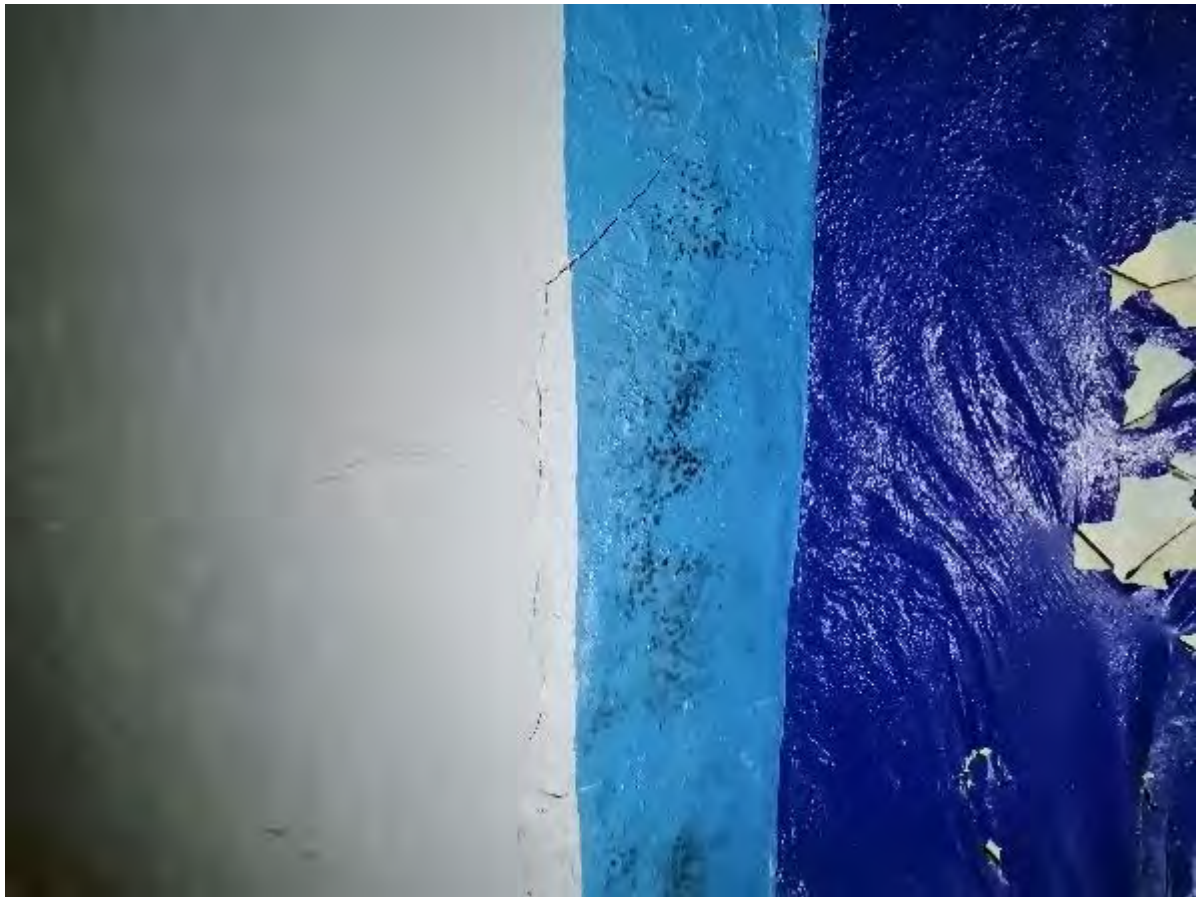
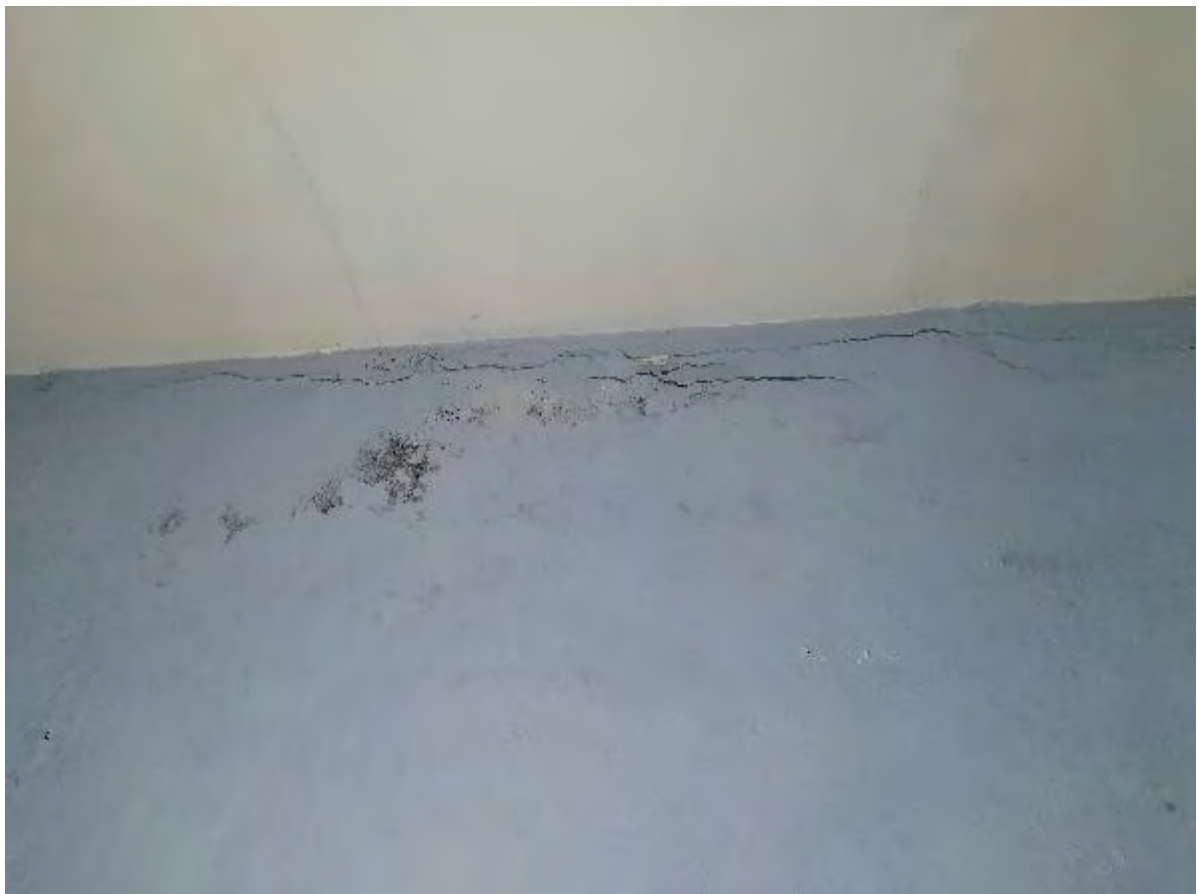
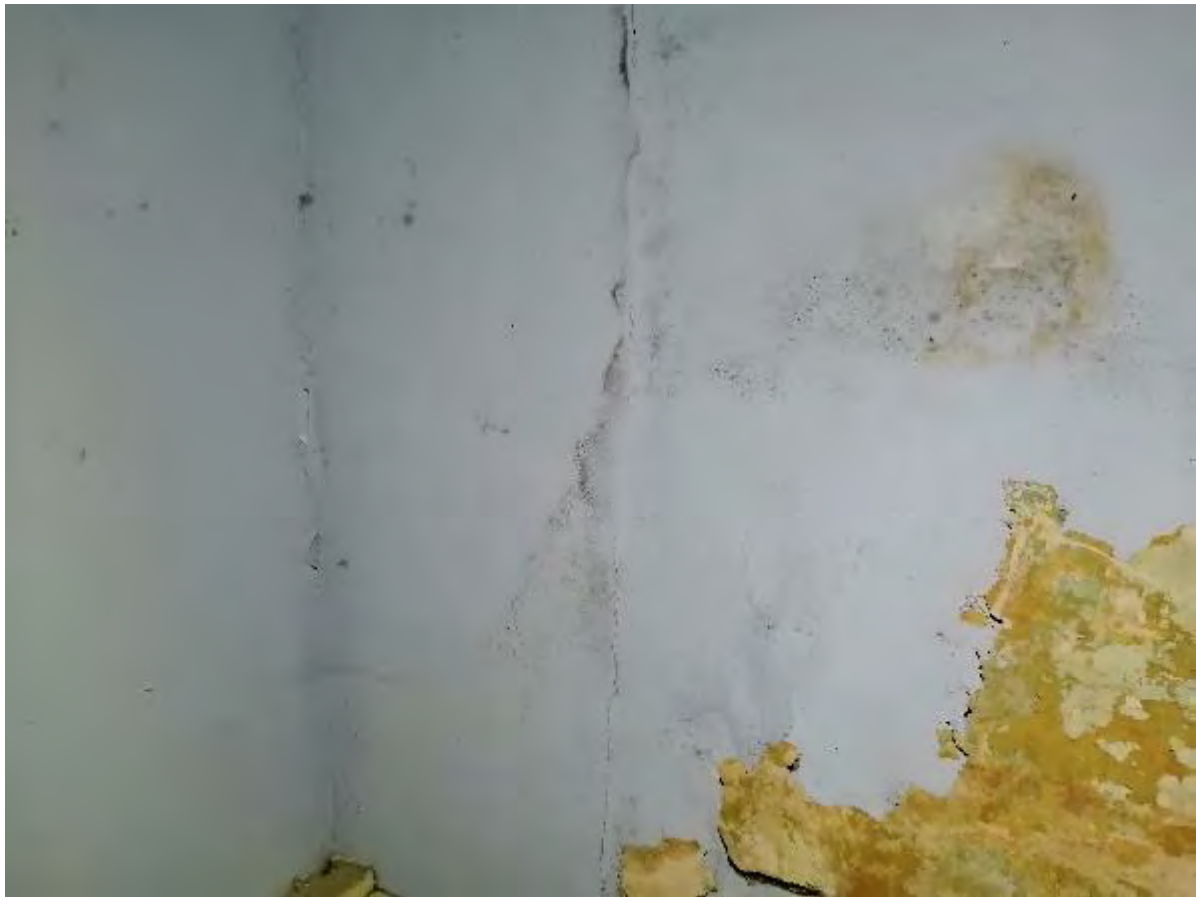
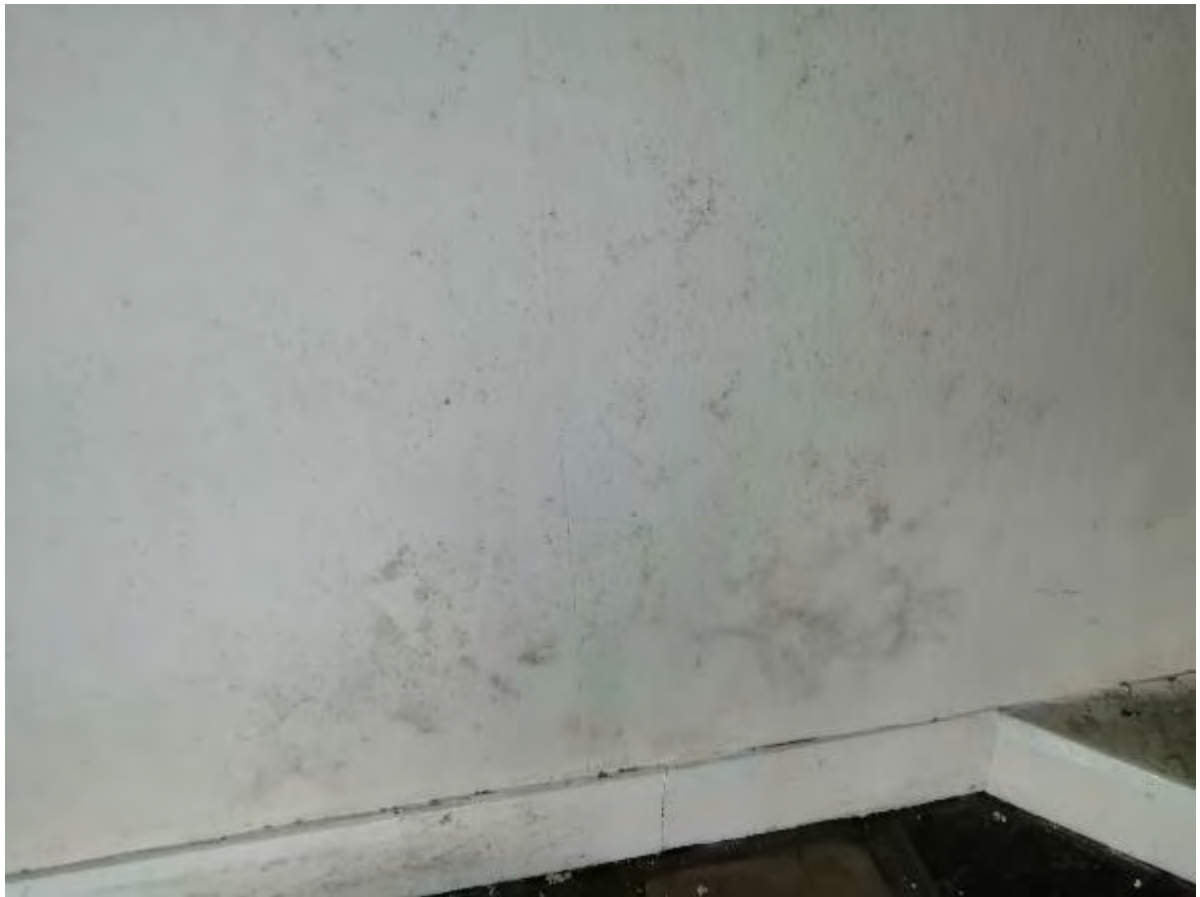
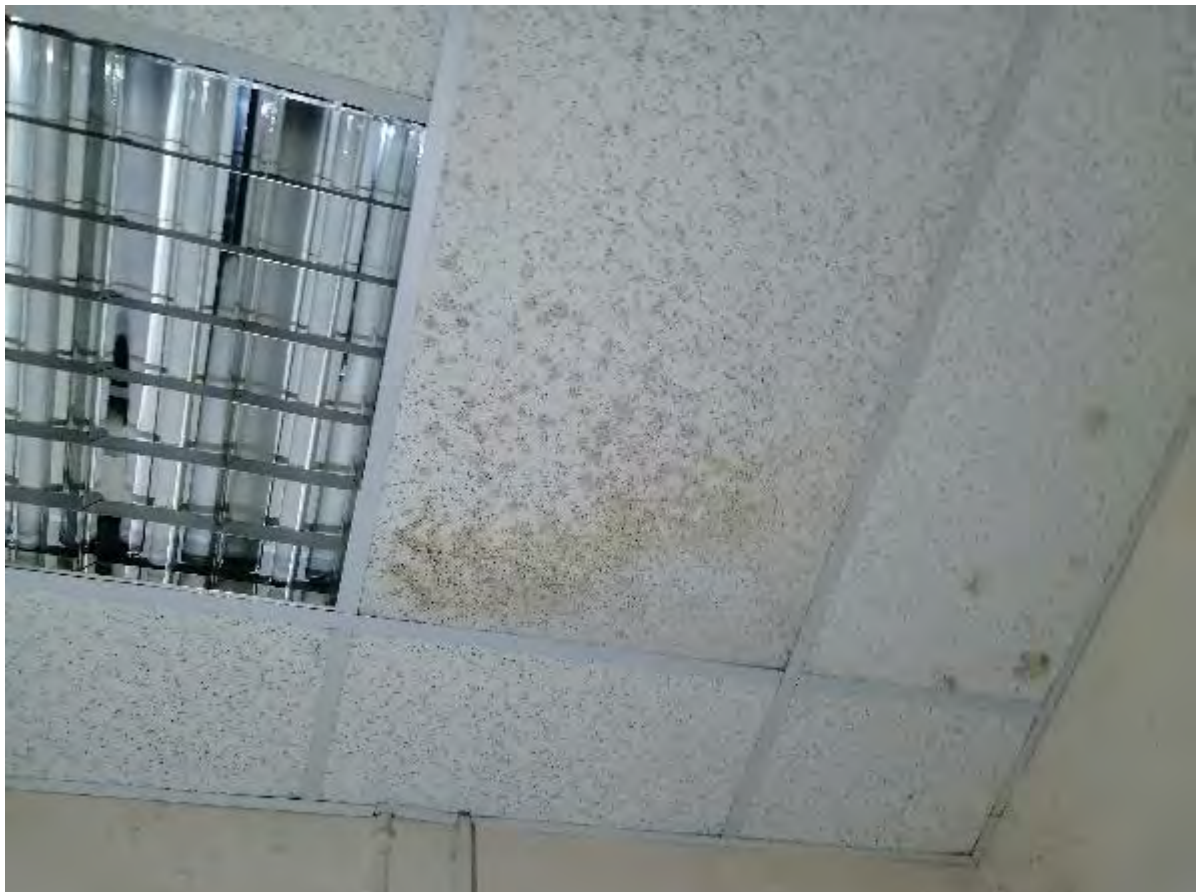
It shall be recognised that solid wall construction as adopted throughout the property offers less protection against penetrating damp when compared to cavity wall construction used in the extension. Damp can be more prevalent during winter months and can be exacerbated by cracked or defective external render and mortar joints / pointing. Damage to internal wall surfaces most commonly occur due to inadequate passive ventilation into the habitable rooms (i.e. no trickle vents or secondary locks in the window frames), where moisture and condensation is not given an opportunity to escape and ends up damaging the internal wall finishes over time (i.e. condensation damage). Condensation damp was noted in the rear room, front room 1 and male toilets – see photos 145-146, 149, 151, 153, 155 and 166 below.

To minimize and control the build up of moisture internally (and thus damage to internal wall surfaces), a passive means of ventilation is necessary as discussed above regarding trickle vents in the window frameworks - Condition Rating **2** See Section 7.0 Recommendations for guidance on repair works required.

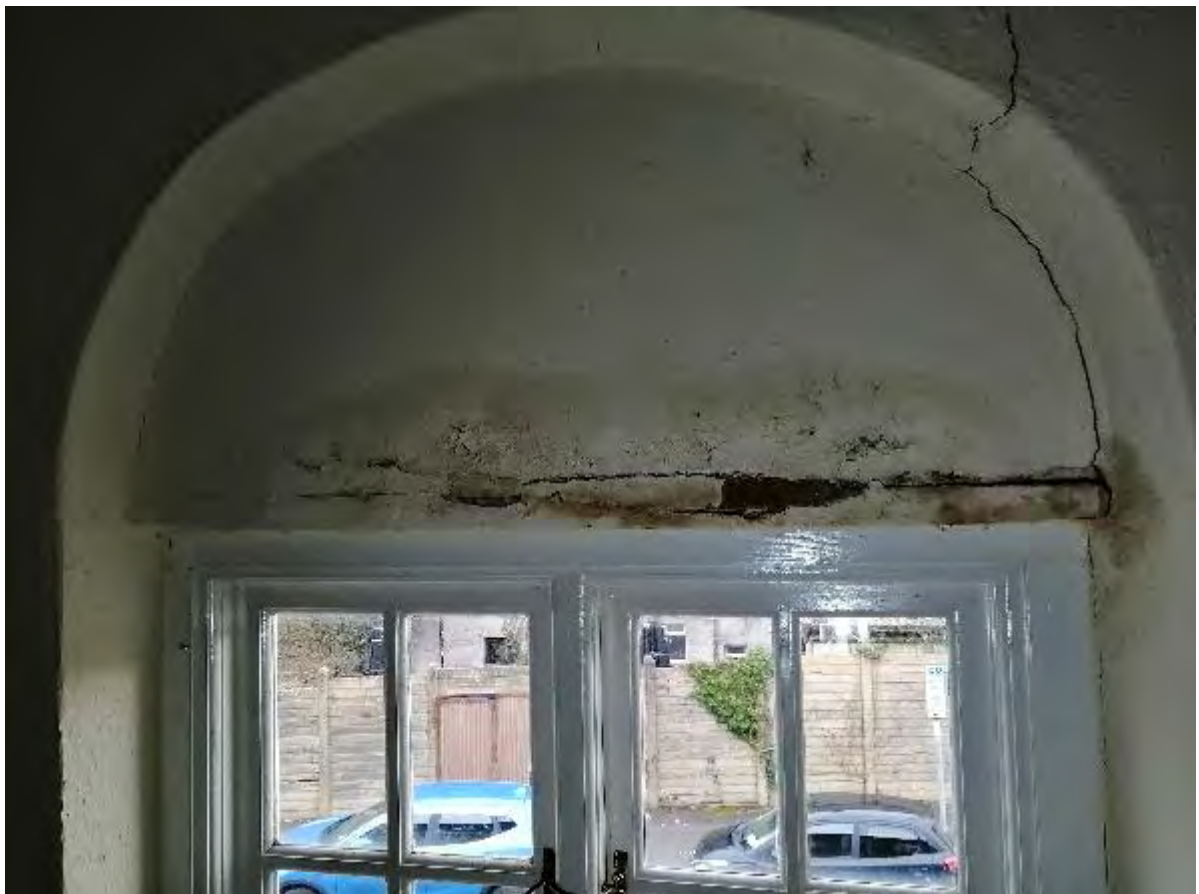
Photo 164 – Penetrating Damp (Front Room 1)

Penetrating damp was noted to the window of the front room 1 – see photo 164 below. It is expected that this penetrating damp is caused by rot to the timber window frame. Condition Rating **3** See Section 7.0 Recommendations for guidance on repair works required.

- Penetrating damp was noted to the window of the front room 1 – see photo 164. It is expected that this penetrating damp is caused by rot to the timber window frame

4). Penetrating damp was noted to the window of the front room 1 – see photo 164 below. It is expected that this penetrating damp is caused by rot to the timber window frame.
