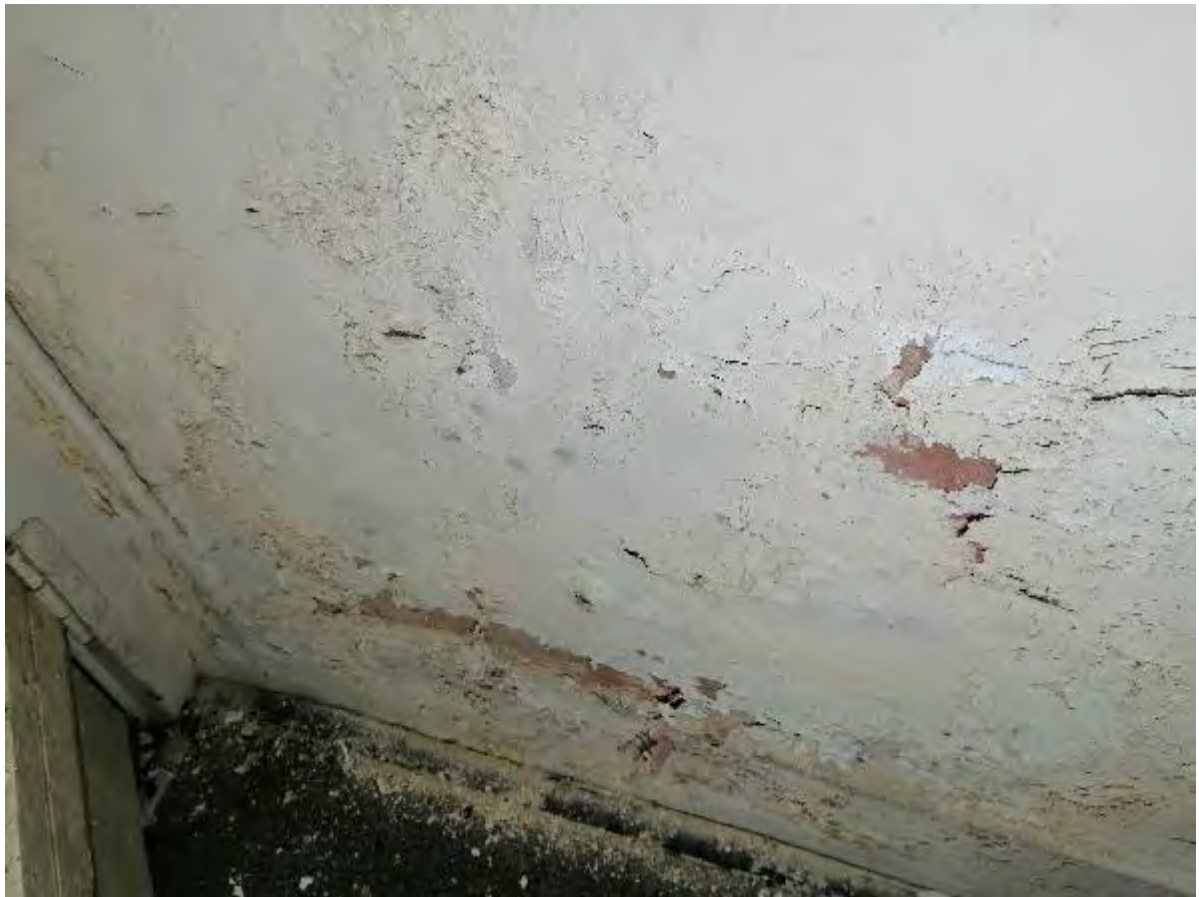
Photo 167 – Penetrating Damp (Male Toilets)

An inspection was undertaken to confirm the presence of damp in the property. Penetrating damp was noted to the external walls of the rear room, front room 1, staircase and male toilets – see photos 143-144, 147-148, 150, 152, 154, 156-163, 165 and 167-168 below. These areas of penetrating damp are expected to be caused by cracking of the external render and stonework mortar joints / pointing. Also, the type of render being cementitious based entraps moisture and prevents the solid wall from suitably ‘breathing’ - Condition Rating **3** See Section 7.0 Recommendations for guidance on repair works required.

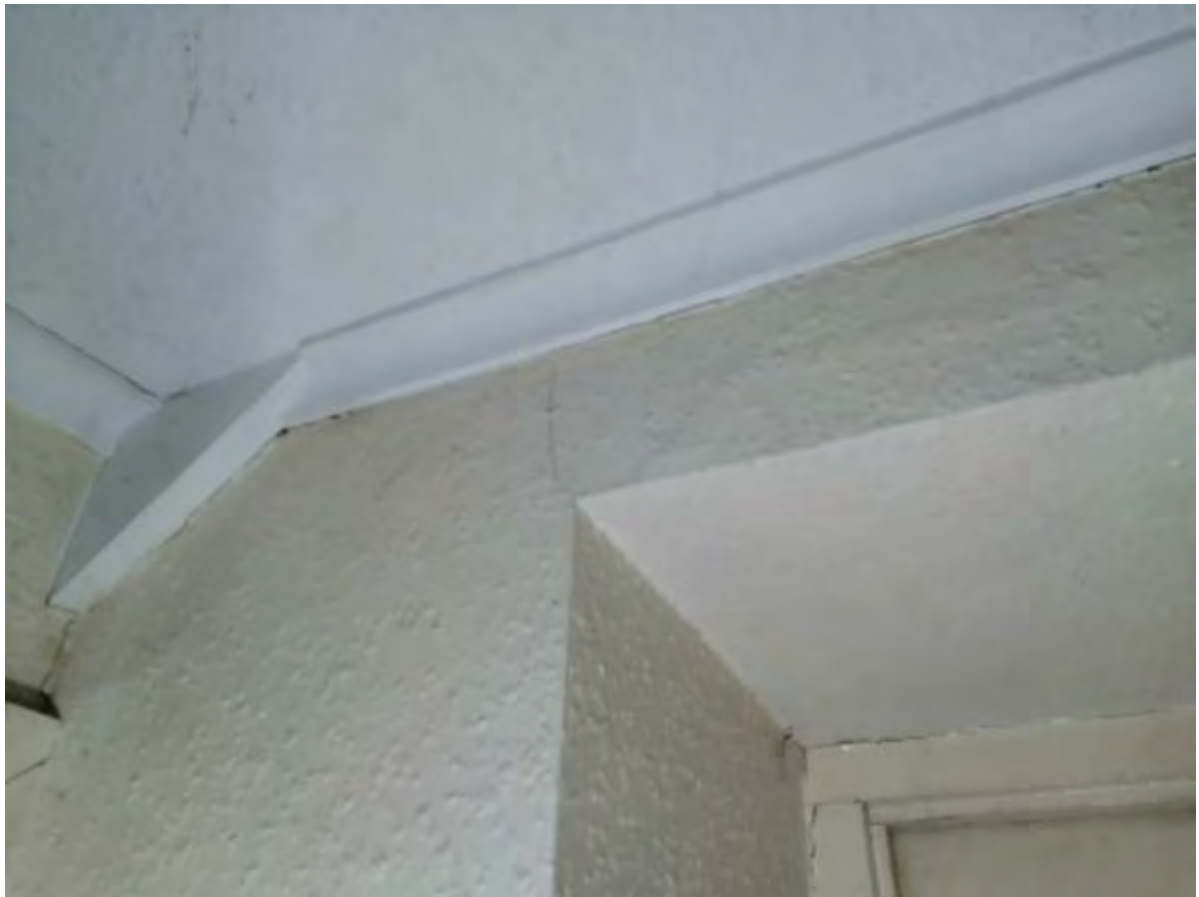
Photo 185 – Wall Plaster Crack (Corridor 1)

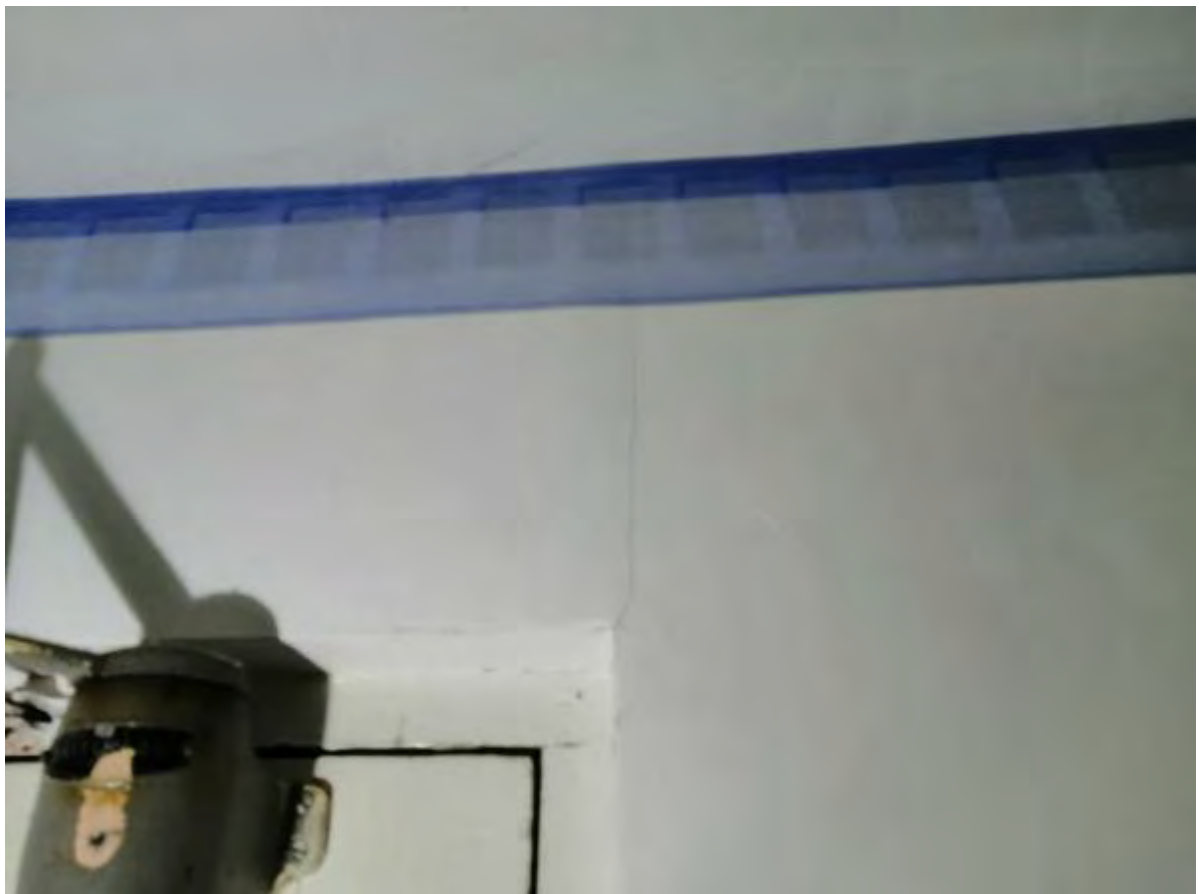
Photo 186 – Wall Plaster Crack (Female Toilets)

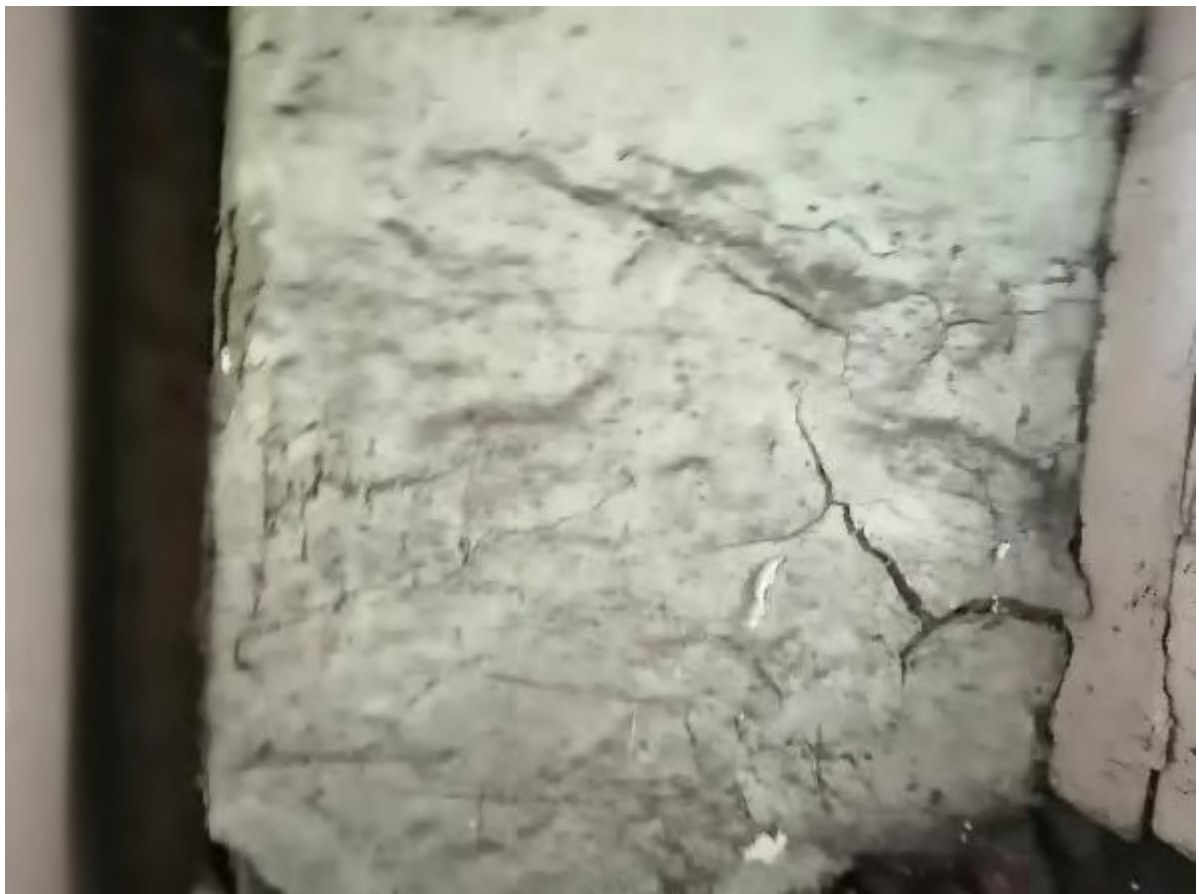
Photo 188 – Wall Plaster Cracking to Archway Behind Stud Wall (Front Room)

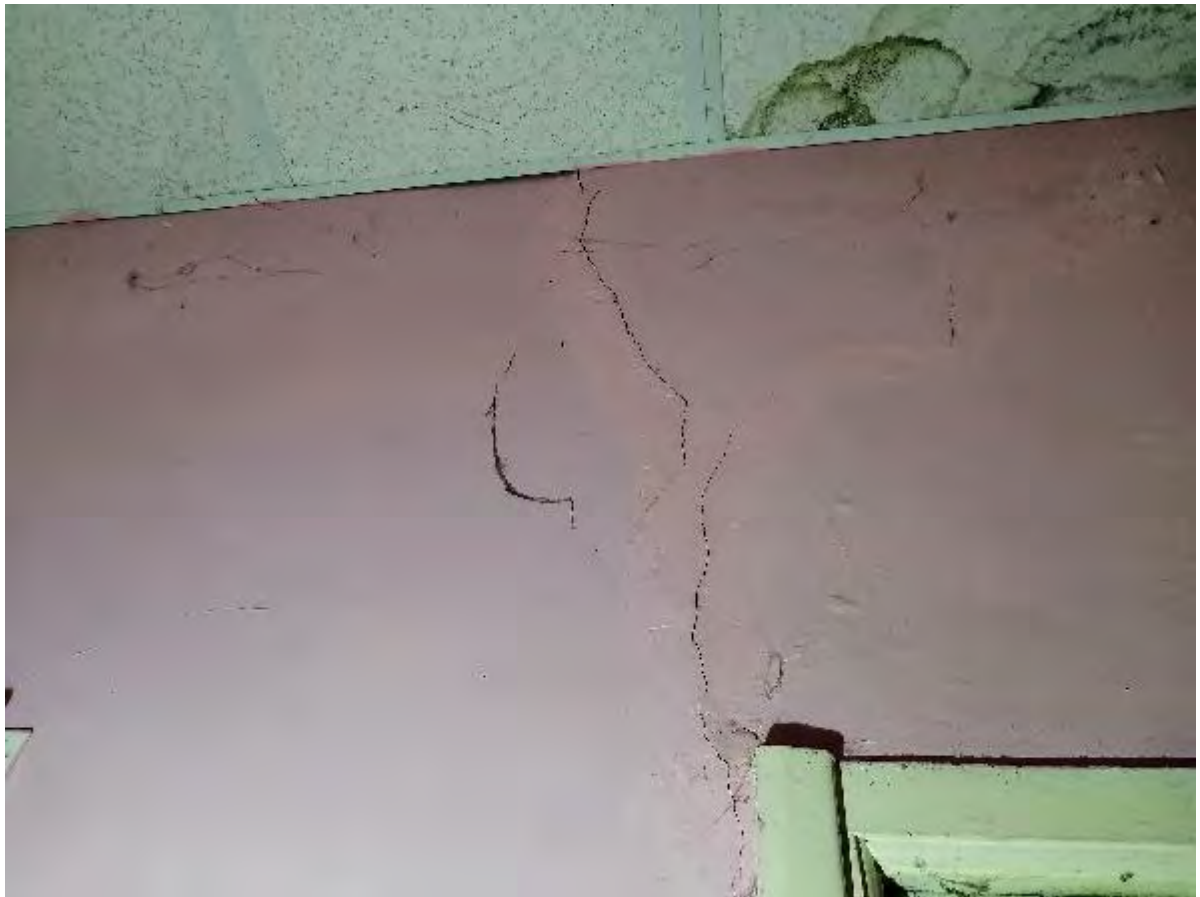
Photo 189 – Wall Plaster Cracking (Corridor 2)

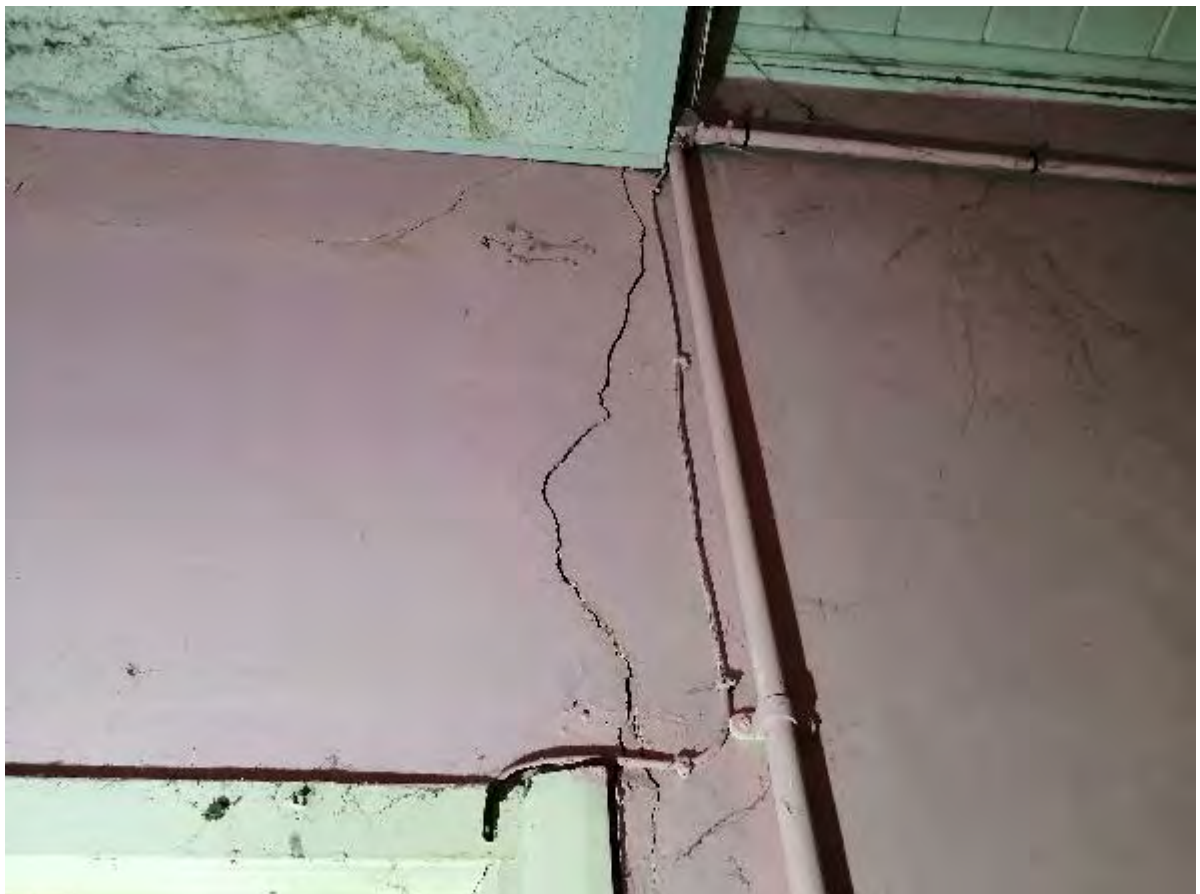
Photo 190 – Wall Plaster Cracking (Corridor 2)

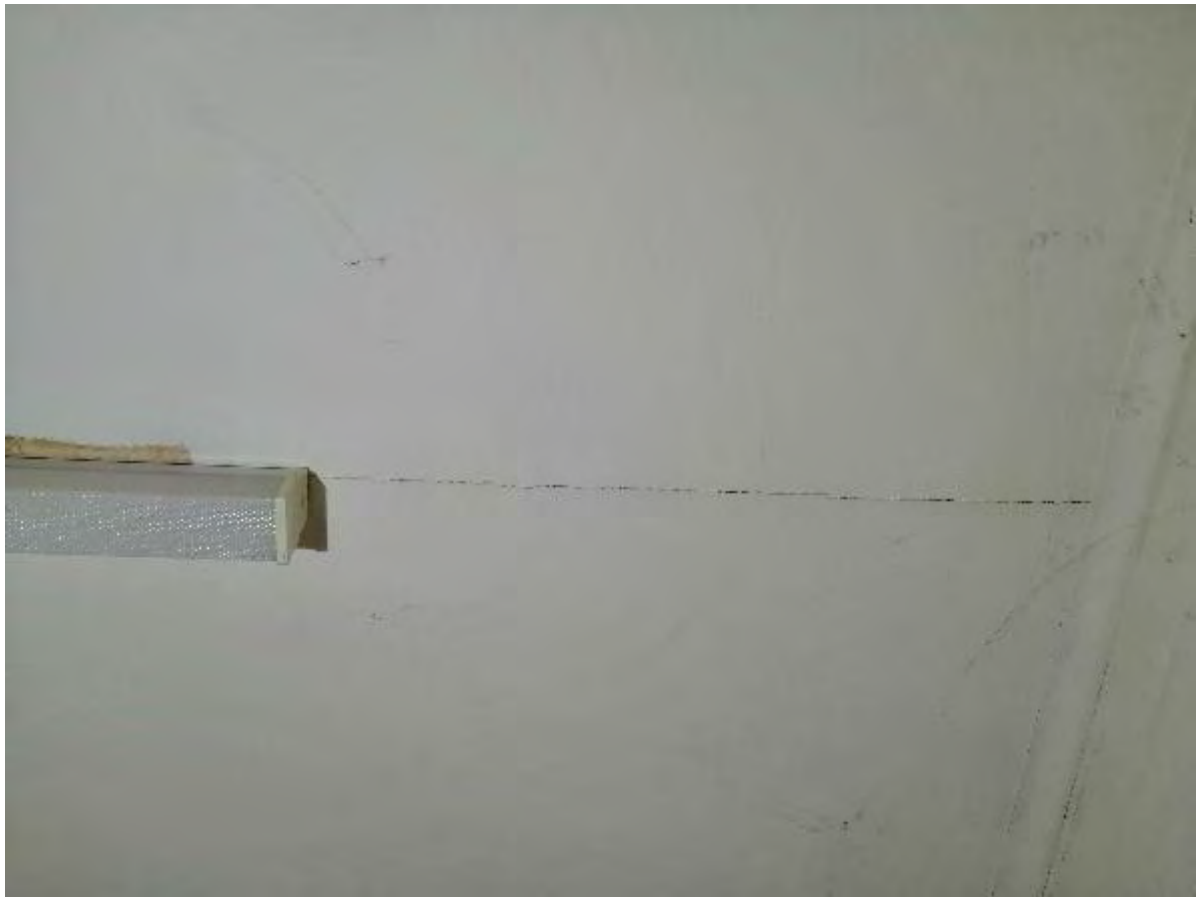
Photo 191 – Ceiling Cracking (Side Room 1)

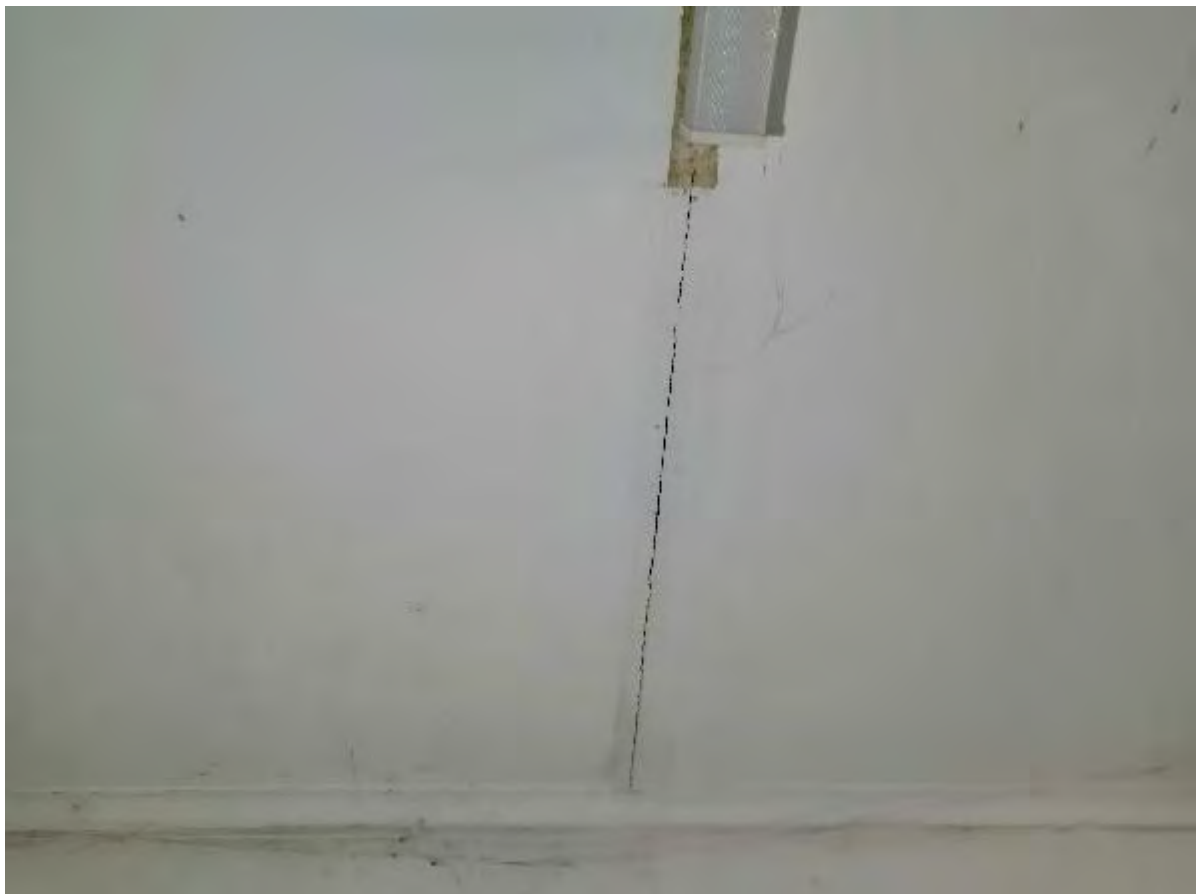
Photo 192 – Ceiling Cracking (Side Room 1)

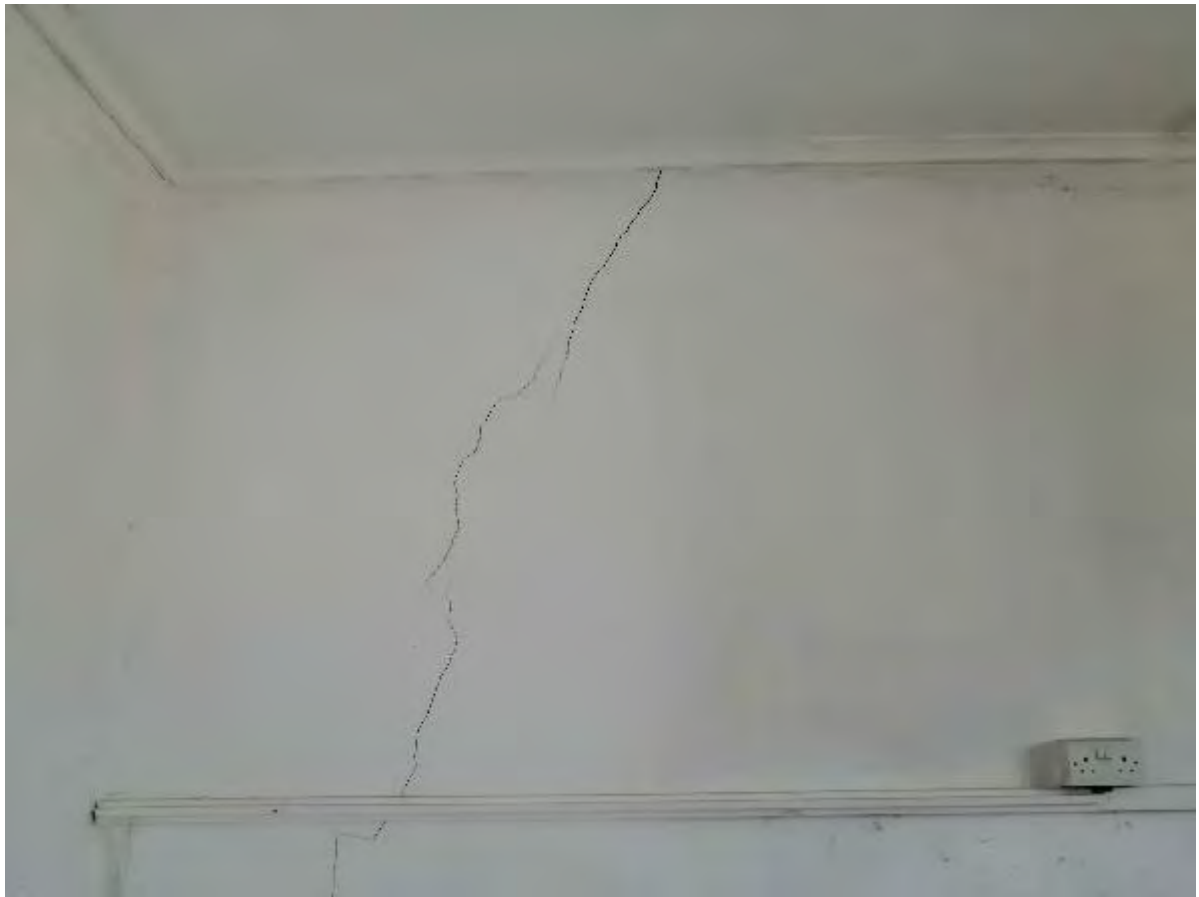
Photo 193 – Wall Plaster Cracking (Side Room 1)

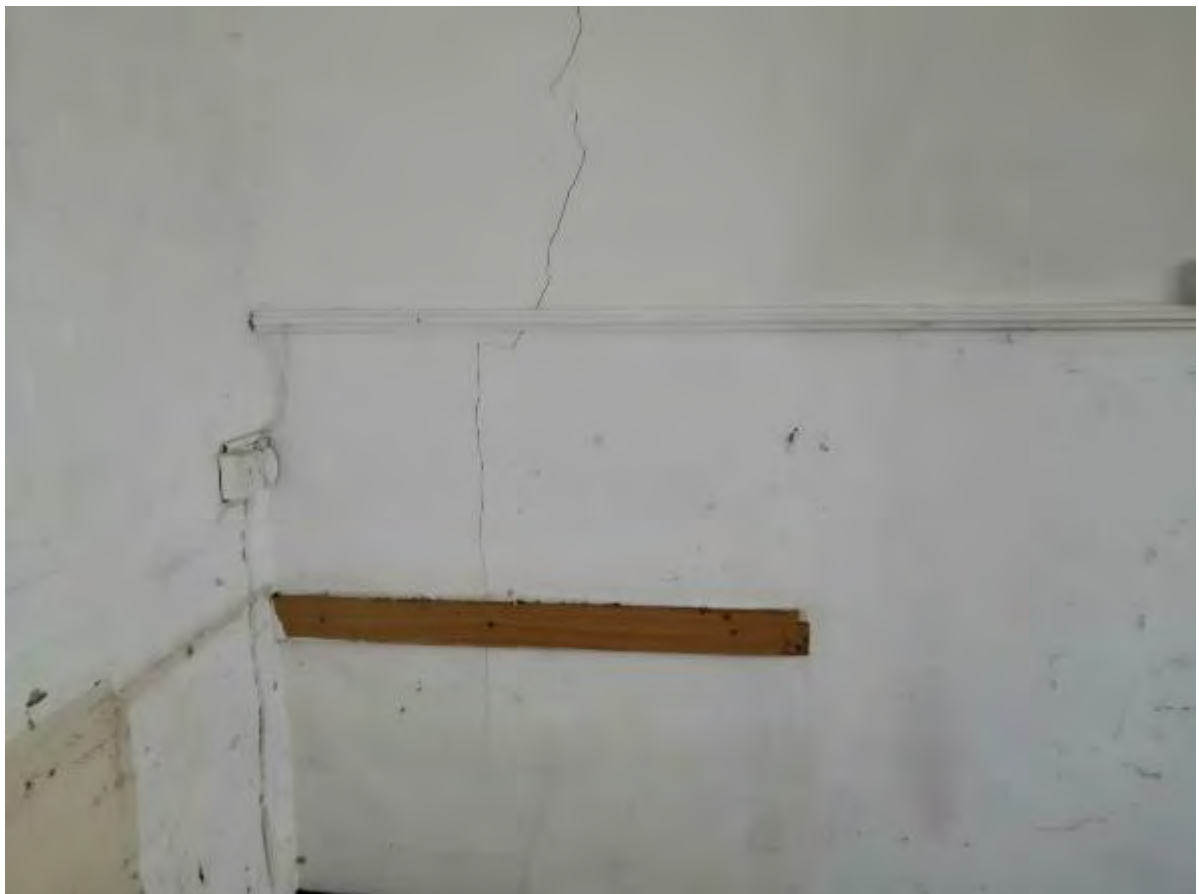
Photo 194 – Wall Plaster Cracking (Side Room 1)

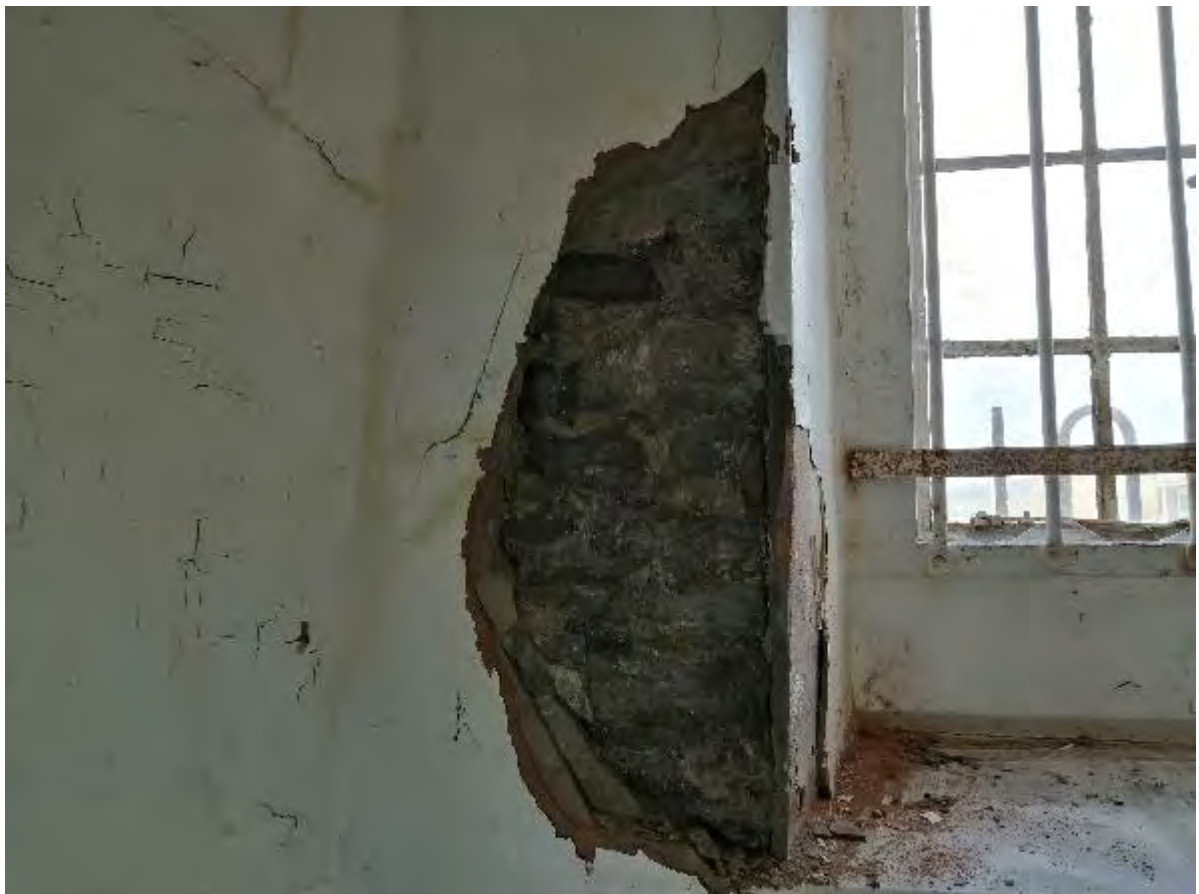
Areas of detached plaster were noted to the side room 1 – see photos 195-196 and 198 below. These areas of detached plaster are expected to be part caused by penetrating damp to the walls in these areas. Condition Rating **2** See Section 7.0 Recommendations for guidance on repair works required.

Photo 198 –Detached Plaster (Side Room 1)

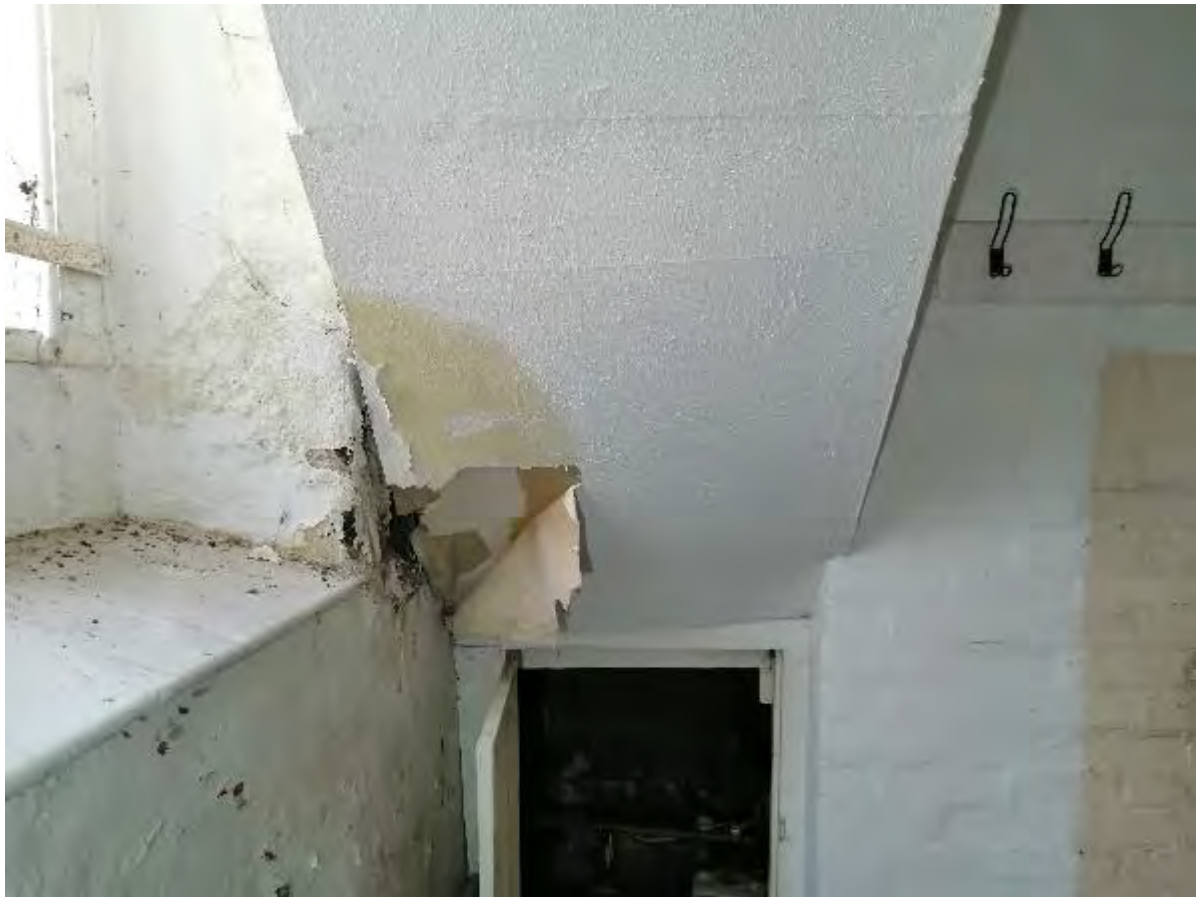
During the survey it was noted that the staircase from corridor 2 to front room 1 was sloping – see photo 199 below. It is suspected that the timber members of the staircases are rotten due to penetrating damp through the right wall elevation. It is recommended that the staircase is not used in its current condition. Further intrusive investigation through the removal of boarding and timber steps should be undertaken to assess the condition and undertake suitable repairs to the underlying timber members. These repairs may require the removal and replacement of the staircase in its entirety. Condition Rating **3** See Section 7.0 Recommendations for guidance on repair works required.

Photo 199 – Slope to Staircase (Side Room 1)

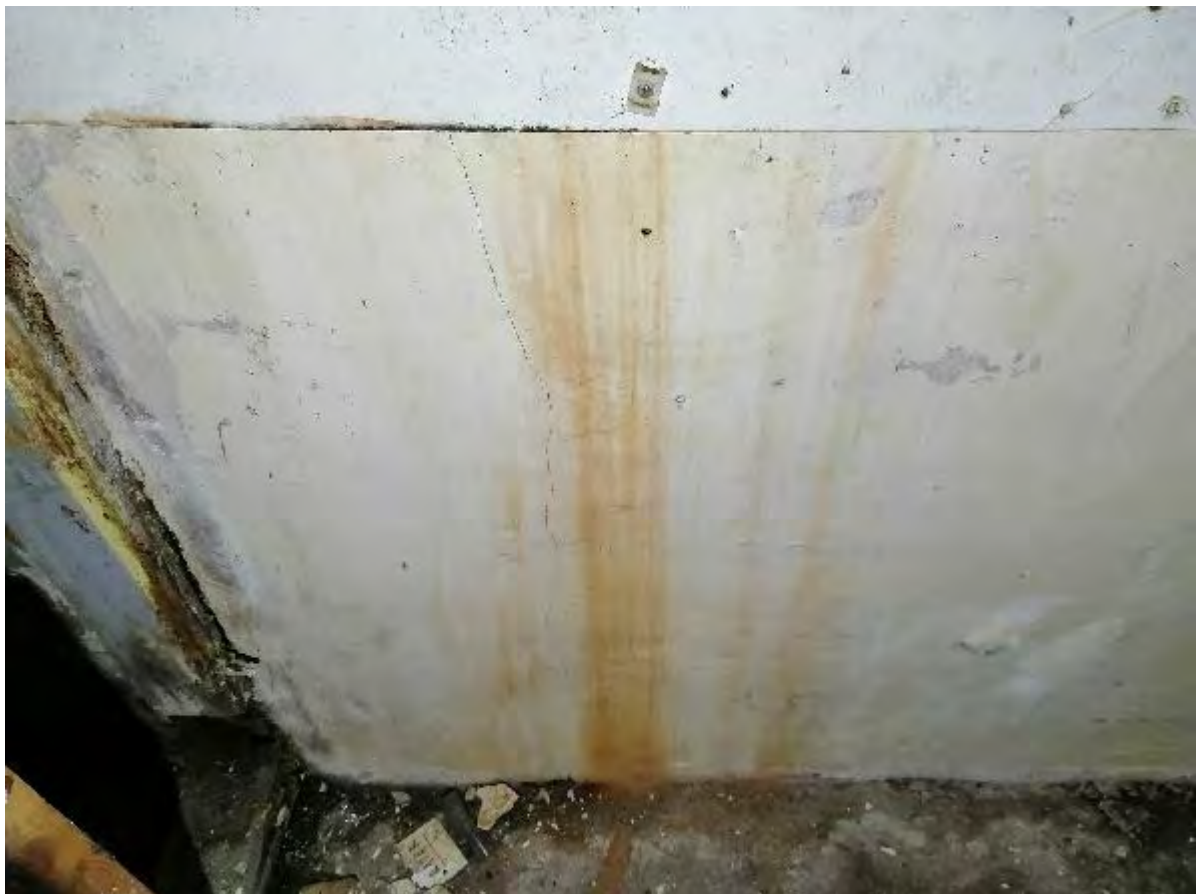
Photo 202 – Wall Plaster Crack (Utility Room 1)

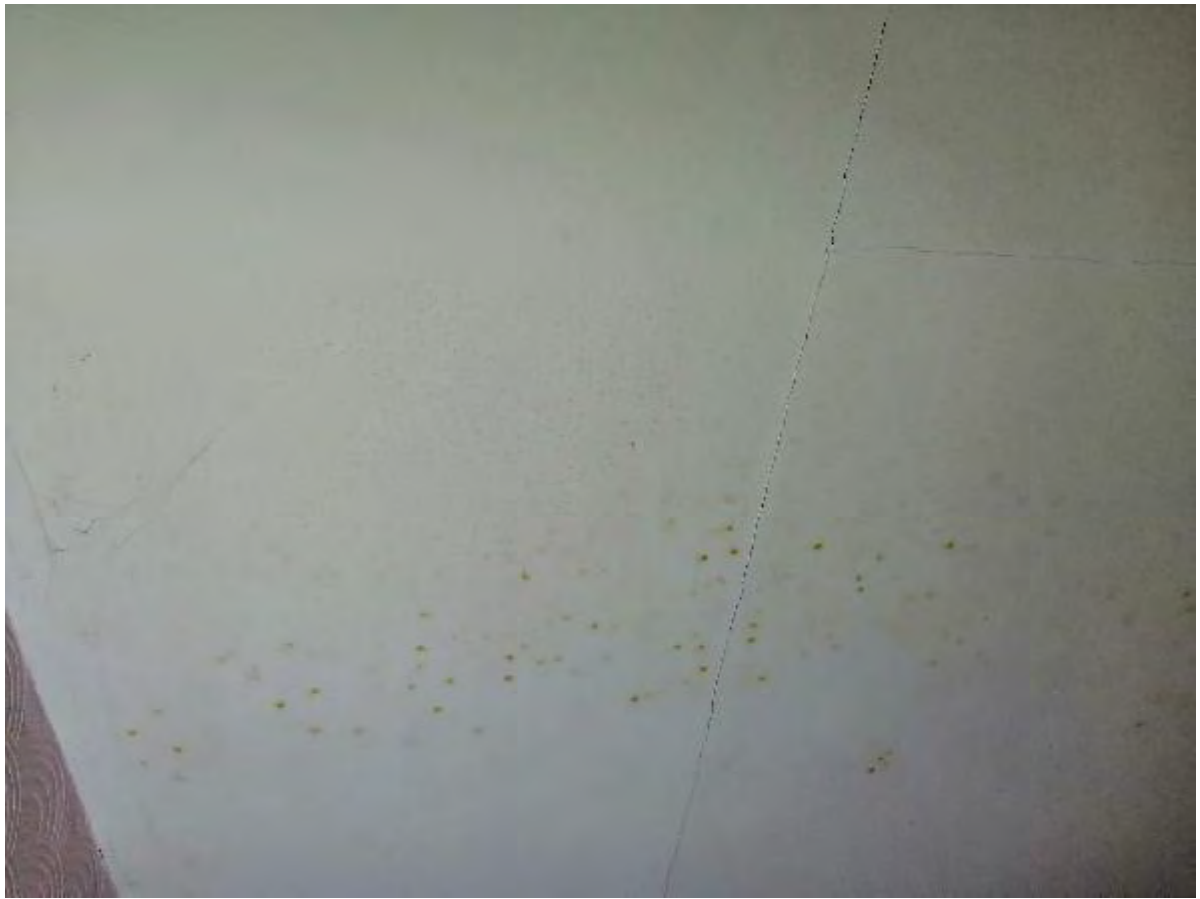
Photo 203 – Ceiling Cracking (Hall)

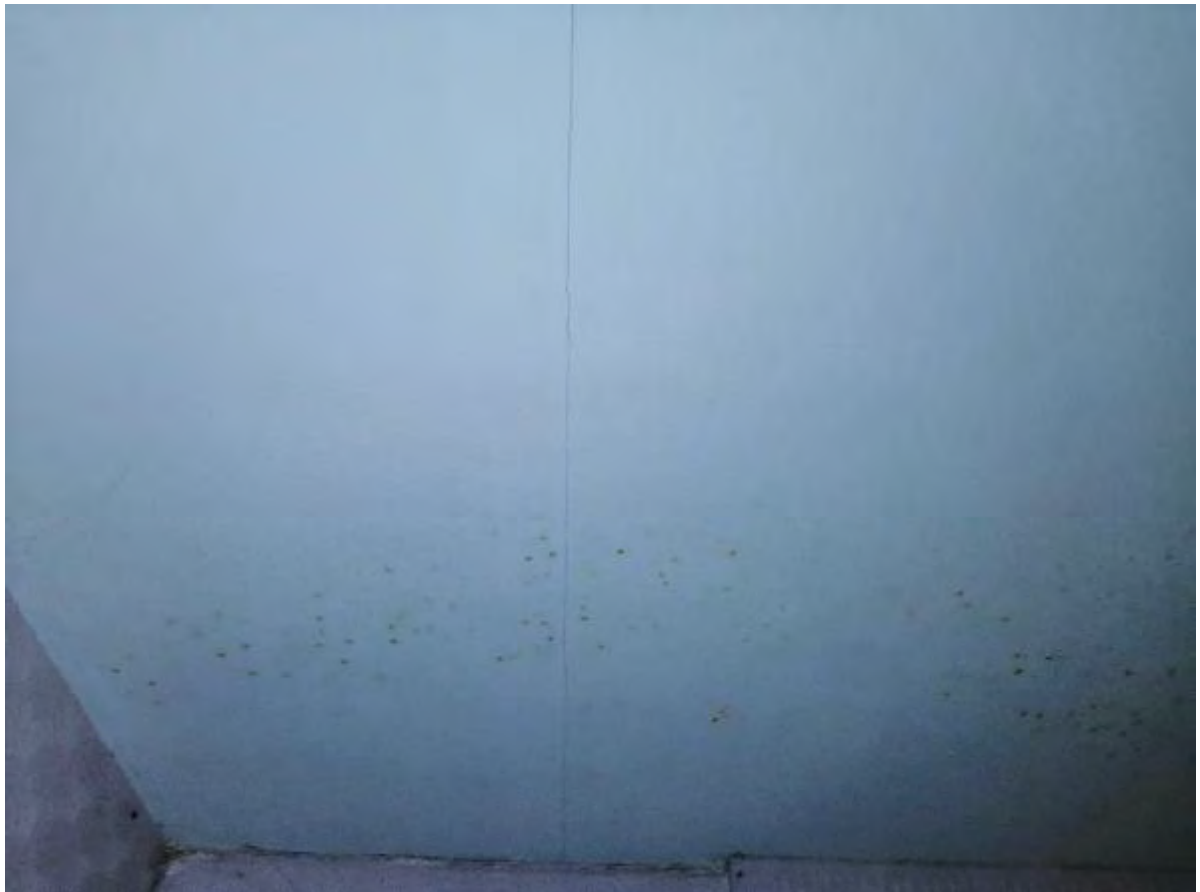
Photo 204 – Ceiling Cracking (Hall)

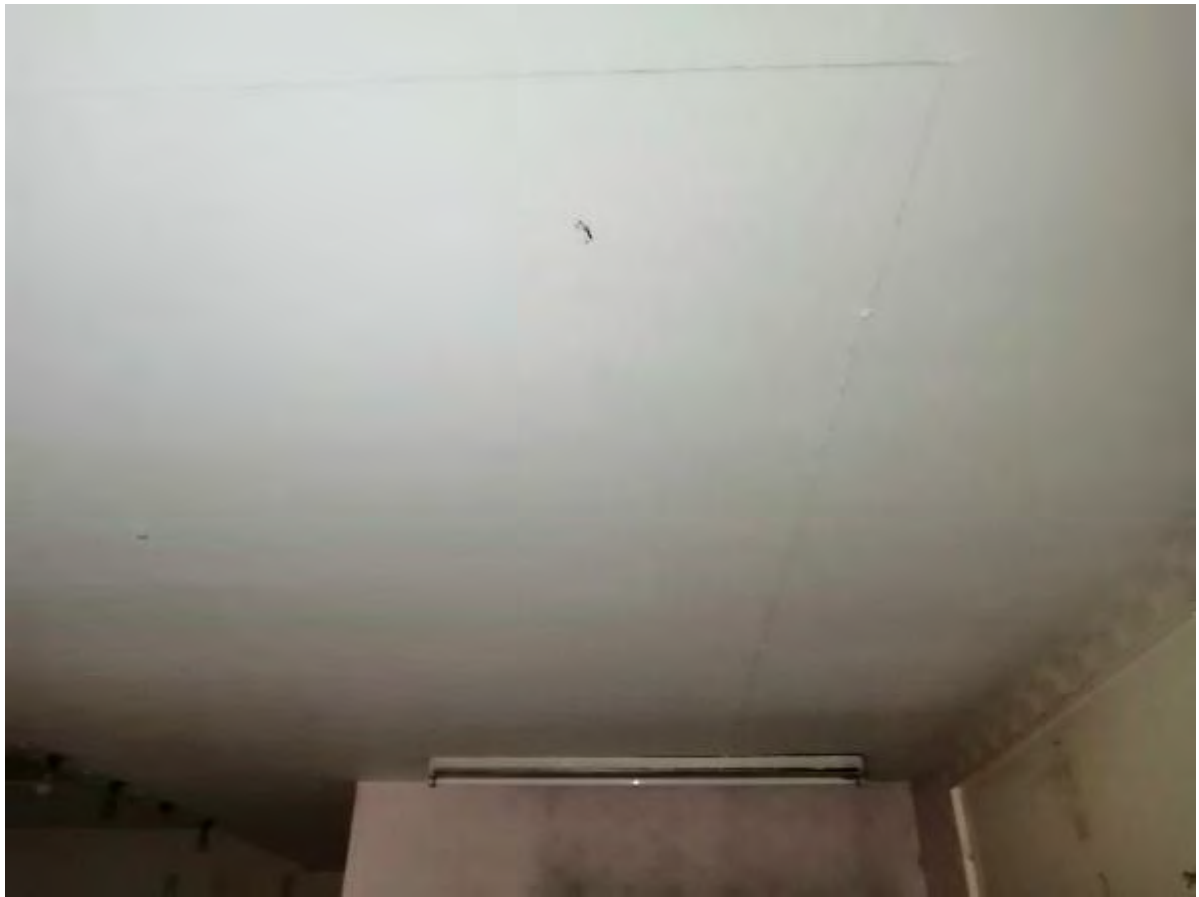
Photo 205 – Ceiling Cracking (Hall)

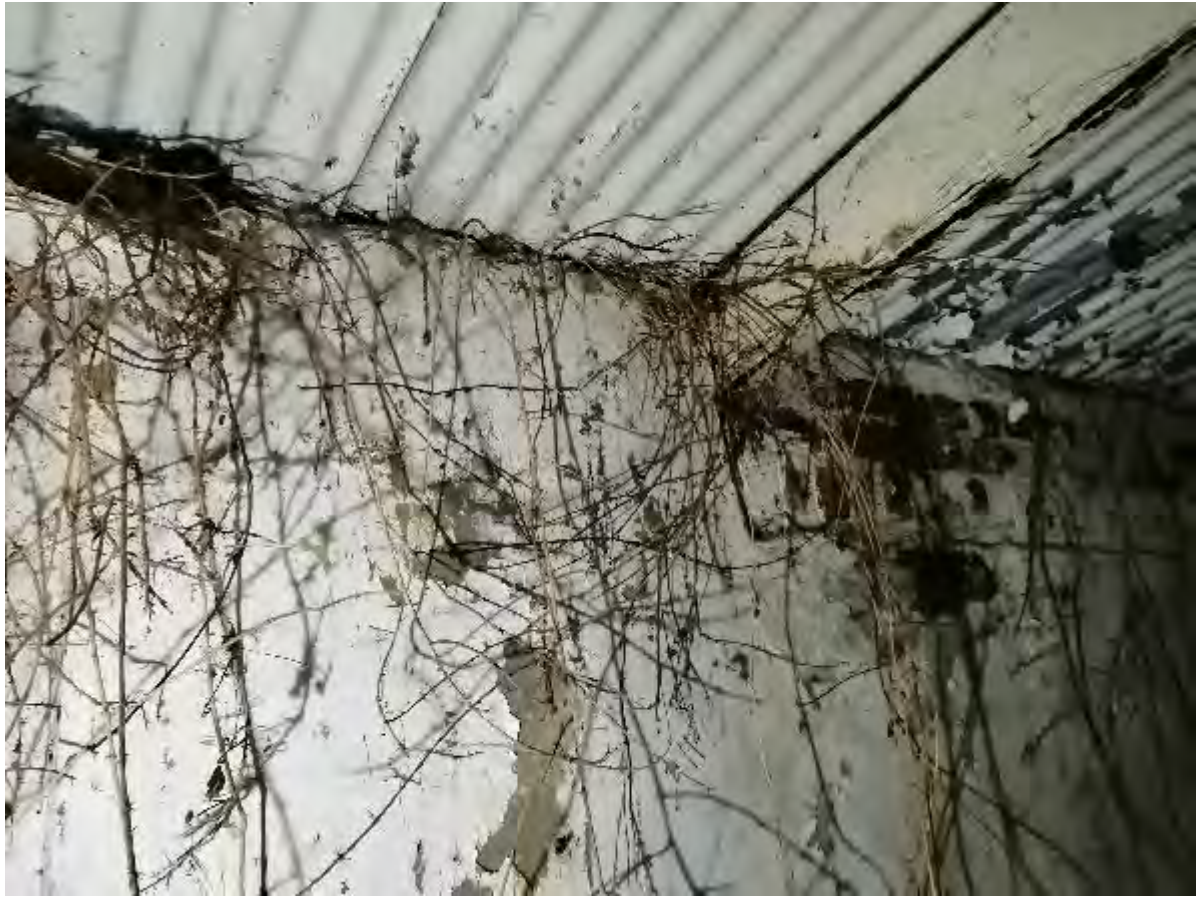
Photo 211 – Internal Vegetation Growth (Fire Exit Room)

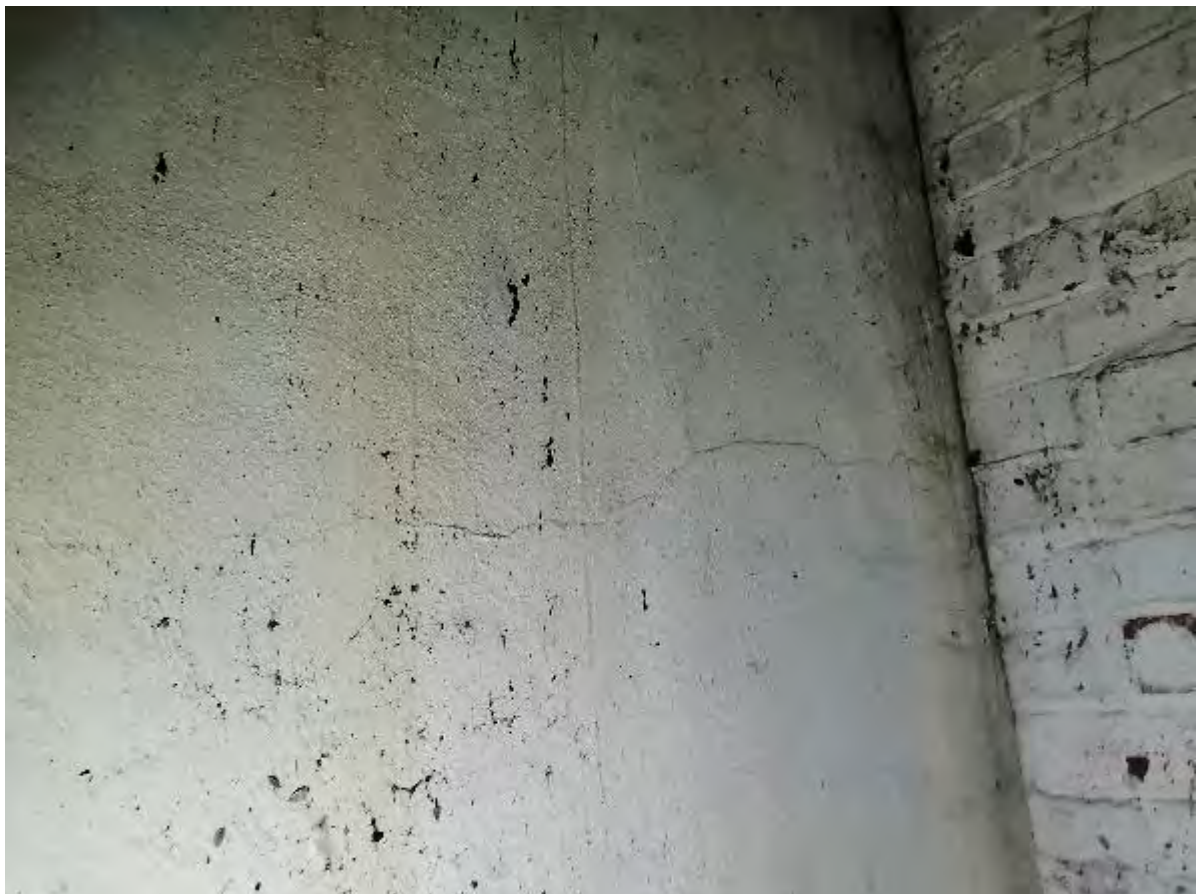
Photo 214 – Wall Plaster Crack (Fire Exit Room)

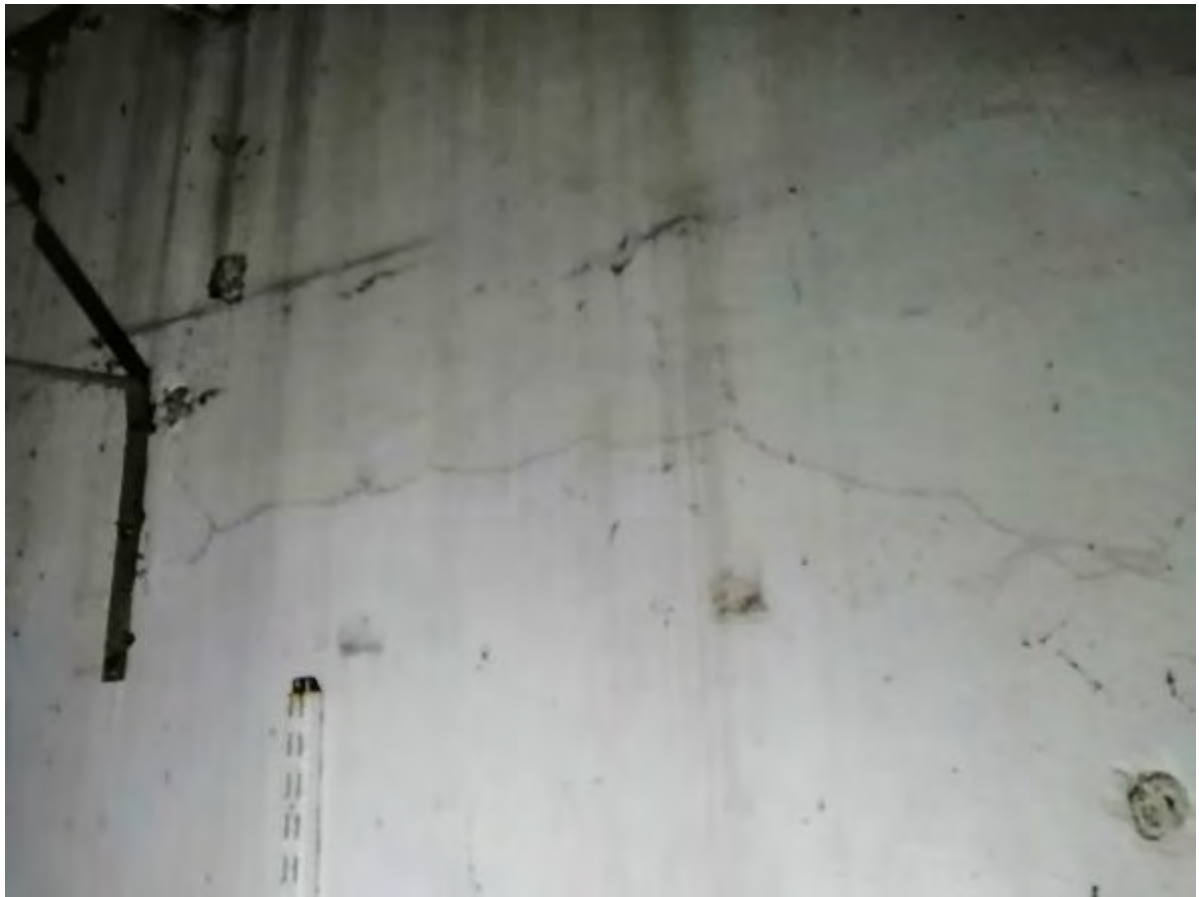
Photo 215 – Wall Plaster Crack (Fire Exit Room)

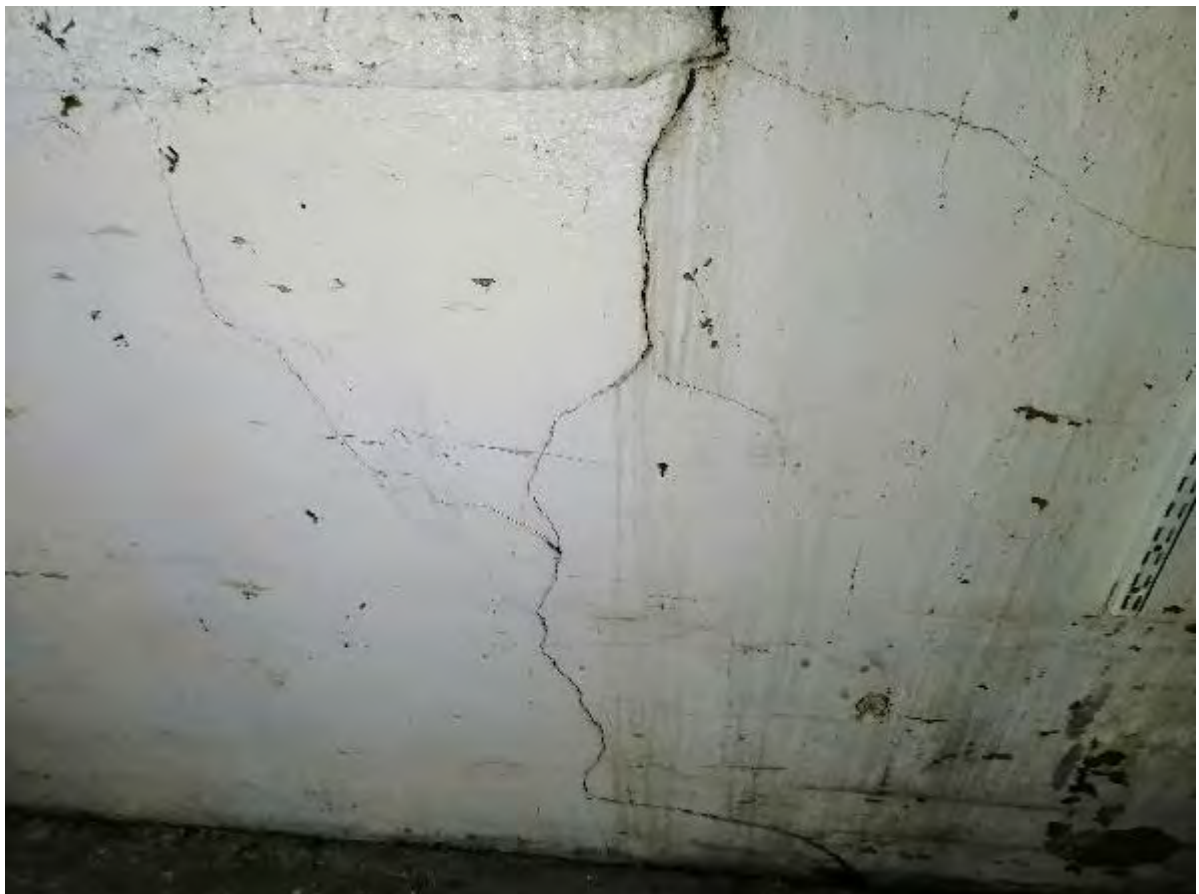
Photo 216 – Wall Plaster Crack (Fire Exit Room)

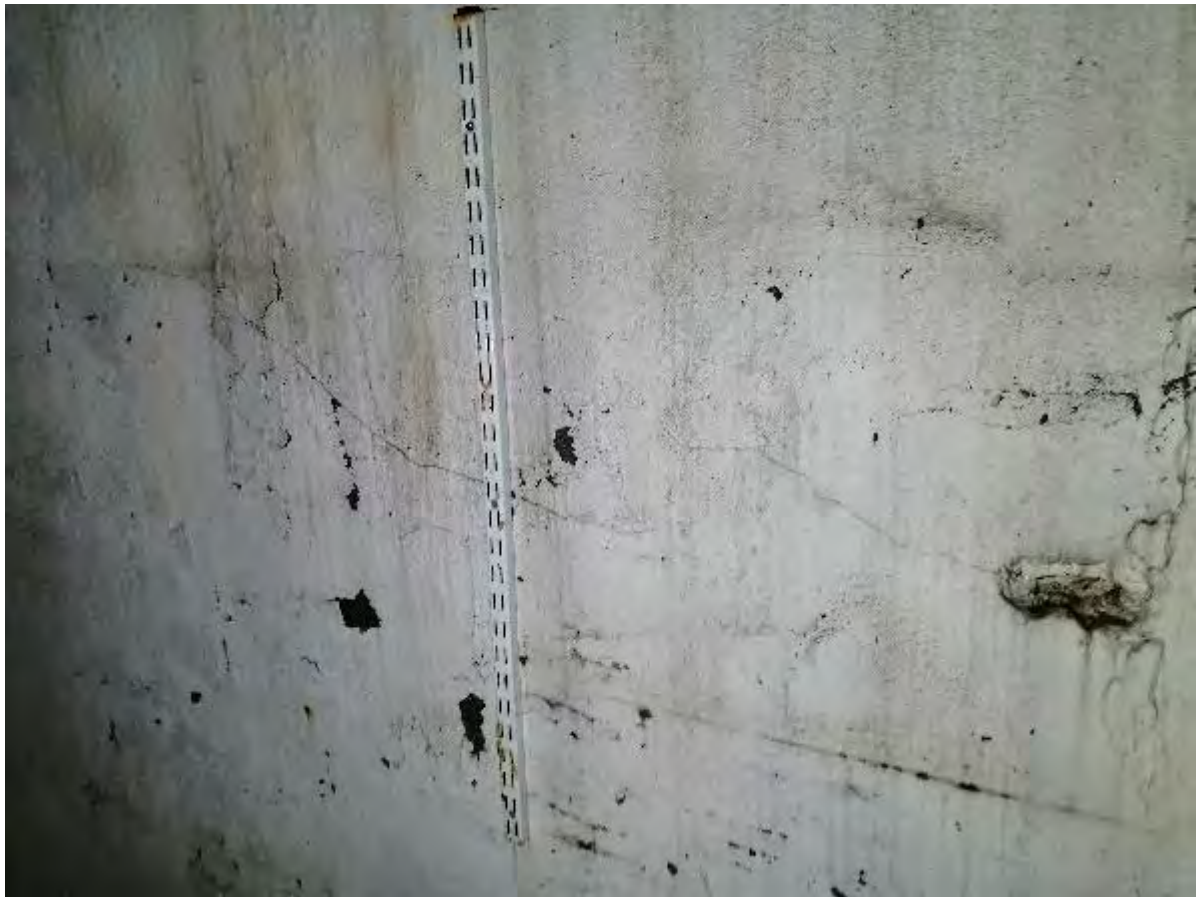
Photo 217 – Wall Plaster Crack (Fire Exit Room)
