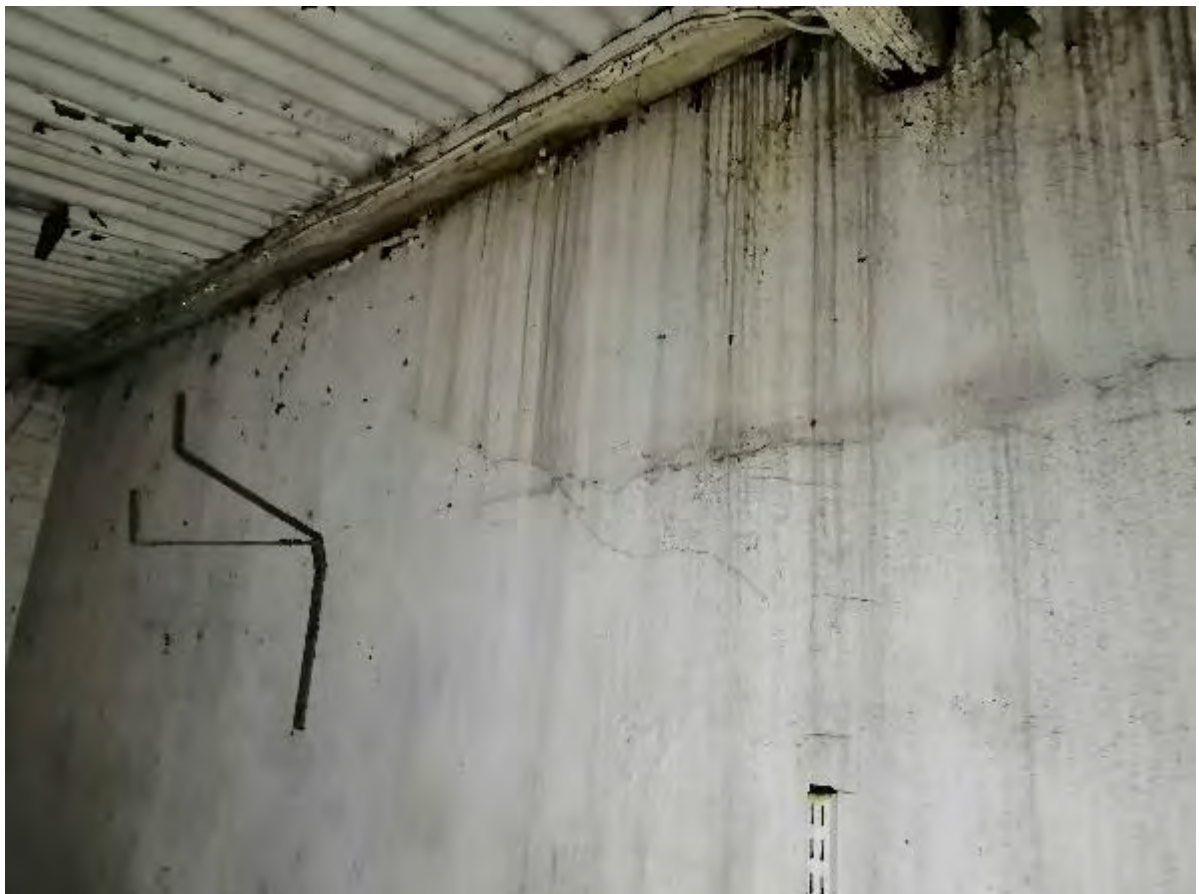
Photo 218 – Wall Plaster Crack (Fire Exit Room)

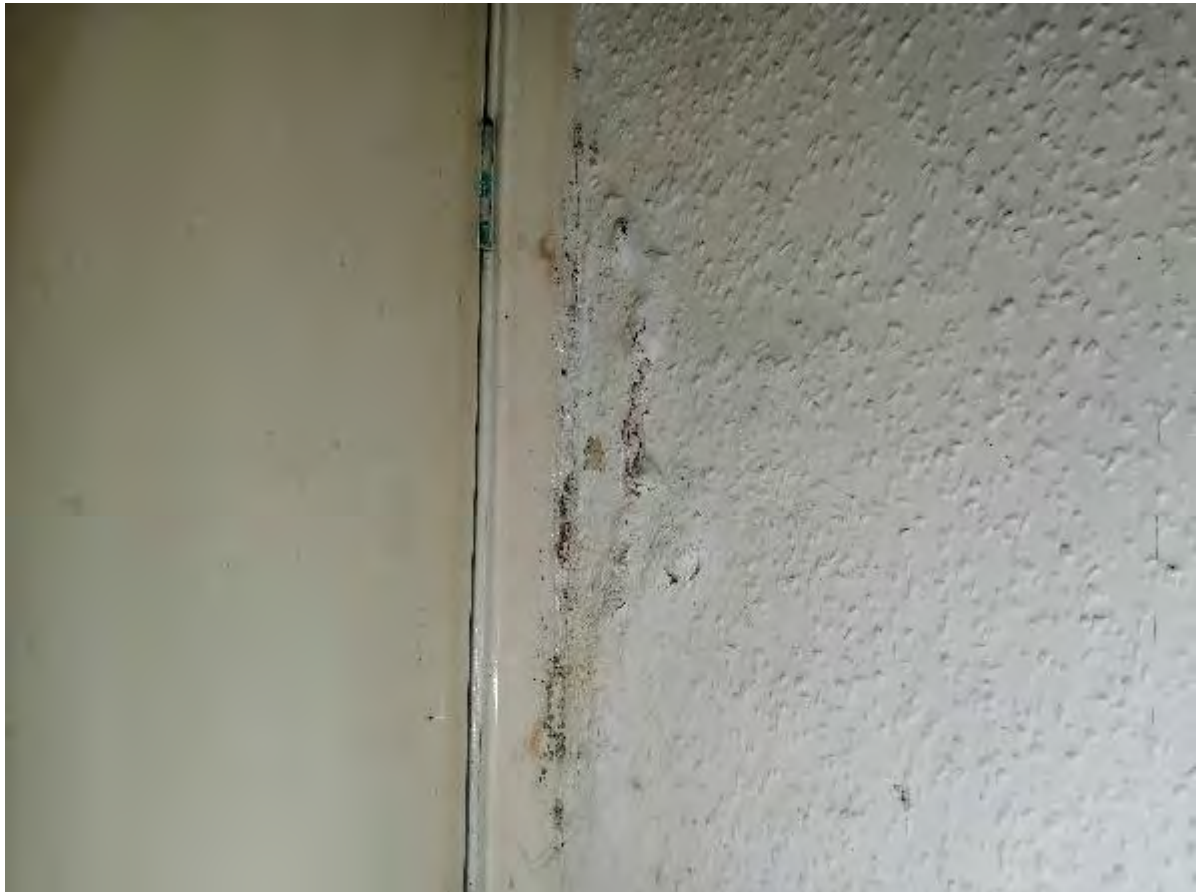
An inspection was undertaken to confirm the presence of damp in the property. Penetrating damp was noted to the external walls under the stairs, corridor 2, side room 1, the kitchen, utility room 1 and the hall – see photos 224, 226-237 and 241-242 below. These areas of penetrating damp are expected to be caused by cracking of the external render and stonework mortar joints / pointing. Also, the type of render being cementitious based entraps moisture and prevents the solid wall from suitably ‘breathing’ - Condition Rating **3** See Section 7.0 Recommendations for guidance on repair works required.

Photo 224 – Penetrating Damp (Corridor 1)

9). Penetrating damp was noted to the external walls under the stairs, corridor 2, side room 1, the kitchen, utility room 1 and the hall – see photos 224, 226-237 and 241-242.

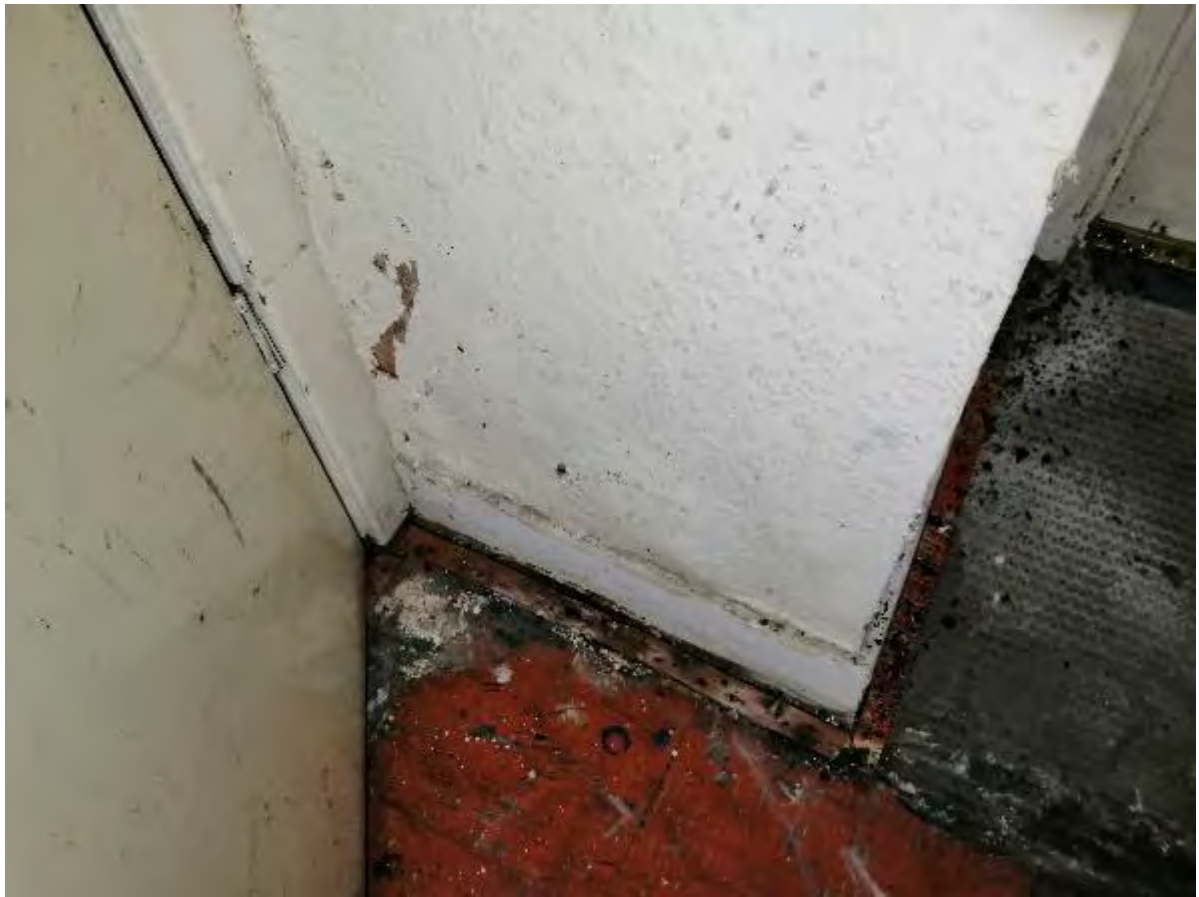
Rising damp was noted to the wall of corridor 1 – see photo 225 below. Condition Rating **3** See Section 7.0 Recommendations for guidance on repair works required.

Photo 225 – Rising Damp (Corridor 1)

11). Rising damp was noted to the wall of corridor 1 – see photo 225.

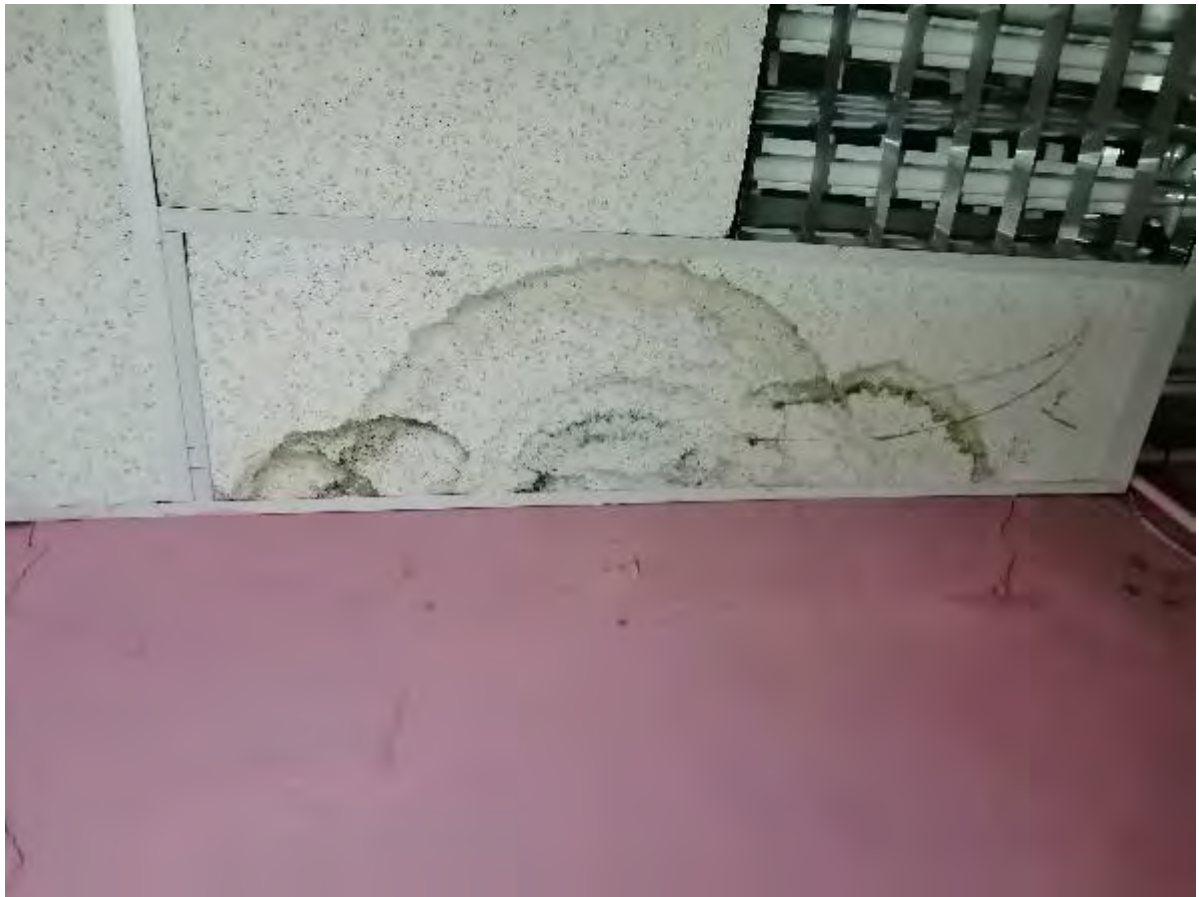
Photo 227 – Penetrating Damp (Corridor 2)

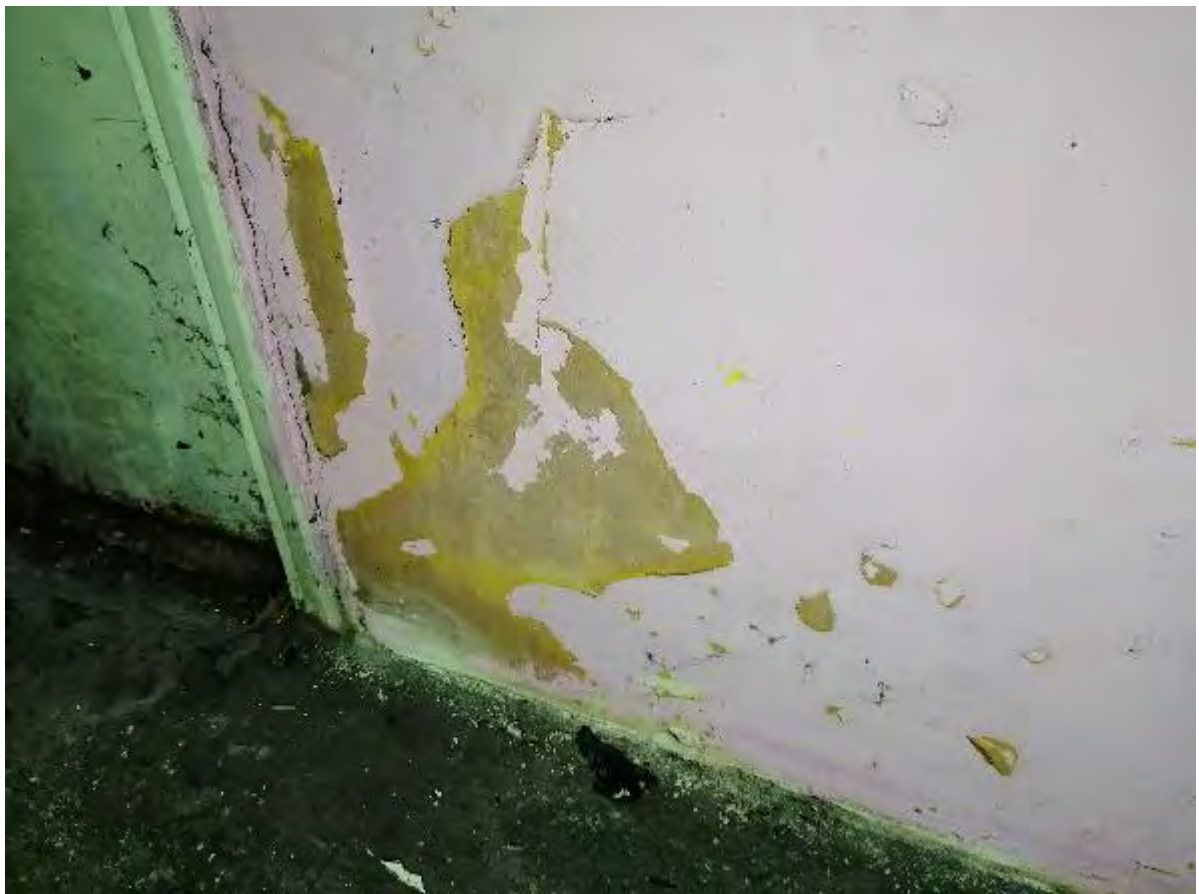
Photo 228 – Penetrating Damp (Corridor 2)

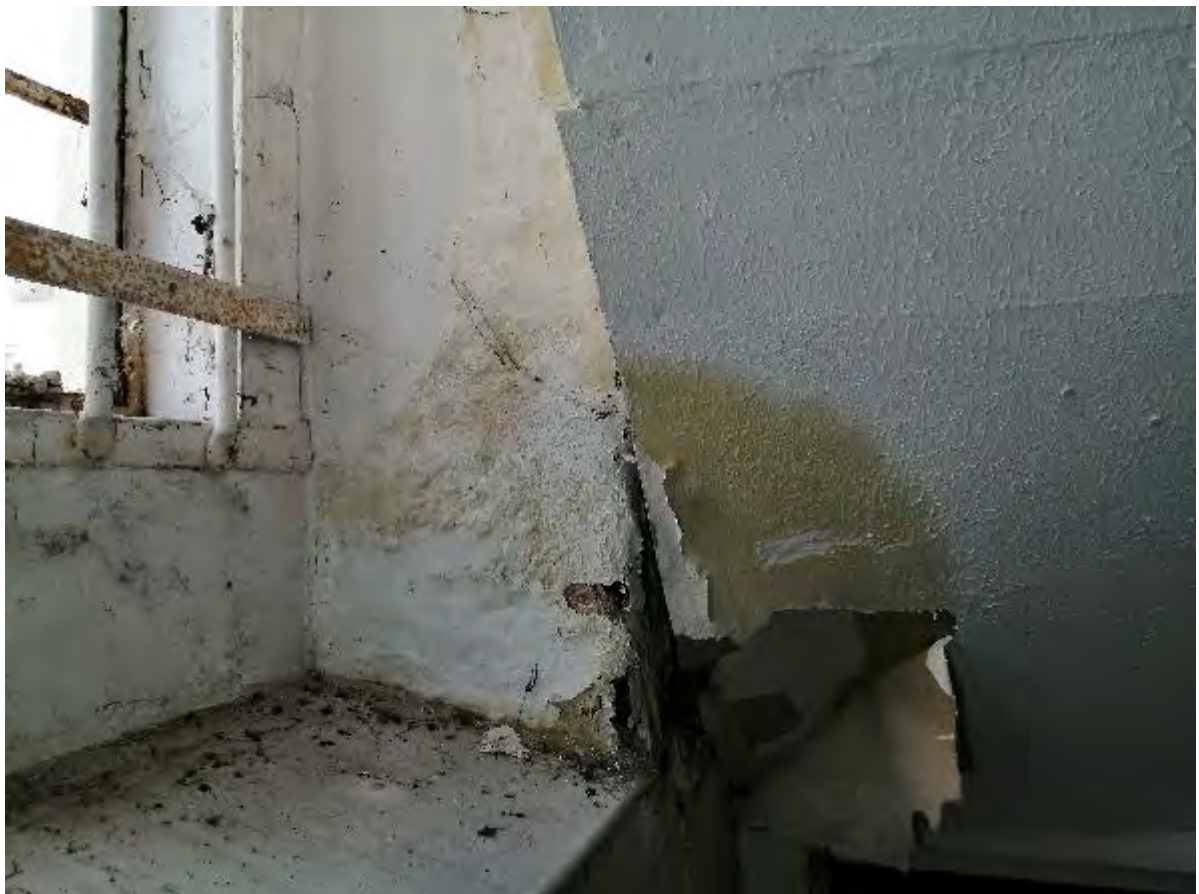
Photo 230 – Penetrating Damp (Side Room 1)

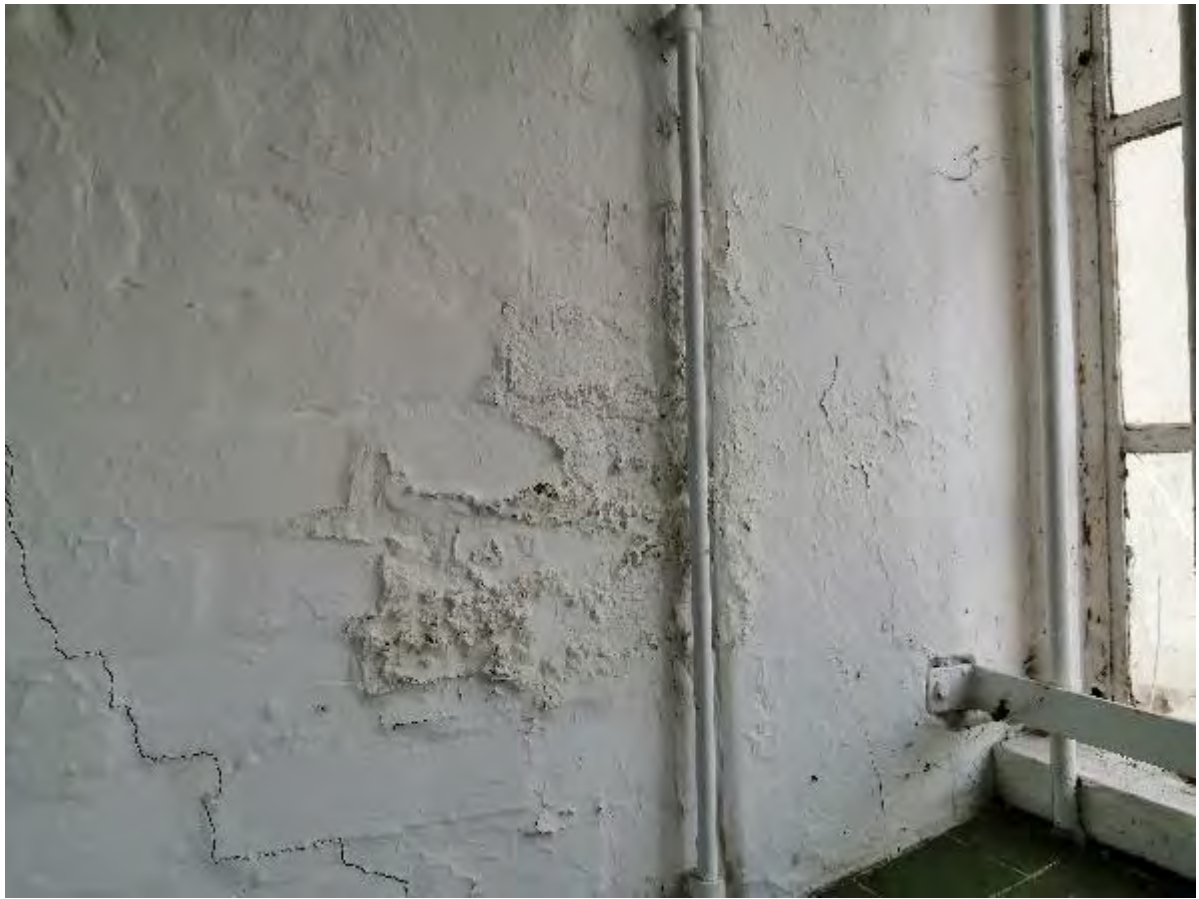
Photo 231 – Penetrating Damp (Kitchen)

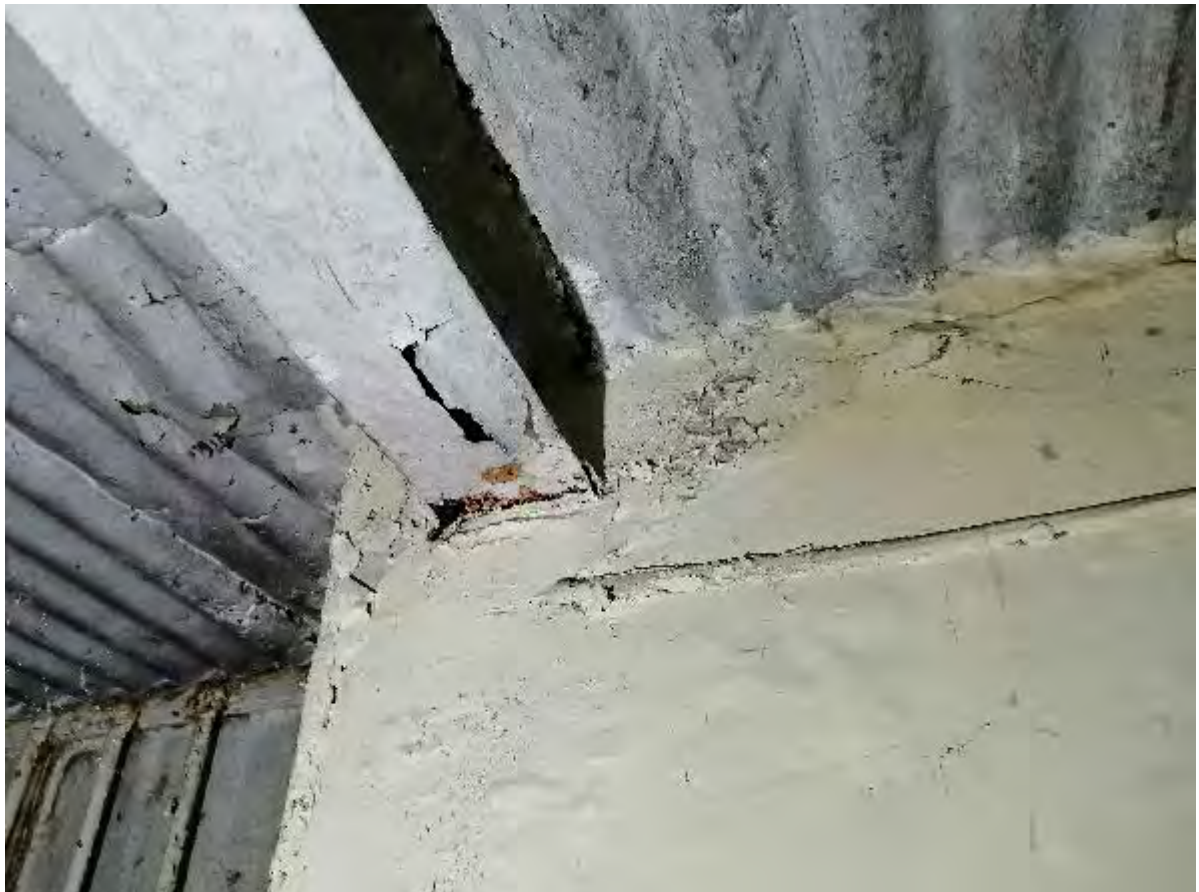
Photo 232 – Penetrating Damp (Utility Room 1)

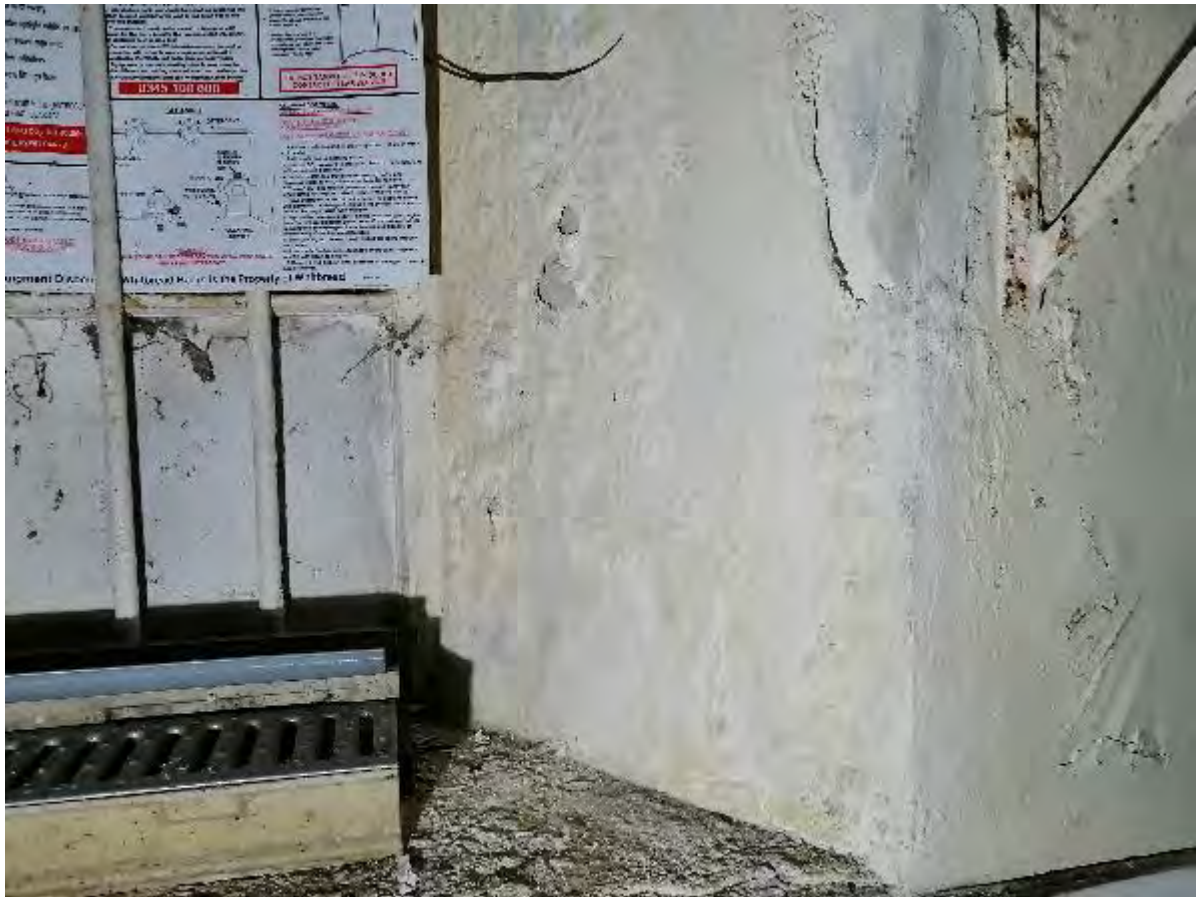
Photo 233 – Penetrating Damp (Utility Room 1)

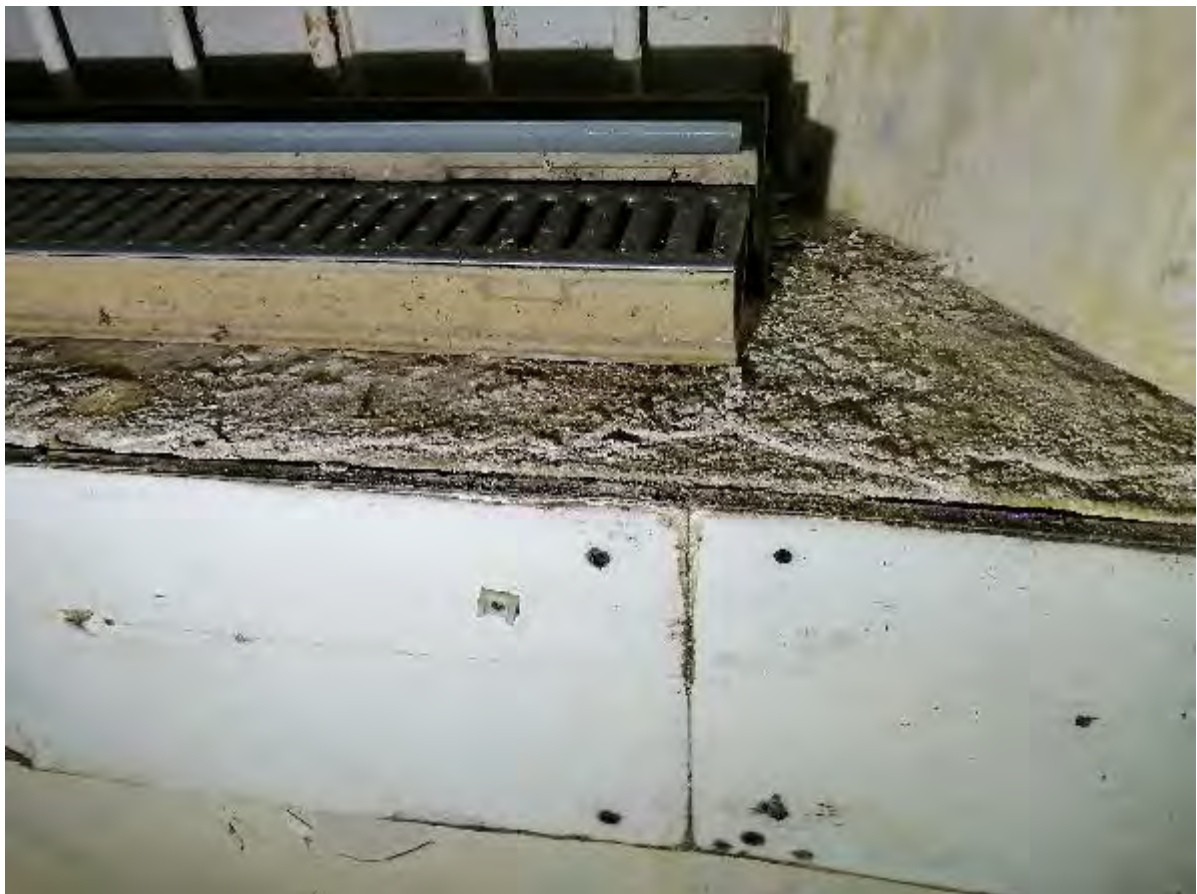
Photo 234 – Penetrating Damp (Utility Room 1)

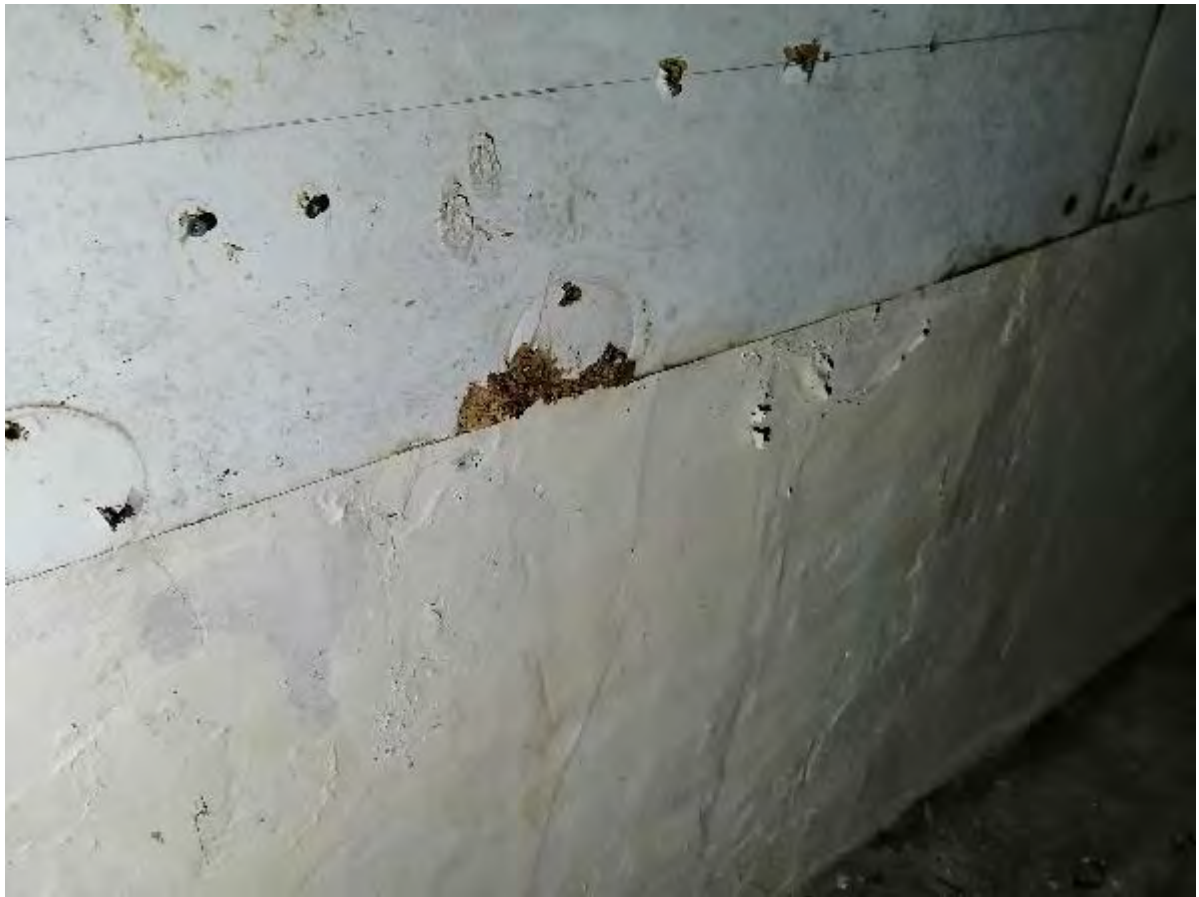
Photo 235 – Penetrating Damp (Utility Room 1)

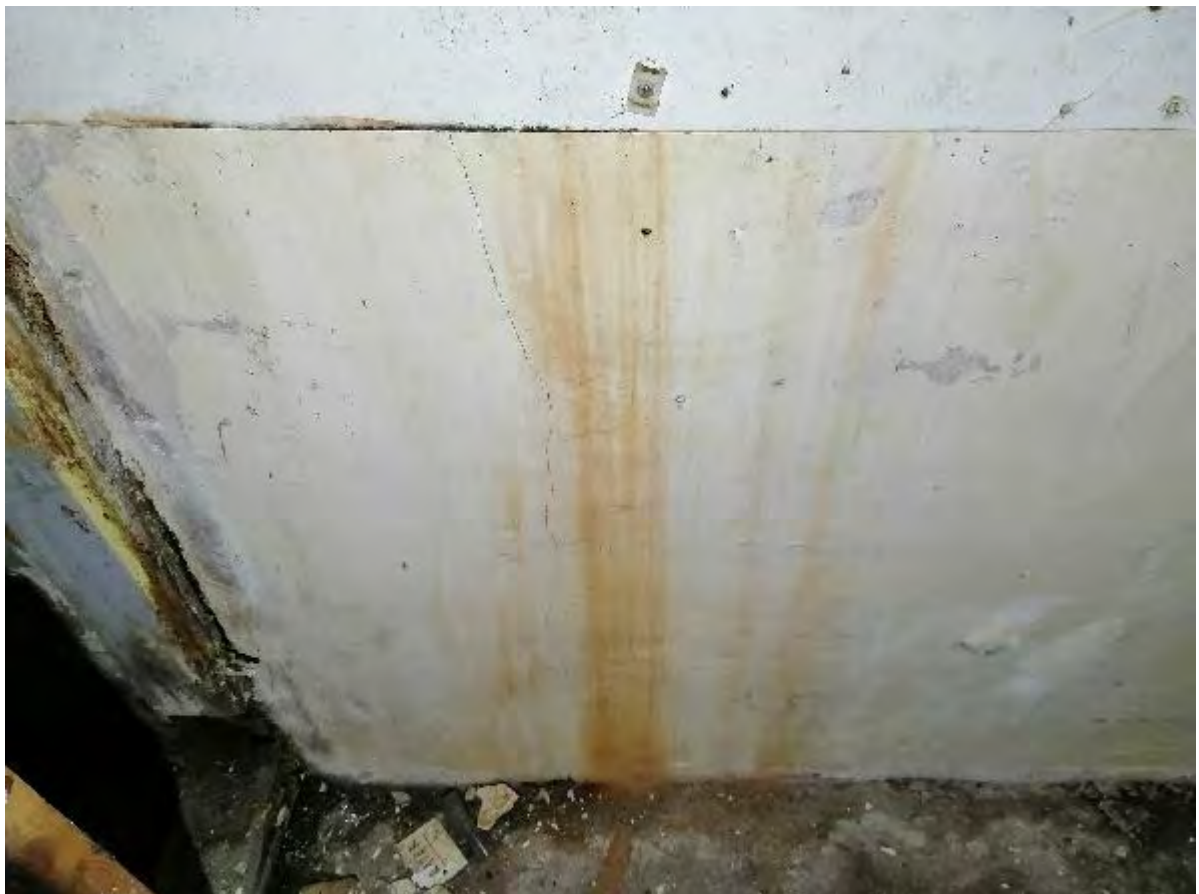
Photo 236 – Penetrating Damp (Utility Room 1)

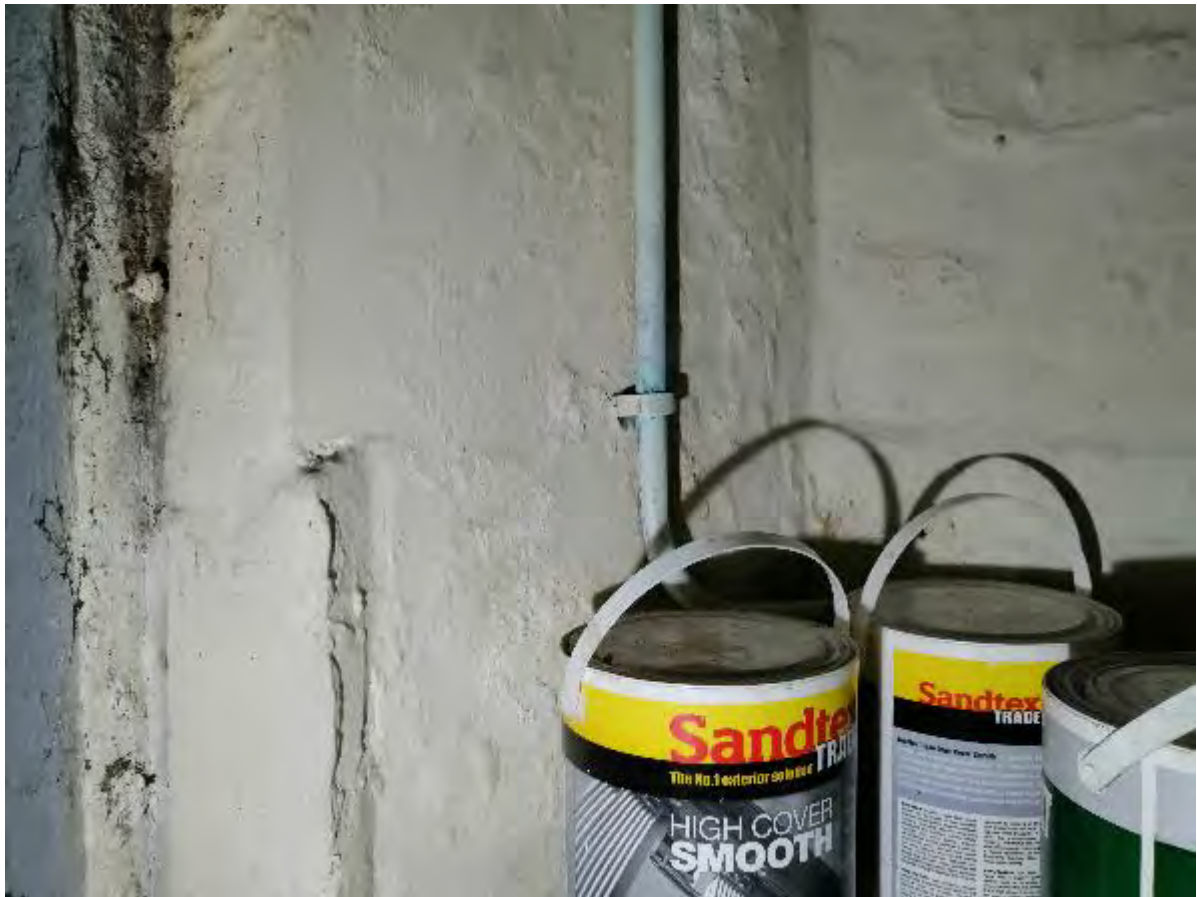
Photo 237 – Penetrating Damp (Utility Room 1)

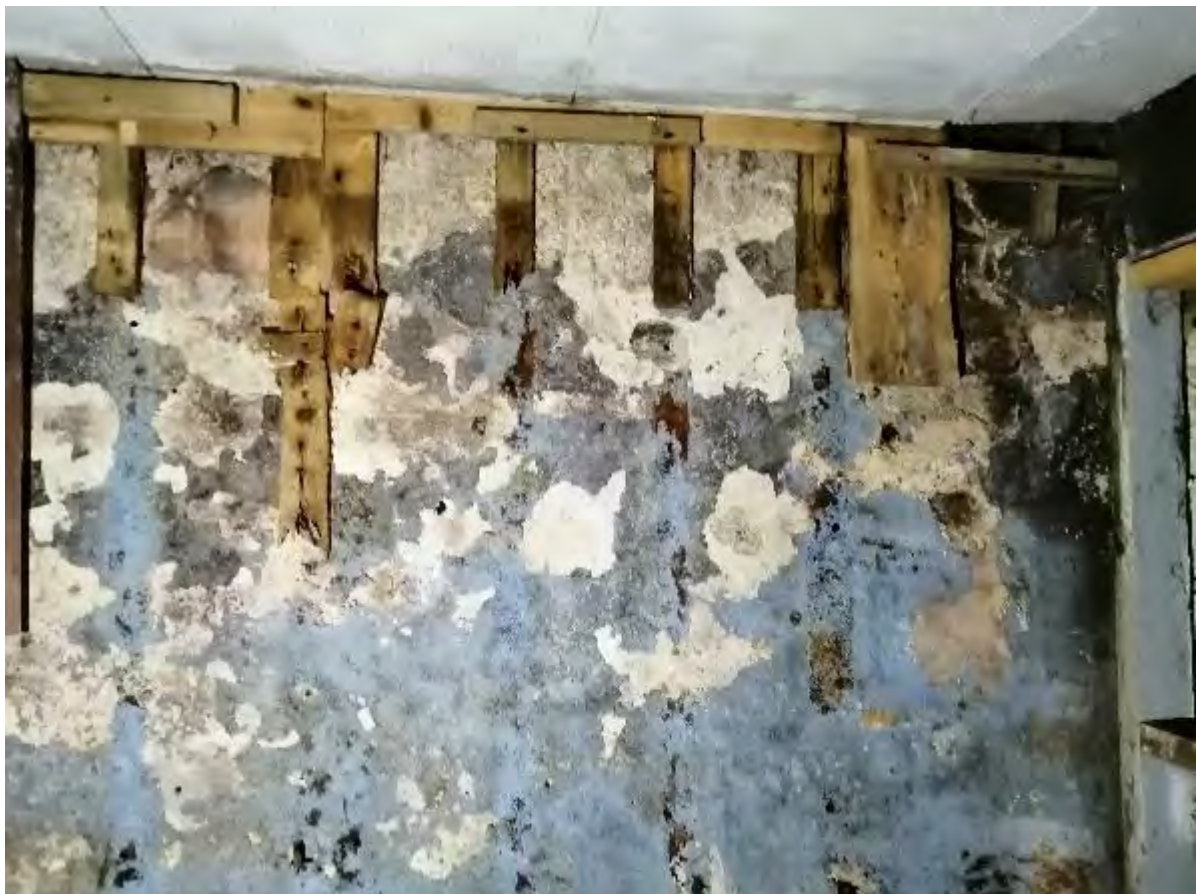
Photo 238 – Penetrating Damp (Hall)

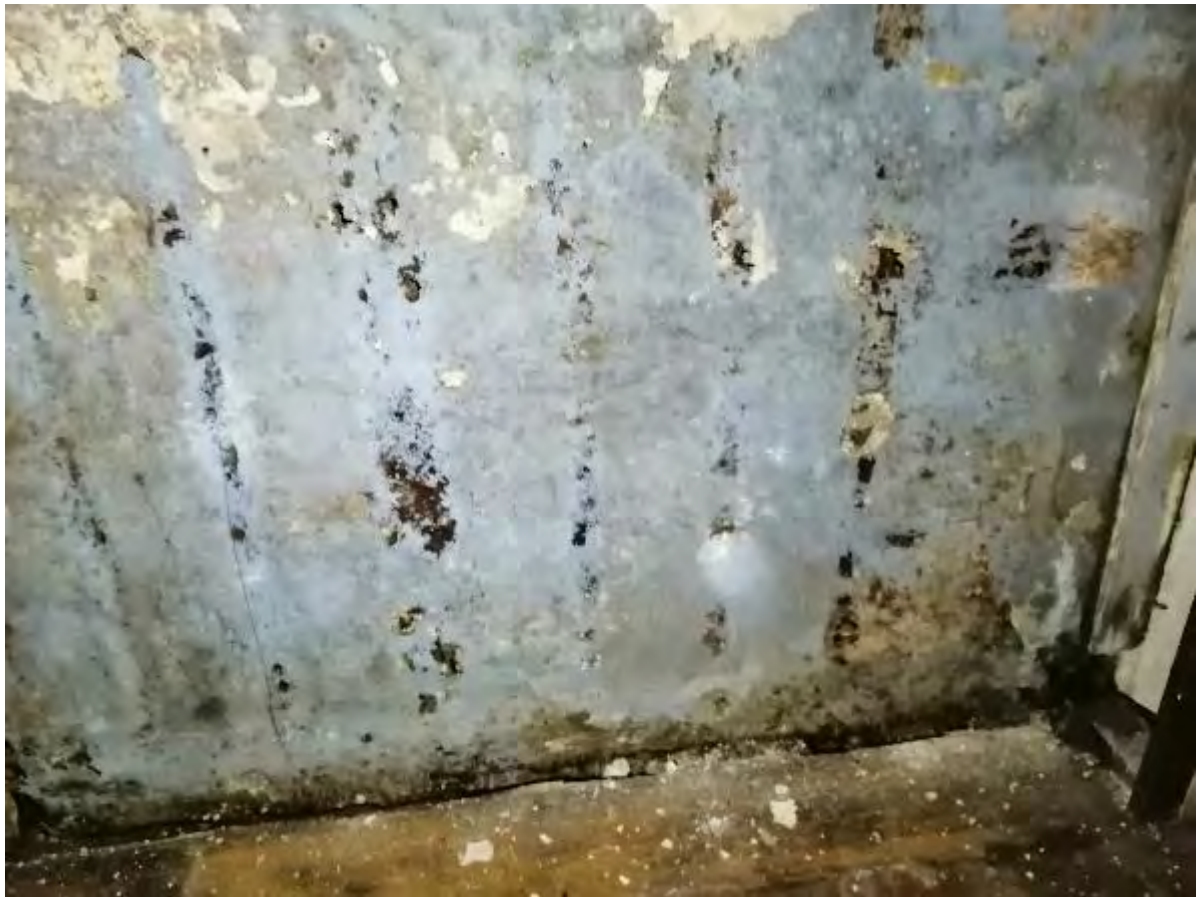
Photo 239 – Penetrating Damp (Hall)

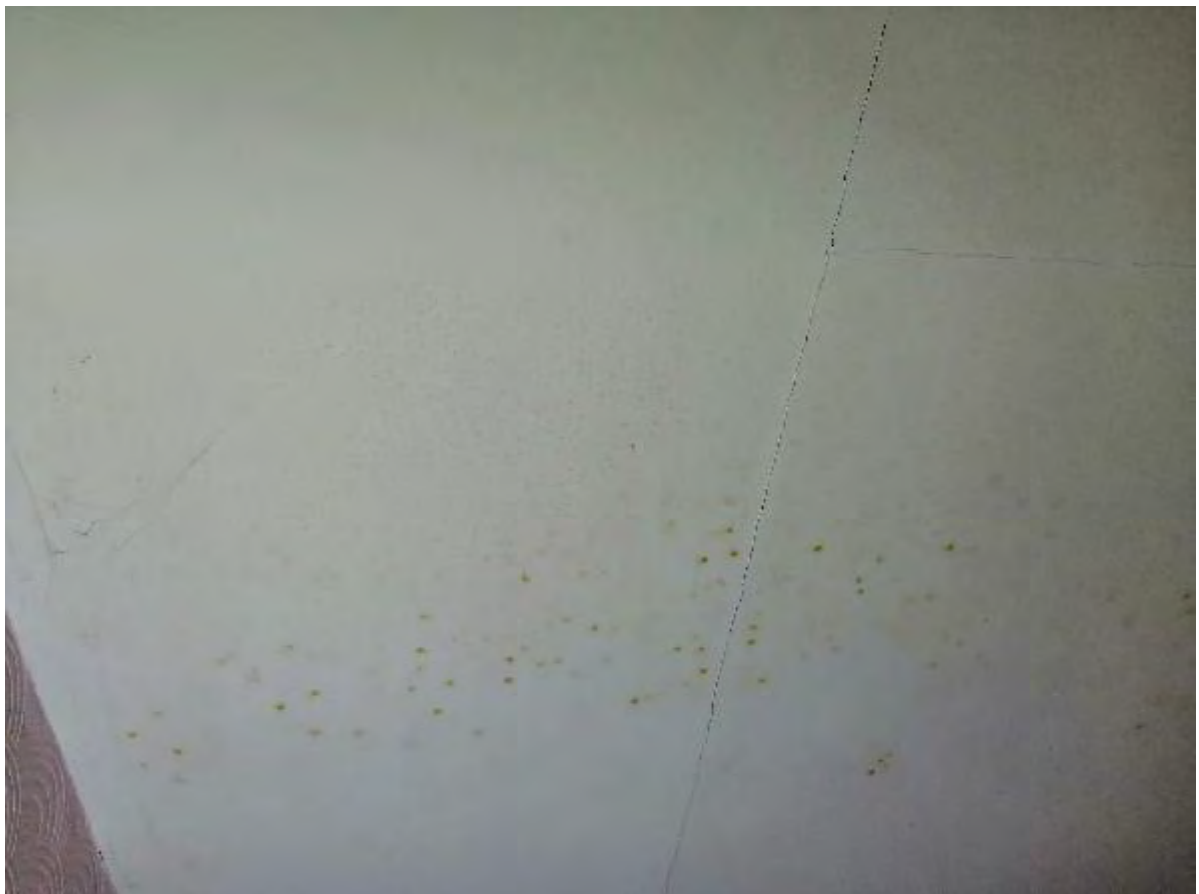
Photo 240 – Condensation Damp (Hall)

- Condensation damp was noted in the rear room, front room 1 and male toilets and to the ceiling in the hall – see photo 240 – see photos 145-146, 149, 151, 153, 155, 166 and 240.

35). Condensation damp was noted in the rear room, front room 1 and male toilets and to the ceiling in the hall – see photo 240 – see photos 145-146, 149, 151, 153, 155, 166 and 240.

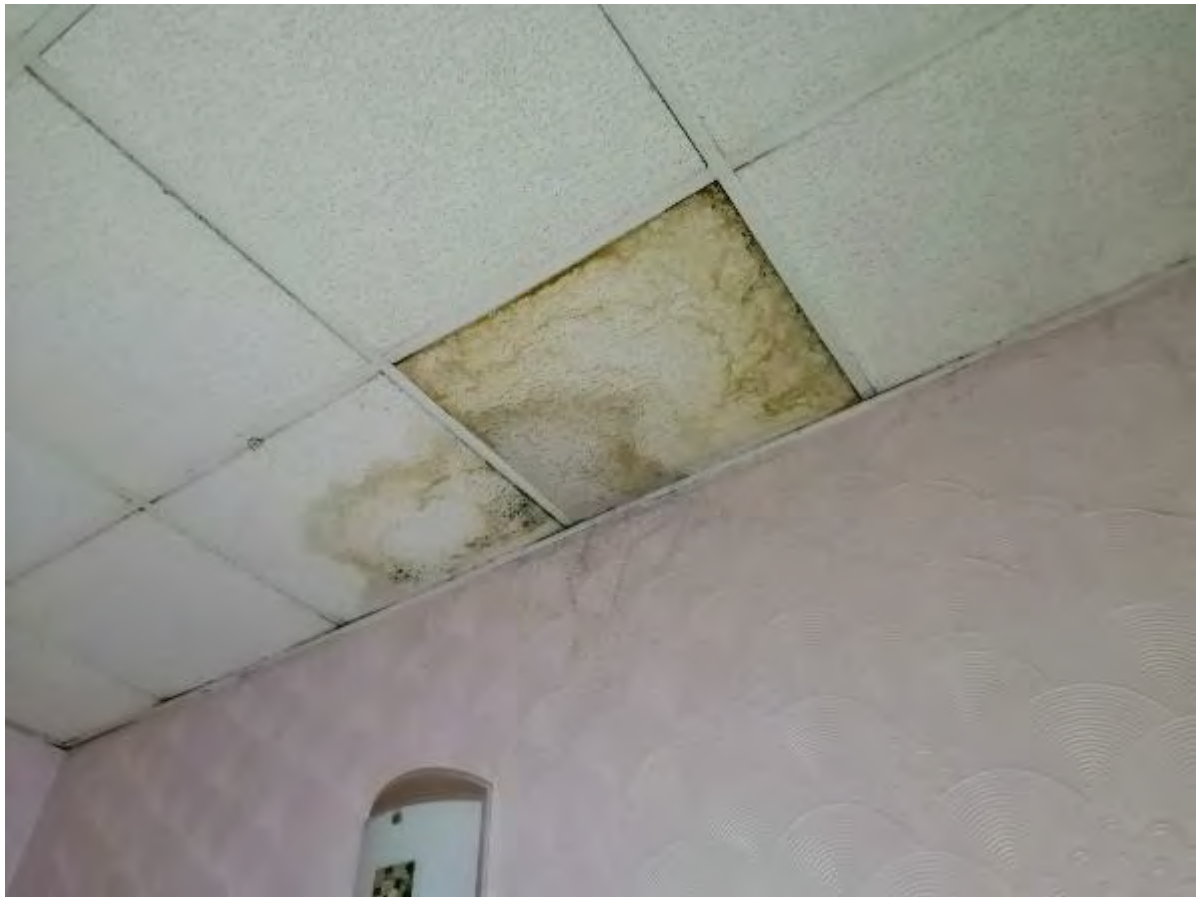
Photo 241 – Penetrating Damp (Hall)

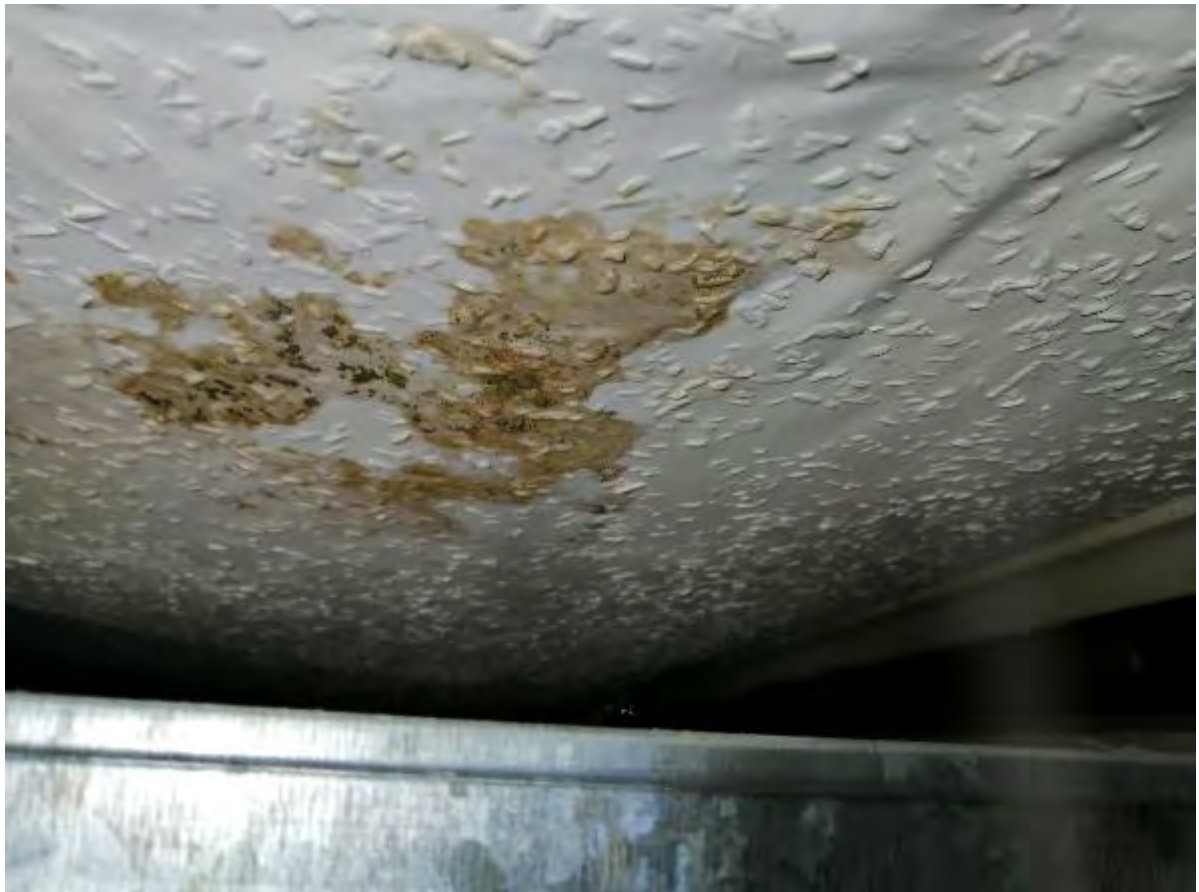
Photo 242 – Penetrating Damp (Hall)

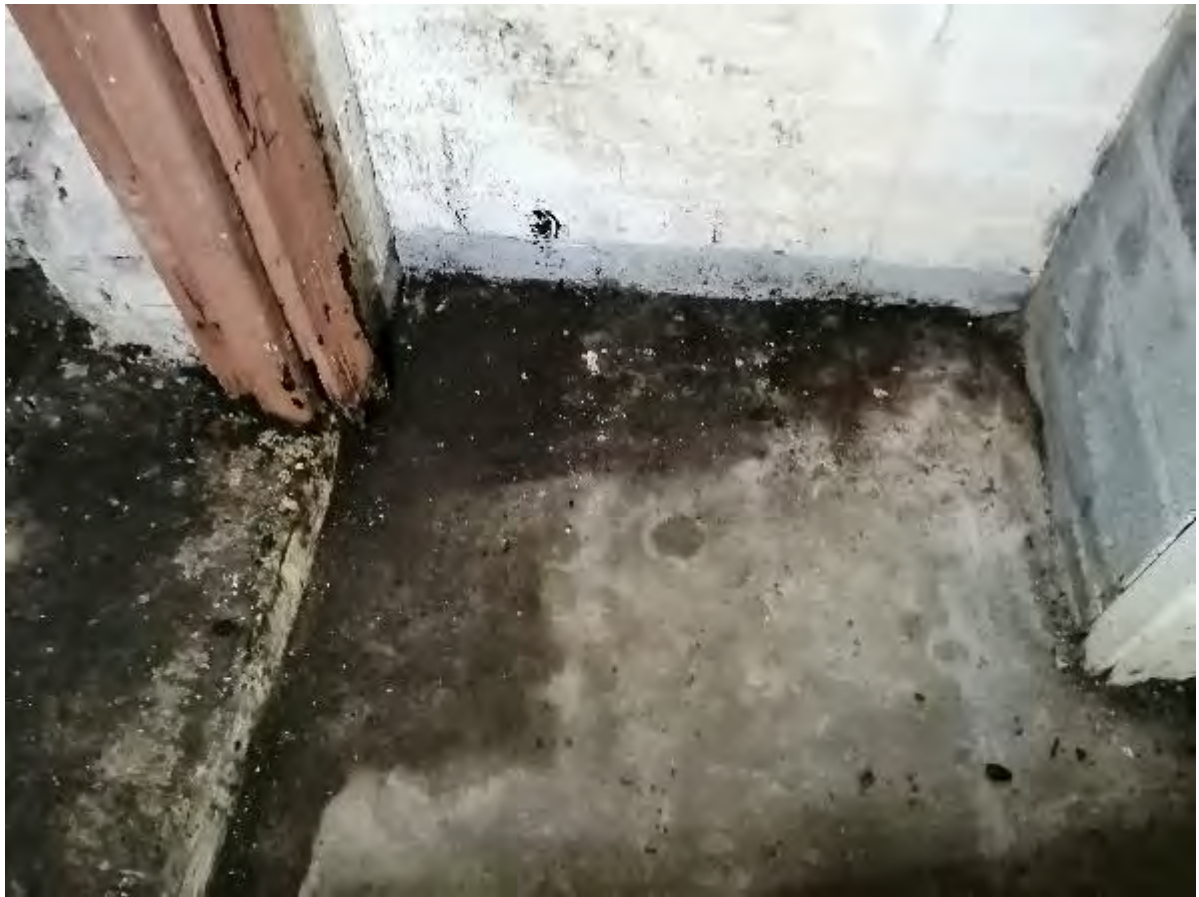
Photo 243 – Penetrating Damp (Corridor 3)

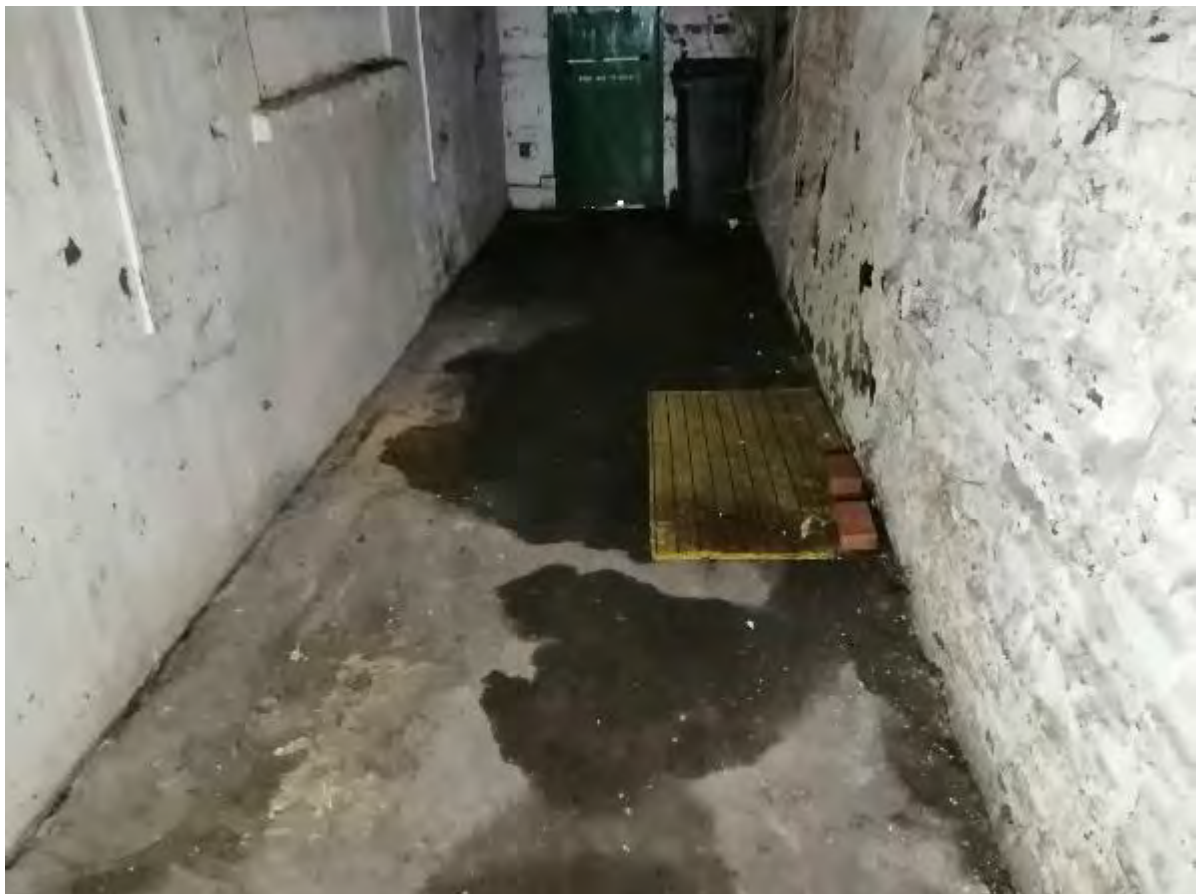
Photo 244 – Penetrating Damp (Fire Exit Room)

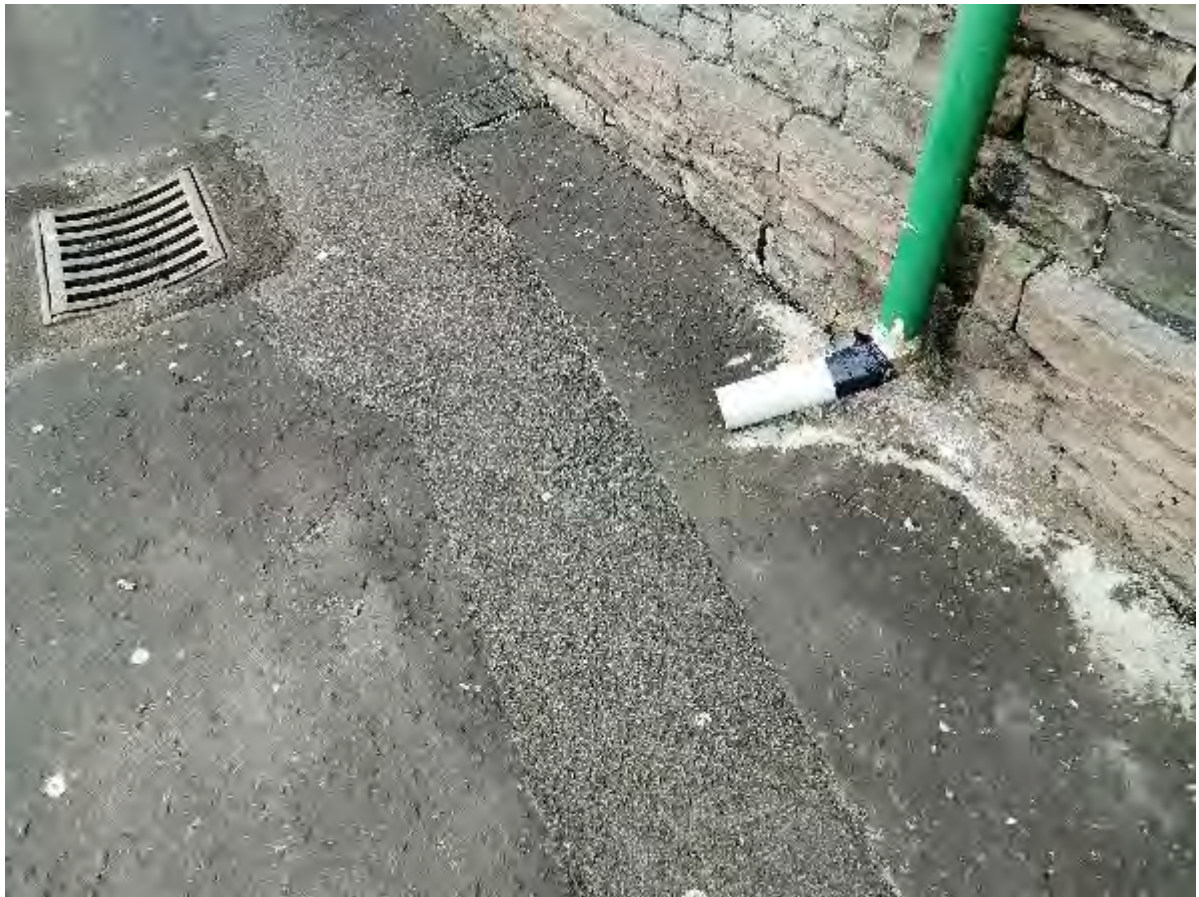
A defective drainage channel and lack of drainage gully to the right wall elevation were noted during the survey – see photos 246-247 below. Additionally, the rainwater down pipes to the front wall elevation discharge to the pavement without a method for removal of water away from the base of the wall – see photos 248-249 below. These defects can allow water to pond and build up against the property increasing the risk of rising and penetrating damp to the internal ground floor areas. It is recommended that the drainage arrangement to the external of the property is rationalised to remove water away from the property wall elevations. Condition Rating **2** See Section 7.0 Recommendations for guidance on repair works required.

Photo 248 – No Drainage to Remove Water from Wall (Front Wall Elevation)
