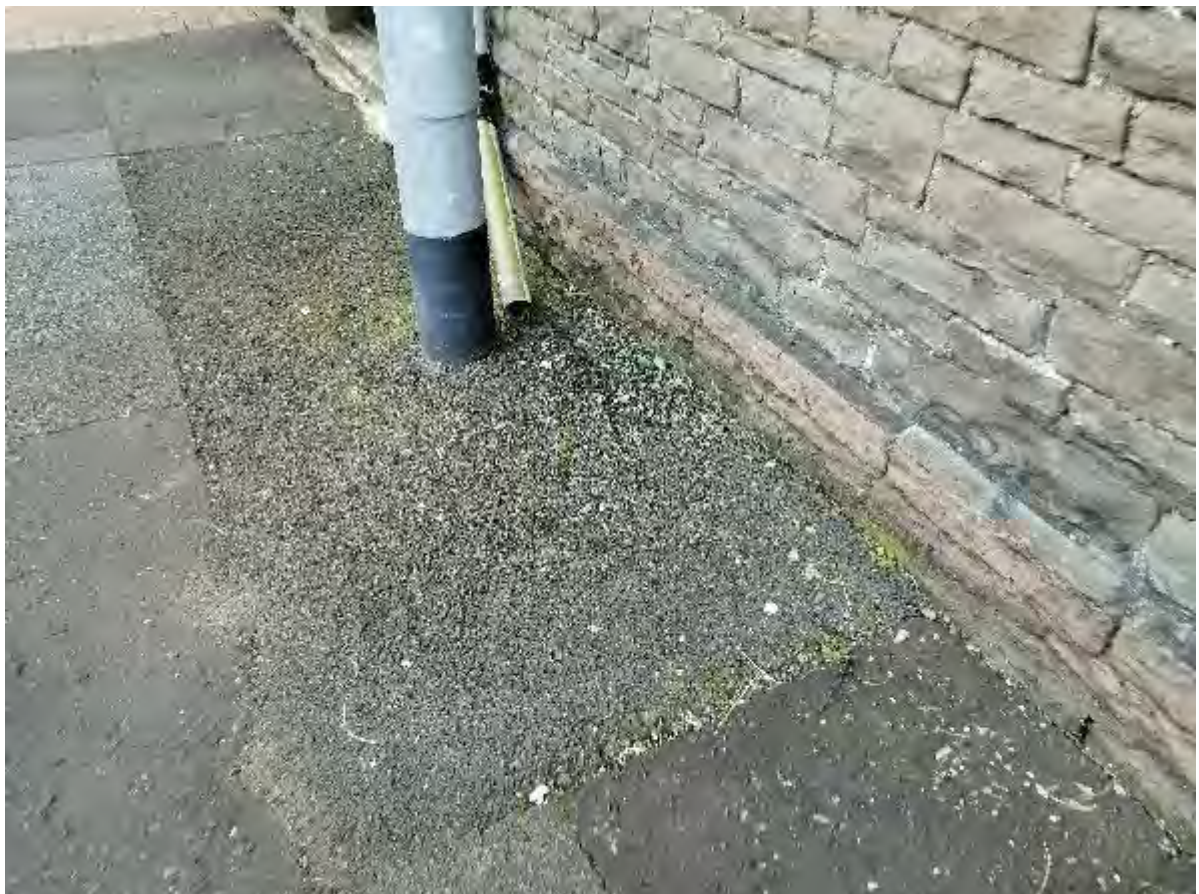
A defective drainage channel and lack of drainage gully to the right wall elevation were noted during the survey – see photos 246-247 below. Additionally, the rainwater down pipes to the front wall elevation discharge to the pavement without a method for removal of water away from the base of the wall – see photos 248-249 below. These defects can allow water to pond and build up against the property increasing the risk of rising and penetrating damp to the internal ground floor areas. It is recommended that the drainage arrangement to the external of the property is rationalised to remove water away from the property wall elevations. Condition Rating **2** See Section 7.0 Recommendations for guidance on repair works required.

Photo 249 – No Drainage to Remove Water from Wall (Front Wall Elevation)
