# ASBESTOS REFURBISHMENT SURVEY

Moose Hall, Neath SA11 3LU

1 Dec 2021

ALL100645/21/CE-1

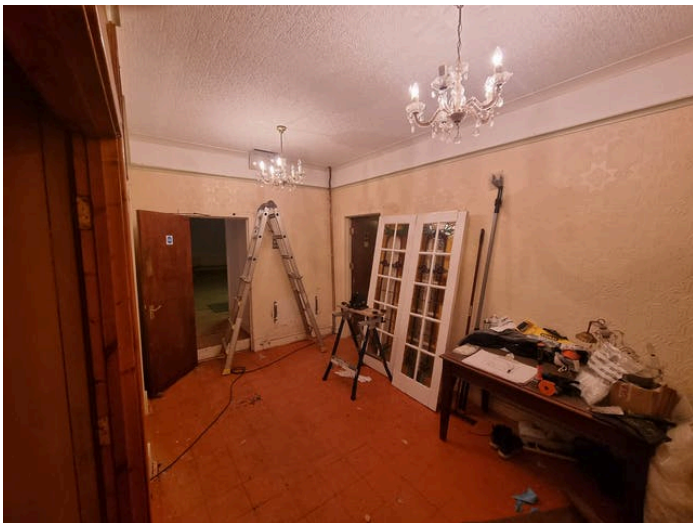
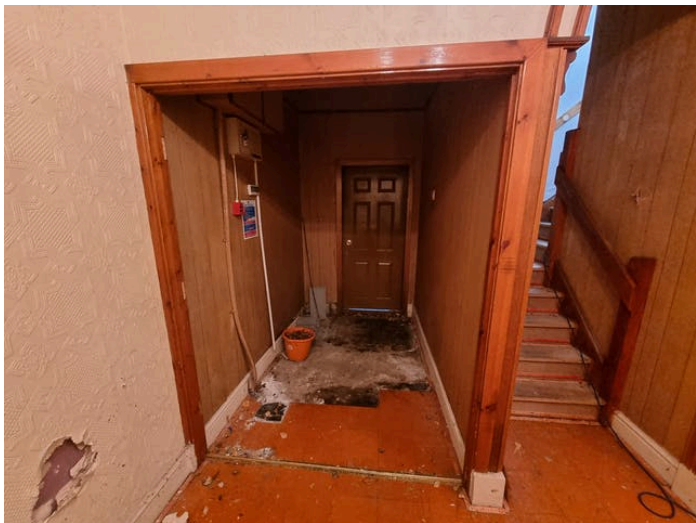
| Location Notes | Tongue and groove panelling to ceiling within void / Modern fuse box within ceiling void / Plasterboard ceiling with decorative paper / Mixture of plasterboard and wood panelling throughout room / Vinyl floor tiles - a section of tiles have been removed near the entrance doorway, although bitumen residue remains | | |

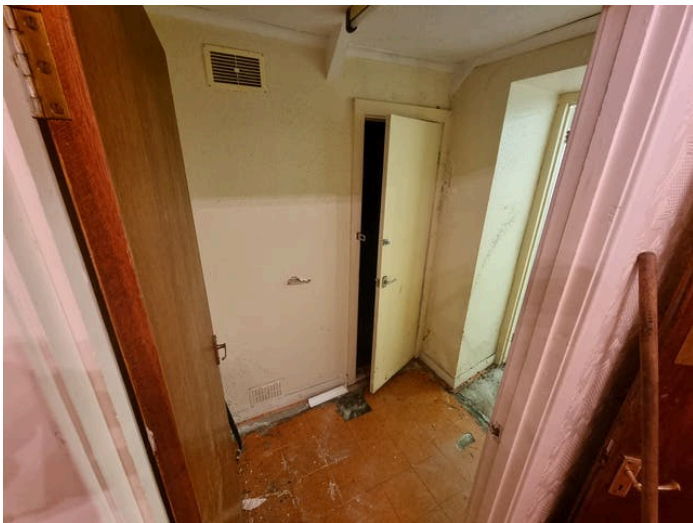
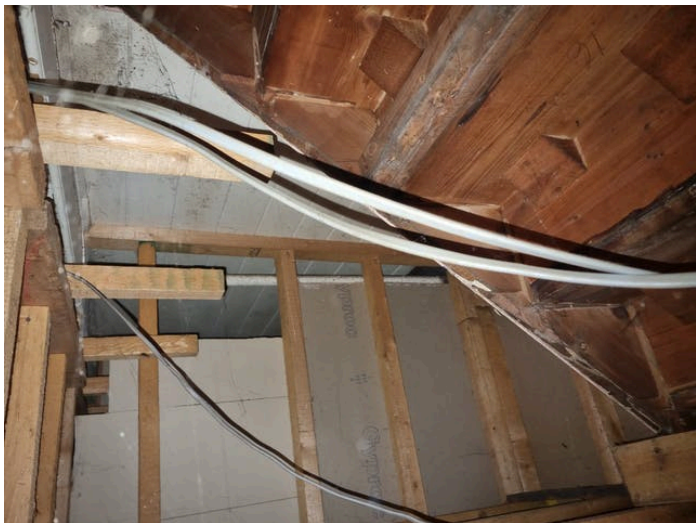
| Location Notes | Compressed wood ceiling panelling with decorative paper / Void above ceiling inspected and revealed wooden tongue and groove panelling, underside of wood stairwell and plasterboard wall panelling / Mixture of plasterboard and solid walls with decorative paper / vinyl floor tiles | | |

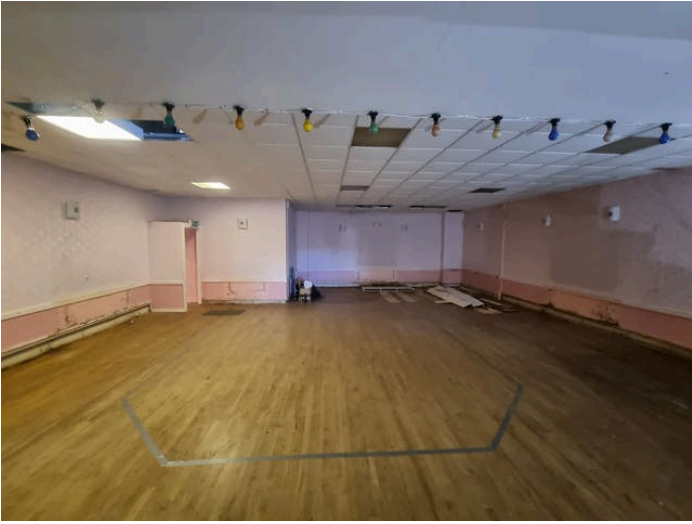
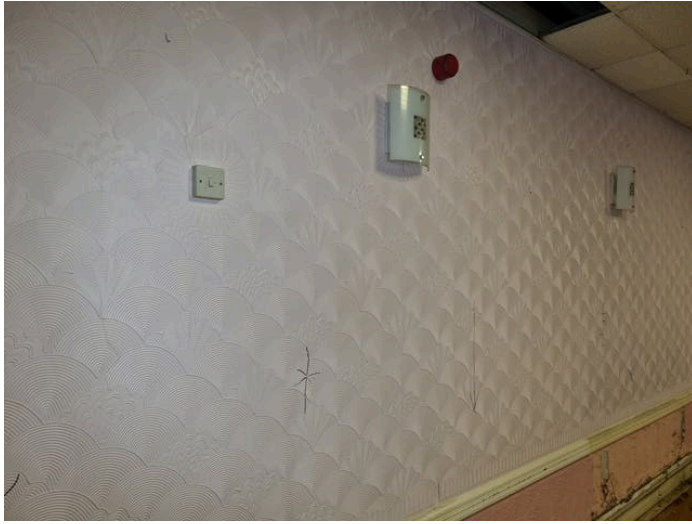
| Location | 006 - | Item | Textured Coating to upper sections of plasterboard walls |

| Strategy / Sample Id | Sample / 100645/16 | Fibre Type | NADIS |
| General Comments | Fan pattern to upper section of walls only | | |

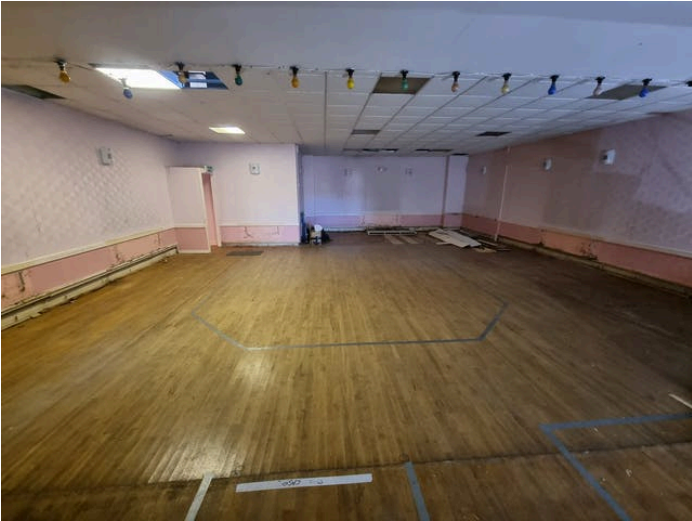
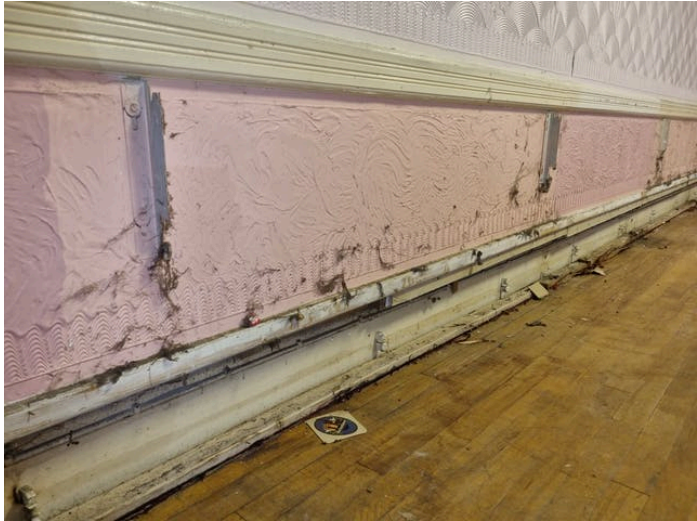
| Location | 006 - | Item | Textured Coating to lower sections of plasterboard walls |

| Strategy / Sample Id | Sample / 100645/17 | Fibre Type | NADIS |
| General Comments | Swirl pattern | | |

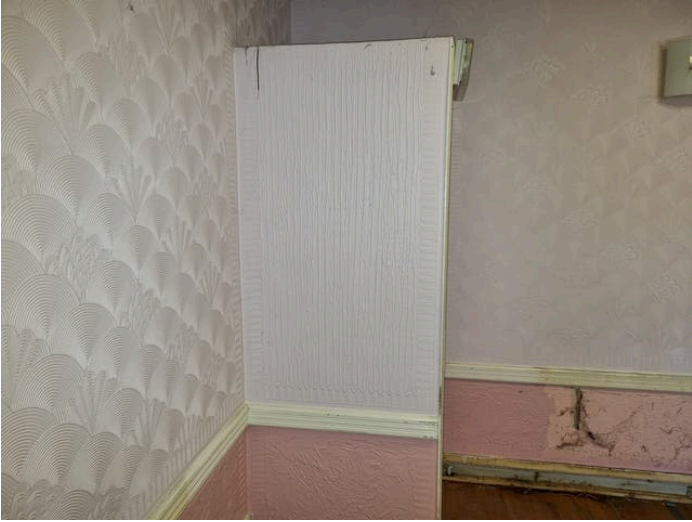
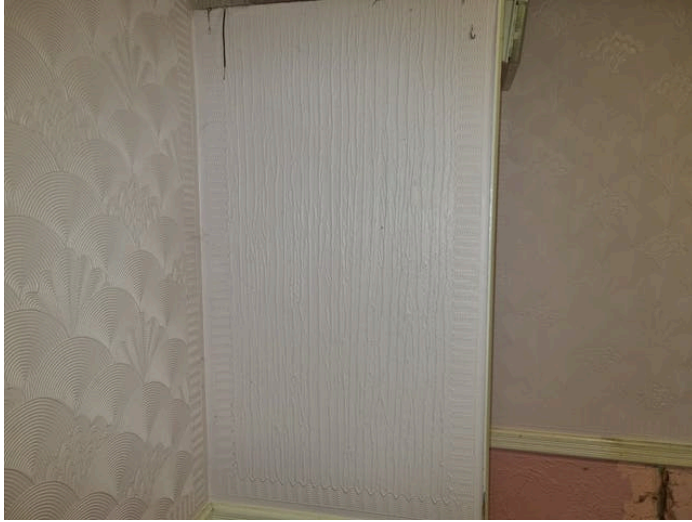
| Location | 006 - | Item | Textured Coating to upper section of plasterboard wall of entrance doorway (Room 0/06 side) |

| Strategy / Sample Id | Sample / 100645/18 | Fibre Type | NADIS |
| General Comments | Straight pattern | | |

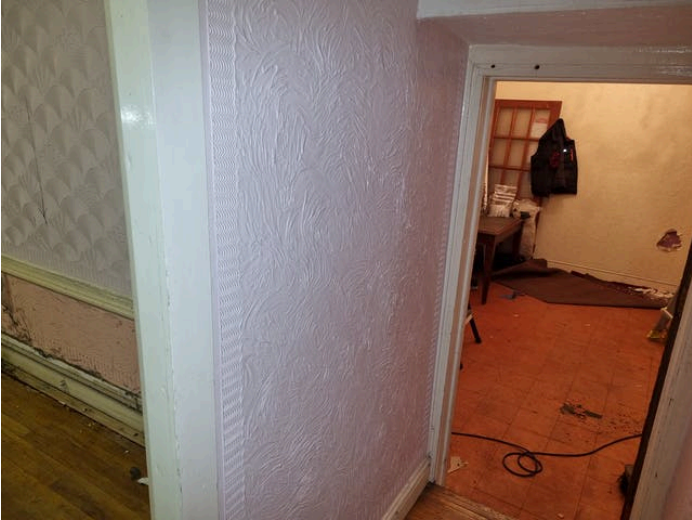
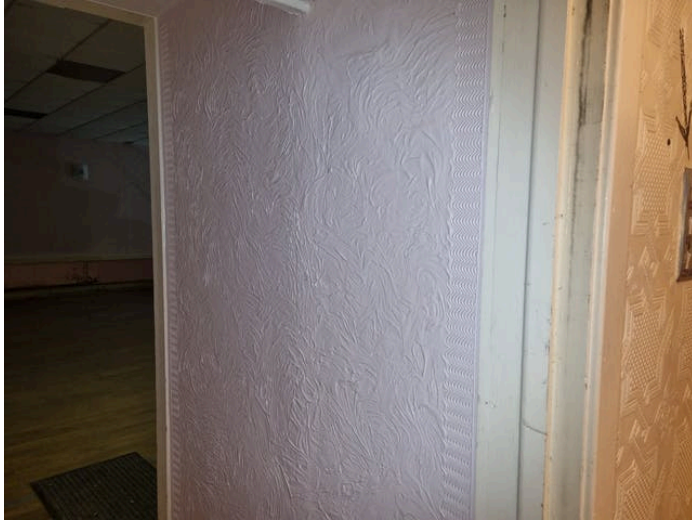
| Location | 006 - | Item | Textured Coating to plasterboard wall of entrance doorway (Room 0/01side) |

| Strategy / Sample Id | Sample / 100645/19 | Fibre Type | NADIS |
| General Comments | Swirl pattern | | |

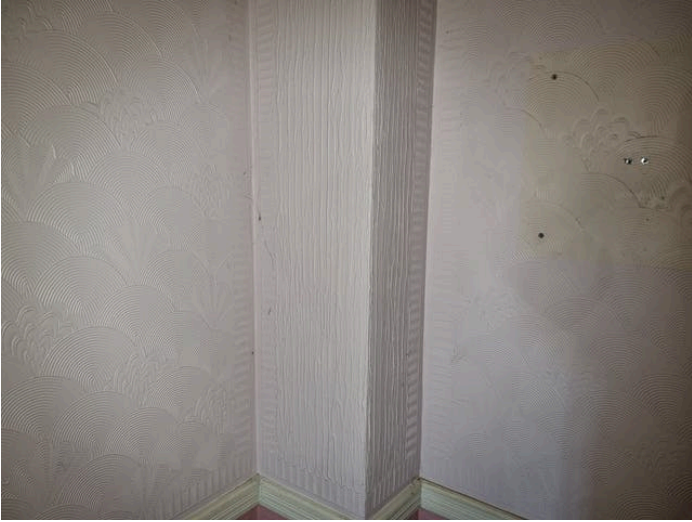
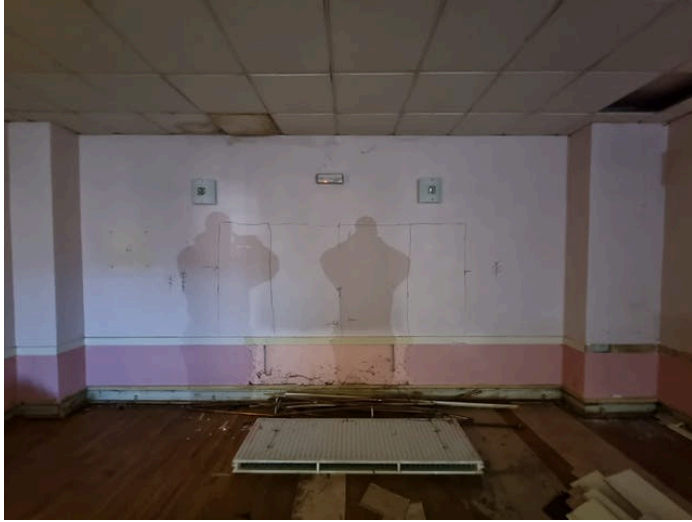
| Location | 006 - | Item | Textured Coating to corner box sections of plasterboard walls to LHS wall (Two boxing present) |

| Strategy / Sample Id | Sample / 100645/20 | Fibre Type | NADIS |
| General Comments | Straight pattern | | |

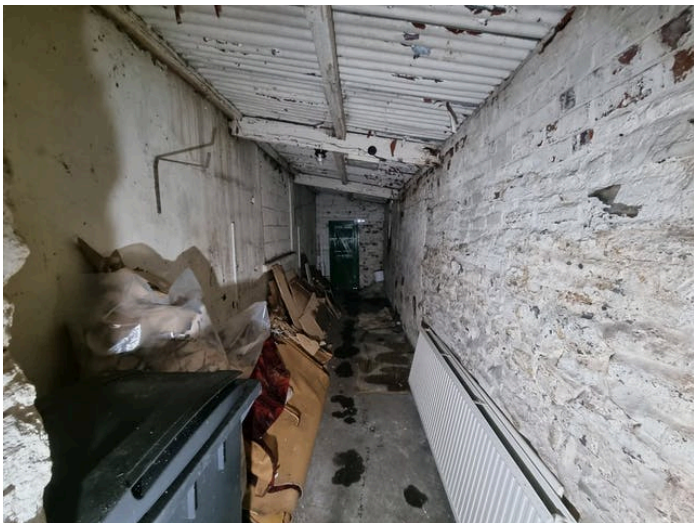
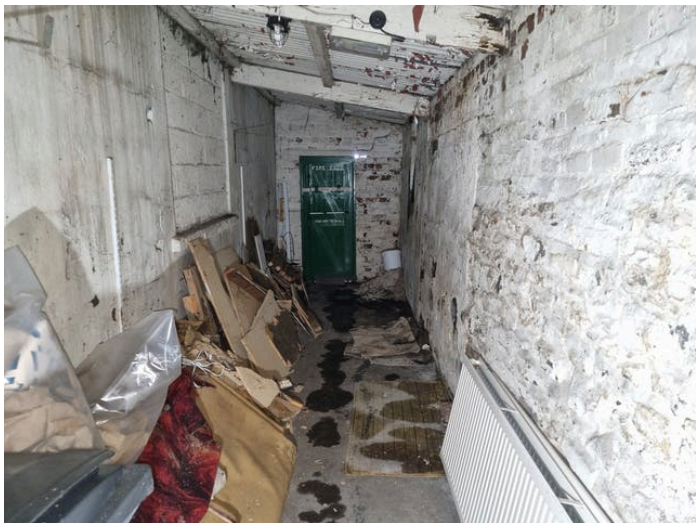
| Location Notes | Concrete Ceiling (Corrugated effect possibly due to installation) / Brick walls / Concrete floor / Stored Paper backed sheet vinyl flooring present on floor | | |

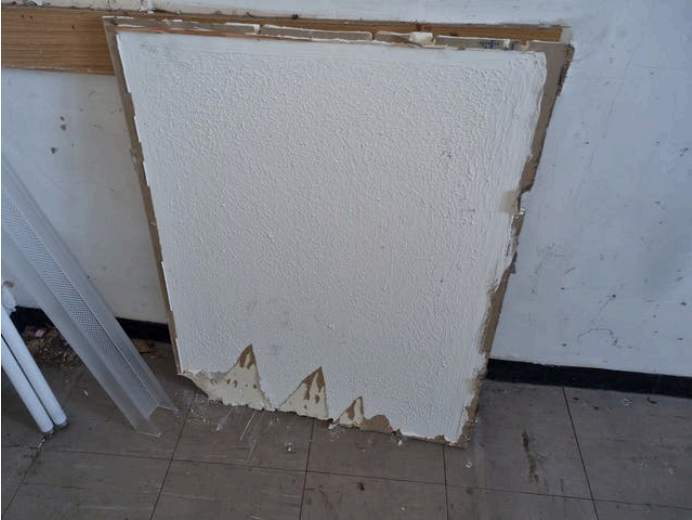
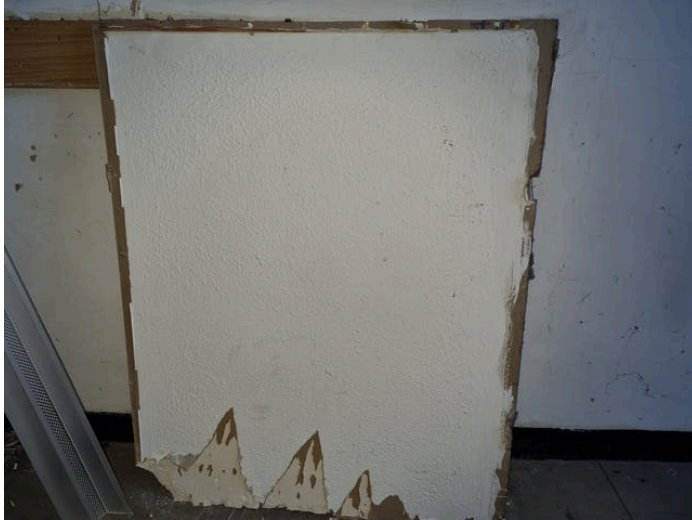
| Location | 013 - | Item | Textured Coating to panel that formerly covered hole in wall |

| Strategy / Sample Id | Sample / 100645/27 | Fibre Type | NADIS |

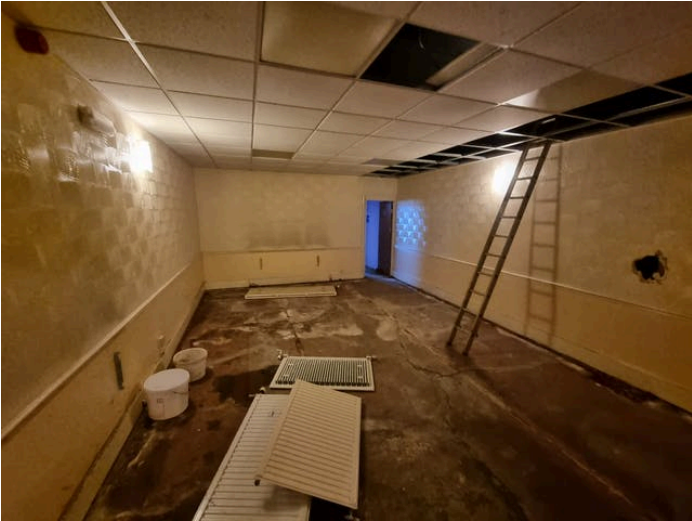
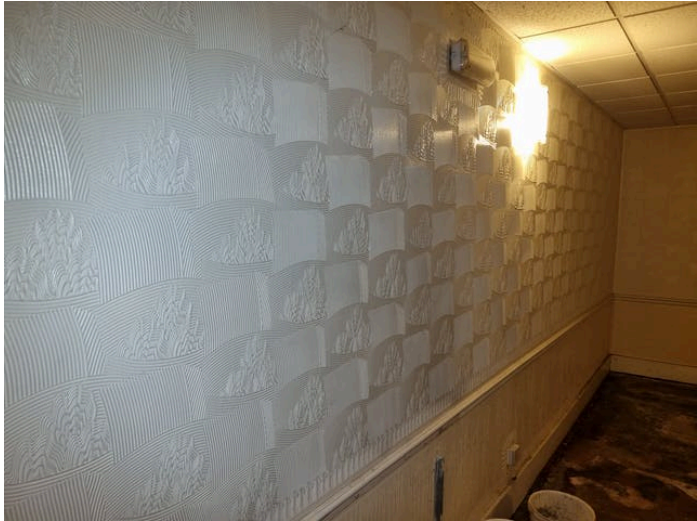
| Location | 015 - | Item | Textured Coating to upper sections of plasterboard walls |

| Material | Textured Coating | Extent | 27 m. sq.(Approximately) |
| Strategy / Sample Id | Sample / 100645/28 | Fibre Type | NADIS |
| General Comments | Straight and swirl pattern | | |

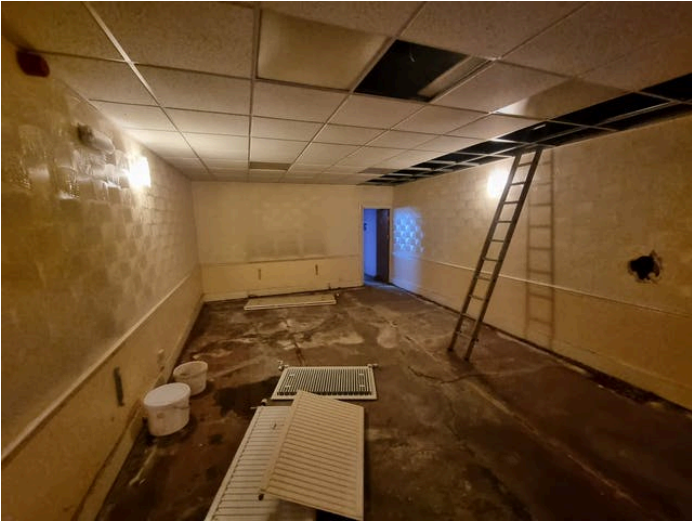
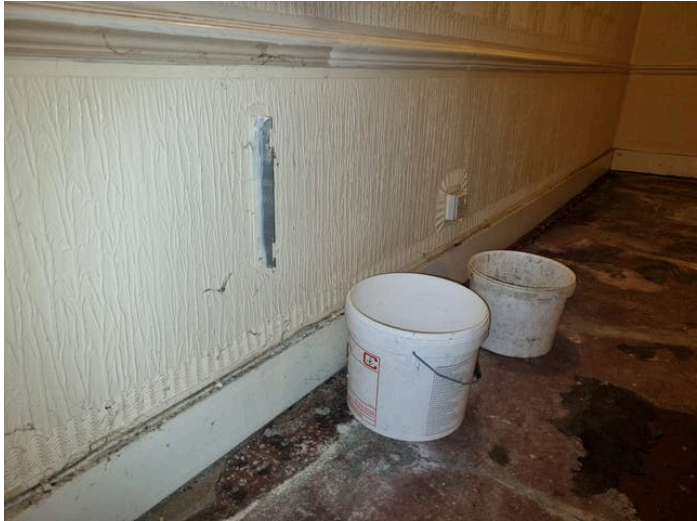
| Location | 015 - | Item | Textured Coating to lower sections of plasterboard walls |

| Material | Textured Coating | Extent | 22 m. sq.(Approximately) |
| Strategy / Sample Id | Sample / 100645/29 | Fibre Type | NADIS |
| General Comments | Straight pattern | | |

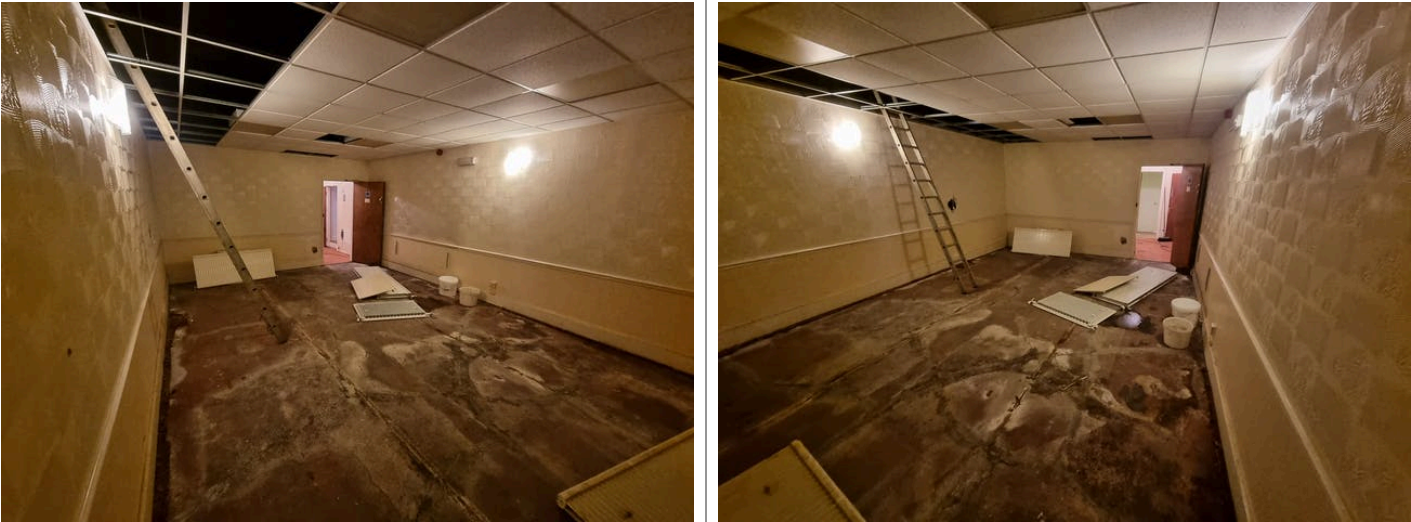
| | | Cellulosic suspended ceiling tiles / Wooden tongue and groove ceiling above suspended ceiling / Decorative coating to plasterboard walls / Solid walls present behind plasterboard / Concrete floor | |

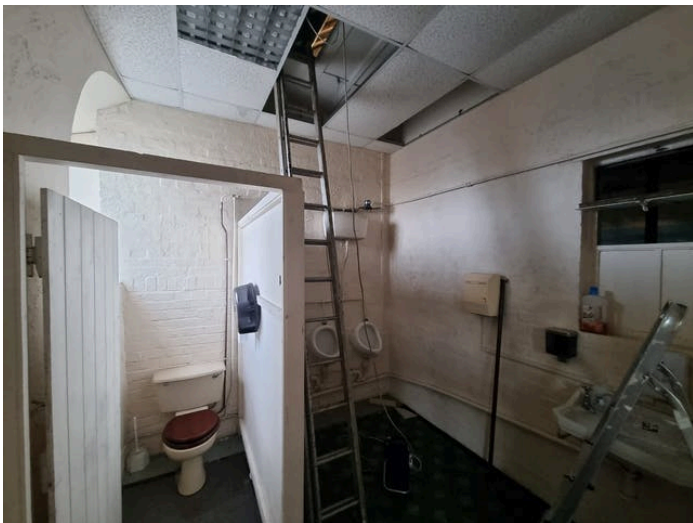
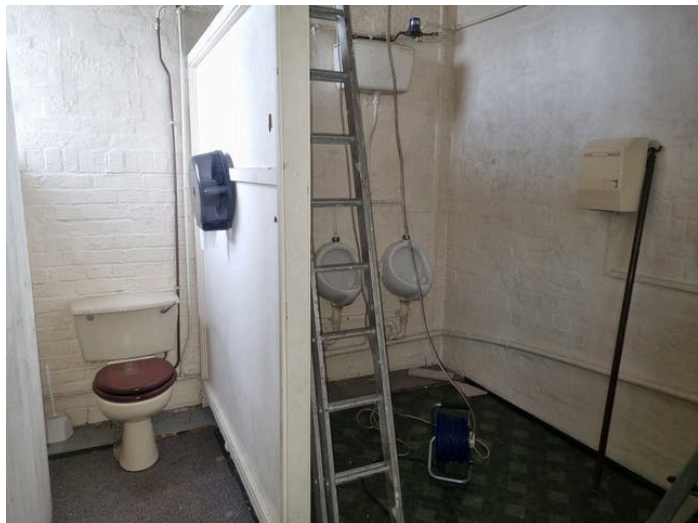
| Location Notes | Cellulosic suspended ceiling tiles / Cement panelling above suspended ceiling / Textured paint to solid walls / Wood panelling g to cubicle partition / Metal and wood framed windows / Wood panelling adjacent to external window / Porcelain sinks and toilet and urinals / Wood panneling covering door/ Mixture of sheet vinyl and vinyl floor tiles / See roof void 1 for observations of ceiling void above | | |

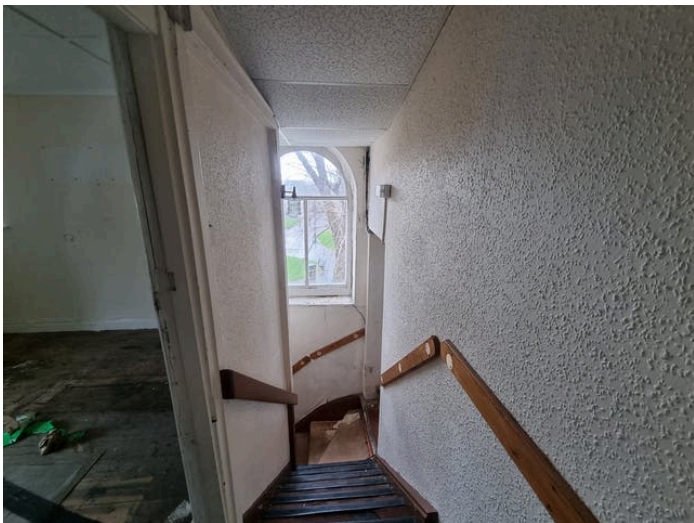
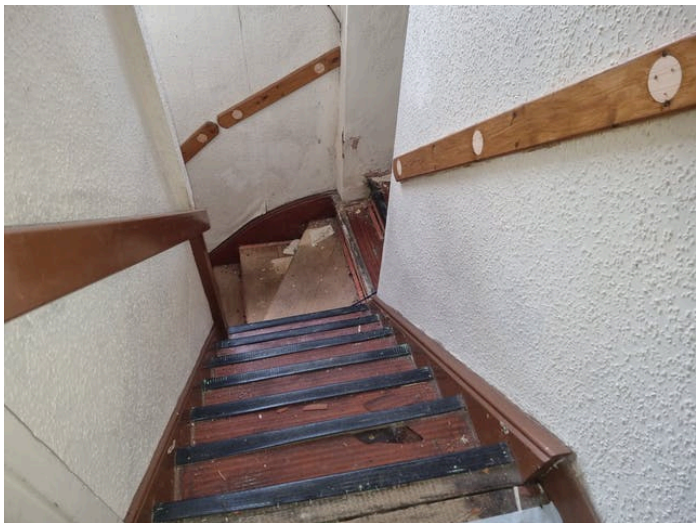
| Location Notes | Cellulosic suspended ceiling tiles / Lath and plaster with decorative paper above suspended ceiling / Mixture of plasterboard and tongue and groove wood wall panelling beneath decorative wall paper / Wooden stairwell with wood effect laminate to steps | | |

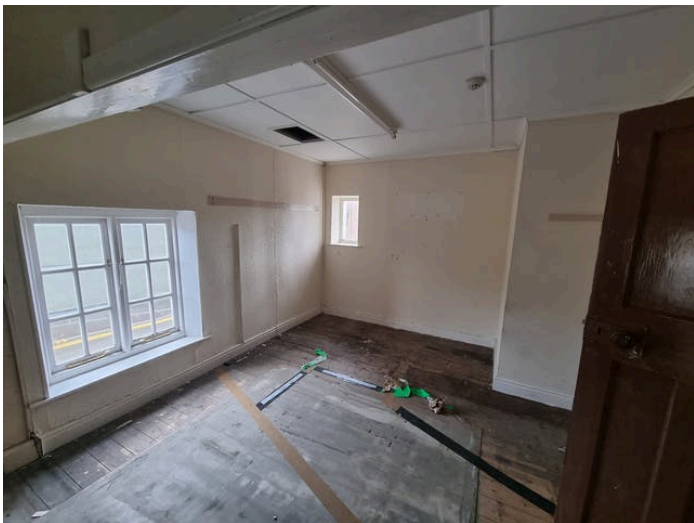
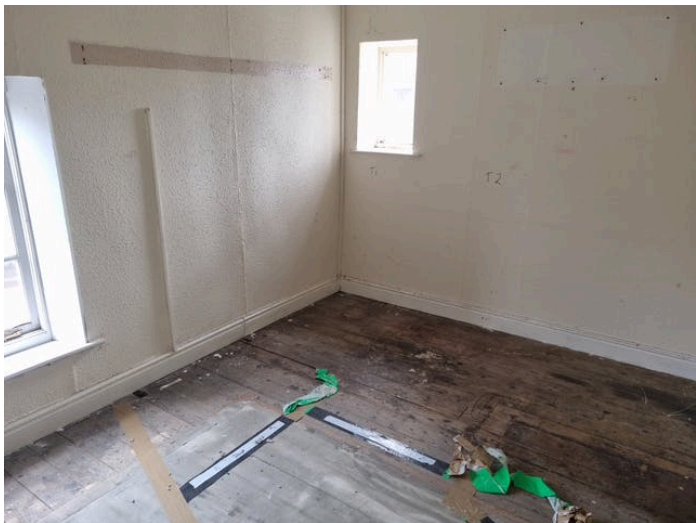
| Location Notes | Compressed wood panelling to suspended ceiling / See roof void 2 observations for above ceiling / Mixture of solid walls and wood tongue and groove panelling beneath decorative wall paper / Wooden floorboards | | |

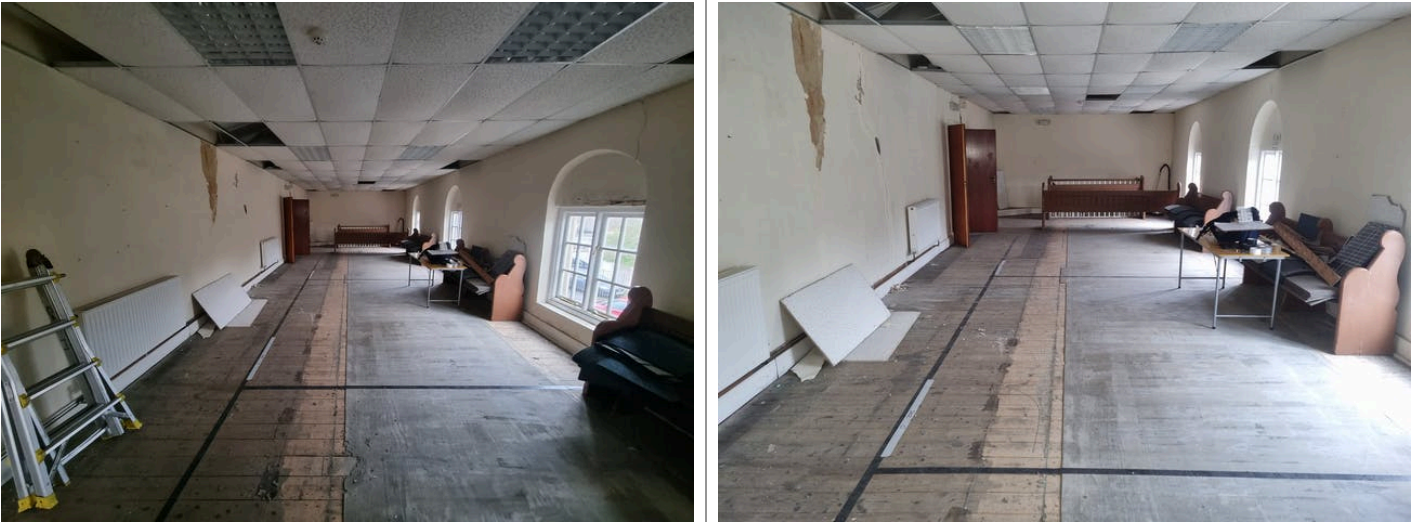
| Location | 004 - | Item | |

| | | Cellulosic suspended ceiling / Mixture of solid walls and wood tongue and groove panelling beneath decorative wall paper / Wooden floorboards | |

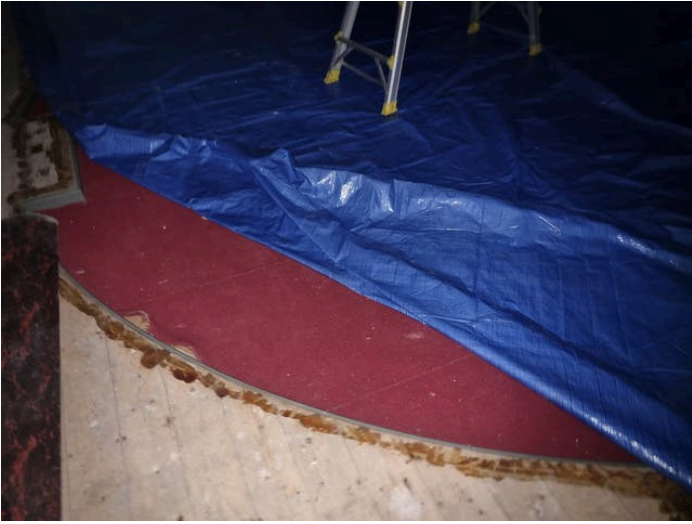
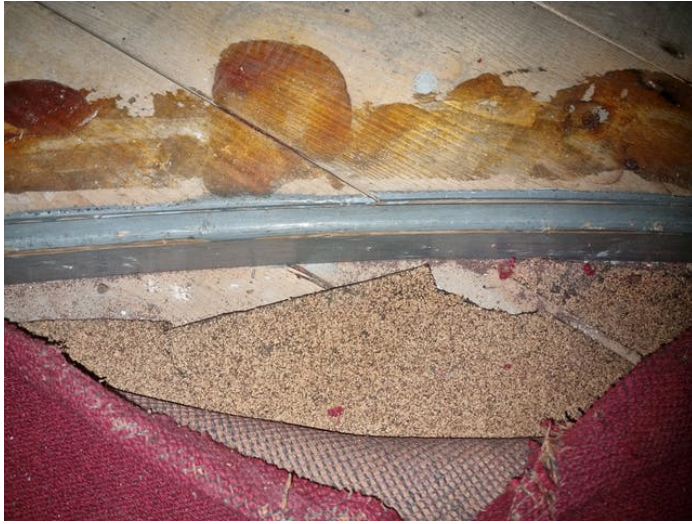
| Location | 005 - | Item | Composite lining beneath carpet to sunken floor section |

| Material | Composite | Extent | 12 m2 |
| Strategy / Sample Id | Sample / 100645/08 | Fibre Type | NADIS |

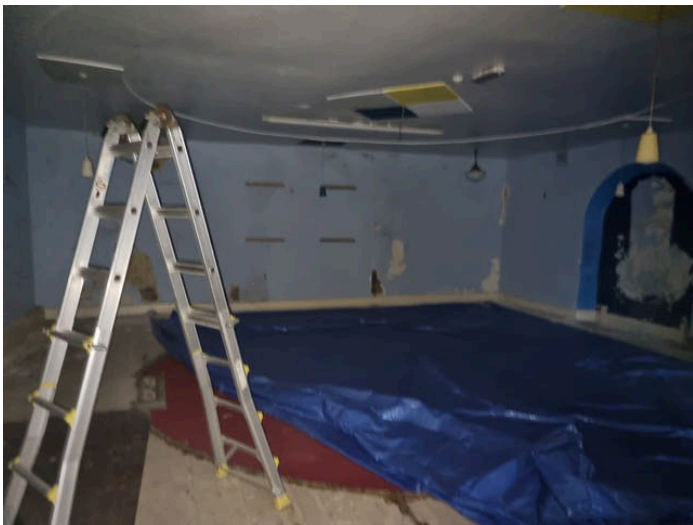
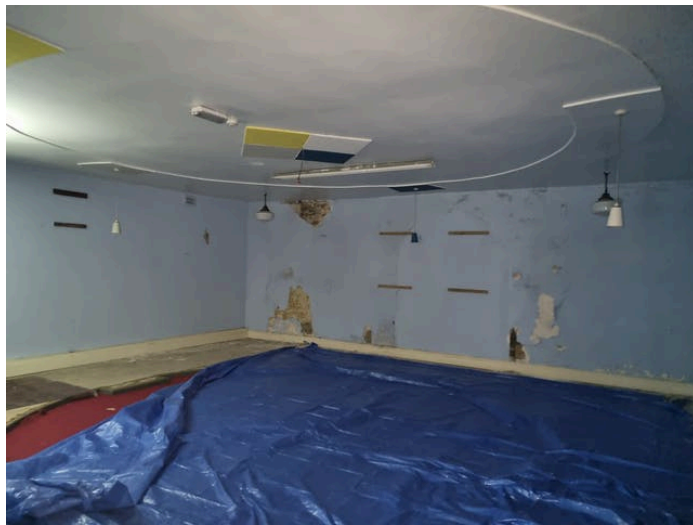
| Location Notes | Plaster ceiling with decorative coloured compressed wood panelling / Solid walls / Wooden floorboards with sunken floor to centre of room / Carpet to sunken floor section / Intrusion to LHS wall panelling revealed twin skinned plasterboard panelling and adjacent ceiling void of room 0/06 | | |
