**MR & MRS HILL**

**MOOSE HALL, CASTLE STREET, NEATH**

**BUILDING INSPECTION REPORT (PROTECTED SPECIES)**

Document Ref: E21106701 Doc 01 – 18 JANUARY 2022

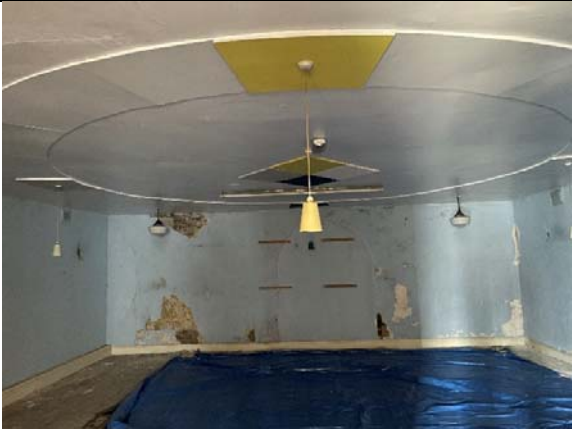
| Target Note | Description/comment |
|---|---|
| <b>Ground Floor</b> | <p data-bbox="328 695 1289 789">Rooms 0/11, 12, 13, 15, 05, 06 &amp; 01 are all relatively light and open with suspended ceiling and painted walls offering no features for bats. No obvious means of access as windows to rooms 0/11 &amp; 0/12 are all sound.</p> <p data-bbox="328 1255 1247 1314">Cellar area to rear of bar (room 0/10) is darker but no obvious means of access for birds or bats and no evidence noted.</p> |
