## Structural Survey (Inspection)

**Moose Hall  
Castle Street  
Neath  
SA11 3LU**

Structural Surveys UK were commissioned to undertake a Full Structural Survey (Inspection) to a residential property at Moose Hall, Castle Street in Neath.

The property is detached grade 2 listed former Wesleyan Methodist Chapel which has previously been converted into a hall and has been derelict for a number of years.

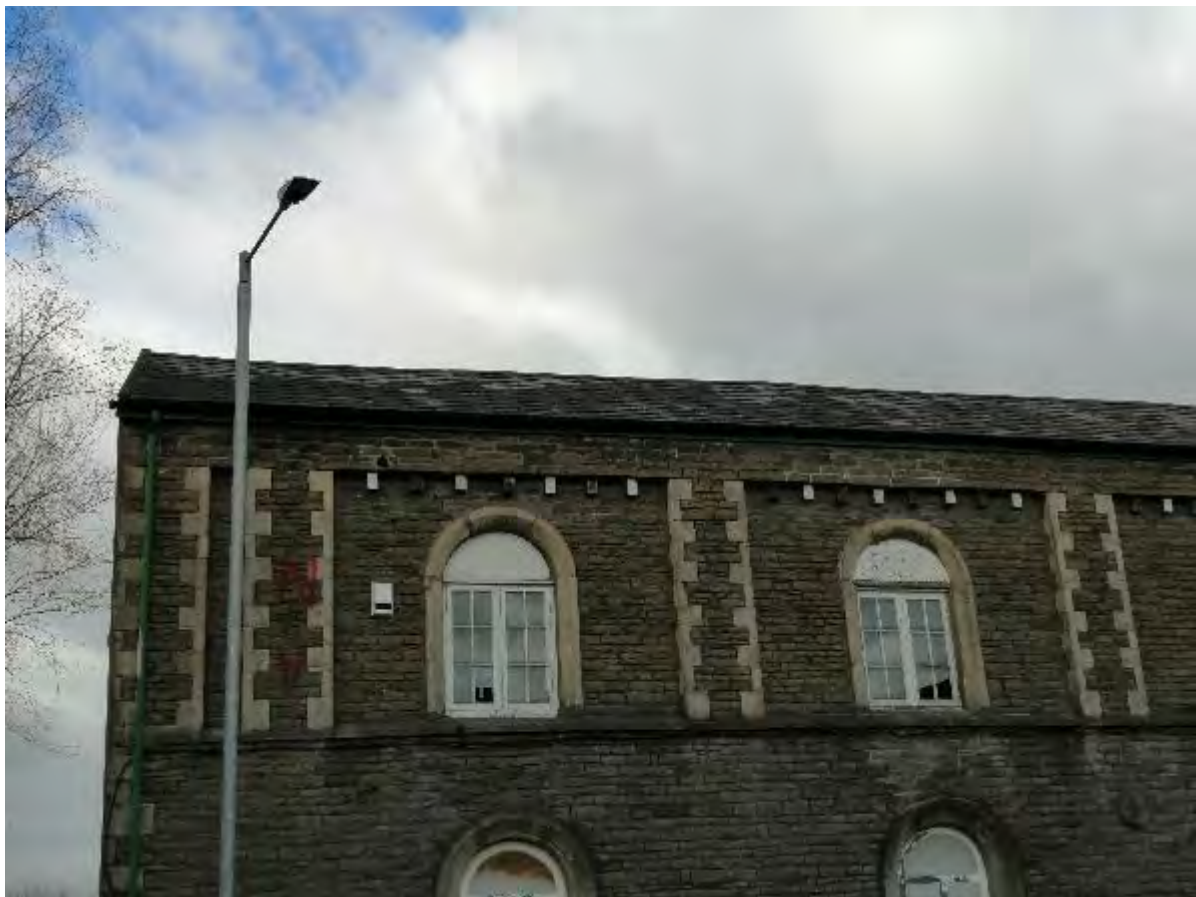
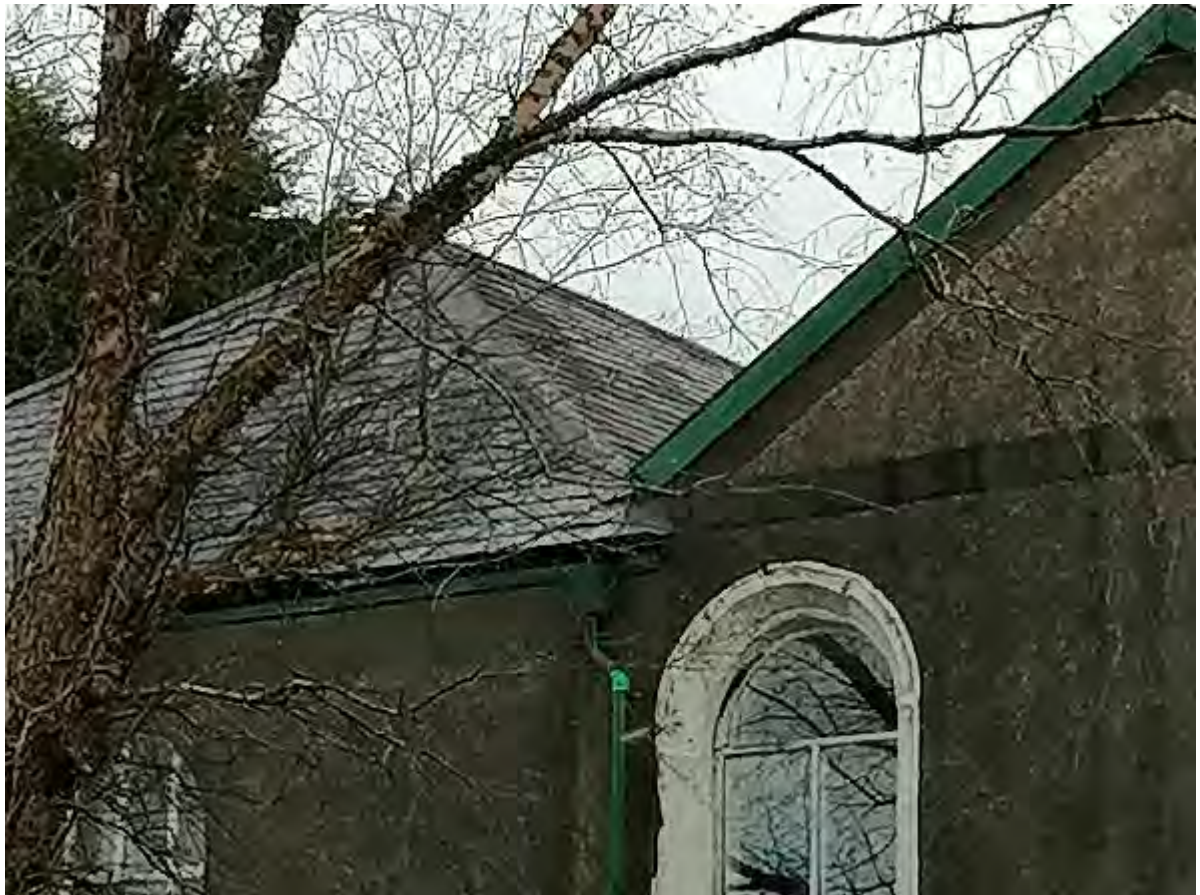
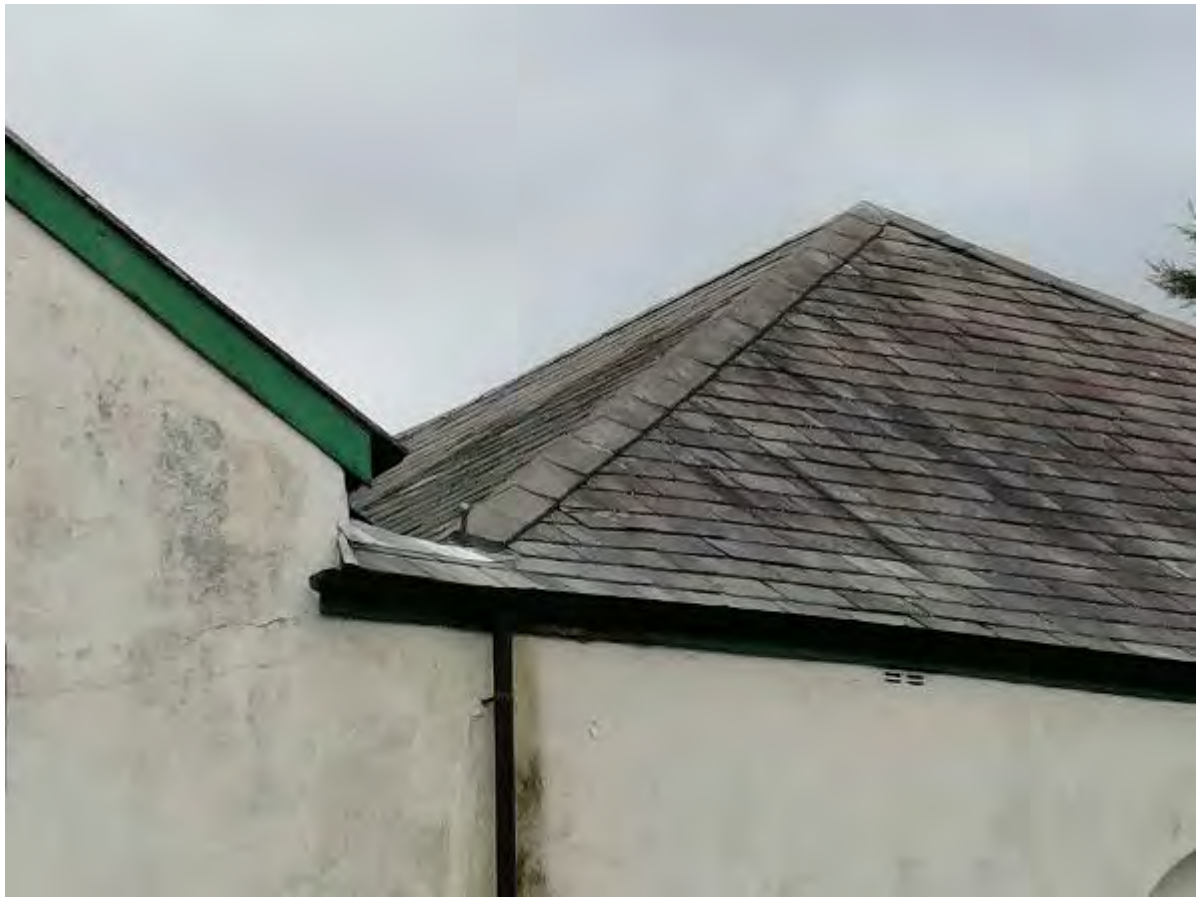
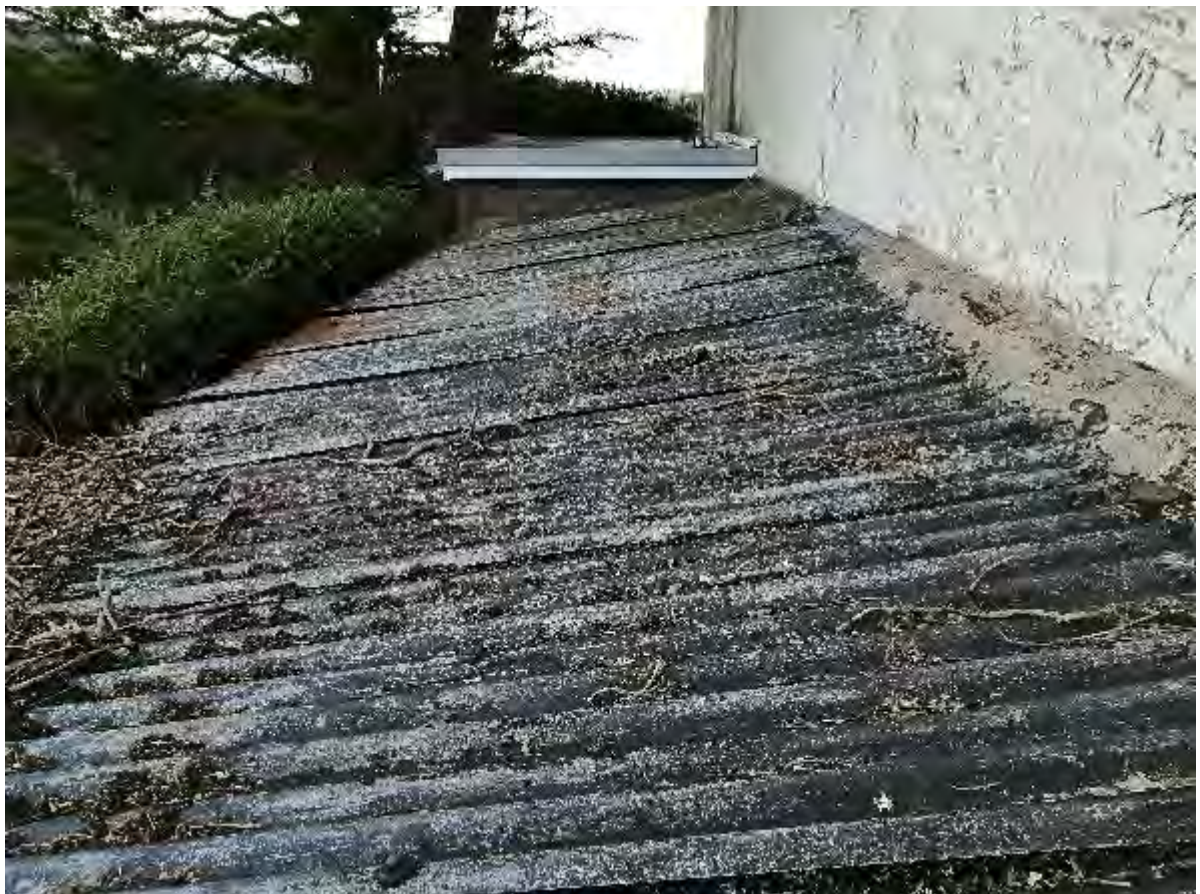
We noted no major undulation, deflection or other distortion to the roof structure of the property, i.e. sagging or leaning of the timber frames to the front or rear elevations – See Photo 1 to 10. Minor sagging was noted to the front roof profile – see photo 20 below. The alignment of the roof profile was satisfactory and did not raise concerns regards the integrity of the structural timber frameworks beneath (when inspected externally).

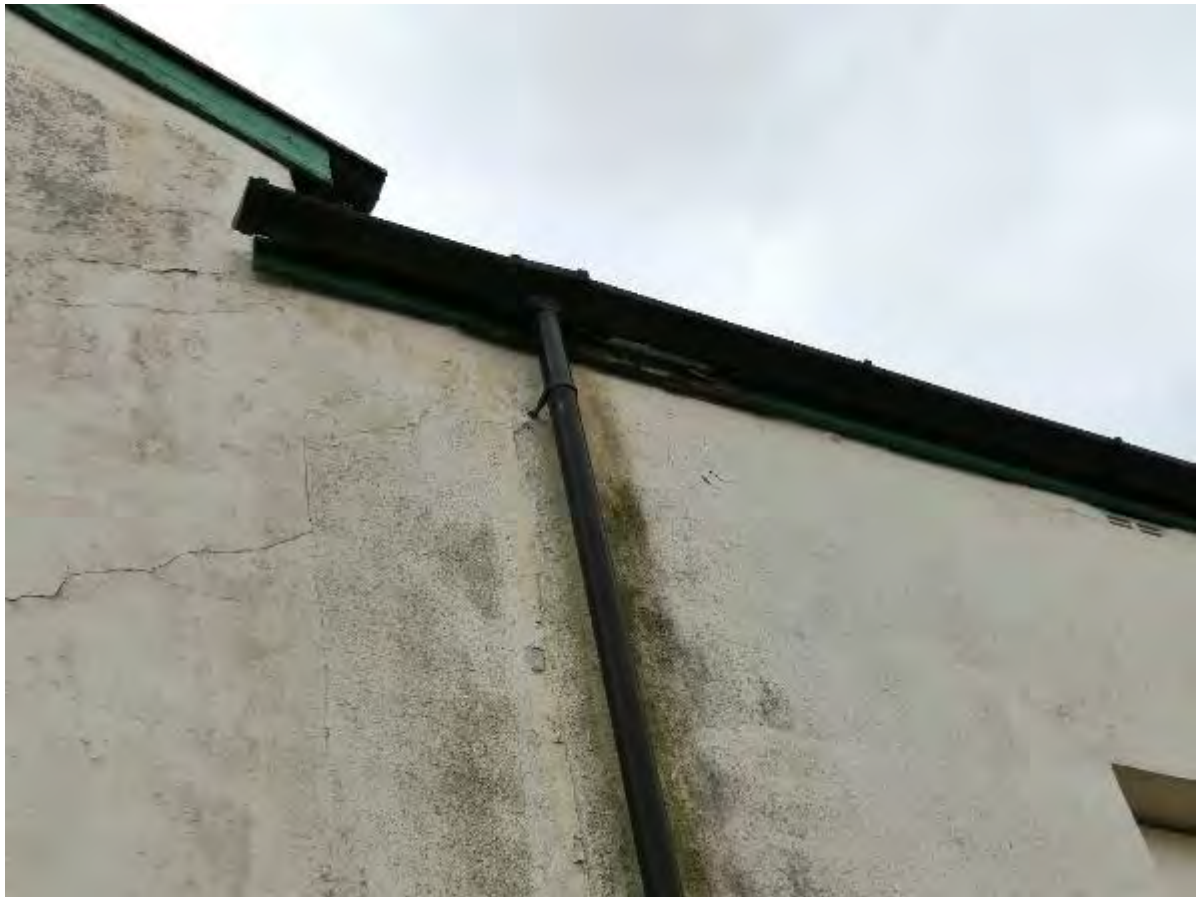
- The timber fascia board to the property were noted to be weathered and will require repair or renewal in areas of rot damage.
- Poor guttering to the roof line was evident with multiple missing gutter sections and defective sections to the rear roof profile – see examples in photos 11-14, which can lead to rainwater discharging down the face of the wall (potential damp issues).

Photo 16 – Weathered Fascia Board (Right Roof Profile)

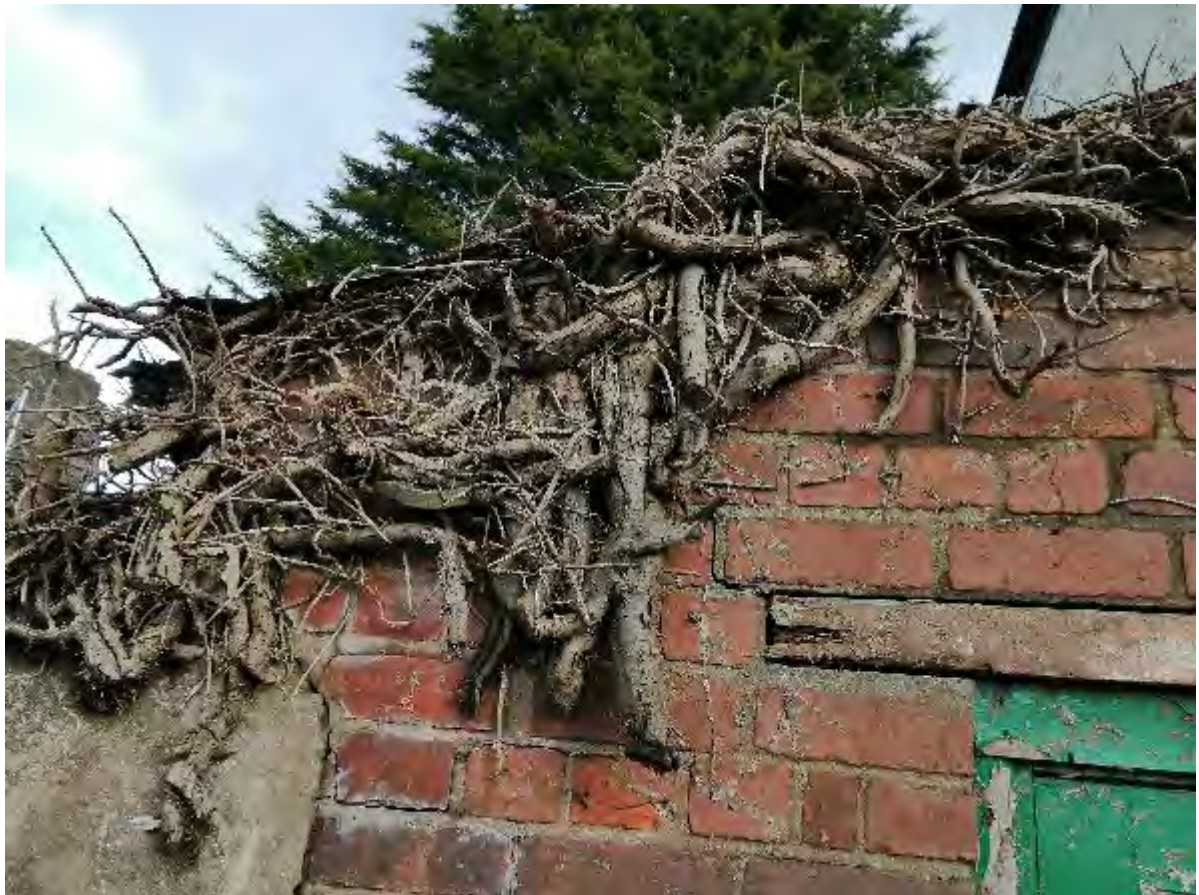
- A number of damaged tiles were noted to the front roof profile.
- Significant vegetation growth was noted to the rear extension roof and the rear roof profile, rear, left side and right side wall elevations and internally in the fire exit room.

Photo 17 – Vegetation Growth Under Roof Tiles (Rear Roof Profile)

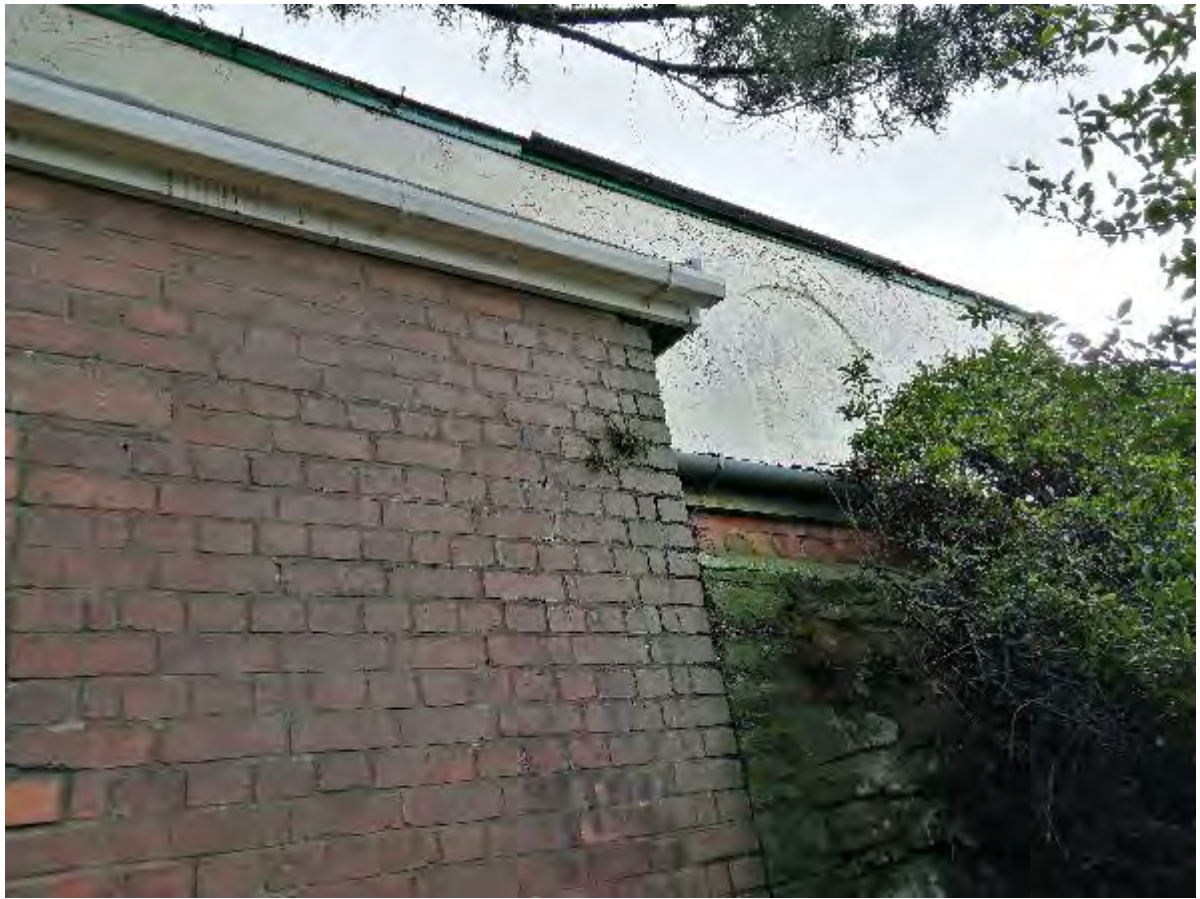
Photo 33 – Vegetation Growth (Rear Wall Elevation)

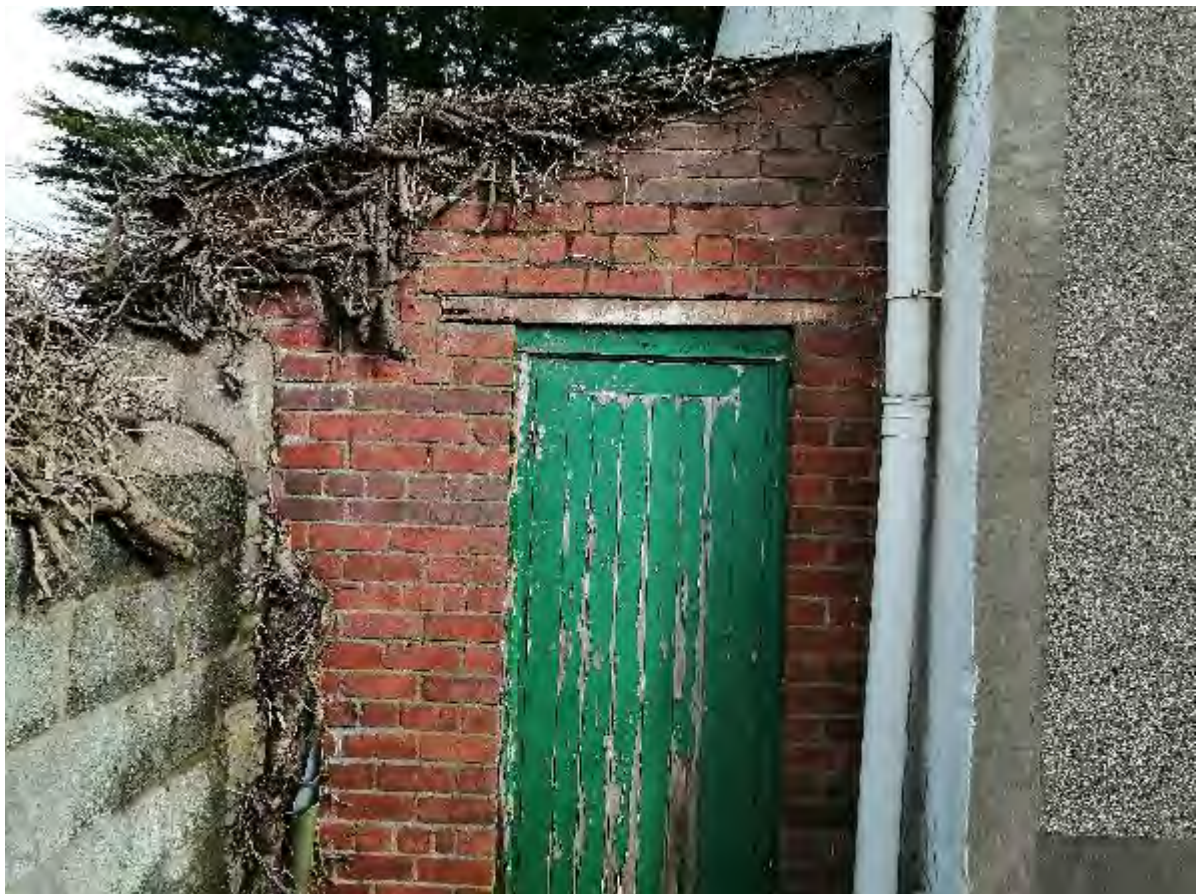
Photo 34 – Vegetation Growth (Left Wall Elevation)
