# 0346- Main Road Dyffryn Cellwen, Neath

Tree Survey Summary - REV A

Tree Survey by Tree Scene, summary by Hickman & Smith Architects

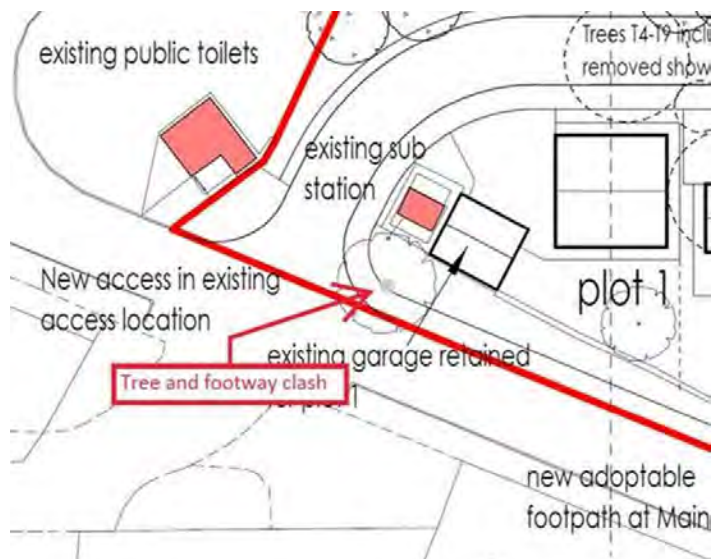
Would you be able to offer your comment on whether you would find it acceptable to remove this tree (planting new trees elsewhere on the site) in order to make the footpath achievable? Or would you feel strongly that the tree should be retained- in which case, would you be willing to see the footpath stop before the tree?
