## 4.1 Photographic Record - First Floor

SECOND FLOOR PHOTOGRAPHS

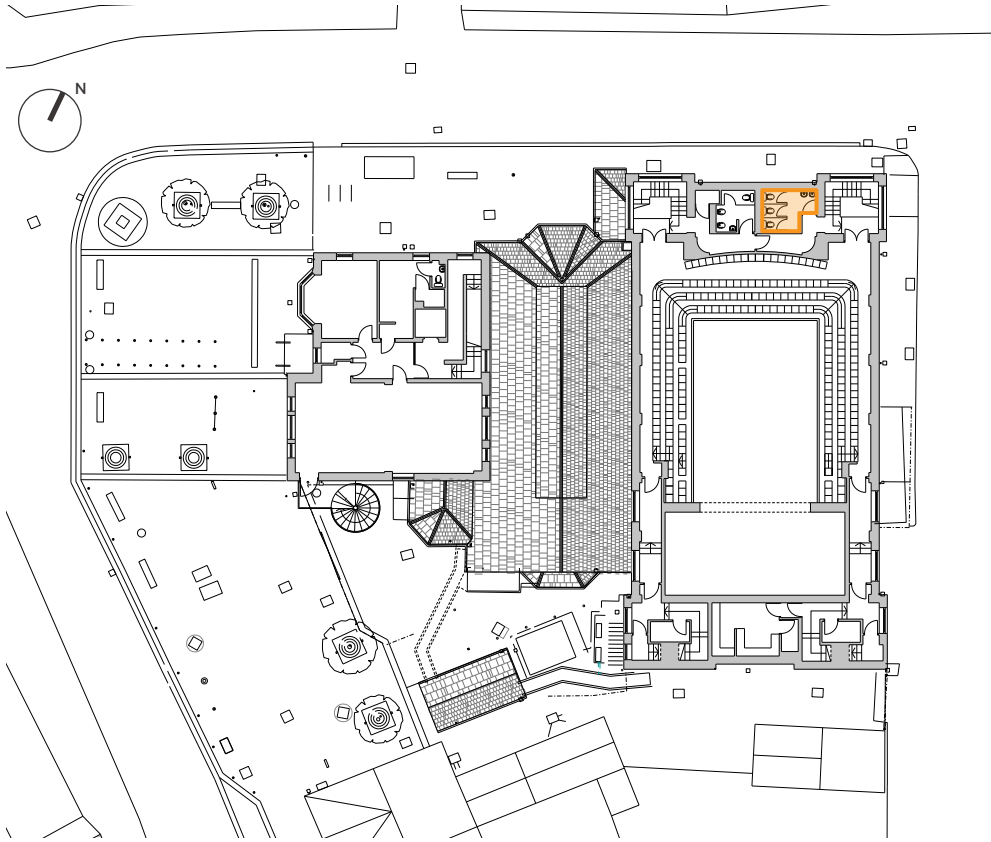
### Female WCs

Generally, the first floor female WCs contain no features of historical merit. The internal toilet cubicles, light fittings, floor finishes and sanitaryware all appear to be modern installations.

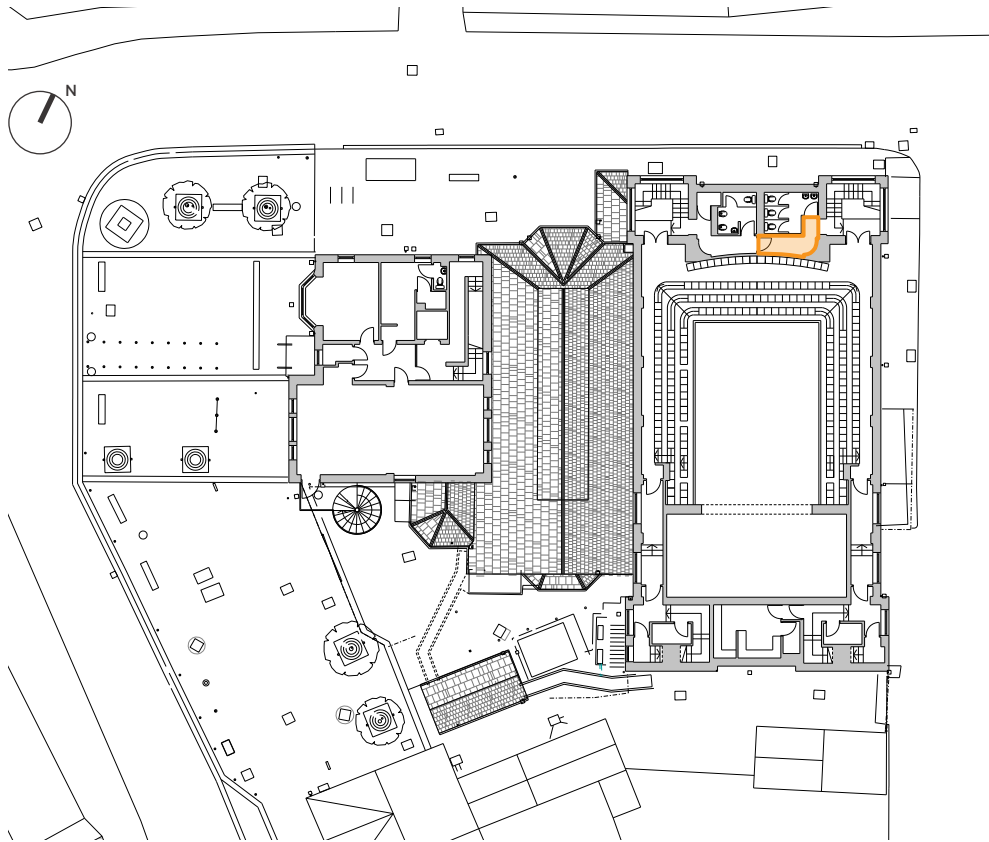
### Corridor

The existing interconnected corridor space contains no visible historic features, with the column within the space appearing to have been built during the 1990s.

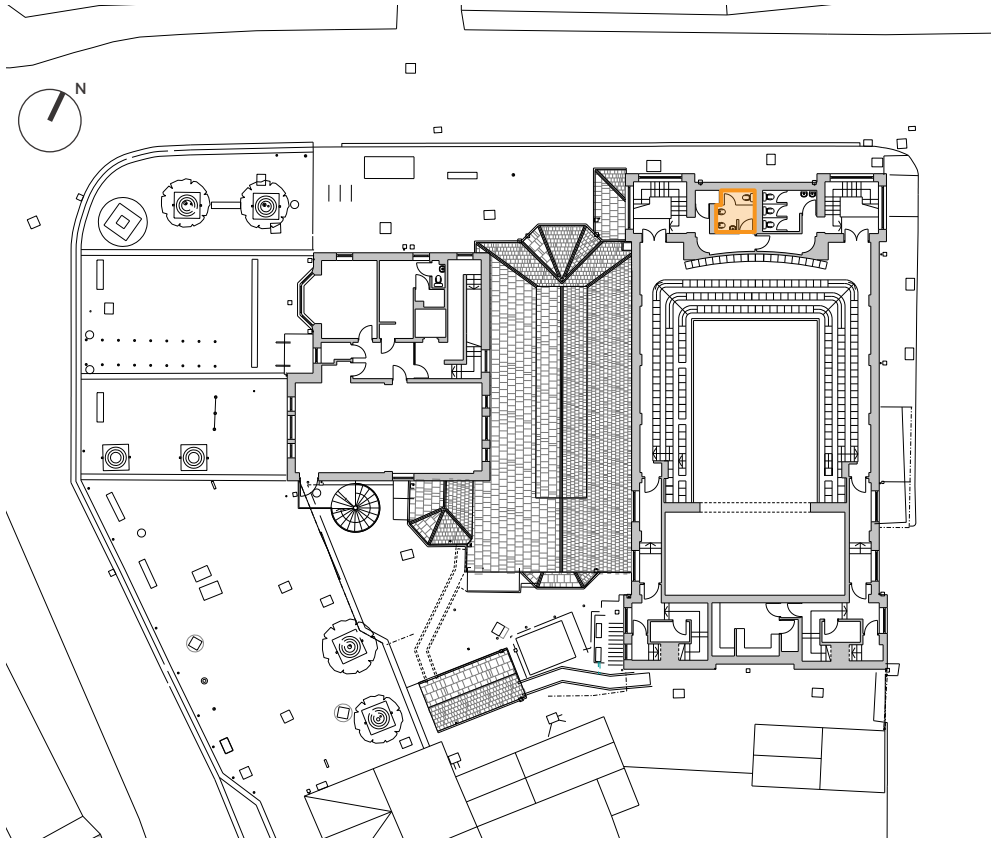
### Male WCs

Generally, the first floor male WCs contain no features of historical merit. The internal toilet cubicles, light fittings, floor finishes and sanitaryware all appear to be modern installations.

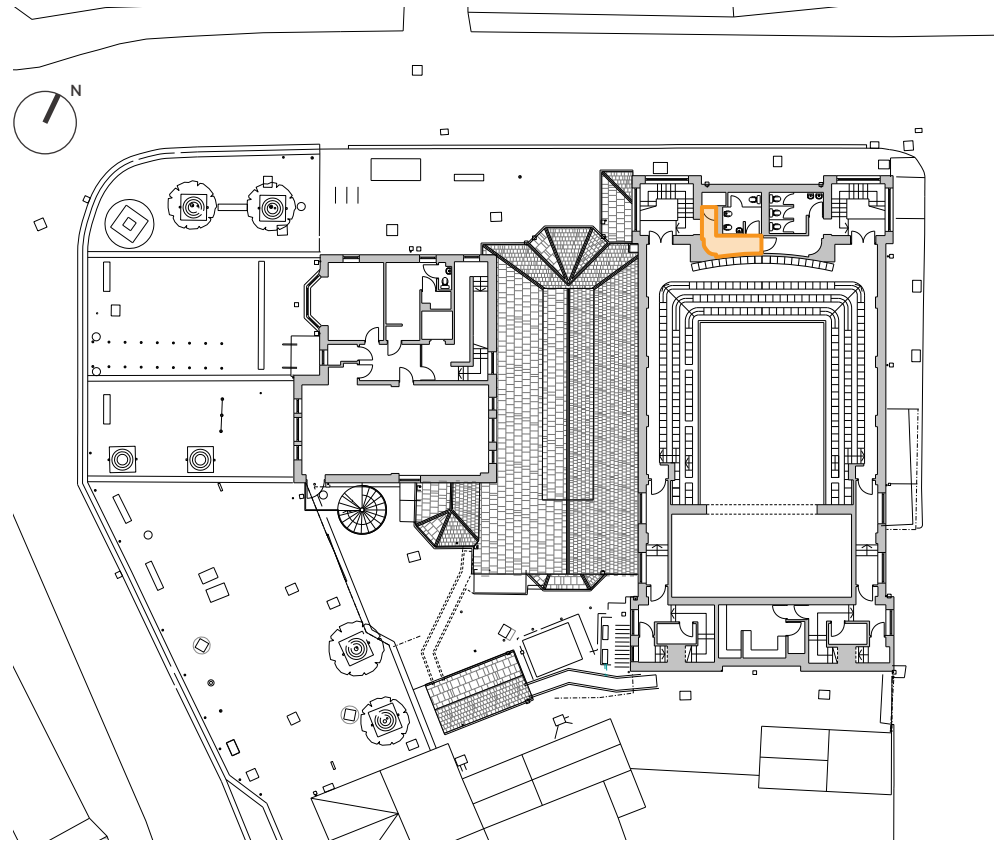
### Corridor

The existing interconnected corridor space contains no visible historic features, with the curved columns within the space appearing to have been built during the 1990s.

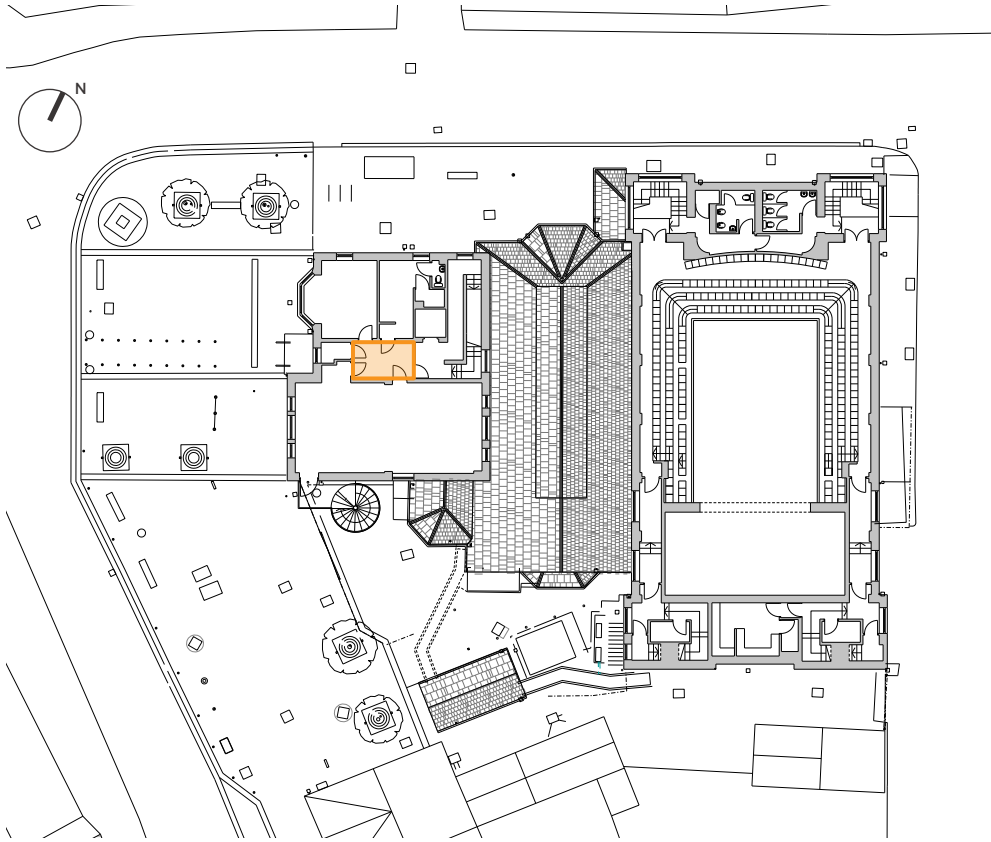
### Corridor / Lobby

The internal corridor / lobby space on the first floor has very little in the way of historic features, with the exception of the plaster cornice that runs around the perimeter of the room. All other features and finishes appear to be modern in nature.

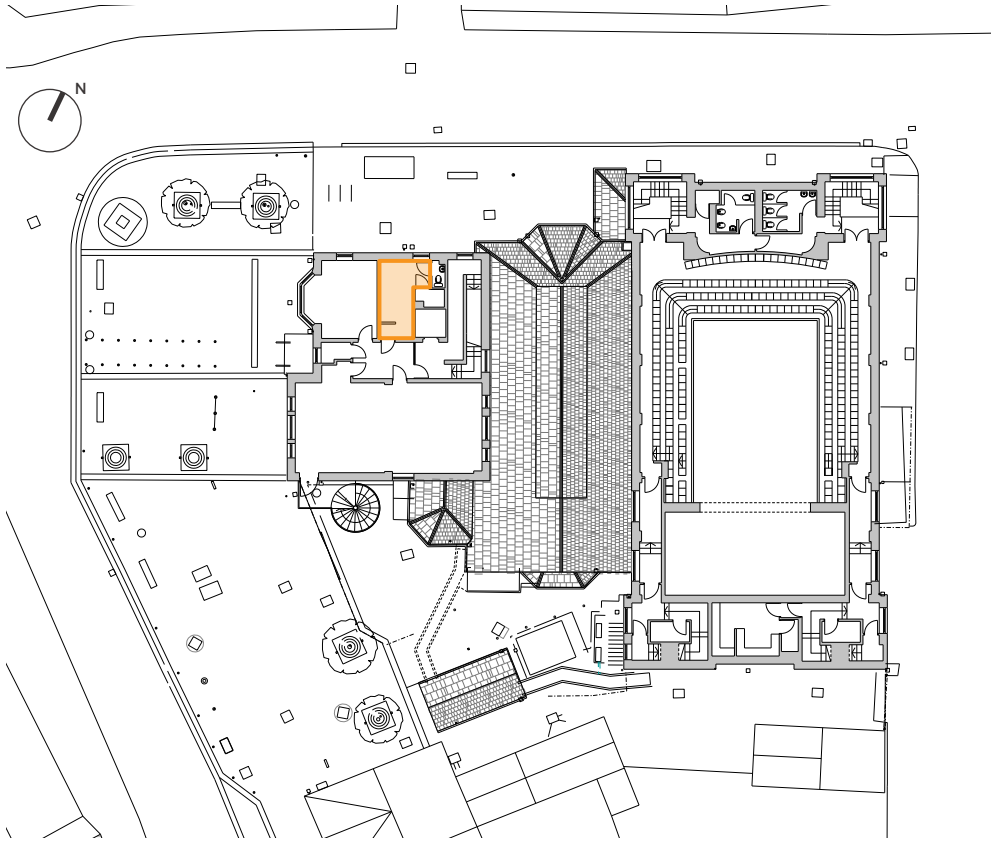
### Changing Room

In general, the first floor changing rooms contains very little historic fabric. The wall finishes, floor finishes, internal doors, light fittings, and fixed furniture all appear to be modern insertions. The only notable historic fabric is the timber sash window.

Additionally the space appears to have been subdivided with a partition to create the shower area and toilet

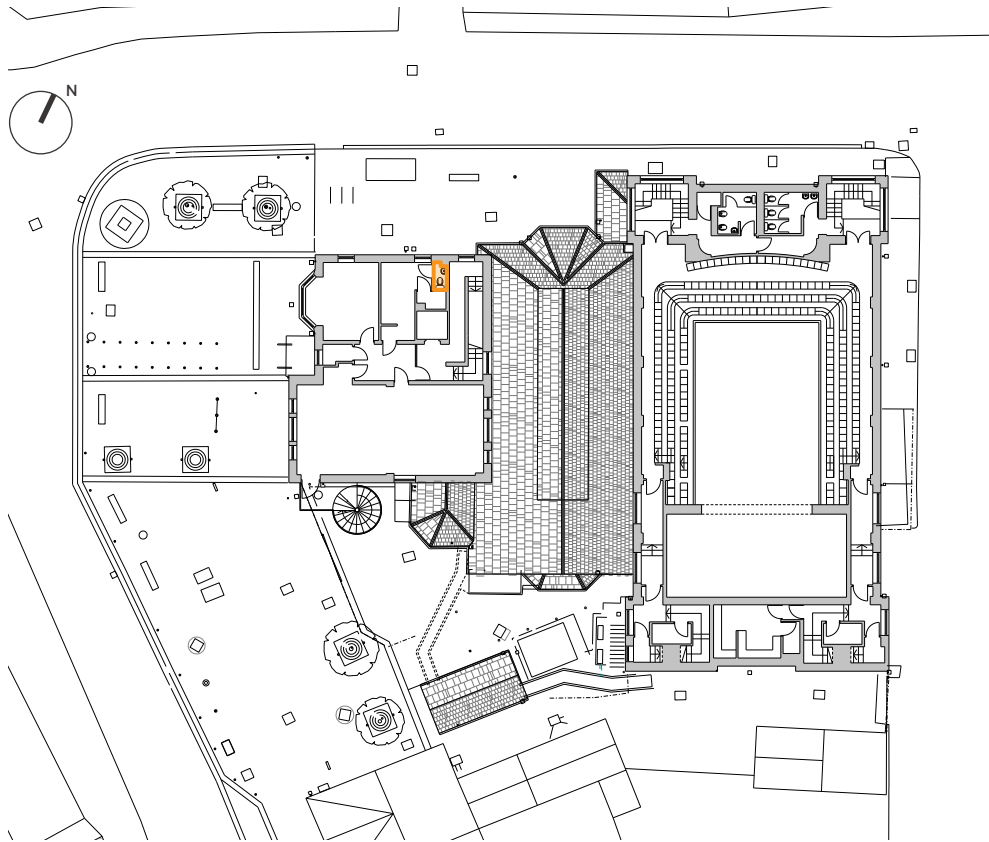
### Changing Room WC

Accessed off the changing room is a WC. The WC contains no fabric of historic value with all finishes and sanitaryware fittings being modern insertions.

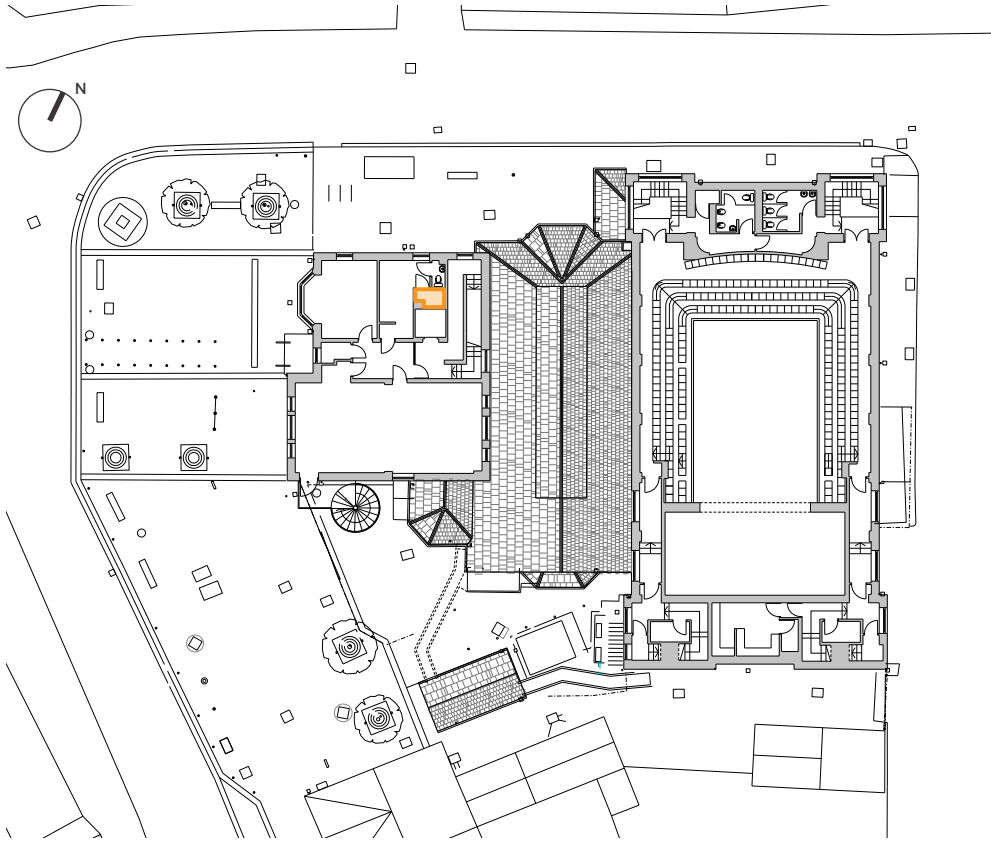
Store

Accessed off the changing room is a shower cubicle, currently used as a storage room. The existing finishes and fittings all appear to be modern interventions with there being no visible historic fabric within.

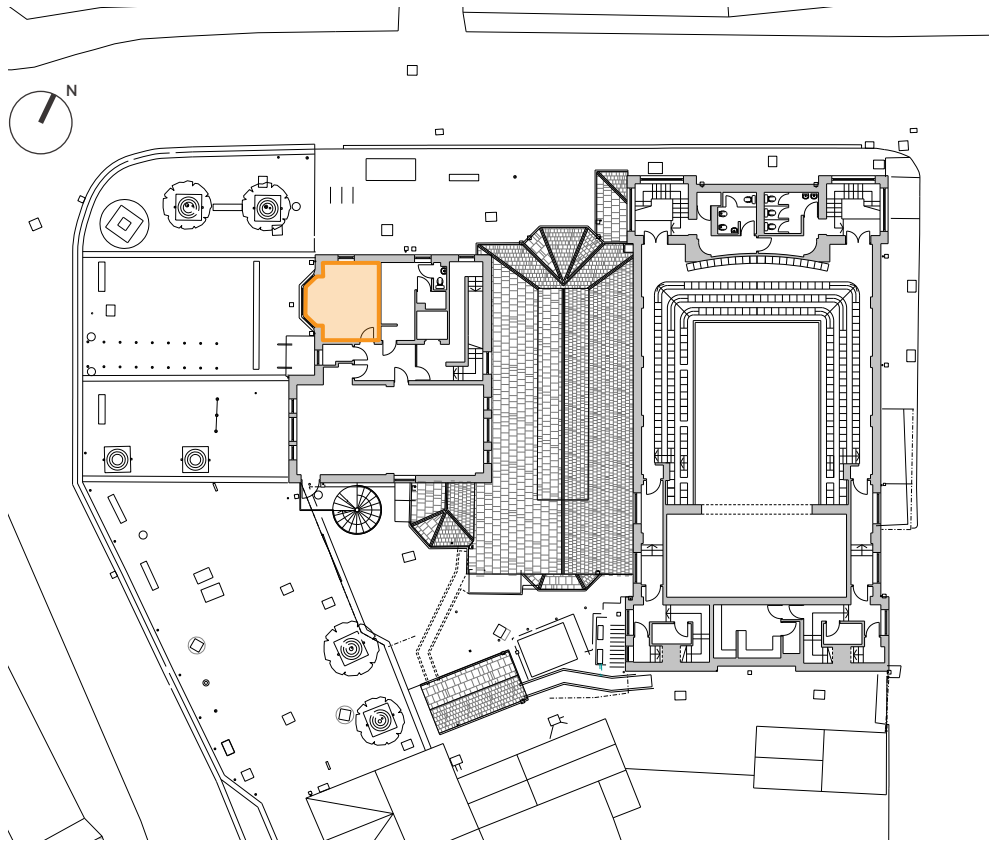
### Meeting Room

The existing meeting room is characterised by its bay window, which is presumed to be original fabric. Modern interventions within the room include: lighting fixtures and floor finishes. The most prominent historical features within the space include: the timber sash windows and cornicing to the perimeter of the room.

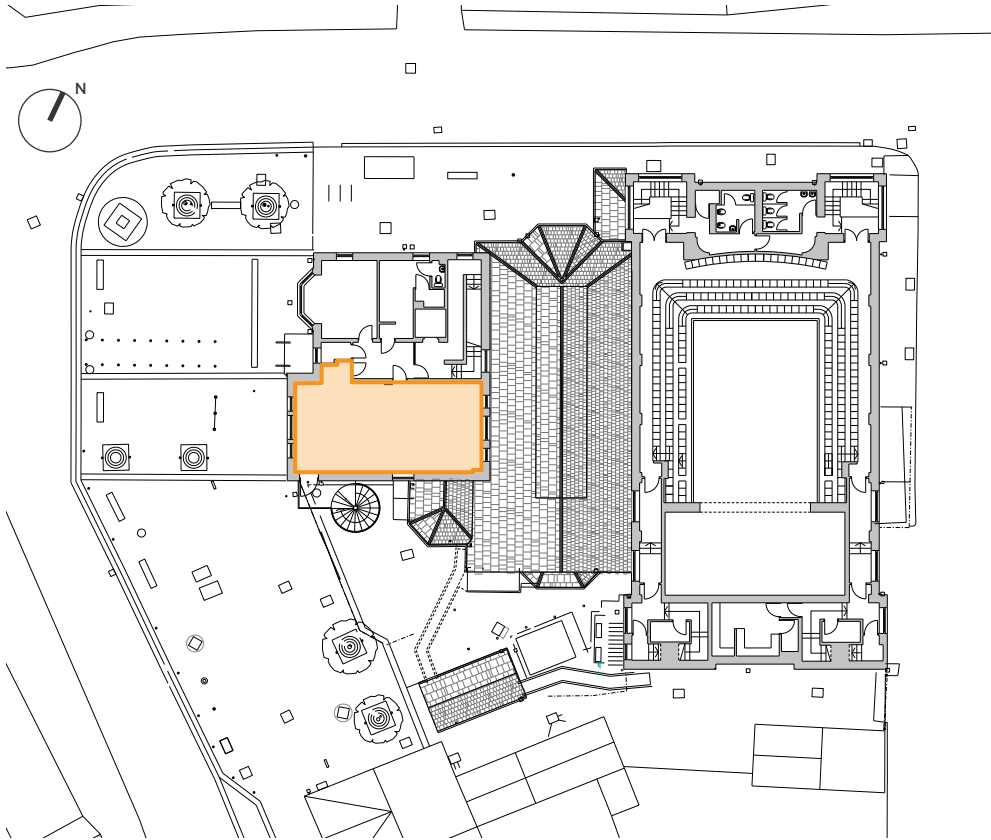
### Multi-Purpose Room

The multi-purpose room contains a few historical features, mainly the 2 No. fireplaces, cornicing around the perimeter of the room, and the 4 No. timber sash windows. Modern insertions in the space include: light fittings and wall finishes.

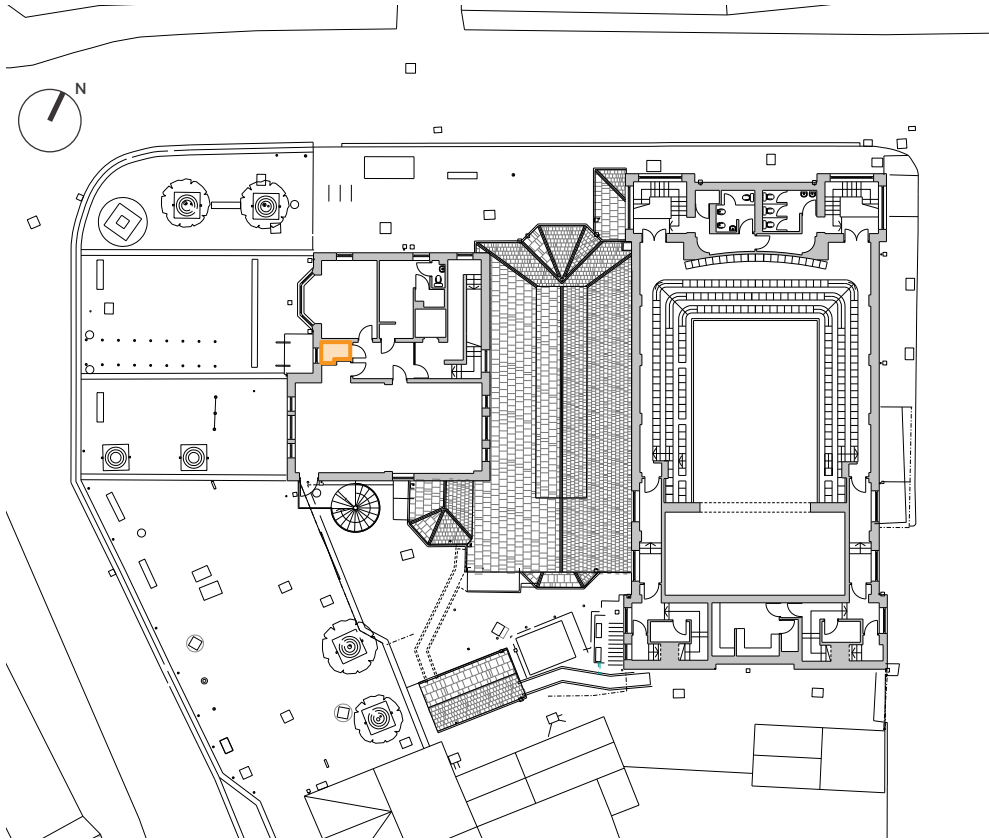
### Store

Located adjacent to the office space is a store room. Due to the fixed shelves constructed within the room it is hard to fully determine if there are any historical features within the room, although from inspection it appears to contain no historic fabric.

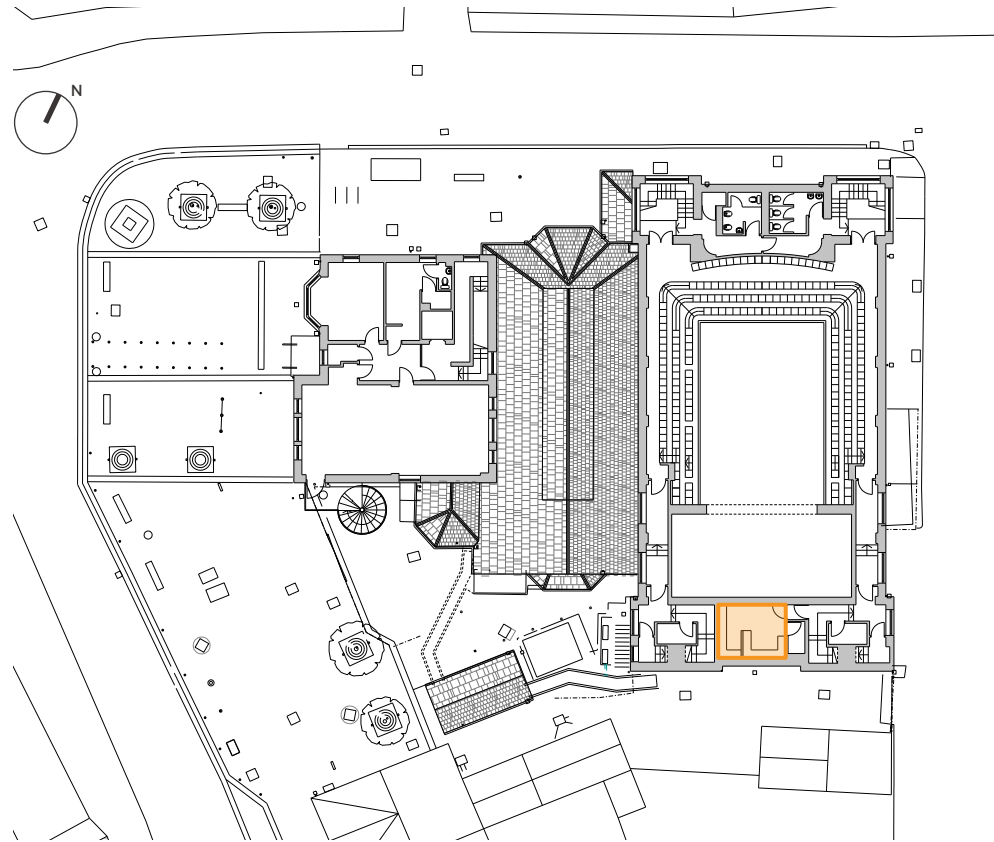
### Dressing Room

Generally, the first floor dressing room contains no historic features with all light fittings floor finishes, wall finishes and fixed furniture being modern insertions.

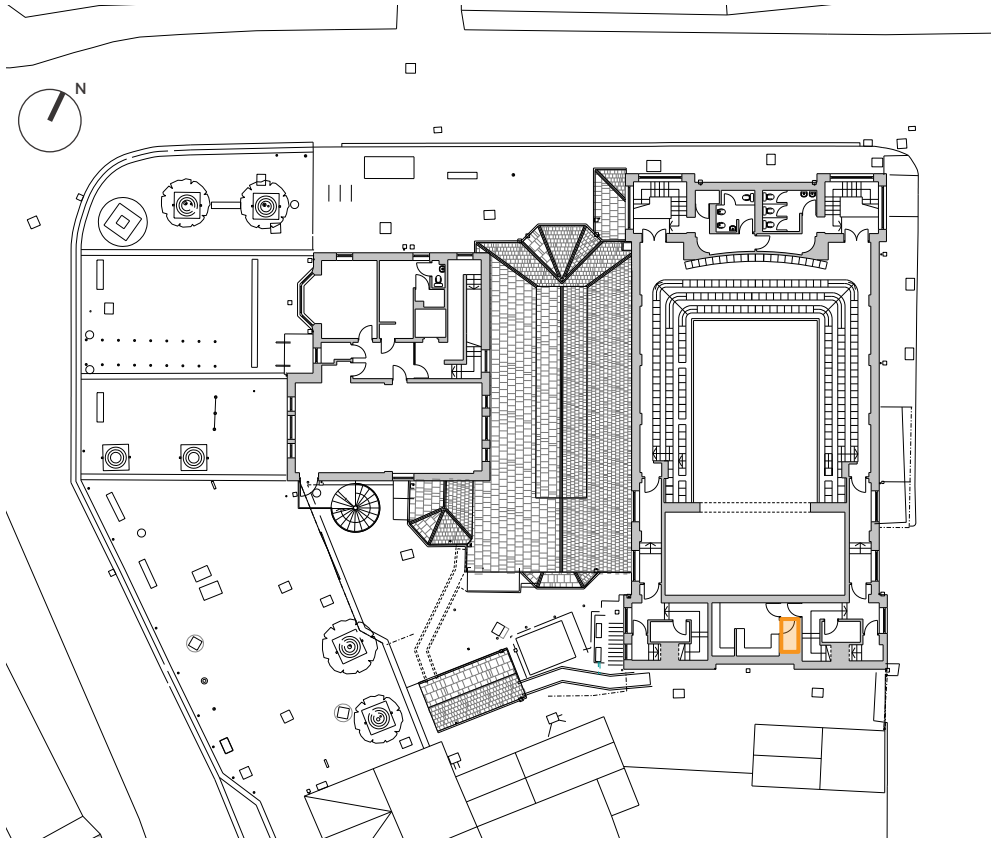
### Shower

In close proximity to the first floor dressing room is a shower cubicle. Much like the changing room there is no visible evidence of any historic fabric. All floor finishes, wall finishes and fixtures within the room appear to be modern interventions.

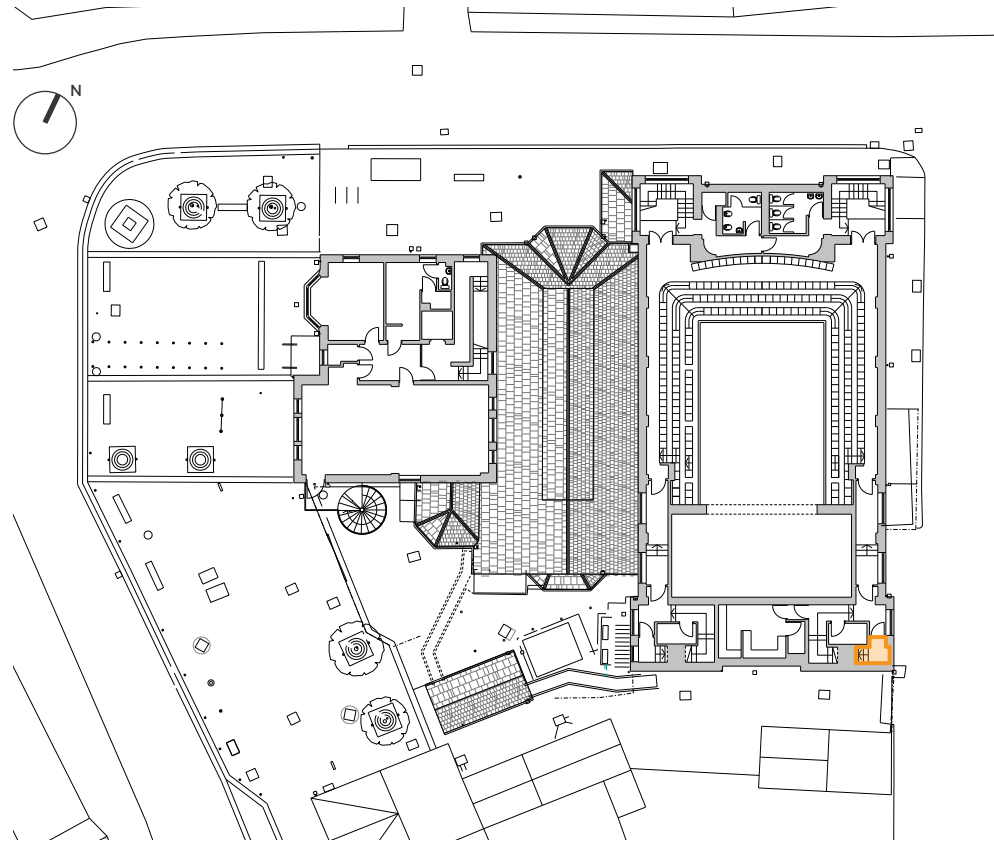
### Stair to Plant

Leading up to the plant room is an existing modern staircase. There is no visible historic fabric within this area.

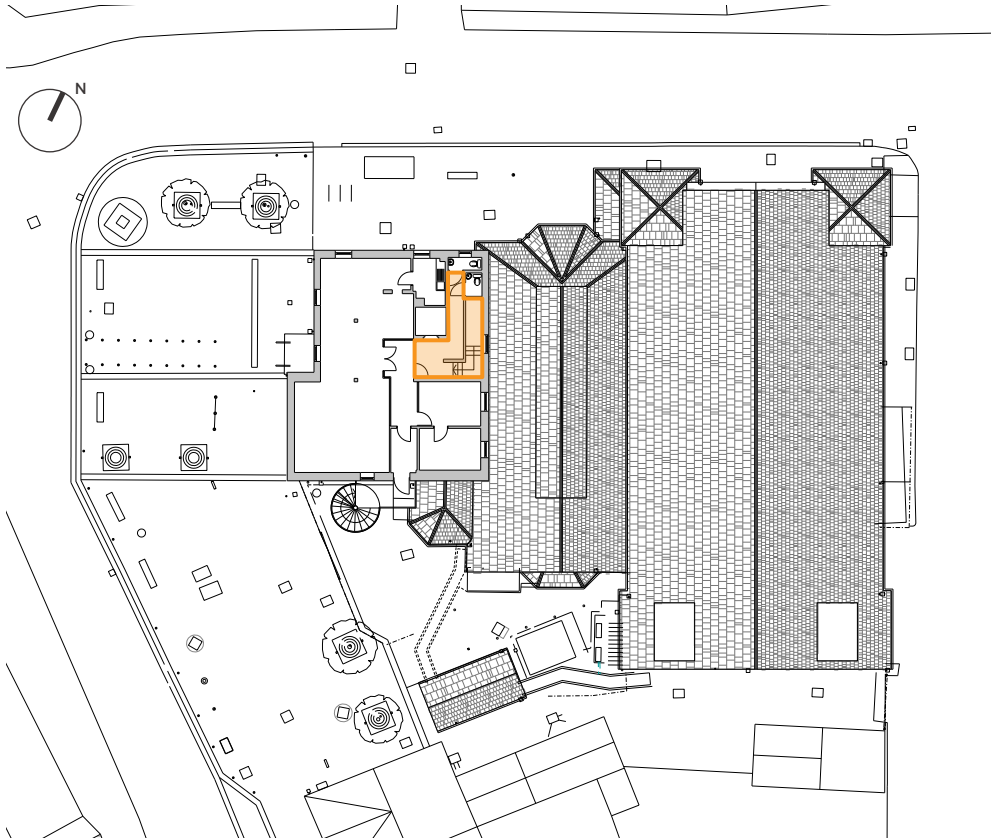
### Stair + Landing

On the second floor landing there are only a couple of historical features, including: the timber sash window and visible supporting timber roof beams.

It is not clear whether the current stair is a replacement of the original stair or whether the original stair was in another location but the everything that is currently within this stair core is 1990's in age.

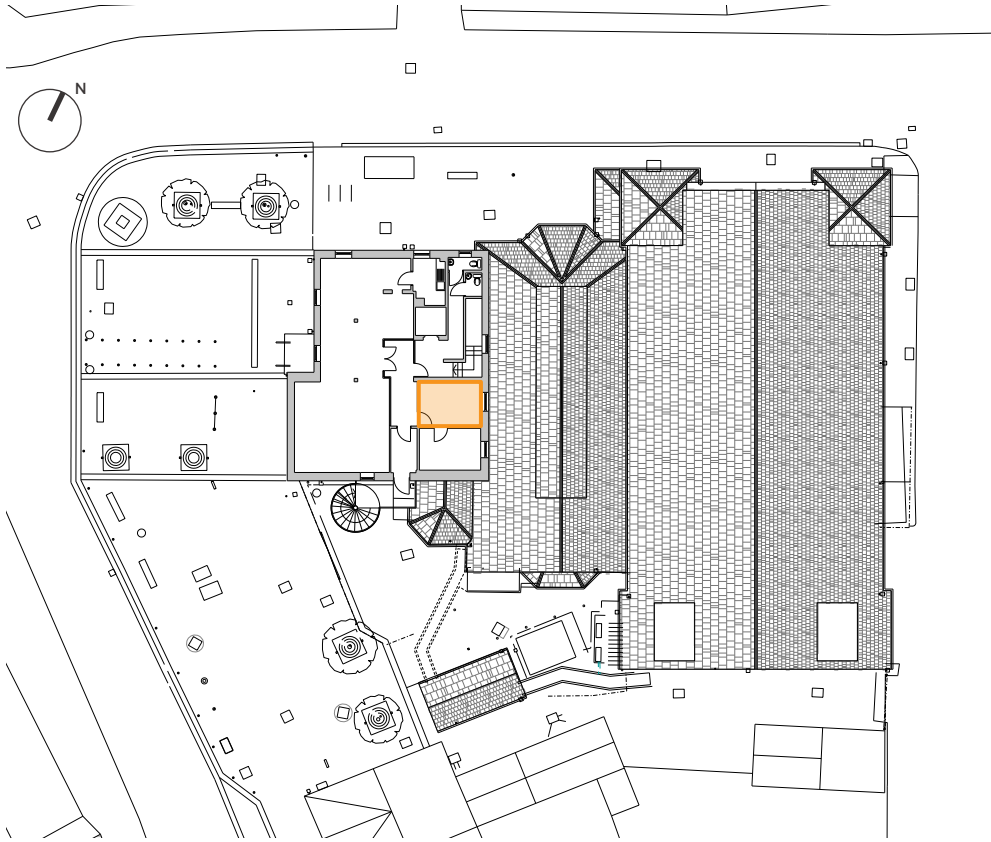
### Office

The office space is characterised by the roof form above, with the chamfered corner and expressed timber beams appearing to be original features. The existing timber sash window also appears to be an original feature. Other finishes and fittings within the space are likely more modern insertions.

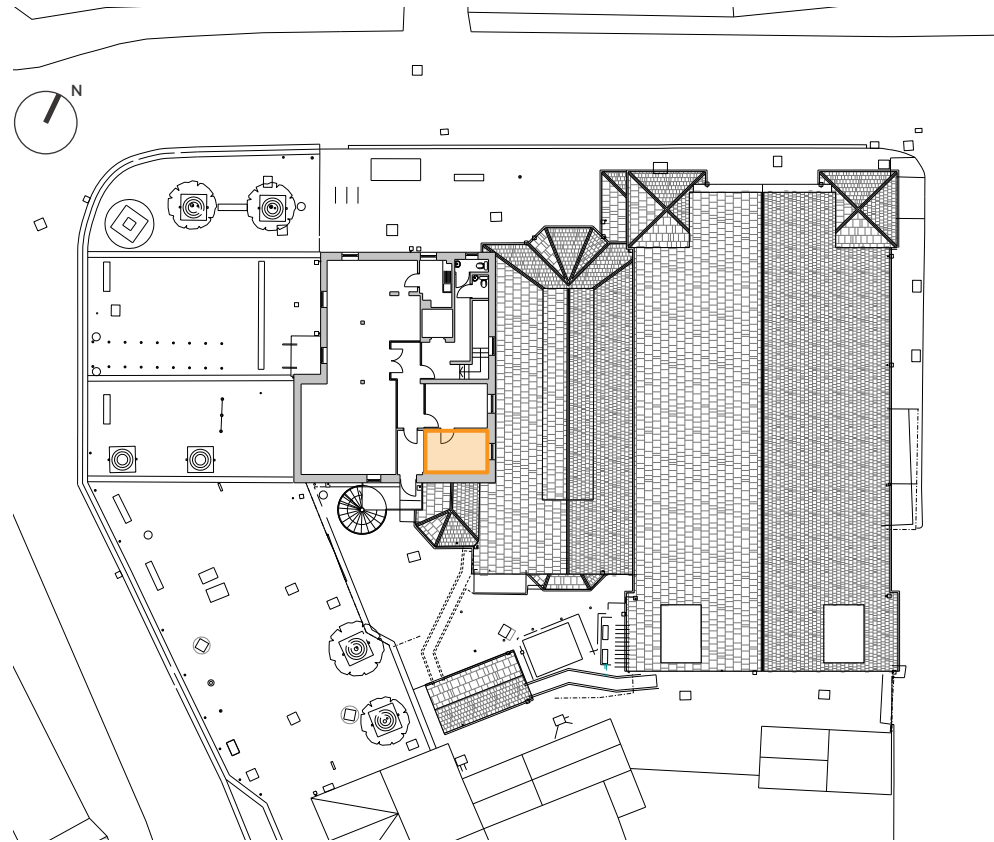
### Office

The smaller office space contains little historic fabric, with only the timber sash window appearing to be original.

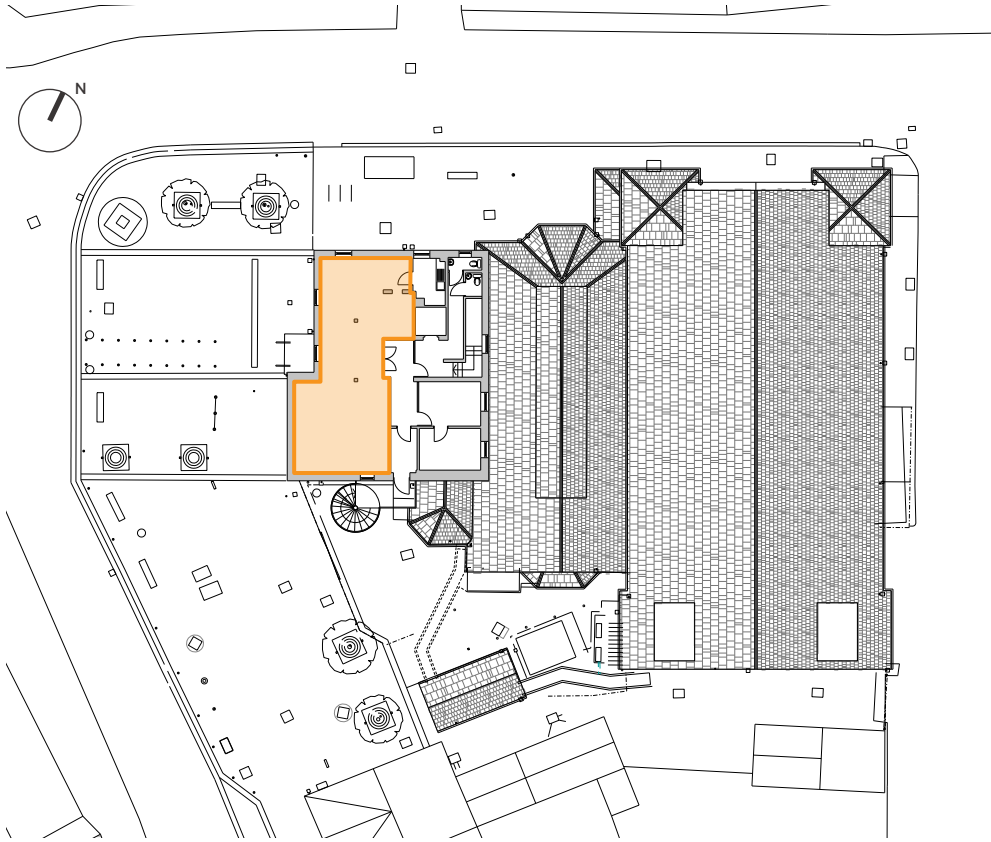
### Gallery

The gallery space on the second floor contains a few notable items of historic fabric. These include: the A-framed timber roof beams, supporting timber columns, and timber sash windows. The rooflights, lighting, flooring and glazed internal walls appear to have been modern interventions.

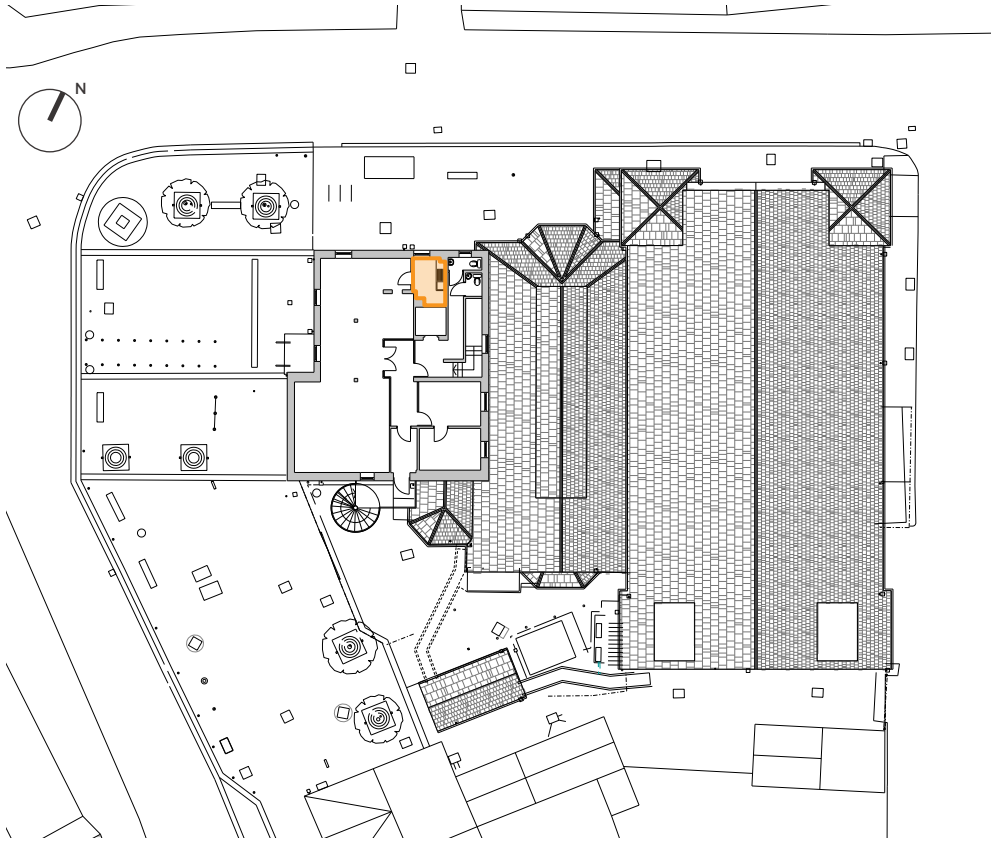
### Kitchen

Access off the second floor gallery is the second floor kitchenette. Within this space there are limited historical features, with the flooring, wall finishes and kitchen furniture all appearing to be modern installations that pre-date the 1996 conversion.

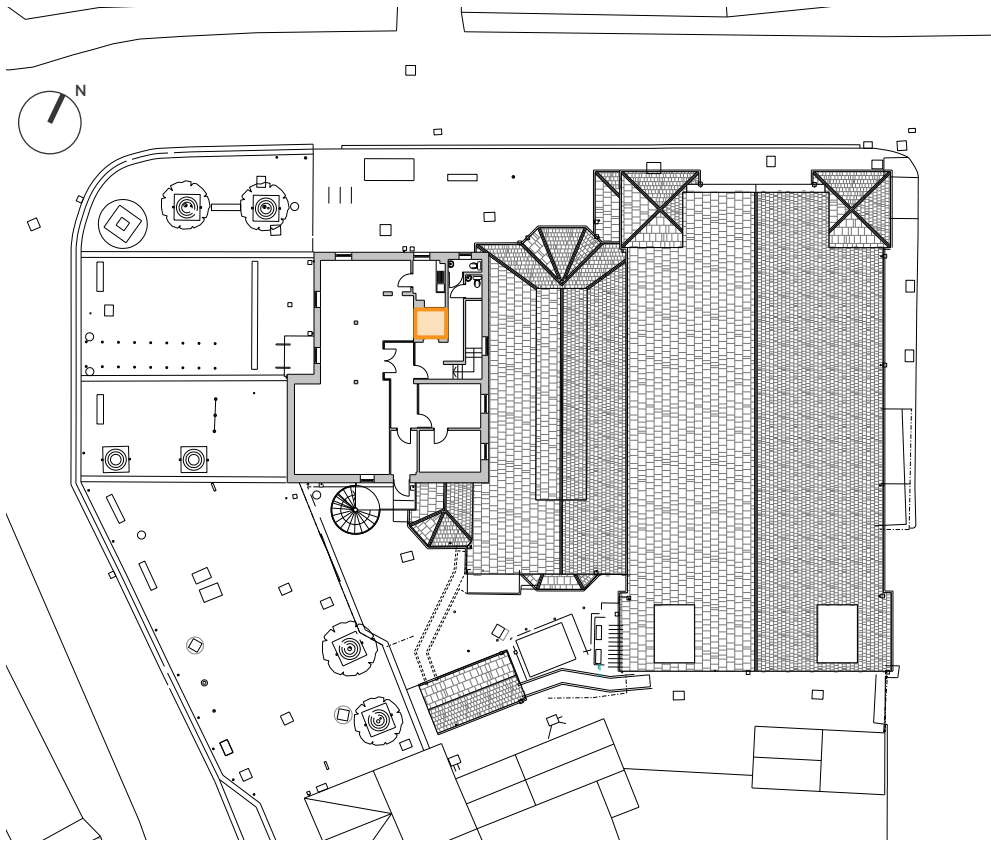
### Lift

Connecting the ground floor, first floor and second floor is an existing lift. A provision for a lift would not have been viable within the original building proposals, therefore it is safe to assume that it is a modern insertion, containing no historic fabric.

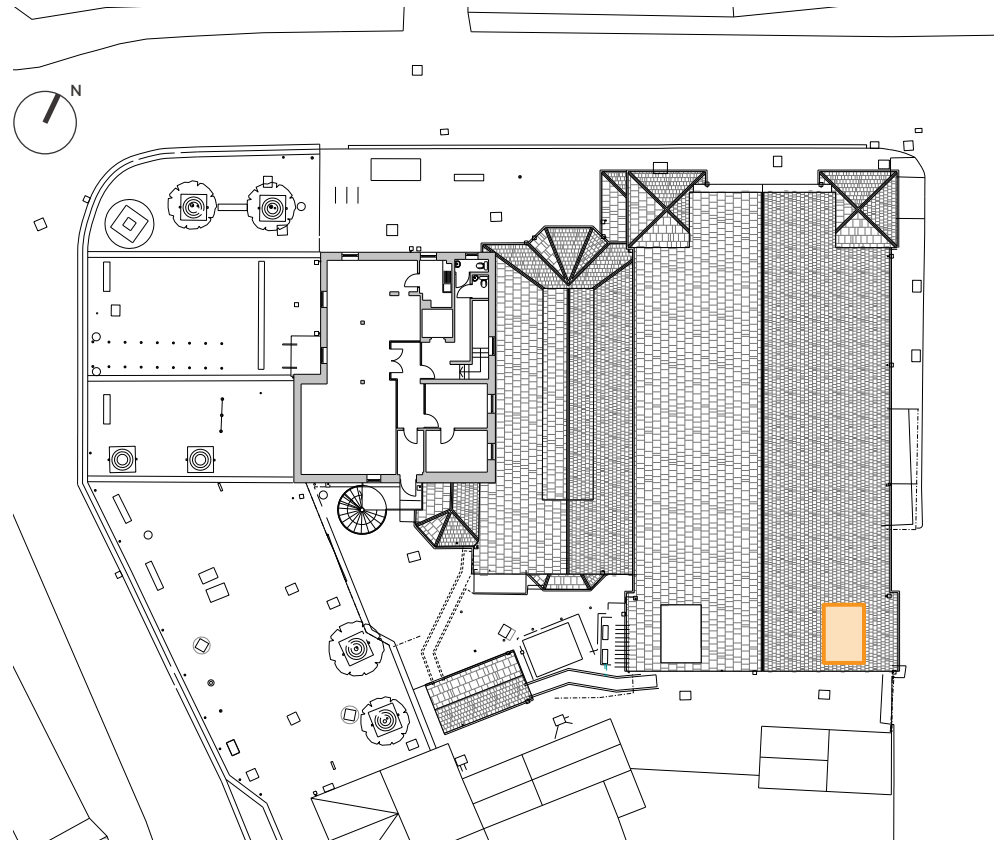
### Plant Room

The existing plant space shows no visible evidence of any historic fabric.
