# Appendix 10

## Hydrology, Geology and Hydrogeological Assessment

## A10.1 WATERCOURSE CROSSING ASSESSMENT

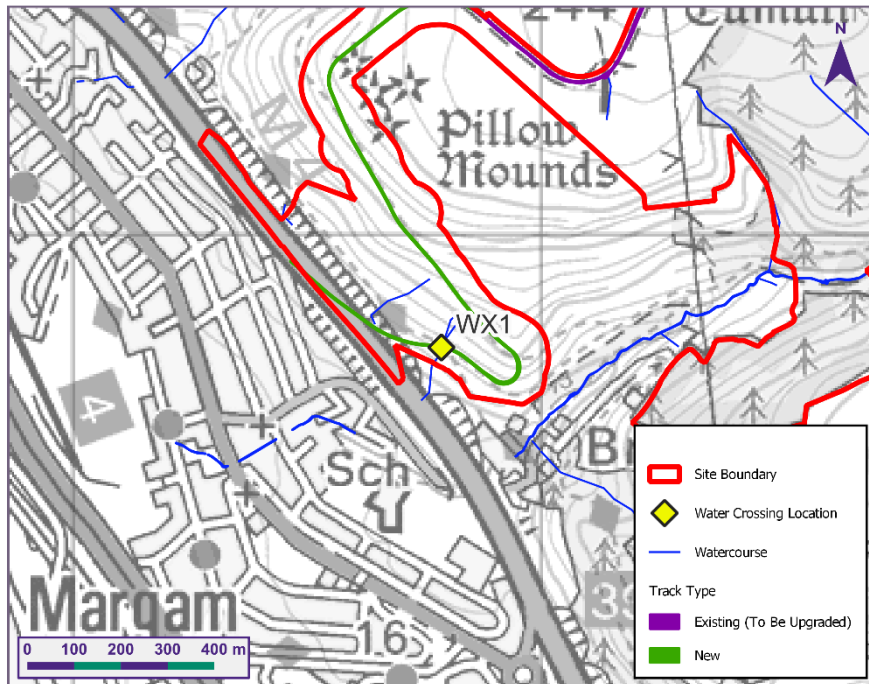
| WX1 (281396, 189361) | | |
|---|---|---|
| | <ul style="list-style-type: none"><li>Existing Crossing: Yes</li><li>Crossing Type (existing): Circular Culvert</li><li>Crossing Material (existing): Plastic</li><li>Crossing Condition (existing): Average</li><li>Channel Type: Incised</li><li>Gradient: Moderate</li><li>Valley form: Shallow vee</li><li>Bank condition: Stable</li><li>Bed material: Fine sand/silt, Coarse gravel, Boulders</li><li>Riparian corridor: Heavily Vegetated (e.g., gorse, bramble), Agricultural Grazing</li><li>Flow condition: Slow</li></ul> <ul style="list-style-type: none"><li><b>Culvert Dimensions (m):</b> 0.45</li><li><b>Water width (m):</b> 0.5</li><li><b>Water depth (m):</b> 0.05-0.1</li><li><b>Bankfull width (m):</b> 1</li><li><b>Bankfull height (m):</b> 0.5</li></ul> <p><b>Note:</b> Plastic culvert on upstream of track is at least half full of silt. Heavily vegetated upstream with brambles, gorse and willow. Sparse gorse, bramble, nettles and bracken on downstream side of track.</p> | |

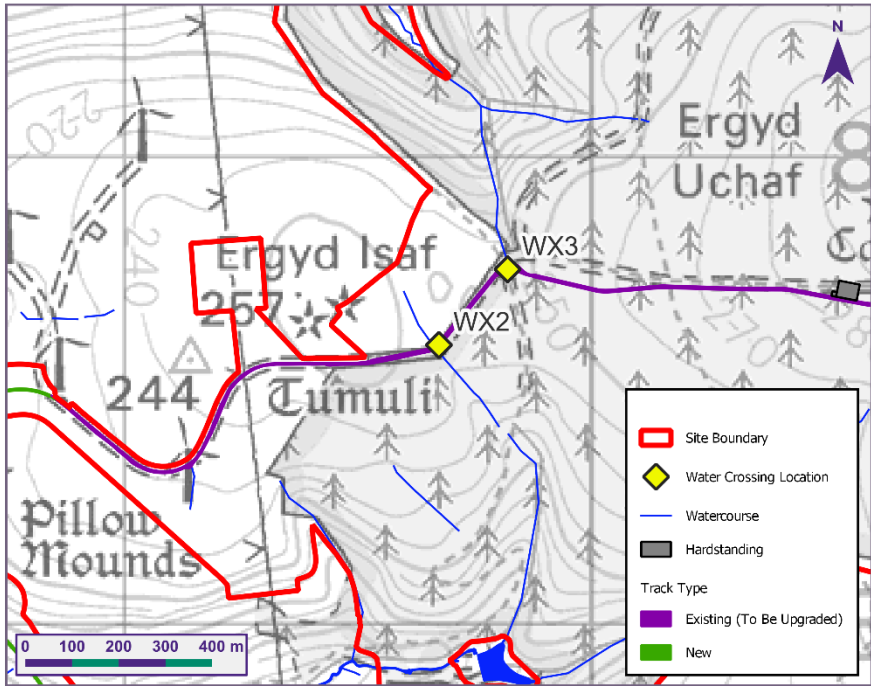
| WX2 (279674, 188596) | | |
|---|---|--|
| | <ul style="list-style-type: none"><li>Existing Crossing: Yes</li><li>Crossing Type (existing): Circular Culvert</li><li>Crossing Material (existing): Plastic</li><li>Crossing Condition (existing): Excellent</li><li>Channel Type: Poorly defined</li><li>Gradient: Gentle</li><li>Valley form: Shallow vee</li><li>Bank condition: Stable</li><li>Bed material: Vegetation, Soil, Peat</li><li>Riparian corridor: Heavily Vegetated (e.g., gorse, bramble), Agricultural Grazing, Productive Forestry</li><li>Flow condition: Dry</li></ul> <ul style="list-style-type: none"><li><b>Culvert Dimensions (m):</b> 0.62</li><li><b>Water width (m):</b> 0.3</li><li><b>Water depth (m):</b> 0</li><li><b>Bankfull width (m):</b> 4.0</li><li><b>Bankfull height (m):</b> 0.5</li></ul> <p><b>Note:</b> Up to 6 m wide upstream in field, likely braided and more of a marsh than a channel. More defined channel downstream.</p> | |

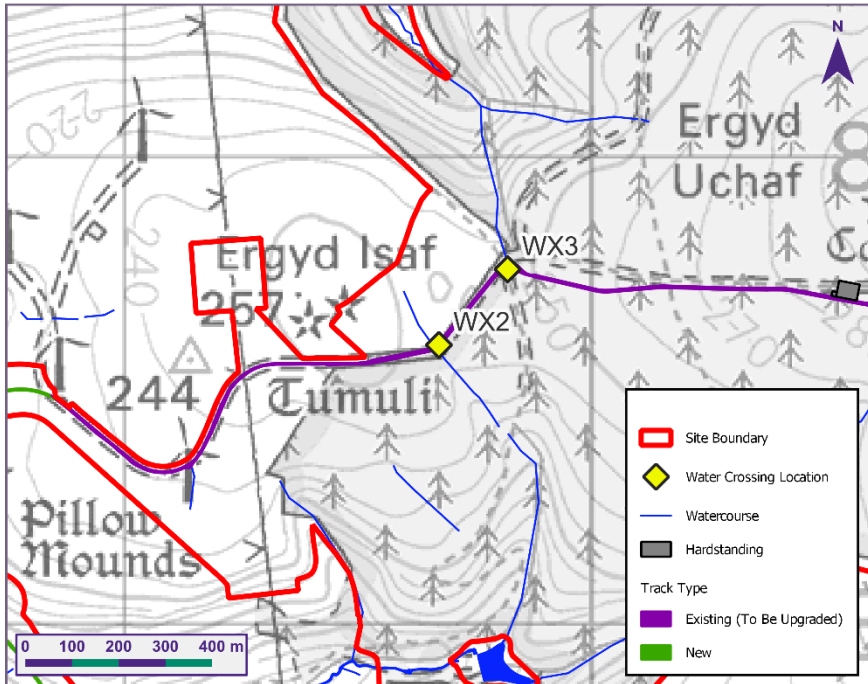
| WX3 (279821, 188758) | | |
|---|---|---|
| <p>© Crown Copyright 2023. All rights reserved. Ordnance Survey Licence 0100031673.</p> | <ul style="list-style-type: none"><li>Existing Crossing: Yes</li><li>Crossing Type (existing): Circular Culvert</li><li>Crossing Material (existing): Plastic</li><li>Crossing Condition (existing): Good</li><li>Channel Type: Incised</li><li>Gradient: Moderate</li><li>Valley form: Deep vee, Shallow vee</li><li>Bank condition: Stable</li><li>Bed material: Vegetation, Fine sand/silt</li><li>Riparian corridor: Heavily Vegetated (e.g., gorse, bramble), Agricultural Grazing, Productive Forestry</li><li>Flow condition: Stagnant</li></ul> <ul style="list-style-type: none"><li><b>Culvert Dimensions (m):</b> 0.8</li><li><b>Water width (m):</b> 1.0</li><li><b>Water depth (m):</b> 0</li><li><b>Bankfull width (m):</b> 2.0</li><li><b>Bankfull height (m):</b> 0.5</li></ul> <p><b>Note:</b> very close to watershed. Too heavily vegetated by brambles for accurate channel measurements.</p> | |

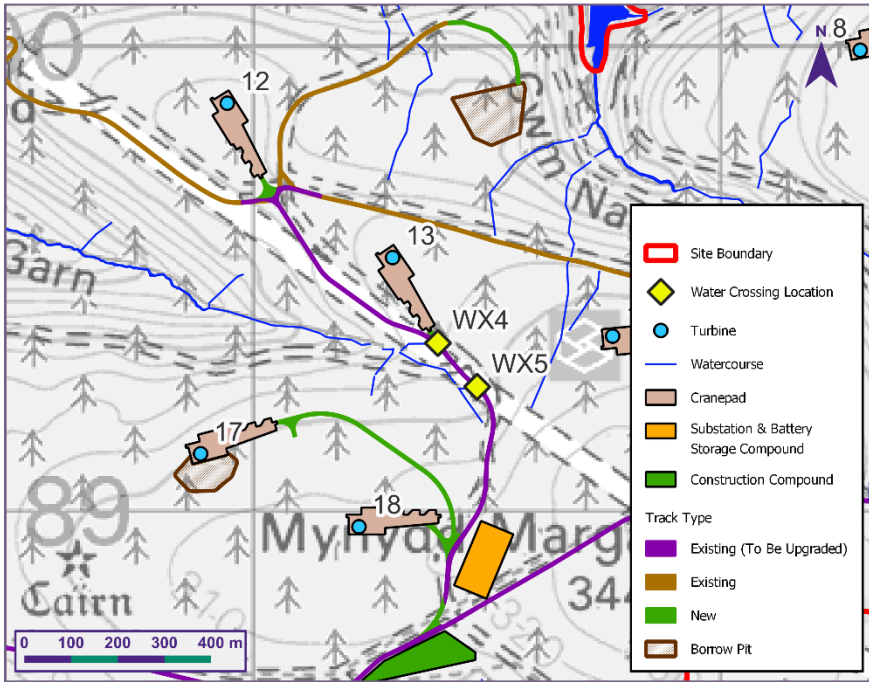
| WX4 (281396, 189361) | | |
|---|---|--|
| | <ul style="list-style-type: none"><li>Existing Crossing: Yes</li><li>Crossing Type (existing): Circular Culvert</li><li>Crossing Material (existing): Concrete</li><li>Crossing Condition (existing): Good</li><li>Channel Type: Incised</li><li>Gradient: Gentle</li><li>Valley form: No obvious valley sides</li><li>Bank condition: Stable</li><li>Bed material: Fine sand/silt, Coarse gravel, Boulders</li><li>Riparian corridor: Heavily Vegetated (e.g., gorse, bramble), Productive Forestry, Natural Woodland</li><li>Flow condition: Slow</li></ul> <ul style="list-style-type: none"><li><b>Culvert Dimensions (m):</b> 0.4</li><li><b>Water width (m):</b> 0.2 - 0.4</li><li><b>Water depth (m):</b> 0.05</li><li><b>Bankfull width (m):</b> 2.0</li><li><b>Bankfull height (m):</b> 1.2</li></ul> <p><b>Note:</b> Upper reaches of watercourse, lots of brambles and vegetation around watercourse at crossing. Existing crossing in good condition in such that there appears to be no restriction to flow and or obvious degradation to the structure.</p> | |

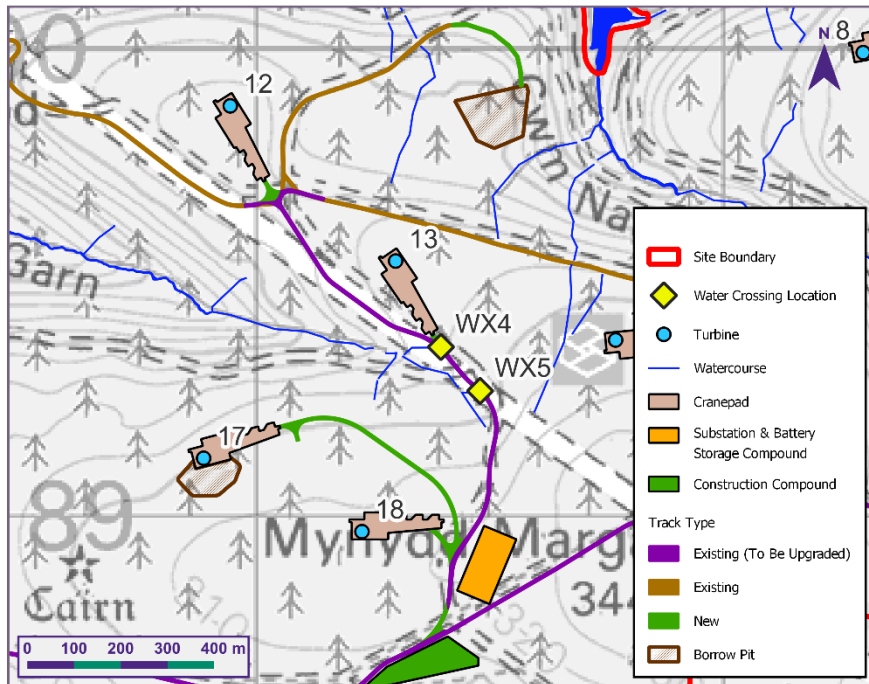
| WX5 (281480, 189267) | | |
|---|---|---|
| | <ul style="list-style-type: none"><li>• <b>Existing Crossing:</b> Yes</li><li>• <b>Crossing Type (existing):</b> Circular Culvert</li><li>• <b>Crossing Material (existing):</b> Concrete</li><li>• <b>Crossing Condition (existing):</b> Good</li><li>• <b>Channel Type:</b> Artificial drainage channel</li><li>• <b>Gradient:</b> Gentle</li><li>• <b>Valley form:</b> No obvious valley sides</li><li>• <b>Bank condition:</b> Stable</li><li>• <b>Bed material:</b> Vegetation</li><li>• <b>Riparian corridor:</b> Productive Forestry, Moorland, Heavily Vegetated (e.g., gorse, bramble)</li><li>• <b>Flow condition:</b> Stagnant</li></ul> <ul style="list-style-type: none"><li>• <b>Culvert Dimensions (m):</b> 0.4 m</li><li>• <b>Water width (m):</b> N/A</li><li>• <b>Water depth (m):</b> N/A</li><li>• <b>Bankfull width (m):</b> N/A</li><li>• <b>Bankfull height (m):</b> N/A</li></ul> <p><b>Note:</b> This does not exist as a natural water crossing with the watercourse starting downstream of the track. Presumably to allow the upstream catchment to drain now there is a track in place an artificial roadside ditch and culvert have been put in place. Road is in very good condition and wide.</p> | |

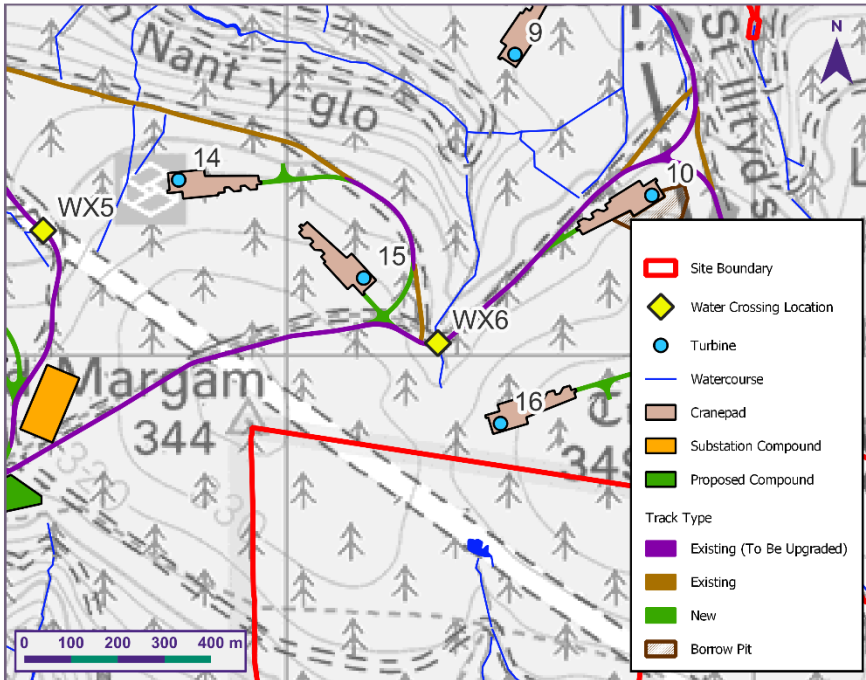
| WX6 (282325, 189025) | | |
|---|---|---|
| <div></div> <p>© Crown Copyright 2023. All rights reserved. Ordnance Survey Licence 0100031673.</p> | <ul style="list-style-type: none"><li>• <b>Existing Crossing:</b> Yes</li><li>• <b>Crossing Type (existing):</b> Circular Culvert</li><li>• <b>Crossing Material (existing):</b> Concrete</li><li>• <b>Crossing Condition (existing):</b> Good</li><li>• <b>Channel Type:</b> Incised</li><li>• <b>Gradient:</b> Moderate</li><li>• <b>Valley form:</b> Shallow vee, Asymmetrical</li><li>• <b>Bank condition:</b> Stable</li><li>• <b>Bed material:</b> Fine sand/silt, Coarse gravel, Boulders</li><li>• <b>Riparian corridor:</b> Heavily Vegetated (e.g., gorse, bramble), Productive Forestry, Natural Woodland</li><li>• <b>Flow condition:</b> Moderate</li></ul> <ul style="list-style-type: none"><li>• <b>Culvert Dimensions (m):</b> 0.9 m</li><li>• <b>Water width (m):</b> 0.3 - 0.8</li><li>• <b>Water depth (m):</b> 0.05 - 0.1</li><li>• <b>Bankfull width (m):</b> 4.0</li><li>• <b>Bankfull height (m):</b> 1.0 - 1.5</li><li>• <b>Flooded Bankfull width (m):</b> 4.0</li></ul> <p><b>Note:</b> Existing wide crossing in what appears to be good condition. Channel deeper and narrower upstream of crossing.</p> | |

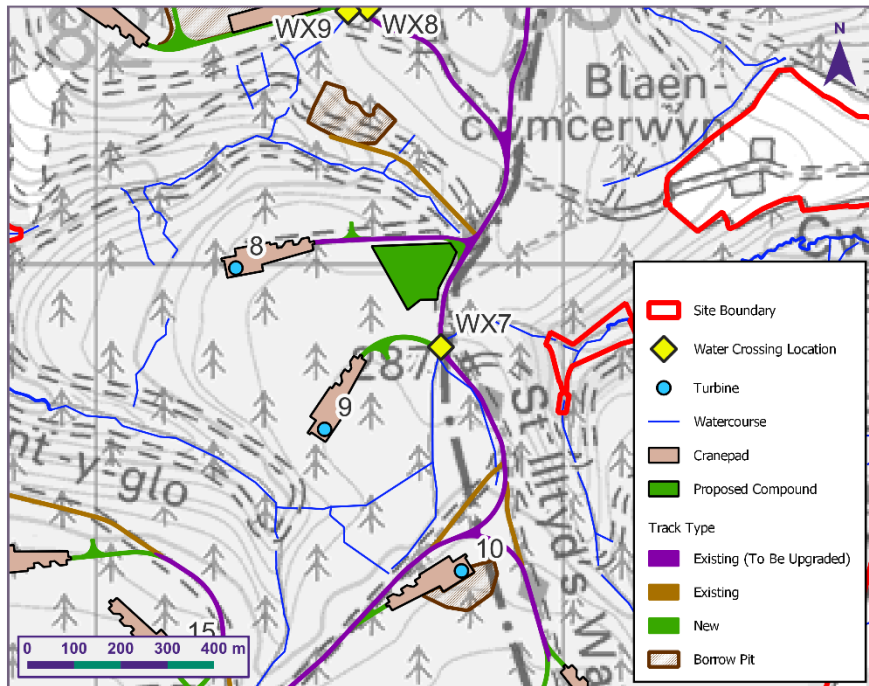
| WX7 (282739, 189822) | | |
|---|---|---|
| <div></div> <p>© Crown Copyright 2023. All rights reserved. Ordnance Survey Licence 0100031673.</p> | <ul style="list-style-type: none"><li>Existing Crossing: Yes</li><li>Crossing Type (existing): Circular Culvert</li><li>Crossing Material (existing): Concrete</li><li>Crossing Condition (existing): Good</li><li>Channel Type: Incised</li><li>Gradient: Moderate</li><li>Valley form: Shallow vee</li><li>Bank condition: Stable</li><li>Bed material: Fine sand/silt, Coarse gravel, Boulders</li><li>Riparian corridor: Natural Woodland, Productive Forestry</li><li>Flow condition: Moderate</li></ul> <ul style="list-style-type: none"><li>Culvert Dimensions (m): 0.9 m</li><li>Water width (m): 1.5 - 2.0</li><li>Water depth (m): 0.05 - 0.4</li><li>Bankfull width (m): 2.2</li><li>Bankfull height (m): 1.0</li></ul> <p><b>Note:</b> Although not so close to the break in slope, this crossing is similar to WX7 near the edge of the plateau. Older concrete culvert but in good condition with well-maintained wide road in place. Old, engineered dam to slow flow before culvert entrance.</p> | |

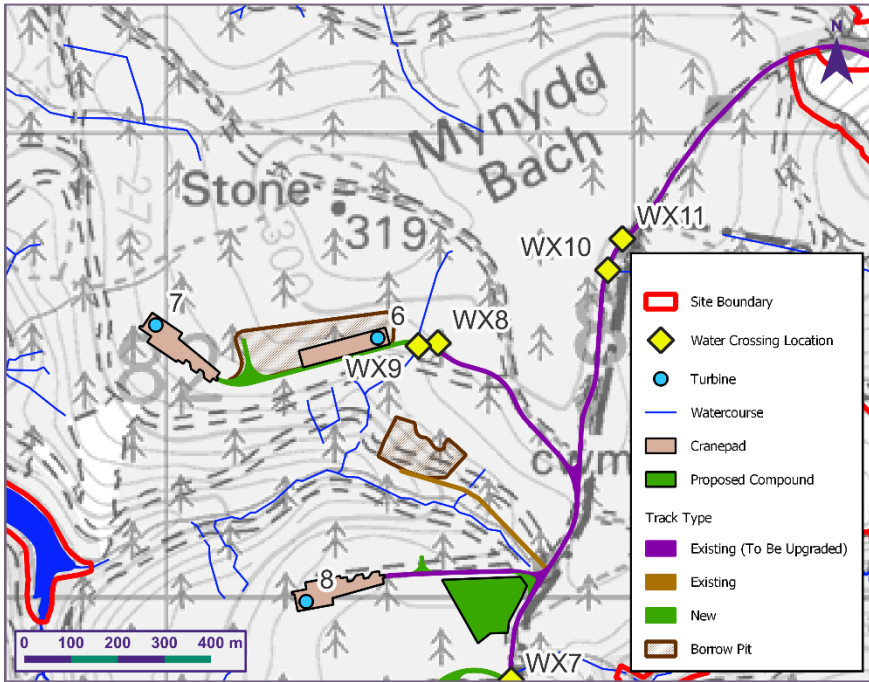
| WX8 (282582, 190547) | | |
|---|---|--|
| | <ul style="list-style-type: none"><li>• <b>Existing Crossing:</b> Yes</li><li>• <b>Crossing Type (existing):</b> Circular Culvert</li><li>• <b>Crossing Material (existing):</b> Plastic</li><li>• <b>Crossing Condition (existing):</b> Good</li><li>• <b>Channel Type:</b> Incised</li><li>• <b>Gradient:</b> Moderate</li><li>• <b>Valley form:</b> Shallow vee</li><li>• <b>Bank condition:</b> Stable</li><li>• <b>Bed material:</b> Fine sand/silt, Coarse gravel, Boulders</li><li>• <b>Riparian corridor:</b> Productive Forestry</li><li>• <b>Flow condition:</b> Moderate</li></ul> | |
| | <ul style="list-style-type: none"><li>• <b>Culvert Dimensions (m):</b> 0.6</li><li>• <b>Water width (m):</b> 0.3 - 2.7</li><li>• <b>Water depth (m):</b> 0.05 - 0.2</li><li>• <b>Bankfull width (m):</b> 1.4 - 4.0</li><li>• <b>Bankfull height (m):</b> 1.0 - 1.7</li></ul> <p><b>Note:</b> Water crossing in good condition in place with evidence of recent upgrading and engineering (old, discarded culverts, unvegetated verges). Wide road in good condition. Larger channel widths and depths are from dug out pool area at entrance to culvert. Generally, 0.05 m depth, 0.4 m width. Note that WX9 is an almost identical crossing, ~30 m west.</p> | |

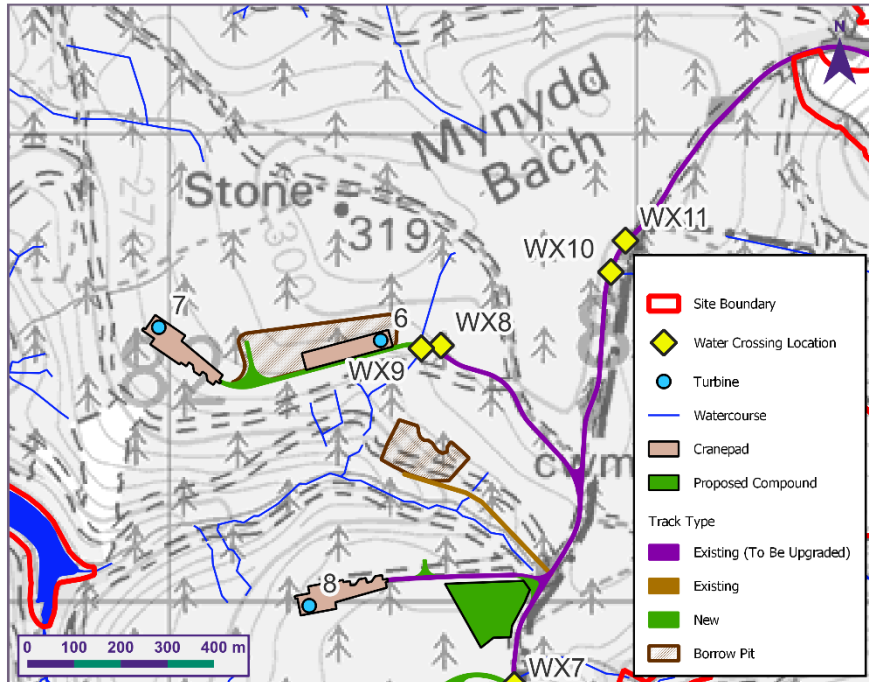
| WX9 (282540, 190541) | | |
|---|---|---|
| | <ul style="list-style-type: none"><li>• <b>Existing Crossing:</b> Yes</li><li>• <b>Crossing Type (existing):</b> Circular Culvert</li><li>• <b>Crossing Material (existing):</b> Plastic</li><li>• <b>Crossing Condition (existing):</b> Good</li><li>• <b>Channel Type:</b> Incised</li><li>• <b>Gradient:</b> Moderate</li><li>• <b>Valley form:</b> Shallow vee</li><li>• <b>Bank condition:</b> Stable</li><li>• <b>Bed material:</b> Fine sand/silt, Coarse gravel, Boulders</li><li>• <b>Riparian corridor:</b> Productive Forestry</li><li>• <b>Flow condition:</b> Moderate</li></ul> <ul style="list-style-type: none"><li>• <b>Culvert Dimensions (m):</b> 0.6 m</li><li>• <b>Water width (m):</b> 0.3 - 2.7</li><li>• <b>Water depth (m):</b> 0.05 - 0.45</li><li>• <b>Bankfull width (m):</b> 1.4 - 4.0</li><li>• <b>Bankfull height (m):</b> 1.0 - 1.7</li></ul> <p><b>Note:</b> Water crossing in good condition in place with evidence of recent upgrading and engineering (old, discarded culverts, unvegetated verges). Wide road in good condition. Larger channel widths and depths are from dug out pool area at entrance to culvert. Generally, 0.05 m depth, 0.4 m width. Note that WX8 is an almost identical crossing, ~30 m east.</p> | |

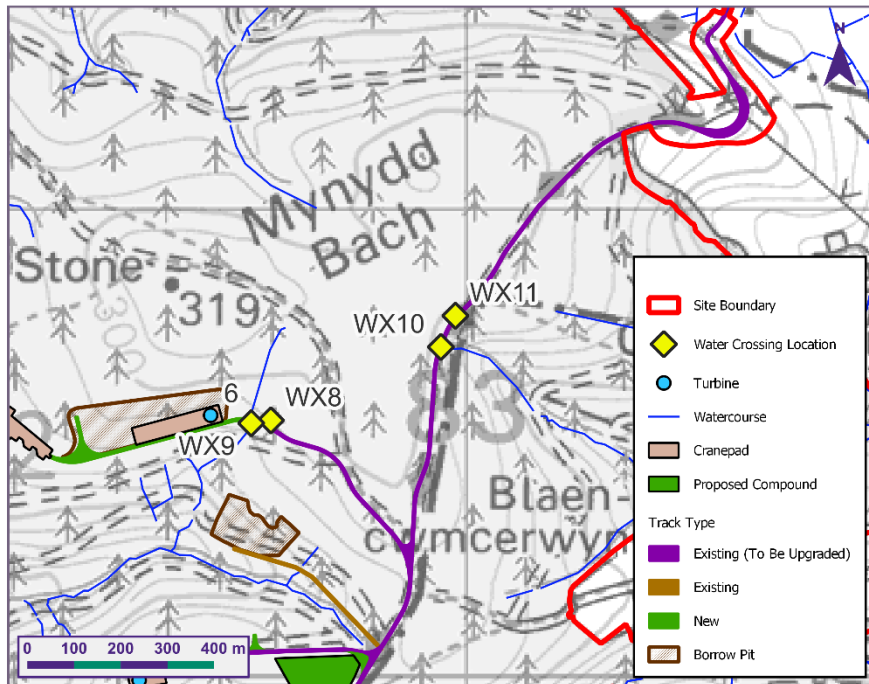
| WX10 (282946, 190704) | | | | |
|---|---|---|--|--|
| | <ul style="list-style-type: none"><li>• <b>Existing Crossing:</b> Yes</li><li>• <b>Crossing Type (existing):</b> Circular Culvert</li><li>• <b>Crossing Material (existing):</b> Plastic</li><li>• <b>Crossing Condition (existing):</b> Good</li><li>• <b>Channel Type:</b> Incised</li><li>• <b>Gradient:</b> Gentle</li><li>• <b>Valley form:</b> No obvious valley sides (upstream), Deep vee (downstream), Gorge (downstream)</li><li>• <b>Bank condition:</b> Stable</li><li>• <b>Bed material:</b> Fine sand/silt, Coarse gravel, Boulders</li><li>• <b>Riparian corridor:</b> Natural Woodland, Productive Forestry</li><li>• <b>Flow condition:</b> Slow</li></ul> | | | |
| <ul style="list-style-type: none"><li>• <b>Culvert Dimensions (m):</b> 0.45</li><li>• <b>Water width (m):</b> 0.3 - 0.8</li><li>• <b>Water depth (m):</b> 0.15</li><li>• <b>Bankfull width (m):</b> 1.7</li><li>• <b>Bankfull height (m):</b> 1.0</li></ul> <p><b>Note:</b> Wide track in good condition at existing crossing. Crossing sits at the edge of the sedimentary plateau, so is very flat upstream, and within 3 m downstream drops into a very steep sided vee valley or gorge. Note that WX11 is a very similar crossing, ~50 m north.</p> | | | | |

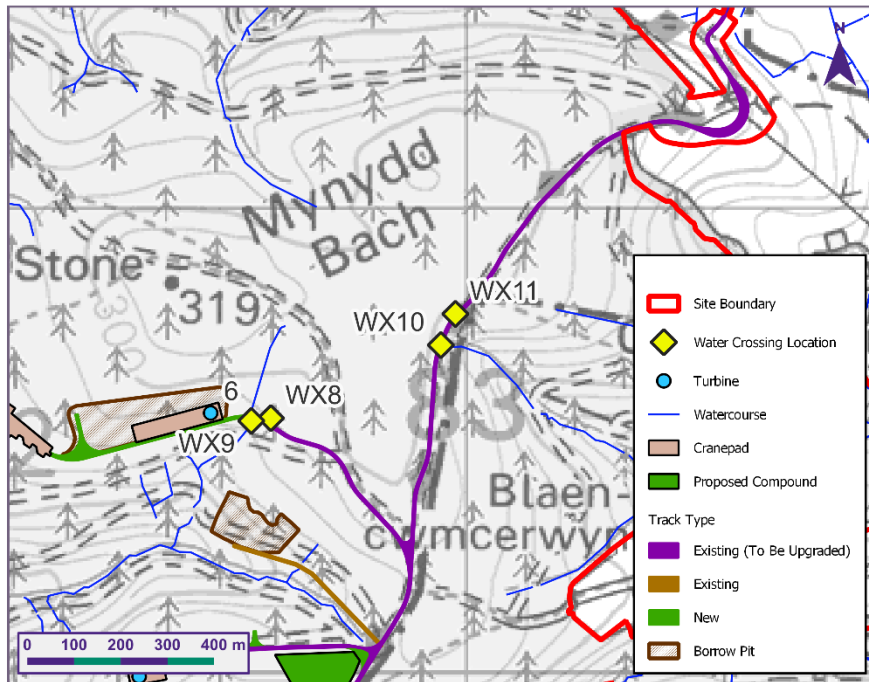
| WX11 (282977, 190771) | | |
|---|---|---|
| <div></div> <p>© Crown Copyright 2023. All rights reserved. Ordnance Survey Licence 0100031673.</p> | <ul style="list-style-type: none"><li>Existing Crossing: Yes</li><li>Crossing Type (existing): Circular Culvert</li><li>Crossing Material (existing): Plastic</li><li>Crossing Condition (existing): Good</li><li>Channel Type: Incised</li><li>Gradient: Gentle</li><li>Valley form: No obvious valley sides (upstream), Deep vee (downstream), Gorge (downstream)</li><li>Bank condition: Stable</li><li>Bed material: Fine sand/silt, Coarse gravel, Boulders</li><li>Riparian corridor: Natural Woodland, Productive Forestry</li><li>Flow condition: Slow</li></ul> <ul style="list-style-type: none"><li>Culvert Dimensions (m): 0.45</li><li>Water width (m): 0.3 - 0.8</li><li>Water depth (m): 0.15</li><li>Bankfull width (m): 1.7</li><li>Bankfull height (m): 1.0</li></ul> <p><b>Note:</b> Wide track in good condition at existing crossing. Crossing sits at the edge of the sedimentary plateau, so is very flat upstream, and within 3 m downstream drops into a very steep sided vee valley or gorge. Note that WX10 is a very similar crossing, ~50 m south.</p> | |

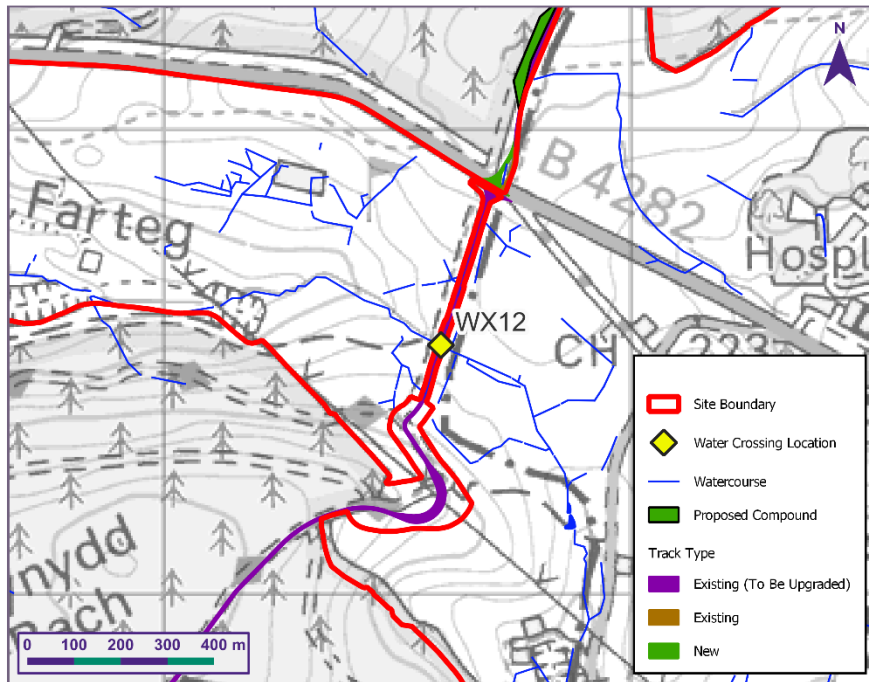
| WX12 (283595, 191540) | | |
|---|---|---|
| <div></div> <p>© Crown Copyright 2023. All rights reserved. Ordnance Survey Licence 0100031673.</p> | <ul style="list-style-type: none"><li>• <b>Existing Crossing:</b> Yes</li><li>• <b>Crossing Type (existing):</b> Circular Culvert</li><li>• <b>Crossing Material (existing):</b> Concrete</li><li>• <b>Crossing Condition (existing):</b> Good</li><li>• <b>Channel Type:</b> Incised</li><li>• <b>Gradient:</b> Moderate</li><li>• <b>Valley form:</b> Deep vee</li><li>• <b>Bank condition:</b> Stable</li><li>• <b>Bed material:</b> Boulders, Coarse gravel, Fine sand/silt</li><li>• <b>Riparian corridor:</b> Moorland, Heavily Vegetated (e.g., gorse, bramble), Other</li><li>• <b>Flow condition:</b> Moderate</li></ul> <ul style="list-style-type: none"><li>• <b>Culvert Dimensions (m):</b> 0.5</li><li>• <b>Water width (m):</b> 0.4</li><li>• <b>Water depth (m):</b> 0.05</li><li>• <b>Bankfull width (m):</b> 1.7</li><li>• <b>Bankfull height (m):</b> 0.7</li><li>• <b>Notes:</b> On golf course. Less incised upstream of culvert</li></ul> | |

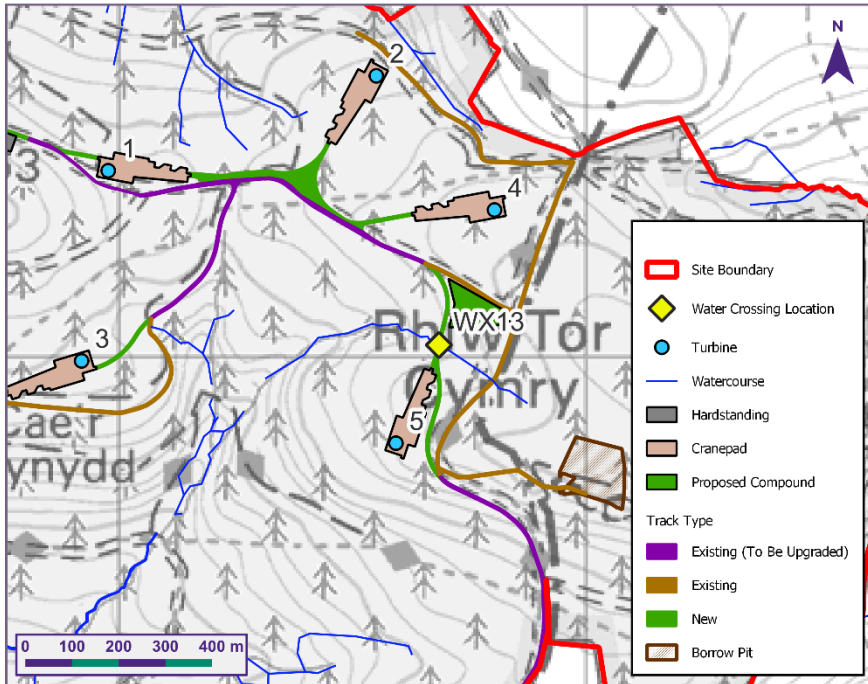
| WX13 (283686, 193024) | | |
|---|---|---|
| | <ul style="list-style-type: none"><li>• <b>Existing Crossing:</b> No</li><li>• <b>Channel Type:</b> Incised</li><li>• <b>Gradient:</b> Moderate</li><li>• <b>Valley form:</b> Shallow vee</li><li>• <b>Bank condition:</b> Stable</li><li>• <b>Bed material:</b> Rounded pebbles, Coarse gravel, Fine sand/silt</li><li>• <b>Riparian corridor:</b> Heavily Vegetated (e.g., gorse, bramble), Productive Forestry</li><li>• <b>Flow condition:</b> Moderate</li><li>• <b>Water width (m):</b> 0.7</li><li>• <b>Water depth (m):</b> 0.15</li><li>• <b>Bankfull width (m):</b> 0.7</li><li>• <b>Bankfull height (m):</b> 0.7</li><li>• <b>Notes:</b> None</li><li>• <b>Proposed Crossing Type:</b> Circular Culvert</li></ul> | |
