**Client Name: Global Centre of  
Rail Excellence**
**Site: GCRE (Onllywyn Washery)**
**Project No.  
5209796**

Client Name: Global Centre of Rail Excellence

Site: GCRE (Main Site)

Project No. 5209796

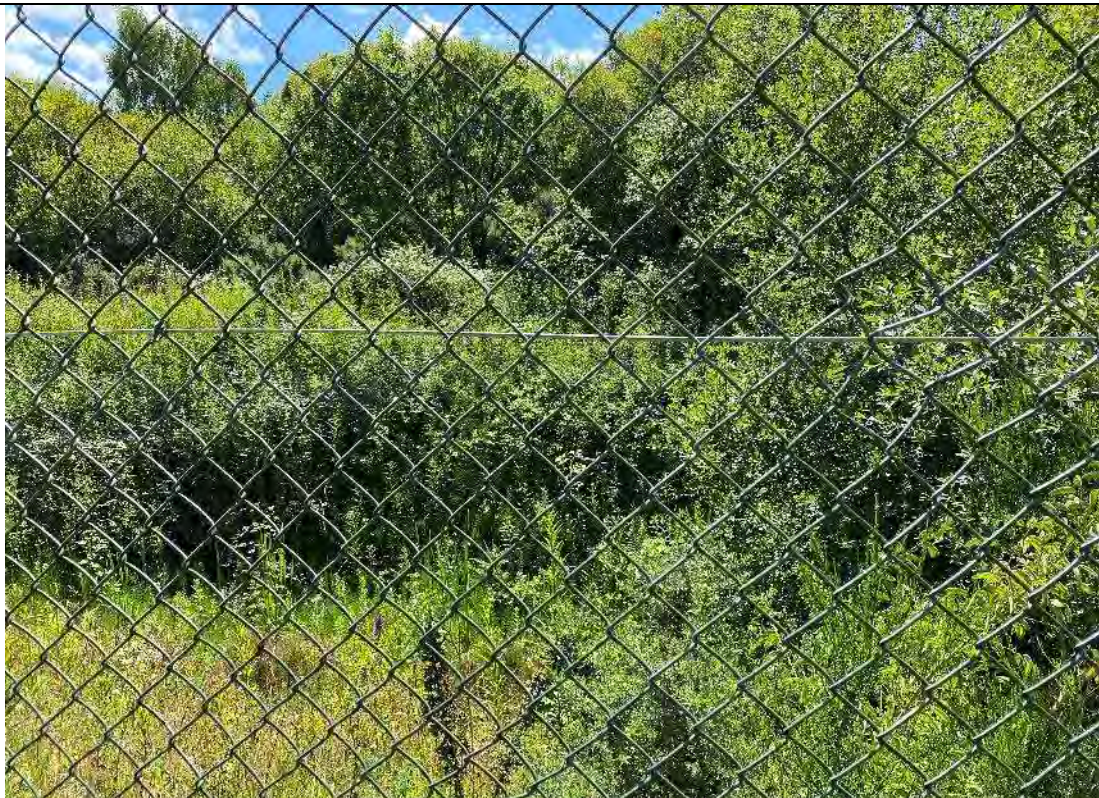
| <b>Lagoons (052 to 054)</b><br><br>View of lagoons in east of site. Vegetation too thick to view well.<br><br>The photograph aspect is west. | | |

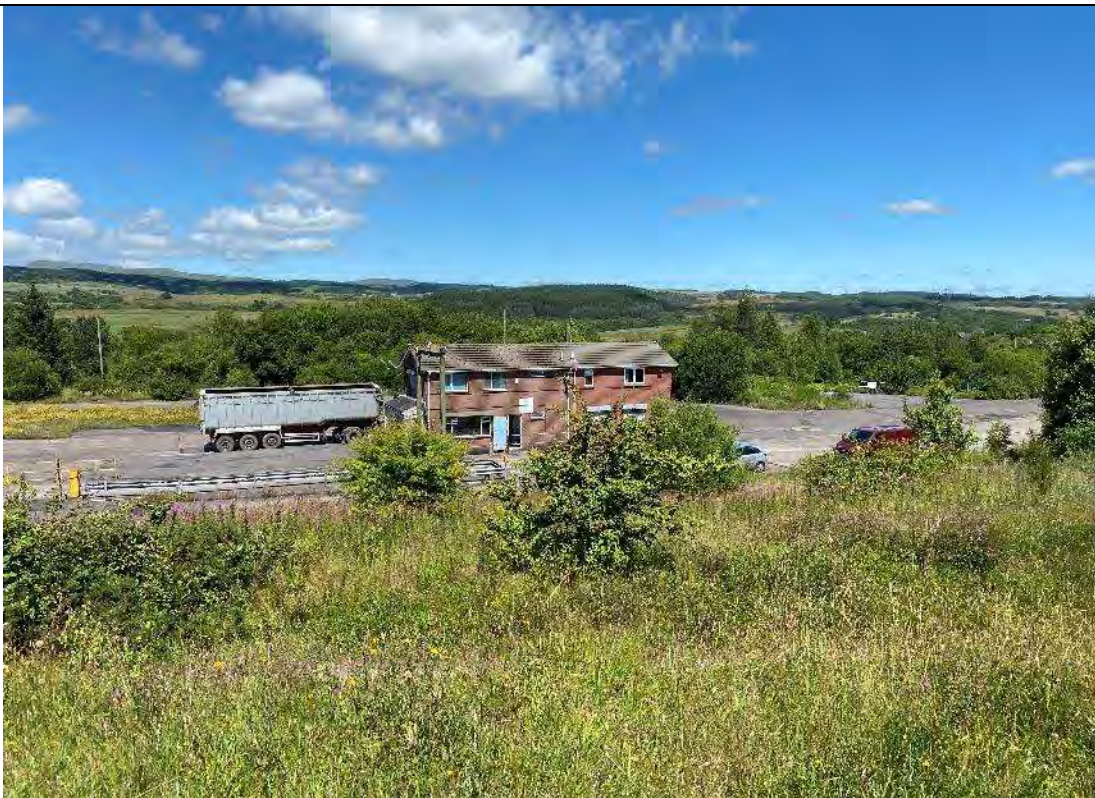
| <b>Weighbridge (048)</b><br><br>View of weighbridge and site office from colliery spoil heap.<br><br>The photograph aspect is north. | | |

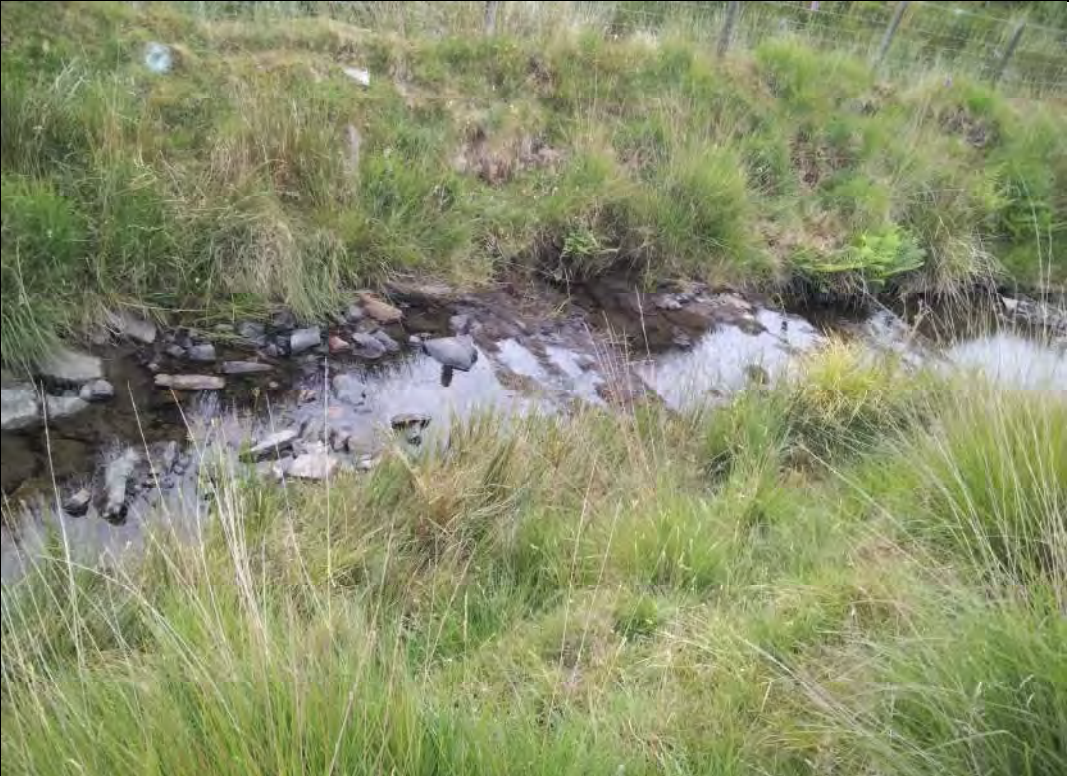
| Photo No. | Date: | |
|---|---|---|
| <b>Surface Water Feature SW-10 CE:</b><br>Surface Water Course (Stream), collecting water from all other discharge drains. Not lined, probably natural. Approximate measurements 0.5m wide, 2.5cm depth. Average speed 0.008m/s, DO 102.5, ORP123.9, Cond 1225.1, pH 8.38, T 19.69. | | |

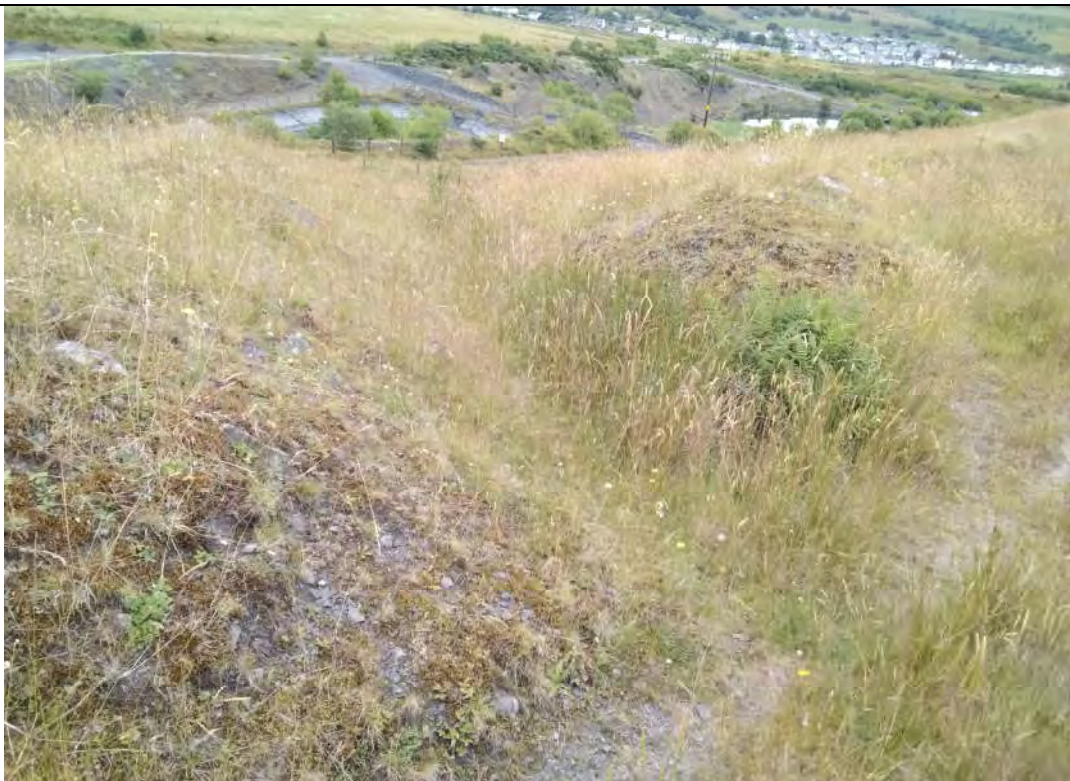
| Photo No. | Date: | |
|---|---|---|
| <b>A Surface Water Feature SW-21 CE:</b><br>Surface Water Course (Minor ditch), collecting runoff/drainage from restoration area. Not lined. Dry at the time. Approximate measurements 3m wide, 0.5m depth. | | |

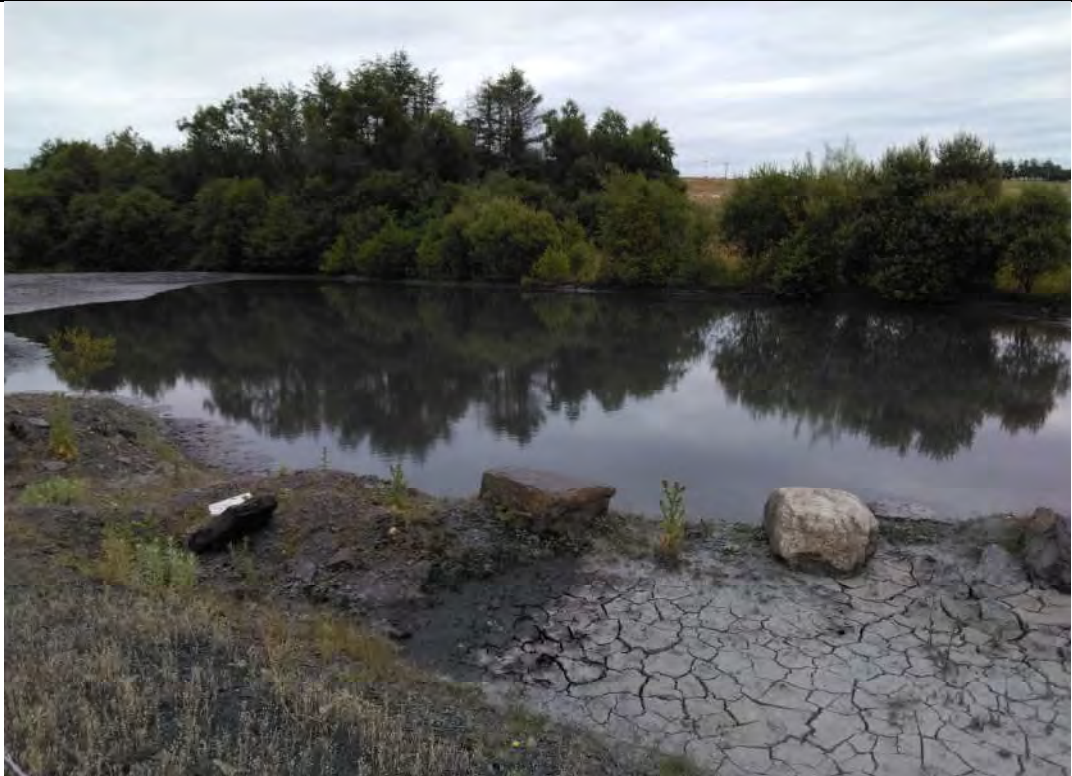
| <p><b>A Surface Water Feature SW-22 CE:</b><br/> Lagoon, no flow out, probably not lined but looked but within a low permeability material, possibly water storage area from runoff from adjacent areas. 20m wide by 50m long. No measurements obtained H&amp;S concerns.</p> | | |

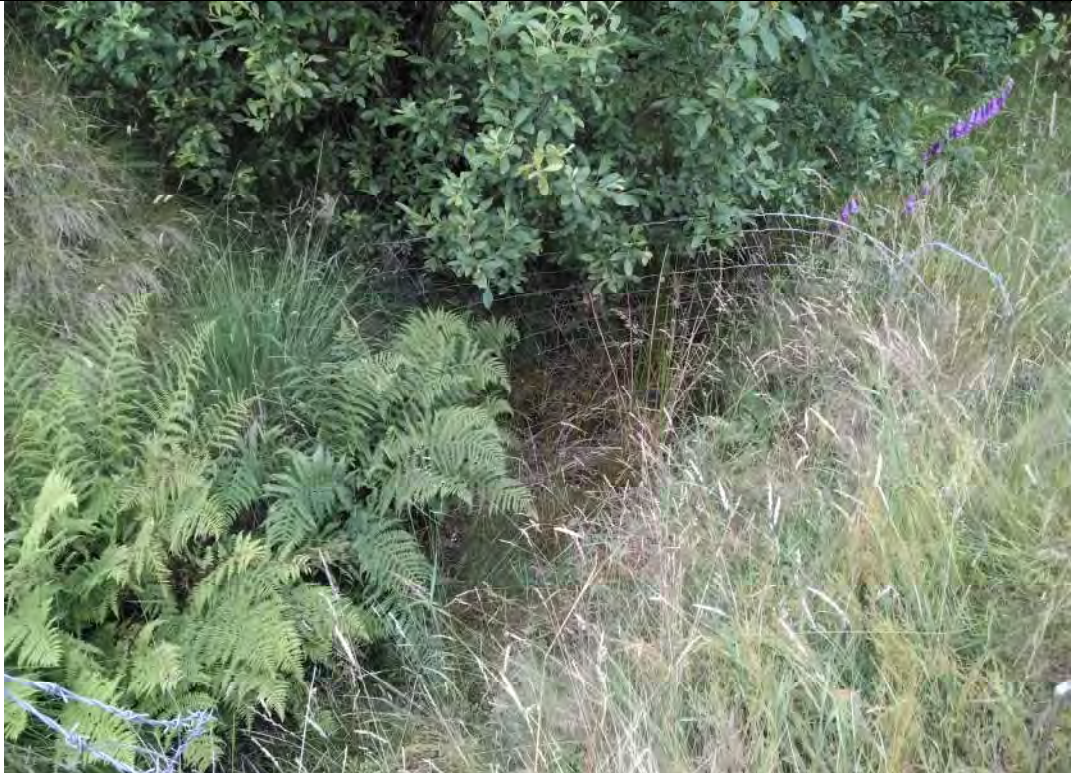
| <p><b>A Surface Water Feature SW-23 CE:</b><br/> Surface Water Course (Minor ditch), collecting runoff/drainage from pastoral areas. Not likely to be lined. Dry at the time. Approximate measurements 1.5m wide, 0.5m depth.</p> | | |

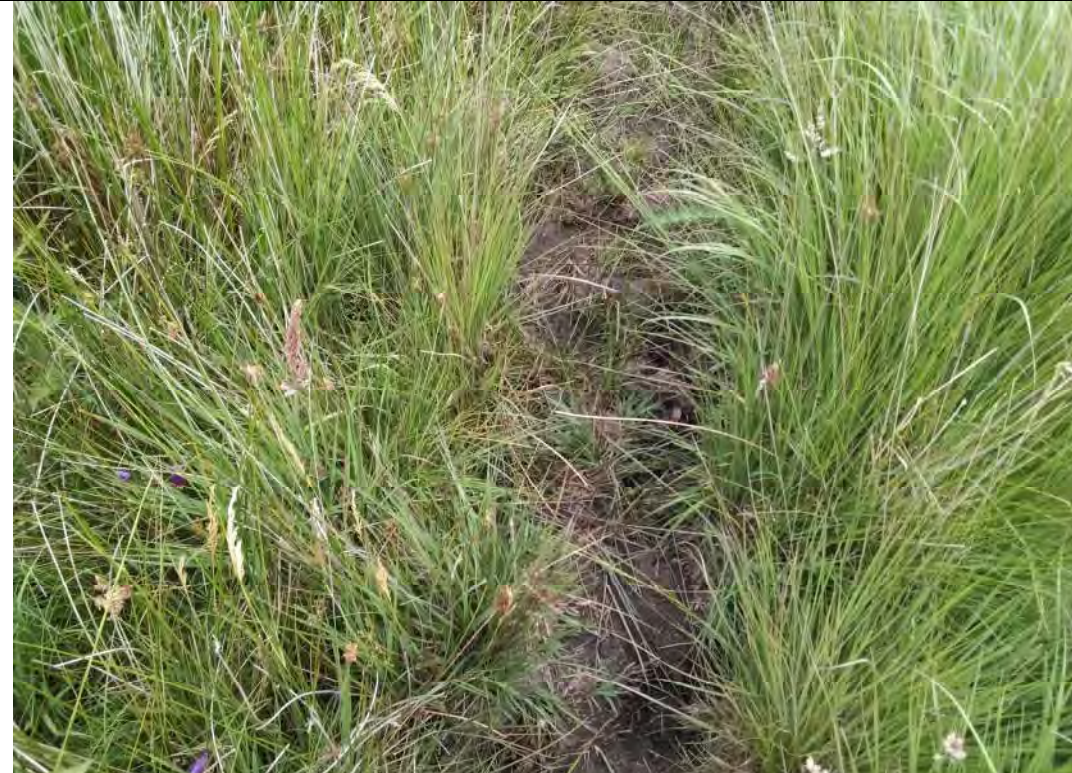
| Photo No. | Date: | |
|---|---|---|
| <b>A Surface Water Feature SW-29 CE:</b><br>Surface Water (minor ditch), land drainage from adjacent areas, dry at the time, not likely to be lined. Approximate measurements 2m wide by 0.2 depth. | | |

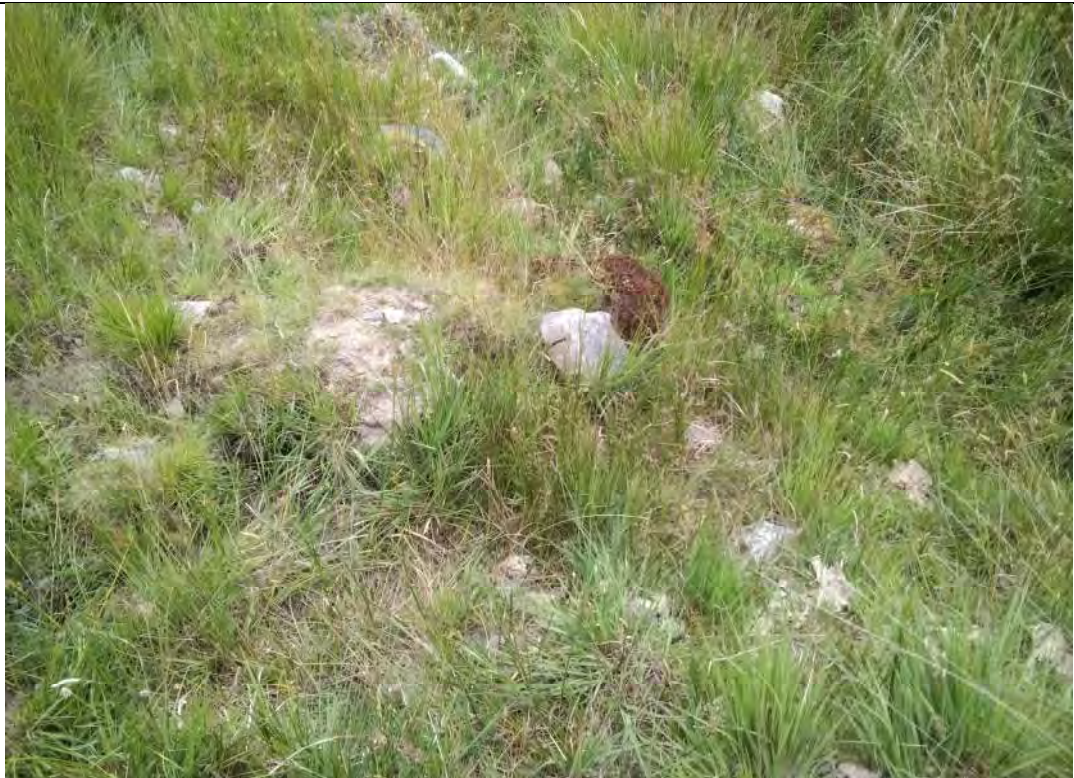
| Photo No. | Date: | |
|---|---|---|
| SW-30 CE | 12 July 2022 | |

| Photo No. | Date: | |
|---|---|---|
| <b>Surface Water Feature SW-30 CE:</b><br>Surface Water (minor ditch), land drainage from adjacent areas, dry at the time, no likely to be lined. Approximate measurements 2m wide by 0.2 depth. | | |

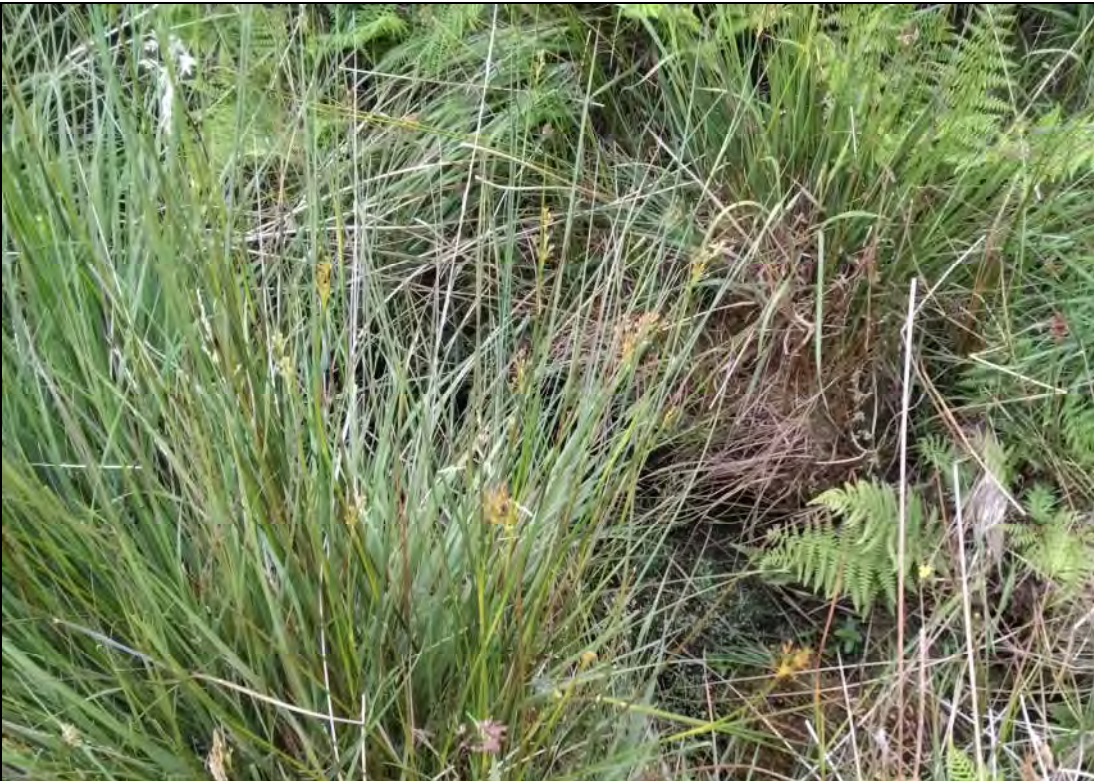
| Photo No. | Date: | |
|---|---|---|
| SW-31 CE | 12 July 2022 | |

| Photo No. | Date: | |
|---|---|---|
| <b>Surface Water Feature SW-31 CE:</b><br>Surface Water (minor ditch), land drainage from adjacent areas, dry at the time, no likely to be lined. Approximate measurements 0.5m wide by 0.2 depth. | | |

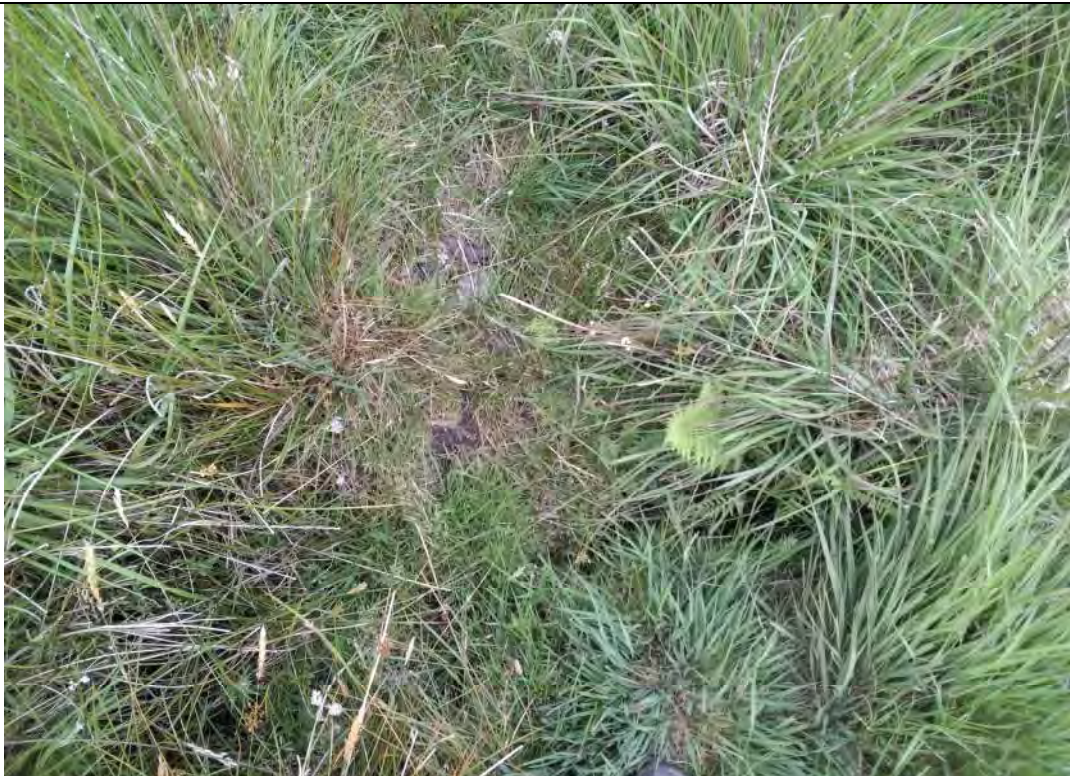
| Photo No. | Date: | |
|---|---|---|
| SW-33 CE | 12 July 2022 | |

| Photo No. | Date: | |
|---|---|---|
| <b>Surface Water Feature SW-33 CE:</b><br>Surface Water (minor ditch), land drainage from adjacent areas, dry at the time, no likely to be lined. Approximate measurements 1m wide by 0.5 depth. | | |

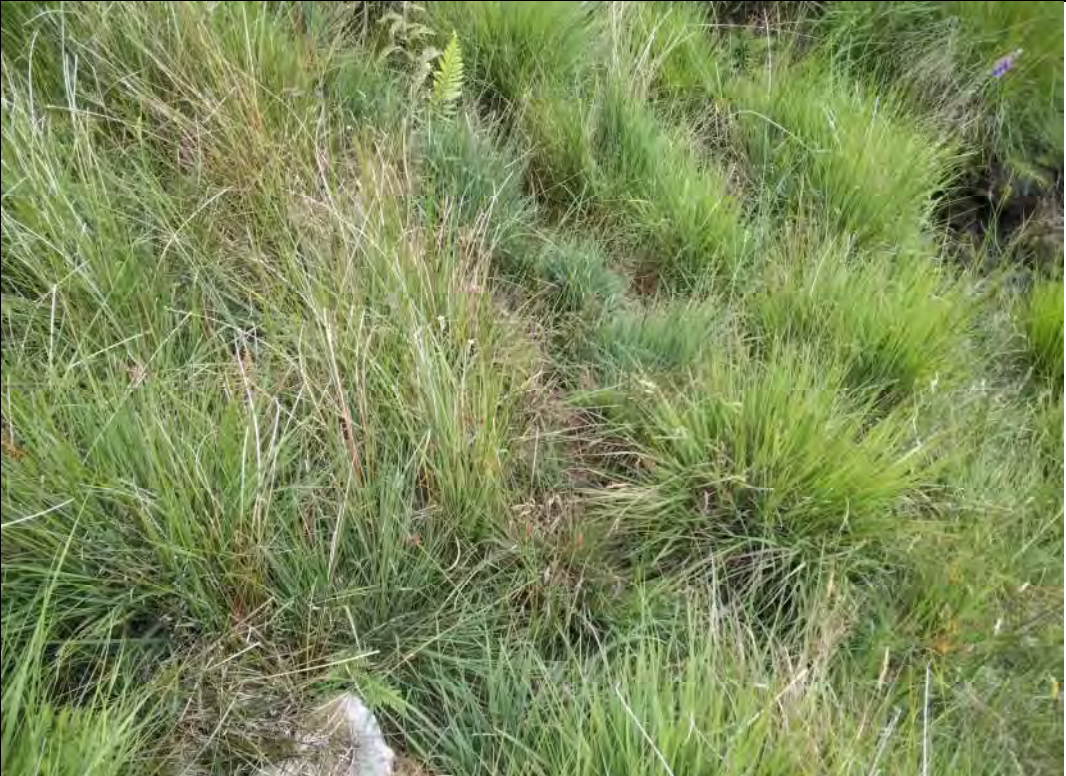
| Photo No. | Date: | |
|---|---|---|
| SW-34 CE | 12 July 2022 | |

| Photo No. | Date: | |
|---|---|---|
| <b>Surface Water Feature SW-34 CE:</b><br>Surface Water (minor ditch), land drainage from adjacent areas, dry at the time, no likely to be lined. Approximate measurements 1m wide by 0.5 depth. | | |

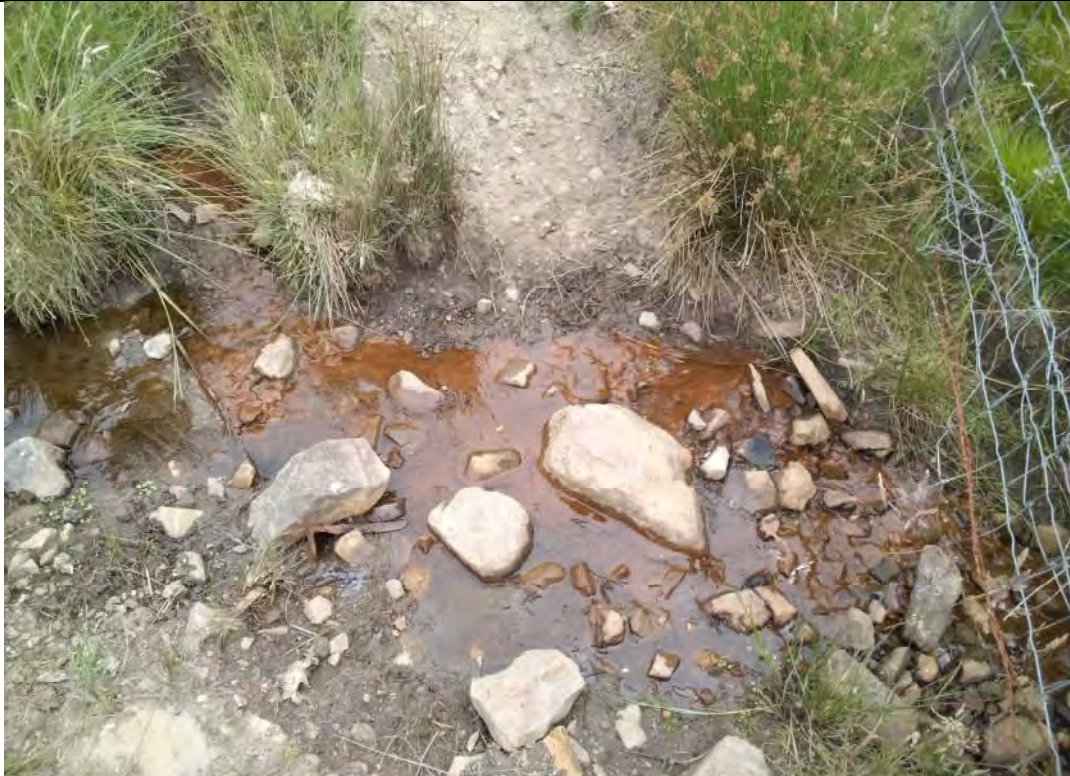
| Photo No. | Date: | |
|---|---|---|
| <b>Surface Water Feature SW-36 CE:</b><br>Surface Water Course (Stream), collecting water from all other discharge drains, rainfall, runoff. Not lined, probably natural. Approximate measurements 1m wide, 2cm depth. Average speed 0.053m/s, no readings taken | | |

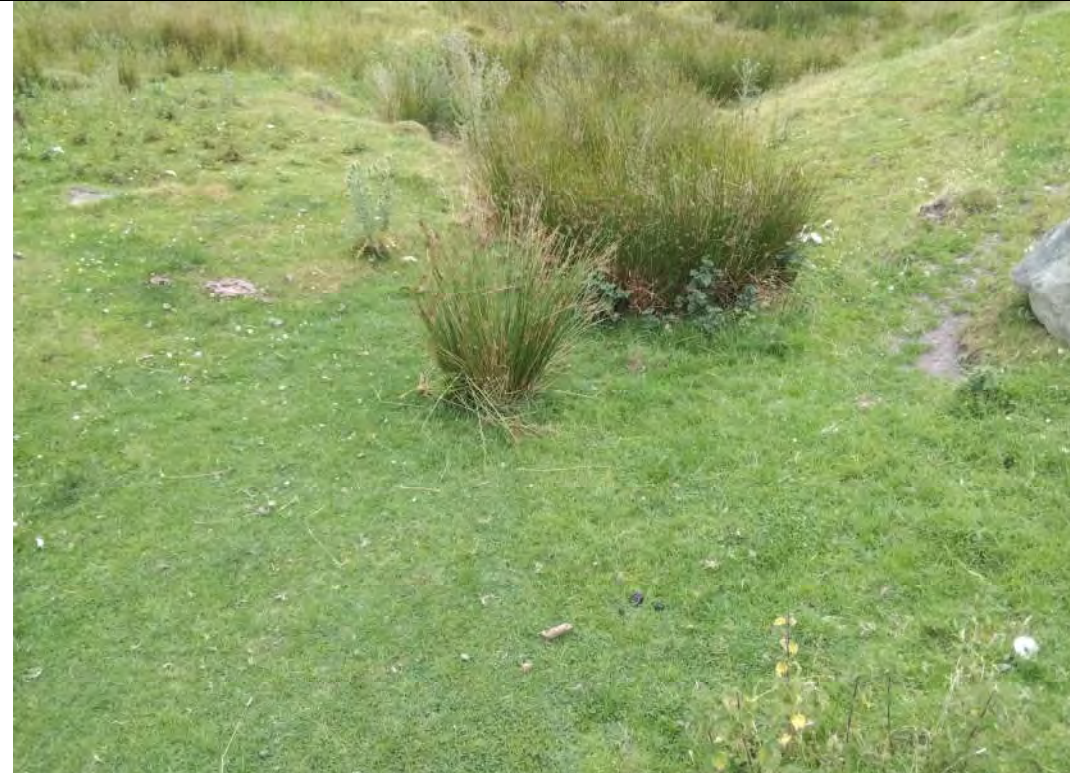
| Photo No. | Date: | |
|---|---|---|
| SW-39 CE | 12 July 2022 | |

| Photo No. | Date: | |
|---|---|---|
| <b>Surface Water Feature SW-39 CE:</b><br>Surface Water (minor ditch), land drainage/runoff from adjacent areas, dry/no flow, no likely to be lined. | | |

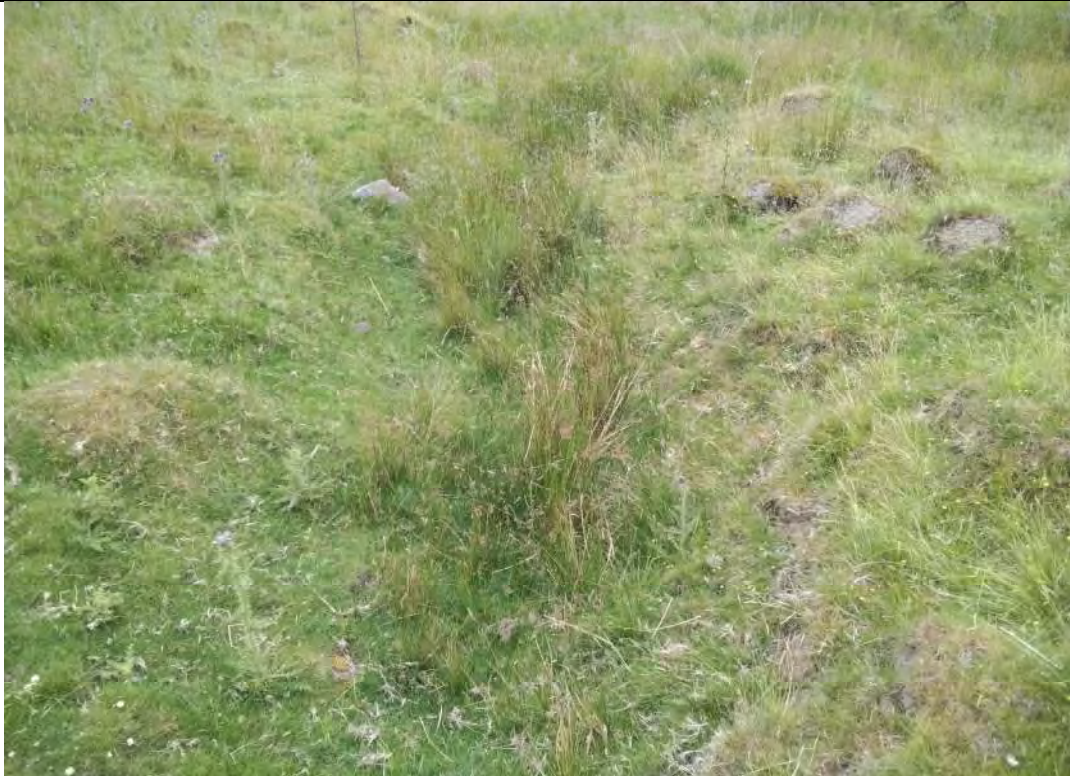
| Photo No. | Date: | |
|---|---|---|
| SW-41 CE | 12 July 2022 | |

| Photo No. | Date: | |
|---|---|---|
| <b>Surface Water Feature SW-41 CE:</b><br>Surface Water (minor ditch), land drainage/runoff from adjacent areas, dry/no flow, no likely to be lined. | | |

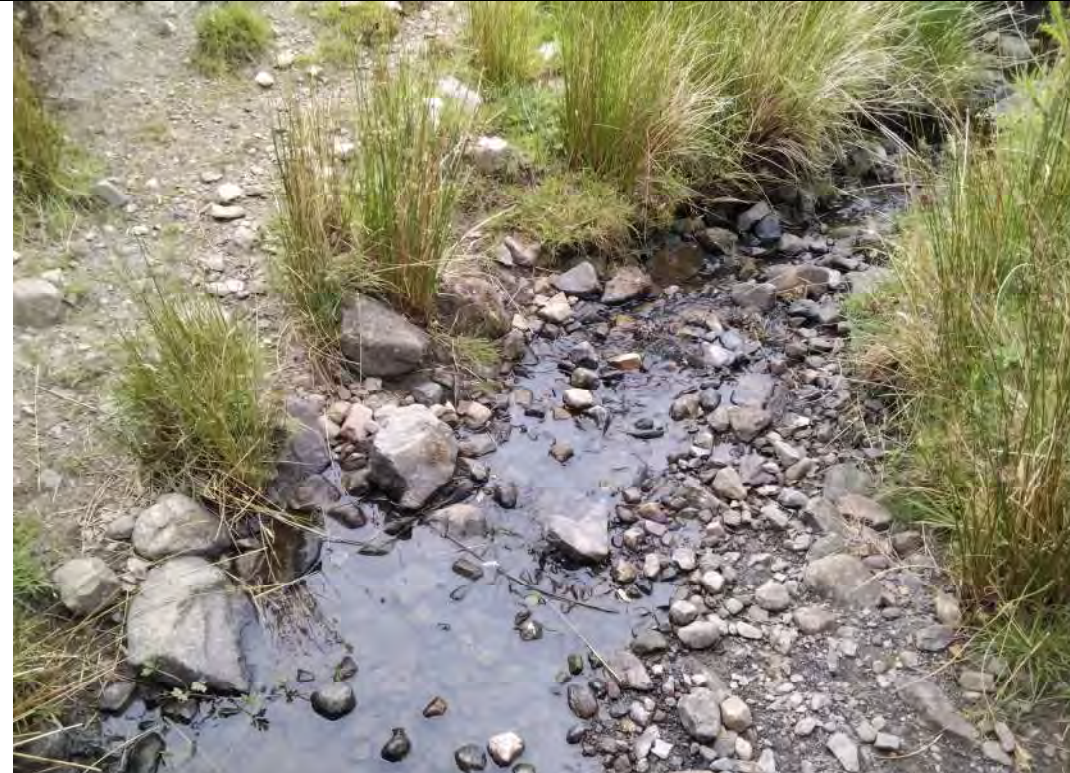
| Photo No. | Date: | |
|---|---|---|
| <b>Surface Water Feature SW-43 CE:</b><br>Surface Water Course (Stream), collecting water from all other discharge drains, rainfall, runoff. Not lined, probably natural. Approximate measurements 75cm wide, 2cm depth. Average speed 0.013m/s, no readings taken | | |

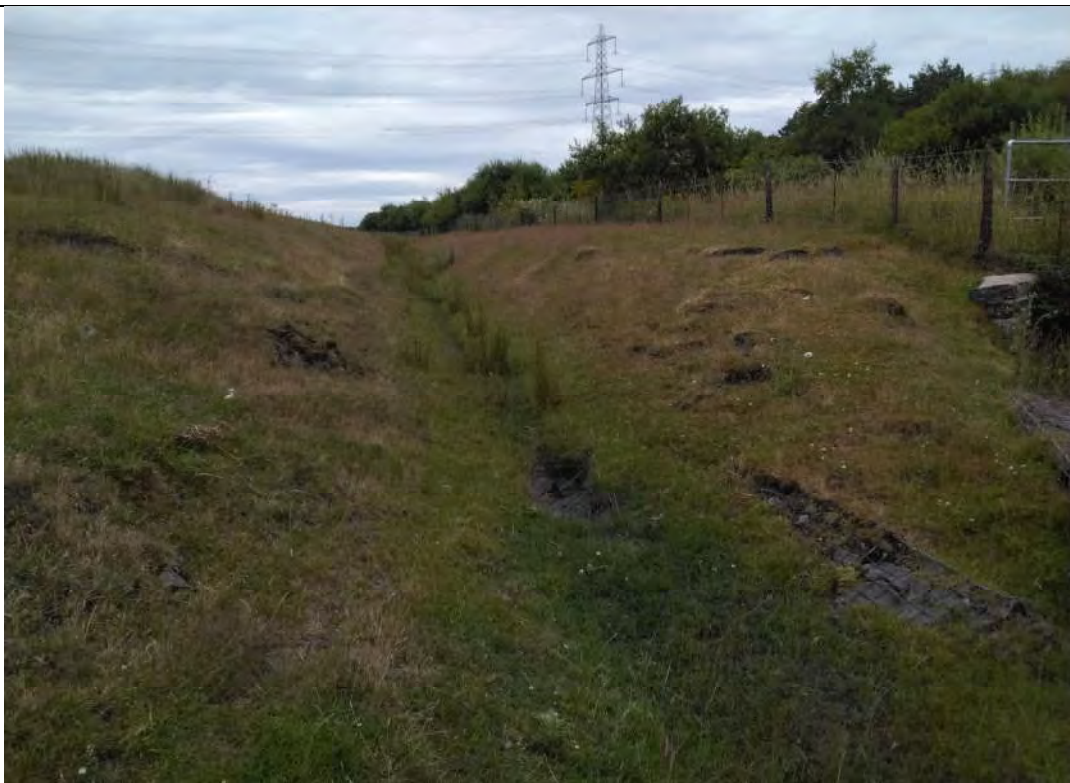
| Photo No.<br>SW-46 CE | Date:<br>12 July<br>2022 | |
|---|---|---|
| <b>Surface Water Feature SW-46 CE:</b><br>Surface Water (minor ditch), land drainage/runoff from adjacent restored and pastoral areas, dry/no flow, no likely to be lined. Approximate measurements 2m wide by 1m depth | | |

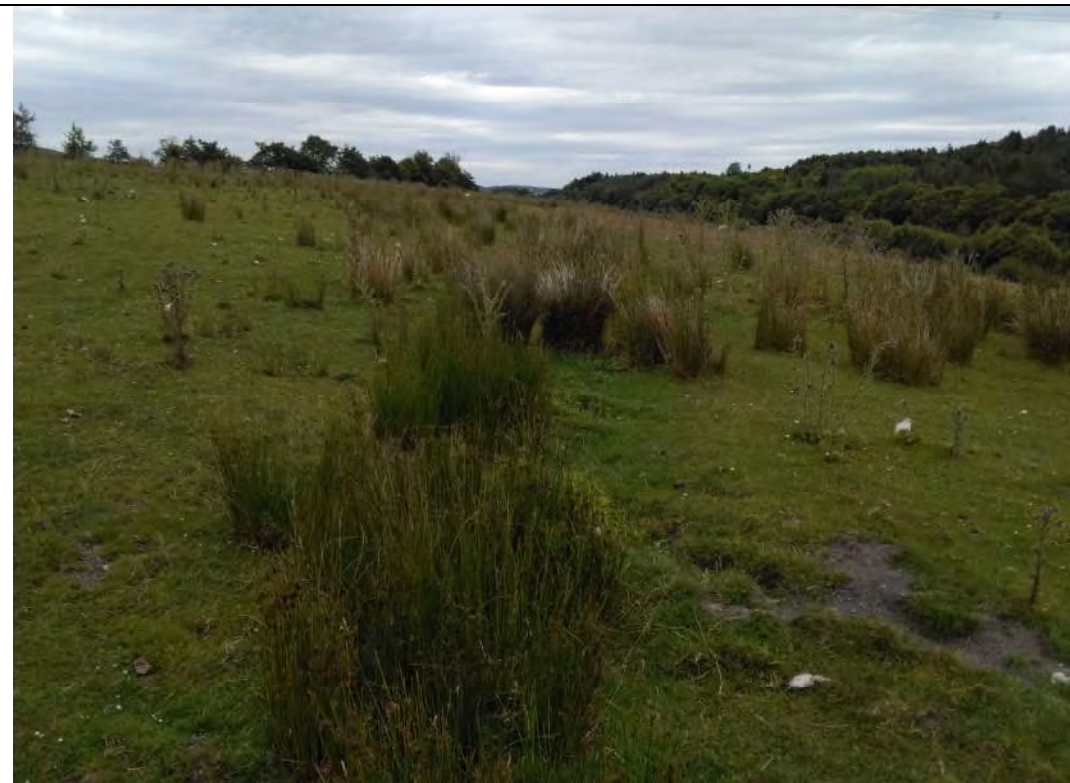
| Photo No.<br>SW-47 CE | Date:<br>12 July<br>2022 | |

| Photo No.<br>SW-47 CE | Date:<br>12 July<br>2022 | |
|---|---|---|
| <b>Surface Water Feature SW-47 CE:</b><br>Surface Water (minor ditch), land drainage/runoff from adjacent restored and pastoral areas, dry/no flow, no likely to be lined. | | |

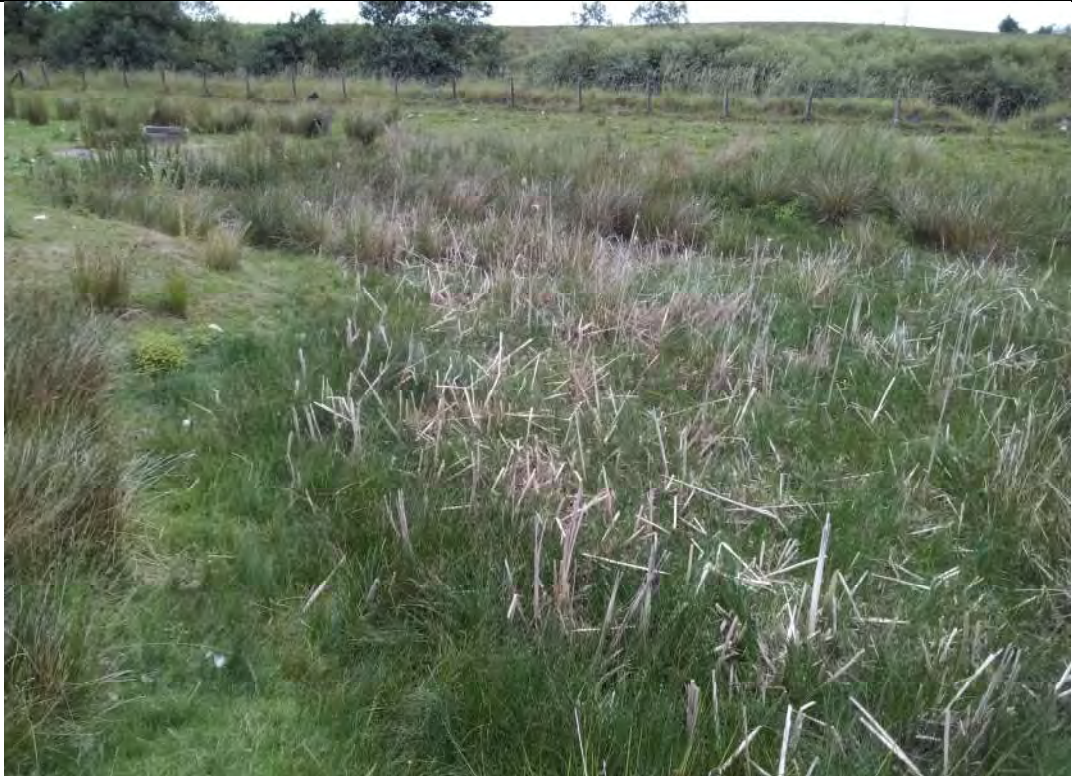
| Photo No. | Date: | |
|---|---|---|
| SW-48 CE | 12 July 2022 | |

| Photo No. | Date: | |
|---|---|---|
| <b>Surface Water Feature SW-48 CE:</b><br>Lagoon dry, runoff from ditch, approximate dimensions 17m wide by 25m length. | | |

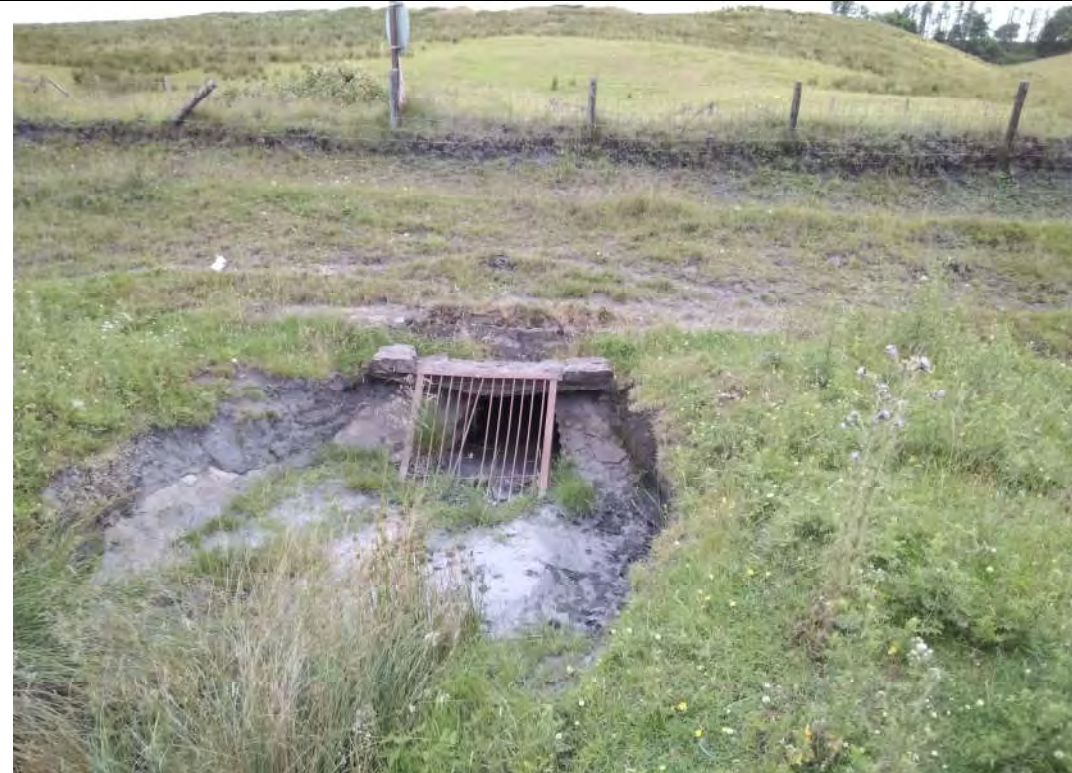
| Photo No. | Date: | |
|---|---|---|
| SW-52 CE | 12 July 2022 | |

| Photo No. | Date: | |
|---|---|---|
| <b>Surface Water Feature SW-52 CE:</b><br>Surface Water (minor ditch), land drainage/runoff from adjacent restored and pastoral areas, no flow, no likely to be lined | | |

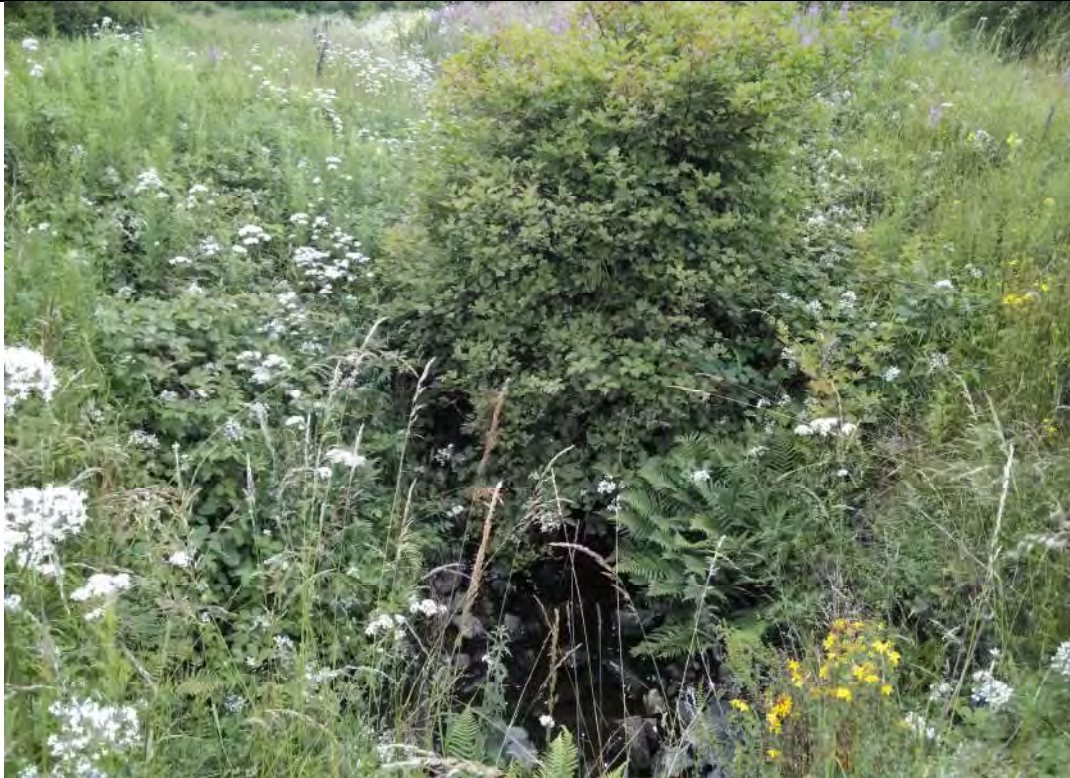
| Photo No. | Date: | |
|---|---|---|
| <b>Surface Water Feature SW-53 CE:</b><br>Surface Water (minor ditch), land drainage/runoff from adjacent restored and pastoral areas, no apparent flow, no likely to be lined. Parameters not taken due to H&S risks. | | |

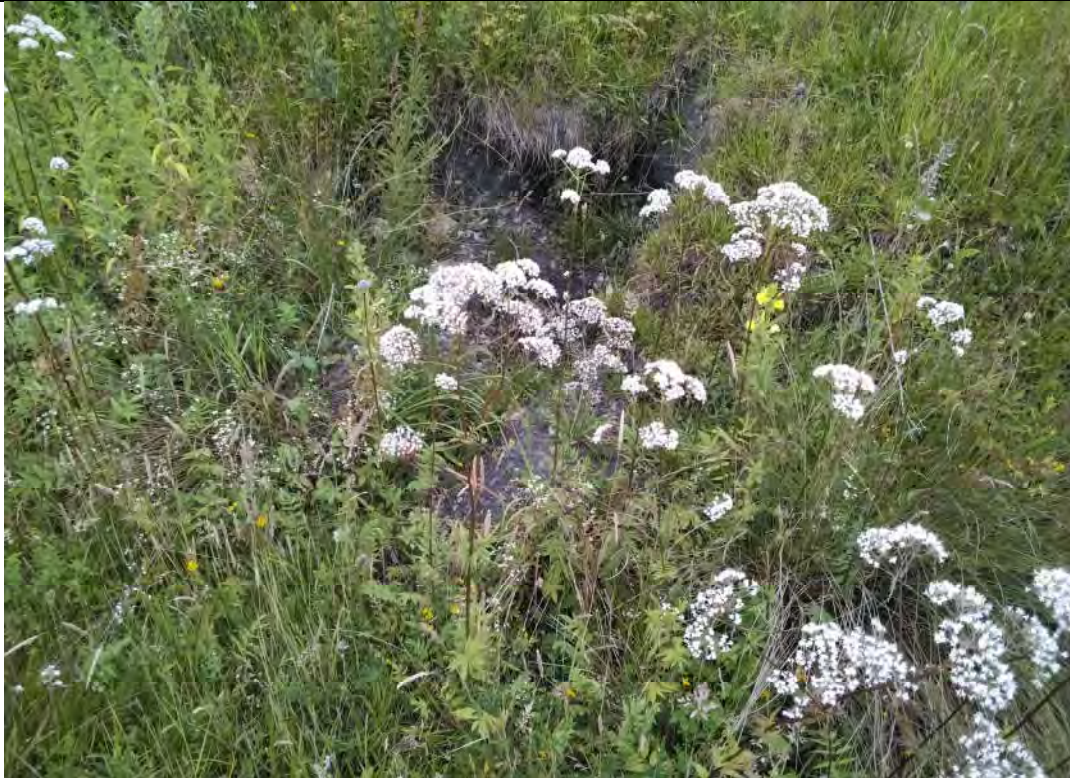
| Photo No. | Date: | |
|---|---|---|
| SW-55 CE | 12 July 2022 | |

| Photo No. | Date: | |
|---|---|---|
| <b>Surface Water Feature SW-55 CE:</b><br>Surface Water (minor ditch), land drainage/runoff from adjacent restored and pastoral areas, dry, no likely to be lined. | | |

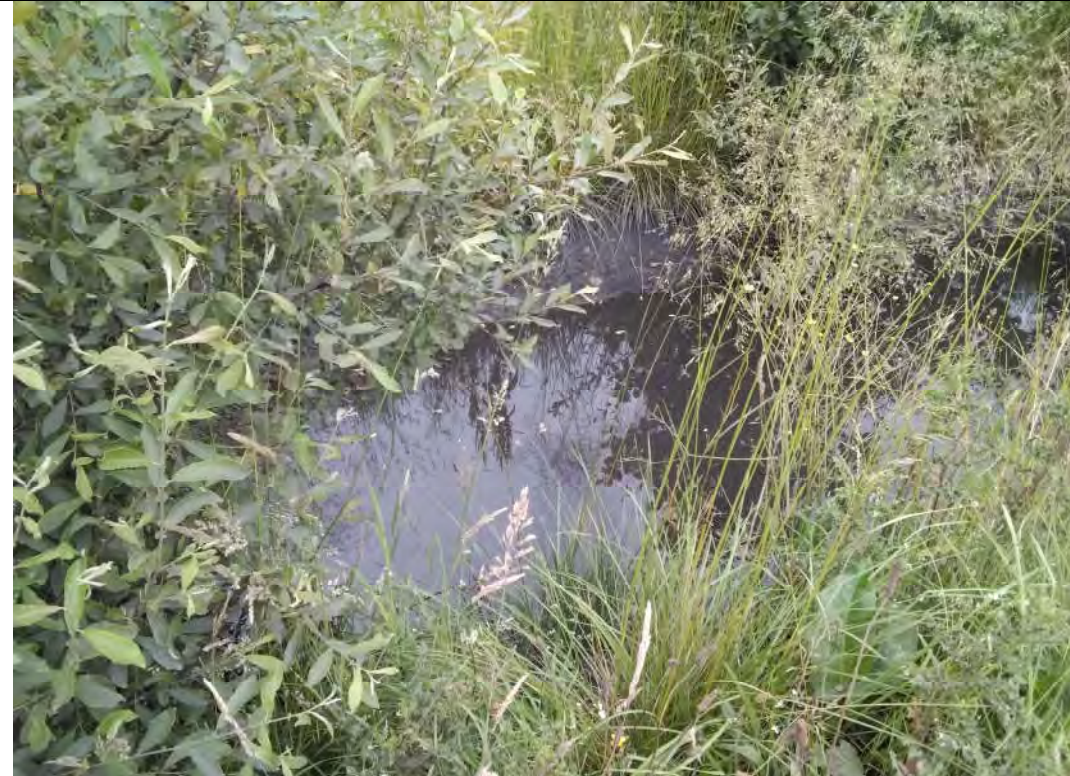
| Photo No. | Date: | |
|---|---|---|
| <b>Surface Water Feature SW-56 CE:</b><br>Surface Water (minor ditch), land drainage/runoff from adjacent restored and pastoral areas, water in the ditch but not apparent flow, no likely to be lined. | | |

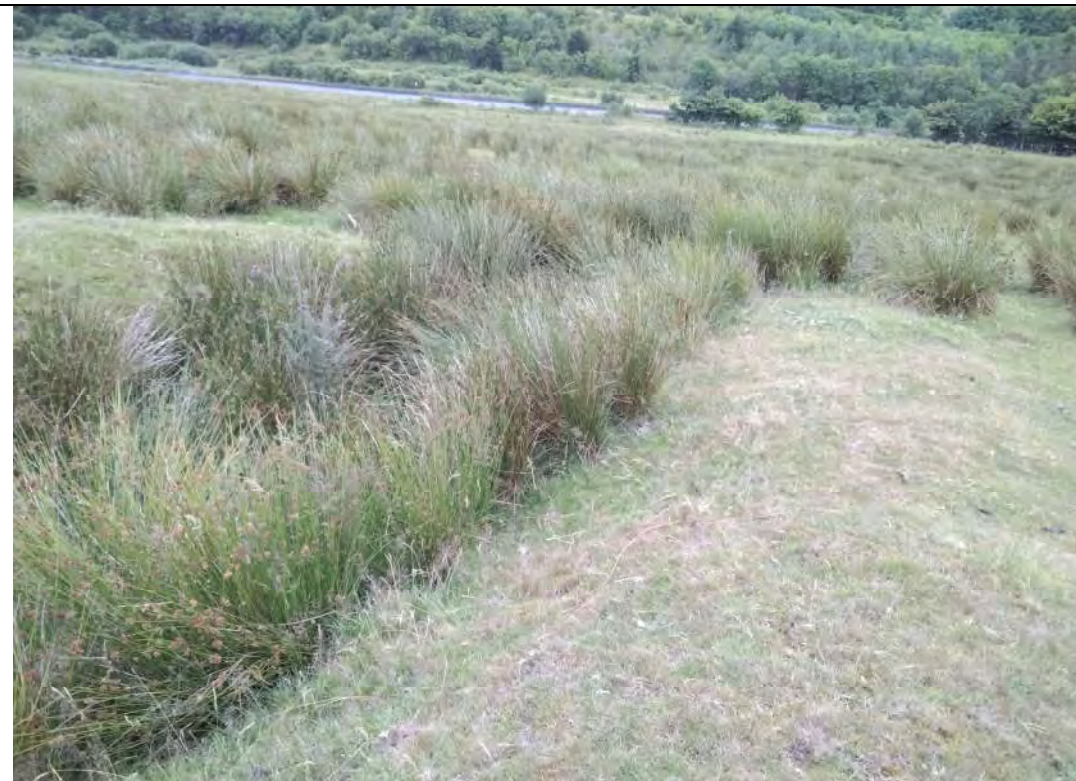
| Photo No. | Date: | |
|---|---|---|
| SW-59 CE | 12 July 2022 | |

| Photo No. | Date: | |
|---|---|---|
| <b>Surface Water Feature SW-59 CE:</b><br>Surface Water (minor ditch), land drainage/runoff from adjacent restored and pastoral areas, dry, no likely to be lined. | | |

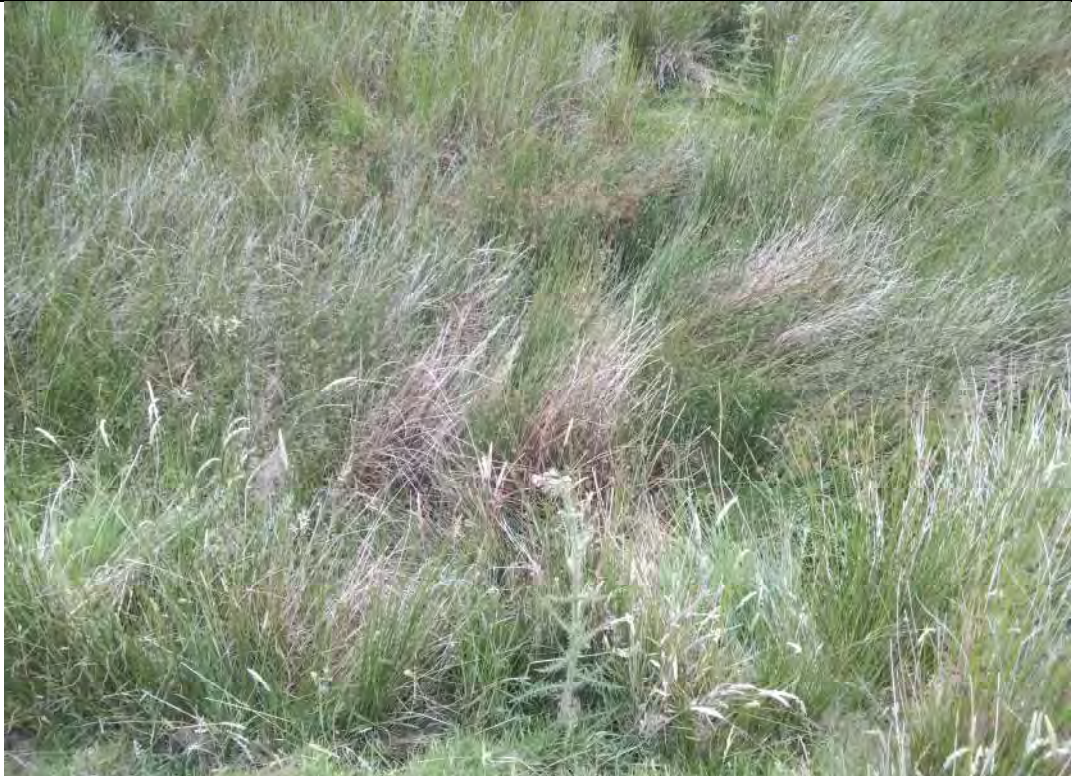
| Photo No. | Date: | |
|---|---|---|
| SW-60 CE | 12 July 2022 | |

| Photo No. | Date: | |
|---|---|---|
| <b>Surface Water Feature SW-60 CE:</b><br>Surface Water (minor ditch), land drainage/runoff from adjacent restored and pastoral areas, dry, no likely to be lined. | | |

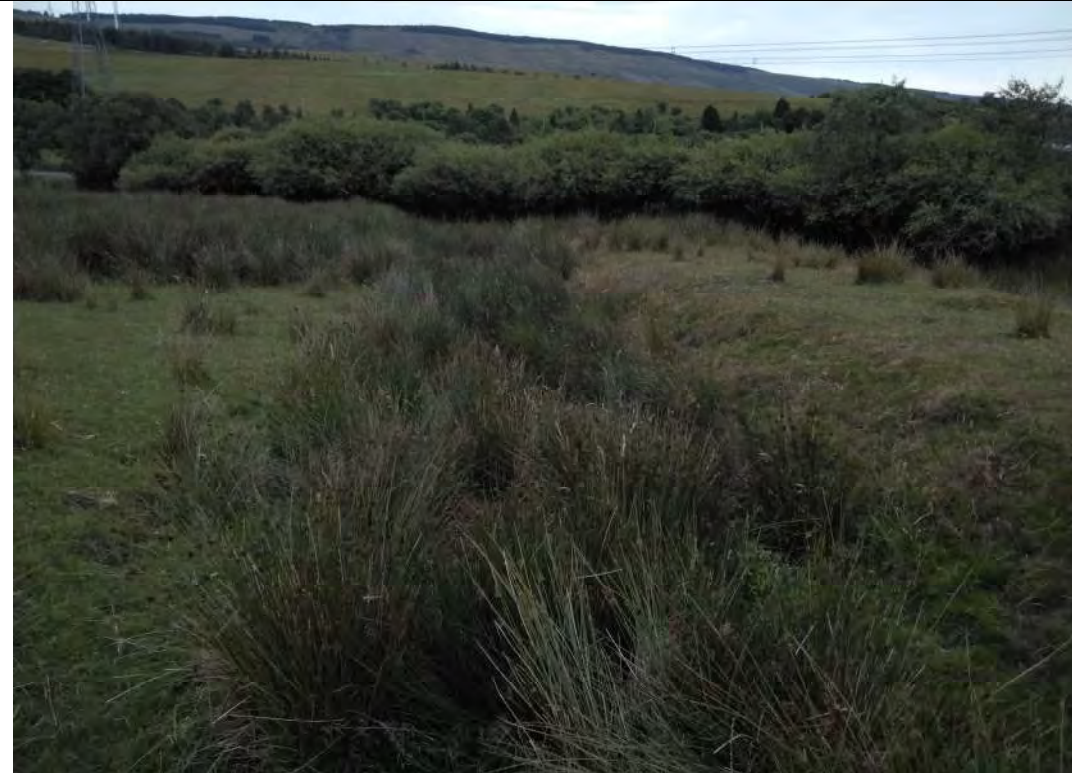
| Photo No. | Date: | |
|---|---|---|
| SW-64 CE | 12 July 2022 | |

| Photo No. | Date: | |
|---|---|---|
| <b>Surface Water Feature SW-64 CE:</b><br>Surface Water (minor ditch), land drainage/runoff from adjacent restored and pastoral areas, dry, no likely to be lined. | | |
