**Client Name: Global Centre of  
Rail Excellence**
**Site: GCRE (Onllywyn Washery)**
**Project No.  
5209796**

Client Name: Global Centre of Rail Excellence

Site: GCRE (Main Site)

Project No. 5209796

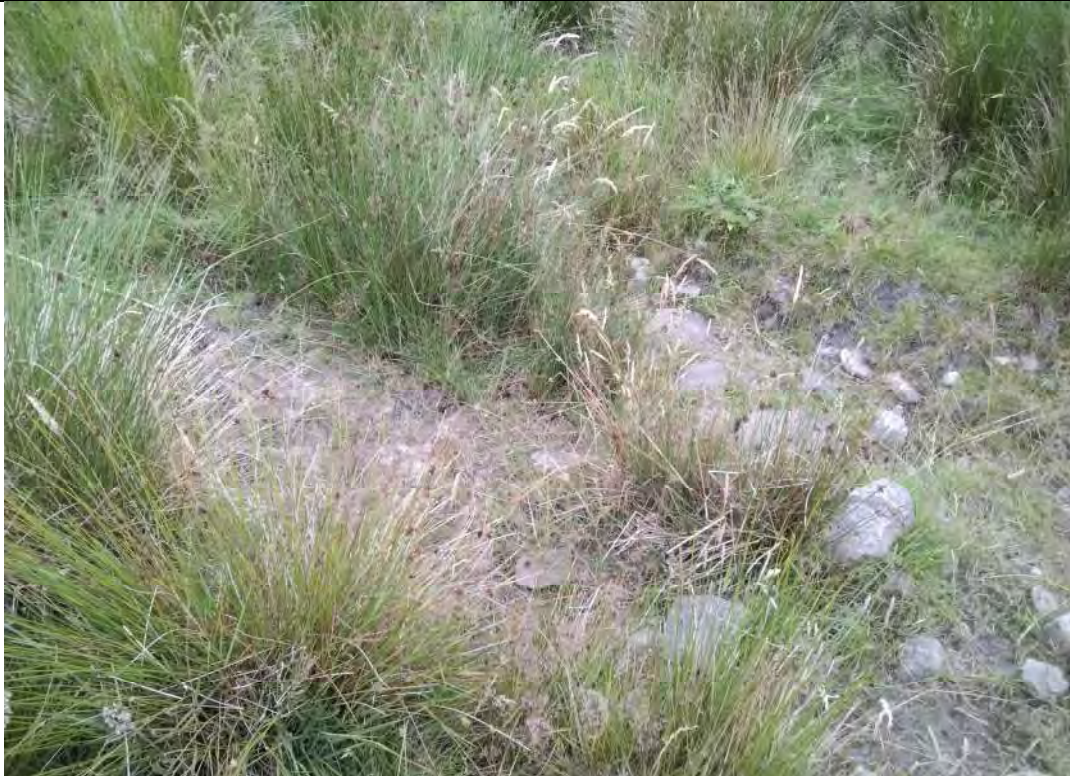
| Photo No. | Date: | |
|---|---|---|
| SW-66 CE | 12 July 2022 | |

| Photo No. | Date: | |
|---|---|---|
| <b>Surface Water Feature SW-66 CE:</b><br>Surface Water (minor ditch), land drainage/runoff from adjacent restored and pastoral areas, dry, no likely to be lined. | | |

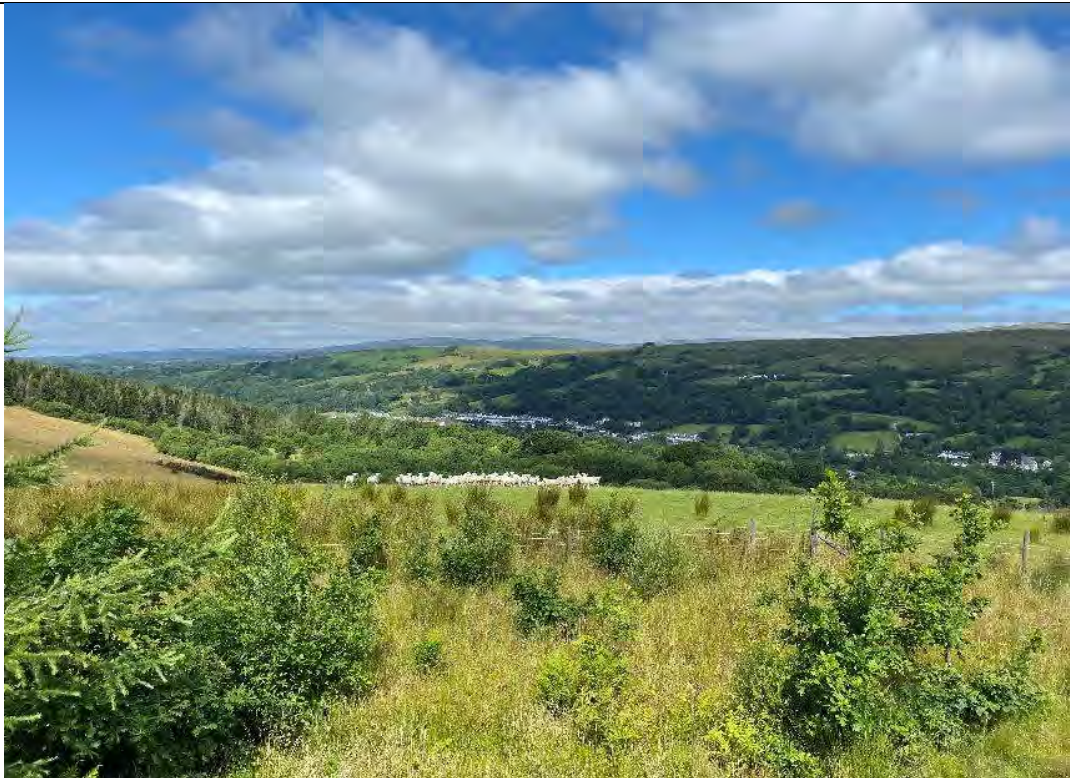
| Photo No.<br>SW-01 DP | Date:<br>12 July<br>2022 | |

| Photo No.<br>SW-01 DP | Date:<br>12 July<br>2022 | |
|---|---|---|
| <b>Offsite View</b><br><br>View of northern site and land offsite.<br><br>The photograph aspect is north. | | |

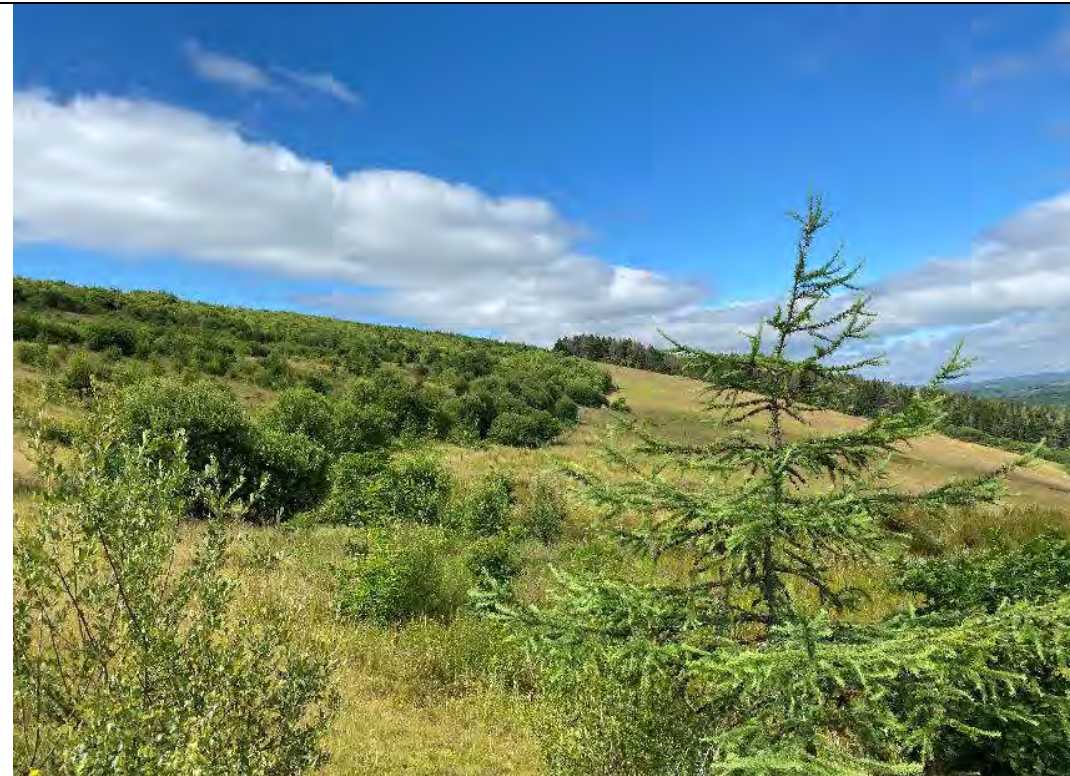
| Photo No.<br>SW-01 CE | Date:<br>12 July<br>2022 | |

| Photo No.<br>SW-01 CE | Date:<br>12 July<br>2022 | |
|---|---|---|
| <b>Norther Main Site</b><br><br>View restored area of open cast mining in north of site.<br><br>The photograph aspect is south. | | |

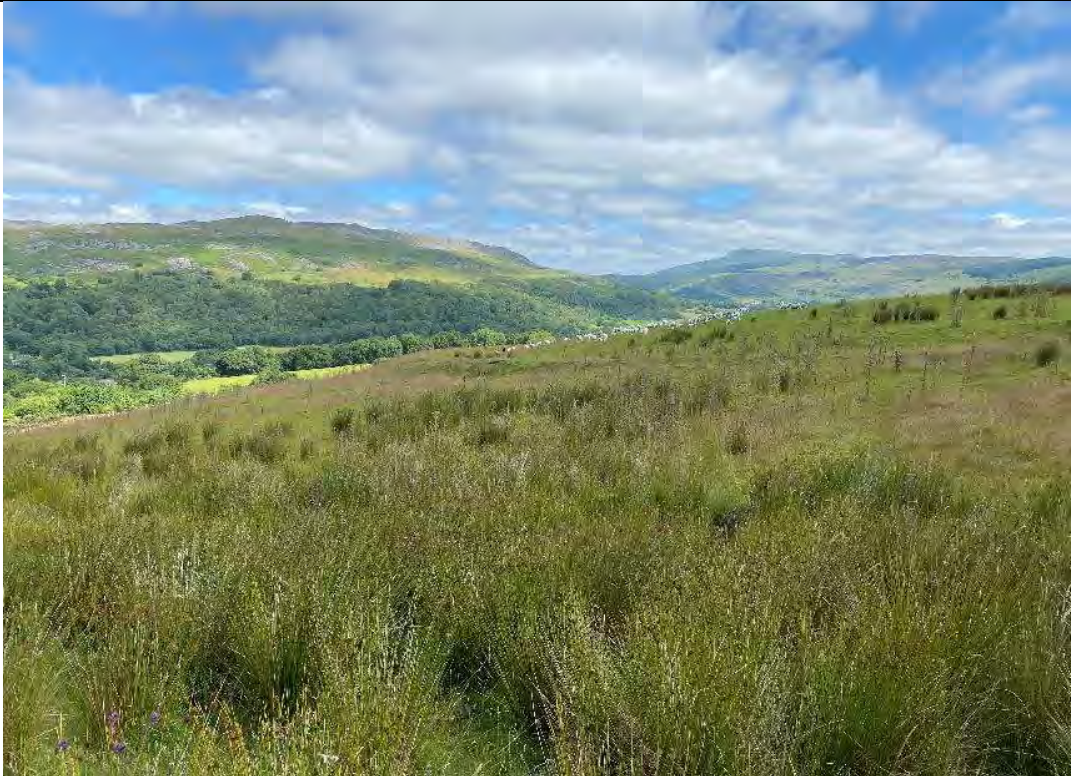
| <p><b>Relict Colliery Structure</b></p> <p>View of topographic change associated with former colliery use.</p> <p>The photograph aspect is north.</p> | | |

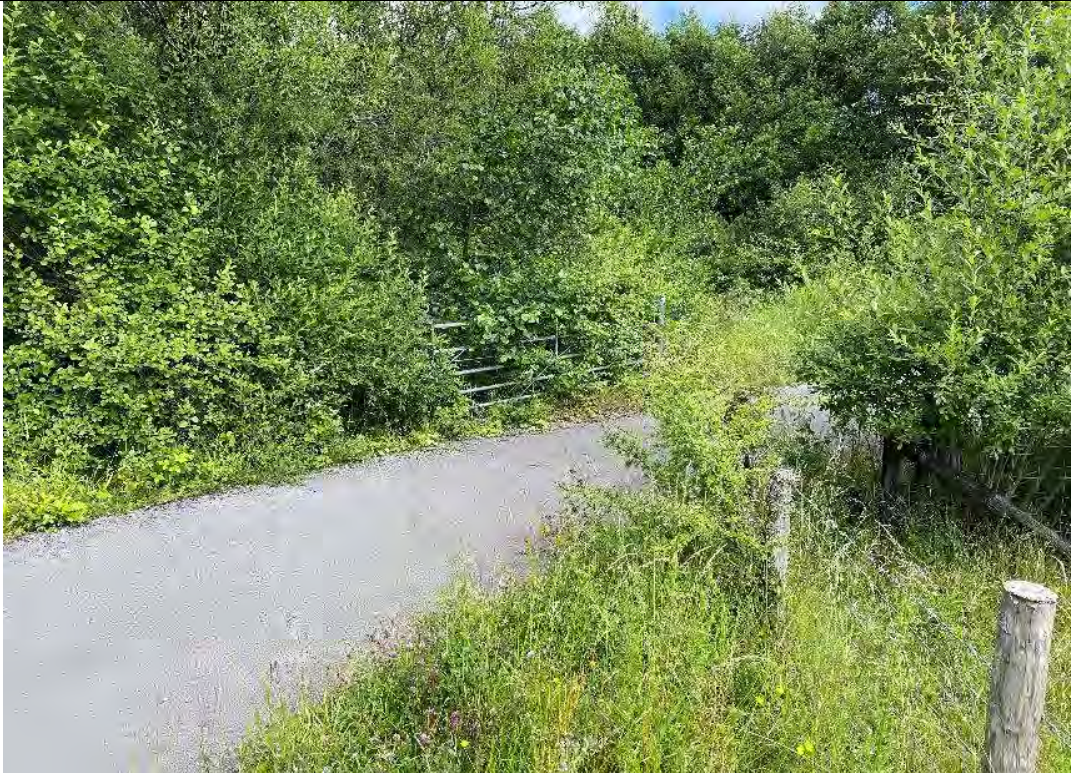
| <p><b>Access Road</b></p> <p>View of asphalt track in north of site.</p> <p>The photograph aspect is west.</p> | | |

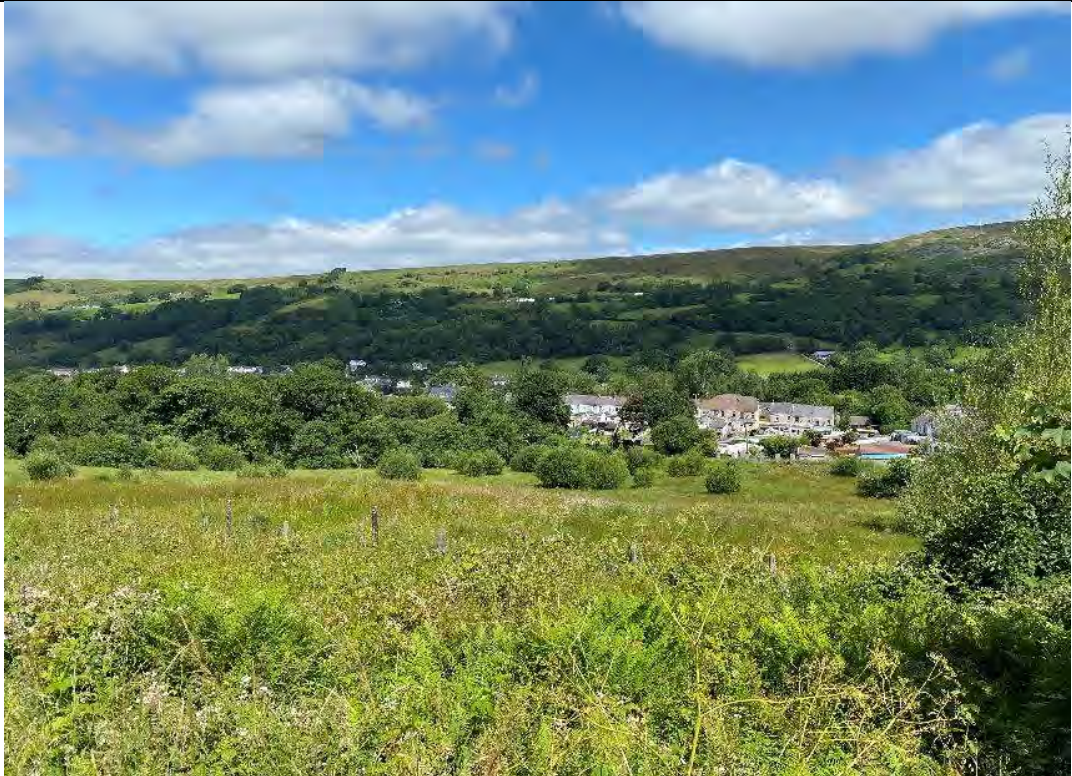
| Photo No. | Date: | |
|---|---|---|
| SW-01 CE | 12 July 2022 | |

| Photo No. | Date: | |
|---|---|---|
| <b>Lagoons (025)</b><br><br>View of residential land off-site to north.<br><br>The photograph aspect is north. | | |

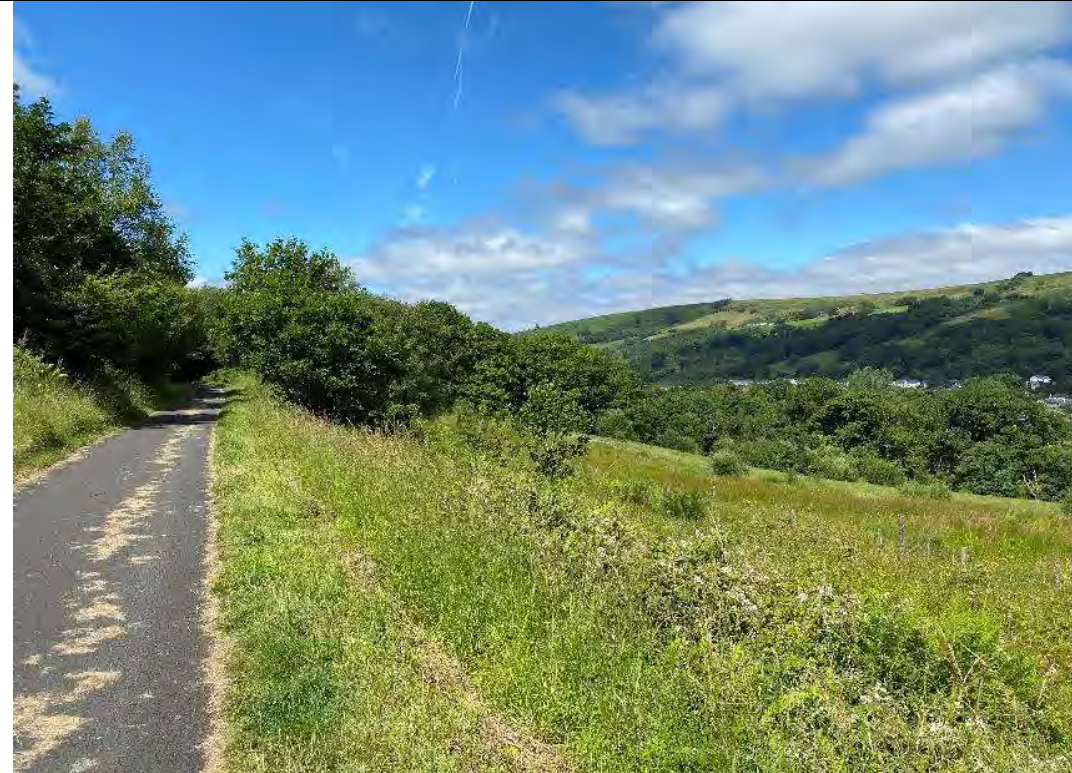
| Photo No. | Date: | |
|---|---|---|
| SW-01 CE | 12 July 2022 | |

| Photo No. | Date: | |
|---|---|---|
| <b>Railway Land (023)</b><br><br>View former railway embankment running along sites northern boundary.<br><br>The photograph aspect is west. | | |

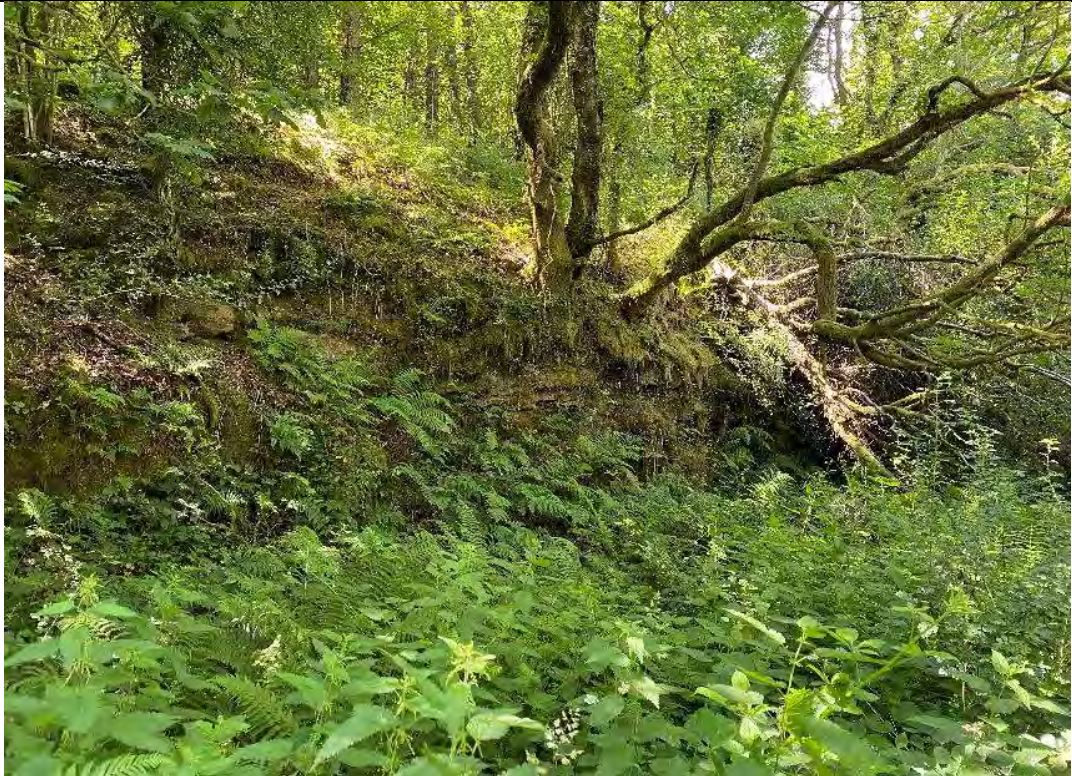
| Photo No.<br>SW-01 CE | Date:<br>12 July<br>2022 | |

| Photo No.<br>SW-01 CE | Date:<br>12 July<br>2022 | |
|---|---|---|
| <b>Plant Crossing</b><br><br>View excavation into bedrock on northern boundary of site.<br><br>The photograph aspect is south-west. | | |

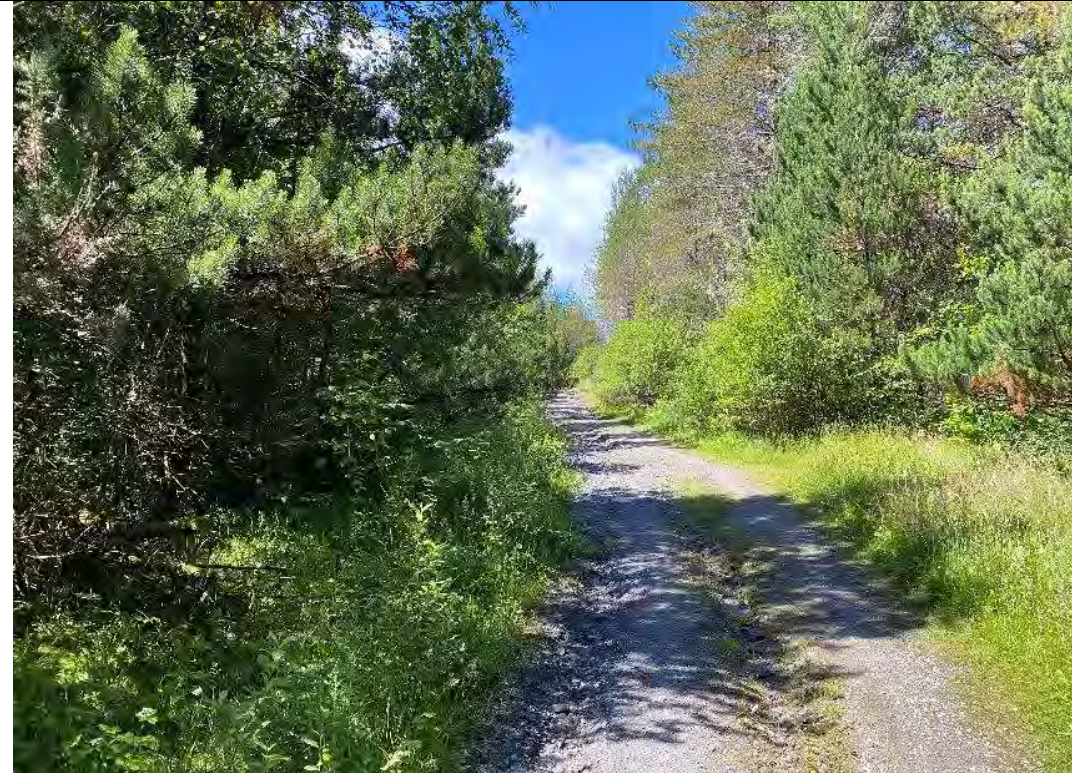
| Photo No.<br>SW-01 CE | Date:<br>12 July<br>2022 | |
|---|---|---|
| <b>Loading bays (026)</b><br><br>View of access track through wood land in north of site. Woods to left and right thick and difficult to navigate in.<br><br>The photograph aspect is south-west. | | |

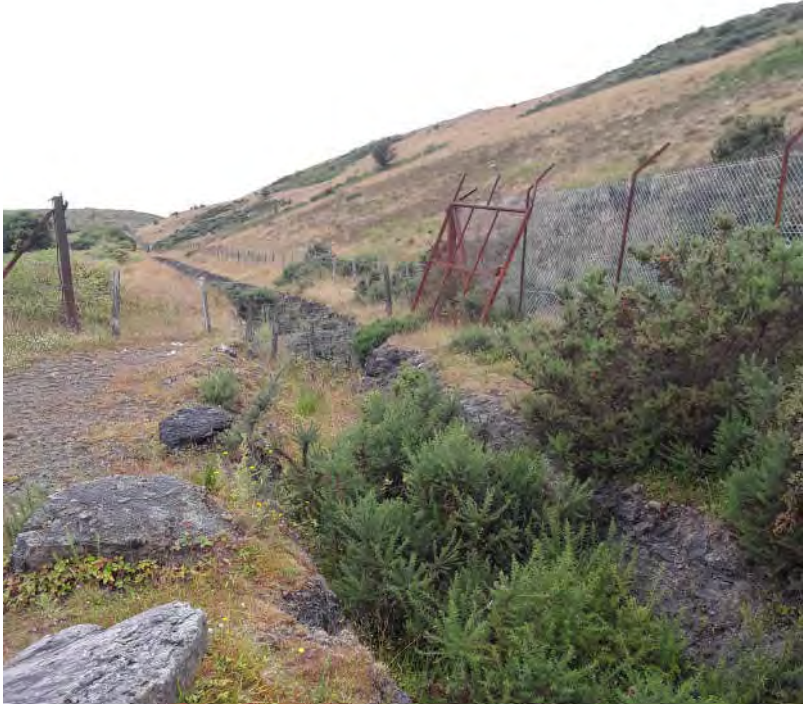
| <b>Surface Water Feature SW-13 DP:</b><br>Continuation of SW03 ditch.<br>Photo aspect is west. | | |

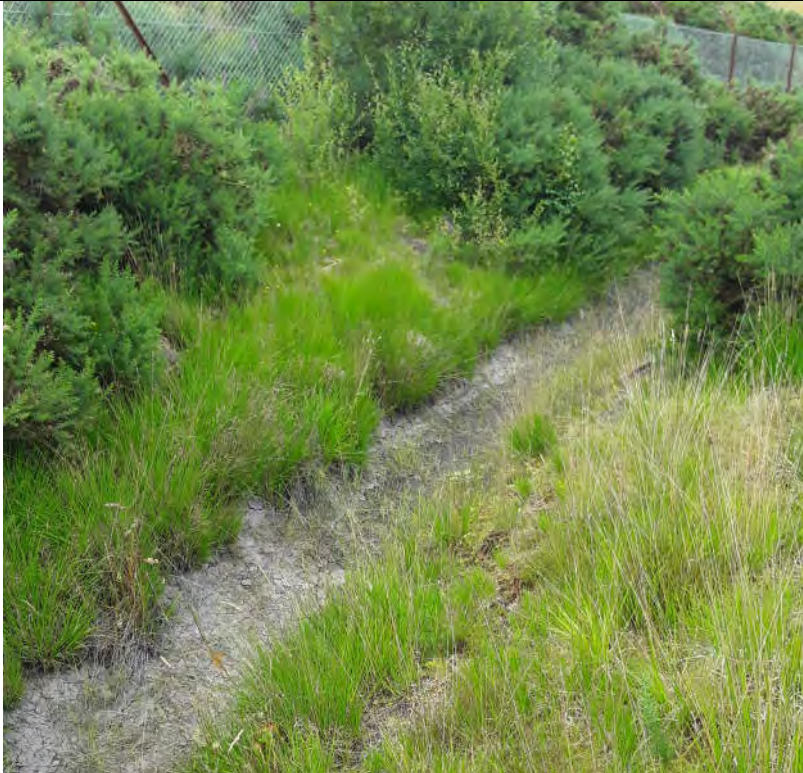
| <b>Surface Water Feature SW-14 DP:</b><br>Continuation of SW14 ditch.<br>Photo aspect is east. | | |

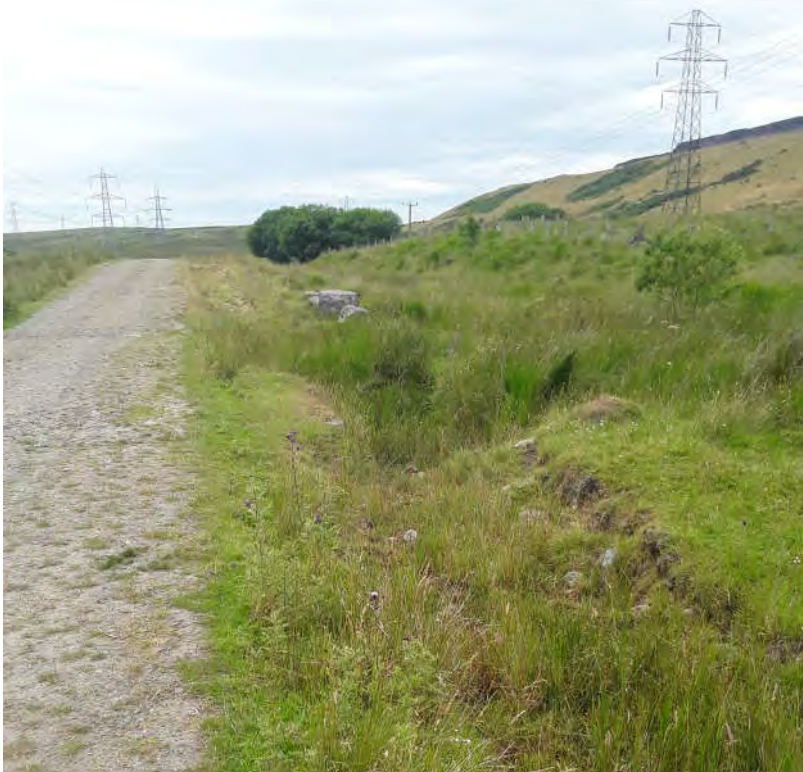
| Photo No.<br>SW-25 DP | Date:<br>12 July<br>2022 | |

| Photo No.<br>SW-25 DP | Date:<br>12 July<br>2022 | |
|---|---|---|
| <b>Surface Water Feature SW-25 DP:</b><br>Continuation of the east to west ditch to the north of the access track in the south of the site.<br><br>The photo aspect is west. | | |

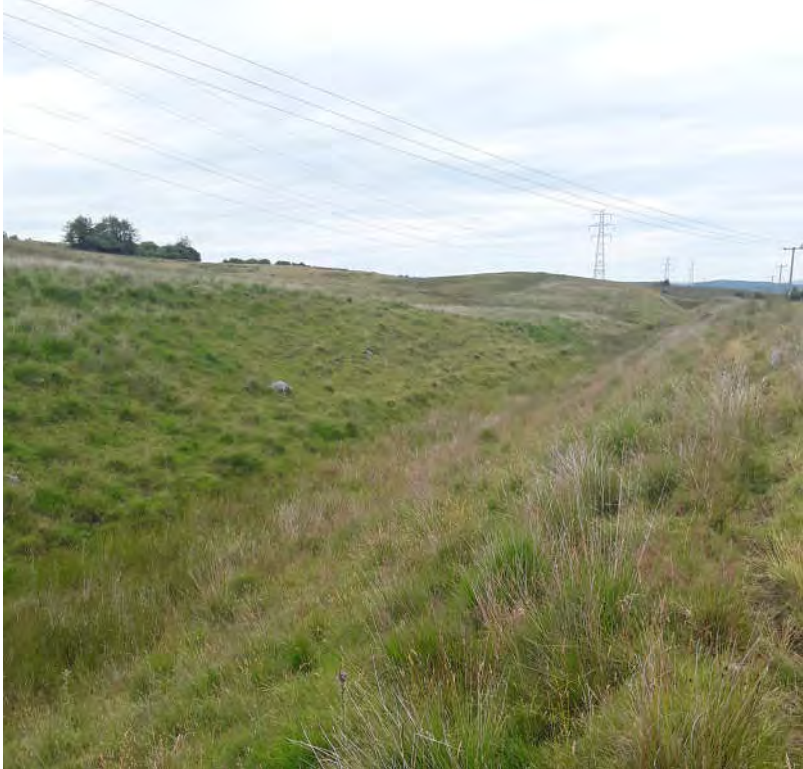
| Photo No.<br>SW-26 DP | Date:<br>12 July<br>2022 | |
|---|---|---|
| <b>Surface Water Feature SW-26 DP:</b><br>Continuation of the east to west ditch to the north of the access track in the south of the site. Drop in elevation from the road, damp at base.<br><br>The photo aspect is east. | | |

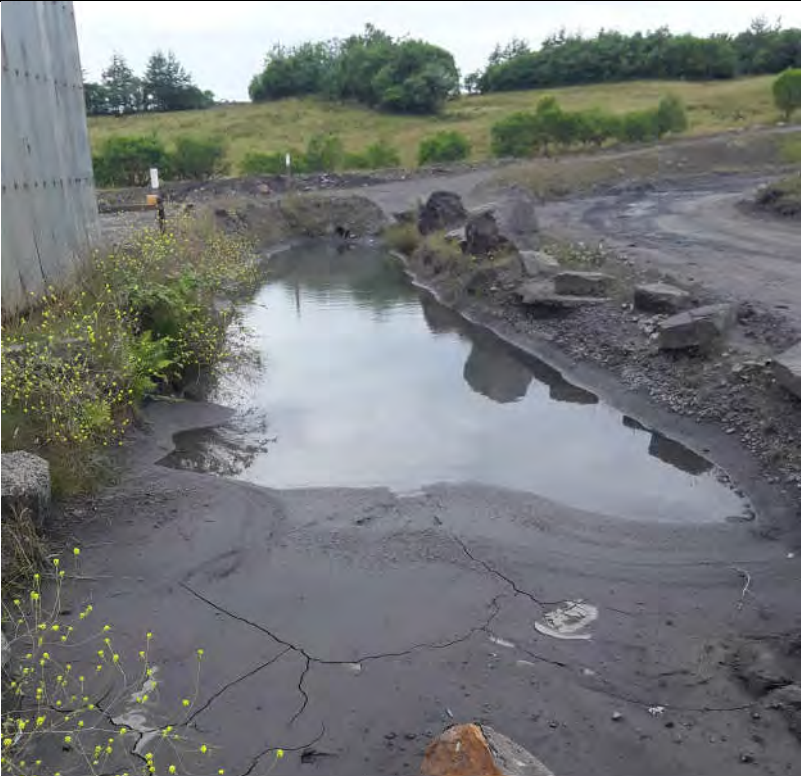
| <b>Surface Water Feature SW-33 DP:</b><br>Black silty pond.<br>Possible overspill from wheel wash area.<br>Approximate measurements 5m wide, 10m length<br>The photo aspect is west. | | |

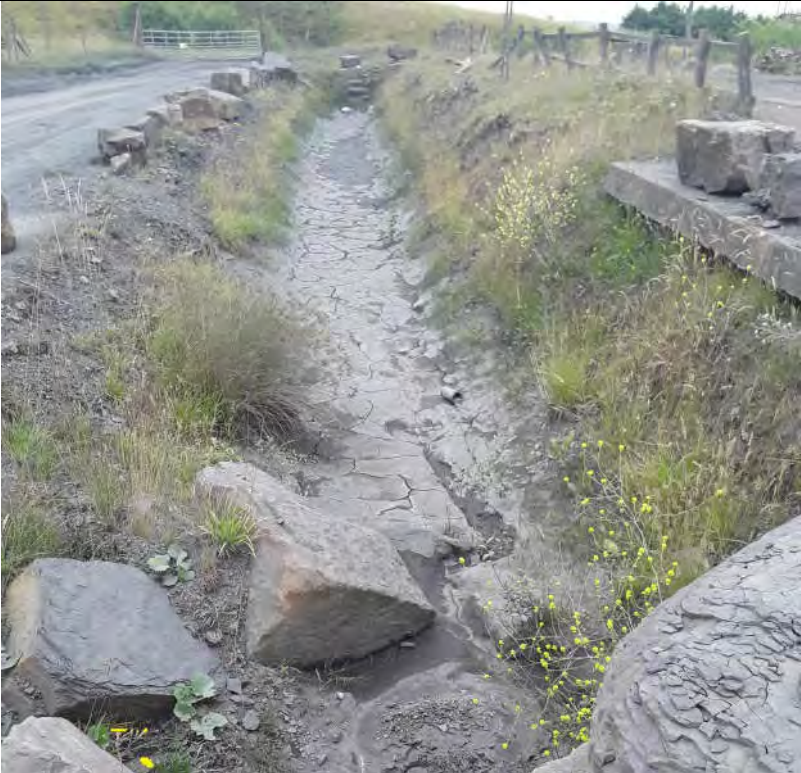
| <b>Photo No.</b><br>SW-34 DP | <b>Date:</b><br>12 July 2022 | |

| <b>Surface Water Feature SW-34 DP:</b><br>Overflow ditch, dry<br>Approximate measurements 5m wide, 30m length<br>The photo aspect is east. | | |

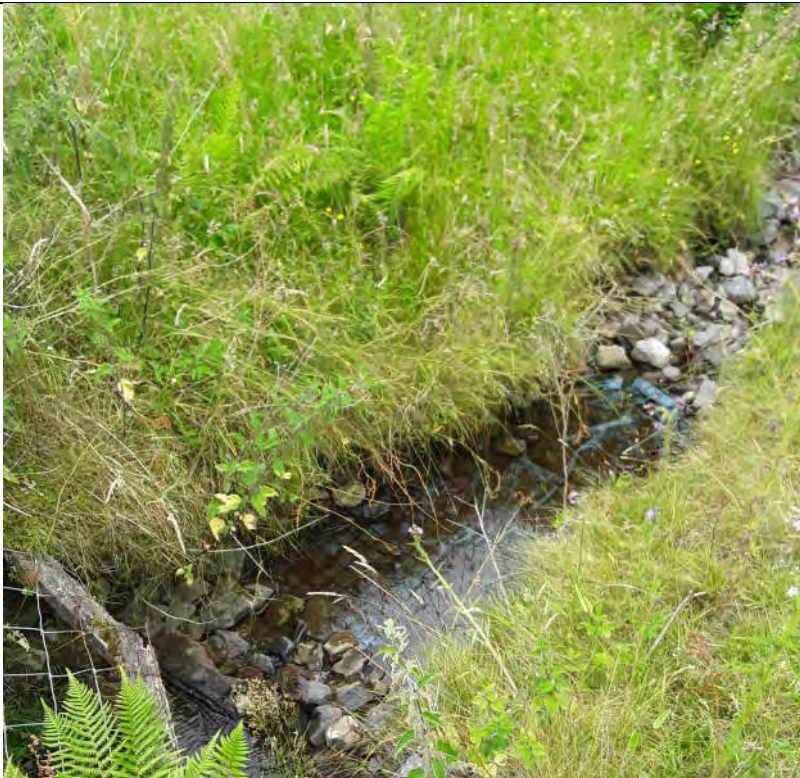
| <b>Surface Water Feature SW-37 DP:</b><br>Rocky ditch with standing water, orientated east to west under road adjacent to the west. Approximate measurements 1m wide, 145 m length 0.6m deep.<br><br>Measurements DO 96.25%, ORP 144.7 mV, Cond 344.20 ms/cm, pH 8.31, T16.5C<br><br>The photo aspect is north. | | |

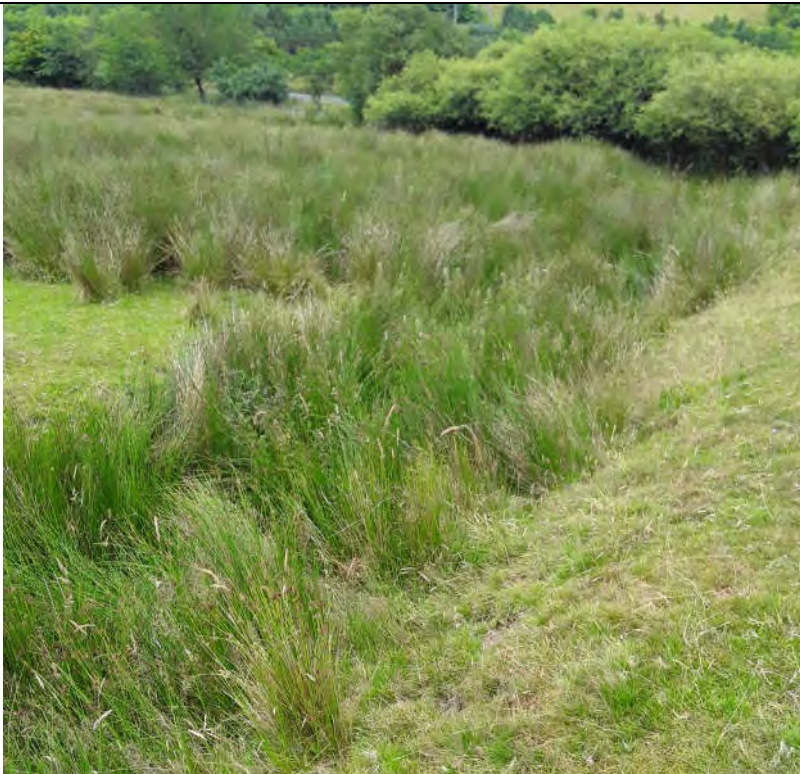
| <b>Photo No.</b><br>SW-38 DP | <b>Date:</b><br>12 July 2022 | |

| <b>Surface Water Feature SW-38 DP:</b><br>Possible dry grassed ditch orientated north to south towards access track.<br><br>The photo aspect is south. | | |

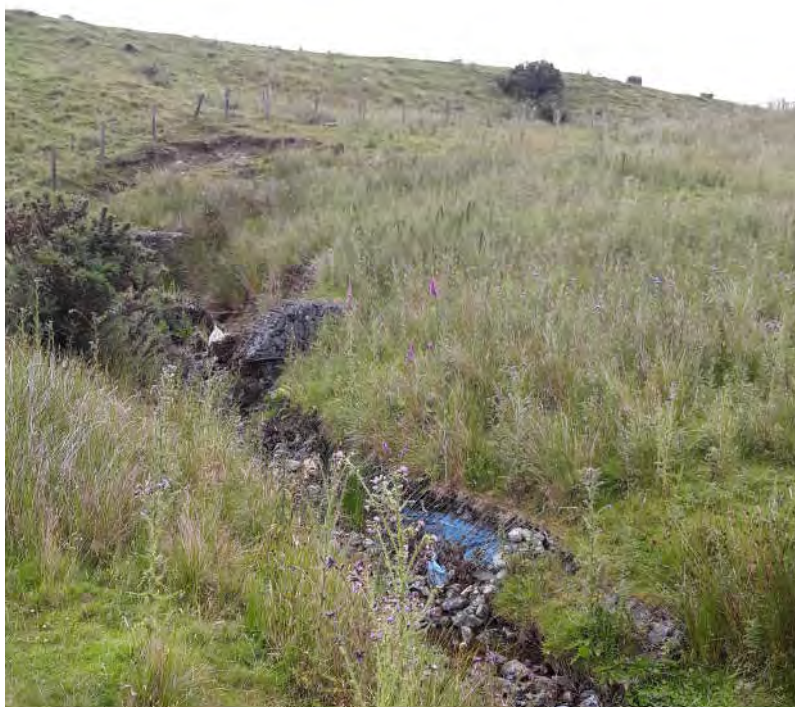
Steep rock gully, orientated north to south, dry with standing water in paces. Lows south towards River Dulais located 320 m south of photo location.

Measurements DO 95.5%, ORP 155.3 mV, Cond 412.5 ms/cm, pH 8.07, T15.4C  
The photo aspect is north

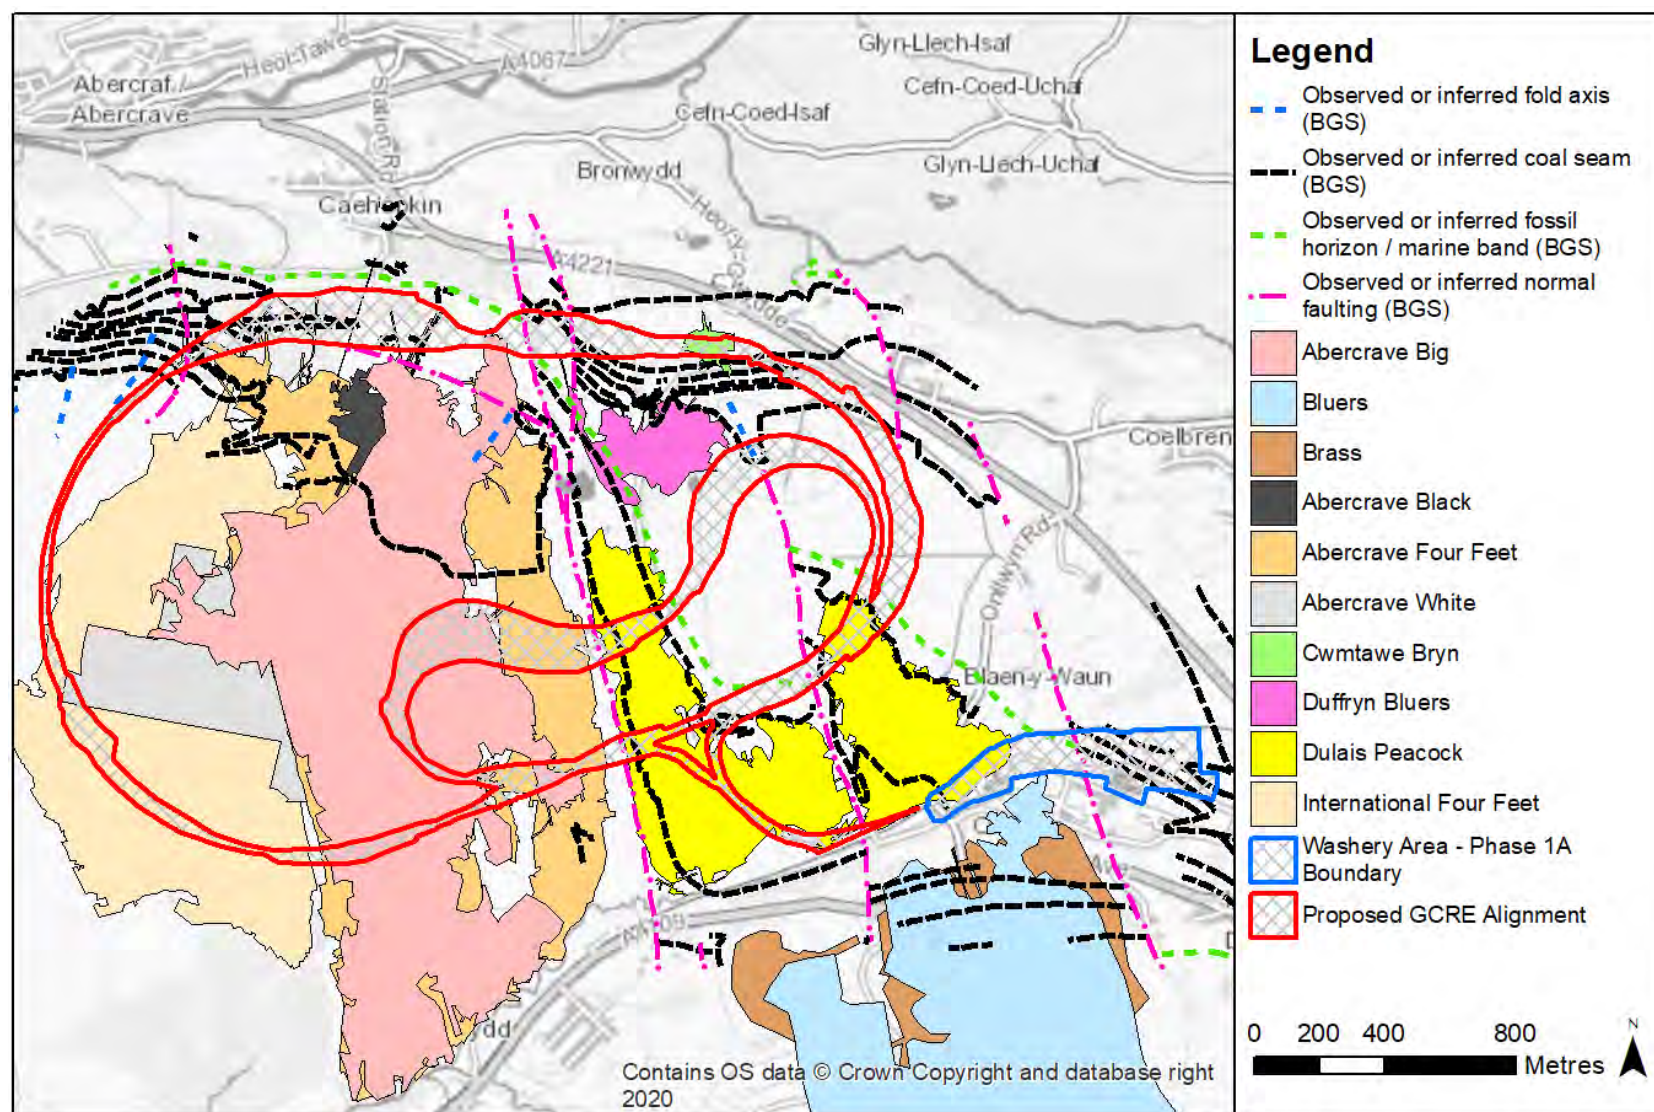
**Figure 3-5 – Locations of recorded mine workings based on mine abandonment plans provided by the Coal Authority; data derived by Arup and Atkins, map generated by Atkins [3]**

Underground workings in the Lower Coal Measures (Cwmtawe Bryn Colliery) occur in the northeast of the site and adjacent to the southern boundary of the site, encroaching into the Washery. Figure 3-5 illustrates the known mineworking's.

Underground workings present on site with less than 20 m of overlaying bedrock were deemed to pose a stability serious risk to the proposed scheme, 20m was used by Arup as the minimum bedrock requirement by Arup to prevent void migration following the '10t rule' after CIRIA C758D [17] and assuming a maximum extraction thickness of 2m.

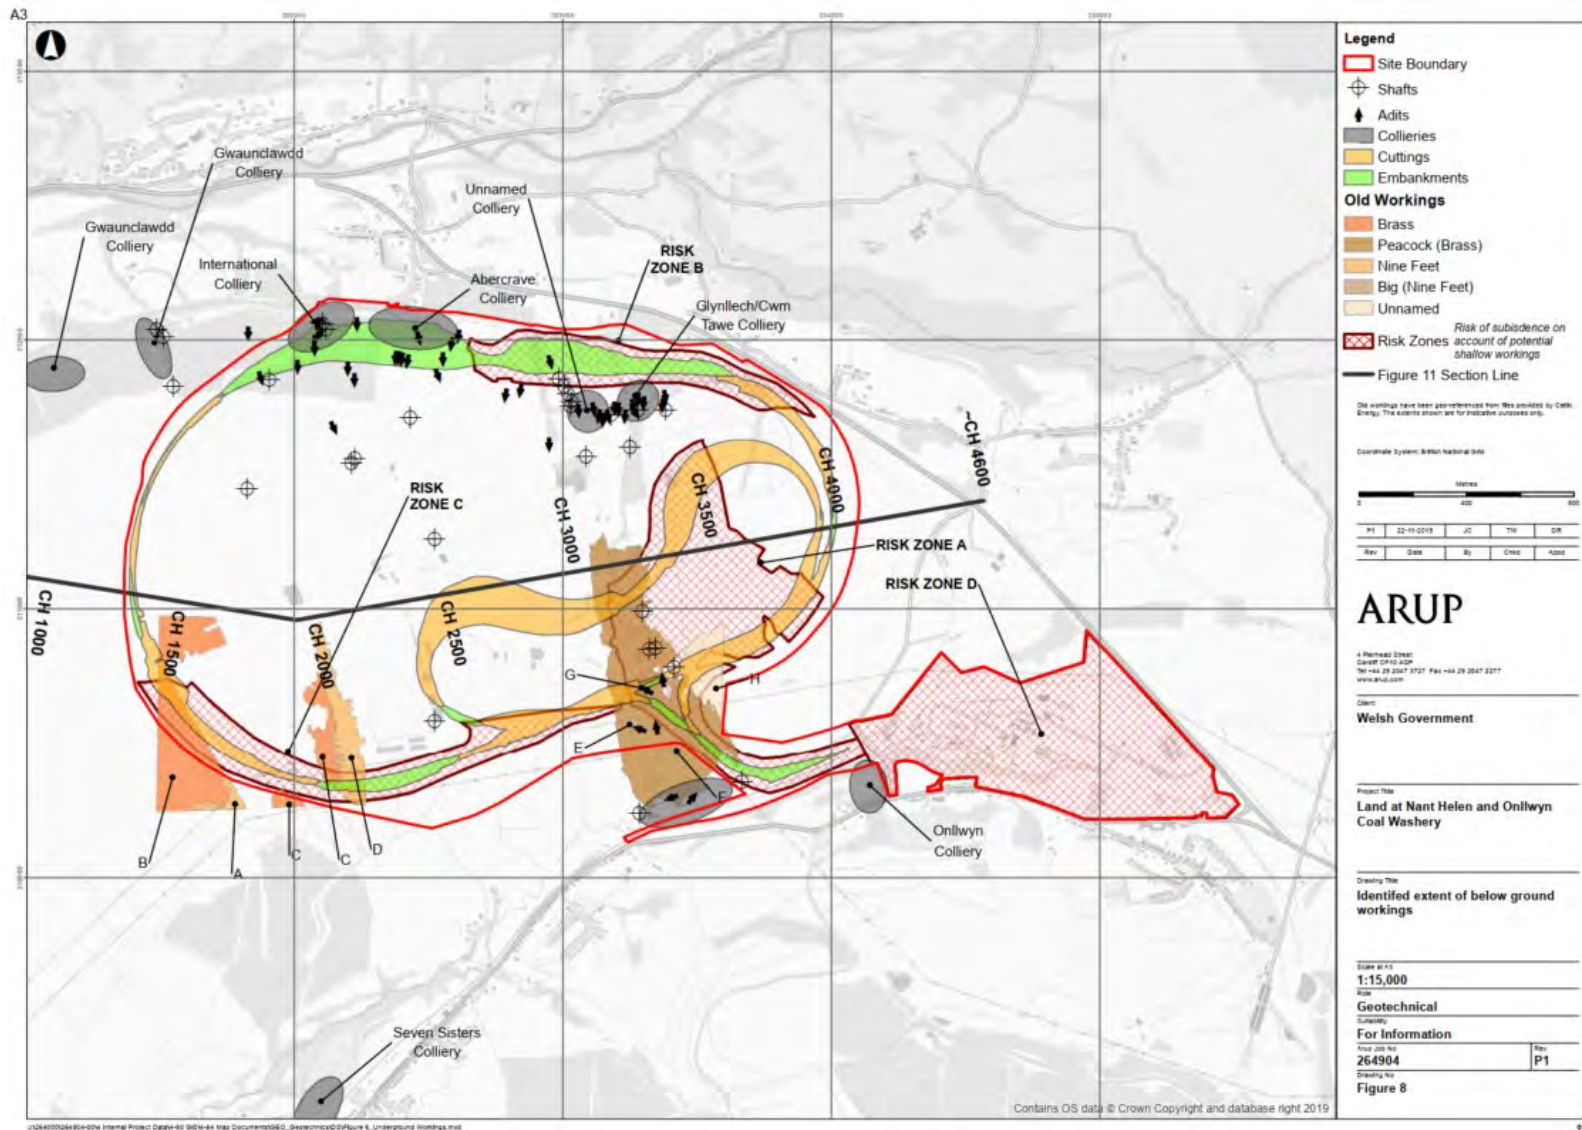
Figure 3-8 - Map of Arup risk zones from the Geotechnical and Geoenvironmental Desk Study by Arup [1].

Taking cognisance of all information, Arup identified four Risk Zones (A, B, C and D) defined by the presence of underground workings, as shown in Figure 3-8. Evidence of known workings beneath the proposed alignment was found within these zones, which therefore have a greater probability of being impacted by mining related instability.

The GI encountered voids in this area which are interpreted as unrecorded mine workings potentially related to working of the New/Lower and Grey/Middle seams. Arup's recommendation was to carry out further intrusive investigations in the area to confirm the extent of the interpreted workings.

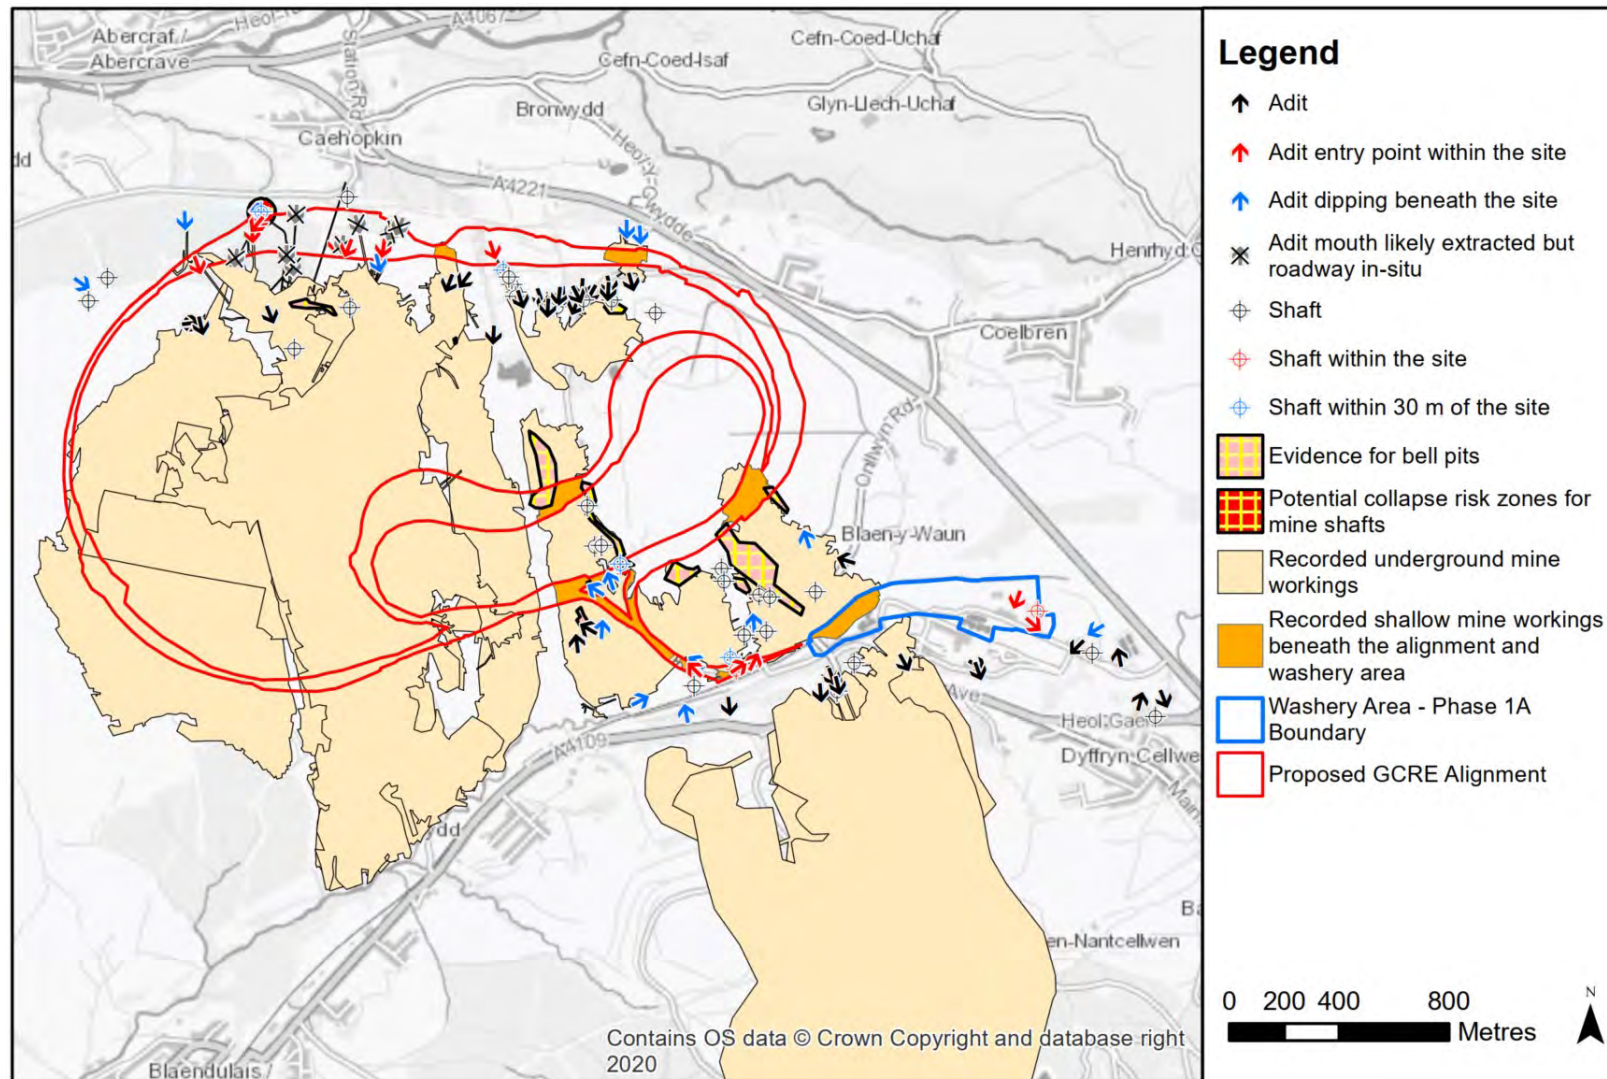
**Figure 4-1 - Simplified overview map of the key mining risks.**

This information is then utilised to update and refine the Risk Zones identified by Arup to provide Atkins' 'Mining Risk Zones' (MRZ), with nine MRZs identified across the alignment and a further MRZ covering the Washery.

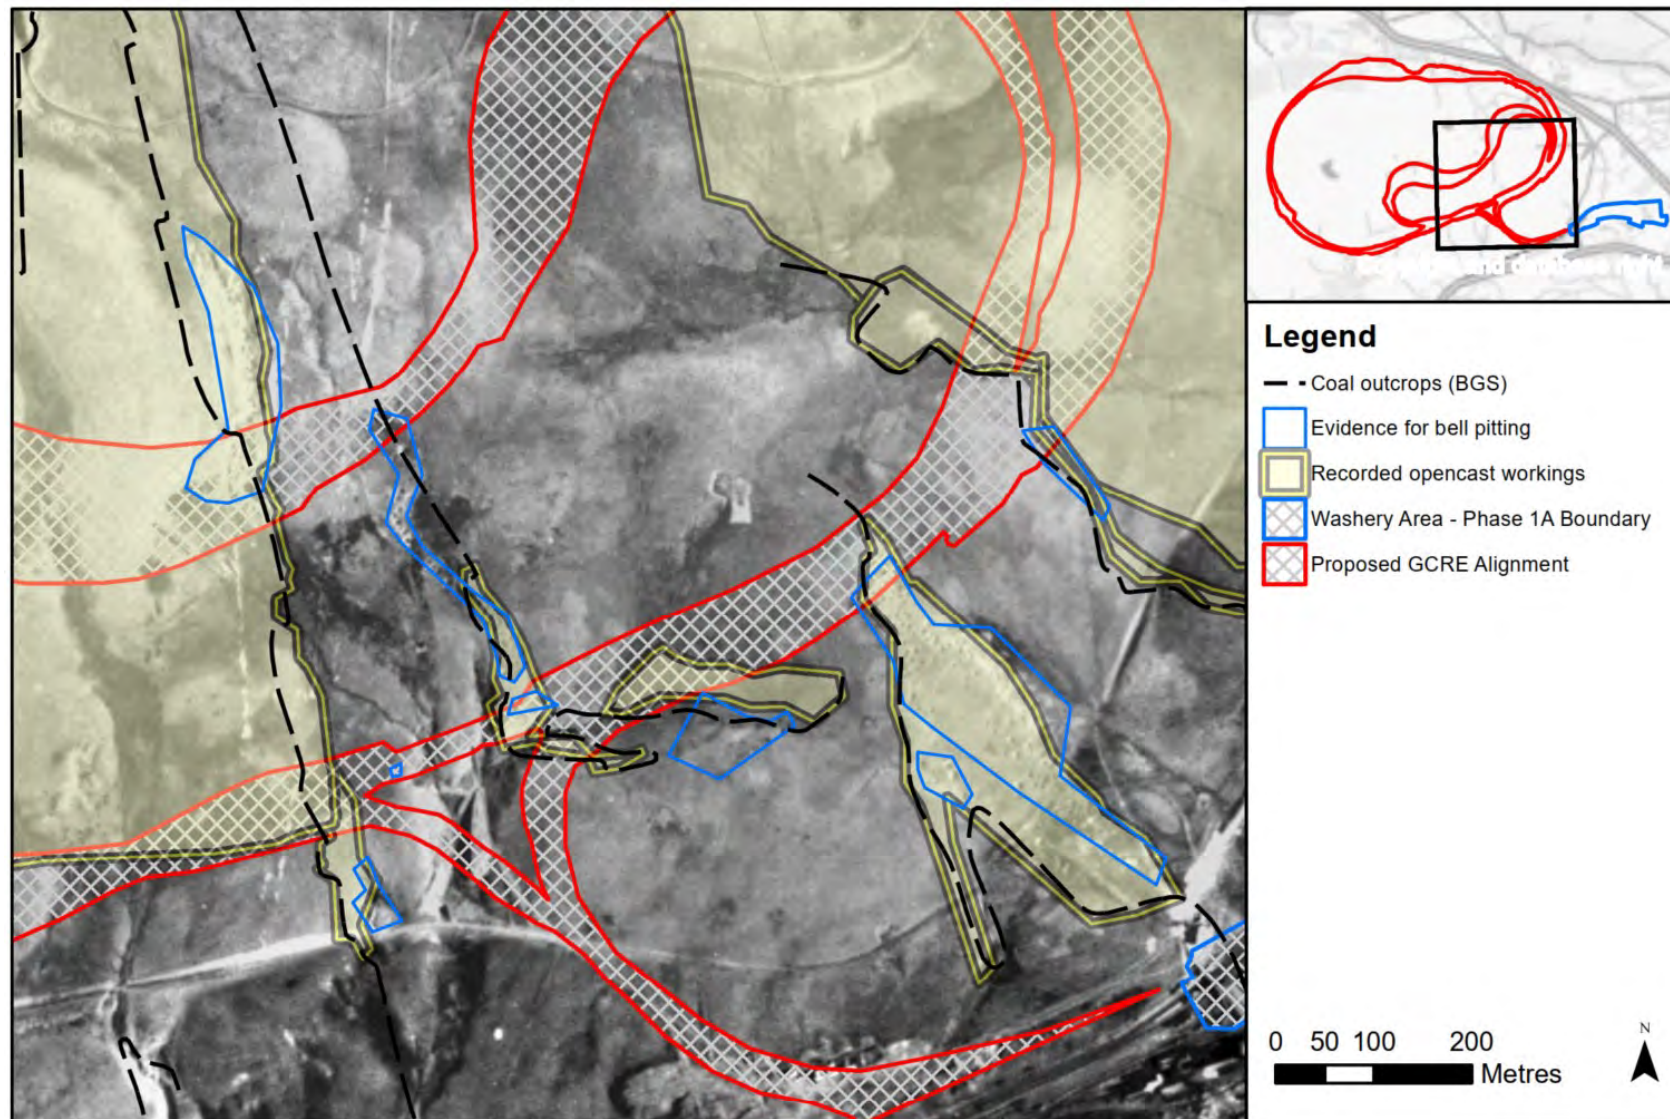
**Figure 4-3 – Areas of potential evidence for bell pits shown on the 1945 historical satellite imagery compared against BGS coal outcrops and areas of recorded opencast workings.**

As shown in Figure 4-3, many of the bell pits overlap with the areas of opencast workings and expected to have been removed, however, some bell pits likely remain in situ, particularly in the northern part of the inner loop.

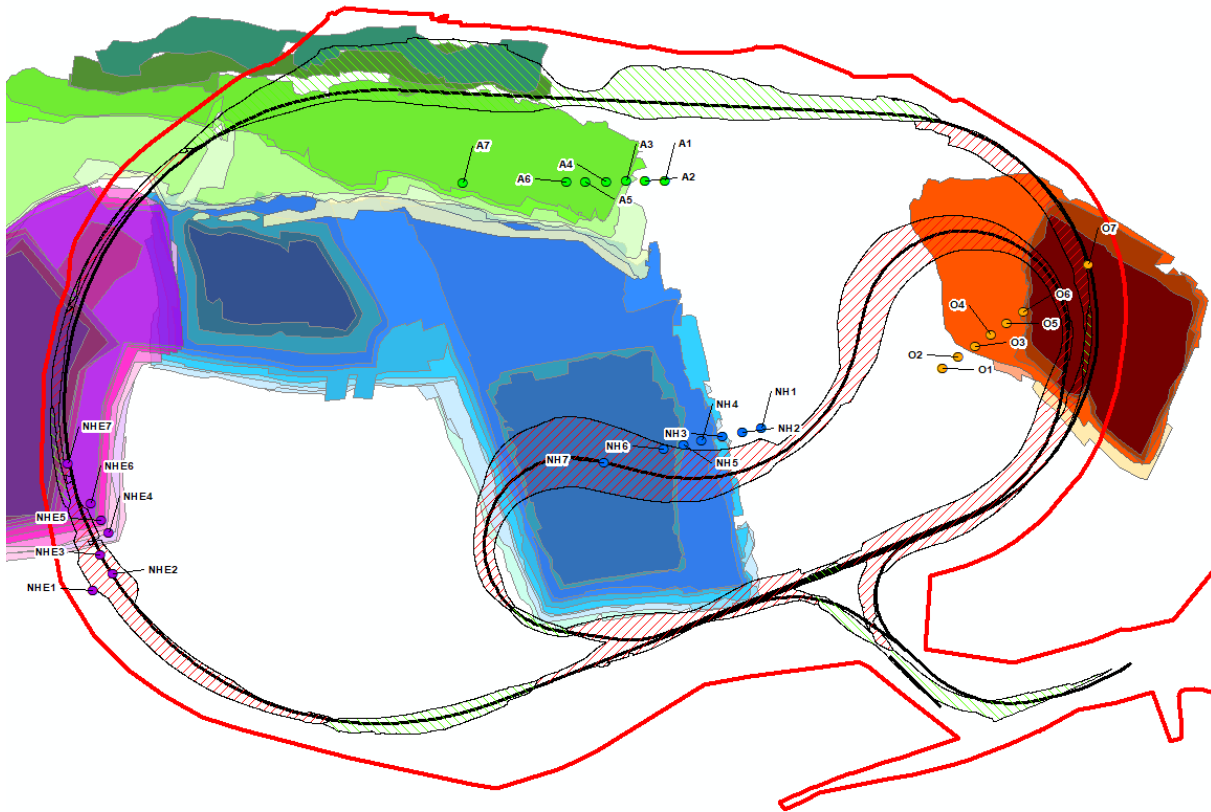
**Figure 7 Settlement monitoring points ("as-built")**

The next five settlement points of each array were then installed at approximately 50m intervals following the alignment of the proposed track route into the areas of opencast backfill. The last point in each array was constructed at a larger spacing to target the locations of anticipated greatest thickness of backfill (based on the opencast completion plans) on the proposed track route, refer to Figure 7 below.

With regards to the Nant Helen Extension monitoring points, it should be noted that the settlement monitoring points differed significantly from those specified. This was primarily due to obstructions (i.e., large ponds and overly sloped ground) encountered during the installation of the monitoring points. Another point of note is that the monitoring points do not necessarily reflect the deepest portion of fill in each opencast site.
