**Client Name: Global Centre of  
Rail Excellence**
**Site: GCRE (Onllywyn Washery)**
**Project No.  
5209796**

Client Name: Global Centre of Rail Excellence

Site: GCRE (Main Site)

Project No. 5209796

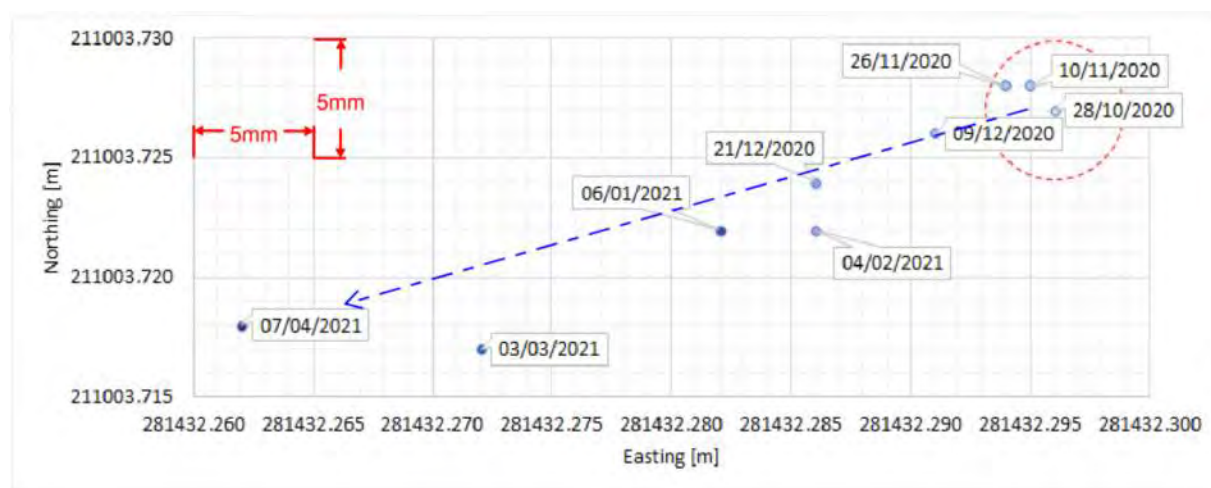
**Figure 8 Surveyed location of NHE7 over the duration of the monitoring period**

At NHE6 and NHE7, where the largest vertical movements were experienced, a noticeable trend in the lateral movement was also identified, see Figure 8 and Figure 9 overleaf.

As presented in Figure 8 above, there is a clear trend (indicated by the blue dashed line) in the change of position for the survey point at NHE7 over time. The survey point appears to be moving in an WSW direction with the exception of a few monitoring dates. For example, between 06/01/2021 and 04/02/2021 where the survey point appears to move easterly; however, it should be noted that this particular movement is only 4mm in magnitude which is close to the error margin of all measurements taken (both position and level,  $\pm 3\text{mm}$ ).

As depicted above, NHE7 is located at the toe of a slope which also falls to in a WSW direction (the fall has been confirmed through review of topographical data). This slope appears to be artificial and is believed to be part of the gradual program of restoration of the Nant Helen Extension void.

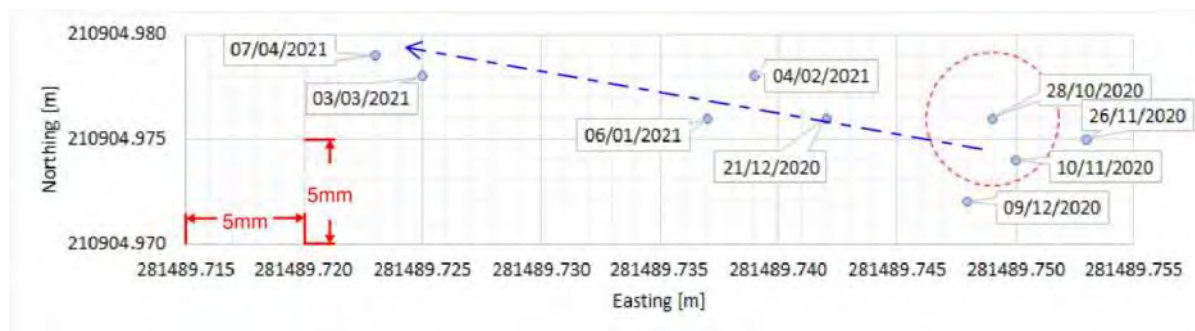
**Figure 9 Surveyed location of NHE6 over the duration of the monitoring period**

A similar trend occurs at NHE6, see Figure 9 below.

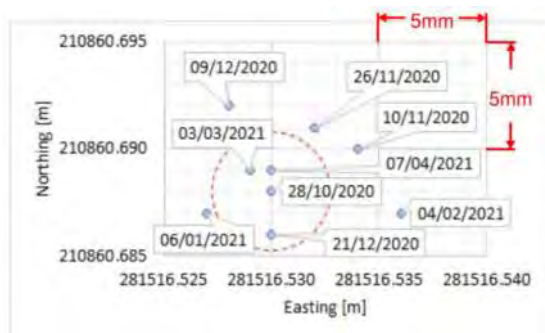
**Figure 10 Surveyed location of NHE5 over the duration of the monitoring period**

When we look at NHE5, where the vertical movements were found to be considerably less (6mm), we can see that there is a much greater consistency in lateral position of the monitoring point, see Figure 10 below. Many sit within, or just outside of the  $\pm 3\text{mm}$  boundary of the originally taken point (see red dashed line).

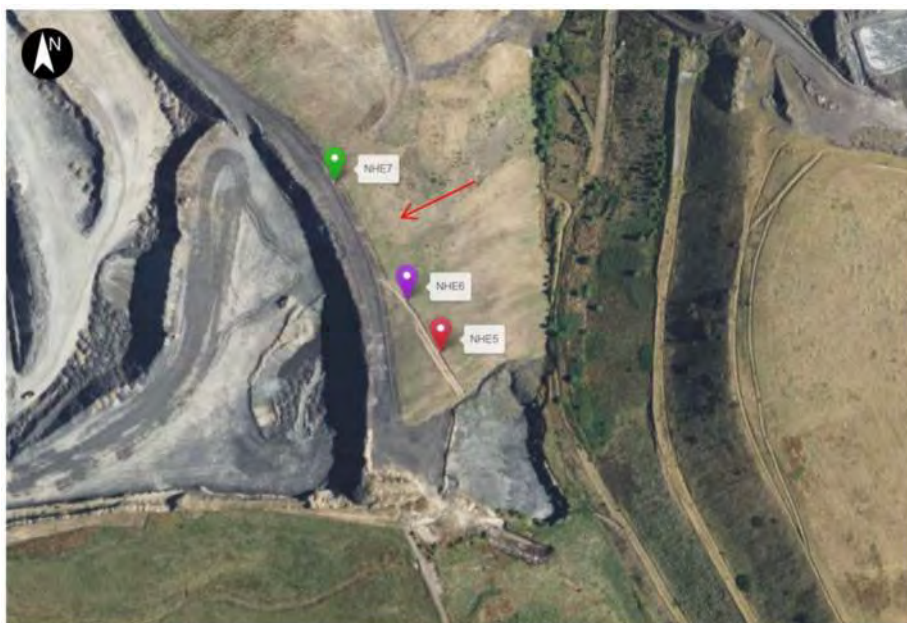
**Figure 11 Initial positions of NHE5-NHE7 plotted against aerial imagery**

When reviewing these movements against the context of the monitoring point locations, it becomes apparent that whilst the magnitude of apparent lateral movement is very small, the lateral movements may be influenced by the presence of excavations and sloping ground adjacent to the monitoring locations, see Figure 11.
