# The former St. Catherines Church and Hall, Neath.

North and West elevations.

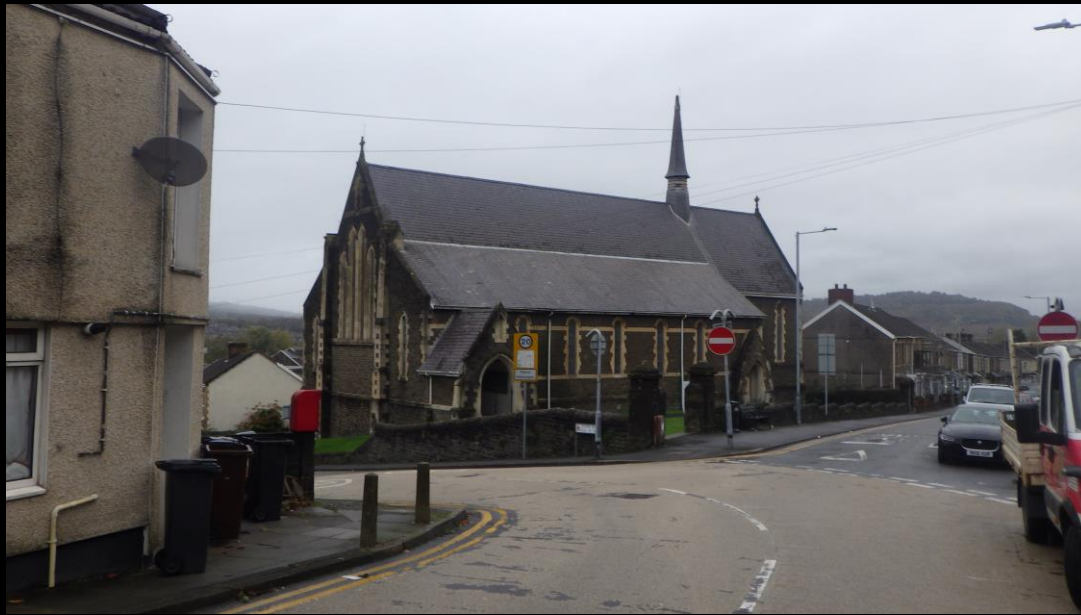
**The view from further up Old Road looking towards the church main entrance and the one-way traffic system.**

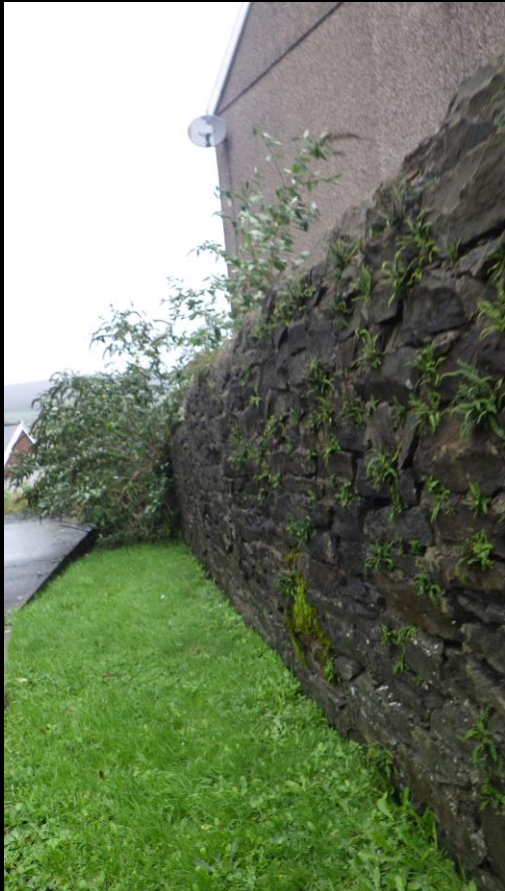
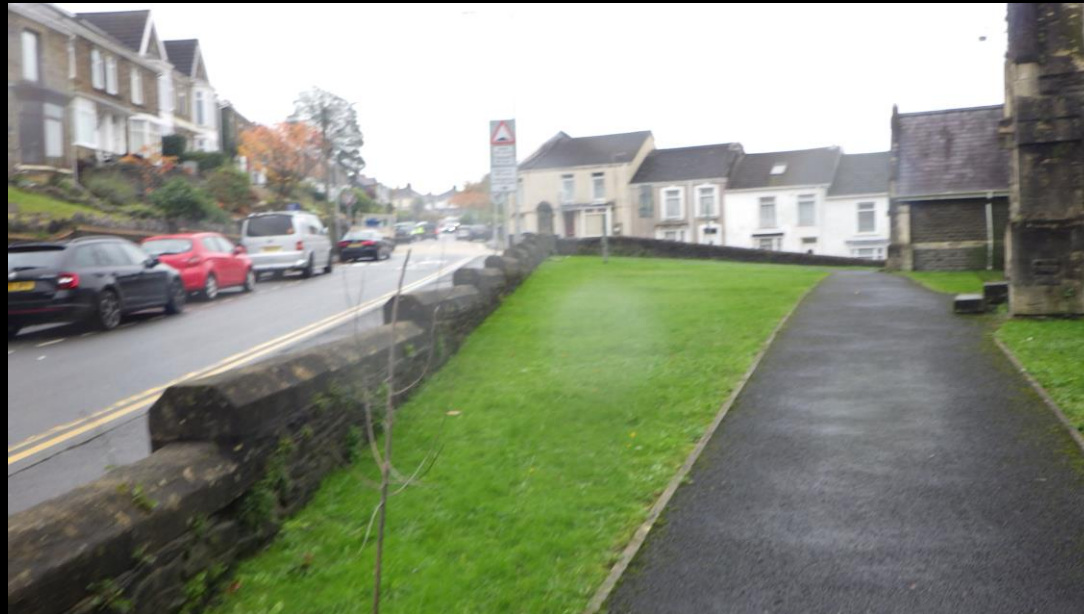
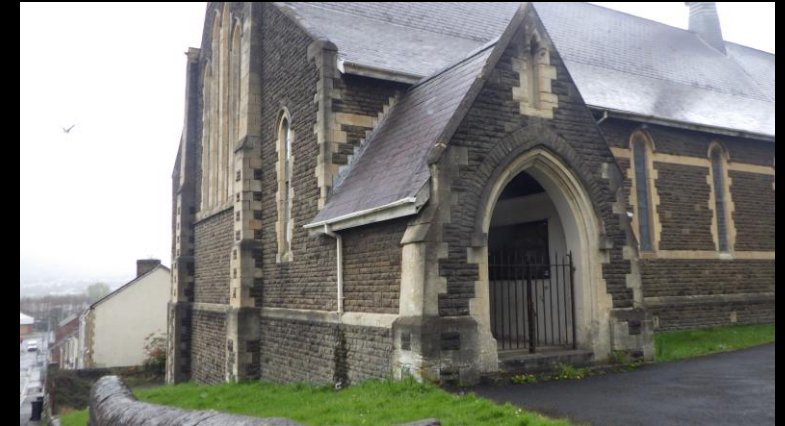
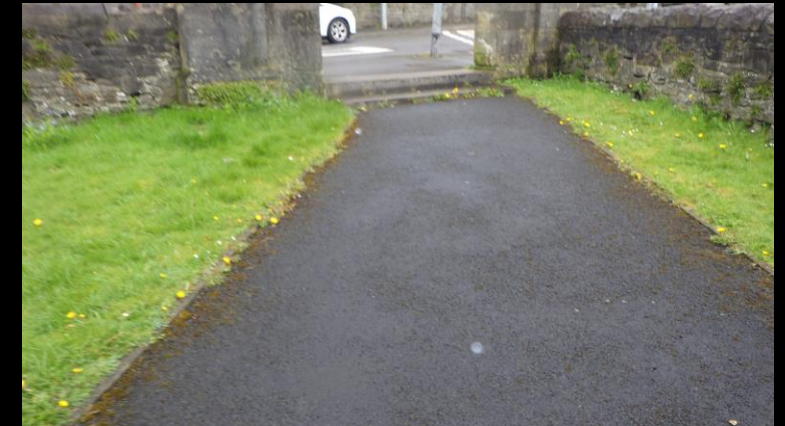
The ground surrounding the church is generally well maintained however there is some wild seeding of vegetation particularly close to the church hall. Repointing of the church boundary walls is something that will increasingly become necessary.

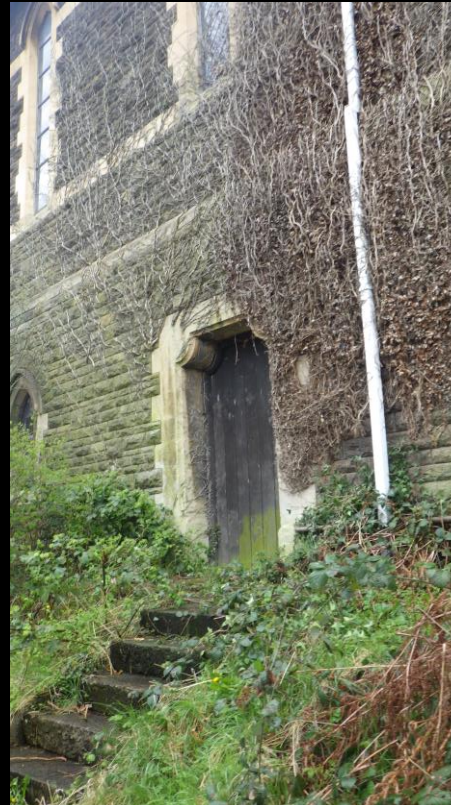
Close to the abutment with the Hall, vegetation has grown wild on the adjacent banking and needs cutting back. The ivy should be removed in accordance with SPAB guidelines.

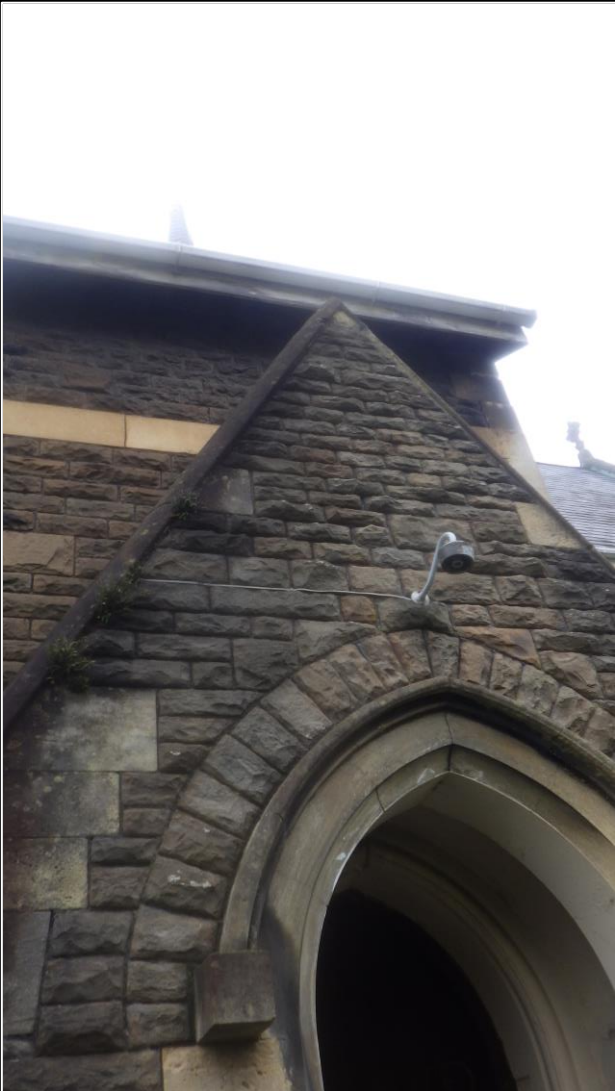
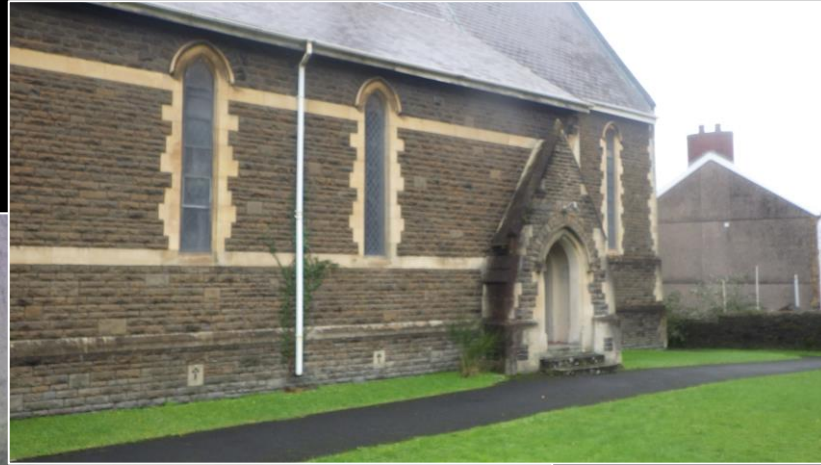
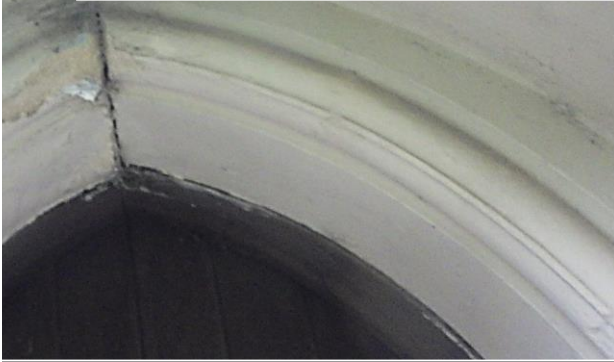
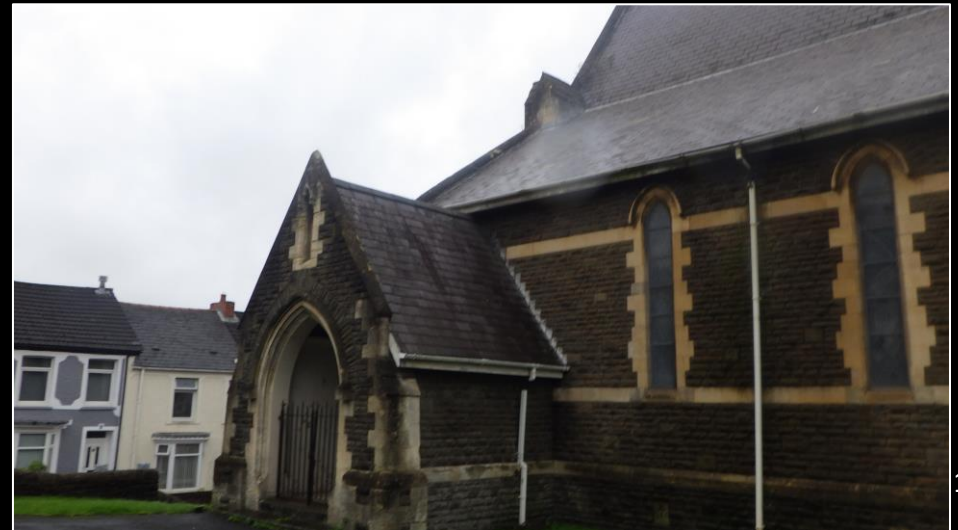
Weathered stonework requires lime-mortar repointing in localised areas using the Ty Mawr Lime Companies Blaenavon dark mix or similar approved.

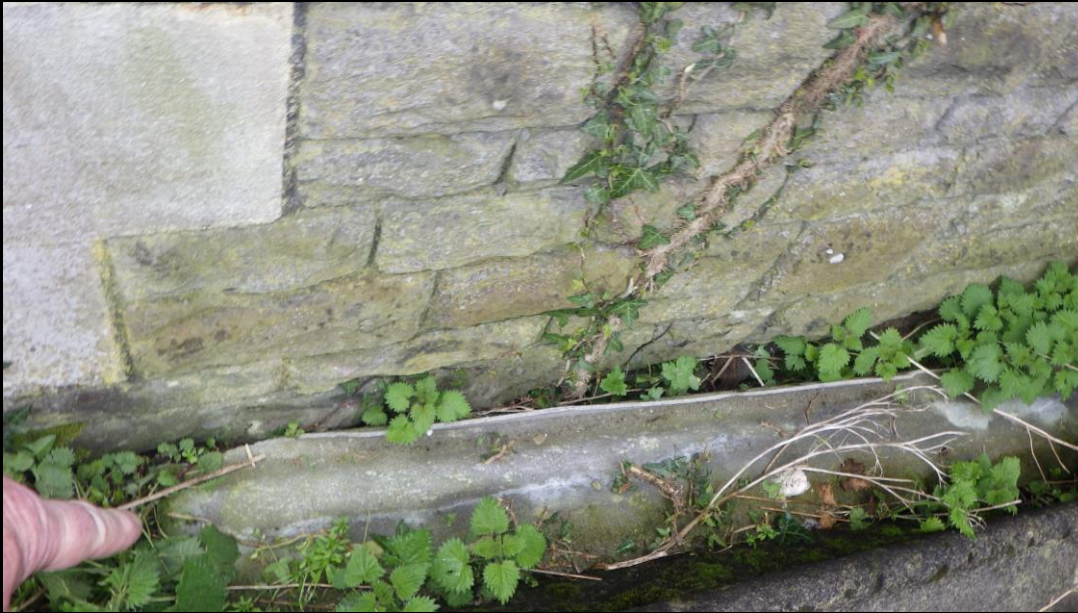
There appears to be a random piece of corrugated fibre cement (possibly asbestos containing) left within the church grounds. This should be double bagged and removed safely with specialist advice obtained.

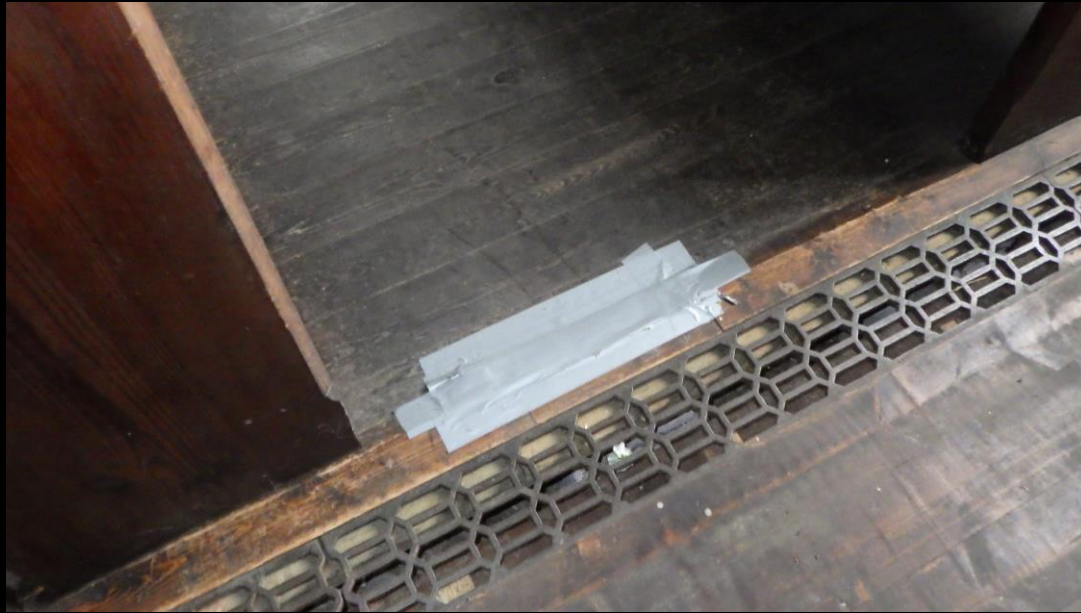
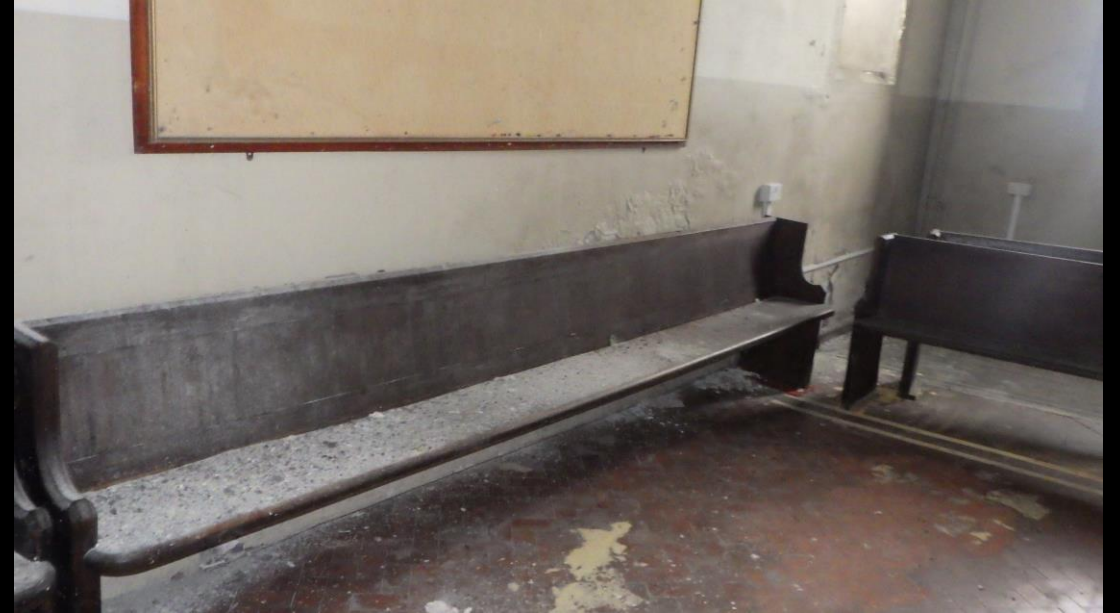
Some of the pews internally have been cut out to allow for modifications to the internal layout of the church. Whether a faculty consent was obtained for this is unclear. The pews are mortise and tenoned into the kerb trimmer that runs alongside the aisle floors. Your conversational reference previously to benches is not correct. The pews have been removed by the parish possibly without faculty consent and are now located towards the rear of the Nave and formed as a meeting space.

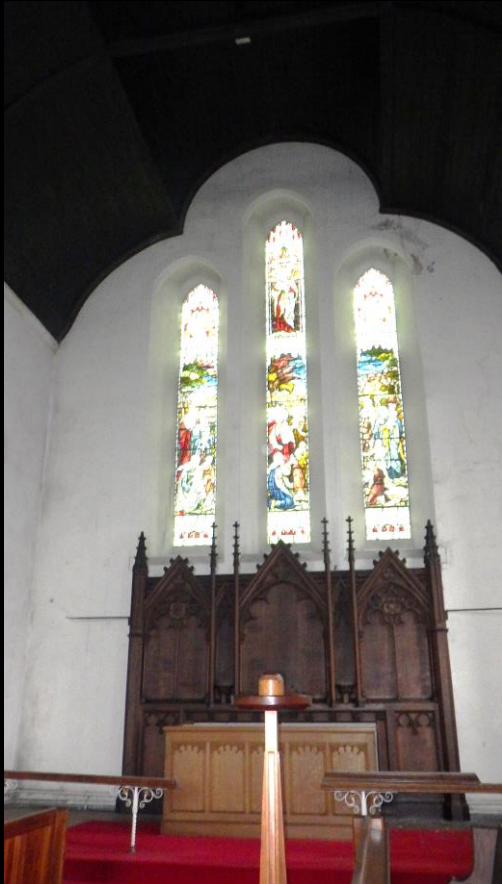
Rainwater has been penetrating at the intersection of the barrel vaulting of the Nave, South Aisle and chancel. High level access will be necessary to investigate. Some fungal decay is suspected and will need to be addressed urgently once scaffolding is available.

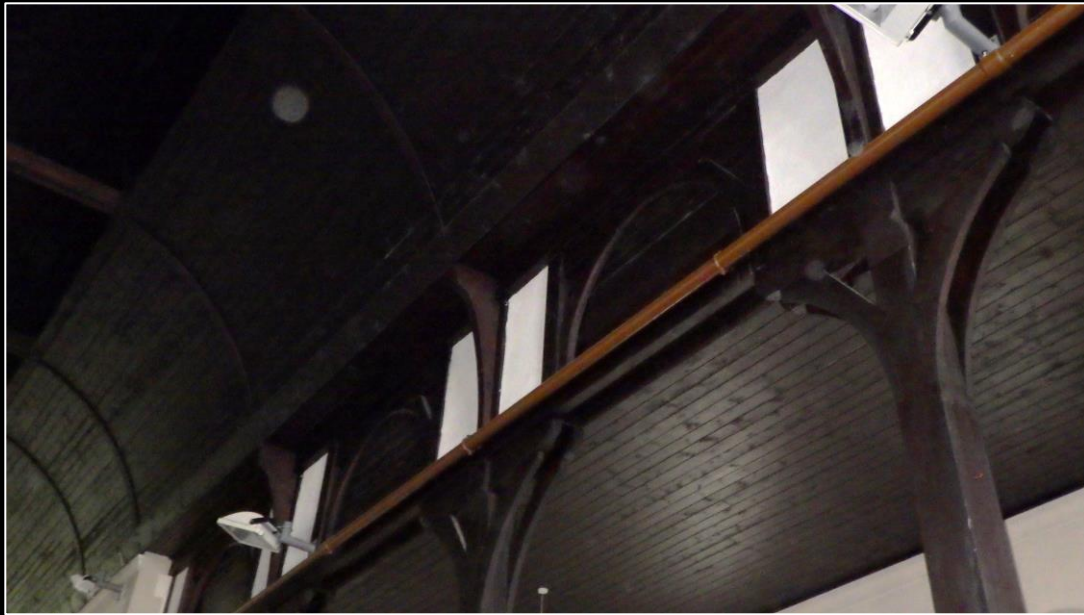
**Access to the high level clerestory and bell tower was not possible.**

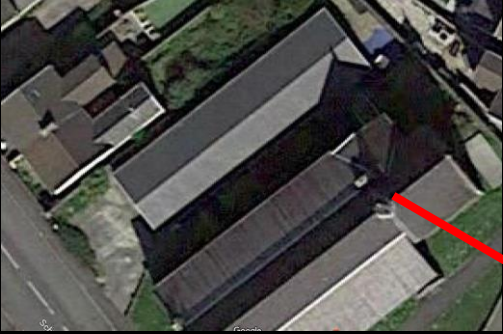
Repairs appear to have been made to the chimney and roof valley intersections. These can only be checked properly via scaffold or drones that are not readily suitable for use in the context of an urban location.

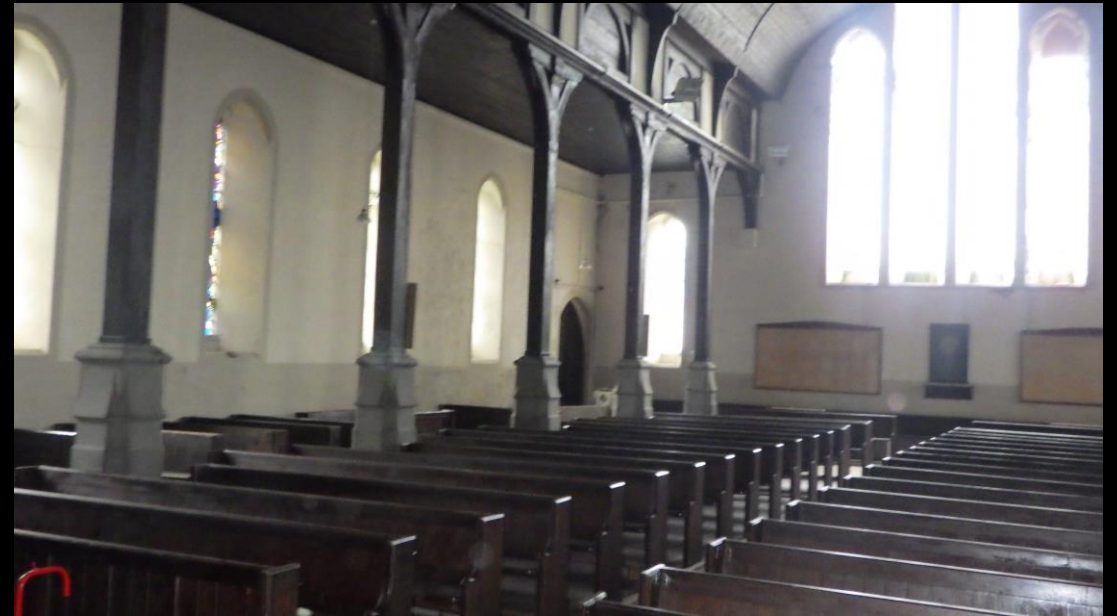
The central and North aisles of the church. The timber posts supporting the roof structure appeared quite basic above the stone base plinths, but are detailed in an early art deco influencing style. Although we suspect cost savings were occasioned when the structure was being built the claim is that it was the developing style of the architect who was prominent in ecclesiastical builds in South Wales.

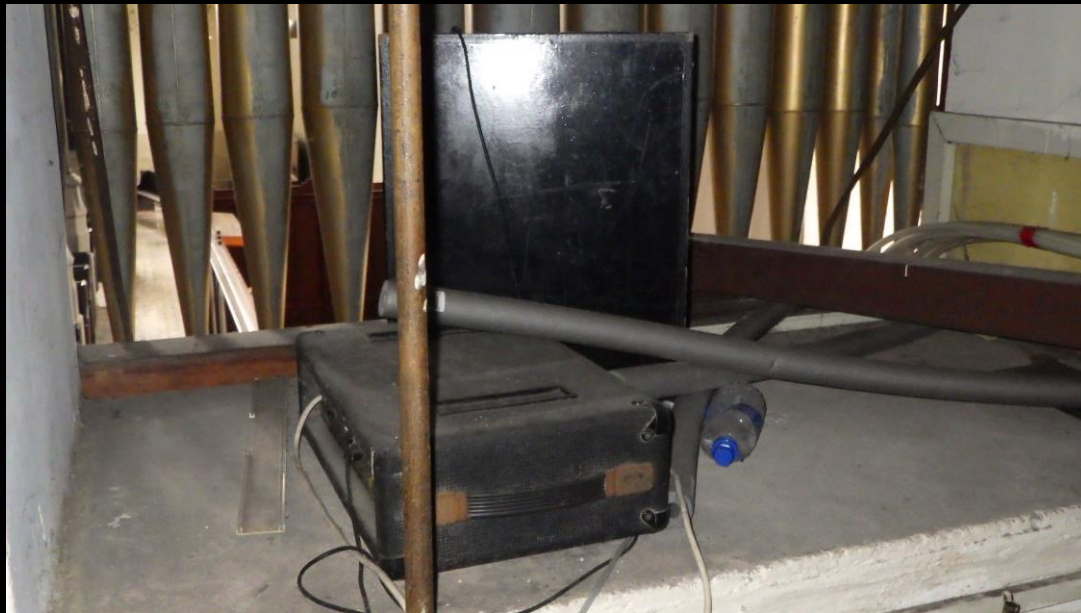
**Amplification systems were incorporated within the church. It is worth checking whether any of these are connected to a hearing aid loop.**

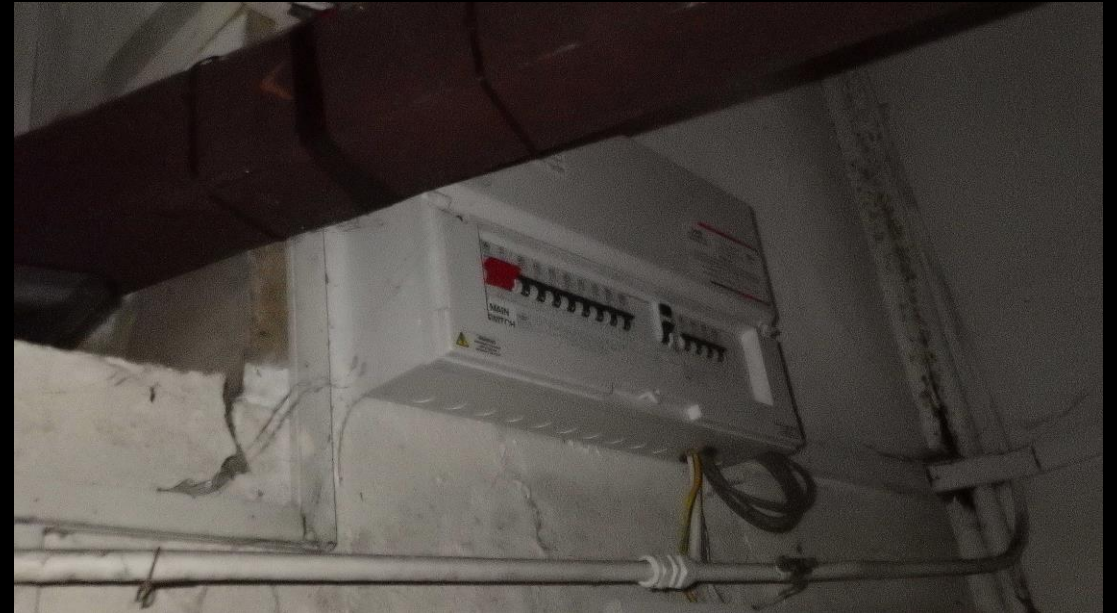
**There are various distribution boards set around the church including this one within the organ loft.**

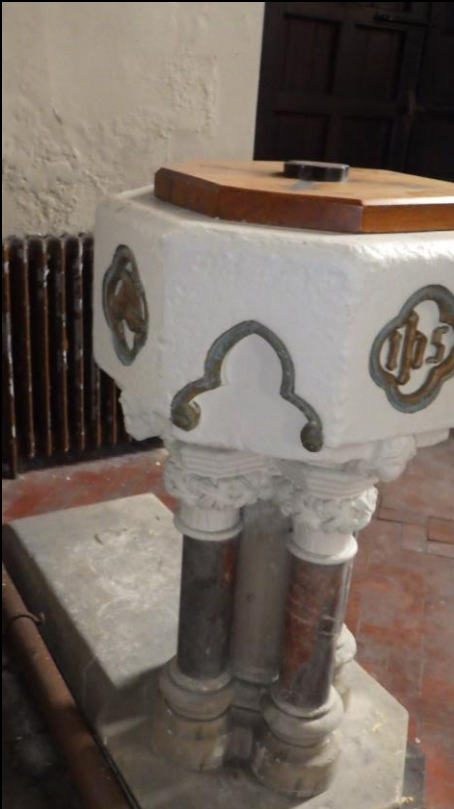
The Font has been crudely paint coated and we would recommend that this is removed using suitably benign paint strippers.

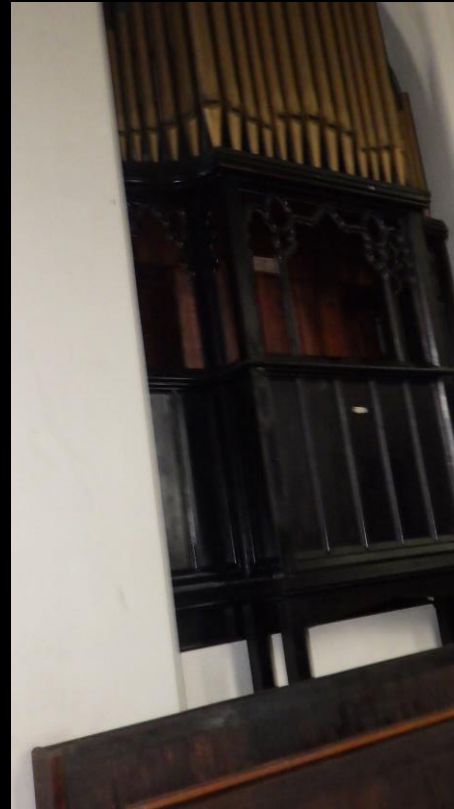
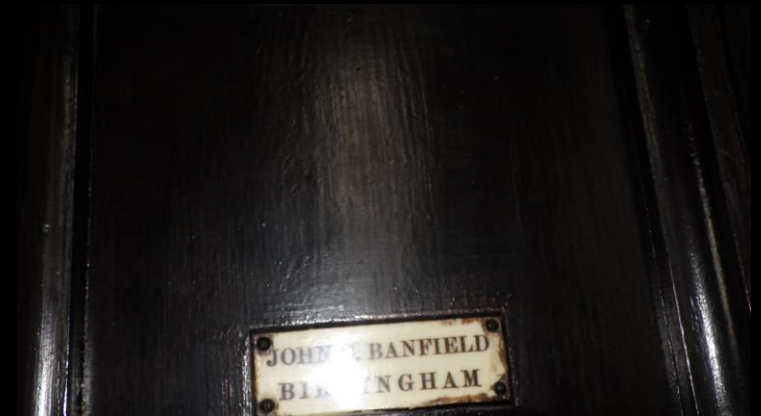
Below right: the organ and its maker's mark. It is highly likely that asbestos-based products will have been utilised within its blower box and possibly some of its piped and ducted mechanisms.

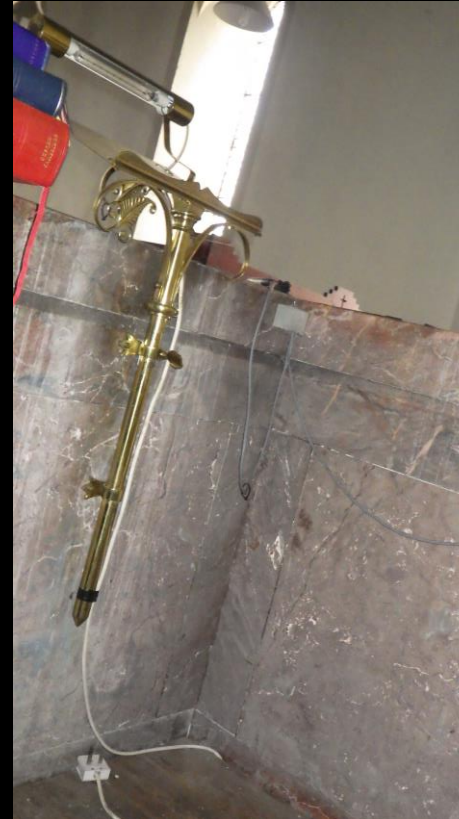
**Retained ecclesiastical finishes and fittings exist at present. You should check the inventory to establish whether, this is to be retained.**

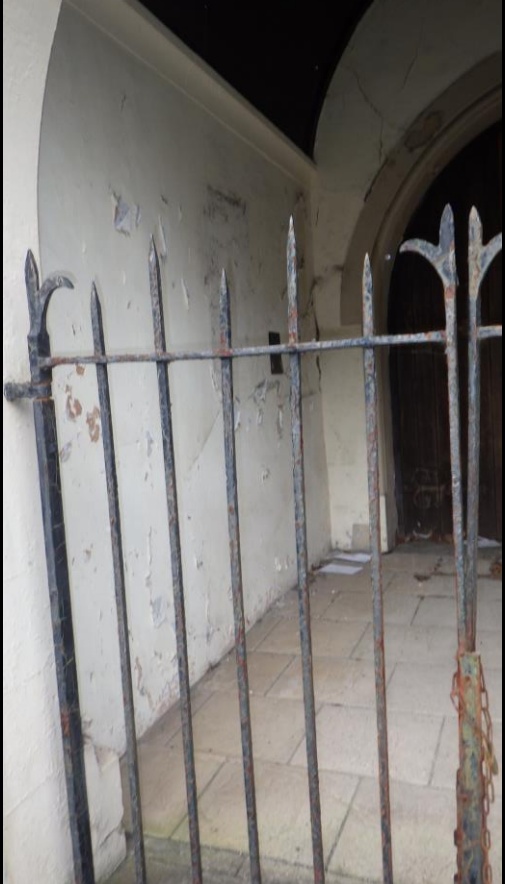
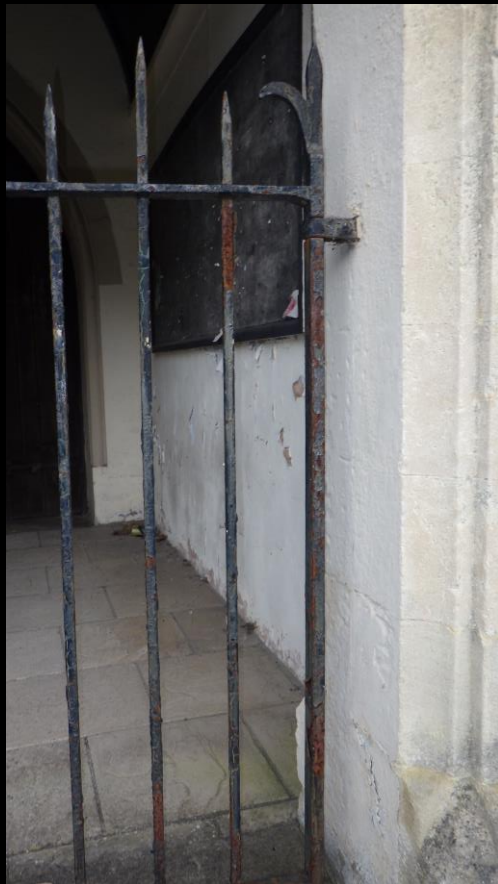
The gates to the South porch require a welder/blacksmith to adjust slightly in order to be able to close effectively. The floor of the South porch is inappropriately covered with riven faced concrete paving slabs.

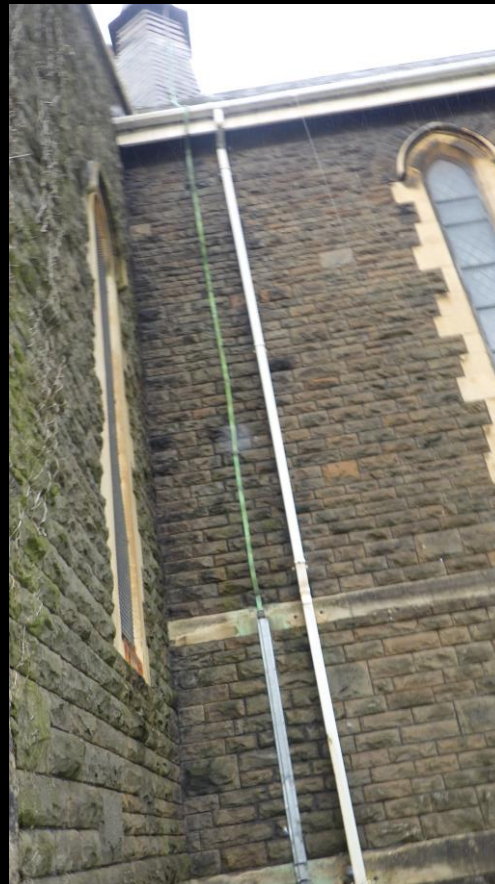
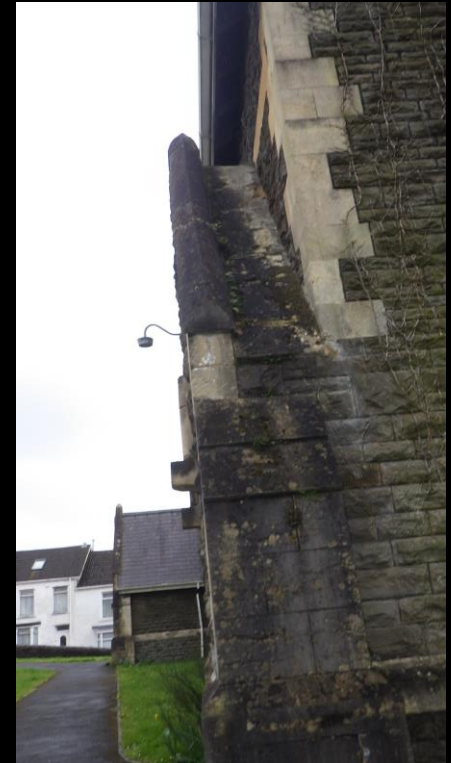
Rainwater downpipes are relatively undersized for such a large roof and will be prone to blockages. Where the chancel doorway opens on the North elevation there is a Lancet arch shaped loggia projection. This, provides a weathering detail to the door. The Bath stone requires removal of vegetation, repointing where water penetration is arising internally within the open loggia space that provides a secondary stepped access approach to the church.

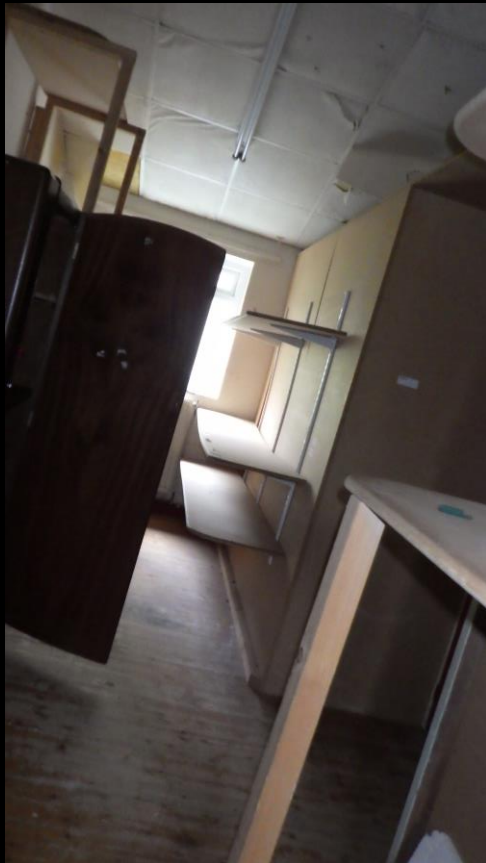
The large storeroom at the back of the hall.

There are signs of mould in the far left corner of the storeroom that needs to be washed down and redecorated. The reason for this is rather unclear at present but significant dampness was not noted. This is possibly due to storage of equipment within this position at sometime in the past. It should be monitored however, and interventions made, if required.

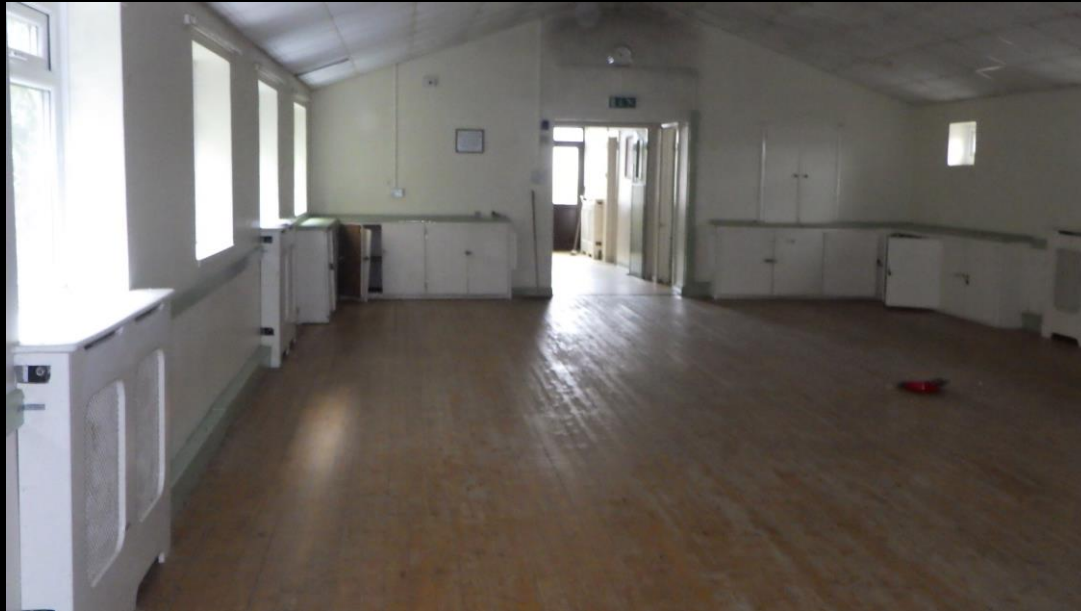
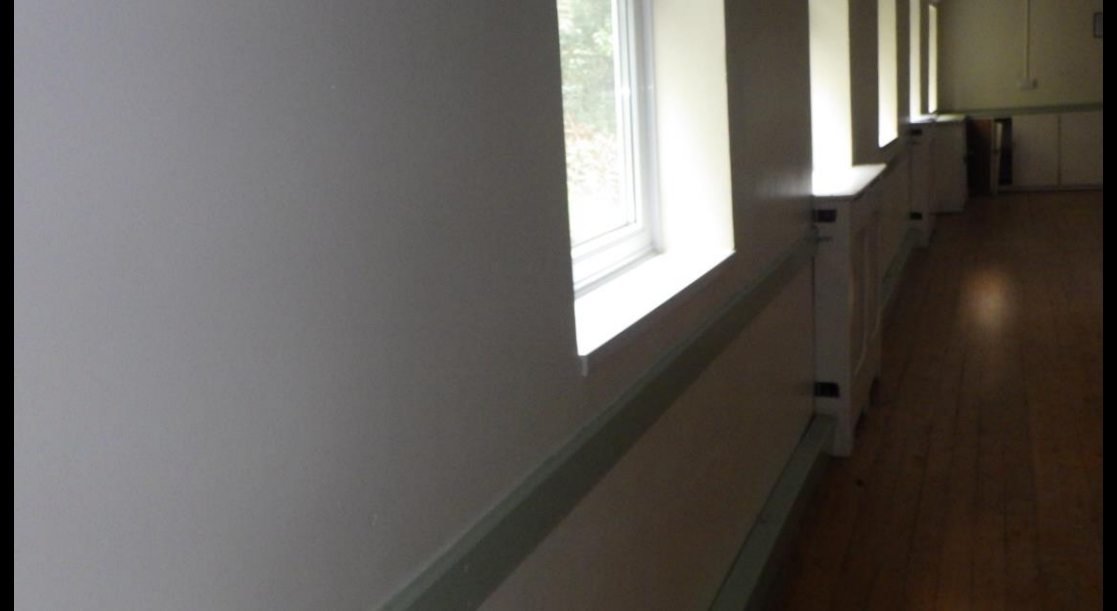
The church hall viewed from the rear. And looking towards the principal entrance.

Whilst the structure of the hall has GRC/Concrete cladding applied externally to the steel frame and timber purlin/sheeting rails supporting the now fibre cement, slate covered roof surface, the inner face of the walling is skimmed and rendered and presumably built of concrete blockwork walling. Steel panelled radiators are typically enclosed in MDF radiator covers to the main hall sections. The radiators the left exposed in secondary areas.

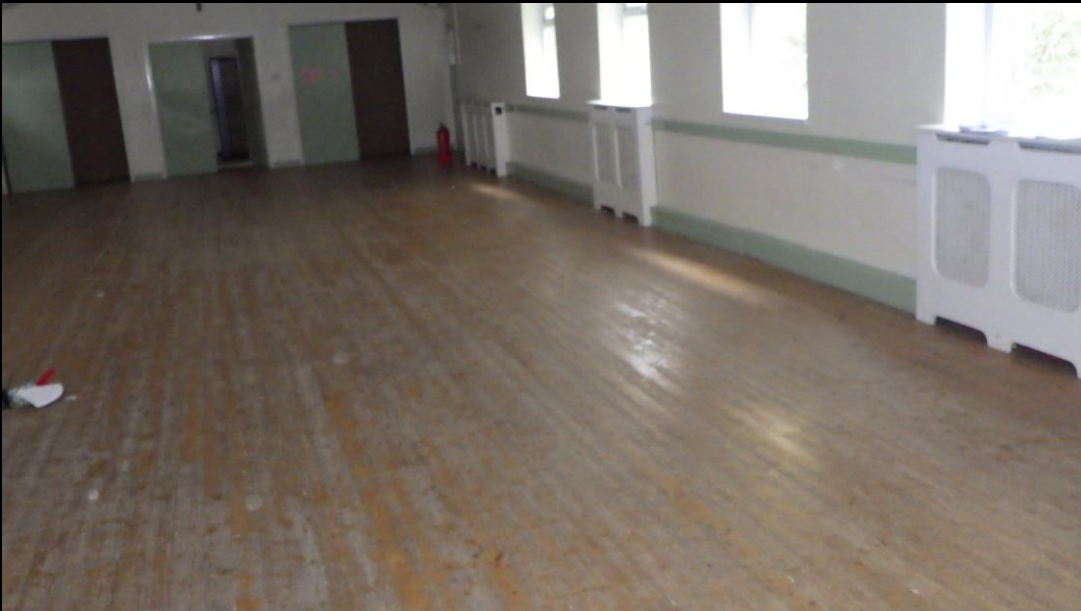
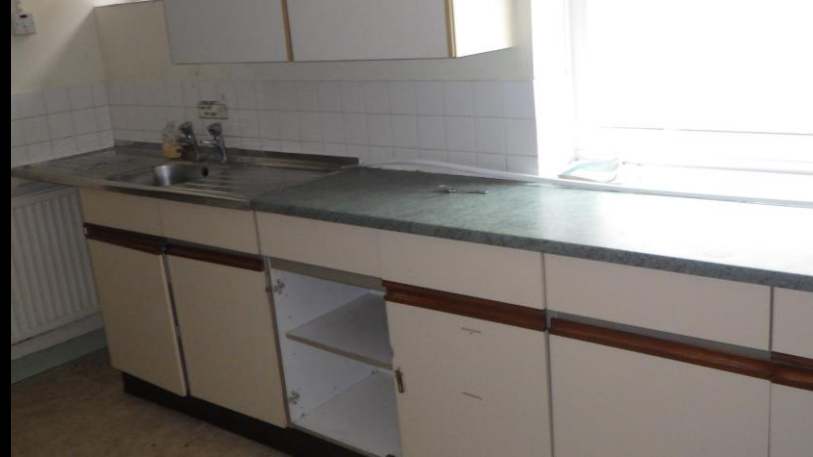
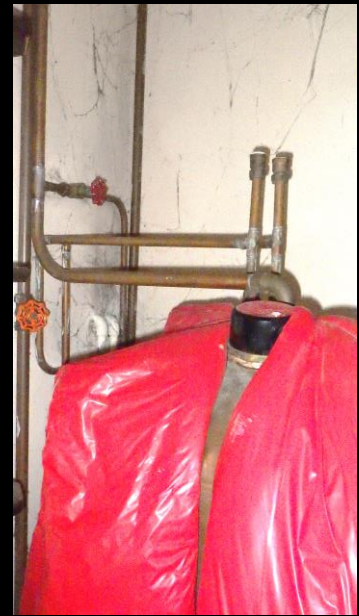
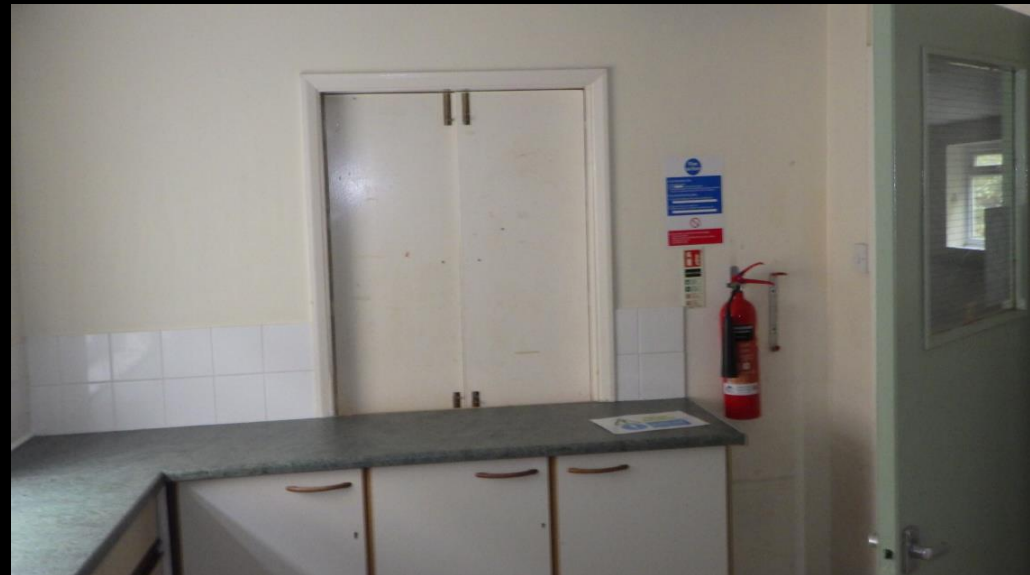
Right: the kitchen area where some repairs are required to kitchen cabinets. There is also a small airing cupboard providing presumably hot water for the kitchen facility. An immersion heater is incorporated.

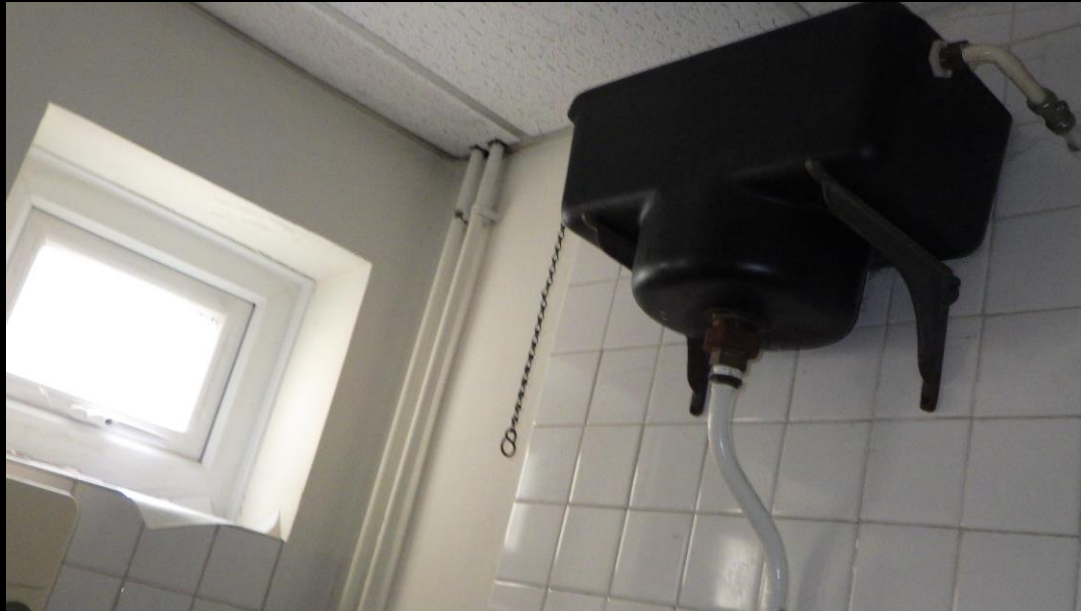
Within the Gents toilet, there is a pull-down chain to the urinal flush. The Dauntless type cistern should be treated with care and not disturbed as it is possibly containing asbestos-based materials.

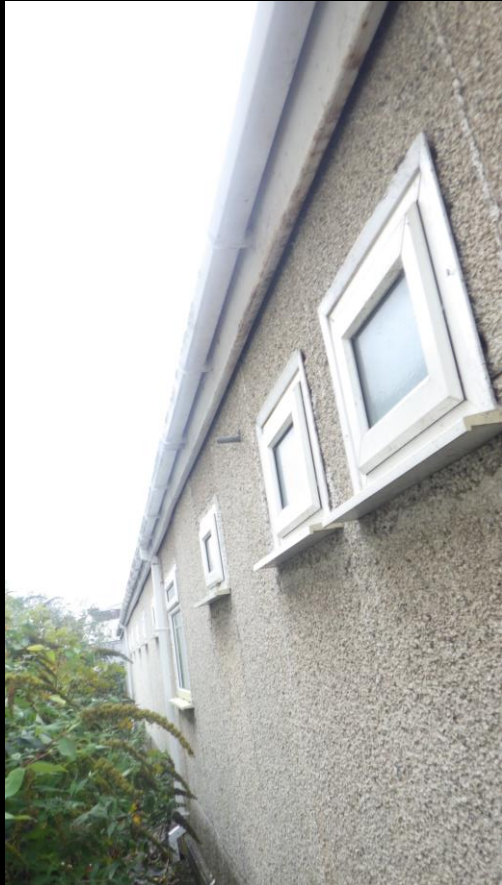
**Replacement PVC clad windows have been inserted.**

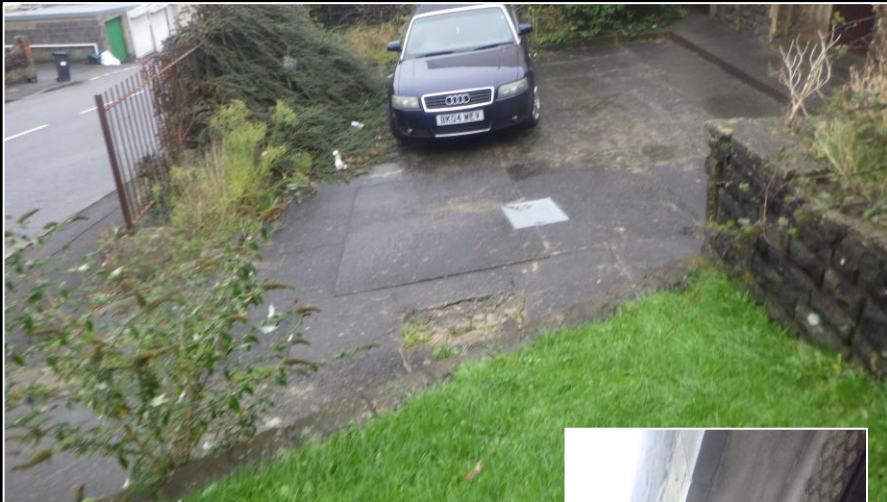
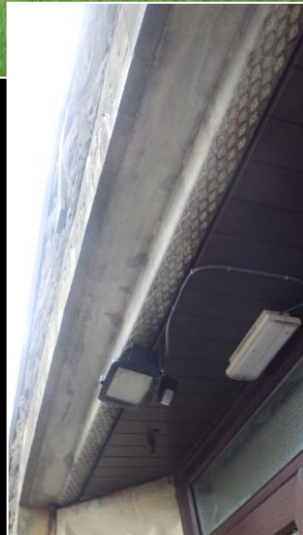
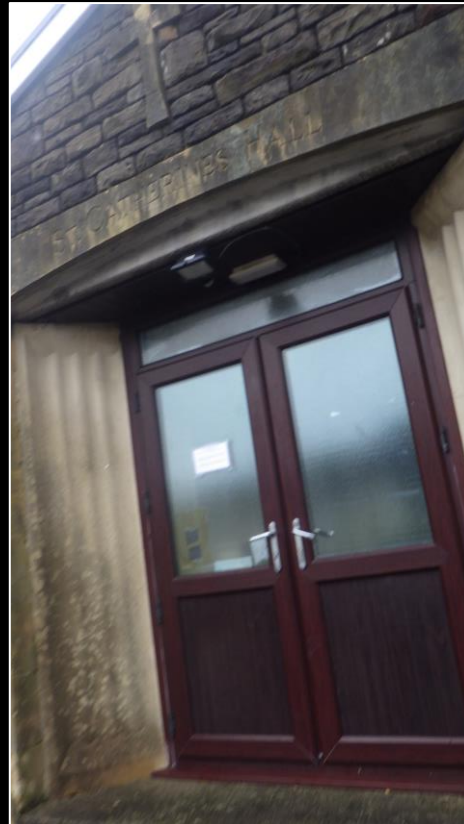
The front entrance approach to the Hall. As indicated the stonework to the front is purely a decorative façade. Moisture penetration is occurring internally within the Hall boiler room where this abuts the plaster-finished internal skin constructed within the Hall. Some of the applied cladding panels are misaligned and may need resecuring.

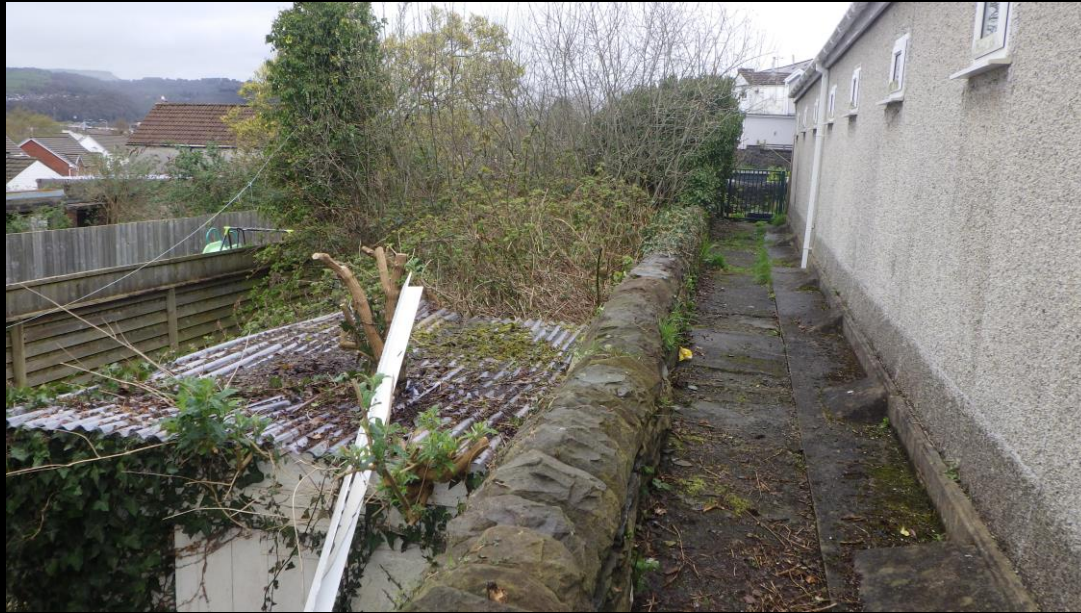
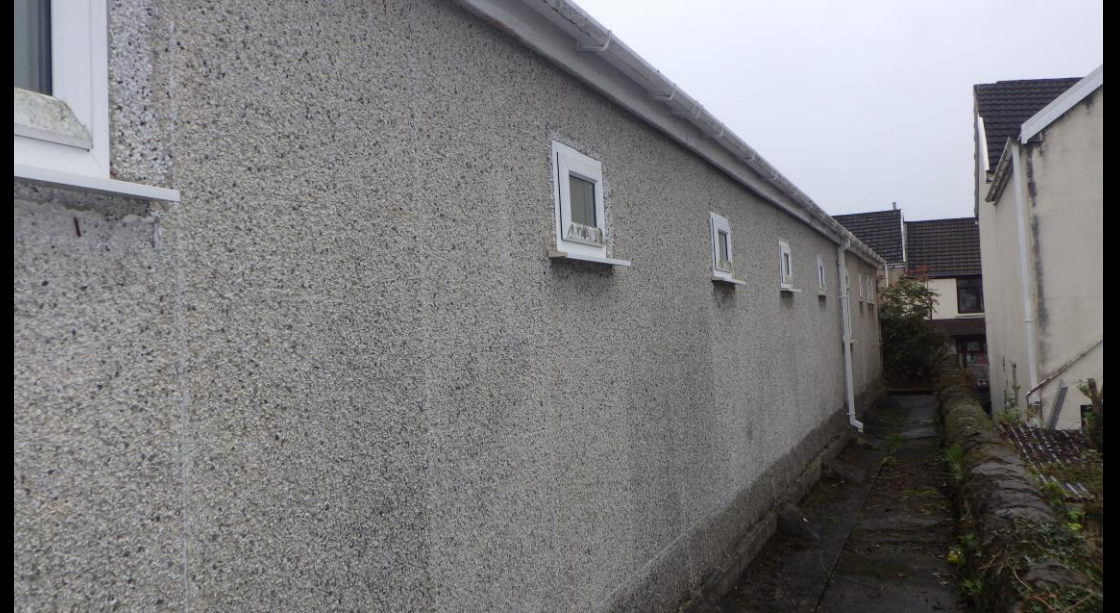
**Responsibility for the management and maintenance and liabilities associated with the church boundary wall will inevitably remain with the purchaser of the church and hall. Repointing and repair works will be necessary.**
