# The former St. Catherines Church and Hall, Neath.

North and West elevations.

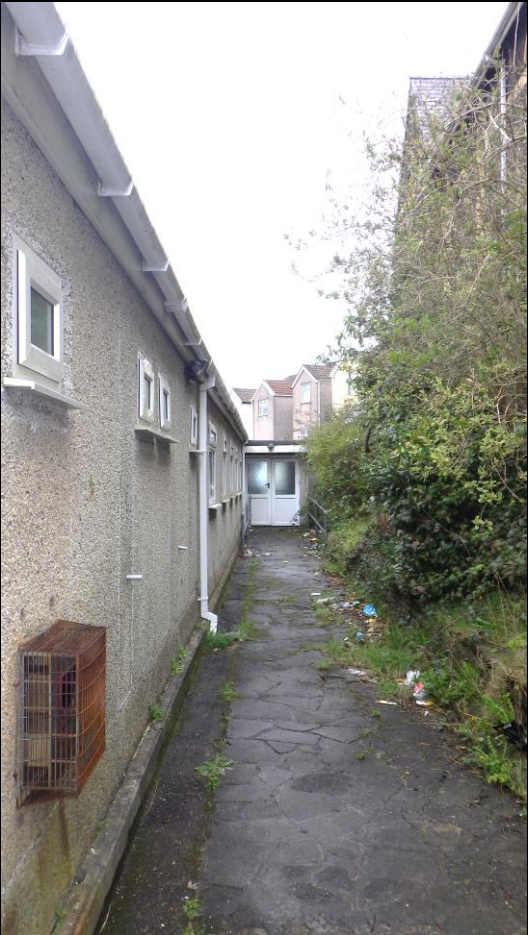
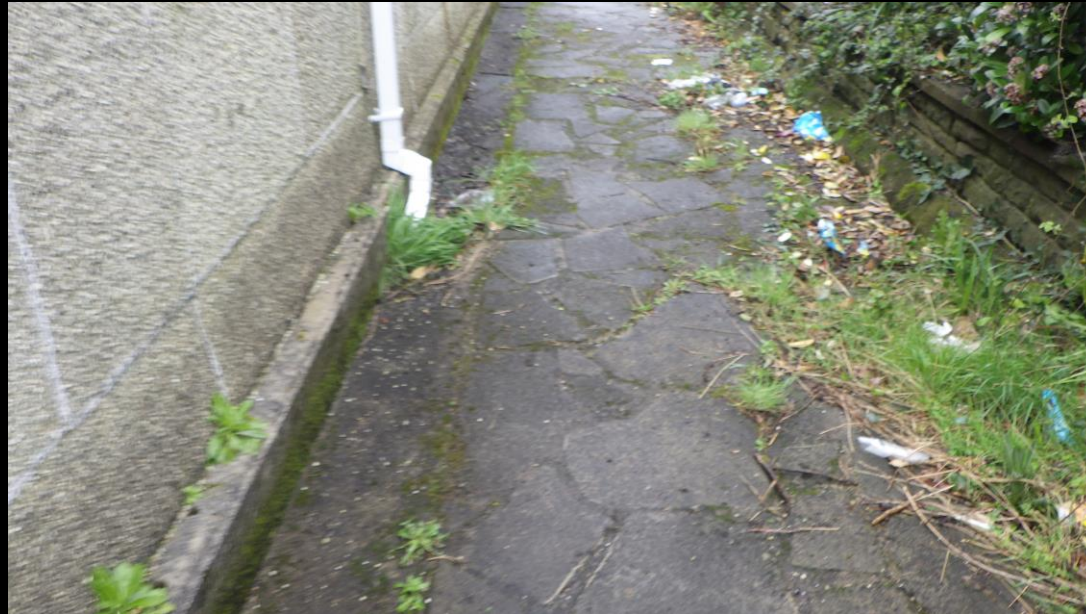
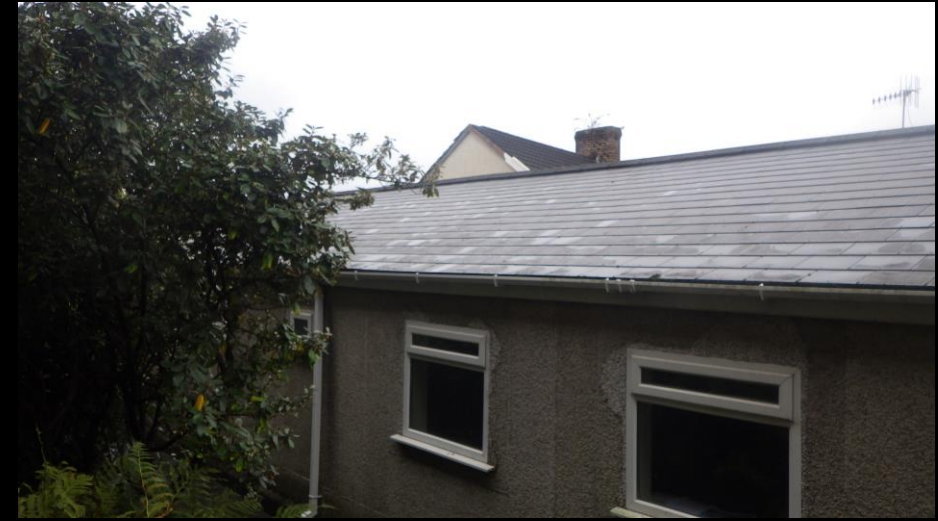
The right side path to the hall is crazy paved.  
The roof is shallow pitched and has been re-  
slated with modern fibre cement slates.

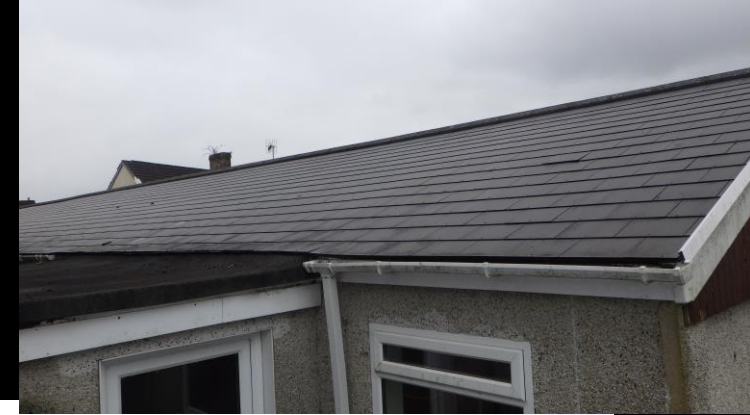
There is a flat felt roof section over the abutment rear lobby of the Hall and the stepped link into the vestry of the church.

Repairs are required to the bargeboard, fascia and soffit, detailing and within a relatively short time recovering of the flat felt roof is likely to be necessary.

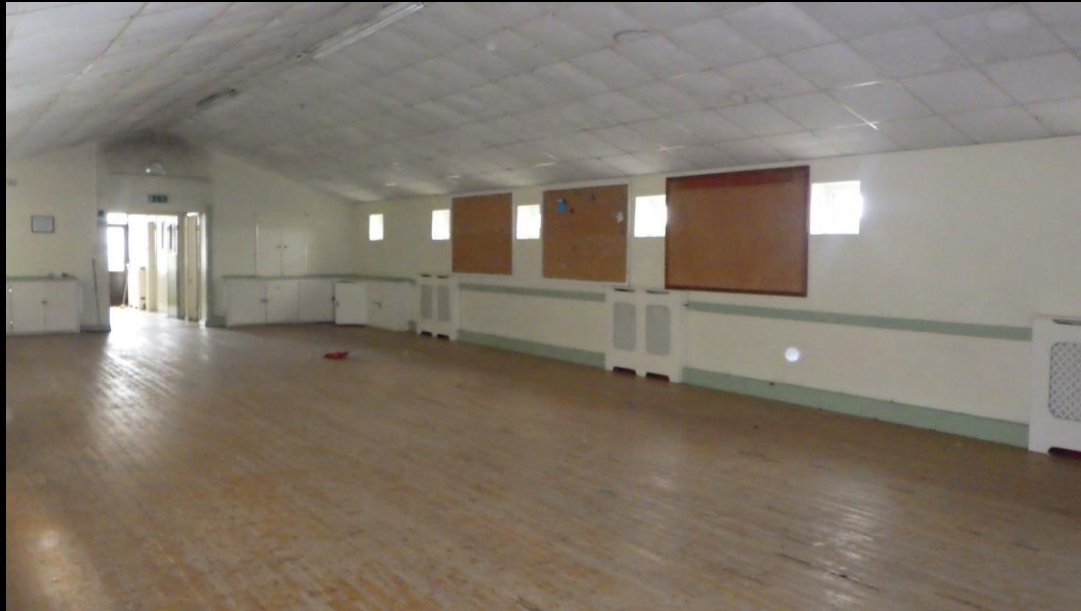
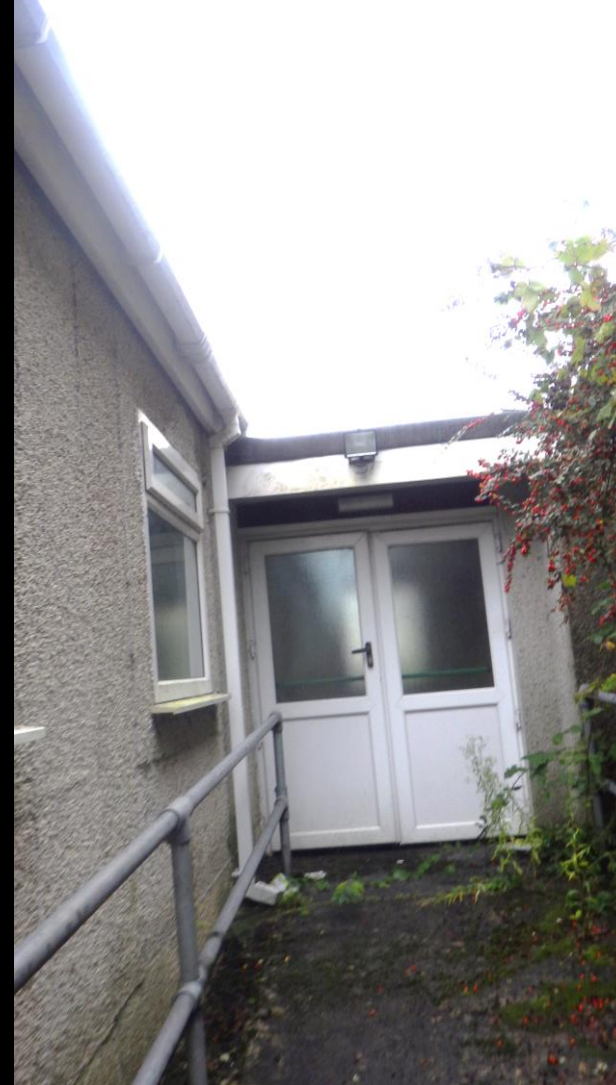
The hall and its right side entrance. Thermal insulation levels are not good and will need to be upgraded as part of any change of use. The detailing of this is important and ideally we would suggest an external wall insulation system is added however these are fraught with challenges particularly at eaves details where there is an insufficient overhang and cold bridging can readily occur. Modifications would be required.

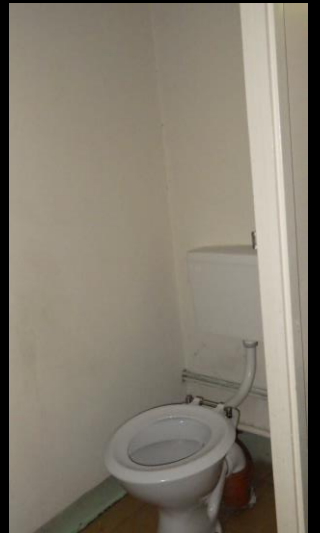
**There is a cracked top to the toilet cistern.**

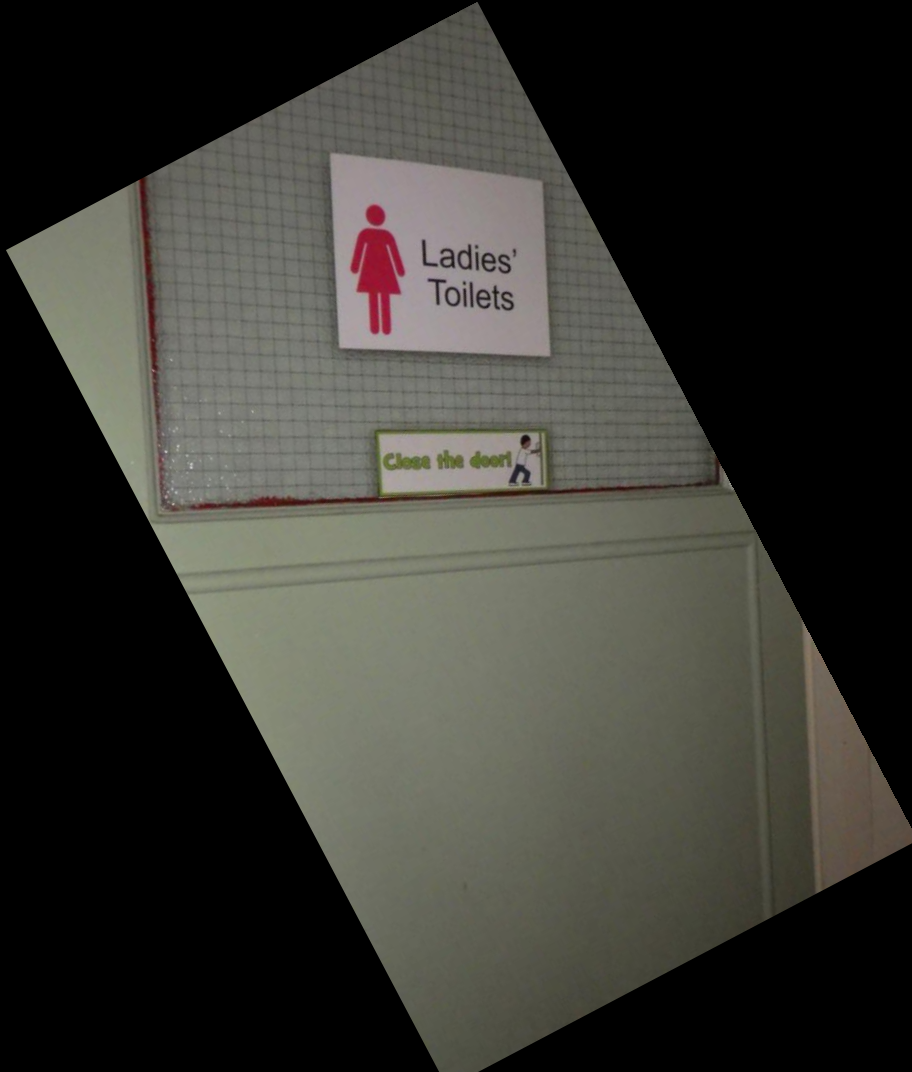
The door is repaired.

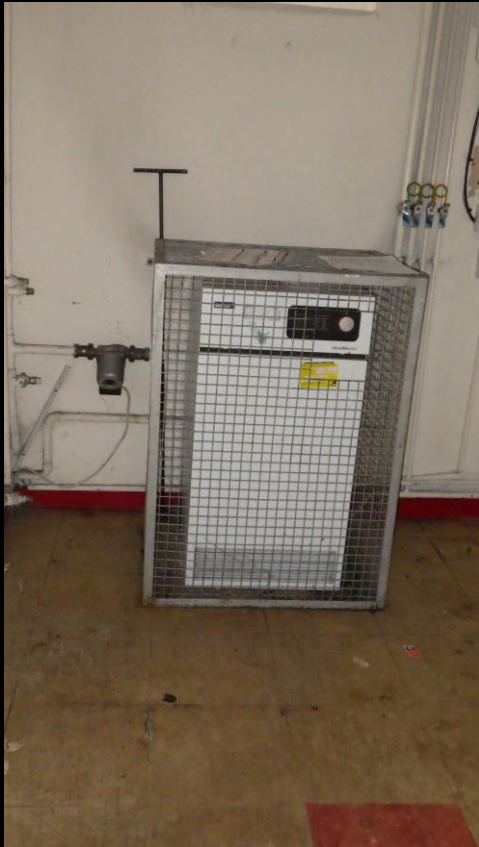
The boiler room in the Hall. The Ideal Mexico boiler is an older variant. These can be quite durable but are less energy-efficient than a modern boiler. Regular servicing and maintenance is critical to their longevity.

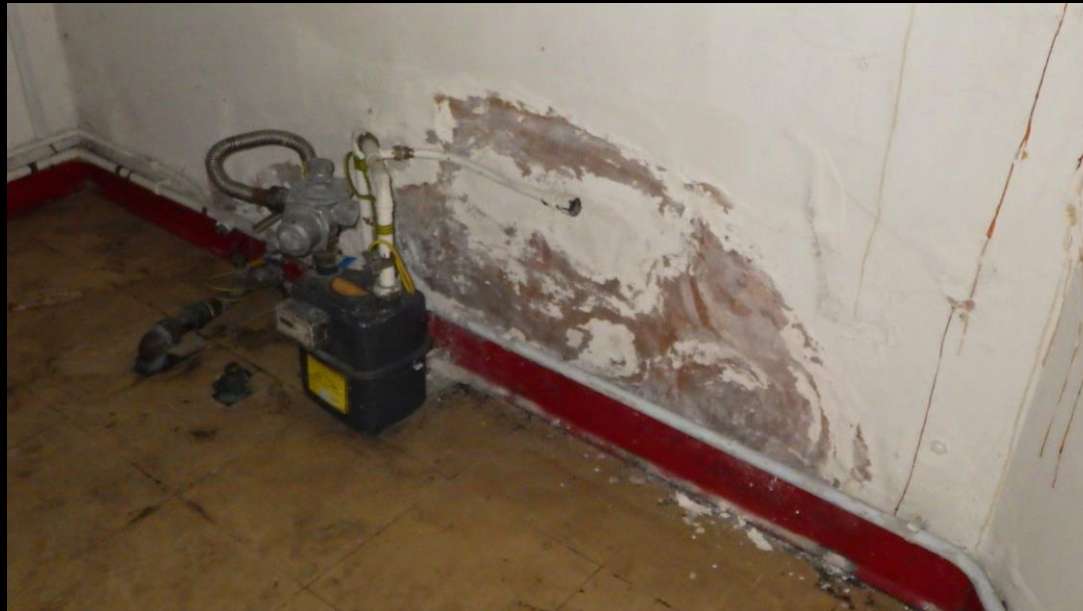
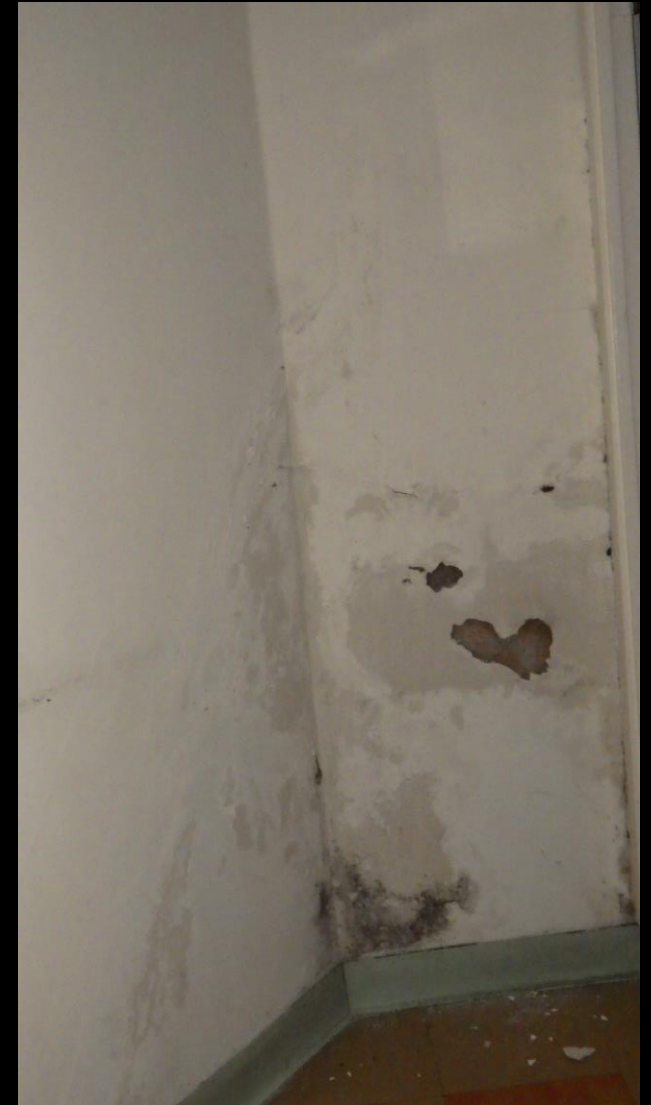
Centre and right: rainwater penetration through the sandstone façade to the front elevation of the Hall is damaging the plaster within the boiler room. There may also be some bridging of the damp proof course, evident.

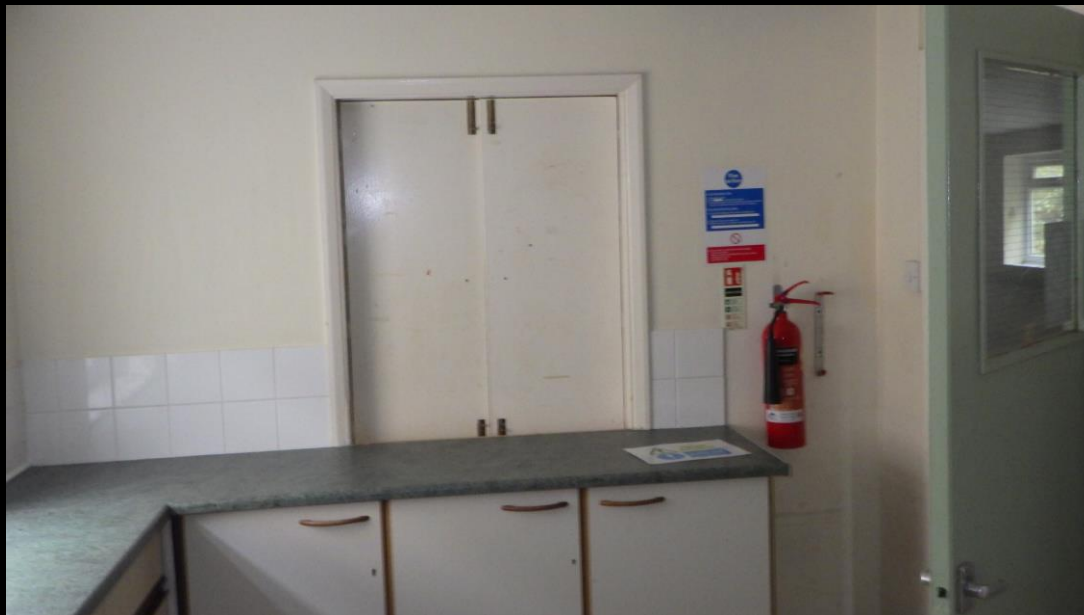
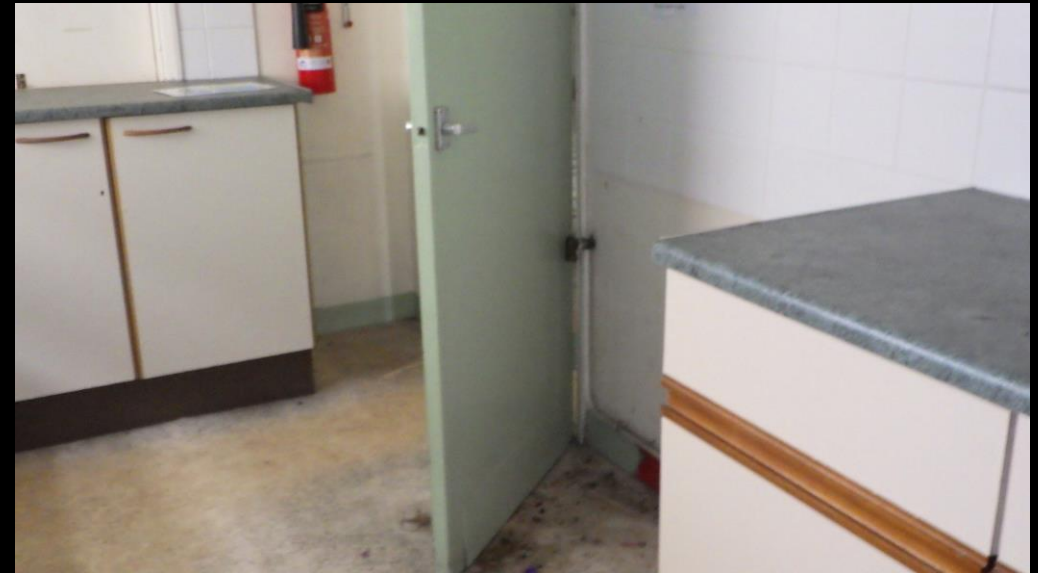
**Kitchen areas are in need of upgrading.**

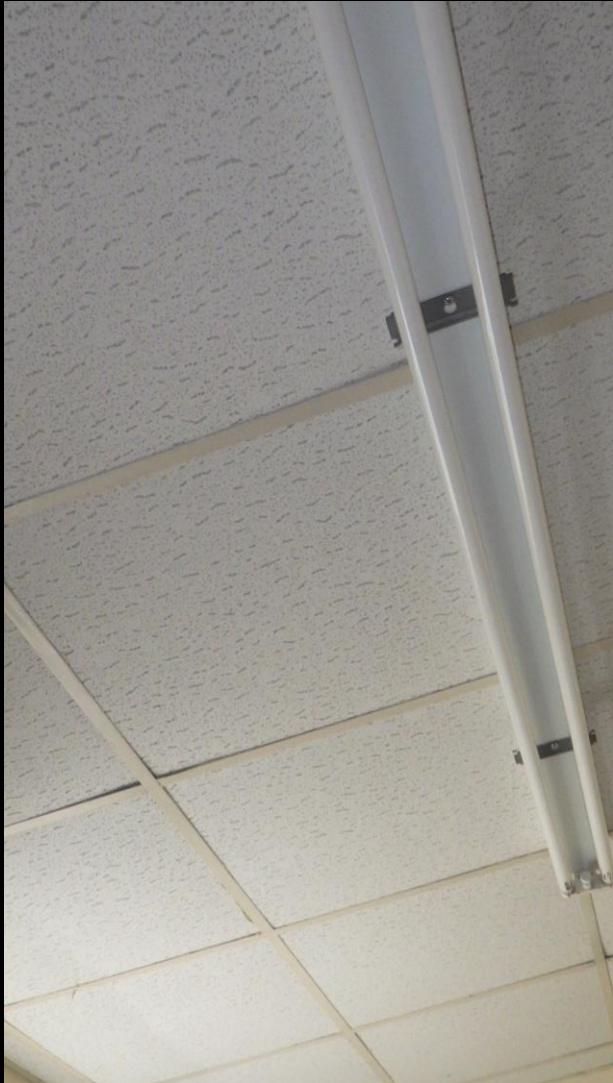
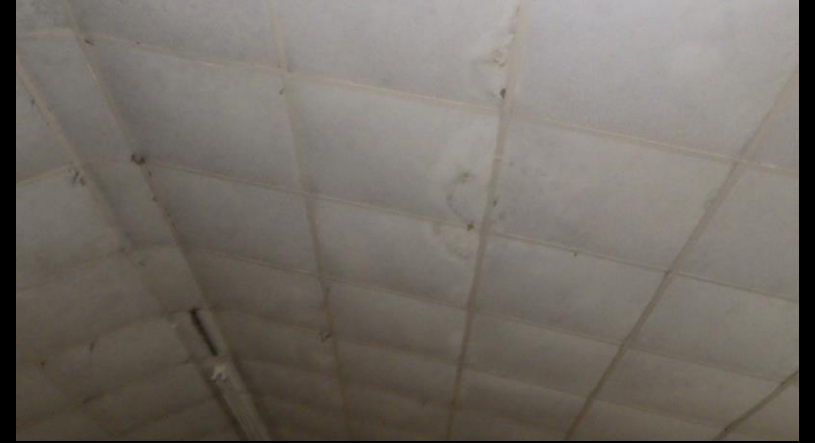
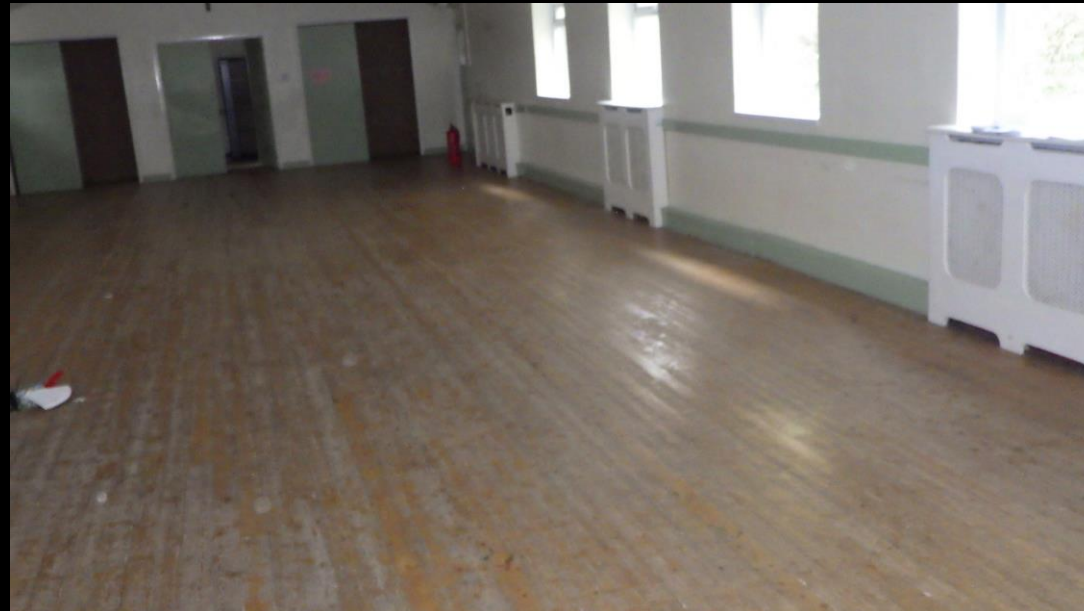
A variety of fittings and linings are provided to the Hall. Many will now need to be upgraded further.

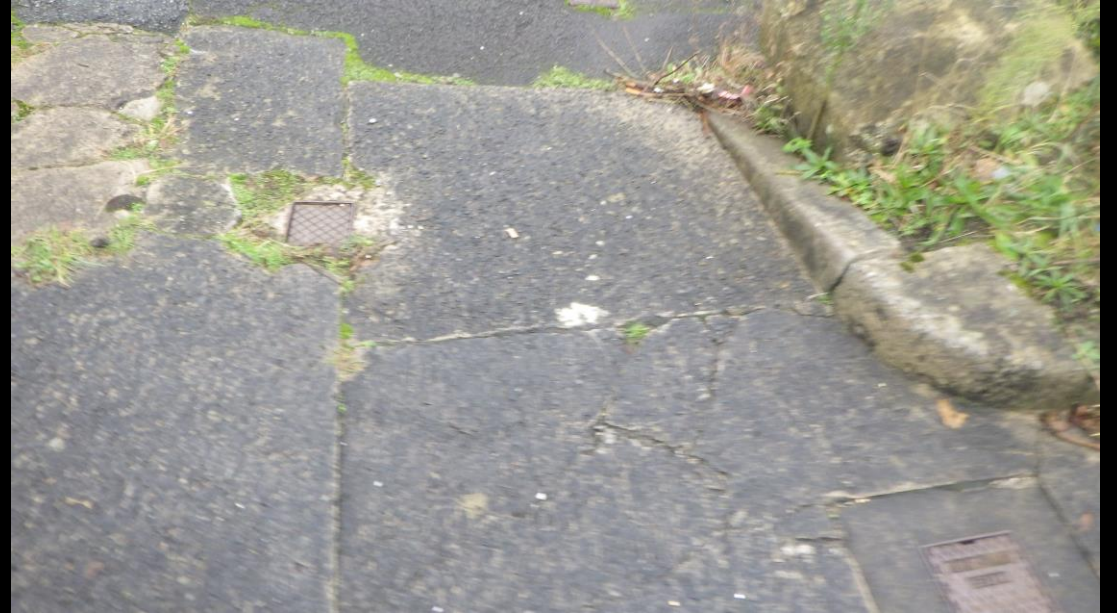
The concrete apron to the entrance approach and parking area. A variety of cold water stop tap duct is set within this. The apron is undulating and has settled slightly.

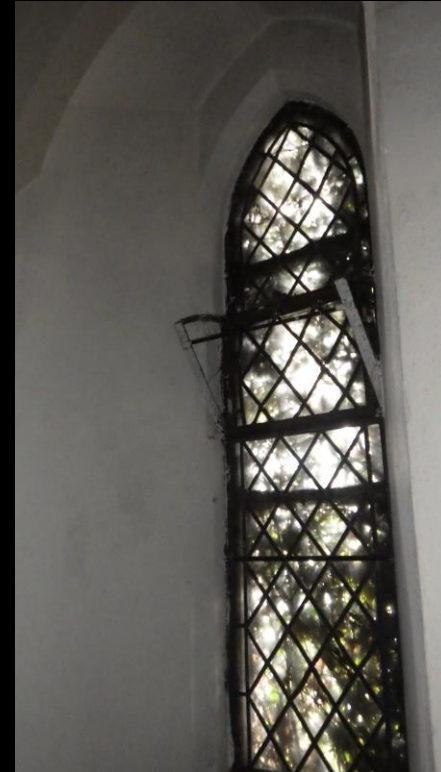
One of the Lancet windows is smothered with ivy vegetation. Top hung inward opening, vents will require easing and adjusting.

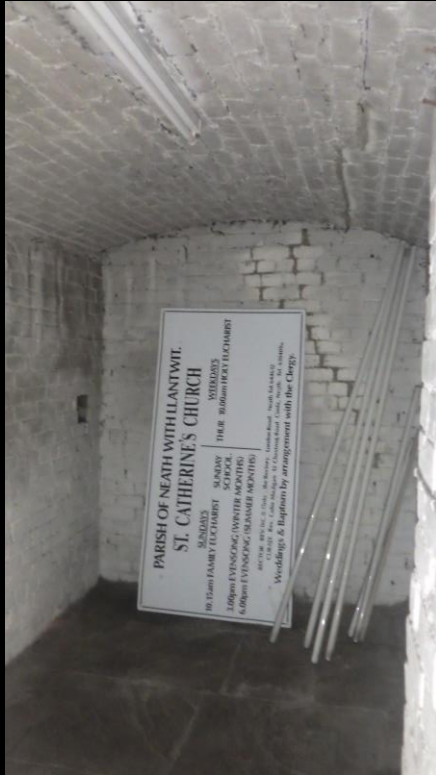
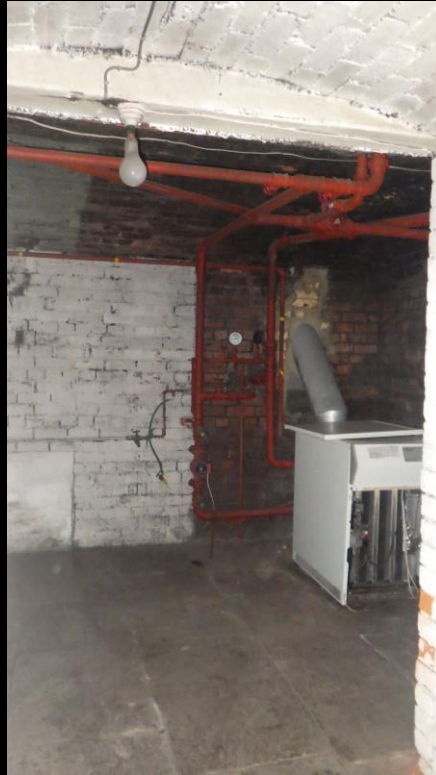
The Church Boiler house.

Pipes need insulating. The Gas boilers inspecting and servicing. Many gas fitters would recommend replacing. We suggest give the limited long term likely use that you enquire as to the availability of parts as replacement is unlikely to be cost viable.

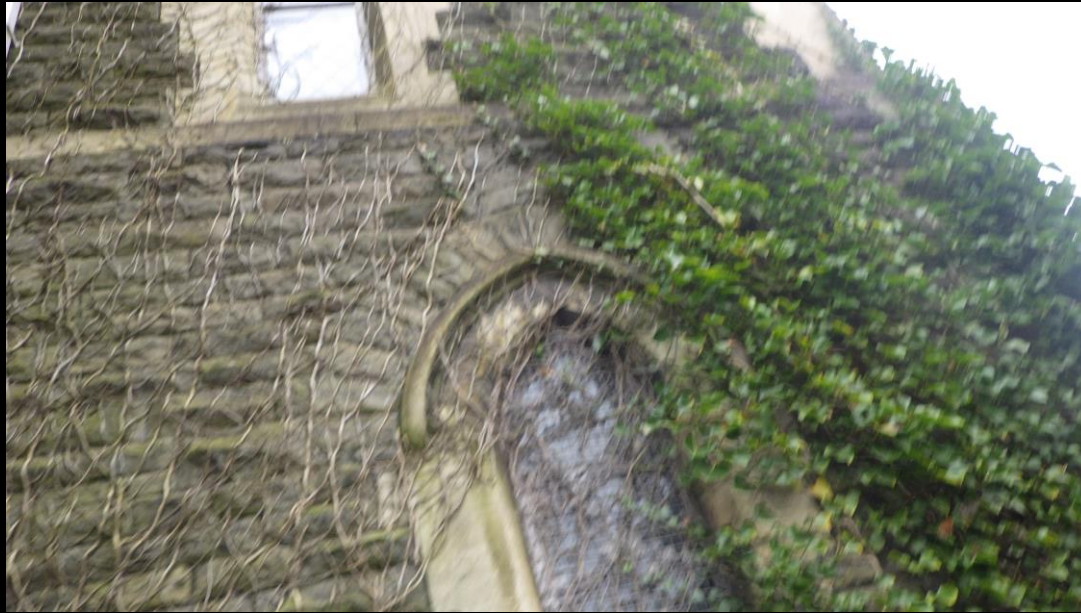
**Ivy overgrown doorway that needs opening.**

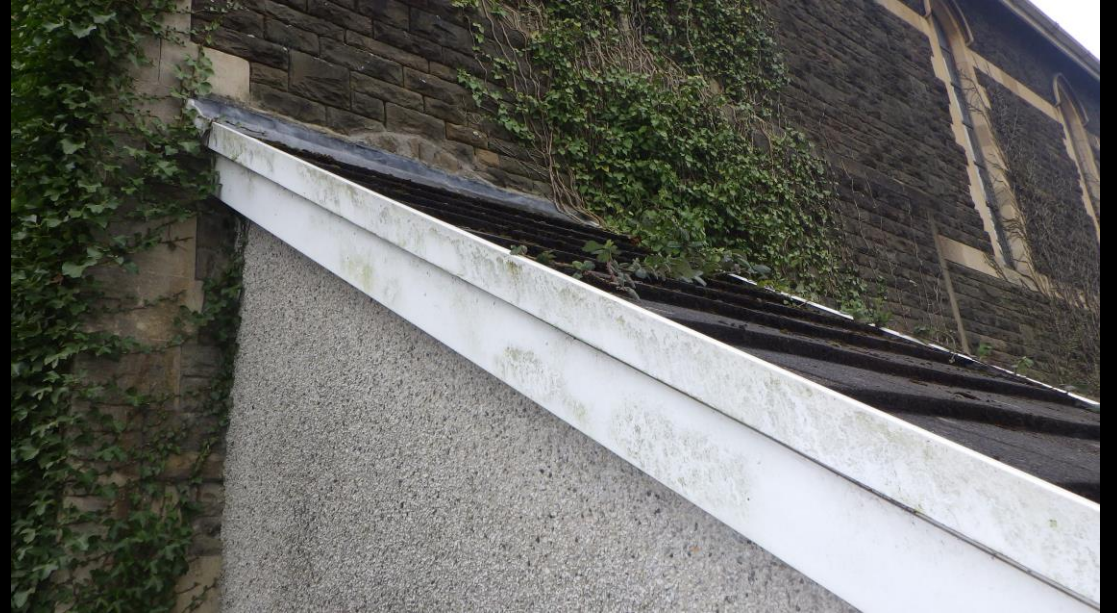
**At the staircase link the lead flashing cuts across a former door head. This is far from ideal.**
