# Bat Survey Report

## Gorphwysfa Chapel, Skewen

| <b>Report title</b> | Preliminary Roost Assessment |

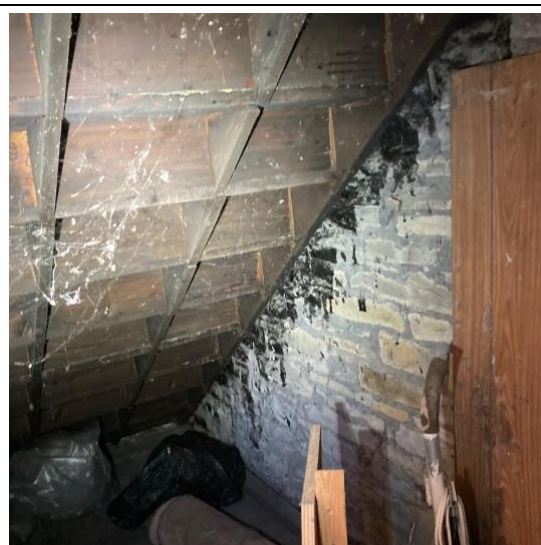
Figure 16. Example of under-stairs cupboard.

- 4.4.1 Internally, the main front lobby area of the chapel has two stair cases, one on either side of the building, with cupboards underneath (see Figure 16 below). The main chapel is on two levels, with rows of pews on the ground floor and a gallery in a 'U' shape above (see Figures 17 and 18 below). A pulpit is present on an elevated platform at the northern end of the chapel, and an organ is present behind this (see Figure 19 for example of inside of organ).

- 4.4.7 No evidence of bats was noted anywhere in the under-stairs cupboards, the chapel, the organ, the schoolroom ground floor and first floor, or the loft void.

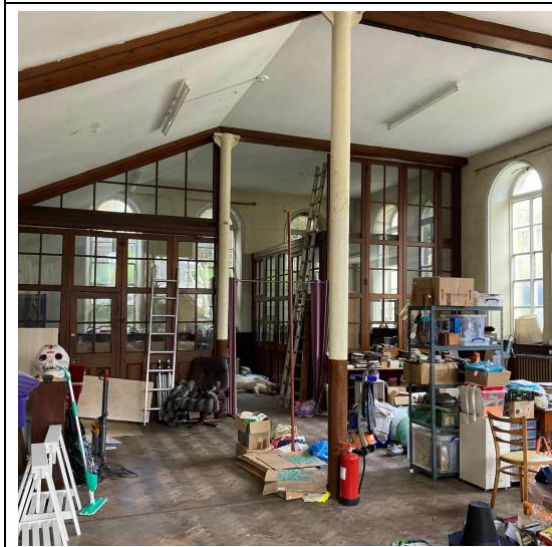
Figure 20. Ground floor of schoolroom (west).

4.4.2 The school room to the rear is built on two levels, with the ground floor largely being open and currently used for storage (Figures 20 and 21). A stage is present at the eastern end of the building, and a small kitchen with a false ceiling is present in the north west corner (Figure 22).

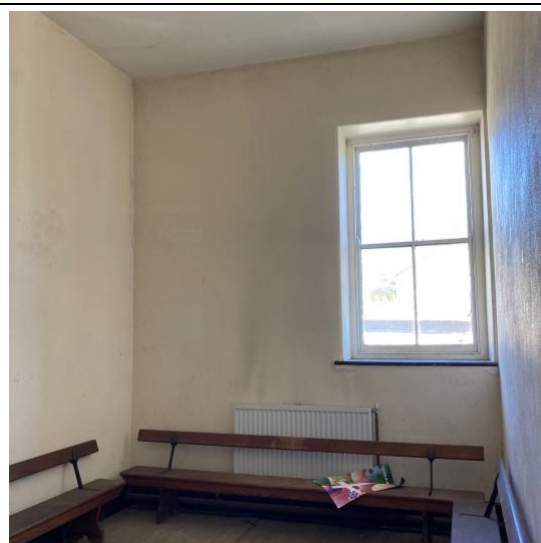
Figure 24. Example of room on first floor.

4.4.4 The first floor of the school room includes a row of five rooms to the rear (north) of the building, with a corridor linking them (see Figure 24 above and 25 below). Two further rooms are present at either end and to the south of this corridor.
