# Maesteg Road

BS5837:2012 Tree Survey

## Revision C - 09.08.2024

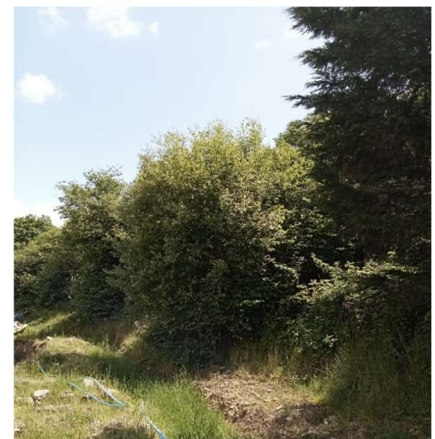
tree as it has an uninterrupted rooting area in every other direction and the embankment will be undisturbed by the development. T373 is in poor condition, the limb overhanging the site has split and needs to be removed. The remaining stem is leaning away from the site; this stem has split and will fail but will not impact on the site. This stem can be removed or retained as required. The hazel coppice on the embankment will not be affected by the development. The embankment is outside the curtilage of the site.

T373 showing split limb
