# Parc Pelenna Holiday Resort

## Phase 1 Ground Conditions Desk Study

*For Trivselhus UK*

*Doc ref:* 16044-HYD-XX-XX-RP-GE-1000

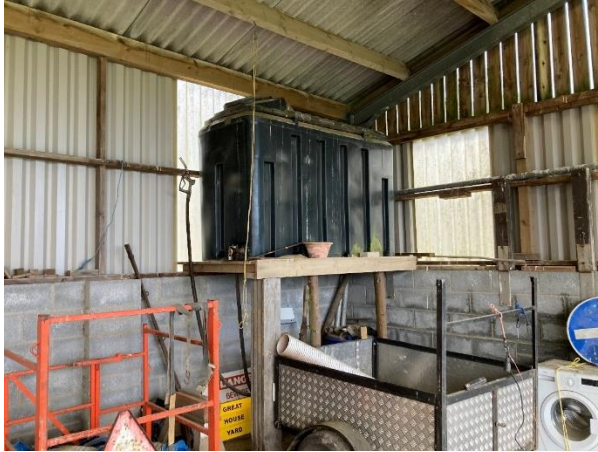
Figure 2.3: Above ground fuel storage tank in the farm building in the south-central area of the site.

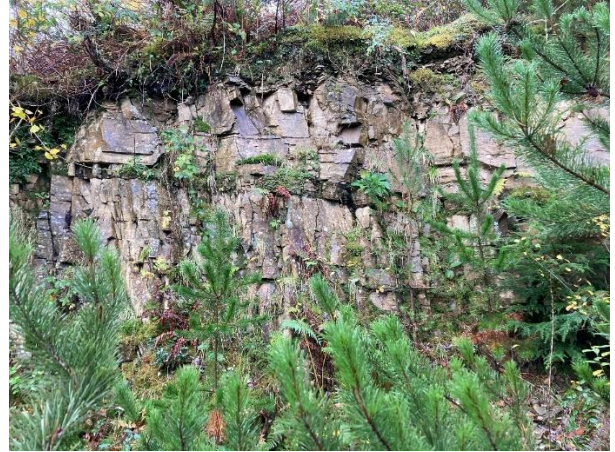
Figure 2.4: Sandstone bedrock exposure in the northwest of the site.

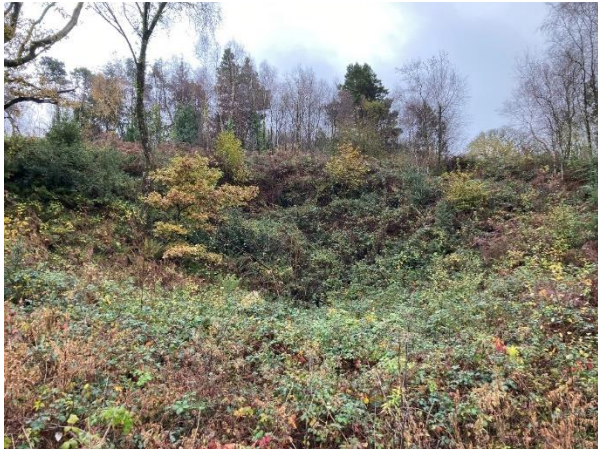
Figure 2.5: Site of the historical Cefn-mawr Colliery.

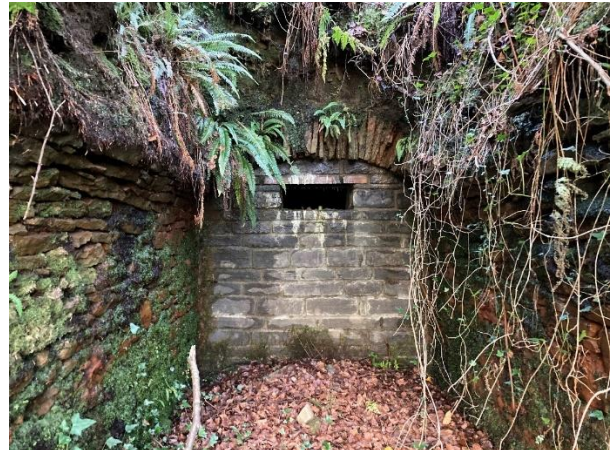
Figure 2.6: Mine adit in the north of the site.

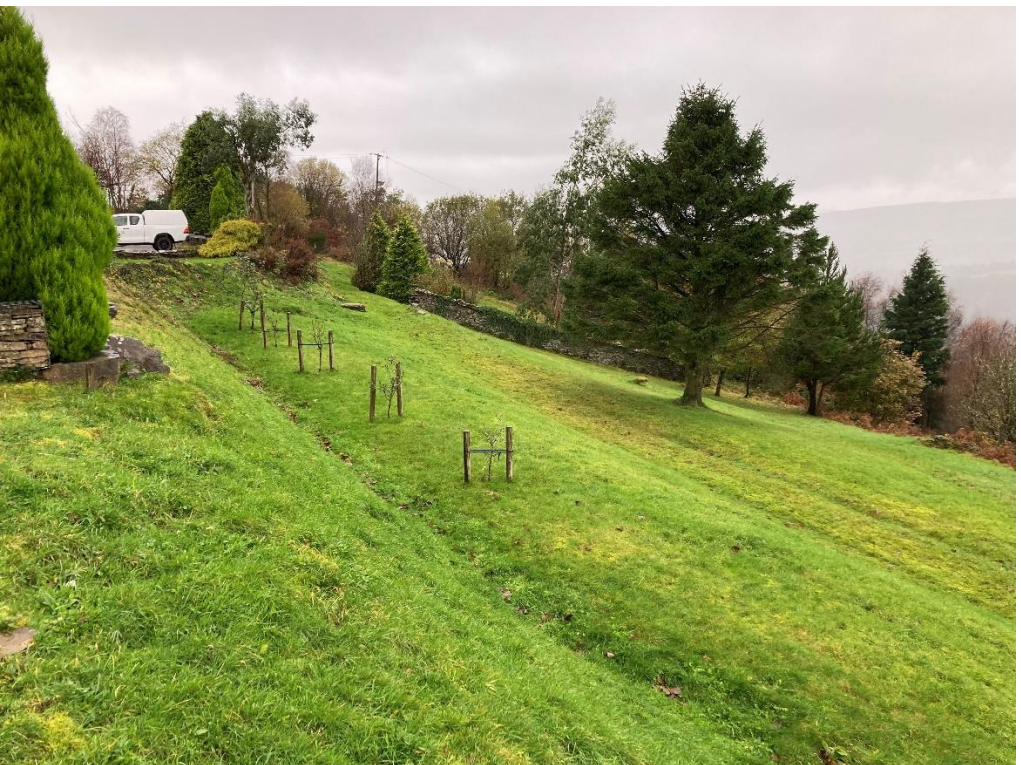
| <b>Desk Study<br/>Photograph 2</b> | |

| <b>Description:</b><br>Terraced lawn in the<br>centre of the site,<br>north of the farm<br>house. | |

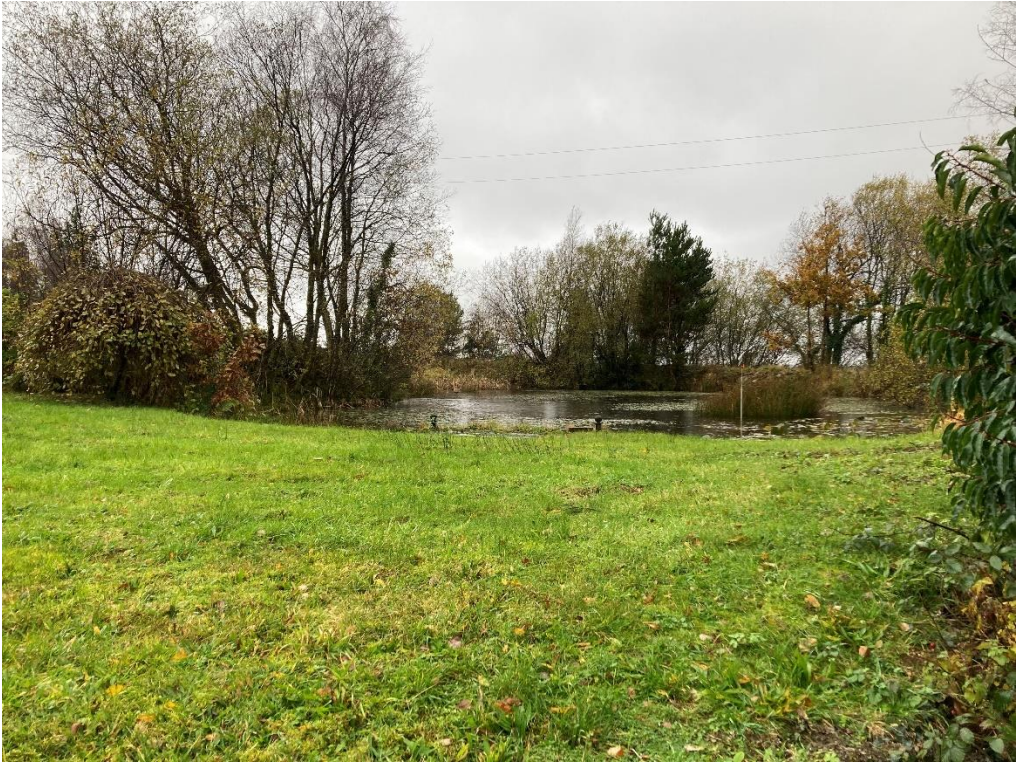
| <b>Desk Study<br/>Photograph 3</b> | |

| <b>Description:</b> One of the two ponds west of the farm house. | |

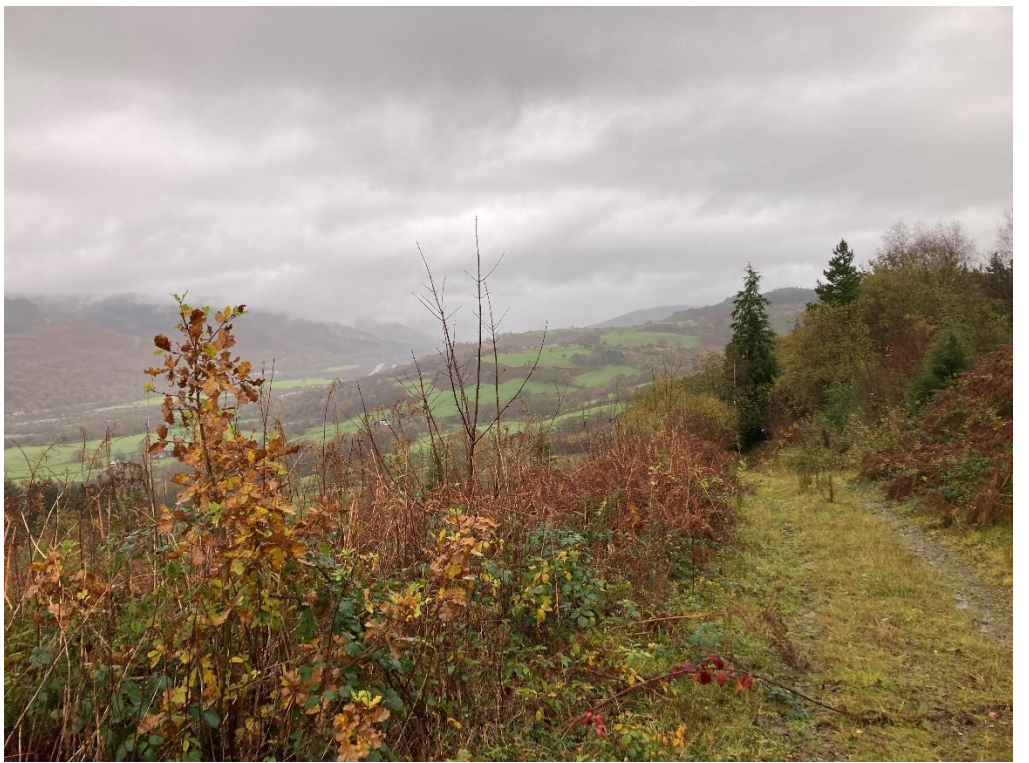
| <b>Desk Study<br/>Photograph 4</b> | |

| <b>Description:</b> Looking northeast across the site, north of the farm house. | |

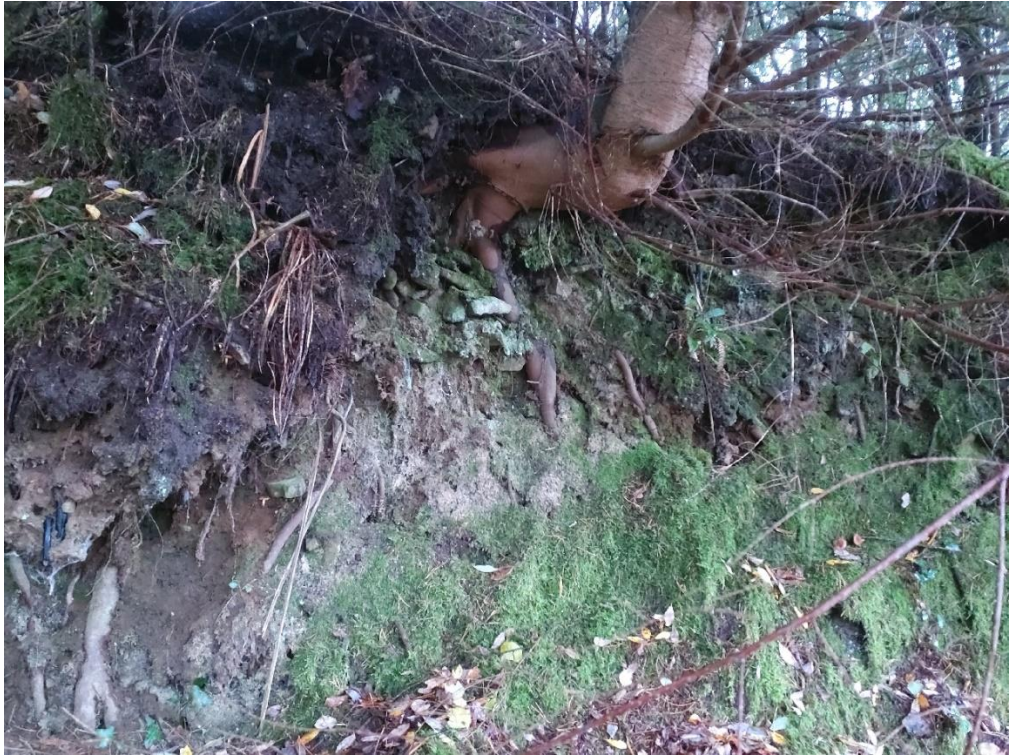
| <b>Desk Study<br/>Photograph 5</b> | |

| <b>Description:</b> Track cutting exposing superficial weathered bedrock. 2m to 3m high and appeared unstable. | |

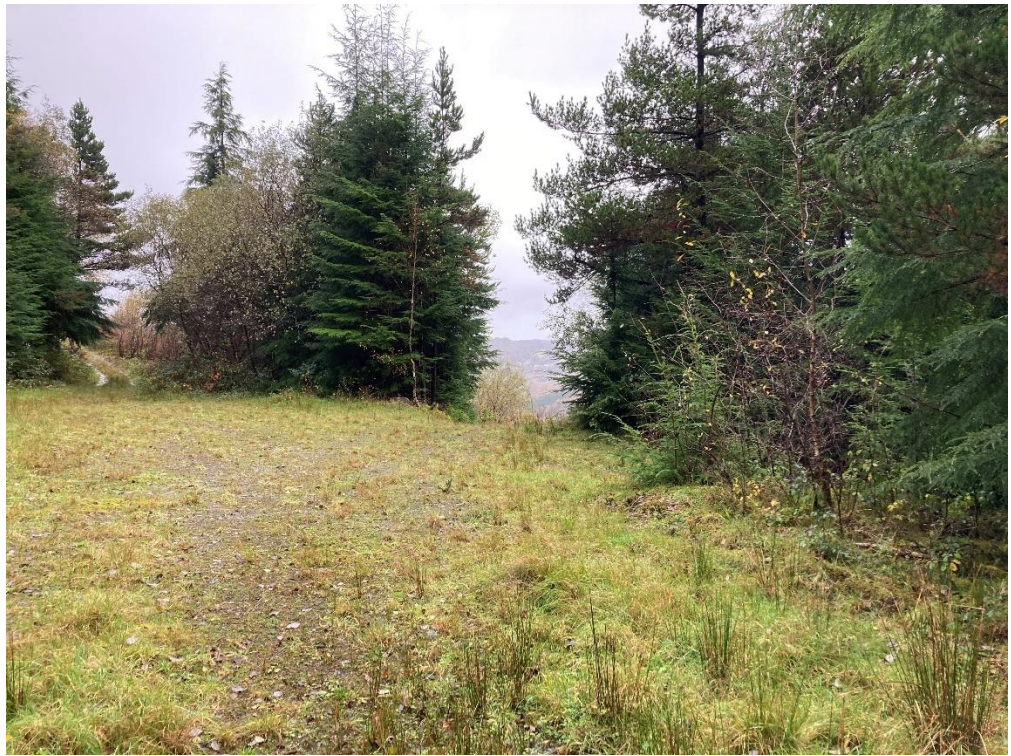
| <b>Desk Study<br/>Photograph 6</b> | |

| <b>Description:</b> Flat track area west of the disused quarry. | |

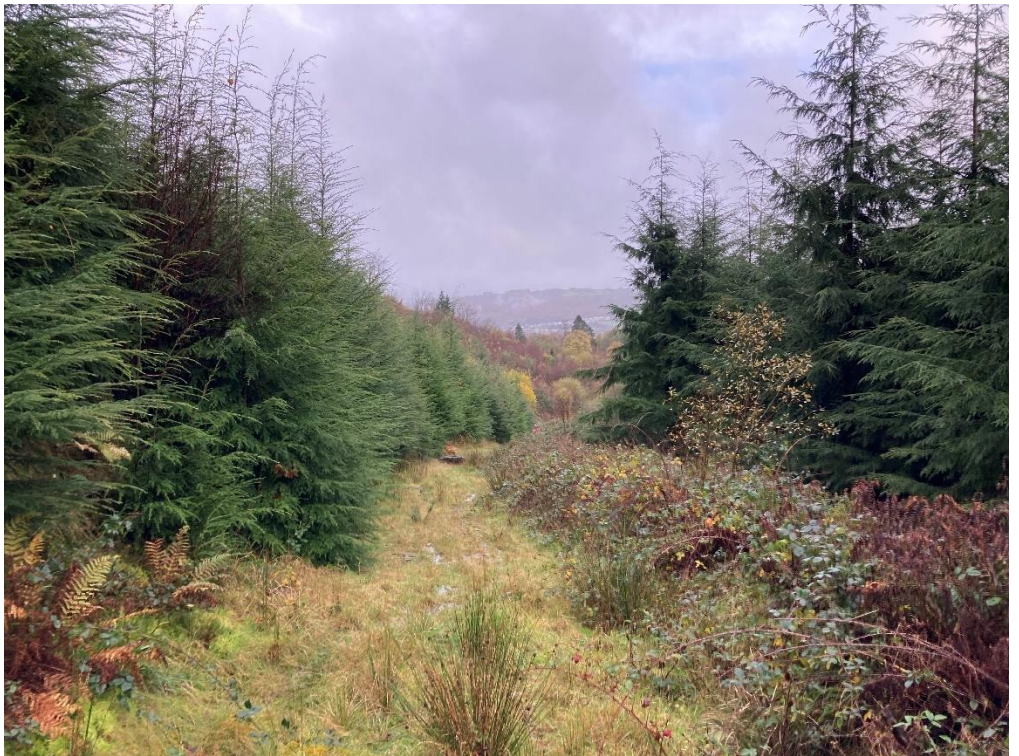
| <b>Desk Study<br/>Photograph 12</b> | |

| <b>Description:</b> Looking northwest down one of the tracks on site in the north. | |

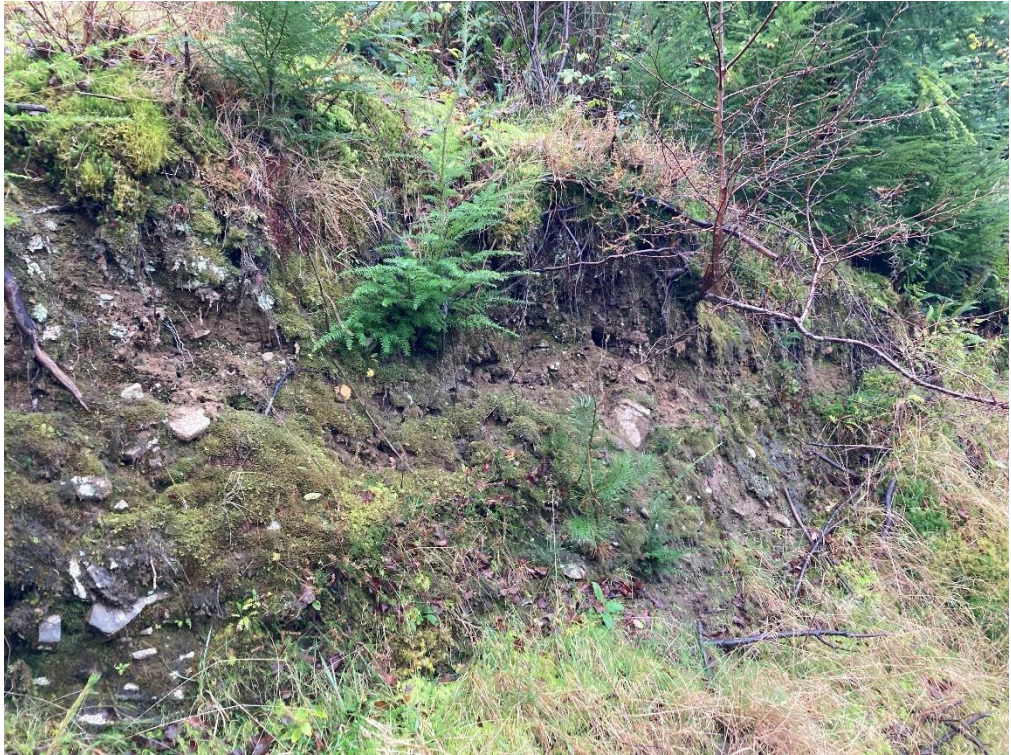
| <b>Desk Study<br/>Photograph 13</b> | |

| <b>Description:</b><br>weathered<br>superficial bedrock<br>material, likely<br>exposed by cutting<br>for track<br>construction. | |

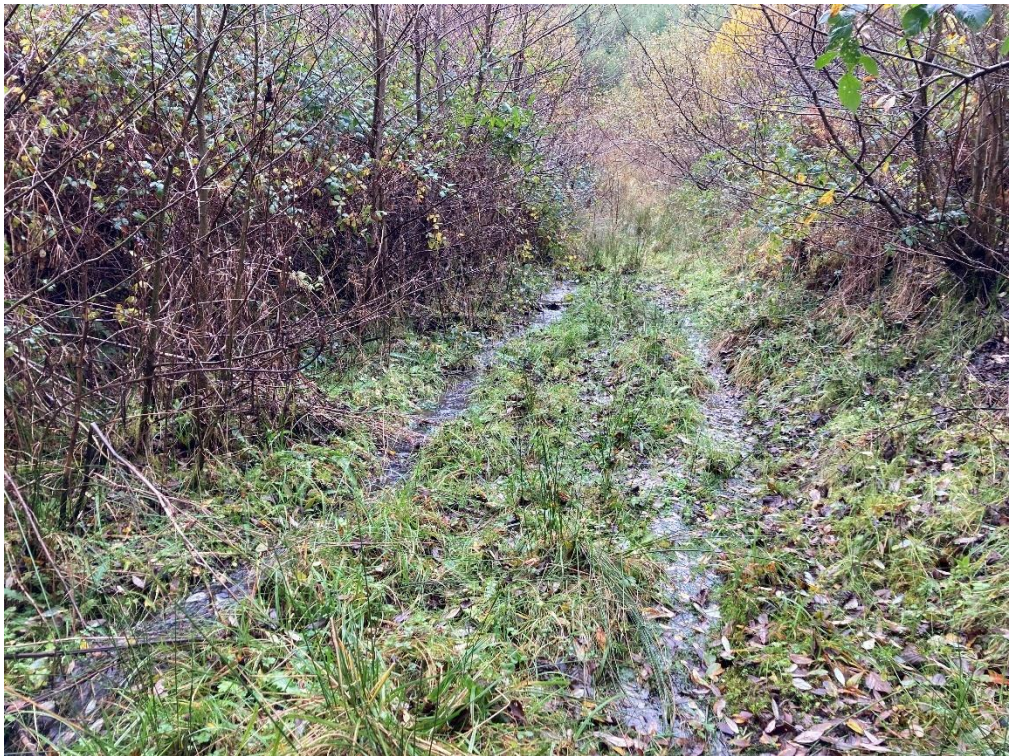
| <b>Desk Study<br/>Photograph 14</b> | |

| <b>Description:</b><br>Waterlogged ground<br>in the north of the<br>site. | |

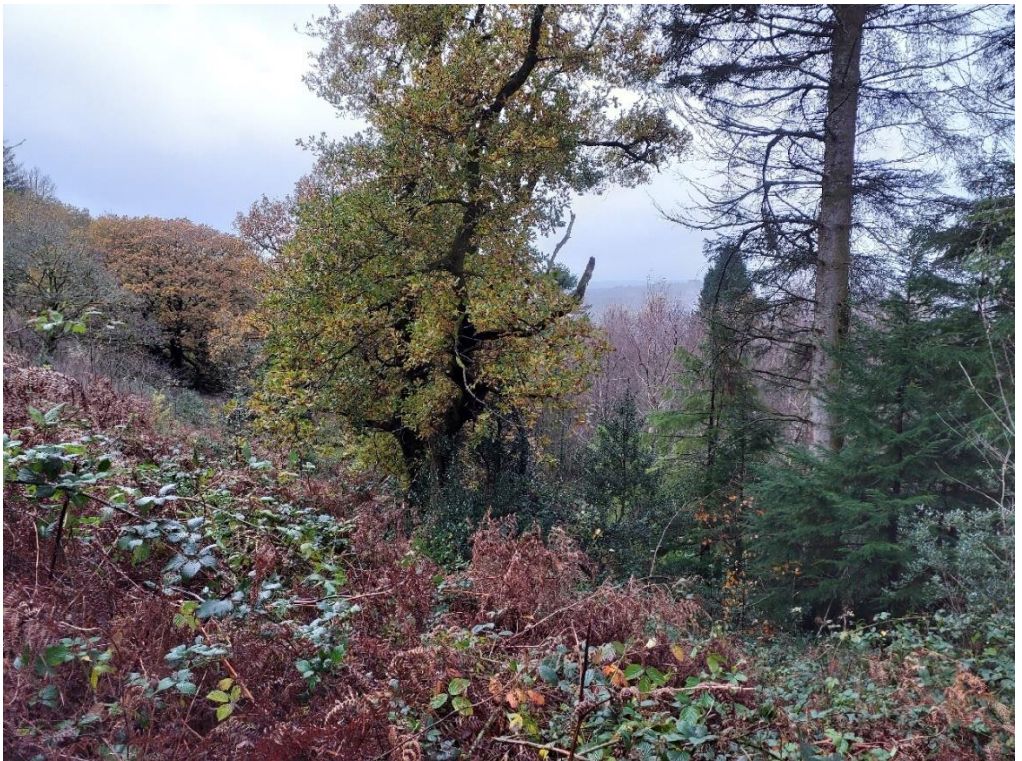
| <b>Desk Study<br/>Photograph 20</b> | |

| <b>Description:</b> Mature vegetation in the northwest of the site. | |

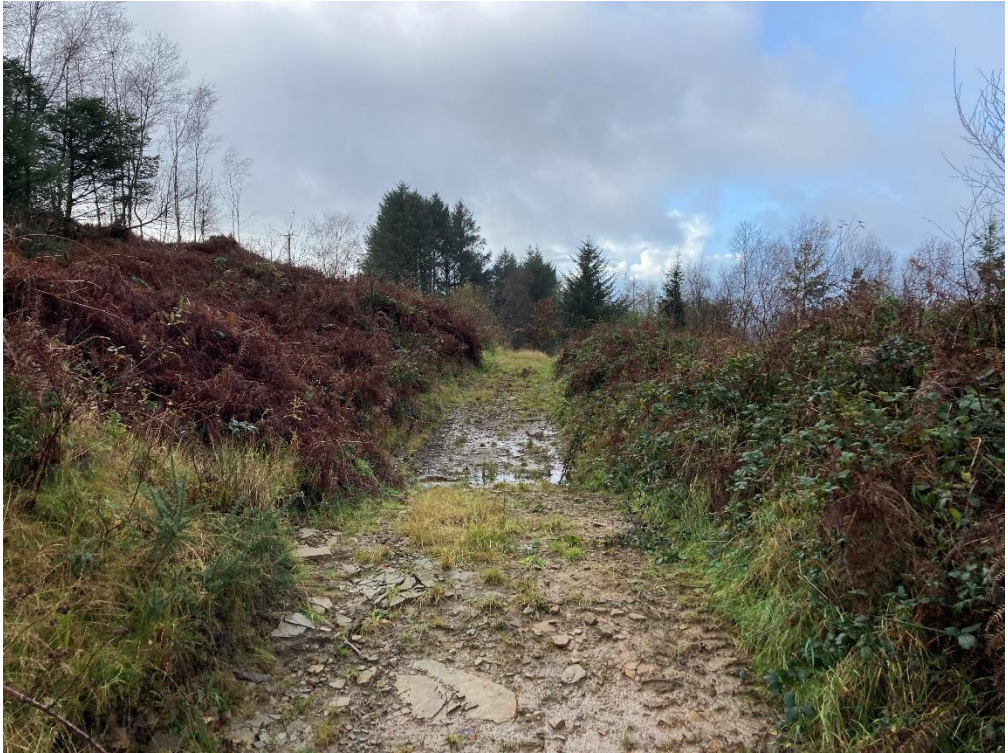
| <b>Desk Study<br/>Photograph 21</b> | |

| <b>Description:</b><br>Hummocky land in the west of the site along a track. | |

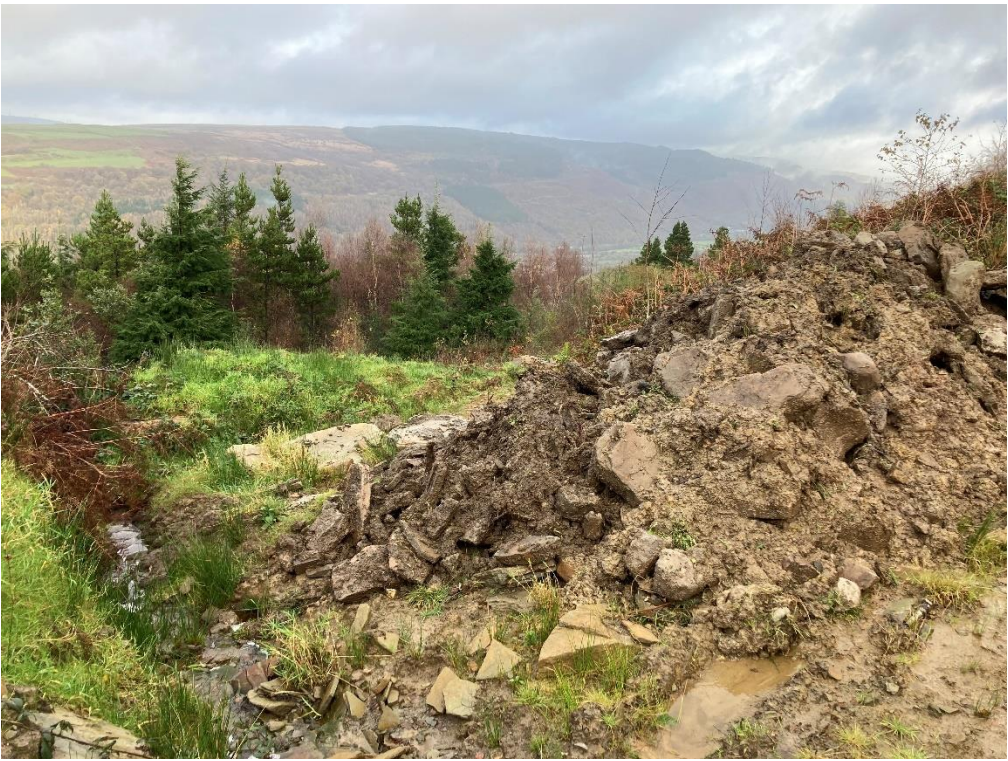
| <b>Desk Study<br/>Photograph 22</b> | |

| <b>Description:</b> Pile of excavated material which appeared natural. | |

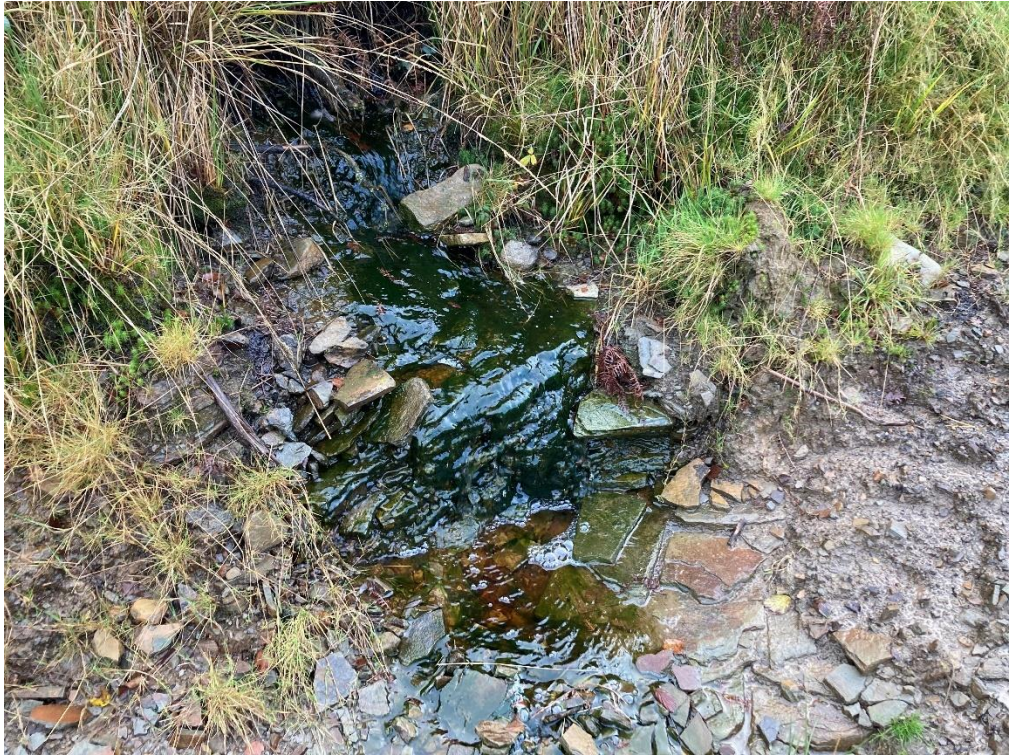
| <b>Desk Study<br/>Photograph 23</b> | |

| <b>Description:</b> Dark runoff indicating possible presence of Peat. | |

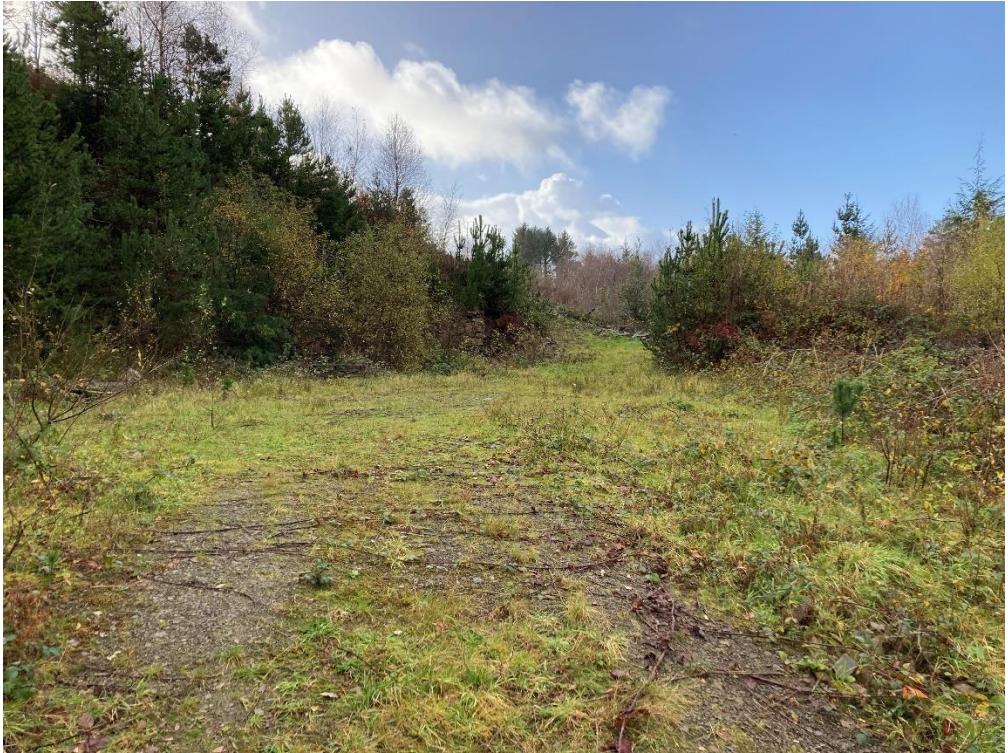
| <b>Desk Study<br/>Photograph 25</b> | |

| <b>Description:</b> Plateau in the central area of the site which appeared to be cut and fill. | |

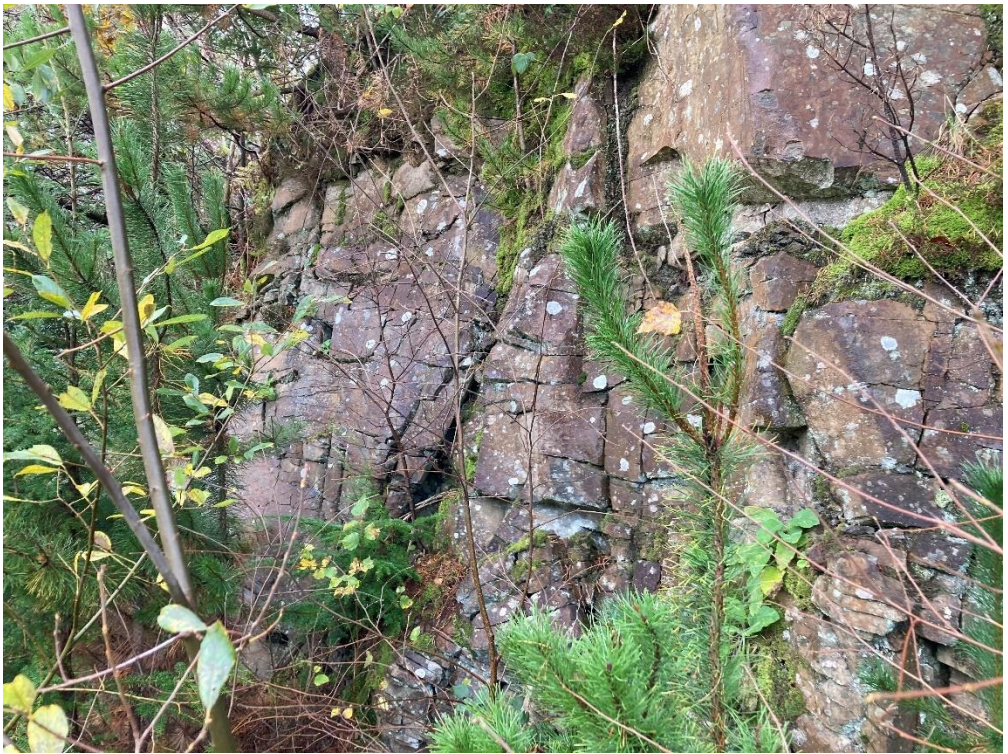
| <b>Desk Study<br/>Photograph 26</b> | |

| <b>Description:</b> Bedrock exposure, thin to thickly bedded, frequently faulted and jointed with some folding. 5m to 15m high. Appeared mostly stable. | |

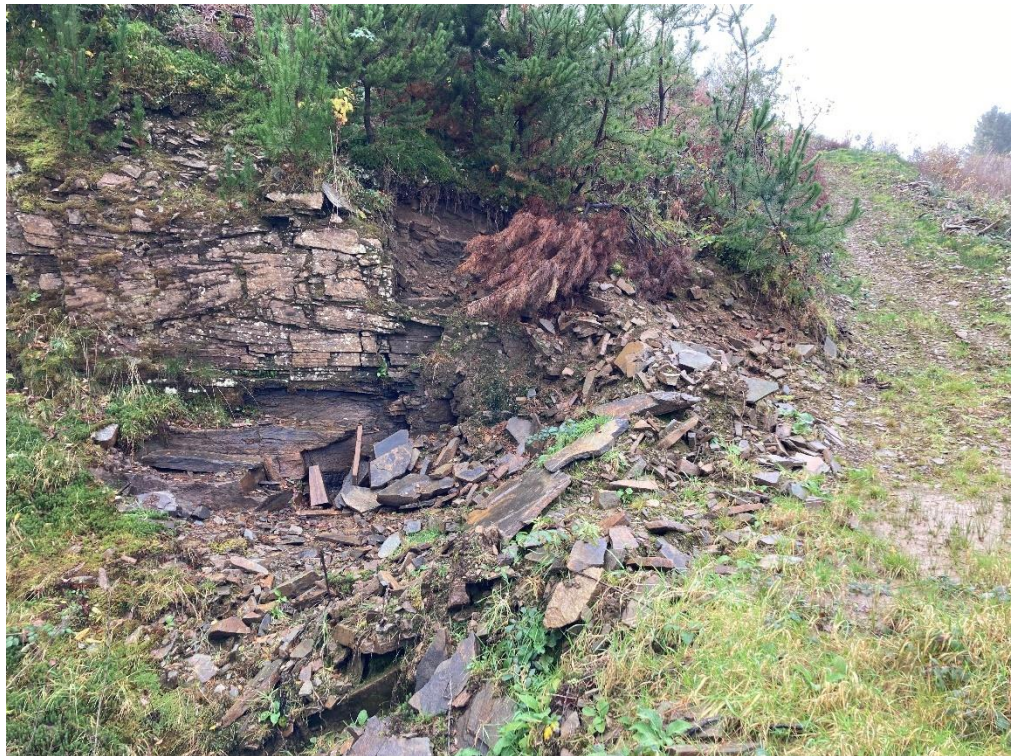
| <b>Desk Study<br/>Photograph 27</b> | |

| <b>Description:</b> Bedrock exposure showing some instability, however this appeared to be human caused. | |

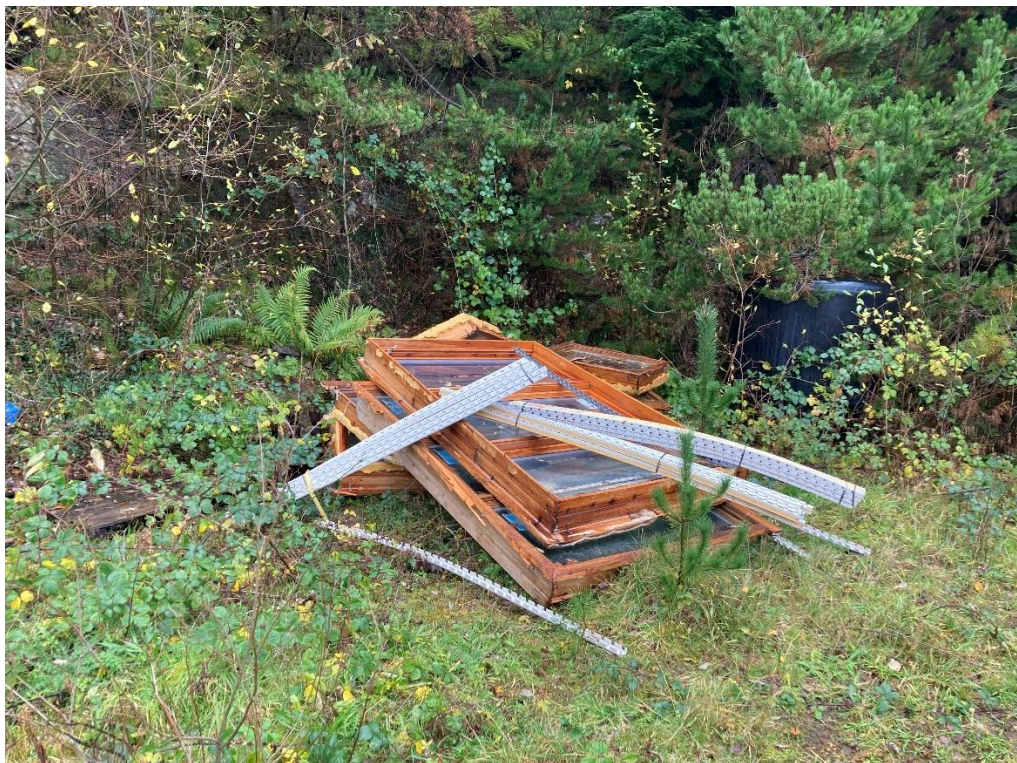
| <b>Desk Study</b><br><b>Photograph 28</b> | |

| <b>Description:</b><br>Materials and waste<br>stored on the cut<br>and fill plateau in the<br>central area of the<br>site. | |

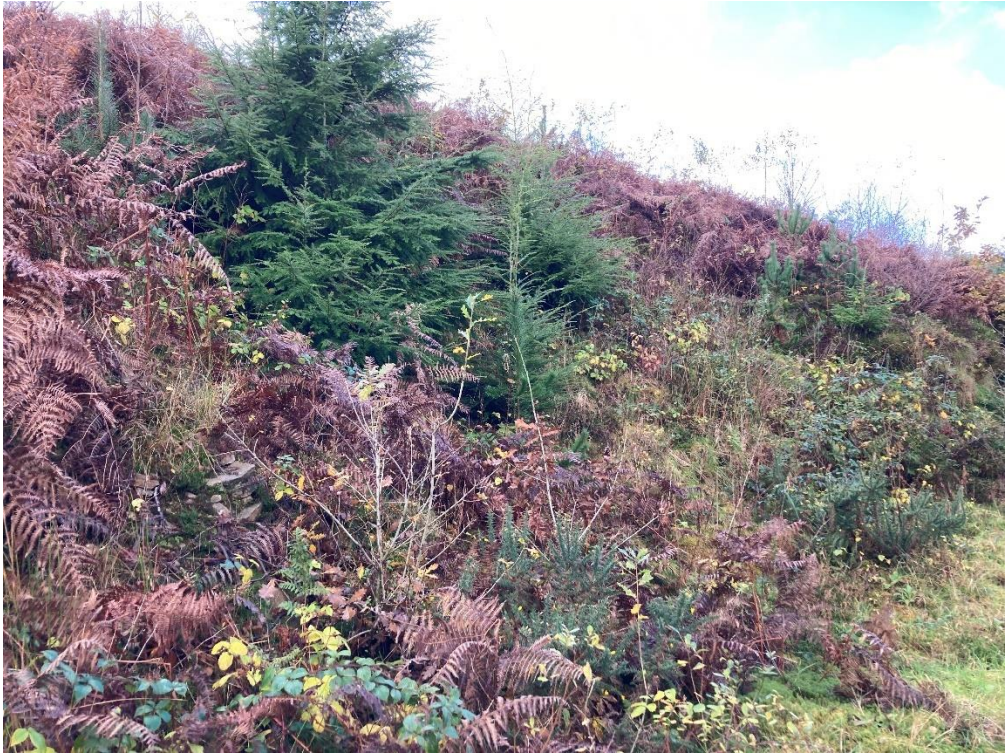
| <b>Desk Study<br/>Photograph 31</b> | |

- » Slope stability issues – general slopes – Slope toes in the northeast of the site showed signs of failure.
- » Mining – The site is underlain by several coal seams which have been worked. A colliery and several adits were historically present on site.

| <b>Description:</b><br>Localised shallow<br>circular failure in the<br>slope. | |

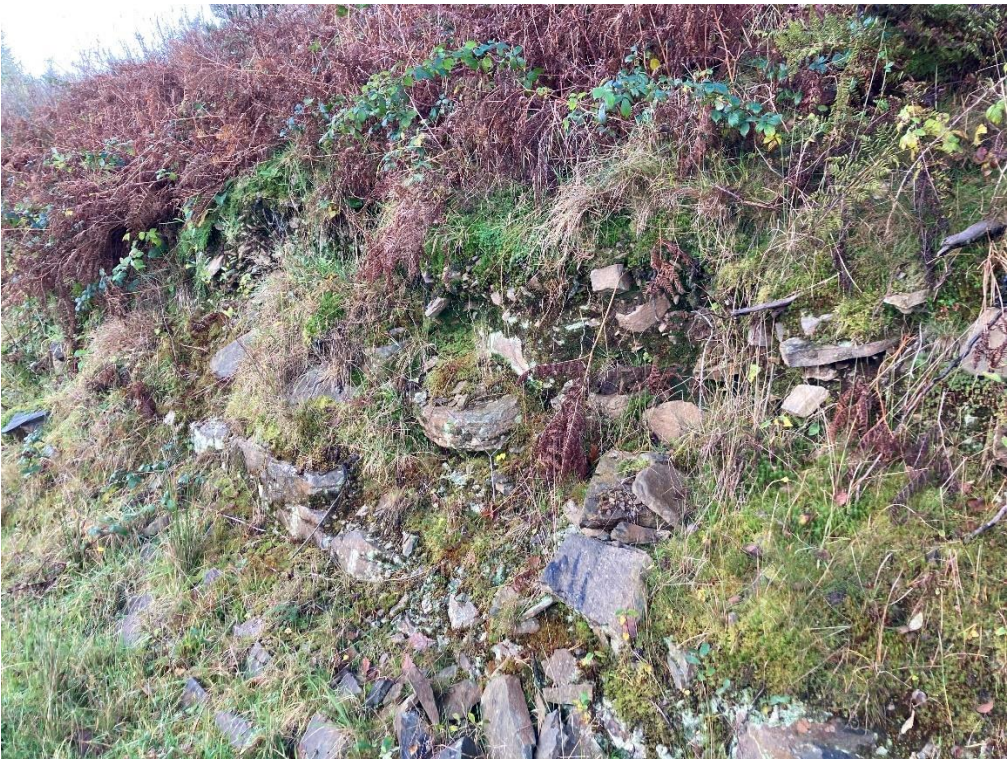
| <b>Desk Study<br/>Photograph 32</b> | |

| <b>Description:</b><br>Superficial<br>weathered bedrock<br>exposure. 15 to 20<br>degree slope,<br>roughly 2m high. | |

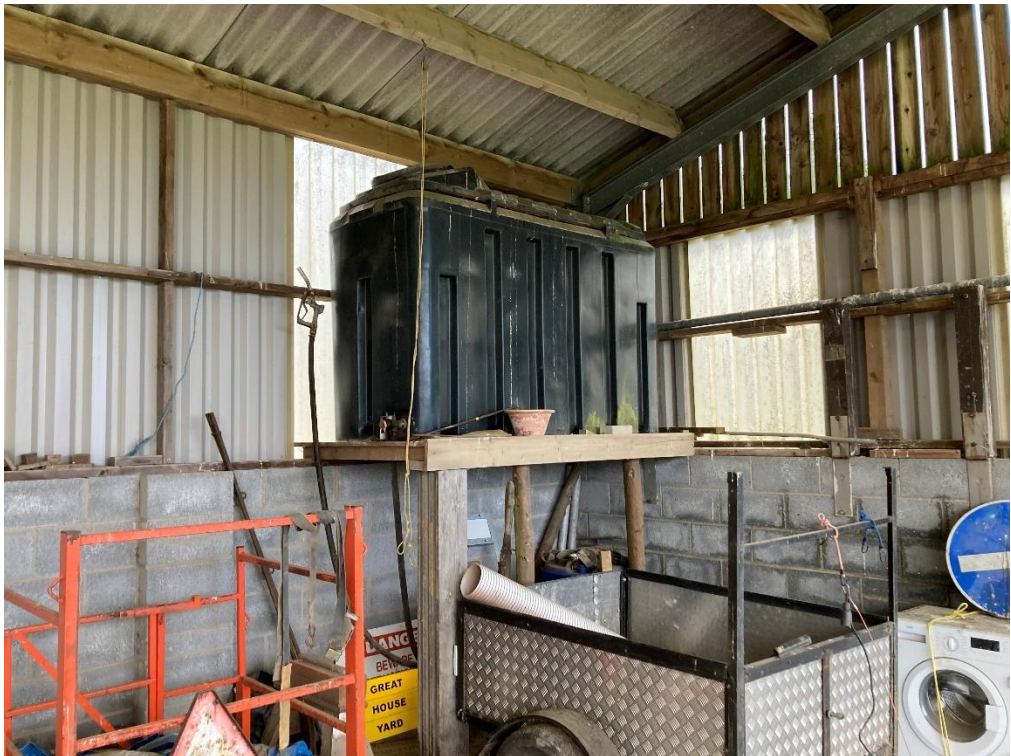
| <b>Desk Study<br/>Photograph 36</b> | |

| <b>Description:</b> Above Ground Storage Tank with a fuelling hose attached in the farm building in the central area of the site. Appeared in good condition with no signs of leaks. | |

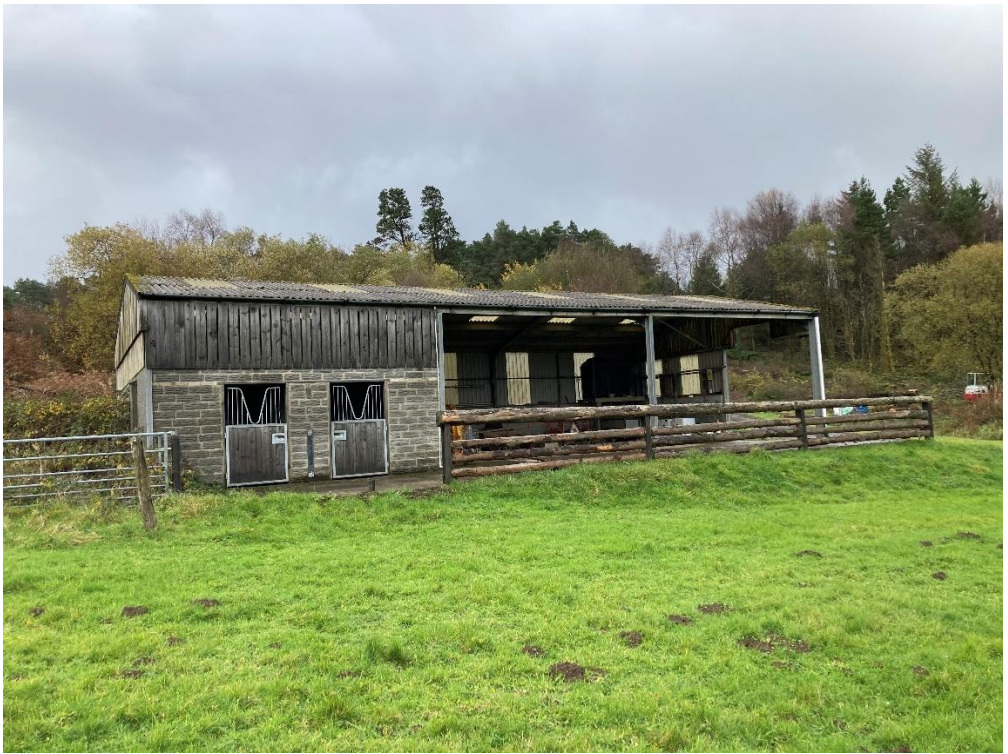
| <b>Desk Study<br/>Photograph 38</b> | |

| <b>Description:</b> Farm building in the south-central area in the site showing the asbestos tiled roof. | |

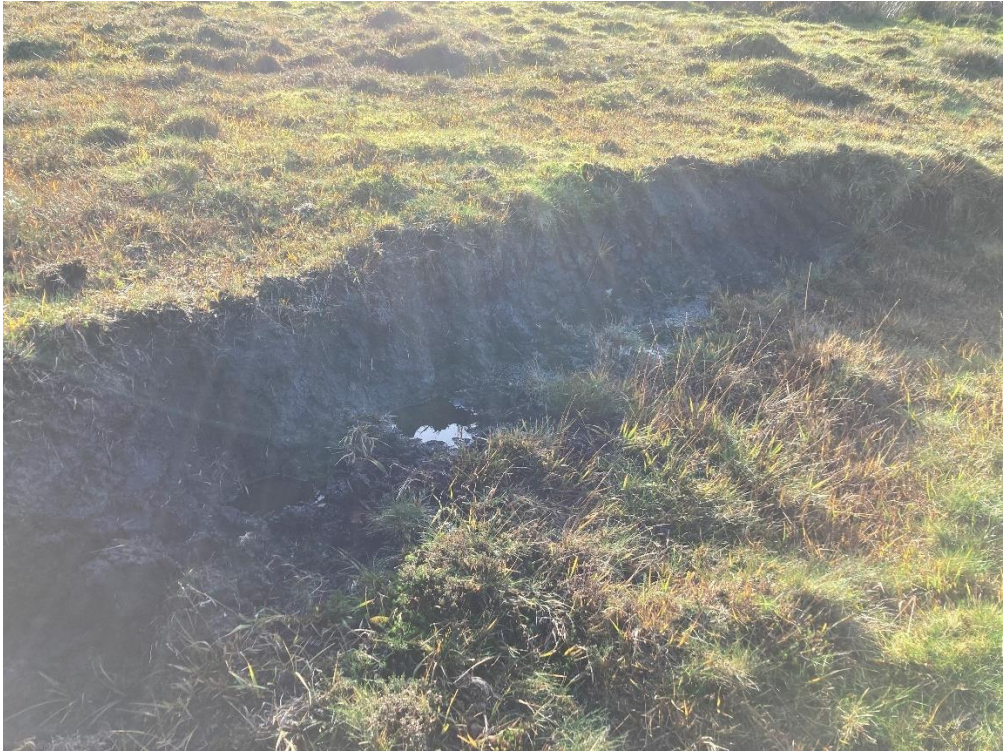
| <b>Desk Study<br/>Photograph 47</b> | |

- » BGS mapped area of Peat beneath the forest floor and joining the western boundary. Peat was found in the field to the west of the zone. Dependant on thickness, this poses significant settlement issues for any new development.
- » Ground conditions across the forest floor were extremely soft and waterlogged, likely due to surface water retention caused by the mapped peat.
- » Surface slope is shallow.
- » An electricity transmission line passes through the site.
- » Mine abandonment plans indicate that the Wenallt seam has been worked in the central-south part of the zone and a roadway passes in from the north, from the direction of the Cefn-mawr Colliery, and leaves towards the southeast.
- » Overall geotechnical risk rating - **High**

| <b>Description:</b><br>Exposure of peat in<br>the land west of the<br>site. | |

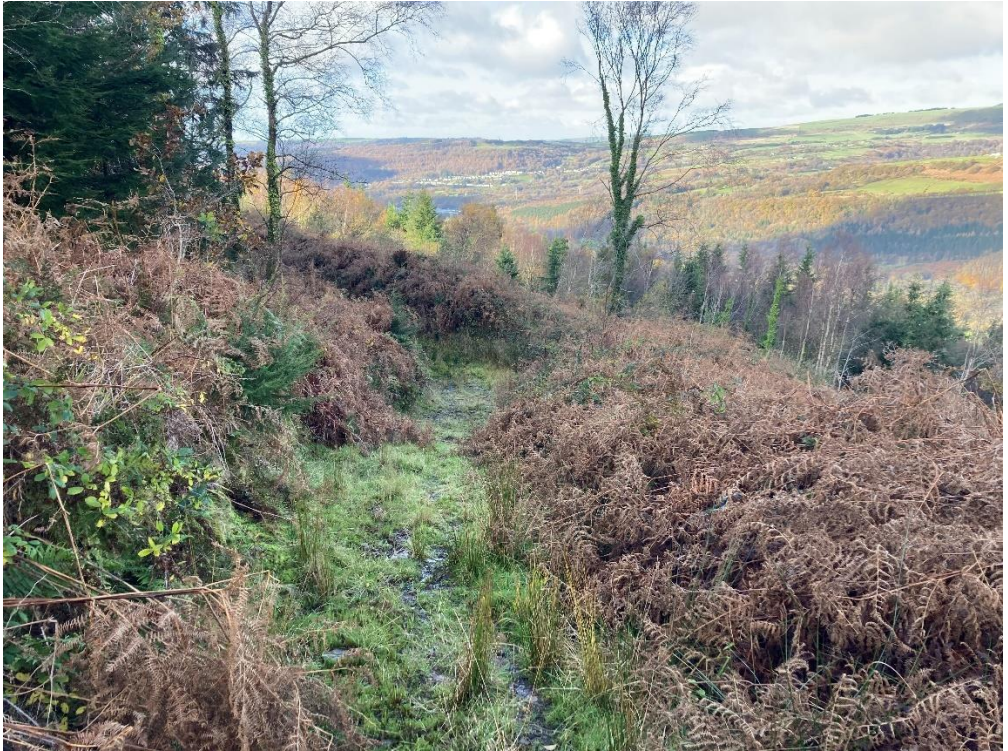
| <b>Desk Study<br/>Photograph 49</b> | |

| <b>Description:</b><br>Hummocky ground at the northern base of the forest in the east. Boggy conditions encountered frequently. | |

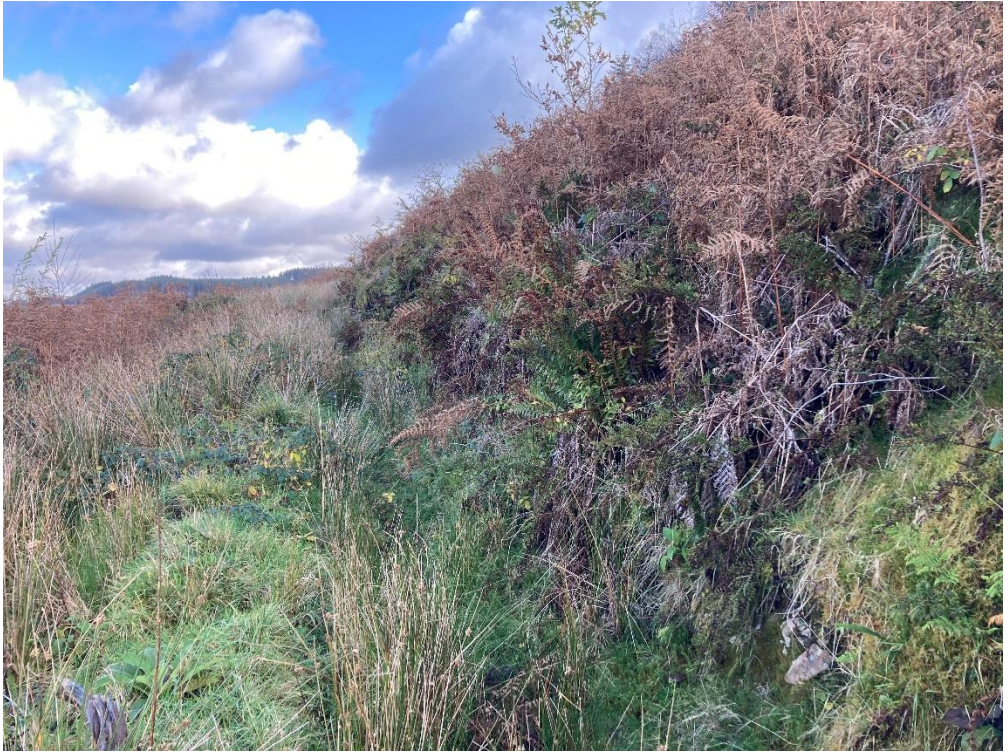
| <b>Desk Study<br/>Photograph 53</b> | |

| <b>Description:</b><br>Superficial<br>weathered bedrock<br>exposure, ~1.5m<br>high and appearing<br>stable. | |

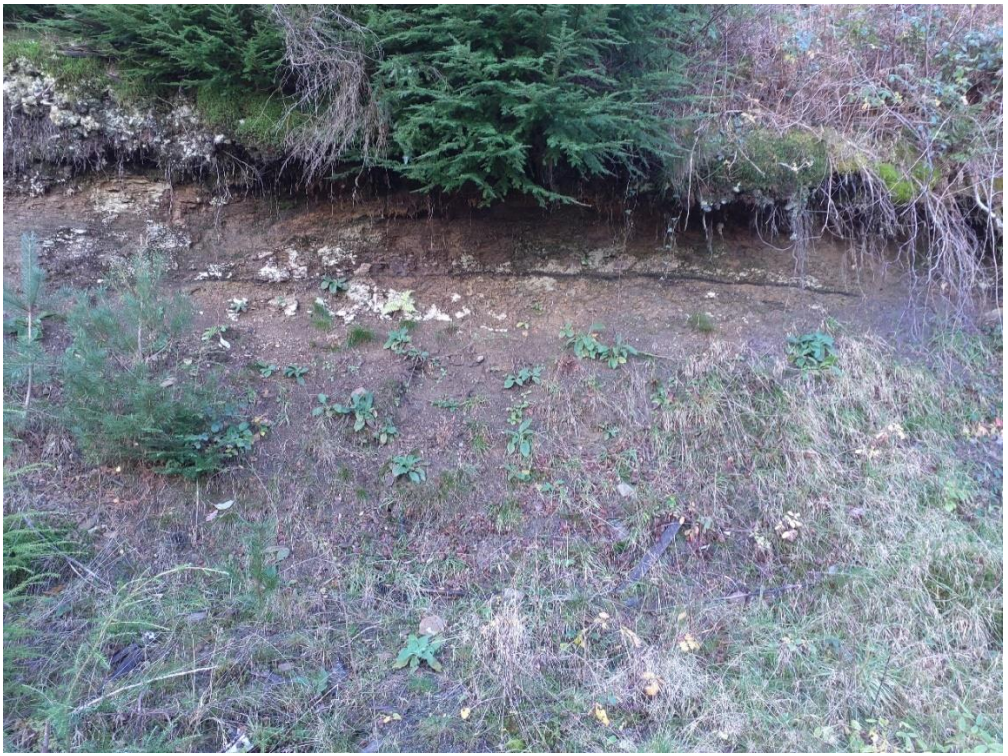
| <b>Desk Study<br/>Photograph 58</b> | |

| <b>Description:</b><br>Superficial weathered bedrock exposure, possibly a failure plane. 3m to 4m high. Note the band of coal. | |

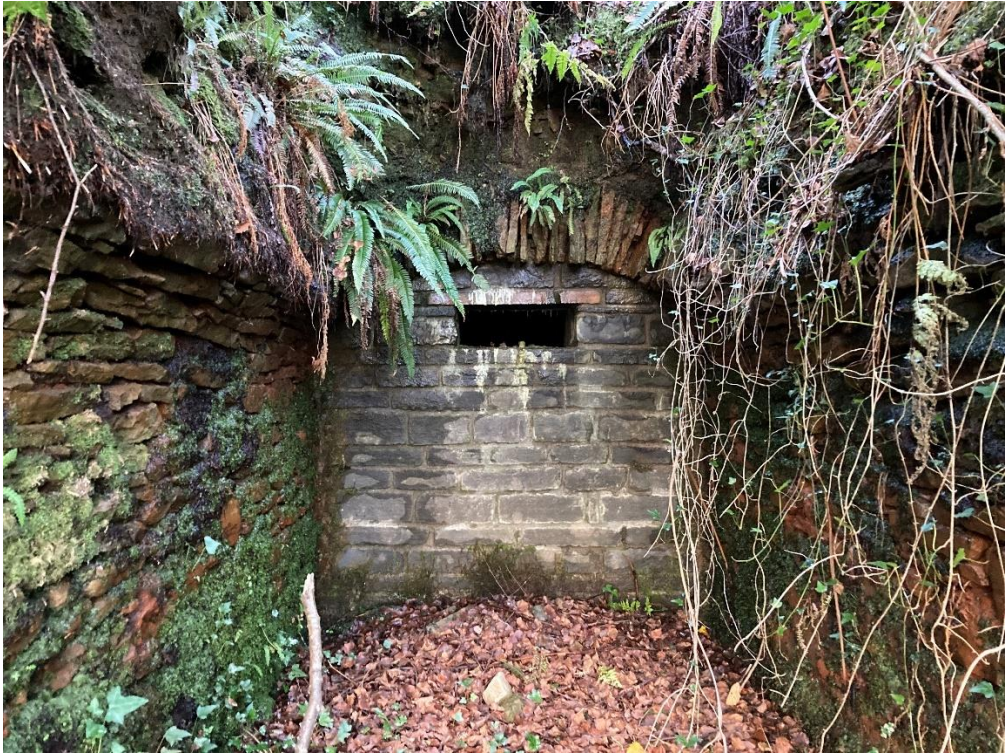
| <b>Desk Study<br/>Photograph 61</b> | |

- » Existing below ground structures to remain (tunnels) – A historical tunnel was noted in the northwest of the site and tunnels are expected to protrude into the site from adit locations.

| <b>Description:</b> Bricked up mine adit at the base of the slope in the north of the site. | |

- » Foundation assessment at proposed development locations;
- » Slope stability assessment at proposed development locations;
- » Vegetation clearance and additional site walkovers to determine distribution of mine adits on site.
