# **Retrospective application for the demolition of a dwelling and the construction of a replacement detached dwelling**

**The Paddock  
Access to Dyffryn Farm  
Dyffryn  
SA10 7BQ**

**Structural Survey Report**

Report Ref: PO-06912

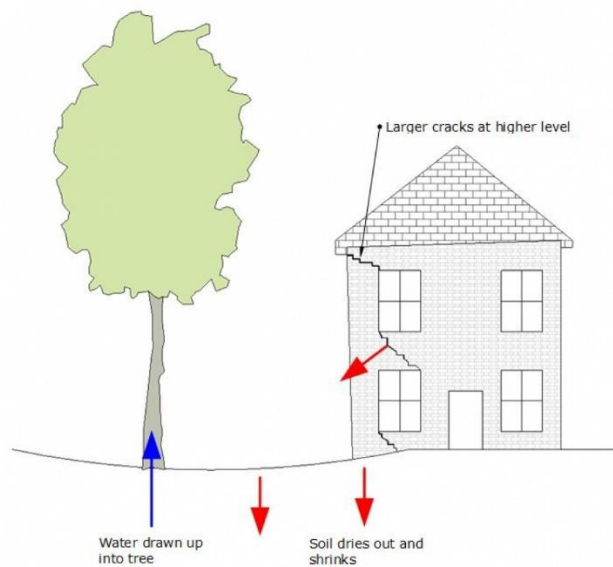
**Figure 1**

Another common cause of subsidence are broken drains which cause water to leak out into the clay which over time weakens it significantly. There are more rare instances of subsidence due to coal mining or other mining activity beneath a property however this is less common and usually highlighted as part of a legal review prior to your purchase. Subsidence cracks are most commonly wider at the top of a property, and the cracks will generally travel diagonally in opposition to the downward movement, this can be seen in Figure 1.

A common repair for subsidence is to remove the offending tree in stages so that heave does not occur (explained below) and underpin the property, repairing significant cracks and repointing.

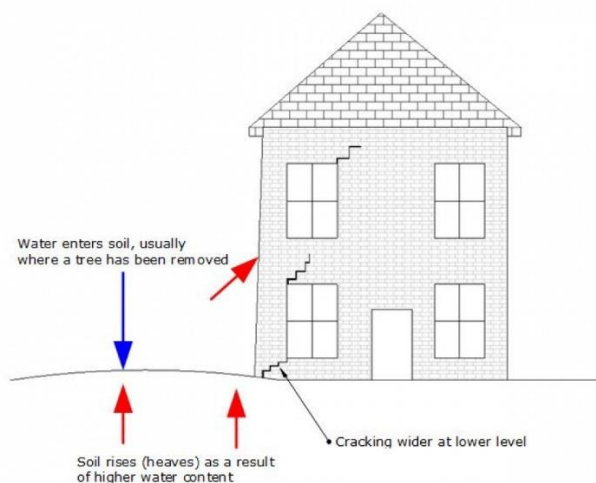
**Figure 2**

This is the upward movement of soil and can broadly be considered the opposite of subsidence. This is caused as a result of dry soils expanding due to water being reintroduced. The most common example of heave is where a large tree is removed and the water which it would have drawn up is now introduced back into the soil. This is why it is best to remove a large tree over time so that there is no sudden heave. Where heave occurs, cracking is normally wider at the bottom of the property and tapers as it rises, and cracks generally occur at right angles to the diagonal and upward movement. This can be seen in Figure 2.

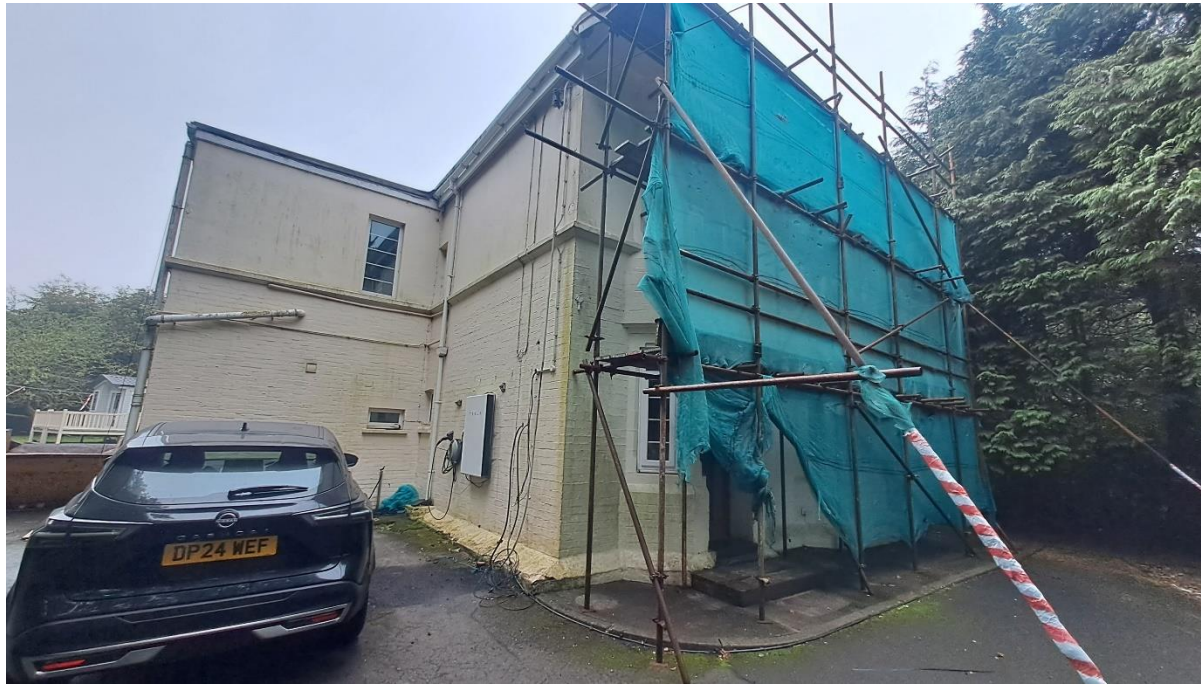
**Photograph 1 – Front elevation**

The property is a two-storey detached house at Neath Port Talbot. The property is currently undergoing a wholesale refurbishment. Photograph 1 illustrates the front elevation of the property.
