## Method Statement

### Neath Masonic Hall

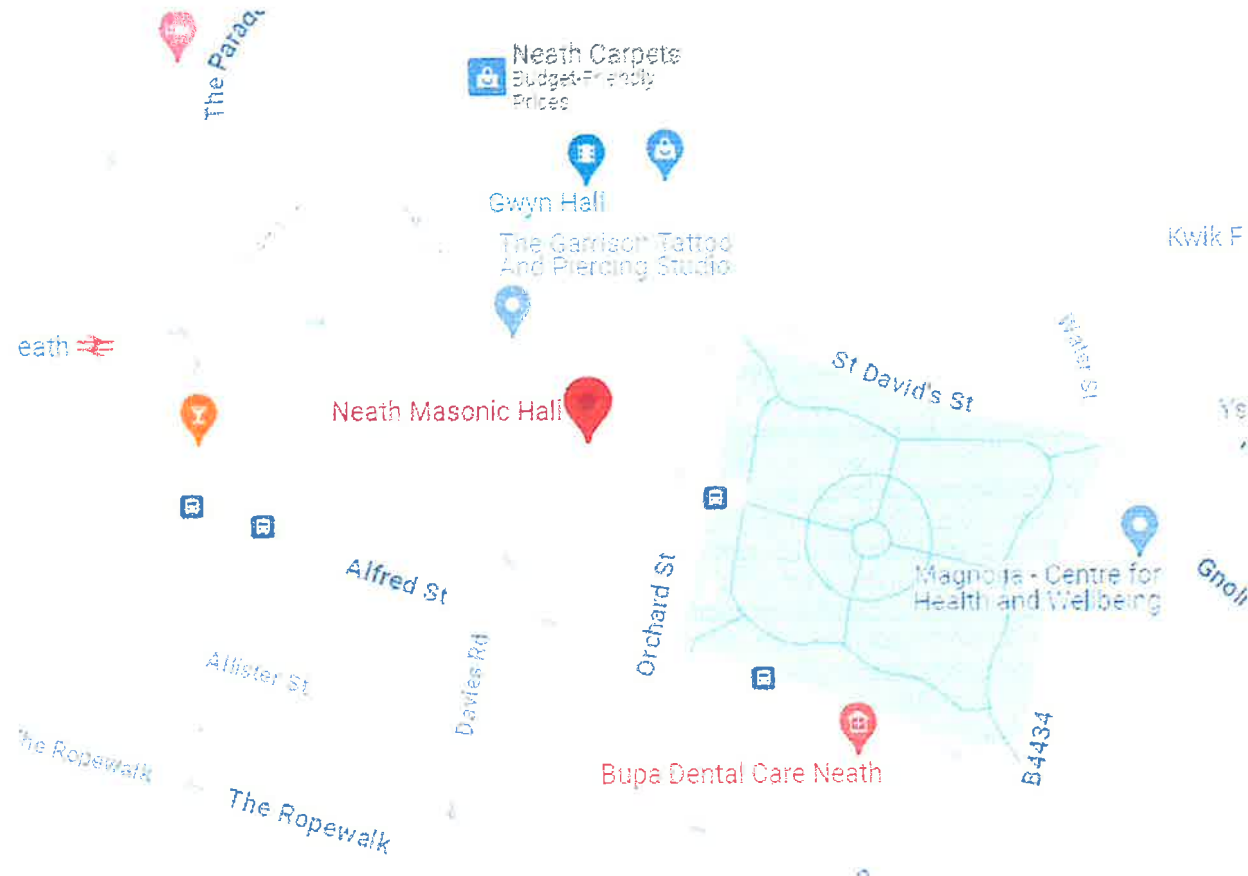
#### Building position

The building is situated on a pedestrian section of Queen Street in Neath town centre. It has a visual impact to people that regularly use the Town. The work needs to be carried out for both safety and aesthetic reasons. The high-level masonry is in danger of deteriorating at an increasing rate if the Buddleia if it is not dealt with soon. It would also have an uplifting effect to the street to see it being brought back to a state of good repair.

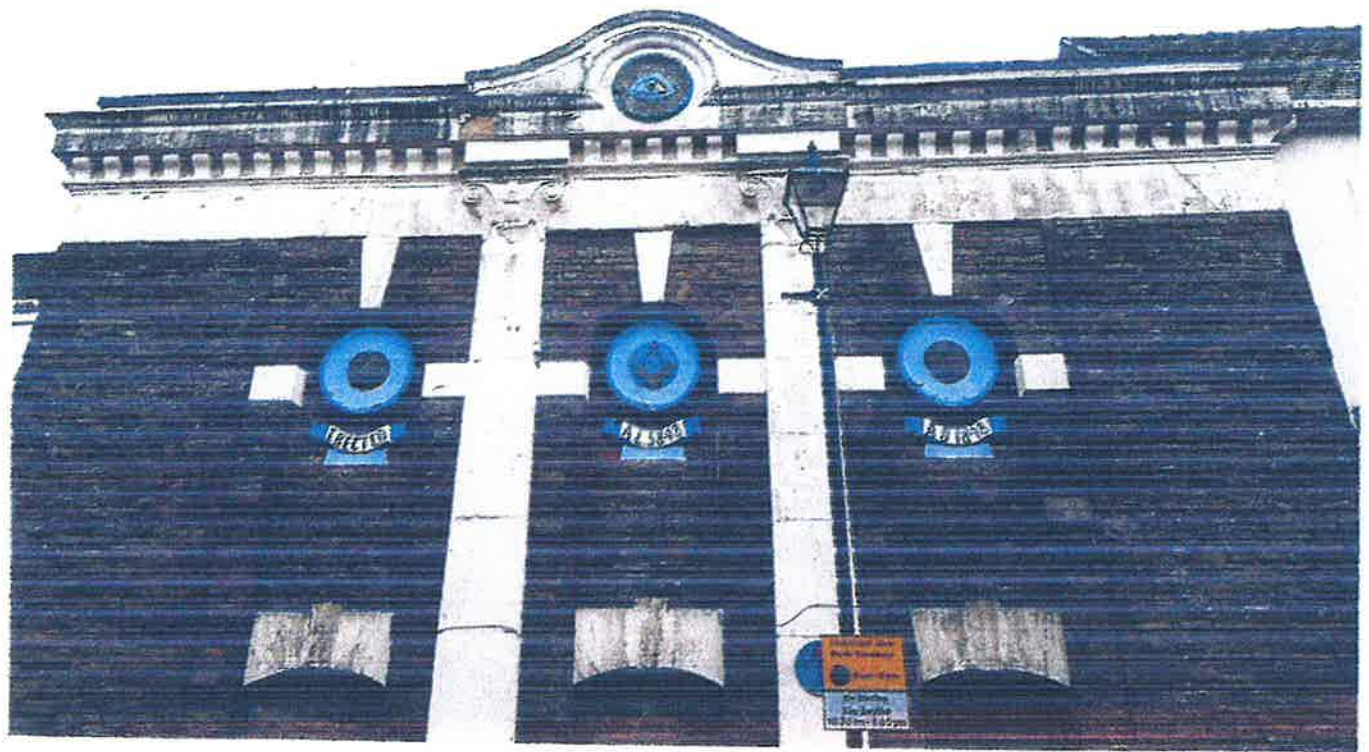
The proposed works to the Neath Masonic building are intended to rectify the centuries of wear on the fabric of the buildings frontage, to return it to good decorative and structural standards, to the necessary specifications that such a CADW listed building requires. Within that intent is not only the return to presentable condition, but also one of safety for users of the building, and the public that pass it on a frequent basis, given it's town centre location. Also necessary is the removal of improperly applied 'protective coatings' that have in fact added to the deterioration of the façade in part. It cannot be considered acceptable for it to remain in the current unsightly and hazardous condition, though safety measures are in place to prevent access to the perimeter area.
