## Drainage Survey Report

**Job Number : 18075**

**Project Name: Former Swelco Factory, Cwmgors**

**Company: Bluefield Land**

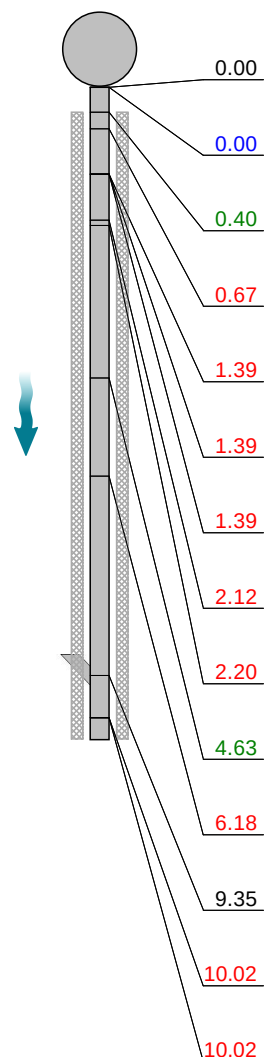
| Scale: 1:120 | Position [m] | Code | Observation | MPEG | Photo | Grade |
|---|---|---|---|---|---|---|
| <b>Depth: 1.15 m</b><br><b>MHF1</b> | | | | | | |

| Scale: 1:120 | Position [m] | Code | Observation | MPEG | Photo | Grade |
|---|---|---|---|---|---|---|
| | 0.67 | CSJ | Cracks, spiral at joint from 9 o'clock to 10 o'clock | 00:00:25 | | 3 / 2 |
| | 1.39 | FLJ | Fracture, longitudinal at joint at 4 o'clock | 00:00:46 | 1 | 3 / 2 |
| | 1.39 | FLJ | Fracture, longitudinal at joint at 2 o'clock | 00:00:52 | 2 | 3 / 2 |
| | 1.39 | CCJ | Crack, circumferential at joint from 2 o'clock to 4 o'clock | 00:00:54 | | 2 / 2 |
| | 2.12 | FCJ | Fracture, circumferential at joint from 2 o'clock to 4 o'clock | 00:01:10 | 3 | 3 / 2 |
| | 2.20 | CLJ | Crack, longitudinal at joint at 10 o'clock | 00:01:22 | | 2 / 2 |
| | 6.18 | FSJ | Fracture, spiral at joint from 8 o'clock to 10 o'clock | 00:02:32 | 4 | 4 / 2 |
| | 10.02 | FLJ | Fracture, longitudinal at joint at 10 o'clock | 00:03:33 | 5 | 3 / 2 |
| | 10.02 | FSJ | Fracture, spiral at joint from 1 o'clock to 3 o'clock | 00:03:50 | 6 | 4 / 2 |

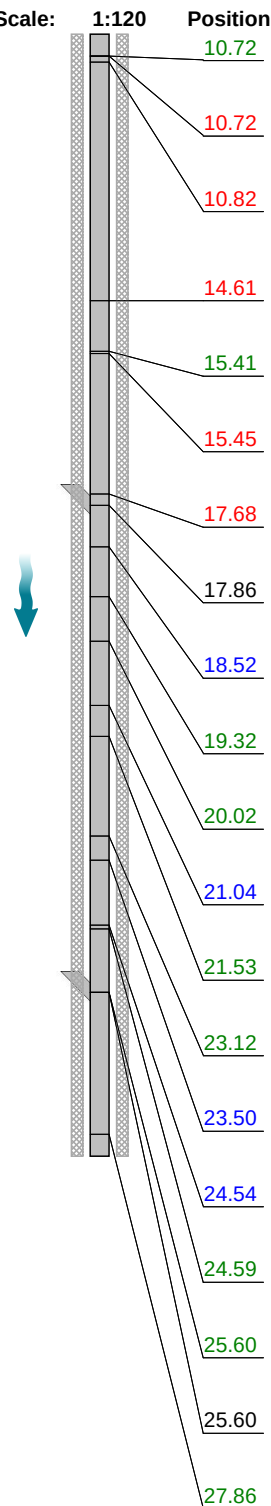
| Scale: | 1:120 | Position [m] | Code | Observation | MPEG | Photo | Grade |
|---|---|---|---|---|---|---|---|
| | | 10.72 | DEEJ | Attached deposits, encrustation at joint from 3 o'clock to 5 o'clock, 5% cross-sectional area loss | 00:04:09 | | 3 |
| | | 10.72 | FCJ | Fracture, circumferential at joint from 9 o'clock to 2 o'clock | 00:04:14 | 7 | 3 / 2 |
| | | 10.82 | FLJ | Fracture, longitudinal at joint at 9 o'clock | 00:04:26 | 8 | 3 / 2 |
| | | 14.61 | CCJ | Crack, circumferential at joint from 11 o'clock to 1 o'clock | 00:05:17 | | 2 / 2 |
| | | 15.45 | FCJ | Fracture, circumferential at joint from 10 o'clock to 2 o'clock | 00:05:37 | 9 | 3 / 2 |
| | | 17.68 | CCJ | Crack, circumferential at joint from 3 o'clock to 4 o'clock | 00:06:14 | | 2 / 2 |

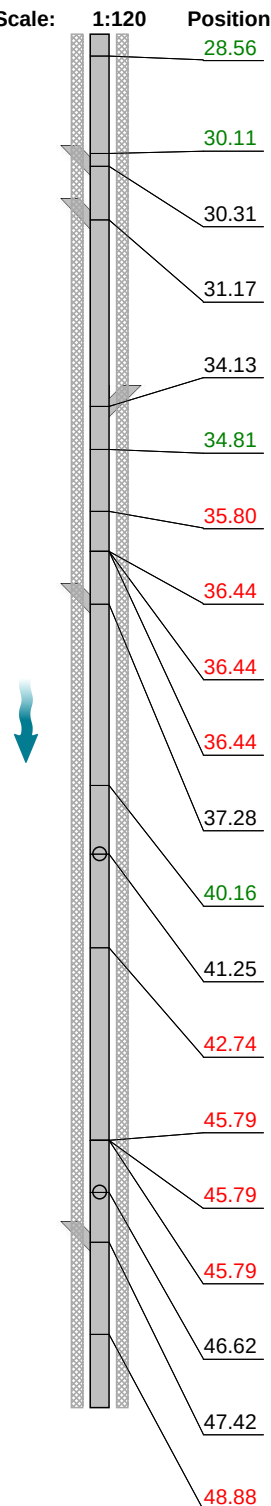
| Scale: | 1:120 | Position [m] | Code | Observation | MPEG | Photo | Grade |
|---|---|---|---|---|---|---|---|
| | | 28.56 | DEEJ | Attached deposits, encrustation at joint from 3 o'clock to 5 o'clock, 5% cross-sectional area loss | 00:08:36 | | 3 |
| | | 30.11 | DEE | Attached deposits, encrustation from 7 o'clock to 11 o'clock, 5% cross-sectional area loss | 00:09:00 | | 3 |
| | | 35.80 | CLJ | Crack, longitudinal at joint at 12 o'clock | 00:10:09 | | 2 / 2 |
| | | 36.44 | FLJ | Fracture, longitudinal at joint at 3 o'clock | 00:10:36 | 10 | 3 / 2 |
| | | 36.44 | CLJ | Crack, longitudinal at joint at 10 o'clock | 00:10:41 | | 2 / 2 |
| | | 36.44 | CCJ | Crack, circumferential at joint from 10 o'clock to 3 o'clock | 00:10:44 | | 2 / 2 |
| | | 42.74 | CLJ | Crack, longitudinal at joint at 9 o'clock | 00:11:53 | | 2 / 2 |
| | | 45.79 | CLJ | Crack, longitudinal at joint at 9 o'clock | 00:12:20 | | 2 / 2 |
| | | 45.79 | CLJ | Crack, longitudinal at joint at 11 o'clock | 00:12:23 | | 2 / 2 |
| | | 45.79 | FLJ | Fracture, longitudinal at joint at 3 o'clock | 00:12:27 | 11 | 3 / 2 |
| | | 48.88 | CCJ | Crack, circumferential at joint from 11 o'clock to 3 o'clock | 00:13:12 | | 2 / 2 |

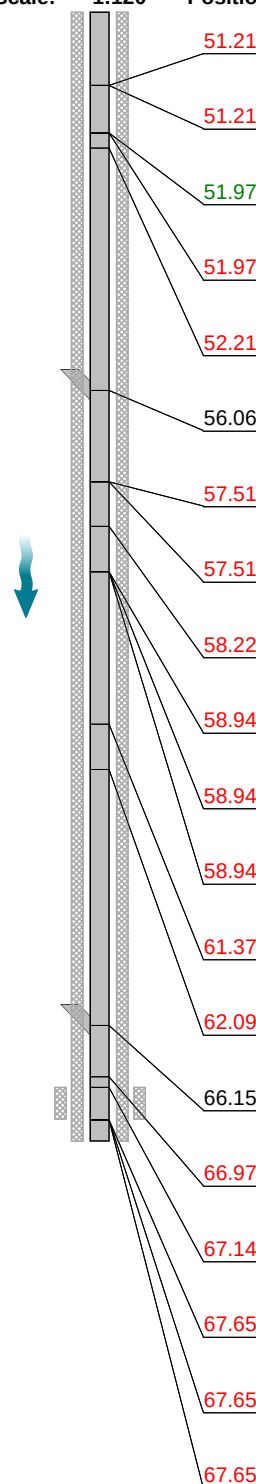
| Scale: 1:120 | Position [m] | Code | Observation | MPEG | Photo | Grade |
|---|---|---|---|---|---|---|
| | 51.21 | CLJ | Crack, longitudinal at joint at 9 o'clock | 00:13:41 | | 2 / 2 |
| | 51.21 | CCJ | Crack, circumferential at joint from 8 o'clock to 12 o'clock | 00:13:45 | | 2 / 2 |
| | 51.97 | IR | Infiltration, running at 12 o'clock | 00:13:56 | 12 | |
| | 51.97 | FLJ | Fracture, longitudinal at joint at 11 o'clock | 00:13:59 | 13 | 3 / 2 |
| | 52.21 | CLJ | Crack, longitudinal at joint at 4 o'clock | 00:14:09 | | 2 / 2 |
| | 57.51 | CSJ | Cracks, spiral at joint from 10 o'clock to 11 o'clock | 00:15:04 | | 3 / 2 |
| | 57.51 | CLJ | Crack, longitudinal at joint at 1 o'clock | 00:15:06 | | 2 / 2 |
| | 58.22 | CSJ | Cracks, spiral at joint from 11 o'clock to 12 o'clock | 00:15:18 | | 3 / 2 |
| | 58.94 | CLJ | Crack, longitudinal at joint at 12 o'clock | 00:15:28 | | 2 / 2 |
| | 58.94 | CLJ | Crack, longitudinal at joint at 10 o'clock | 00:15:29 | | 2 / 2 |
| | 58.94 | CCJ | Crack, circumferential at joint from 8 o'clock to 12 o'clock | 00:15:30 | | 2 / 2 |
| | 61.37 | CLJ | Crack, longitudinal at joint at 10 o'clock | 00:15:49 | | 2 / 2 |
| | 62.09 | CLJ | Crack, longitudinal at joint at 9 o'clock | 00:15:58 | | 2 / 2 |
| | 66.97 | CC | Crack, circumferential from 11 o'clock to 2 o'clock | 00:16:41 | | 2 / 2 |
| | 67.65 F02 | CLJ | Crack, longitudinal at joint at 12 o'clock, finish | 00:16:58 | | 2 / 2 |
| | 67.65 | FLJ | Fracture, longitudinal at joint at 12 o'clock | 00:16:59 | 14 | 3 / 2 |
| | 67.65 | CCJ | Crack, circumferential at joint from 2 o'clock to 5 o'clock | 00:17:22 | | 2 / 2 |

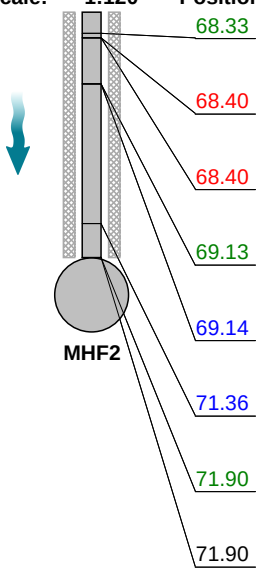
| Scale: | 1:120 | Position [m] | Code | Observation | MPEG | Photo | Grade |
|---|---|---|---|---|---|---|---|
| | | 68.33 | RFJ | Roots, fine at joint | 00:17:33 | | 2 |
| | | 68.40 | CSJ | Cracks, spiral at joint from 11 o'clock to 12 o'clock | 00:17:39 | | 3 / 2 |
| | | 68.40 | FSJ | Fracture, spiral at joint from 12 o'clock to 1 o'clock | 00:17:40 | 15 | 4 / 2 |

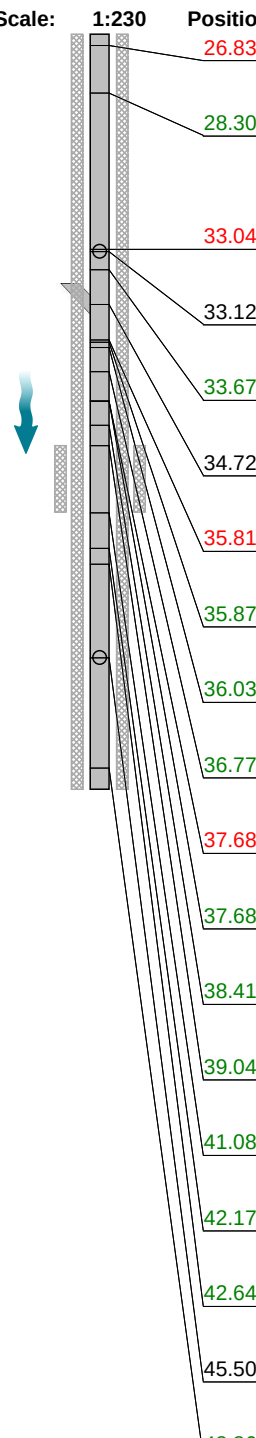
| Scale: | 1:230 | Position [m] | Code | Observation | MPEG | Photo | Grade |
|---|---|---|---|---|---|---|---|
| | | 26.83 | BJ | Broken pipe at joint from 1 o'clock to 2 o'clock | 00:04:00 | 3 | 4 |
| | | 28.30 | RFJ | Roots, fine at joint | 00:04:25 | | 2 |
| | | 33.04 | CLJ | Crack, longitudinal at joint at 1 o'clock | 00:04:59 | | 2 / 2 |

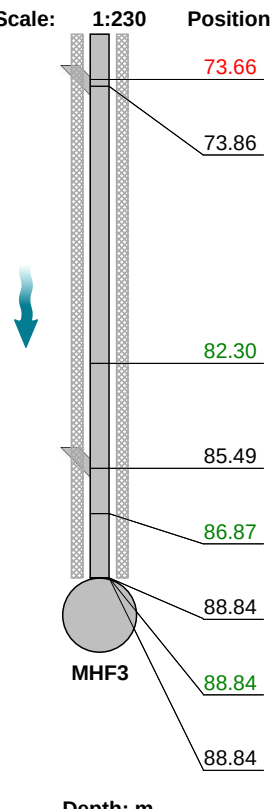
| Scale: | 1:230 | Position [m] | Code | Observation | MPEG | Photo | Grade |
|---|---|---|---|---|---|---|---|
| | | 73.66 | BJ | Broken pipe at joint from 2 o'clock to 5 o'clock | 00:12:56 | 10 | 4 |
| | | 82.30 | RTJ | Roots, tap at joint | 00:13:55 | | 4 |
