# Demolition Survey

Llangatwg Comprehensive School  
Main Road  
Cadoxton  
Neath

# 1.0 Executive summary:

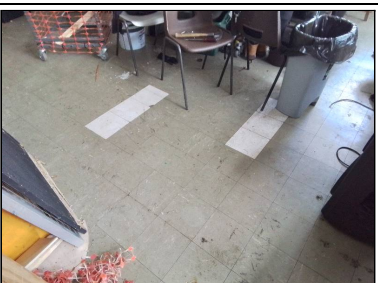
| | CF002279 (S) | Reinforced Composite (1) | Completely Sealed (0) | Low Damage (1) | Easily disturbed |
| Surveyor comments | Label, Arrange removal and dispose of as hazardous waste (in accordance with CAR 2012 & ACoP) prior to refurbishment/demolition works; some damage present and/or vulnerable to further damage, but not causing an immediate hazard. | | | | |

| Recommended action | C - Repair or Remove | | | | |

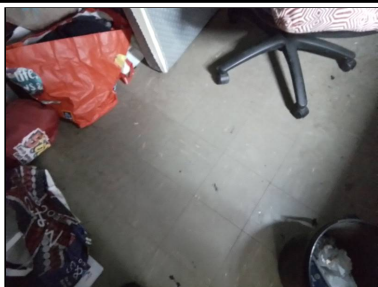
| | As CF002279 (SP) | Reinforced Composite (1) | Completely Sealed (0) | Low Damage (1) | Easily disturbed |
| Surveyor comments | Label, Arrange removal and dispose of as hazardous waste (in accordance with CAR 2012 & ACoP) prior to refurbishment/demolition works; some damage present and/or vulnerable to further damage, but not causing an immediate hazard. | | | | |

| Recommended action | C - Repair or Remove | | | | |

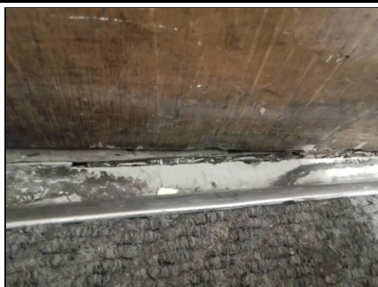
| | Survey Date: | Lead Surveyor | Survey Type | Floor | Inspection No. |
|---|---|---|---|---|---|
| | CF002283 (S) | Reinforced Composite (1) | Completely Sealed (0) | Low Damage (1) | Occasionally likely to be disturbed |
| Surveyor comments | Label, Arrange removal and dispose of as hazardous waste (in accordance with CAR 2012 & ACoP) prior to refurbishment/demolition works; some damage present and/or vulnerable to further damage, but not causing an immediate hazard. | | | | |

| | Survey Date: | Lead Surveyor | Survey Type | Floor | Inspection No. |
|---|---|---|---|---|---|
| Recommended action | C - Repair or Remove | | | | |

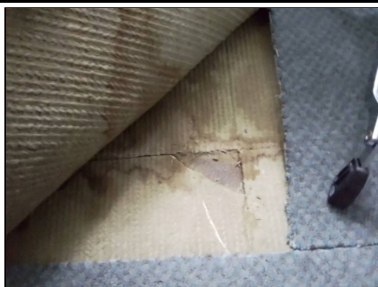
| | Survey Date: | Lead Surveyor | Survey Type | Floor | Inspection No. |
|---|---|---|---|---|---|
| | CF002284 (S) | Reinforced Composite (1) | Completely Sealed (0) | Good Condition (0) | Usually inaccessible or unlikely to be disturbed |
| Surveyor comments | Label, Arrange removal and dispose of as hazardous waste (in accordance with CAR 2012 & ACoP) prior to refurbishment/demolition works; some damage present and/or vulnerable to further damage, but not causing an immediate hazard. | | | | |

| | Survey Date: | Lead Surveyor | Survey Type | Floor | Inspection No. |
|---|---|---|---|---|---|
| Recommended action | C - Repair or Remove | | | | |

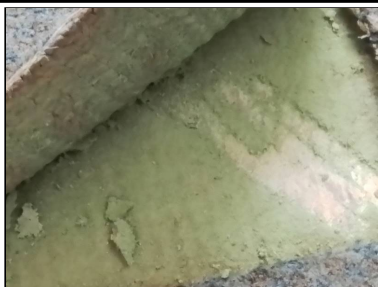
| | Survey Date: | Lead Surveyor | Survey Type | Floor | Inspection No. |
|---|---|---|---|---|---|
| | As CF002284 (SP) | Reinforced Composite (1) | Completely Sealed (0) | Good Condition (0) | Usually inaccessible or unlikely to be disturbed |
| Surveyor comments | Label, Arrange removal and dispose of as hazardous waste (in accordance with CAR 2012 & ACoP) prior to refurbishment/demolition works; some damage present and/or vulnerable to further damage, but not causing an immediate hazard. | | | | |

| | Survey Date: | Lead Surveyor | Survey Type | Floor | Inspection No. |
|---|---|---|---|---|---|
| Recommended action | C - Repair or Remove | | | | |

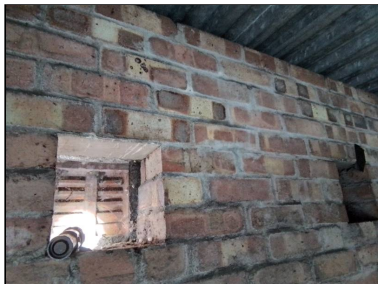
| | CF002289 (S) | Asbestos Cement (1) | Surface Sealed (1) | Good Condition (0) | Usually inaccessible or unlikely to be disturbed |
| Surveyor comments | Label, Arrange removal and dispose of as hazardous waste (in accordance with CAR 2012 & ACoP) prior to refurbishment/demolition works; some damage present and/or vulnerable to further damage, but not causing an immediate hazard. | | | | |

| Recommended action | C - Repair or Remove | | | | |
