# ASBESTOS DEMOLITION SURVEY

Lower Pontneddfechan, Pontneathvaughan Rd, Glynneath, Neath SA11 5NR

ALL110354/25/JG-1

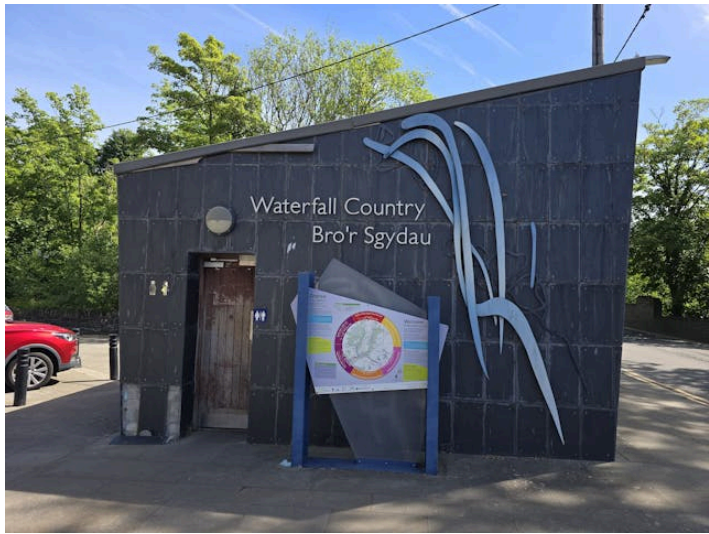
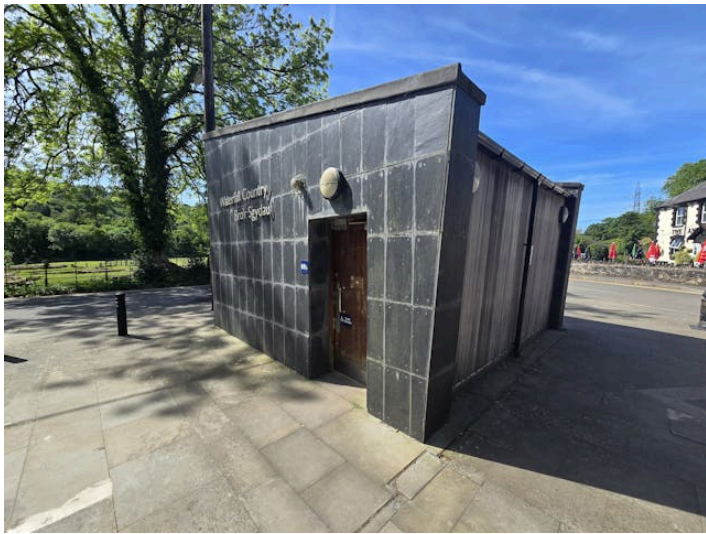
| Location Notes | Location currently in use so survey excluded at this time, waiting for client confirmation of age of construction. Further inspection can be carried out closer to time of demolition when blocked off to public use. | | |

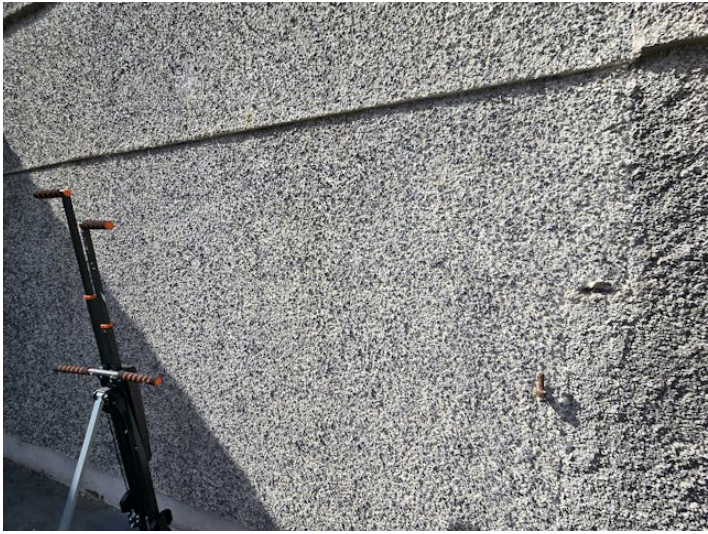
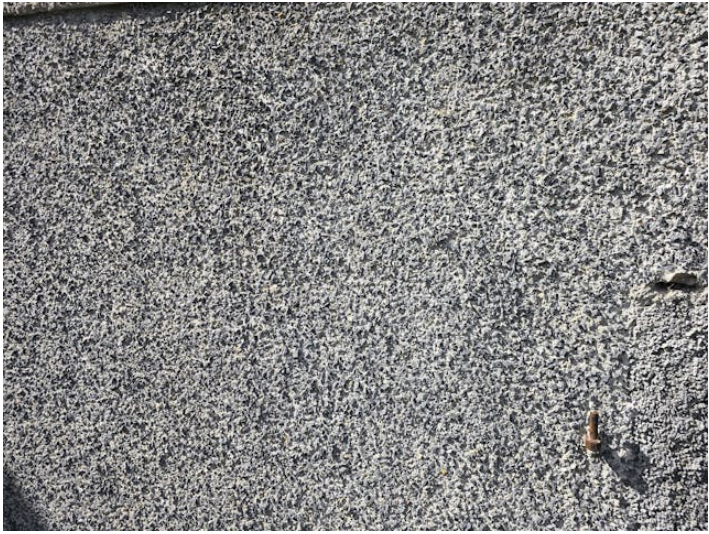
| Location | 03 - RHS Barn | Item | Rendering To Wall |

| Material | Composite | Extent | 30 m. sq. |
| Strategy / Sample Id | Sample / 110354/04 | Fibre Type | NADIS |

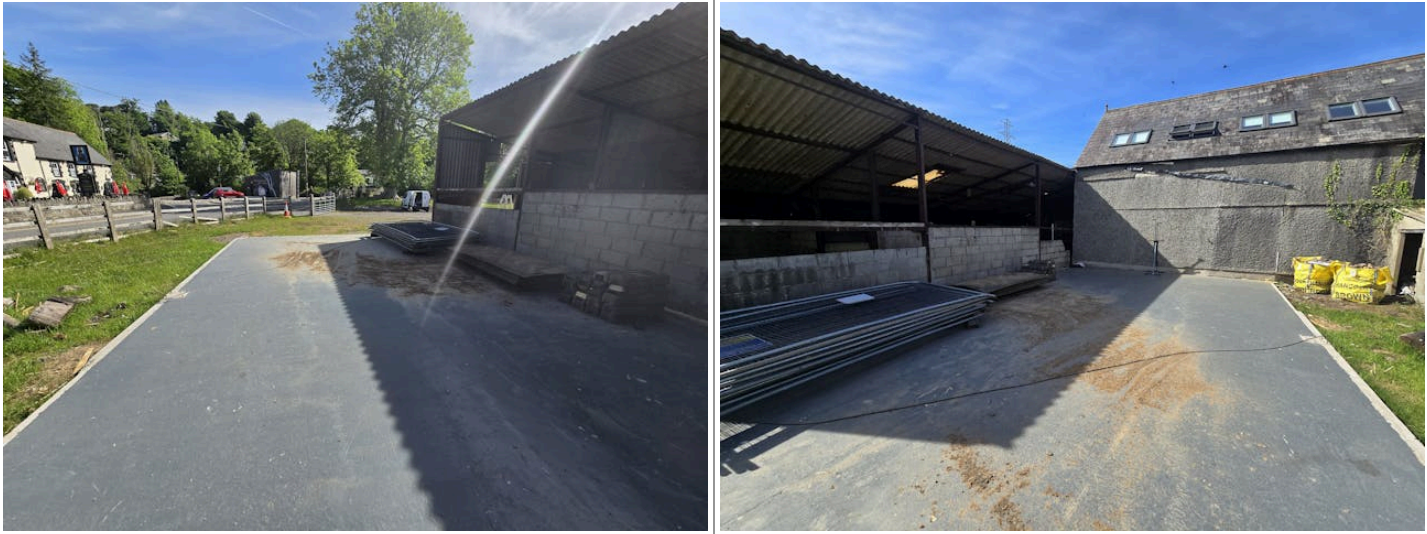
| Location | 03 - RHS Barn | Item | |

| | | <b>Location Notes</b><br>Masonry walls with partial render, painted concrete floor. No visible DPC, metal columns, cement debris to edge next to 0/04 LHS Barn, stored items. | |

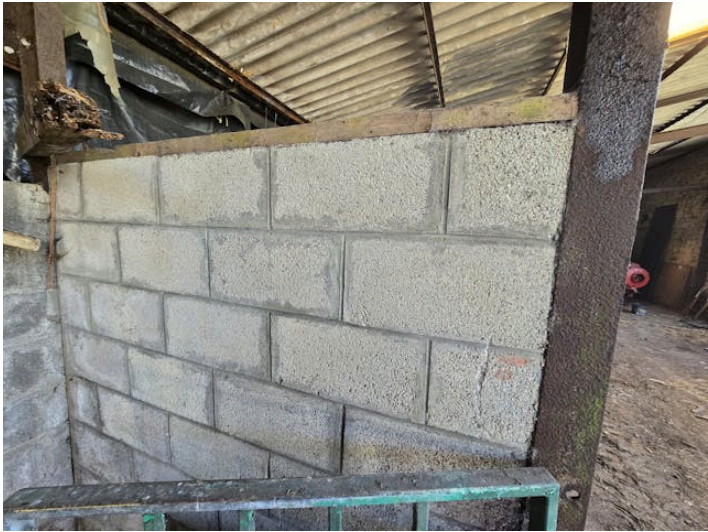
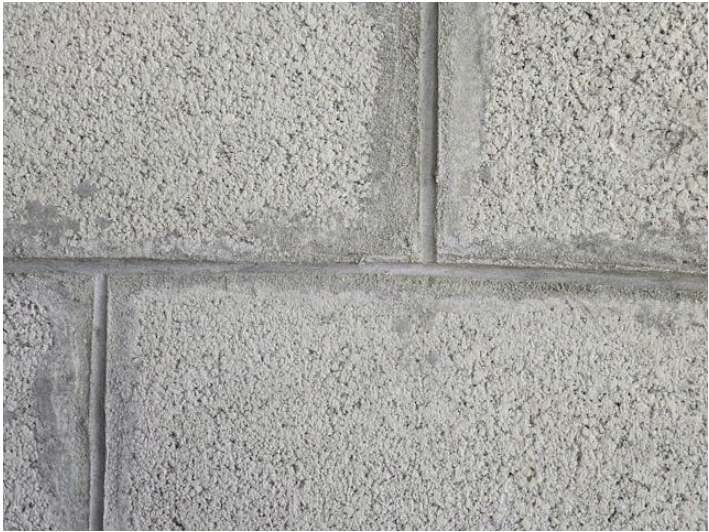
| Location | 04 - Middle Barn | Item | Wall Mortar |

| Material | Composite | Extent | To All Masonry Walls |
| Strategy / Sample Id | Sample / 110354/09 | Fibre Type | NADIS |
| General Comments | Present throughout all buildings. | | |

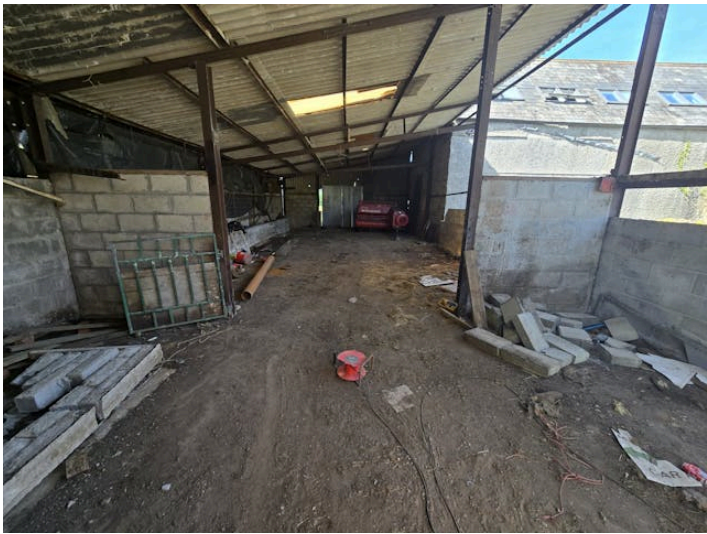
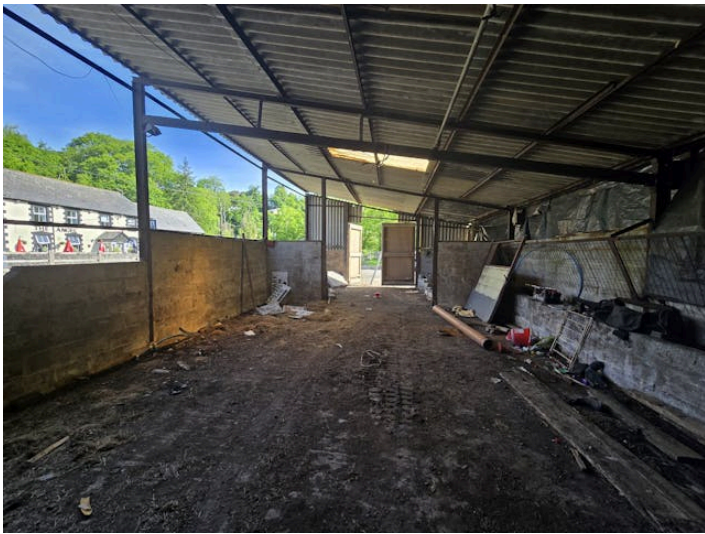
| Location Notes | Cement roof, masonry and cement walls with mortar, concrete floor. Large amount of cement debris present to floor, metal columns, metal beams, PVC sheet skylights, redundant PVC downpipe, wooden doors to front, metal sheet door to rear, wooden panels to wall, MMMF debris to floor, metal framework, modern farming equipment, metal fencing to wall, wooden pallets to wall, general debris throughout, stored items. | | |

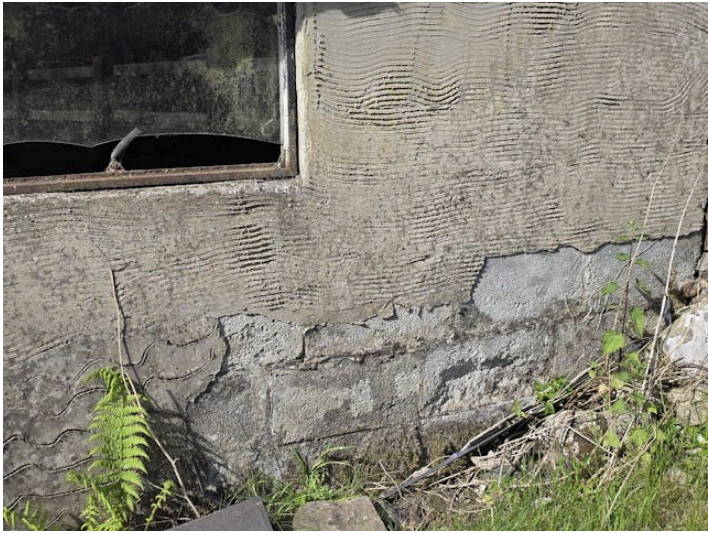
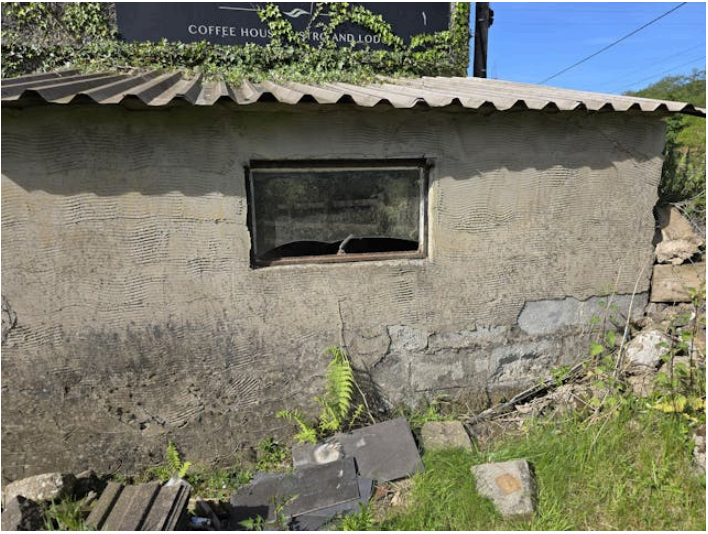
| Location | 02 - Lean-to | Item | Rendering To Wall |

| Material | Composite | Extent | 5 m. sq. |
| Strategy / Sample Id | Sample / 110354/01 | Fibre Type | NADIS |

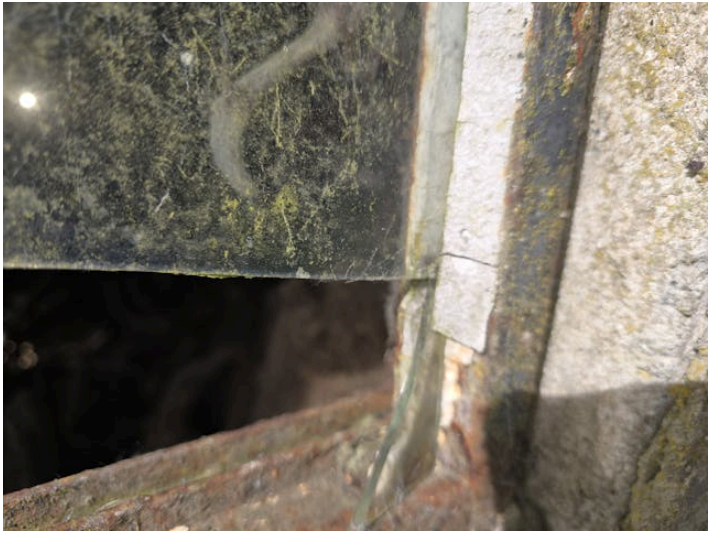
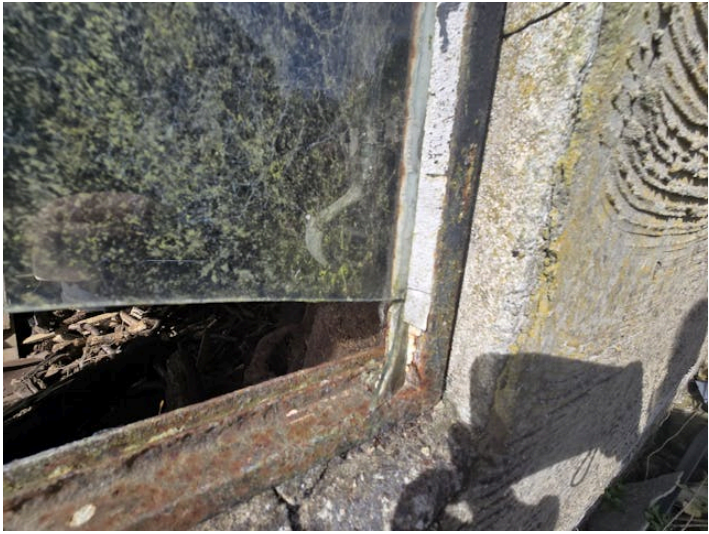
| Location | 02 - Lean-to | Item | Window Putty |

| Material | Composite | Extent | 1 Linear Metre |
| Strategy / Sample Id | Sample / 110354/02 | Fibre Type | NADIS |

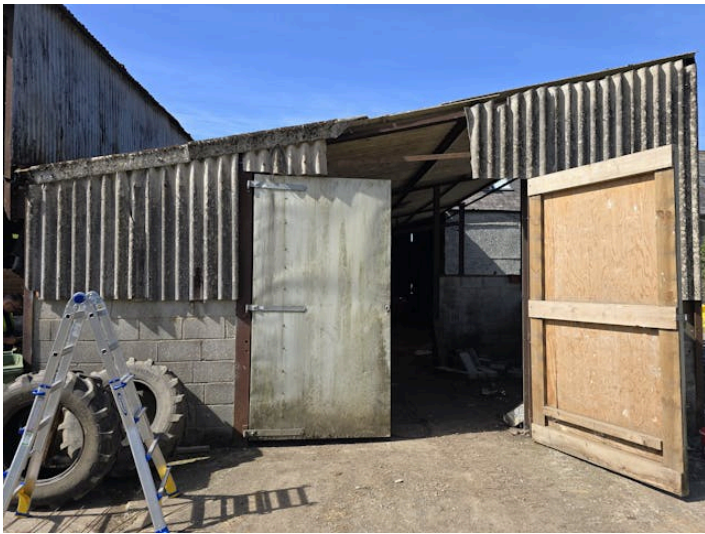
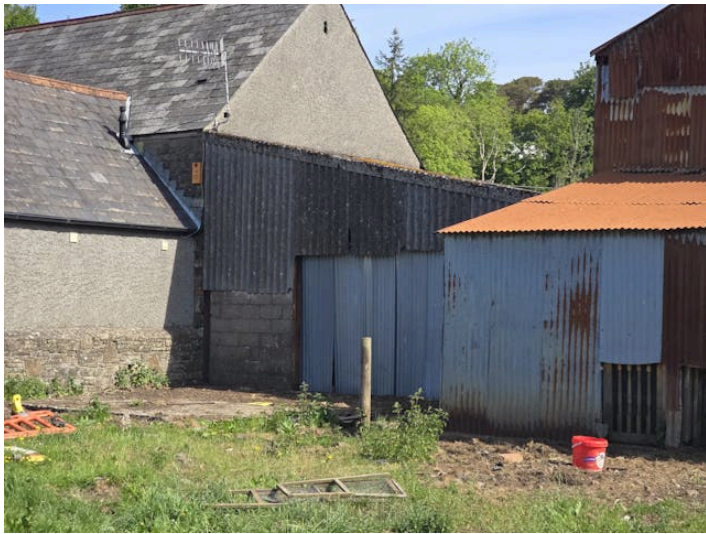
| | | Cement roof, masonry and cement walls with mortar, cement barge boards, PVC watergoods, wooden doors to front, metal columns, cement debris to entrance and local area, no DPC visible, wooden panels to wall, metal sheets to rear. | |

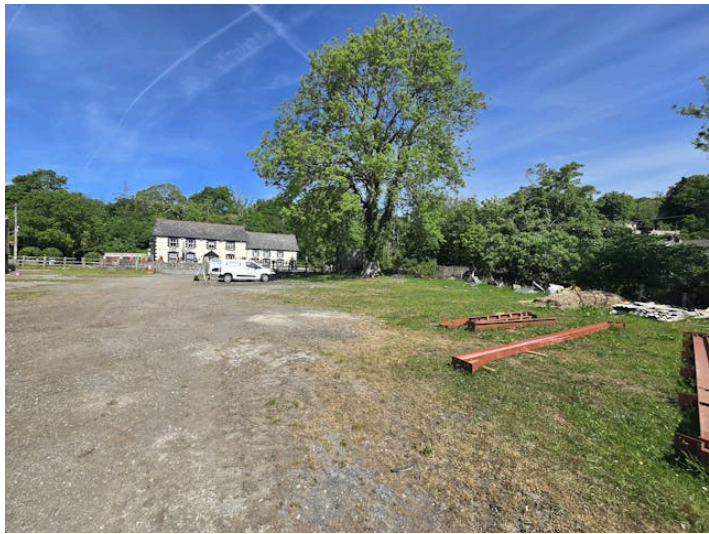
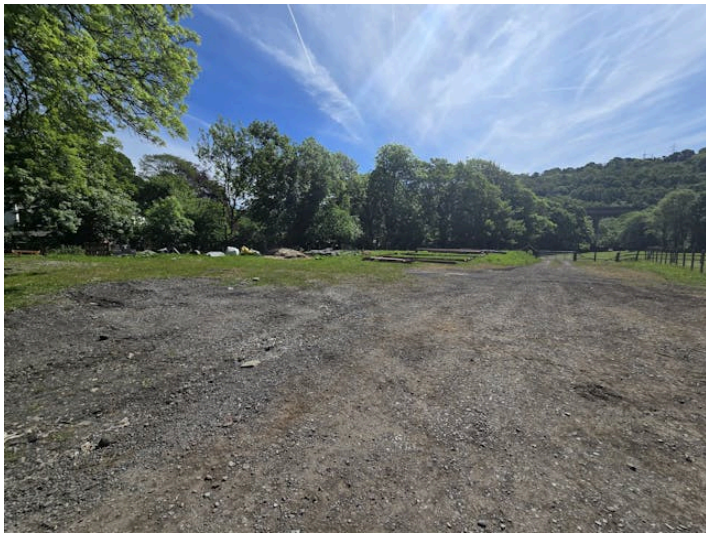
| Location | External Elements | Item | |

- Cement Sheets To Floor / External Elements Externals - This ACM was found on the floor a short distance away from the outbuildings. At the time of inspection these sheets had a high amount of damage. We would recommend that these are removed by a licensed contractor due to the amount present.

| Location Notes | Dirt Floor, vegetation, cement sheets to floor, cement debris to floor, redundant metal beams. | | |
